Fourth Five-Year Review Report

Western Processing Superfund Site

City of Kent
King County, Washington

July 2008

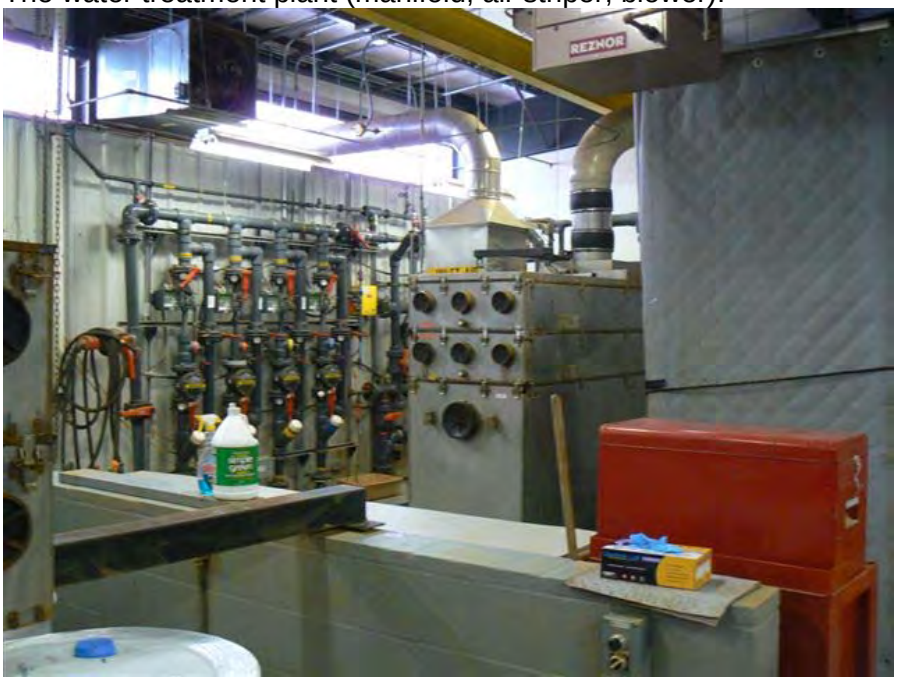
Photo 5: The water treatment plant (manifold, air striper, blower).

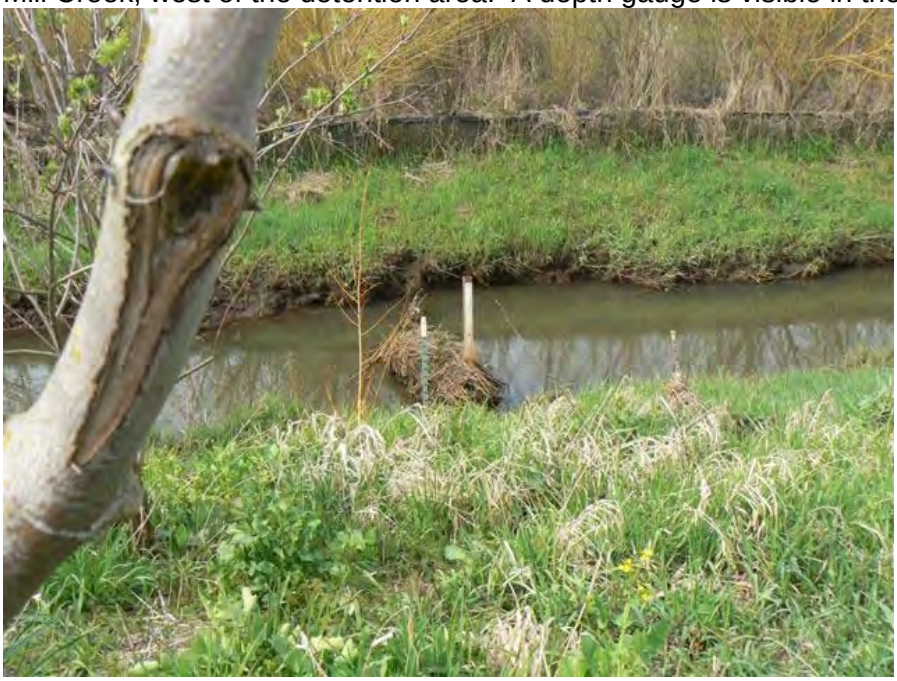
Photo 15: Mill Creek, west of the detention area. A depth gauge is visible in the center.
