SHALLOW SOIL AND SOIL GAS SCREENING CRITERIA EXCEEDANCES
Styrene Finishing Area

Soil and NAPL RI

Del Amo Superfund Site

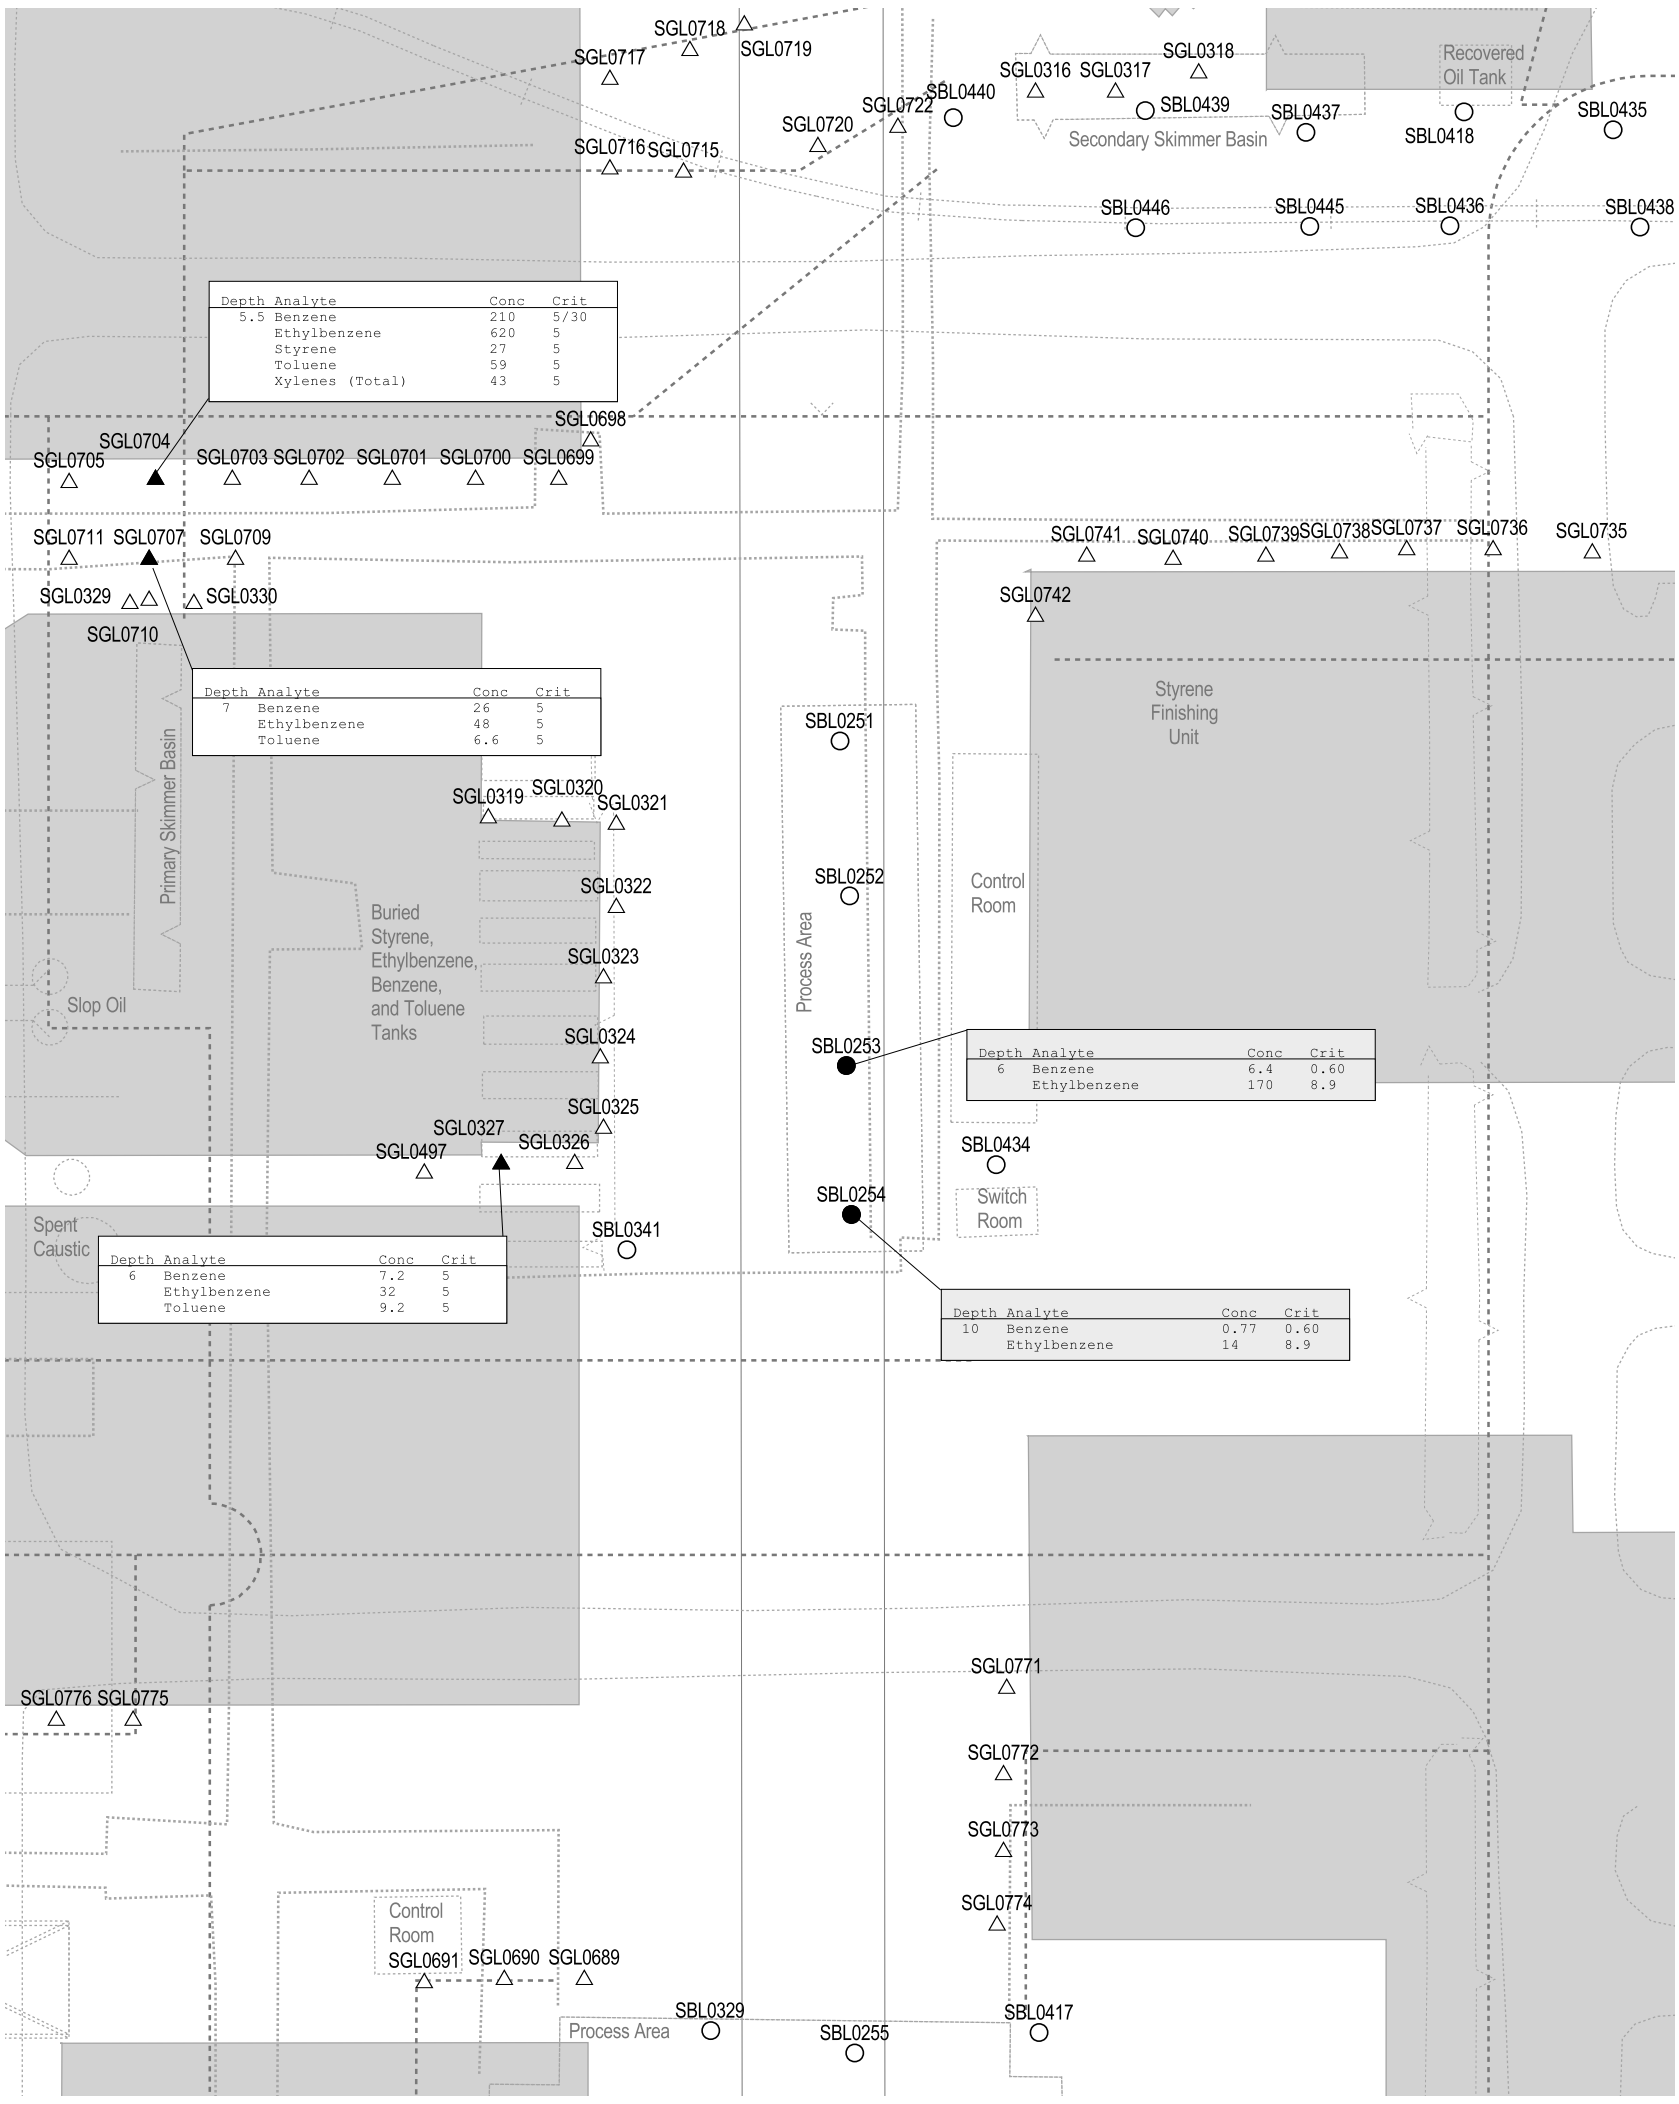
Figure 46

Depth	Analyte	Conc	Crit
5.5	Benzene	210	5/30
	Ethylbenzene	620	5
	Styrene	27	5
	Toluene	59	5
	Xylenes (Total)	43	5

Depth	Analyte	Conc	Crit
7	Benzene	26	5
	Ethylbenzene	48	5
	Toluene	6.6	5

Depth	Analyte	Conc	Crit
6	Benzene	6.4	0.60
	Ethylbenzene	170	8.9

Depth	Analyte	Conc	Crit
6	Benzene	7.2	5
	Ethylbenzene	32	5
	Toluene	9.2	5

Depth	Analyte	Conc	Crit
10	Benzene	0.77	0.60
	Ethylbenzene	14	8.9

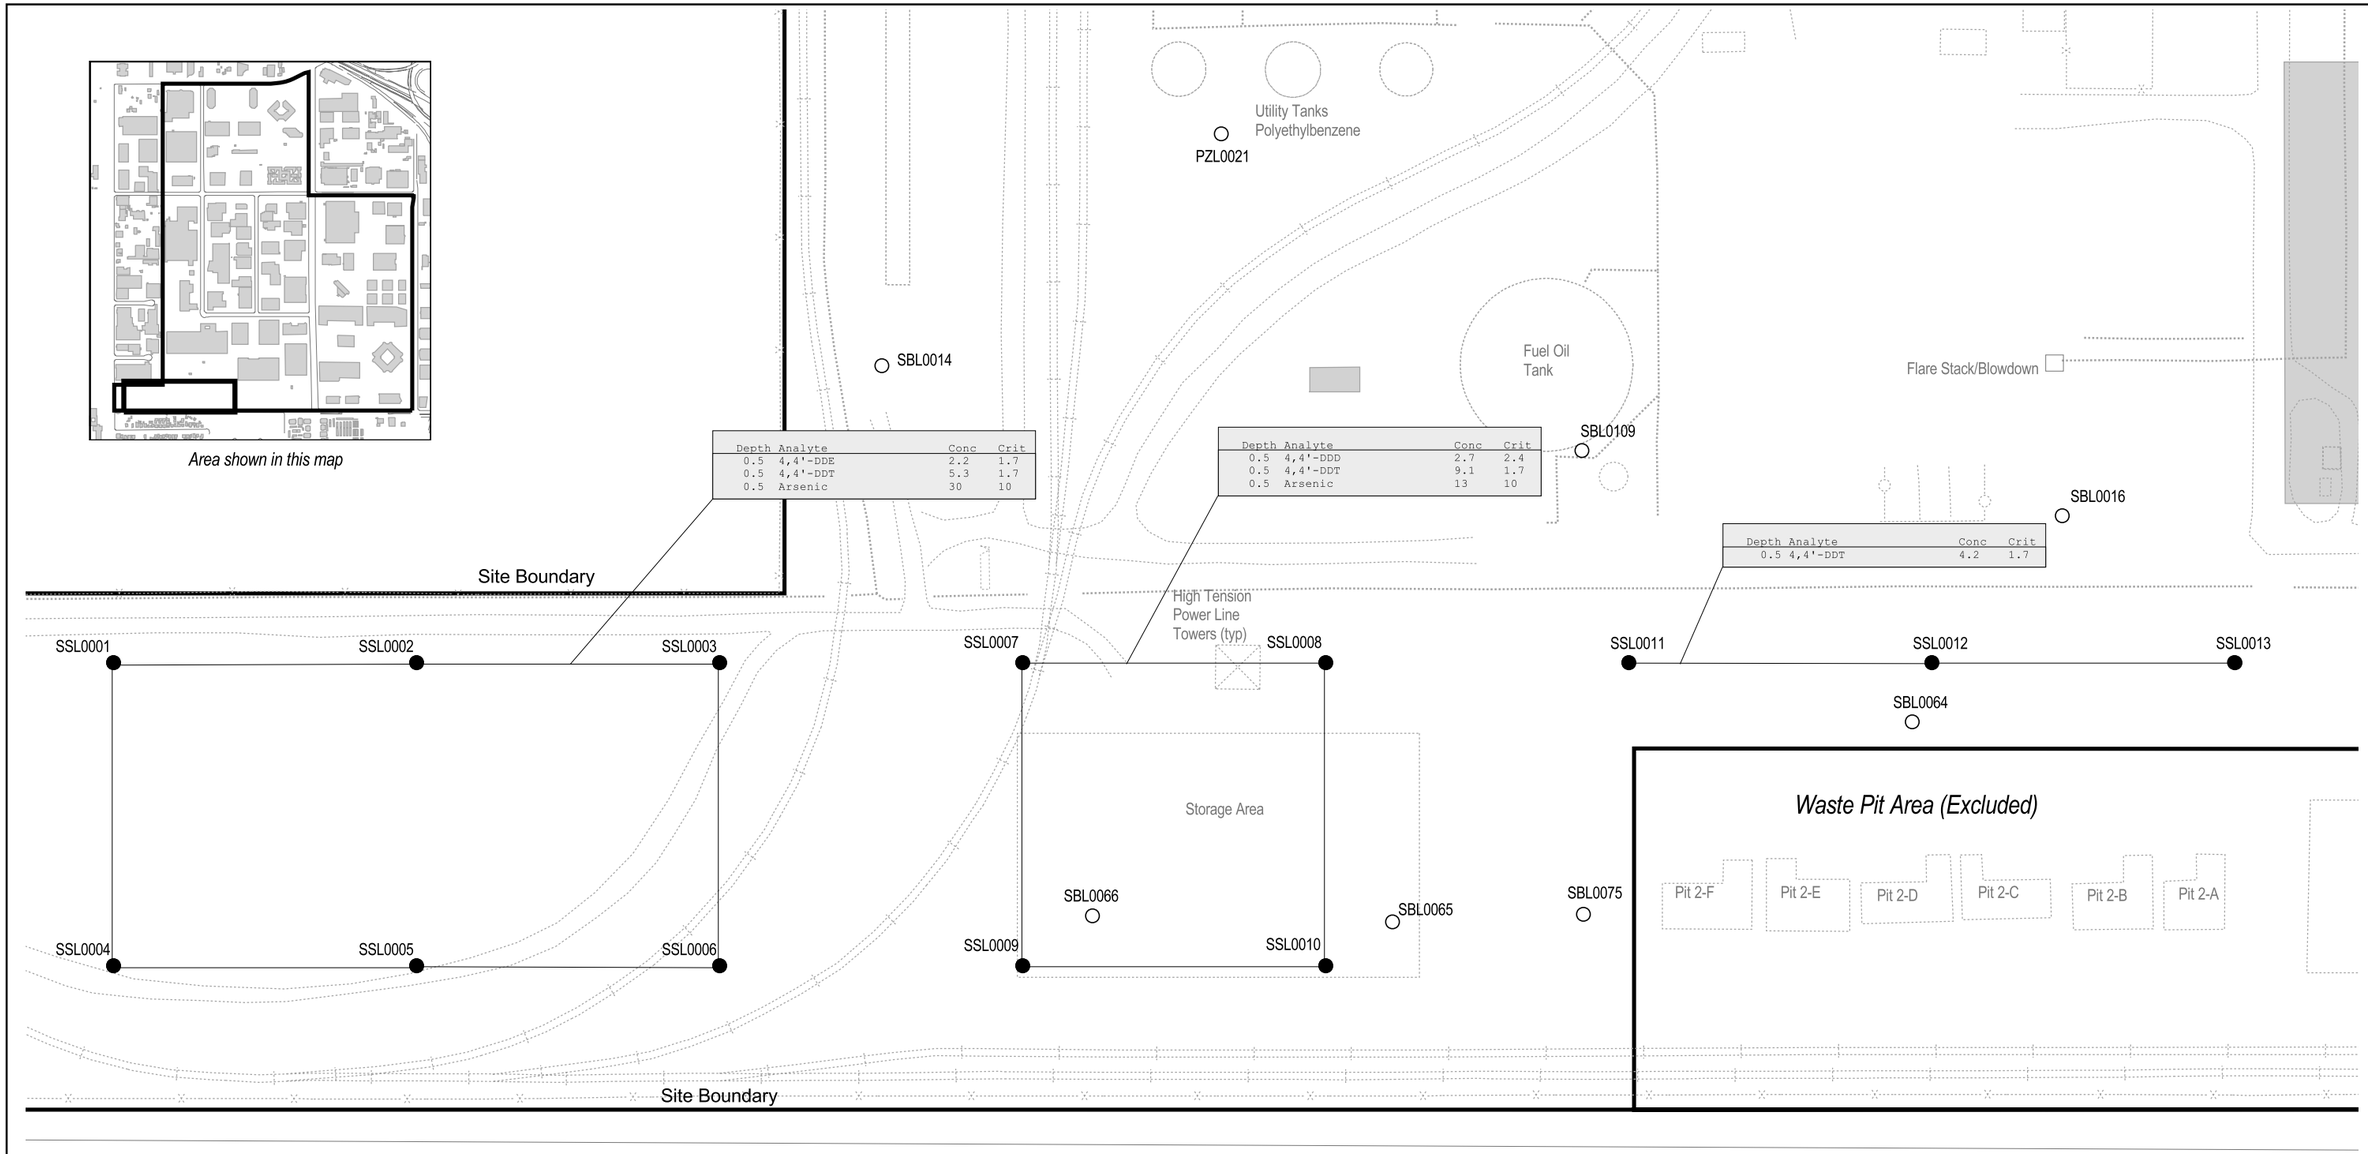
Figure 47

Depth	Analyte	Conc	Crit
0.5	4,4' -DDT	4.2	1.7

SHALLOW SOIL
SCREENING CRITERIA EXCEEDANCES
Southwest Surface Soil Area

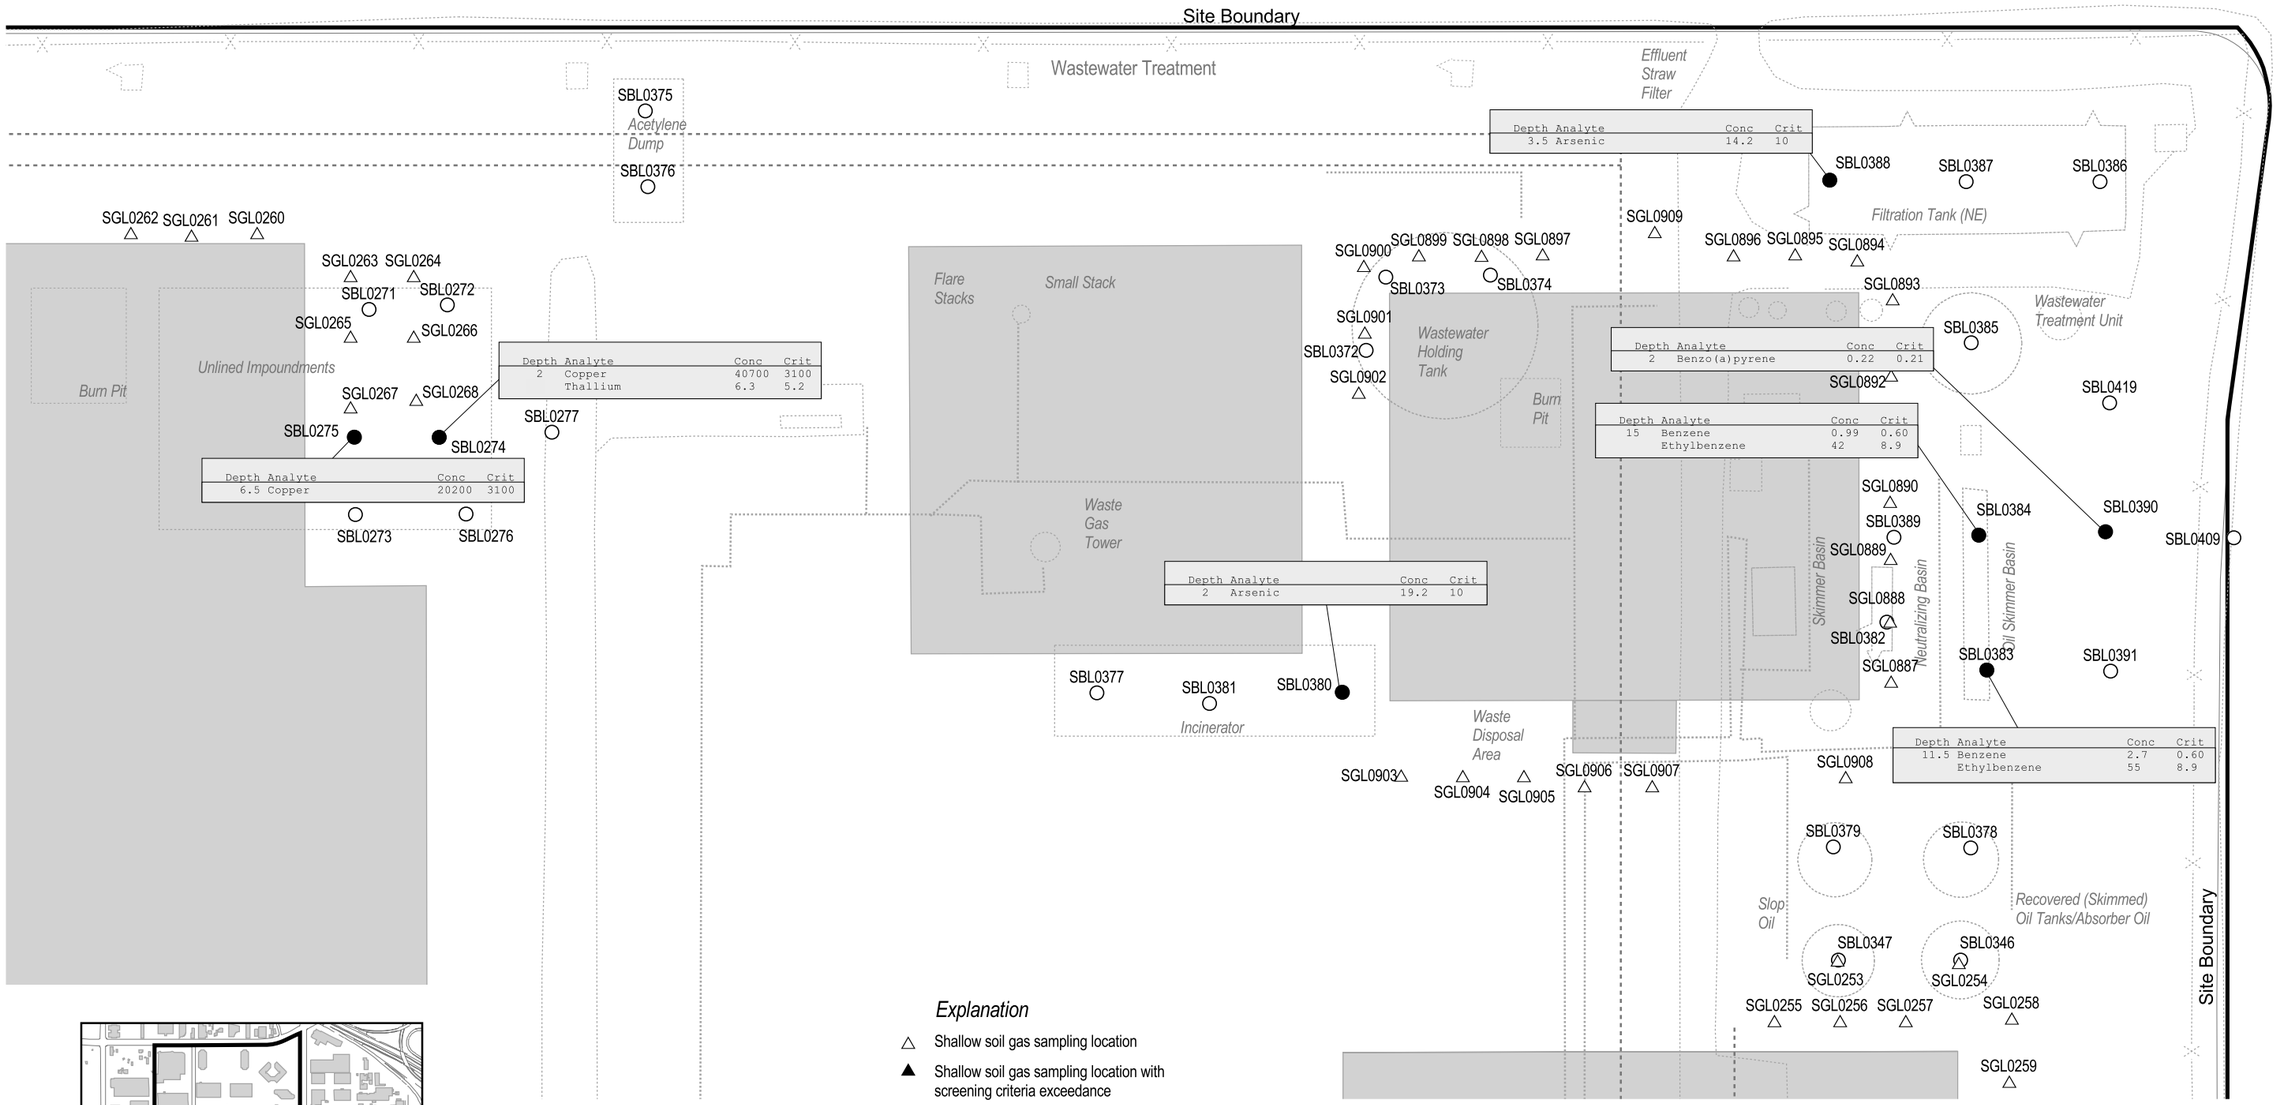
Figure 48

Depth	Analyte	Conc	Crit
2	Arsenic	19.2	10

SHALLOW SOIL AND SOIL GAS SCREENING CRITERIA EXCEEDANCES
Water Treatment Area
Soil and NAPL RI
Del Amo Superfund Site

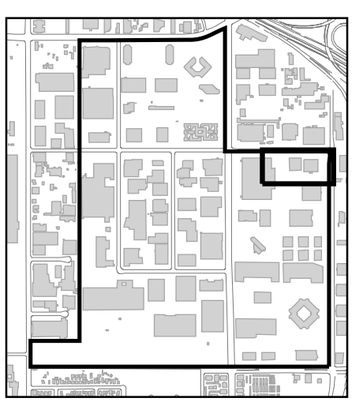
Note: Chemical concentrations at the depicted soil gas sampling locations did not exceed screening criteria. See Section 5 and Table 10 for further explanation of screening criteria.

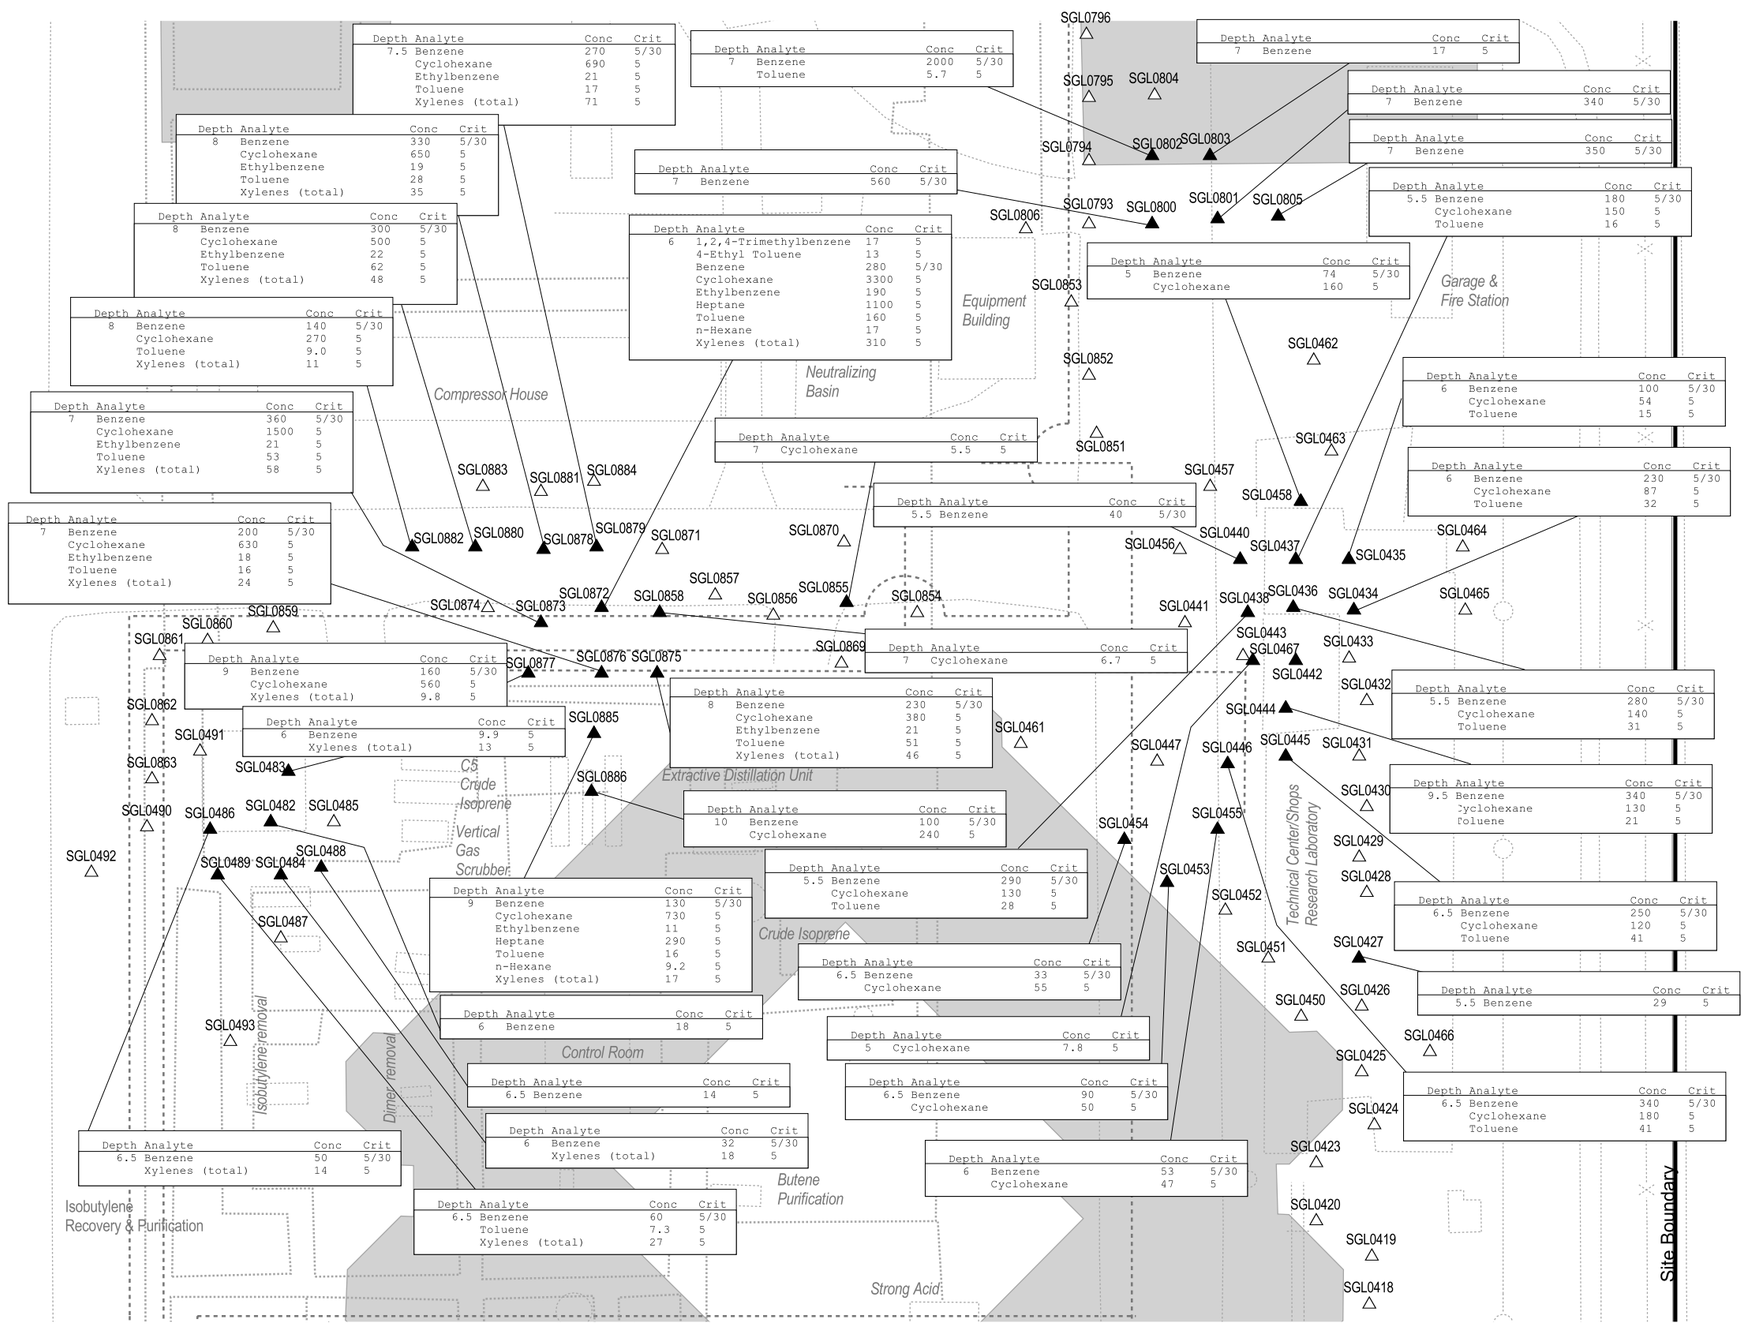
Figure 49

Depth	Analyte	Conc	Crit
7	Benzene	17	5

SHALLOW SOIL GAS SCREENING CRITERIA EXCEEDANCES
Laboratory/Pipelines Area
Soil and NAPL RI
Del Amo Superfund Site

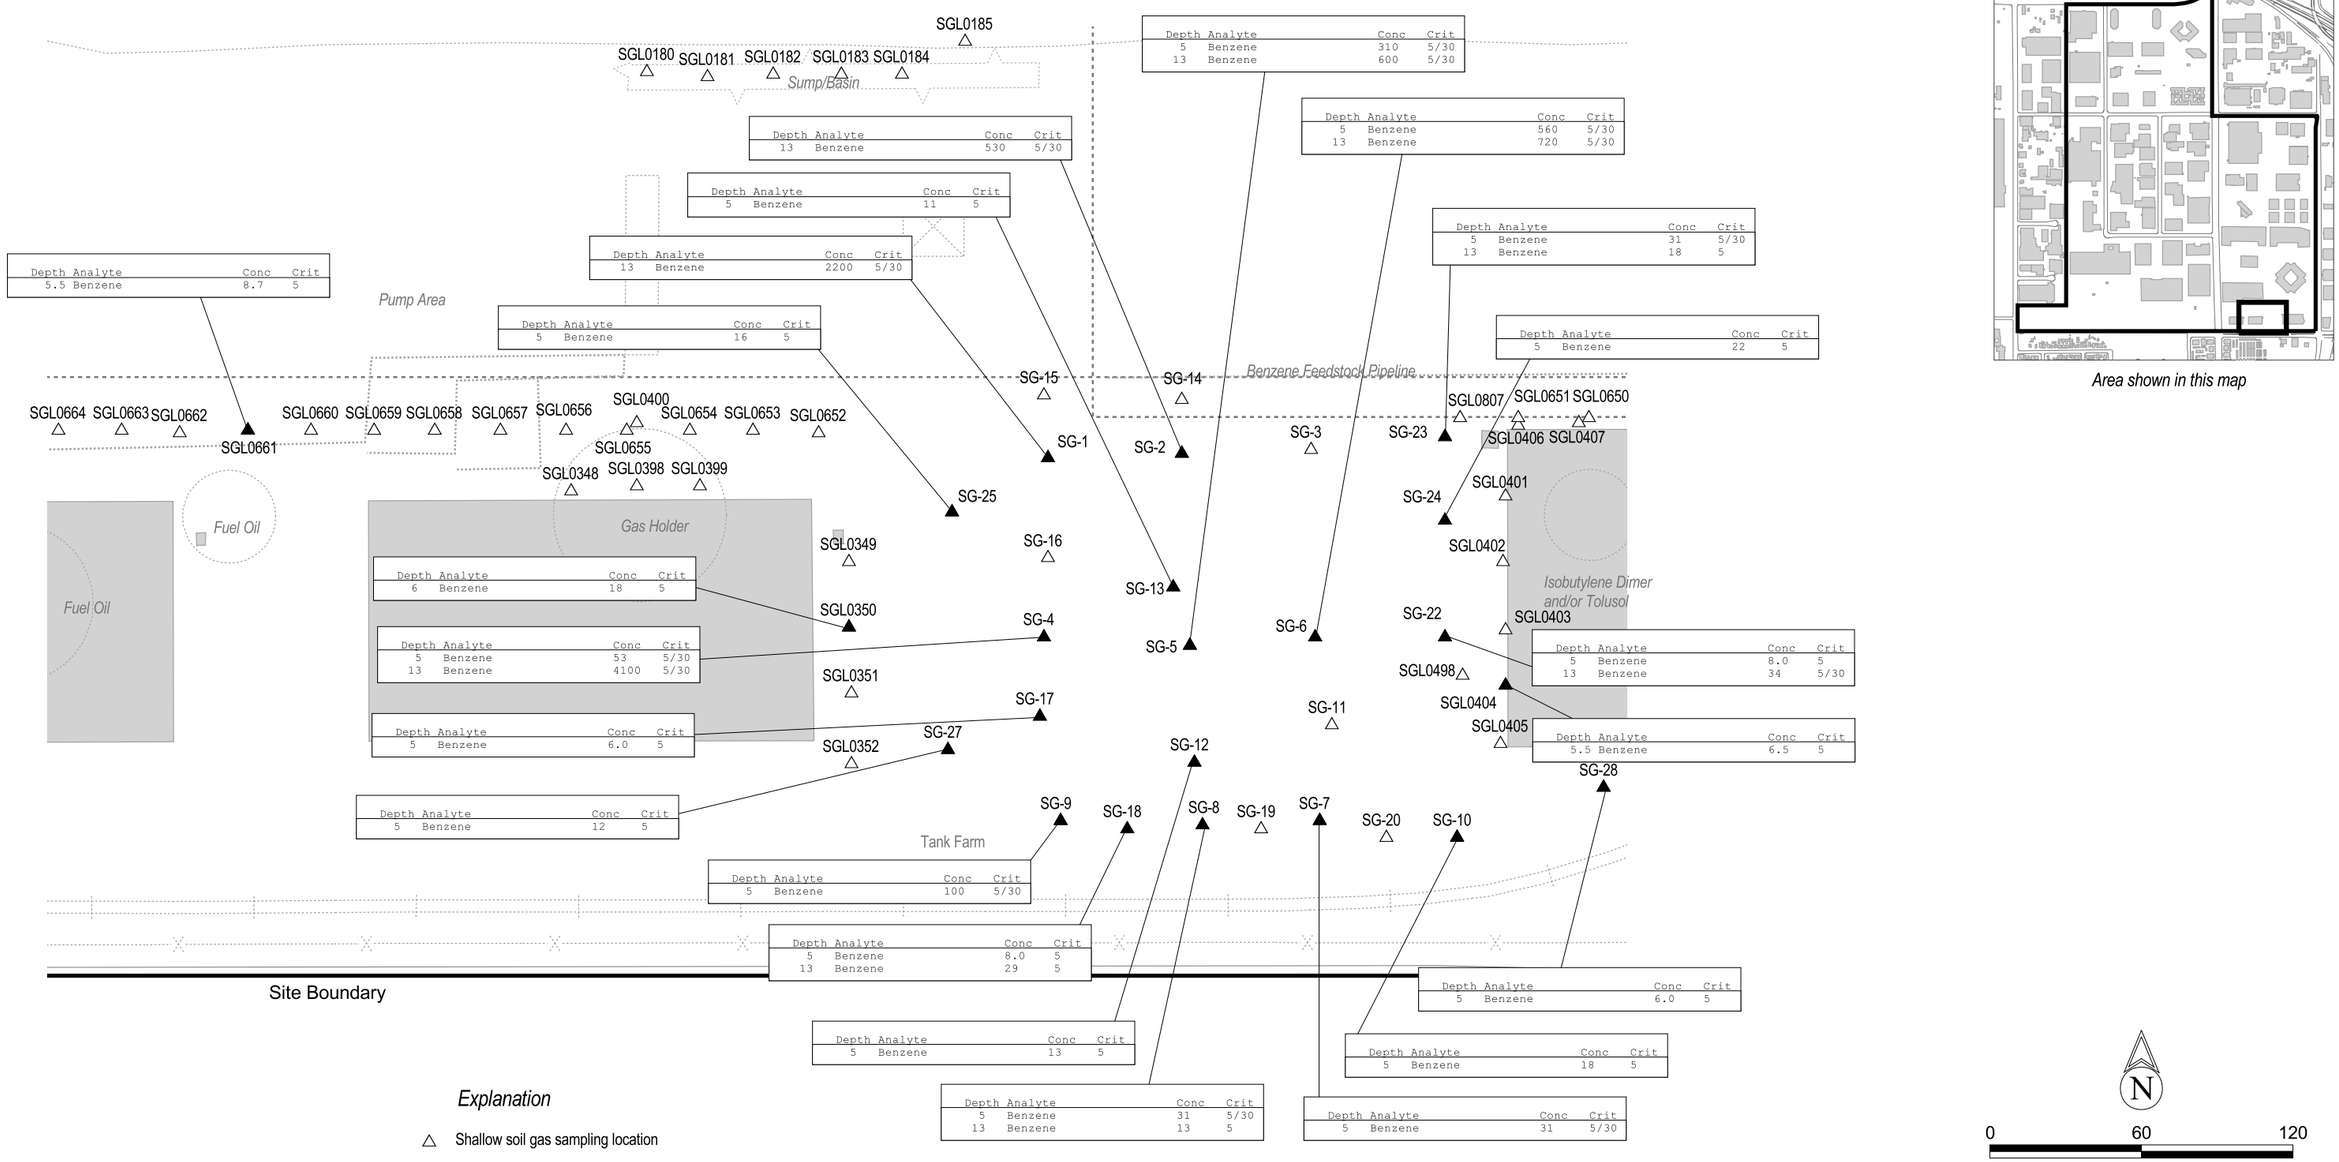
Figure 51

SHALLOW SOIL GAS SCREENING CRITERIA EXCEEDANCES
Benzene Feedstock Pipeline
Soil and NAPL RI
Del Amo Superfund Site

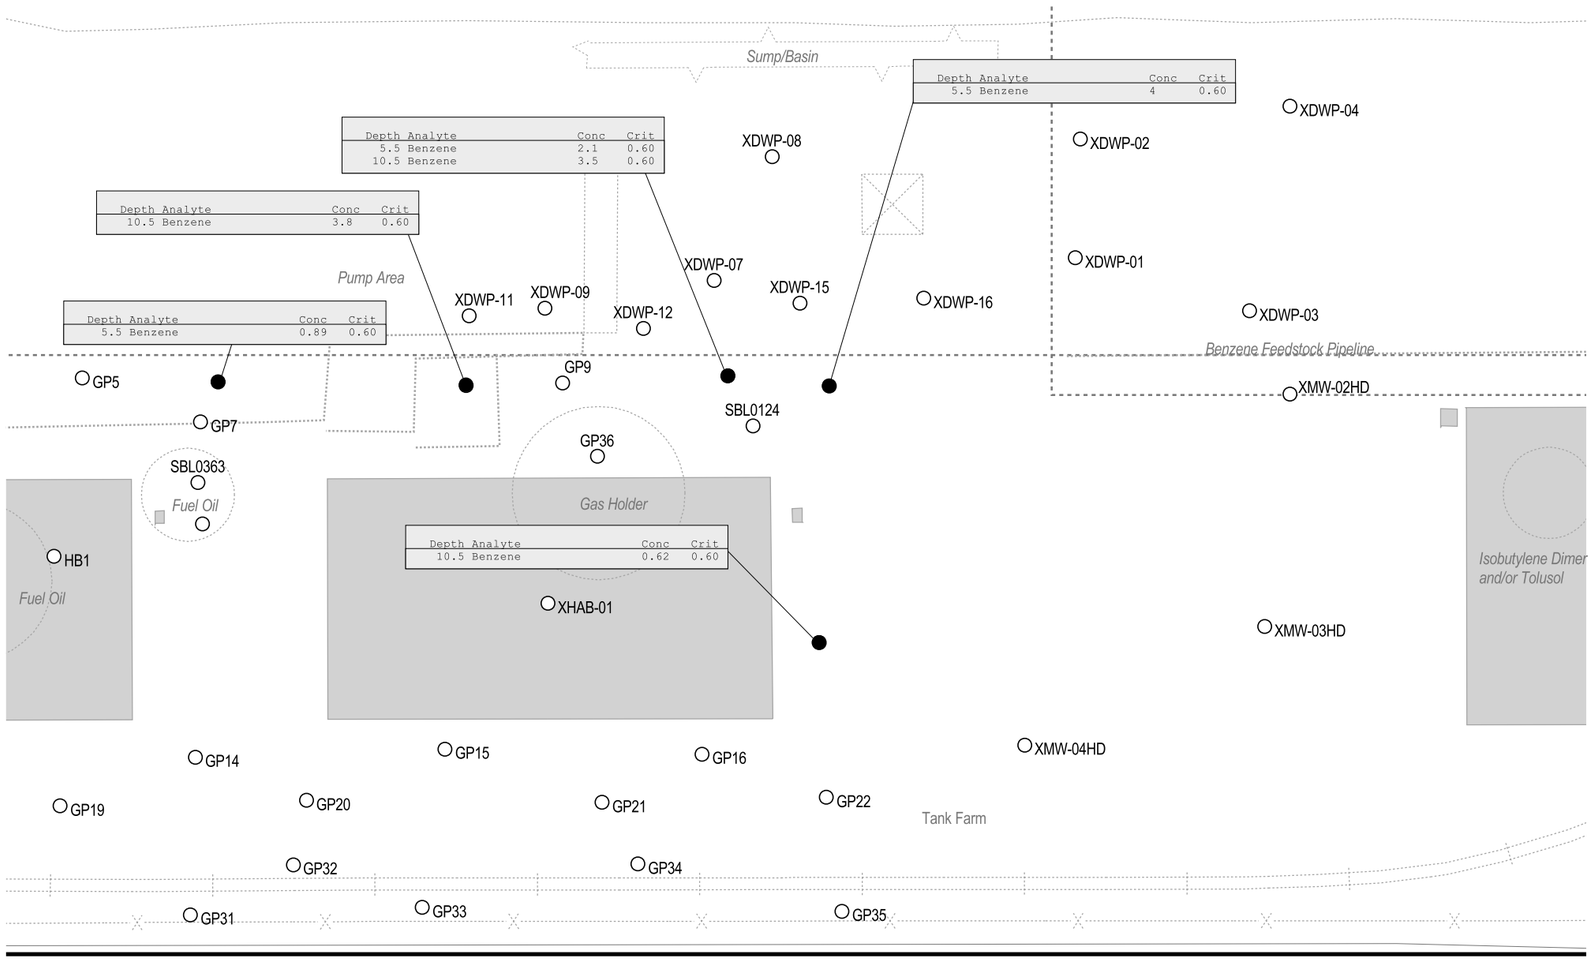
Figure 52

Depth	Analyte	Conc	Crit
5.5	Benzene	4	0.60

SHALLOW SOIL SCREENING CRITERIA EXCEEDANCES
Benzene Feedstock Pipeline
