FIGURE 2
MERCURY, METHYL MERCURY AND TRACE MERCURY IN SOIL, SEDIMENT, SURFACE WATER, AND SEEPS
PHASE 2 REMEDIAL INVESTIGATION
KLAU AND BUENA VISTA MINES
SAN LUIS OBISPO COUNTY, CALIFORNIA

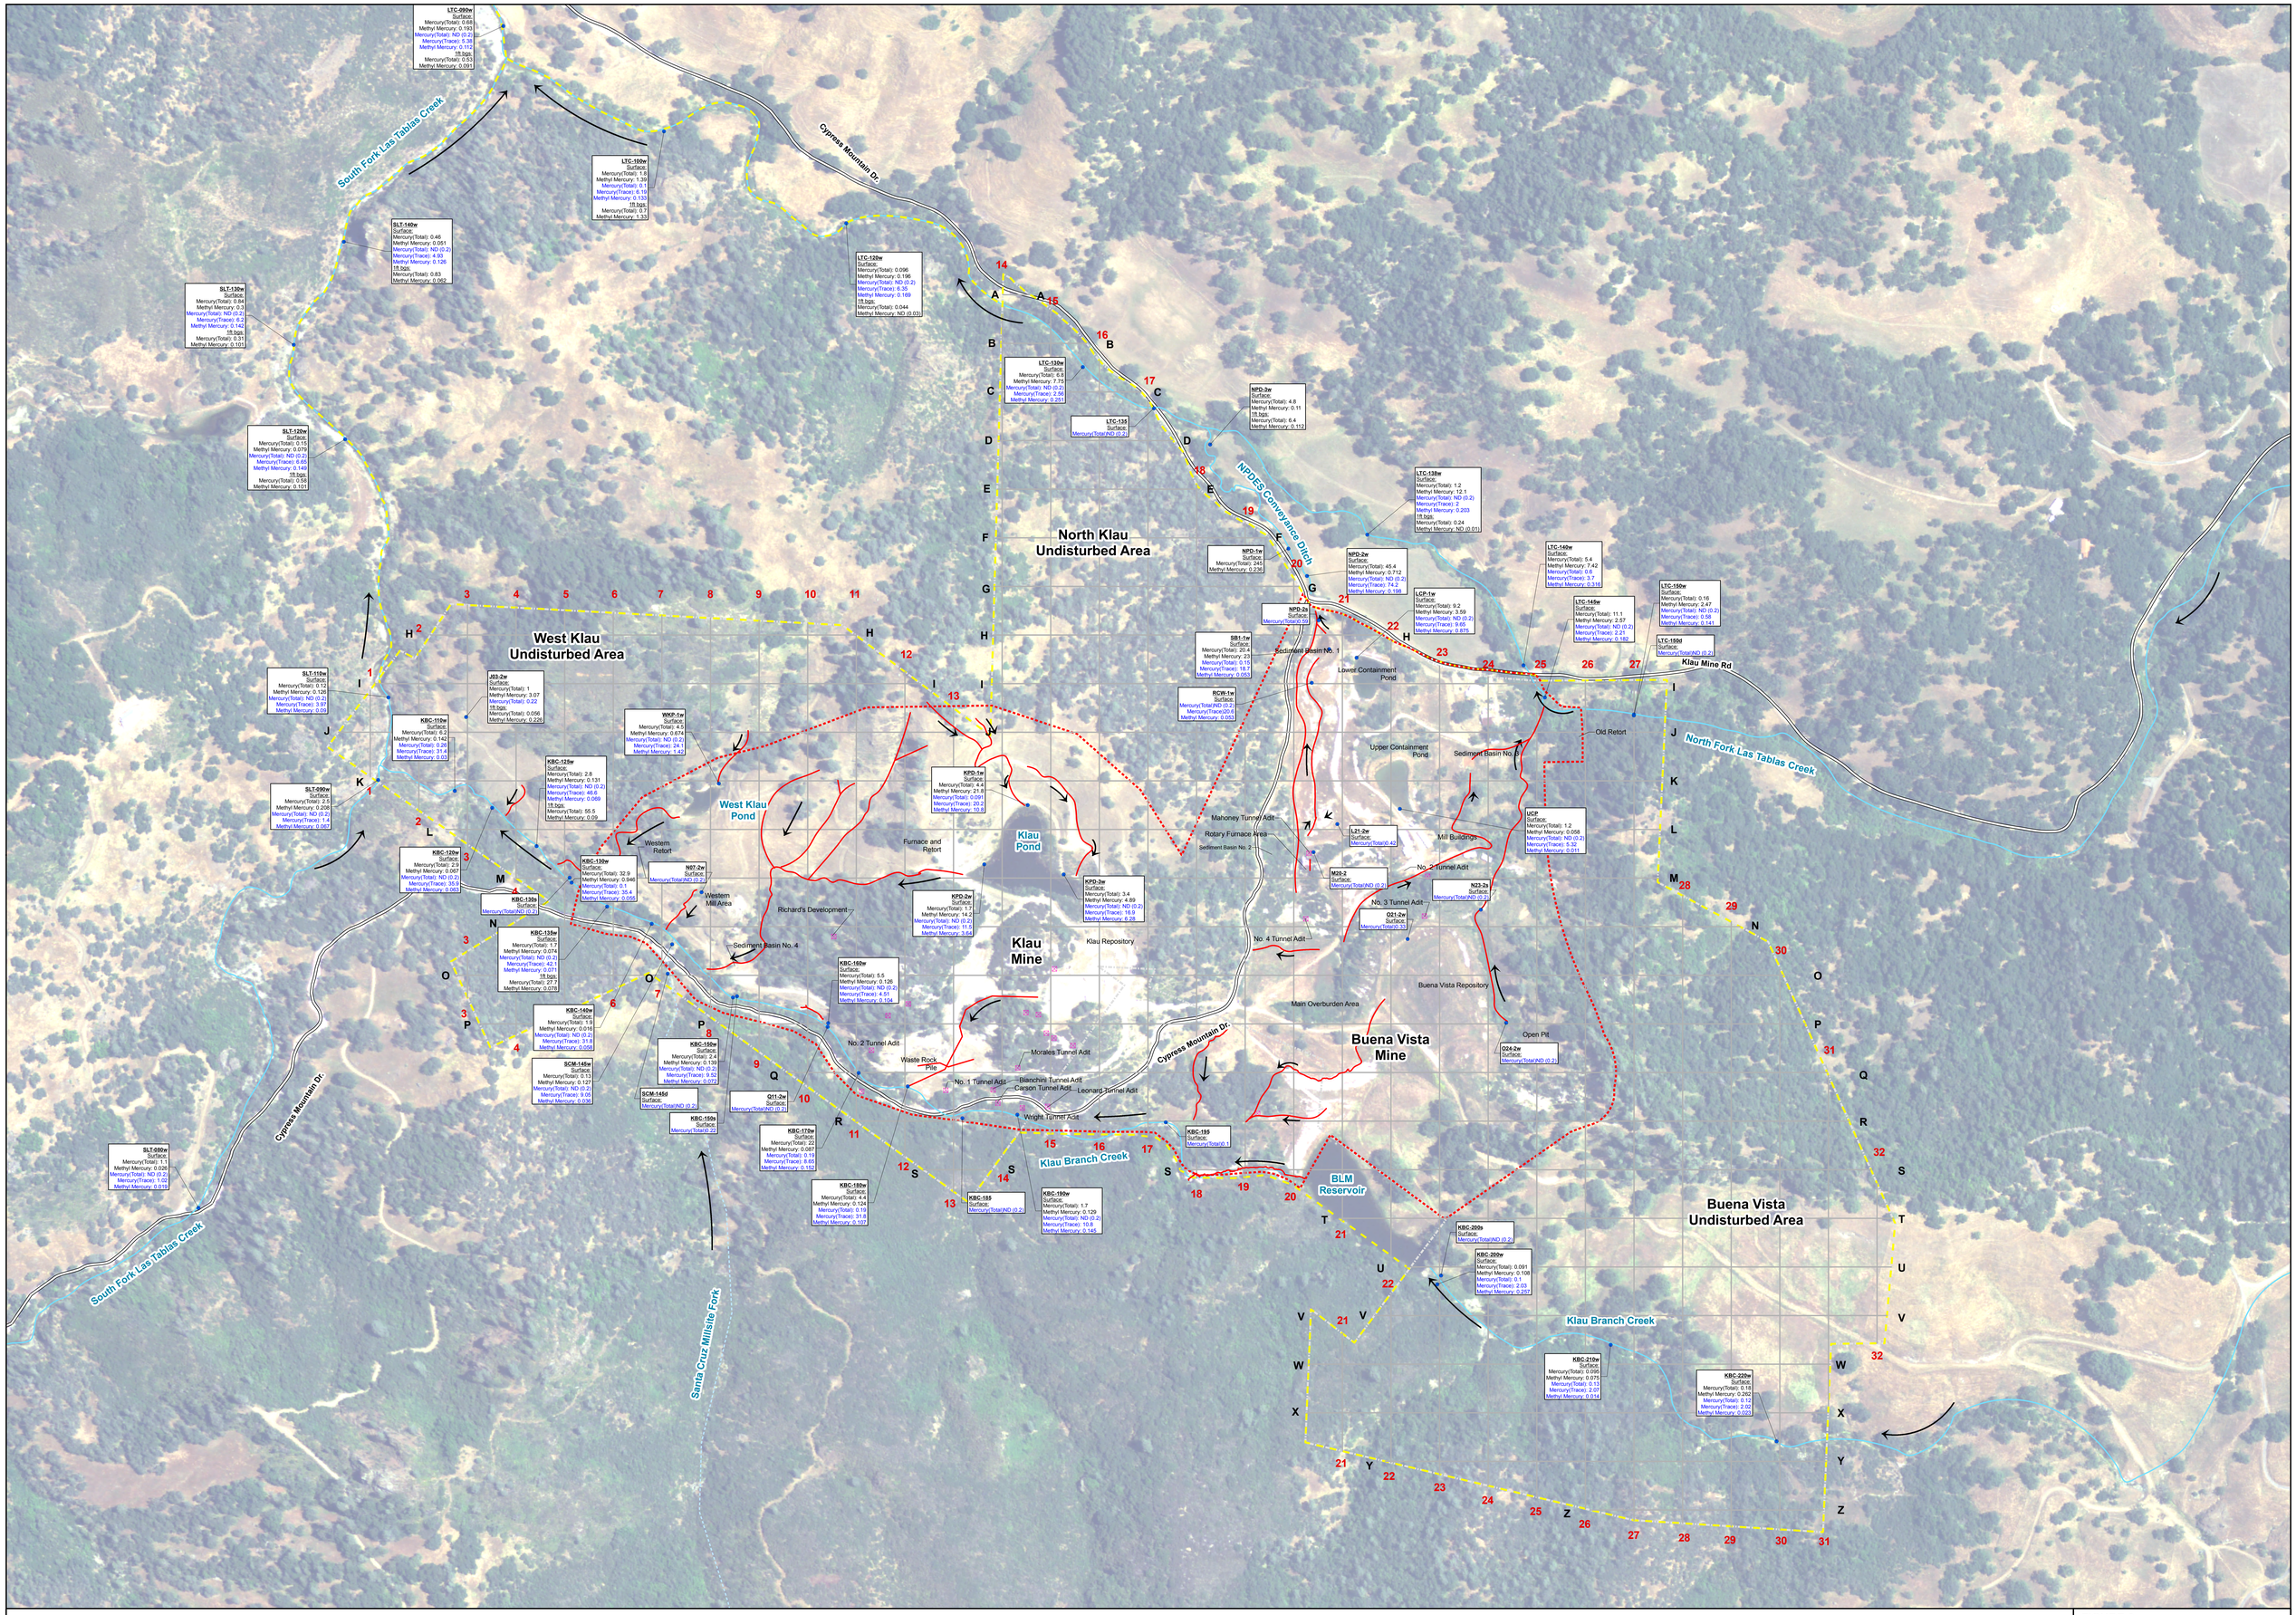
LocID:	LTC-138w
Result @ Surface:	Surface:
Total Mercury in Soil (mg/kg):	Mercury(Total): 1.2
Methyl Mercury in Soil (ng/kg):	Methyl Mercury: 12.1
Total Mercury in Water (µg/L):	Mercury(Total): ND (0.2)
Trace Mercury in Water (ng/L):	Mercury(Trace): 2
Methyl Mercury in Water (ng/L):	Methyl Mercury: 0.203
Result @ 1 ft. BGS:	18 bgs:
Total Mercury in Soil (mg/kg):	Mercury(Total): 0.24
Methyl Mercury in Soil (ng/kg):	Methyl Mercury: ND (0.01)
