# FOURTH FIVE-YEAR REVIEW REPORT FOR

# UNITED HECKATHORN SUPERFUND SITE

# RICHMOND, CONTRA COSTA COUNTY, CALIFORNIA

# Executive Summary

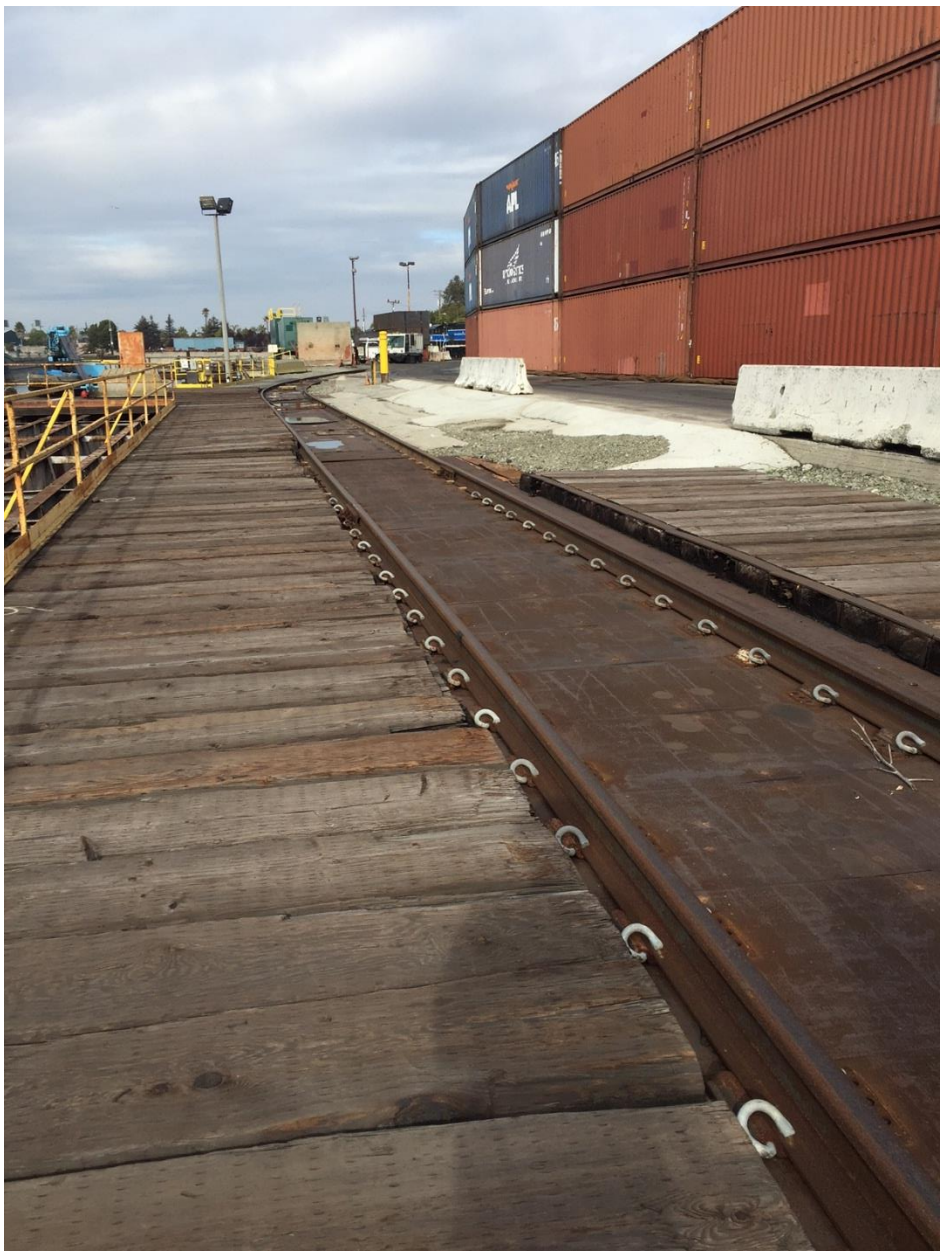
Photo 7. Railroad, Gravel Cap, Asphalt Cap, and  Stormwater Treatment system looking north

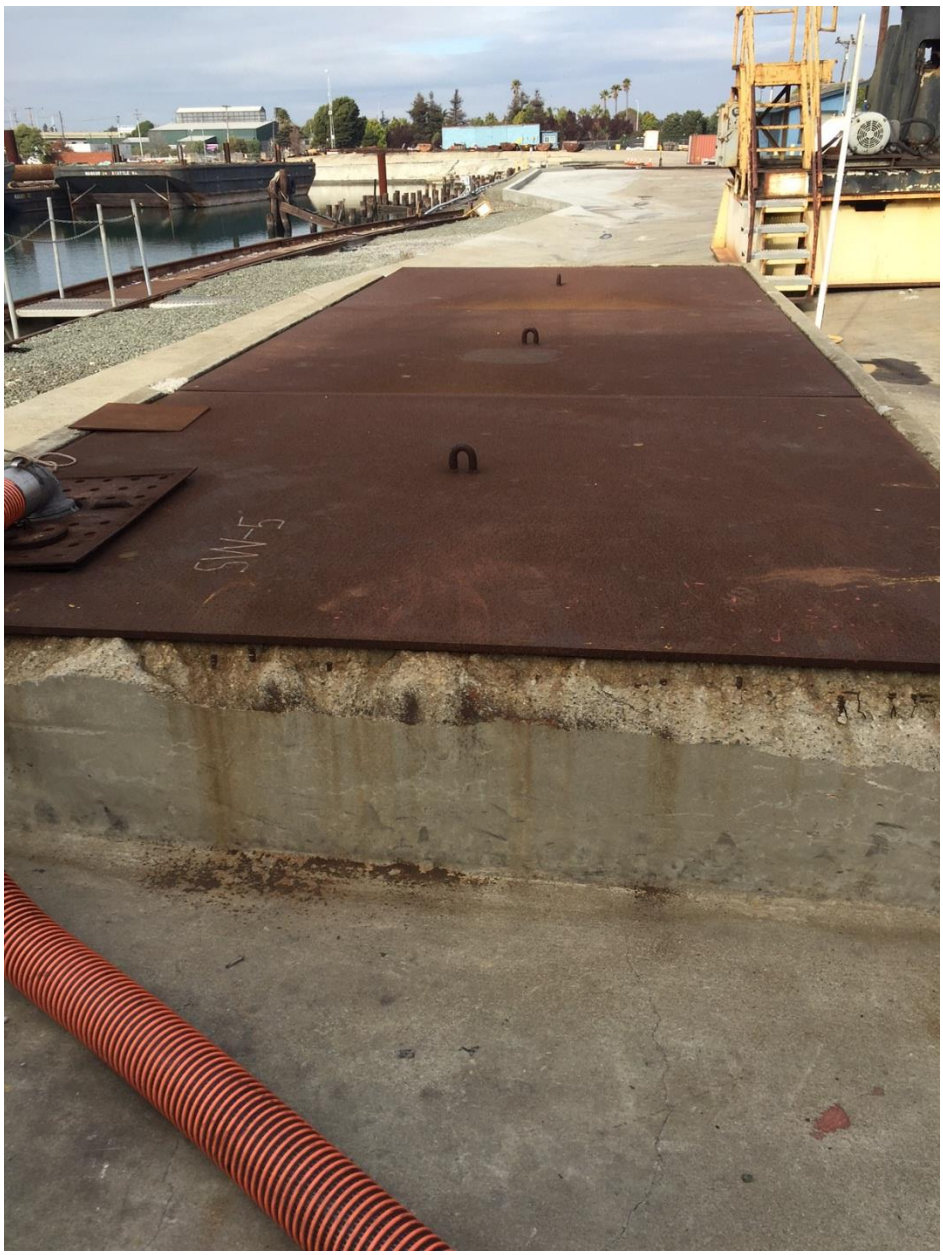
Photo 13. Interceptor SW-5, looking north

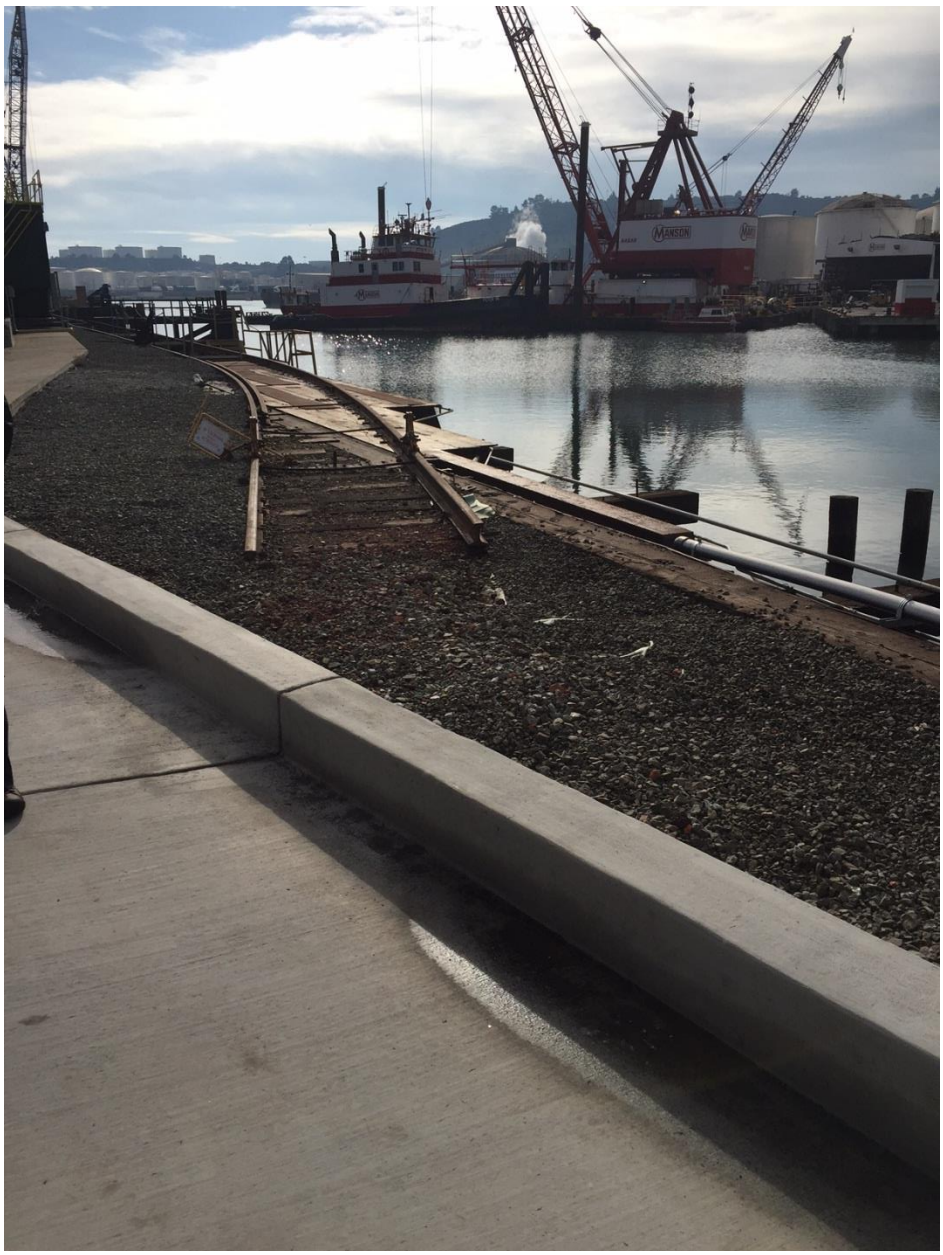
Photo 16. New Cap, Gravel Cap, Railroad Tracks looking south
