Subject: Monthly Landfill Gas Monitoring Letter Report for May 2015
Post-Removal Action, Parcel E-2 Industrial Landfill
Hunters Point Naval Shipyard, San Francisco, California
Contract Number N62473-09-D-2626
Contract Task Order 0007

Monthly Landfill Gas Monitoring Report
Hunters Point Naval Shipyard
San Francisco, California

FIGURE 1
Site Map and
Landfill Gas Monitoring Locations

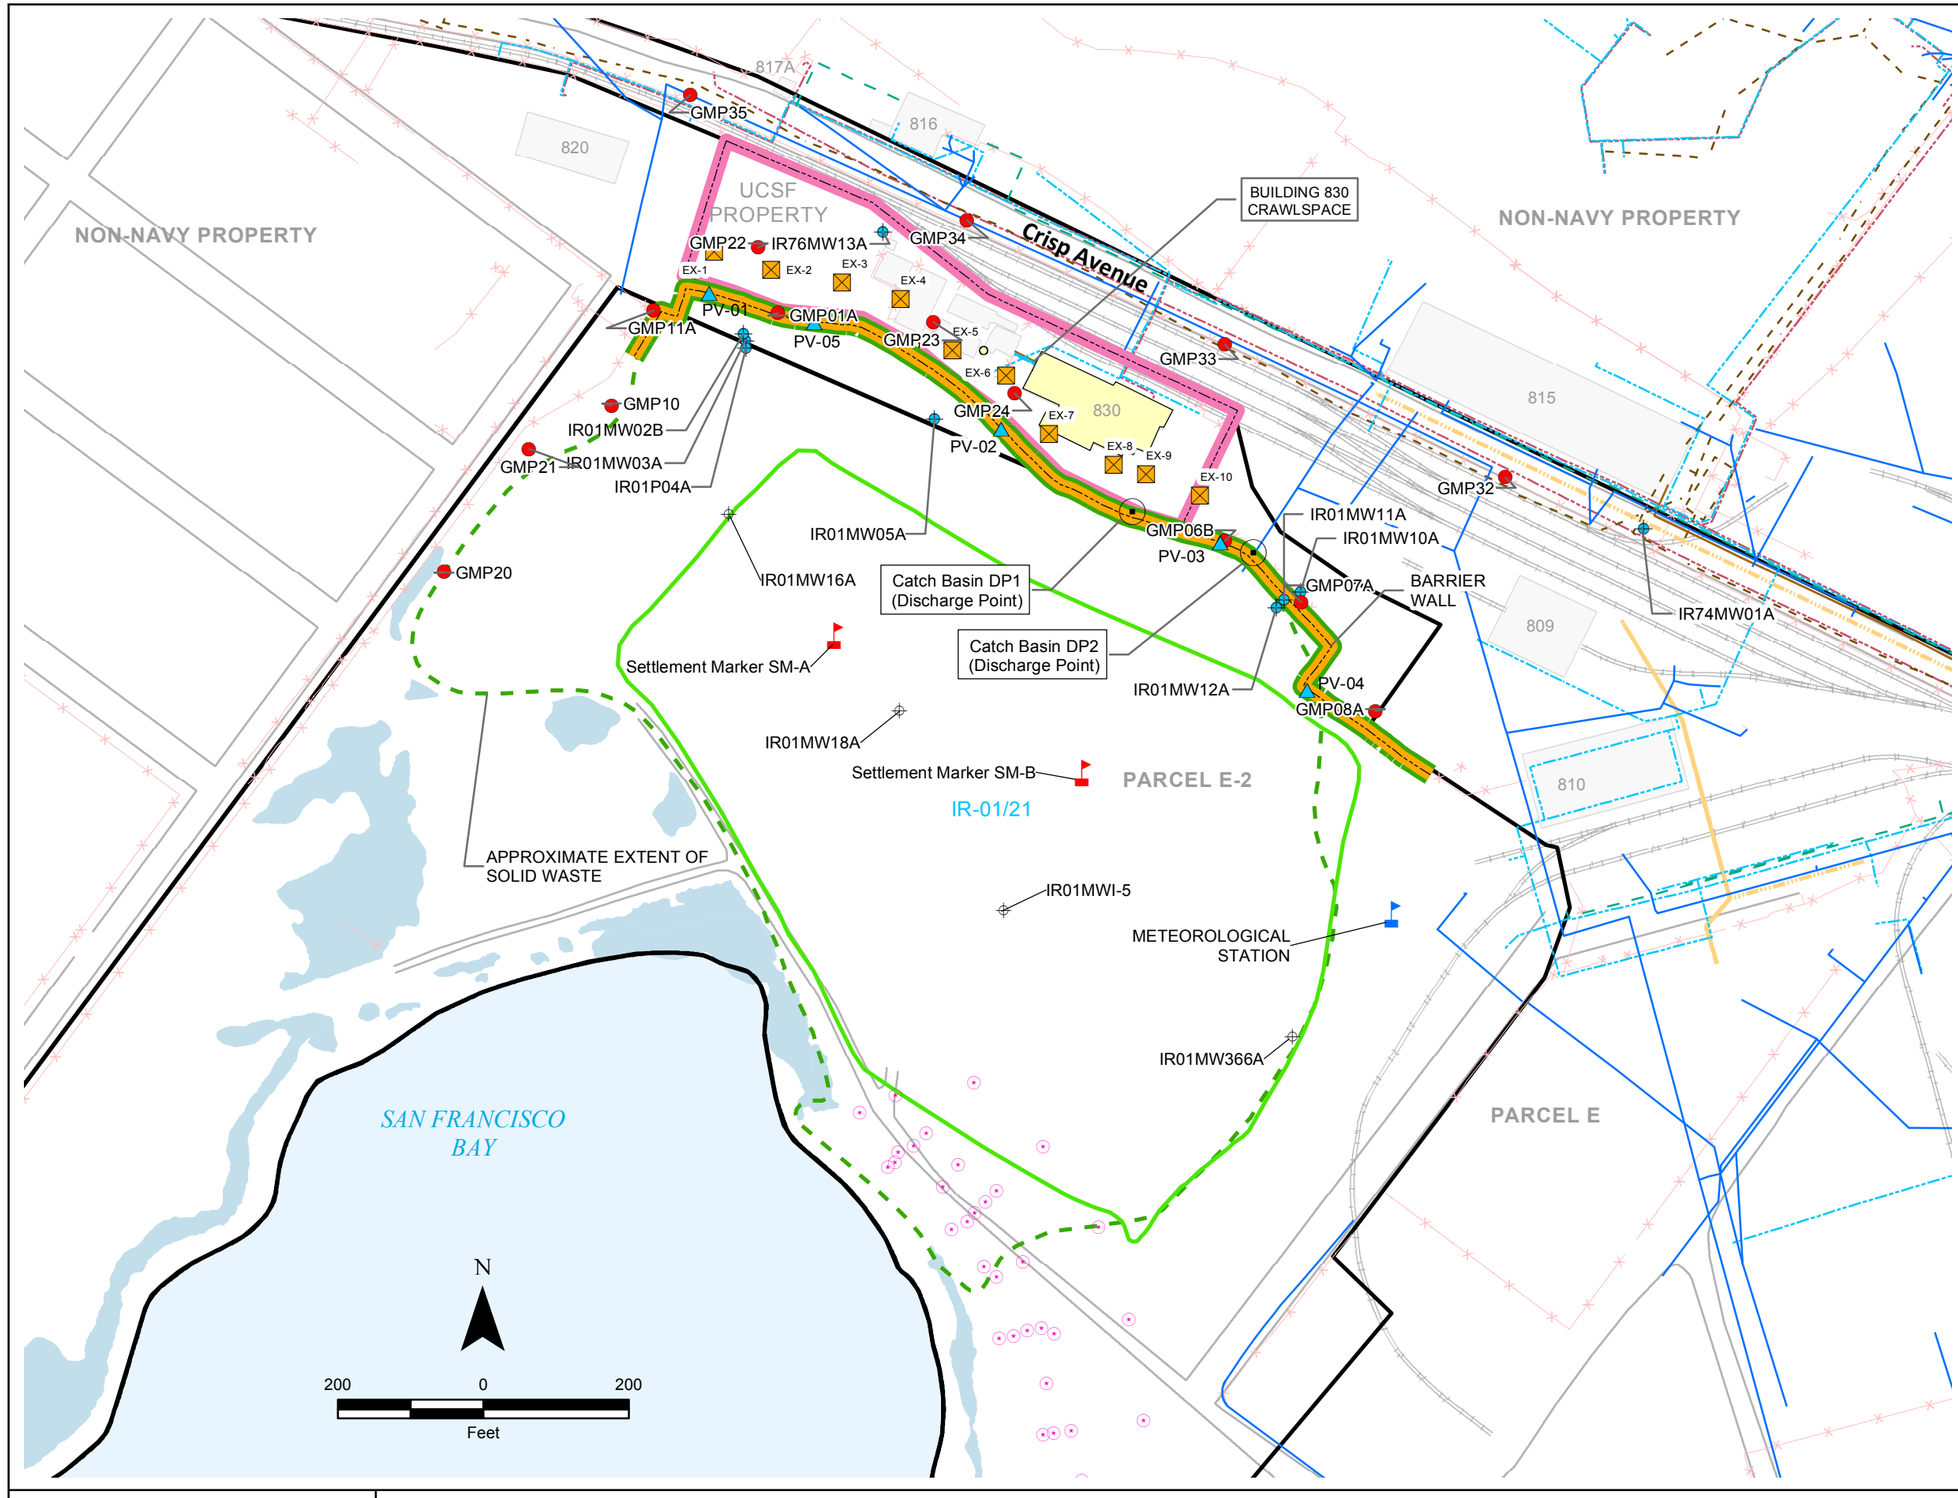
The routine monthly landfill gas monitoring event at Parcel E-2 was performed on Thursday, May 21, 2015. For this event, monitoring via GEM-2000 landfill gas analyzer and photo-ionization detector was performed at gas monitoring probe locations GMP08A, GMP23 and GMP24. GMP08A is located along the fence line of the perimeter of the landfill while GMP23 and GMP24 are located within the UCSF compound as shown on Figure 1.

- Methane was detected by the field monitoring equipment in GMP08A, GMP23, and GMP24 at 0.0%, 0.3%, and 1.5% by volume in air, respectively.

Since all methane readings were below the action levels during this monitoring period, no further action is required.
