FIGURE 2
MERCURY CONCENTRATIONS IN SOIL AND SEDIMENT

PHASE 1 REMEDIAL INVESTIGATION
KLAU AND BUENA VISTA MINES
SAN LUIS OBISPO COUNTY, CALIFORNIA

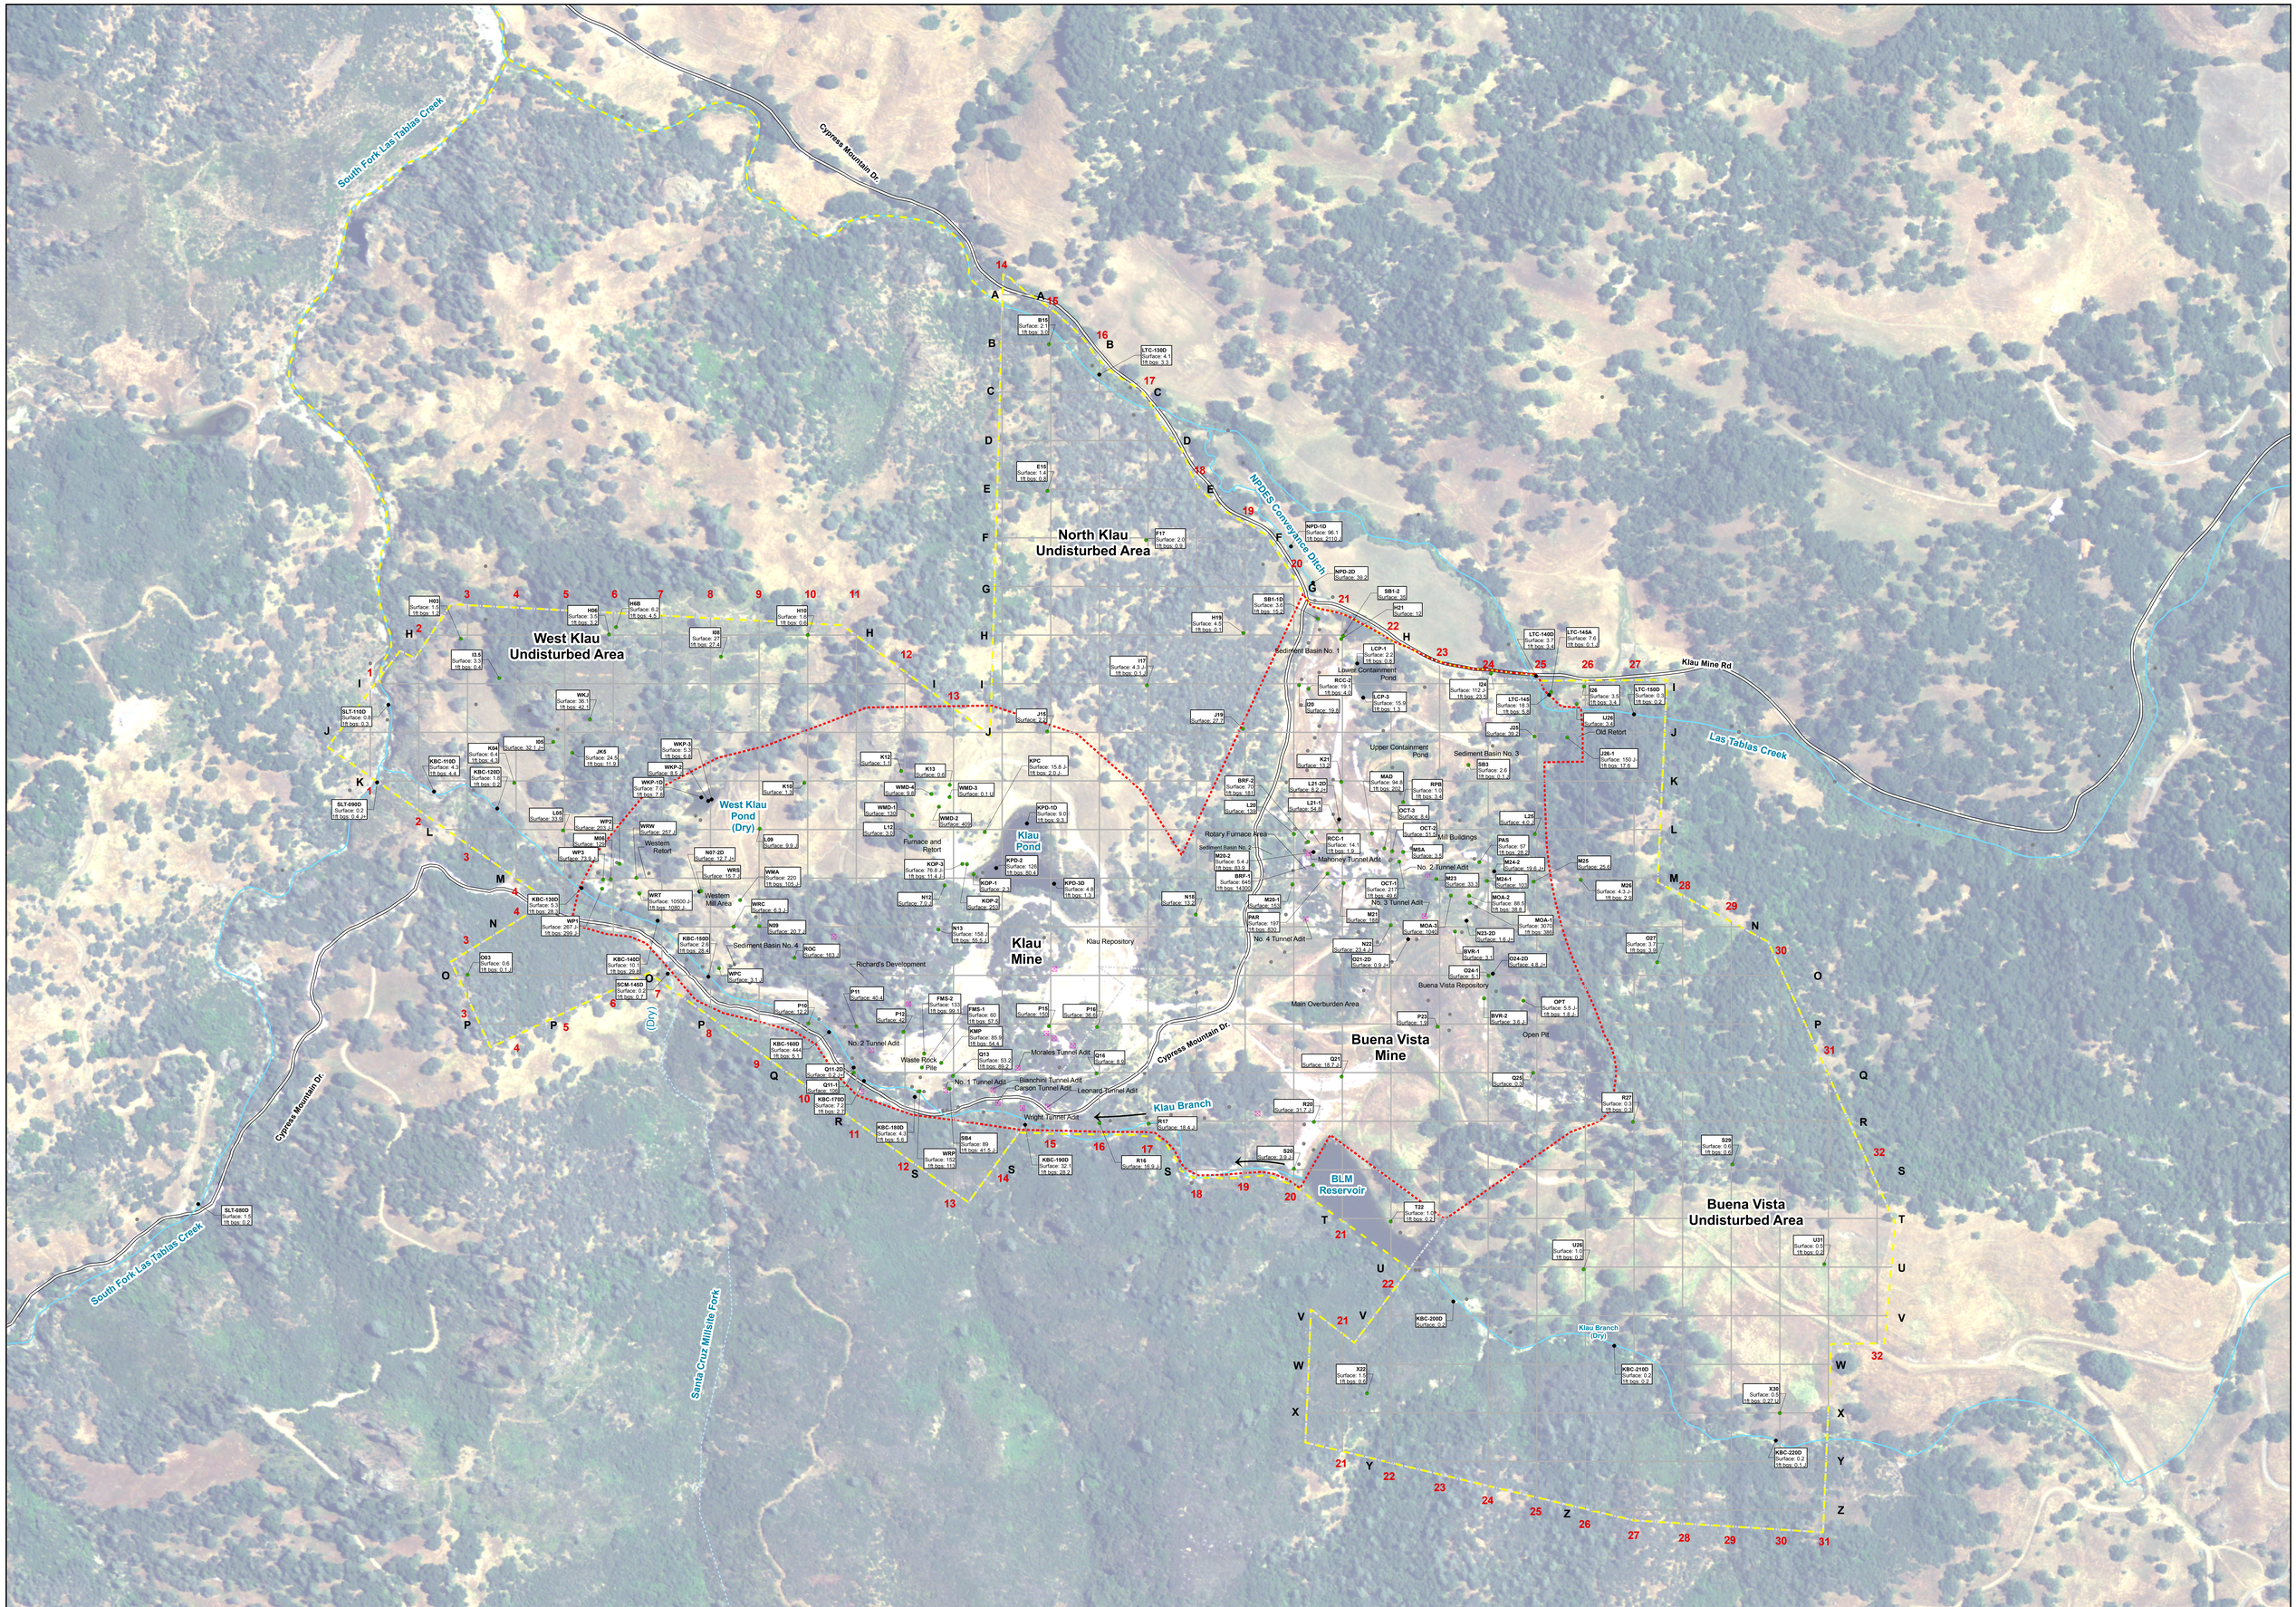
LocID: KBC-150
Result @ Surface: 2.6
Result @1 ft. BGS: 20.4
(All results in mg/kg)
