19th Avenue Landfill Superfund Site 2010 Five Year Review

Appendix J - Photographs of Current Site Condition

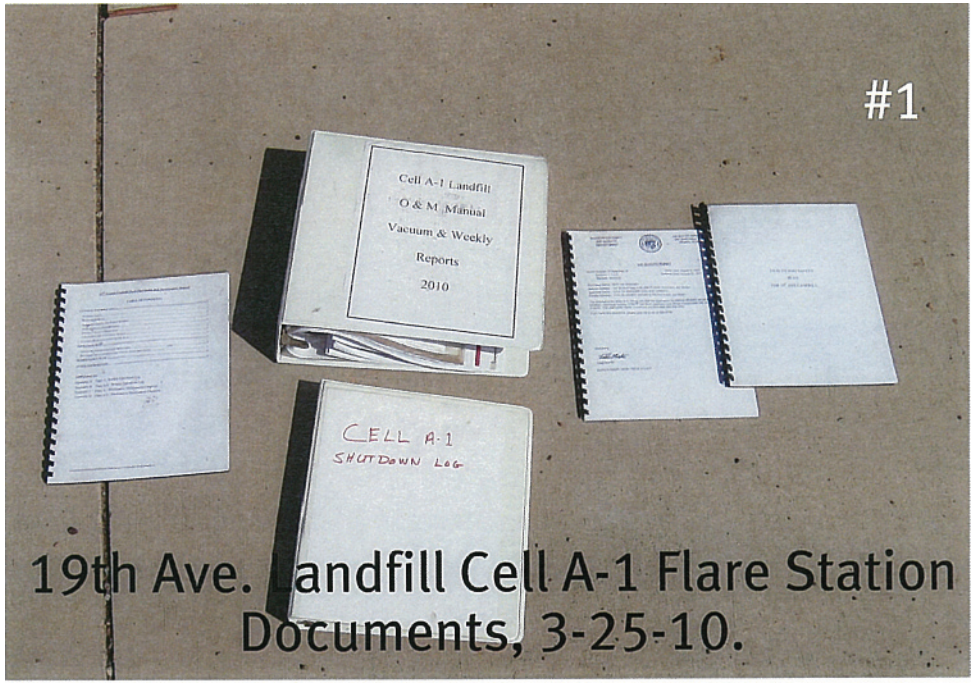
19th Ave. Landfill Cell A-1 Flare Station Documents, 3-25-10.

19th Ave. Landfill Cell A-1 Cap Showing Erosion and Straw Waddles, 3-25-10, looking East.

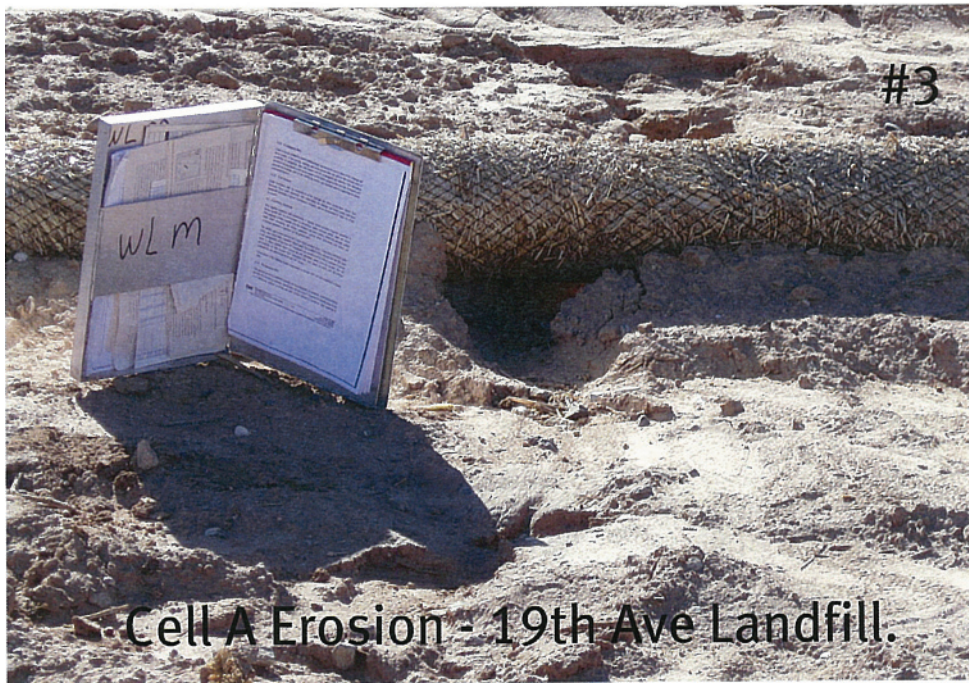
Cell A Erosion - 19th Ave Landfill.

19th Ave. Landfill Cell A Storm Drain Inlet in East Perimeter Drainage Showing Debris on Grate, 3-9-2010, looking East.

19th Ave. Landfill Cell A Landfill Gas Extraction Blowers, 3-9-2010, looking Northeast.

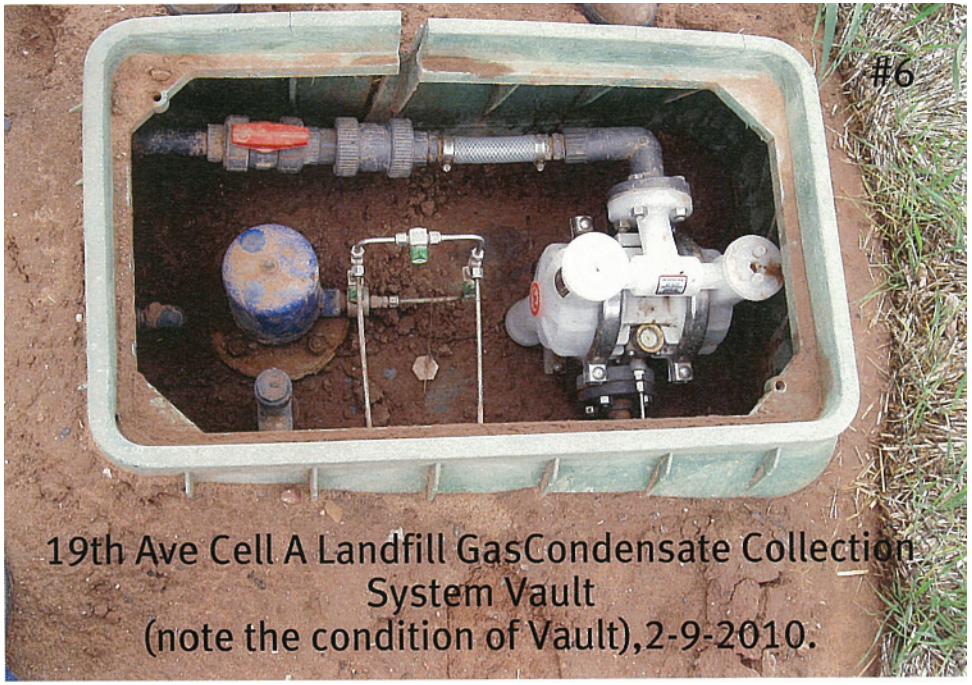
19th Ave Cell A Landfill GasCondensate Collection System Vault (note the condition of Vault), 2-9-2010.

19th Ave. Landfill Cell A
Gas System Condensate Collection Vault Showing Recent Excavation and Leaking Pneumatic Lines.

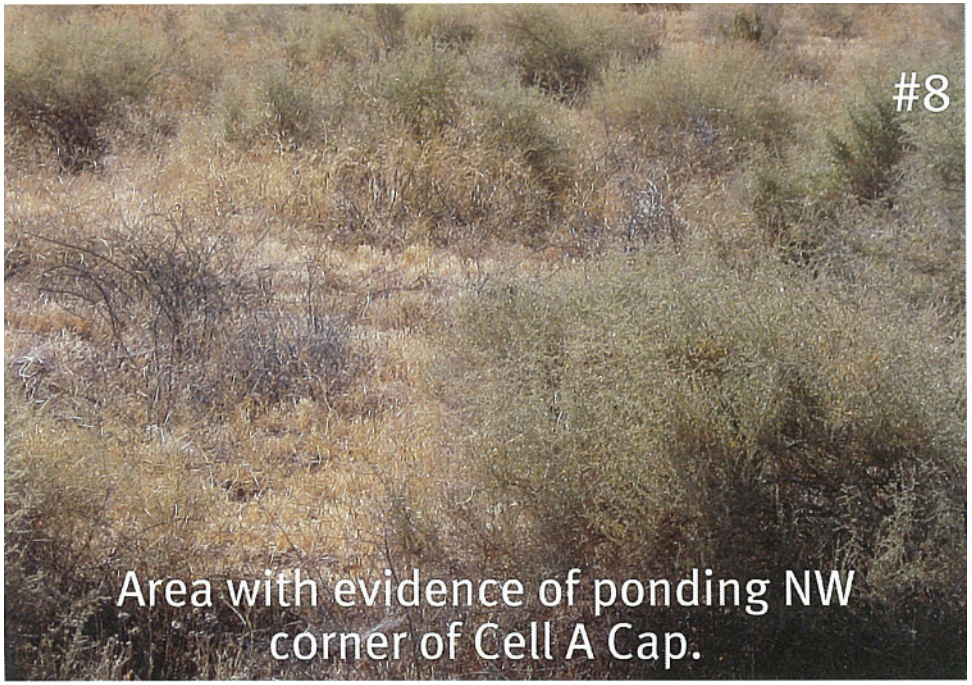
Area with evidence of ponding NW corner of Cell A Cap.

#9
Groundwater Monitoring Well - 19th Avenue Landfill

#10
Cracks in Cap of Cell A - 19th Ave Landfill

#11
Salt River Flow - 19th Ave Landfill.

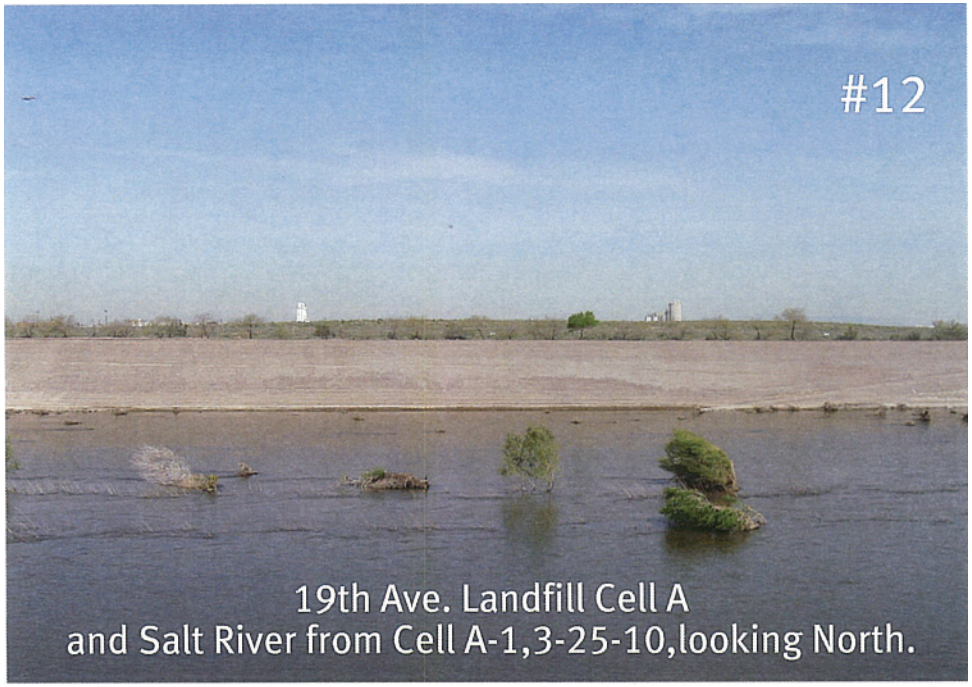
#12
19th Ave. Landfill Cell A
and Salt River from Cell A-1,3-25-10,looking North.

19th Ave. Landfill Cell A Perimeter Landfill Gas Probe at Northwest Corner,3-9-2010.

19th Ave. Cell A Landfill Gas Blower, 3-9-2010,looking Northeast.

19th Ave. Landfill Cell A Signage at Main Entrance Northwest Corner,3-9-2010.

19th Ave. Landfill Cell A South - Central Gate and Signage ,3-9-2010,looking N of Rio Salado Parkway.

#17
19th Ave. Landfill Cell A Southwest Retention Basin
3-9-2010,looking South.

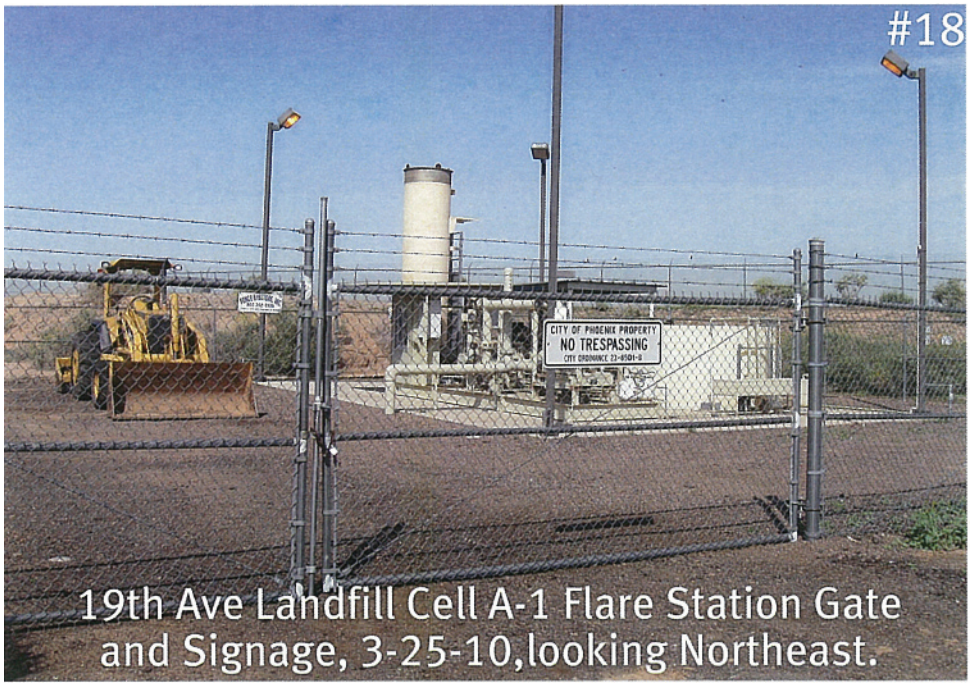
#18
CITY OF PHOENIX PROPERTY
NO TRESPASSING
19th Ave Landfill Cell A-1 Flare Station Gate
and Signage, 3-25-10,looking Northeast.

#19
Erosion By Roadway - 19th Ave Landfill.

#20
A-1 Flare Station with
Cell A Levees & Industrial background.

#21
Rip Area SE Corner of Cell A.

#22
Ramp on Cell A-1 Levee showing
Debris left by River Flows.

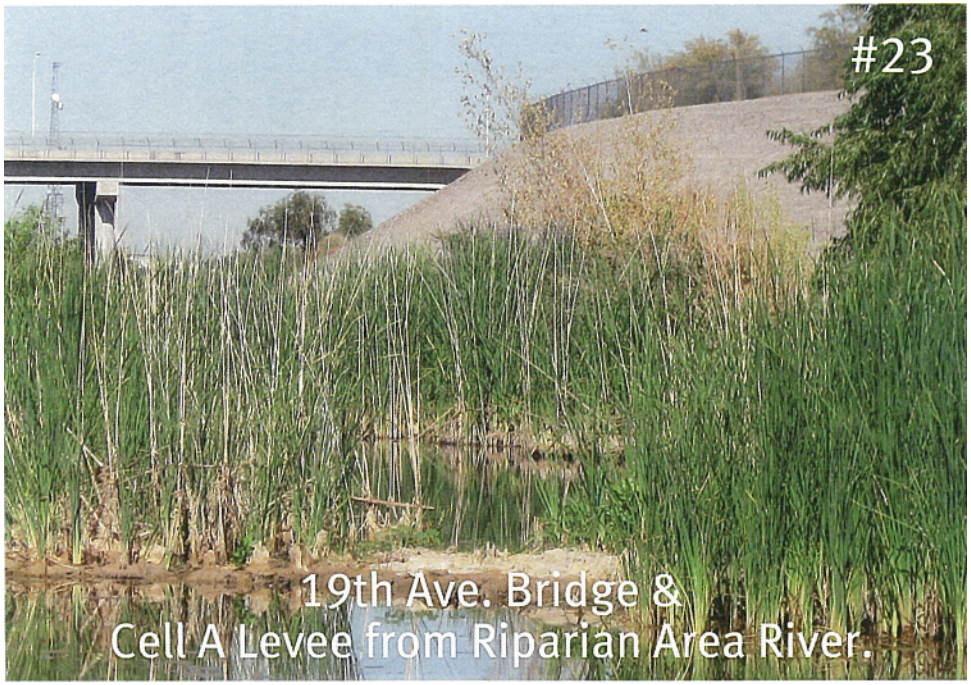
#23
19th Ave. Bridge &
Cell A Levee from Riparian Area River.
