Gas Migration into the Susquehanna River and Surrounding Area . . .

Report on the Investigation of the Natural Gas Invasion of Aquifers in Bainbridge Township of Geauga County, Ohio

September 1, 2008
Ohio Department of Natural Resources
Division of Mineral Resources Management

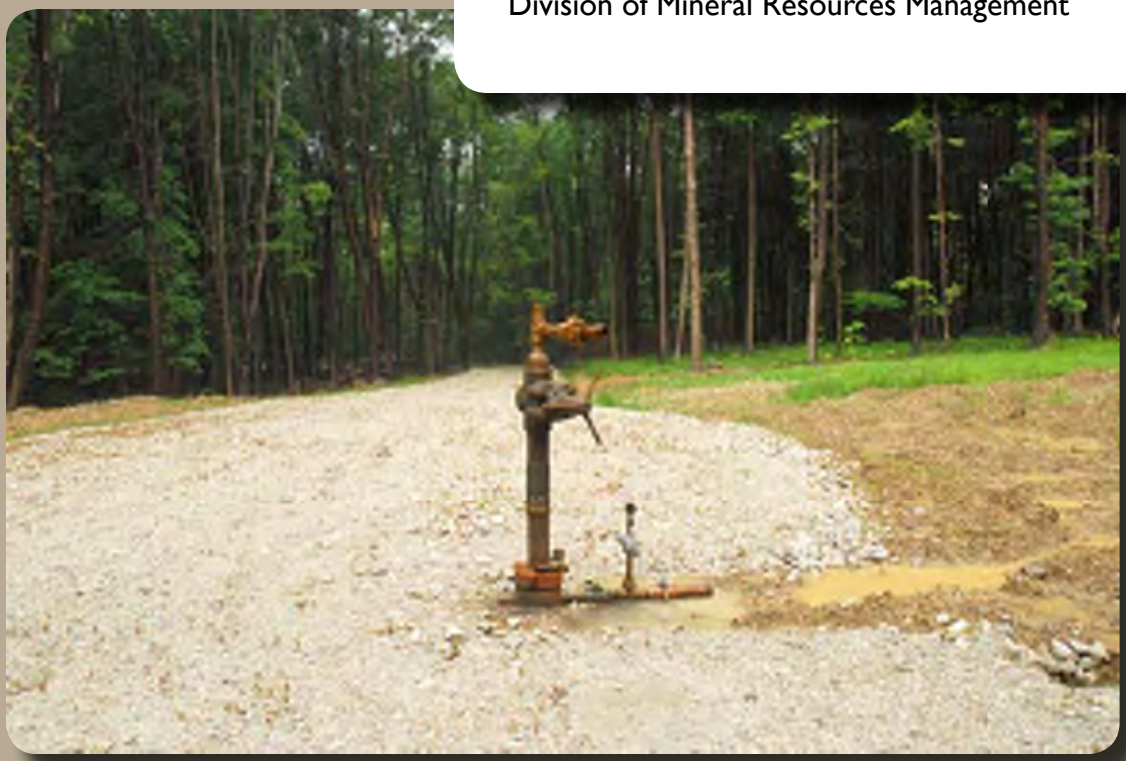
The DMRM determined that accumulation and confinement of deep, high-pressure gas in the surface-production casing annulus of the English No.1 Well, between November 13 and December 15, 2007 resulted in over-pressurization of the annulus. This over-pressurized condition resulted in the invasion, or migration, of natural gas from the annulus of the well into natural fractures in the bedrock below the base of the cemented surface casing. This gas migrated

Three different factors in the drilling and completion of the English No.1 Well are believed to be the primary contributing factors that led to the gas invasion of the shallow aquifers and subsequent explosion in the house on English Drive. The first contributing factor was inadequate cementing of the production casing prior to remedial cementing on December 15 2007. The second contributing factor was the decision to proceed with stimulating, or hydro-fracturing, the well without addressing the issue of the minimal cement behind the production casing. Hydro-fracturing is the process in which fluid is pumped into the oil and gas reservoir through perforations in the production casing t enhance fractures and improve the flow of gas and/or crude oil into the production casing. Finally, the third and most critical contributing factor leading to the incident was the 31 day period after the fracturing stimulation of the "Clinton" sandstone during which the annular space between the surface and production casings was mostly shut in. This confined the deep, high-pressure gas from "Newburg" and/or "Clinton" within this restricted space. Readings taken and reported by OVESC during this shut in period were consistently 320 psi or greater.

1. Inadequate primary cementing of the production casing has been remedied by the subsequent squeeze cementing operations;
2. The deep high-pressure gas zones that were the source of over-pressurization of the aquifers have been isolated and sealed from the well bore through the squeeze cementing procedures;
3. The confinement of annular gas, which caused the build up of pressure, has been eliminated.
