DAMAGE TO THE HISTORIC TOWN OF STAUFEN (GERMANY) CAUSED BY GEOTHERMAL DRILLINGS THROUGH ANHYDRITE-BEARING FORMATIONS

Ingo SASS¹ & Ulrich BURBAUM²

Ingo Sass & Ulrich Burbaum: Damage to the historic town of Staufen (Germany) caused by geothermal drillings through anhydrite-bearing formations

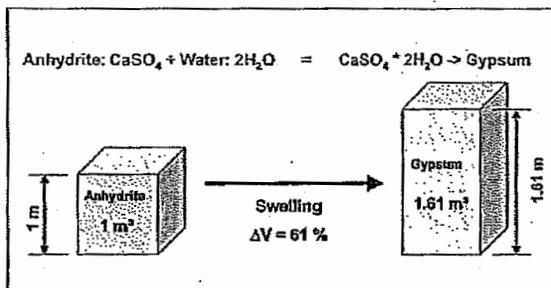
Fig. 8: Swelling process of anhydrite into gypsum.

ing in the formation, with an increase of volume up to 60% (Fig. 8). Swelling processes in anhydrite have been described often (Chiesi *et al.* 2010; Steiner 1989, 1993; 2007). If swelling is prevented due to confining conditions, immense swelling pressures may occur. In some tunnel projects in anhydrite rock, swelling pressures from 1.7 up to 4.7 MPa were monitored (Steiner 1989, 1993, 2007). Swelling could be avoided only if sufficient overburden rock mass is present. The relationship between necessary overburden rock mass and possible swelling pressure is shown in Fig. 9. The dead weight of rock mass related to its depth is compared to the swelling pressure monitored by Steiner (Steiner 1989, 1993, 2007). The anhydrite rock in Staufen is located at about 60 m depth (see below). Thus, the overburden rock mass is insufficient to prevent swelling.

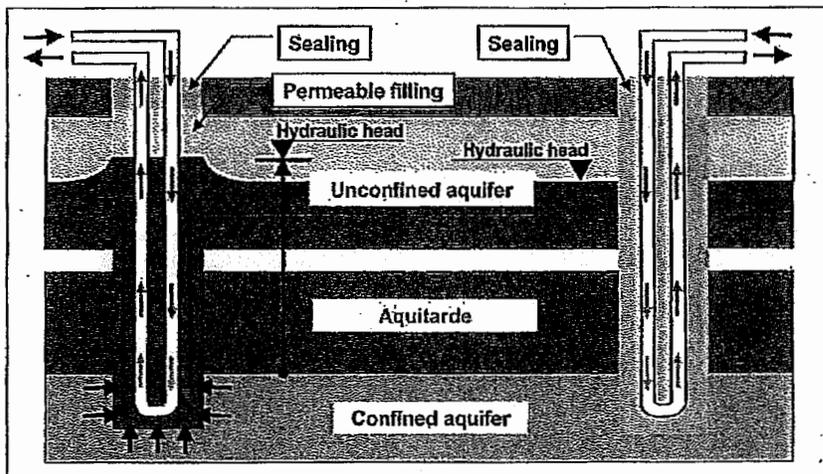
Fig. 10: Filling of borings for borehole heat exchangers.

annular space between exchanger pipes and borehole lining. The heat transport from the surrounding ground to the pipes is dominated by groundwater. For a good heat transport, the borehole backfill should be as permeable as possible (unsealed BHE systems, Fig. 10, left side).

If groundwater is present, it is thermally most efficient to use no backfill. However, regulations in Germany require a complete grouting of the annular space.

A great advantage of sealed systems (Fig. 9 right side) is the protection of

groundwater resources. Using ungrouted BHE systems, heat exchanger fluids (if they contain antifreeze agents like monoethyleneglycol) may contaminate groundwater in case of a leakage from the pipes. Furthermore, layered aquifers are kept from communicating with each other. Additionally, surface contaminants may infiltrate downward into groundwater resources in unsealed BHE systems.

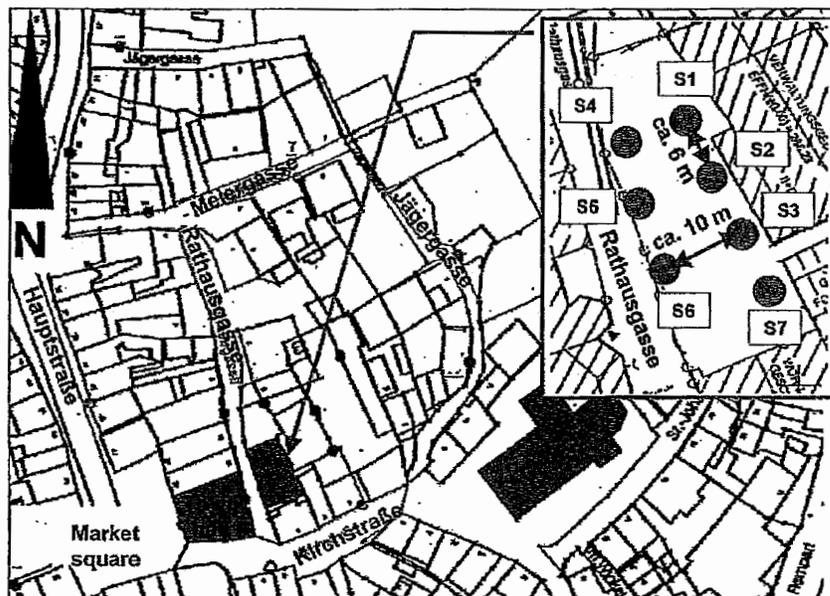
Fig. 11: Site sketch of well locations with interspaces at the city of Staufen town centre.

Well S1 reportedly penetrated artesian groundwater at a depth of 32 m. The piezometric level at the wellhead was at about 0.5 m above ground surface (Report 2007b). All other wells did not encounter artesian conditions (according to residents and the administration of Staufen). It can be concluded that the hydraulic potential of the Muschelkalk karst aquifer was connected

to the borehole S1 via fractures penetrating the Lettenkeuper layers. However, drilling contractor well logs show artesian conditions in all wells. Information on artesian control during drilling operations are missing in the well logs.

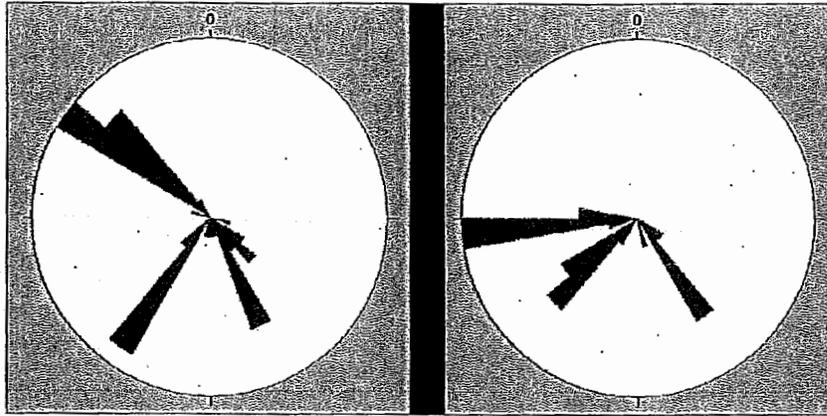
Fig. 19: Rose diagrams of outcrops.
Left: Upper Muschelkalk, Right:
Hauptrogenstein.

The orientation of building damages corresponds to the orientation of the discontinuities (Figs. 18 and 19) that were obtained by a field study in October 2009. It can be concluded that groundwater not only flows through drillings but now through discontinuities, too. The swelling process therefore cannot be stopped by sealing the BHE-Drillings. A larger area remediation approach must be found.
