Colorado NPDES Storm Water Inspection - Construction

NATIONAL DATABASE INFORMATION	
Inspection Date: 3/11/11	Inspection Type: Stormwater Construction
Entry Time: 9:20am	Exit Time: 12:20pm
NPDES ID Number: COR03H278	
Inspector: Natasha Davis	EPA/State/Contractor
Inspector: Stephanie Gieck	EPA/State/Contractor

Facility Location Information:(Name/Location/ Mailing Address)	
Site/Facility Location: Arkansas River Trail Phase 2 4th Street to Clark Street along the south side of the Arkansas River Pueblo, CO	Mail Report to: Michael Brown Langston Concrete Inc. 2335 N Interstate 25 Pueblo, CO 81008

Photographs for Arkansas River Trail 2 - COR03H278

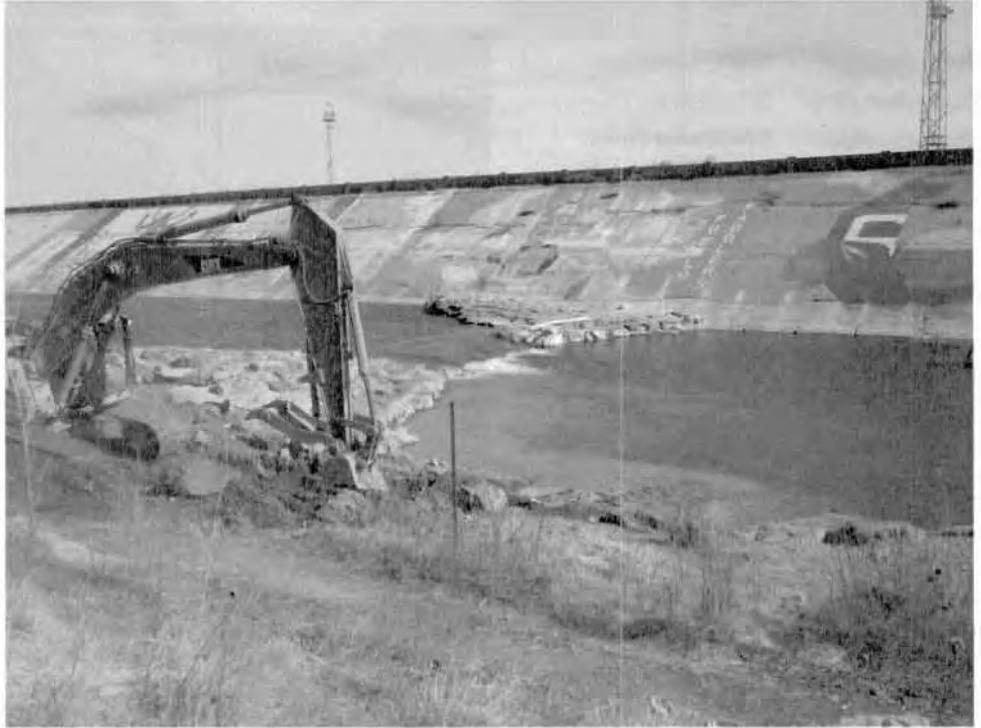
Photo Number 1560

Are stabilization practices properly applied in a timely manner and adequately maintained?	<p><i>(e.g., indicate "yes" or "no"; if "yes", how long without stabilization measures?)</i></p> <p>No, see explanation above. Additionally, the culvert constructed east of Main Street (Photos 1560, 1584, 1585, 1586, 1589) had not been completed but could have been completed in a timely manner, as specified in the SWMP, or additional correctly installed BMPs put in place to prevent direct discharges (Photos 1584, 1586) into the Arkansas River. LCI plans to complete the culvert by installing rip rap.</p>
Are structural controls properly installed and maintained?	<p><i>(e.g., indicate "yes" or "no"; explain if necessary)</i></p> <p>No, there were several areas where the silt fence was not trenched or replaced when damaged, as seen in photos 1563, 1573, 1576, and 1582. There were areas where silt fence was found in the river, as seen in photos 1565, 1566, and 1575. Below the culvert near Main Street, the silt fence could easily be bypassed, as seen in photo 1584. In addition, the culvert installed near the railroad bridge, just west of Clark Street, had filter fabric that had been washed from above the culvert through the pipe (Photo 1583).</p>

Discuss how the structural controls are, or are not appropriate for the site.	<p><i>(e.g., silt fence installed in a live stream)</i></p> <p>LCI plans to install rip rap in the culvert located at the Main Street bridge (photos 1560 and 1585), but delay in construction has prevented this from occurring and allowed sediment erosion into the Arkansas River. Furthermore, the silt fence installed at the base did not surround the area where potential erosion could occur as seen in photo 1584.</p>

Description View to the north of a separate project taking place northwest of Union Avenue.

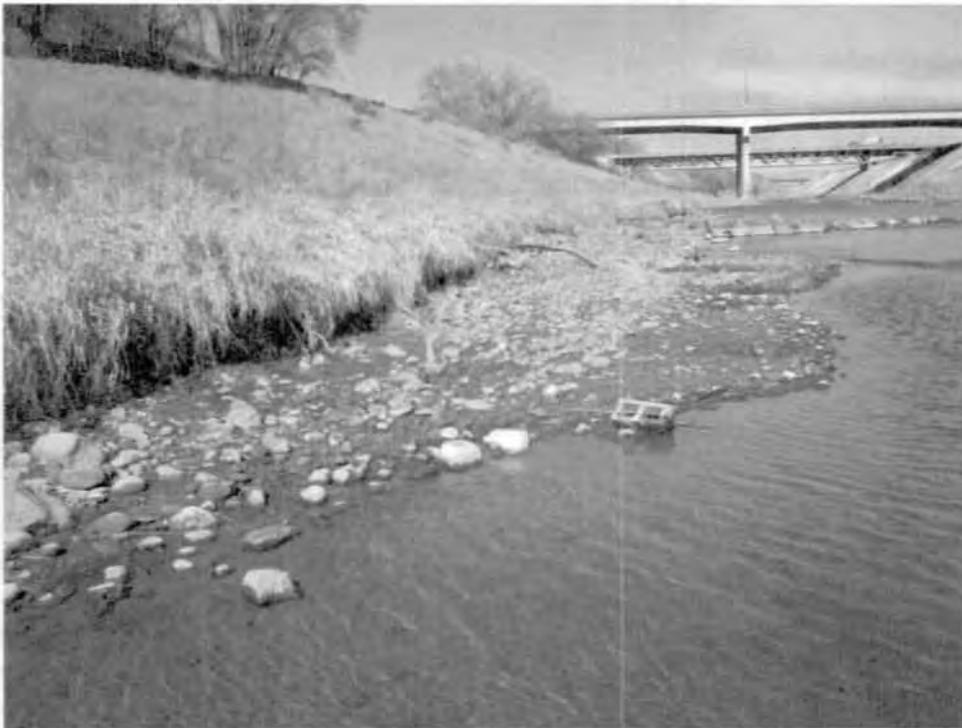
Photo Number 1568

SWPPP Implementation (Site Review)	
Structural and Stabilization Practices	
Any unprotected/exposed slopes/areas without vegetation mulch or matting after construction activity has ceased?	<p><i>(e.g., indicate "yes" or "no"; if "yes", how long without stabilization measures?)</i> <i>(Note: for information only in Colorado)</i></p> <p>Yes, there was one location along the trail approximately 3/4 of the way between Main Street and Clark Street where an approximate five foot wide section of soil was disturbed from the trail down the hill to the river prior to the inspection. The cause of the disturbance is unknown. No BMPs, mulch or matting were in place to control erosion from this area as seen in photo 1577.</p> <p>The unvegetated trail was bordered by silt fence, but there was unprotected disturbed soil on the downhill side of the silt fence (Photo 1568); Mr. Brown stated that LCI had not planned to manage this disturbed area.</p>

Description View of the Arkansas River along the project site looking west toward the Main Street bridge.

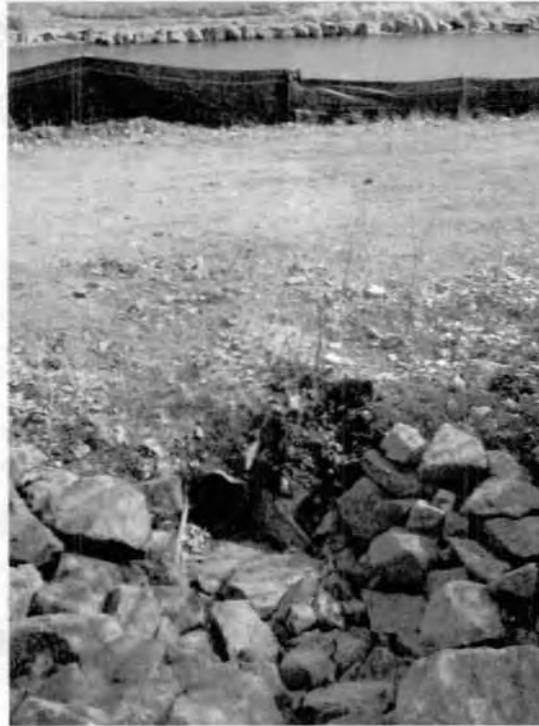
Photo Number 1569
Inspection Date 3/11/2011
Photographer Stephanie Gieck
Description View of a culvert inlet looking north toward the Arkansas River.

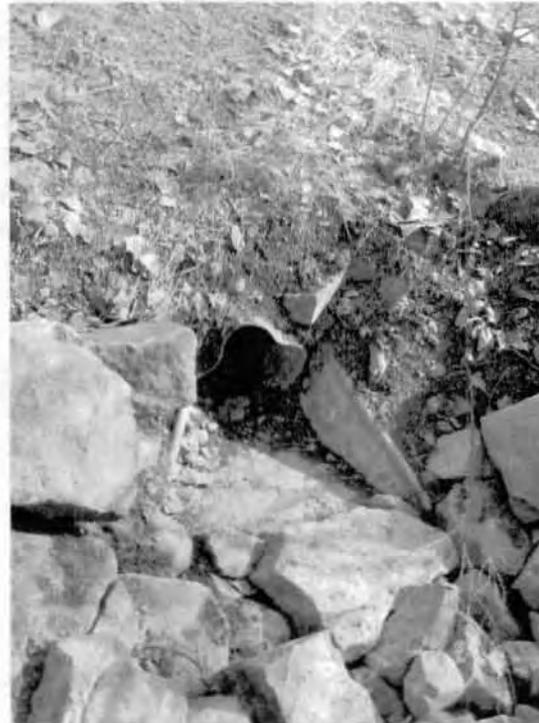
Photo Number 1570
Inspection Date 3/11/2011
Photographer Stephanie Gieck
Description Close-up view of the culvert showing Photo 1569.

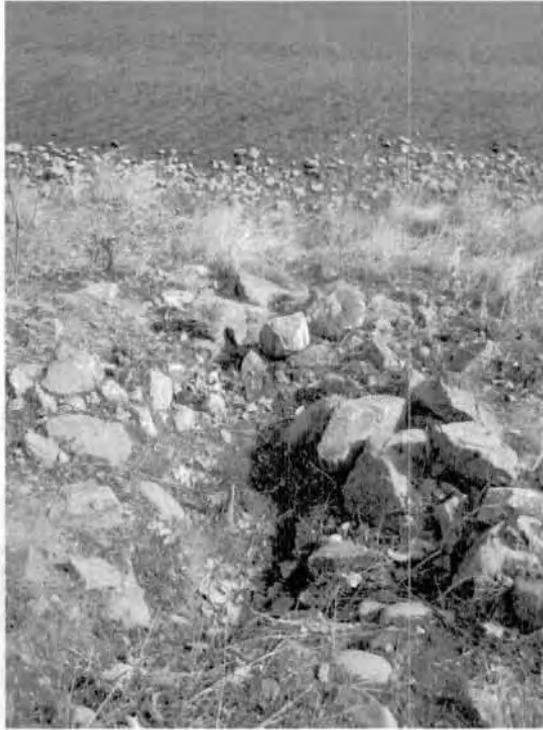
Photo Number 1572

Description View of the culver outlet for the inlet shown in Photos 1569 and 1570.

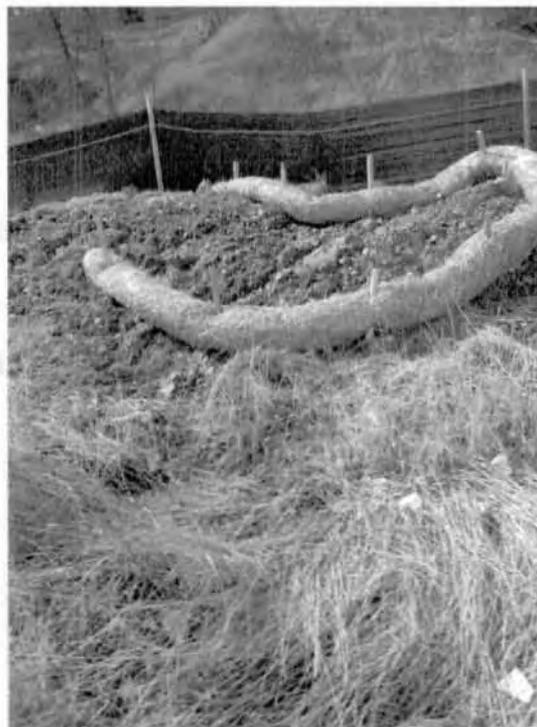
Description View of the downhill side of the silt fence shown in Photos 1572 and 1573.

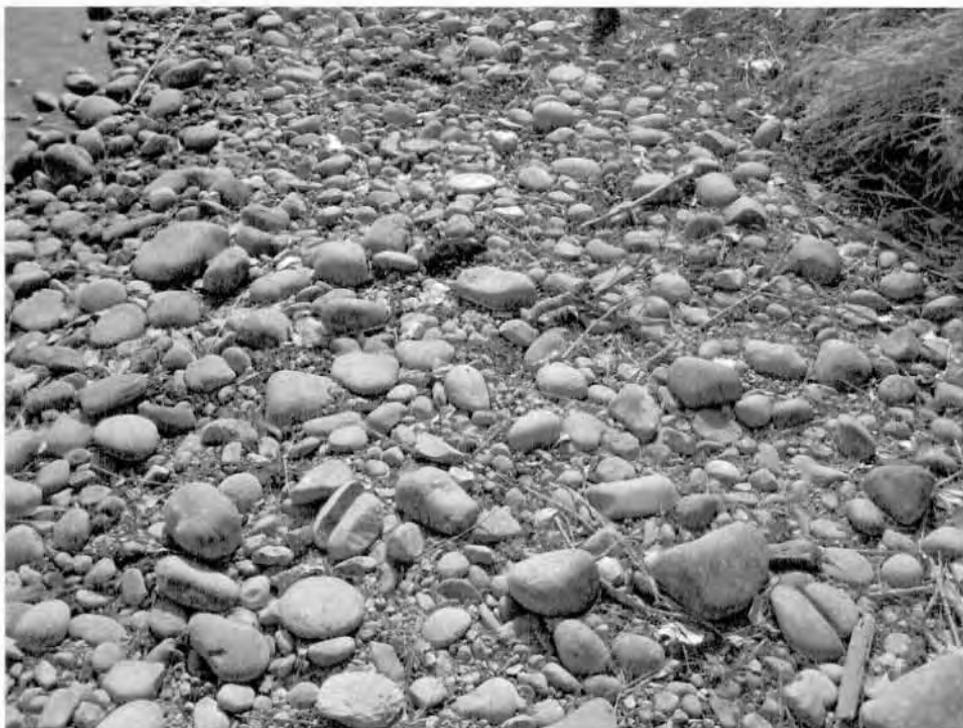
Photo Number 1581
Inspection Date 3/11/2011
Photographer Stephanie Gieck
Description Contrast of typical sediment deposit along the bank of the river approximately 5-10 feet east of Photo 1580.

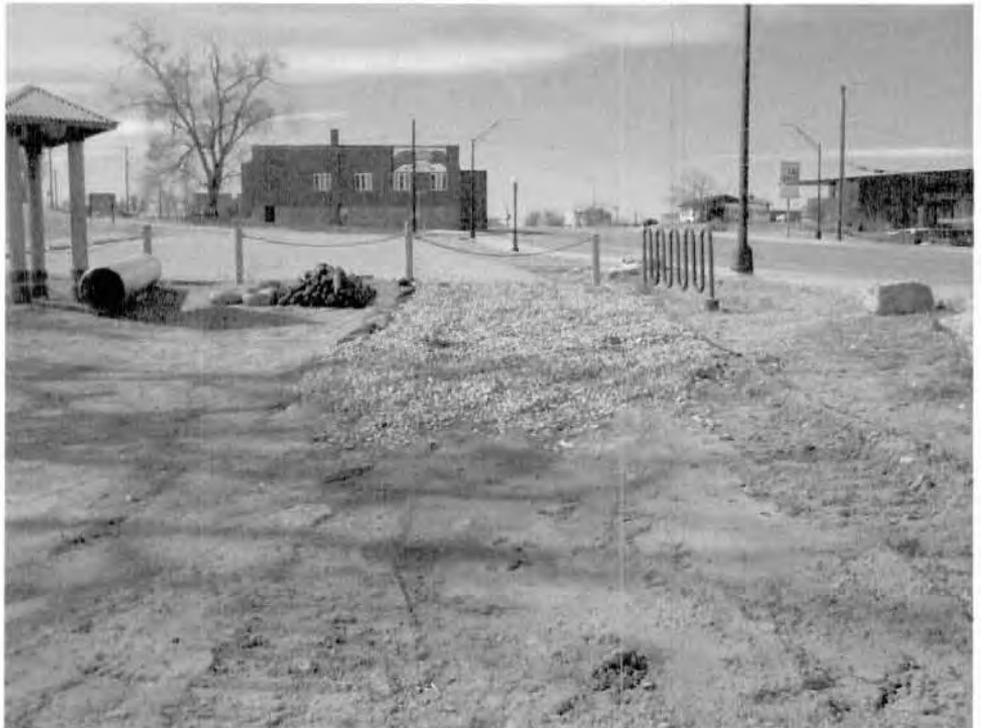
Photo Number 1588
Inspection Date 3/11/2011
Photographer Stephanie Gieck
Description View to the south of a vehicle track out pad along Main St. at the top of the construction site access ramp.
