Environmental Survey and Assessment for Asbestos Containing Materials

Work Area at Tallaboa Industrial Park (formerly PR Olefins)
Road 127, Peñuelas, Puerto Rico
(Work Plan Approved by EPA, Reference No. CAA-02-2014-1009)

Carlos E. Ocasio-Feliciano
Best Environmental Consultants, Inc.
Lead-Asbestos-Mold Consultants
PO Box 560180
Guayanilla, PR 00656-0180

January 29, 2019

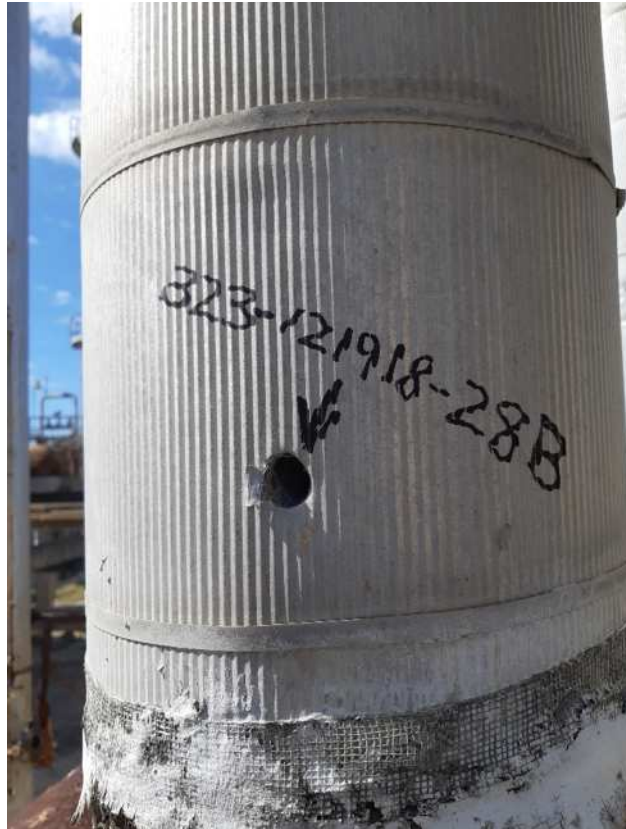
General View Sampling Point #28B, Tank 2, 10' ϕ TSI,
East Side.

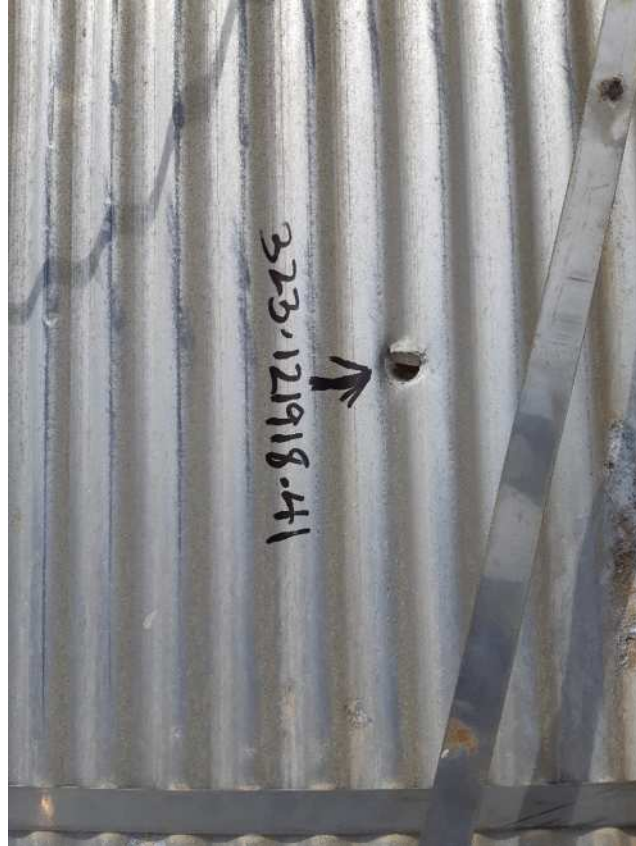
General View Sampling Point #41, Tank 6 TSI, North Side.

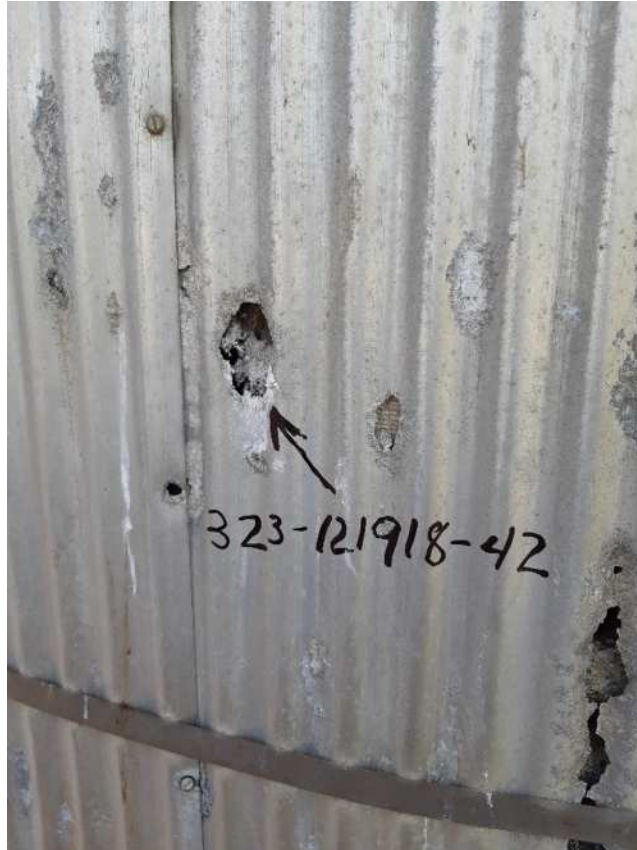
General View Sampling Point #42, Tower 9 TSI, South Side.

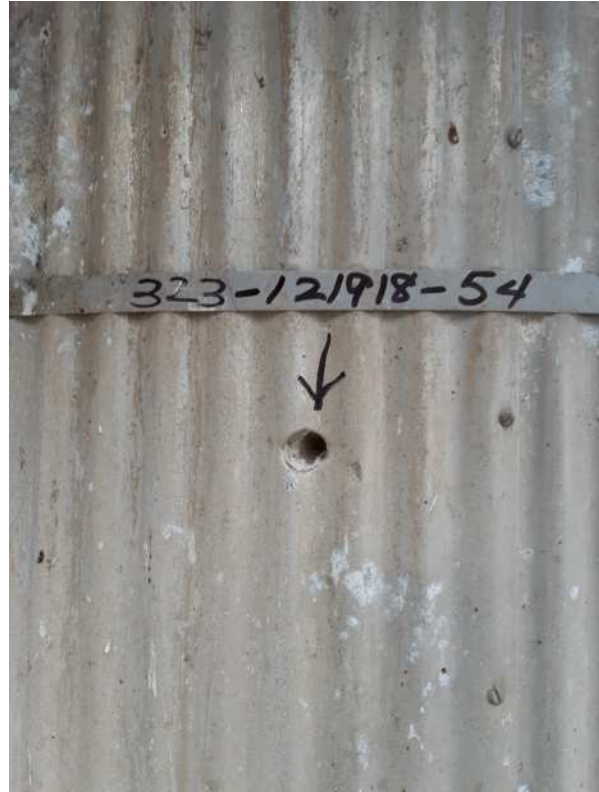
General View Sampling Point #54, Tower 12, South Side

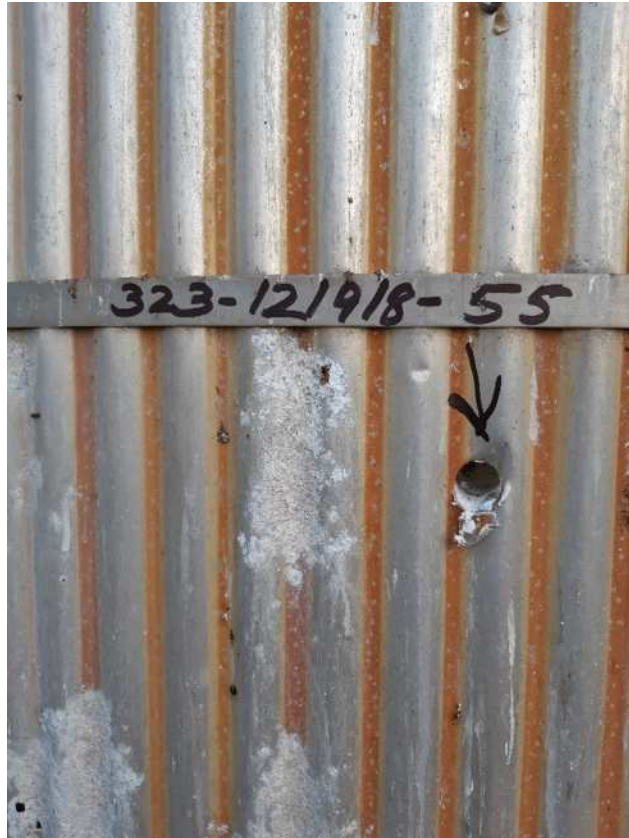
General View Sampling Point #55, Tower 12, North Side
