TS-AMD-82006
JUNE 1982

AERIAL PHOTOGRAPHIC ANALYSIS OF HAZARDOUS WASTE SITES Duwamish Valley, Washington

EPA Region 10

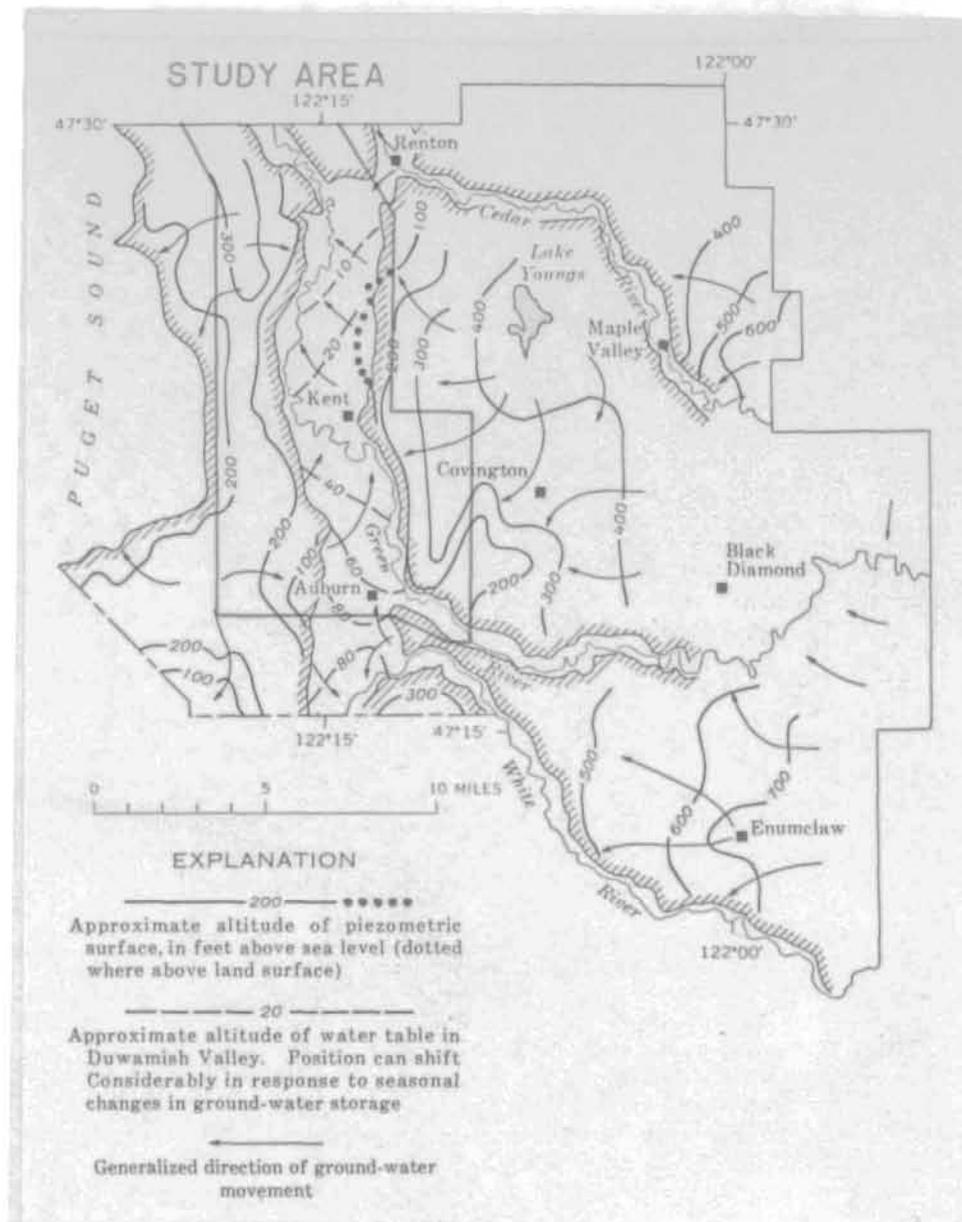
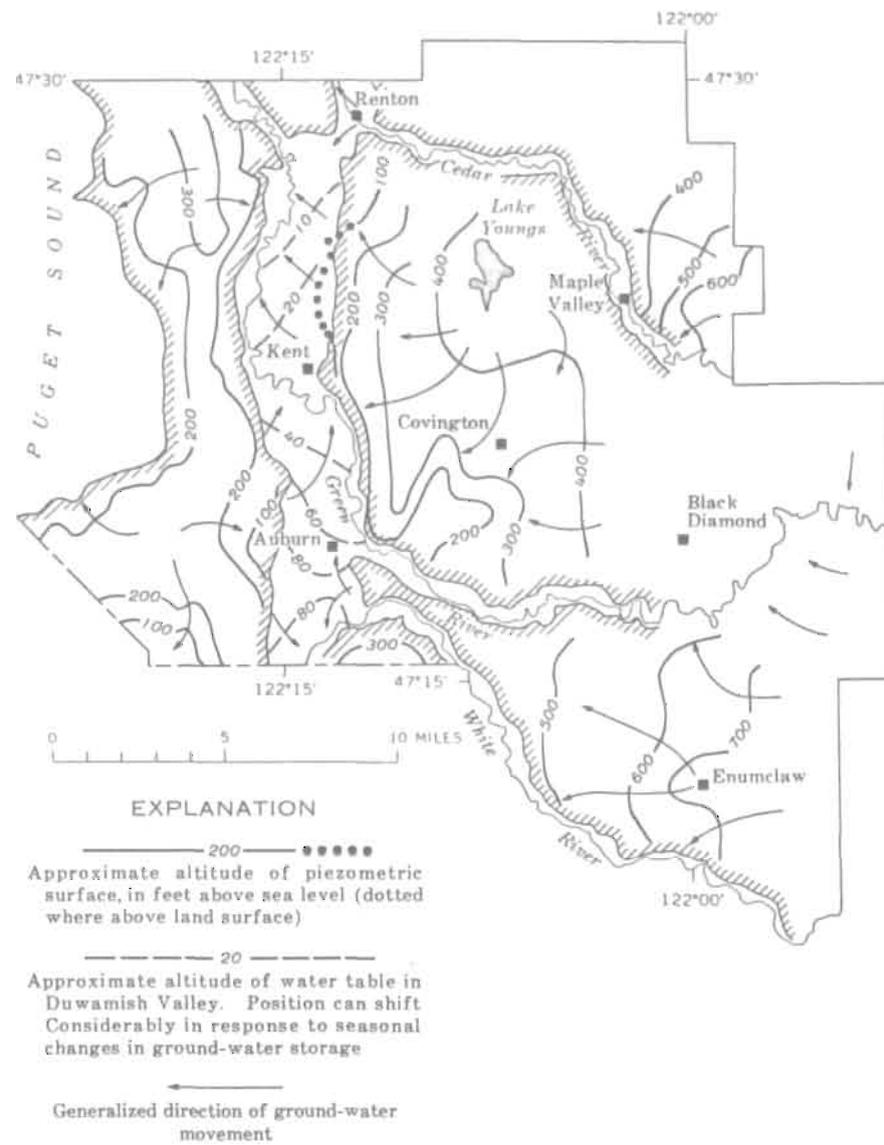
Figure 7. Regional groundwater piezometric surface in Pleistocene deposits, and water table in Recent alluvium of Duwamish Valley.⁵

A water table contour map (Figure 7) shows the general shape of the regional groundwater reservoir and the direction of groundwater movement. In the Duwamish Valley the water table is generally less than 10 feet beneath the surface but in local areas can be as much as 20 feet. In the upland areas the piezometric surface lies some 100-250 feet beneath the land surface. In some places the upland water table is as much as 125 feet above the adjacent valley floor, and (as can be seen in Figure 7) the flow is toward the valley.

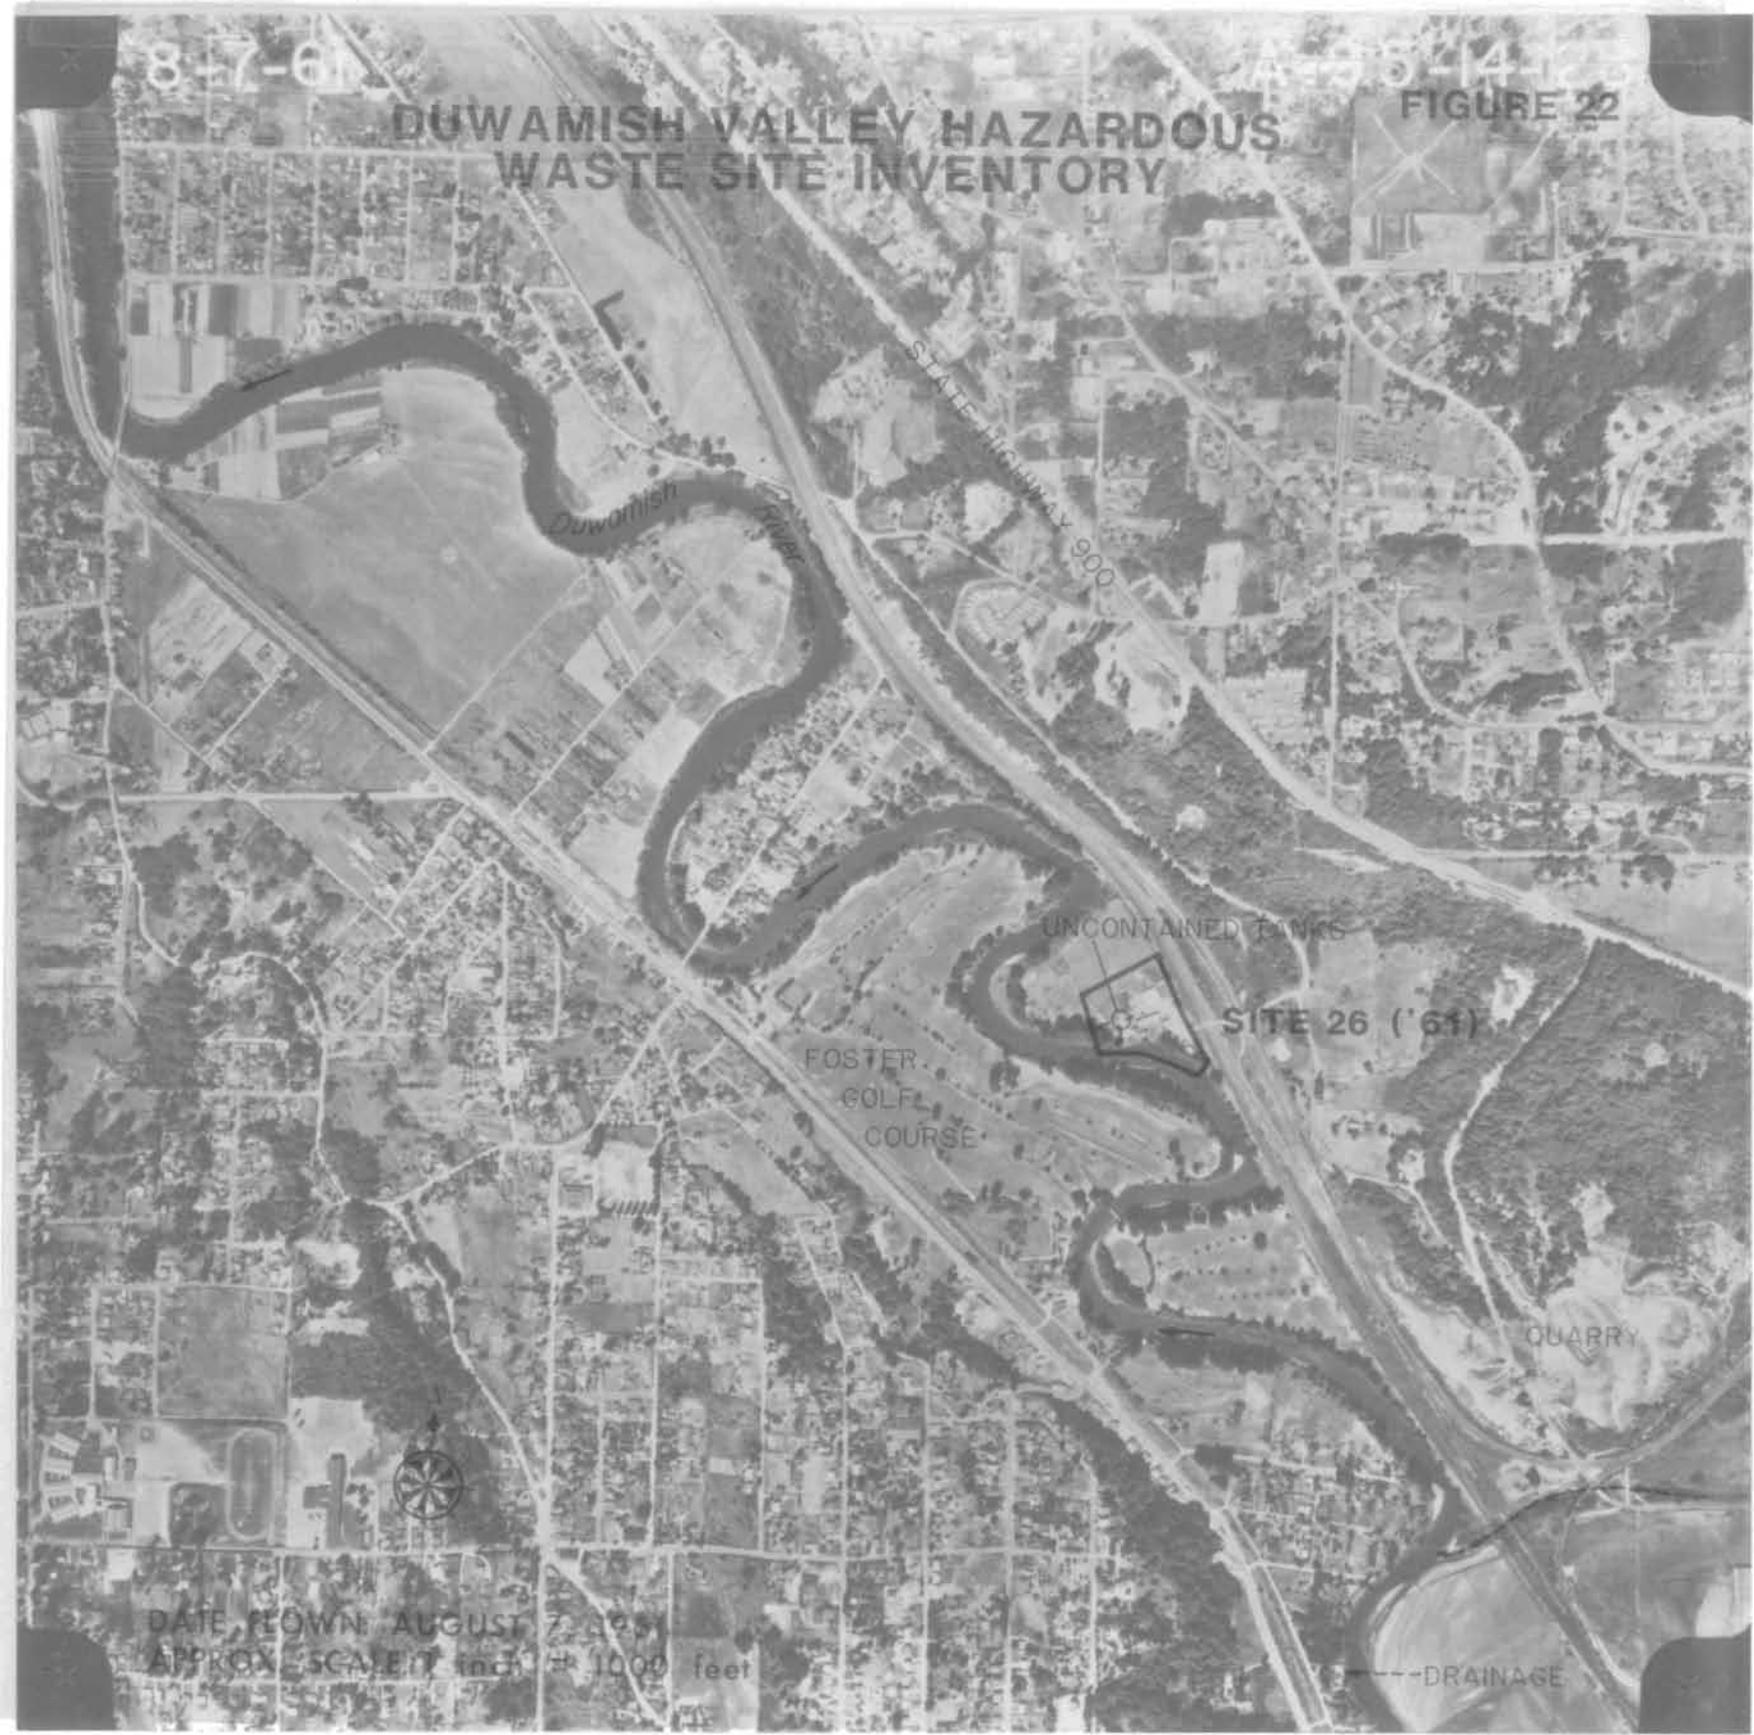
FIGURE 22

SITE 26 ('61) - This small industrial facility is located on the banks of the Duwamish River at Foster (Figure 22). All of the storage/processing tanks are uncontained and any spill would drain into the adjacent river. There is no other evidence of waste disposal.

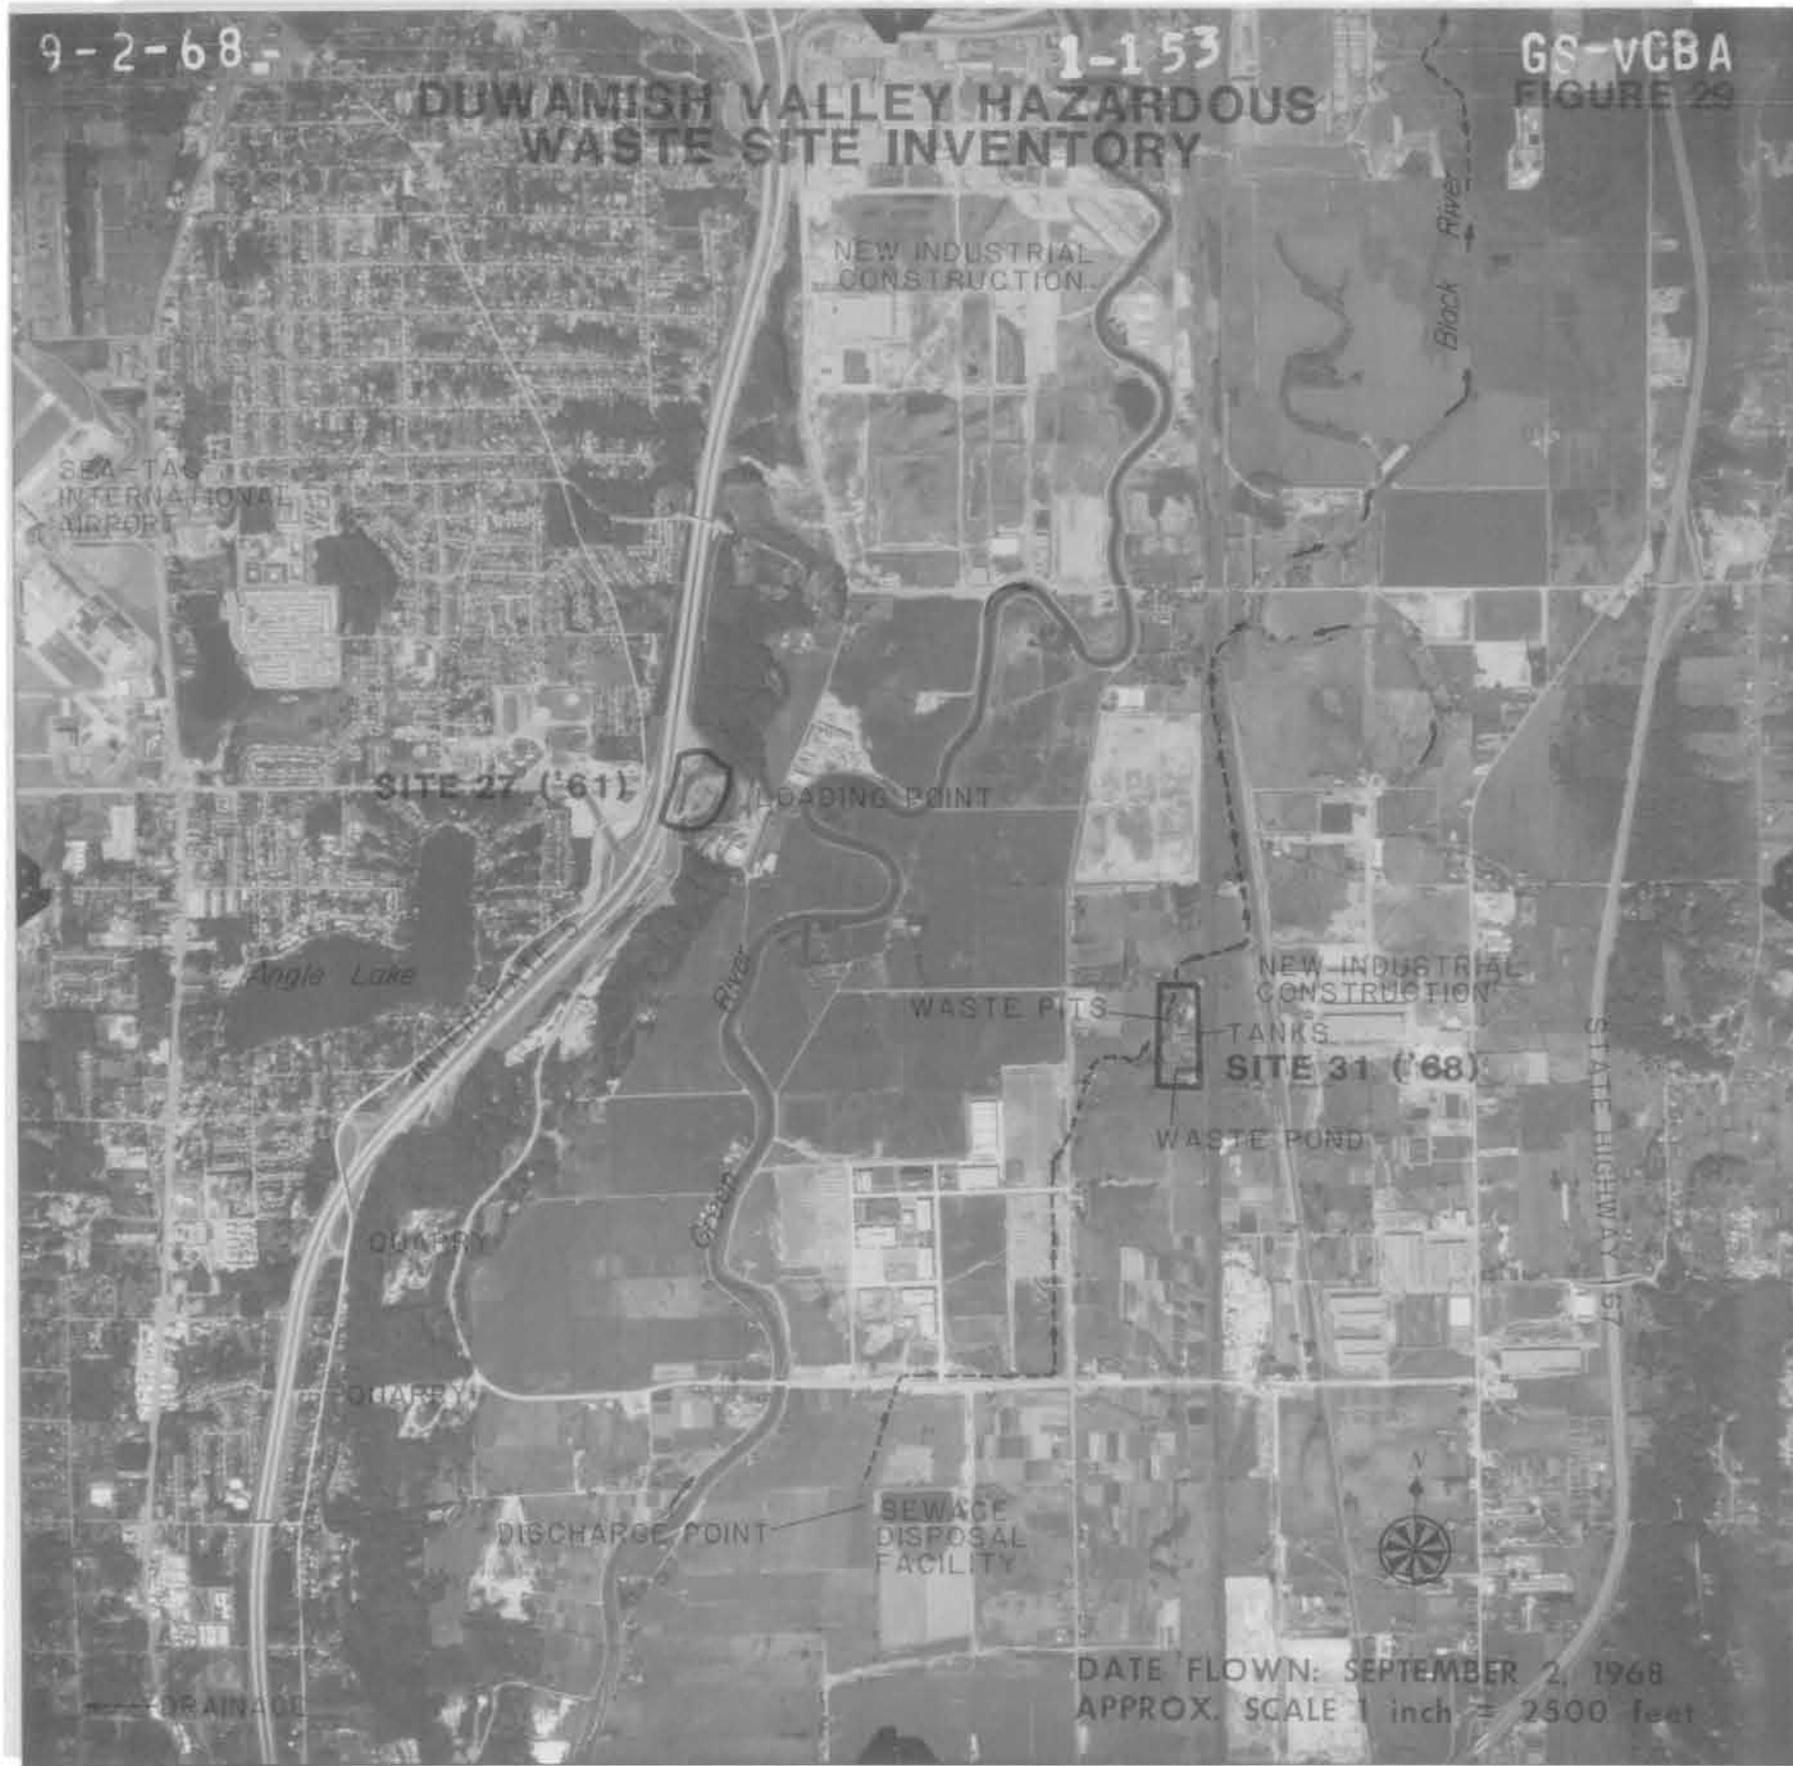
GS-VCBA
FIGURE 29

SITE 27 ('61) - The construction of Interstate 5 has either removed or covered over the garbage dump (Figure 29). The loading/unloading facility is still present and it appears to be in operation as some vehicles are present.

SITE 31 ('68) - This site is a small industrial facility located south of Orilla, Washington (Figure 29). There are at least seven small waste pits present plus a larger waste pond and all appear to contain liquid. What appears to be small storage tanks are located between the pits and the pond. A drainage ditch is located along the west edge of the site. The scale of the photography and the small size of the site preclude any further analysis.

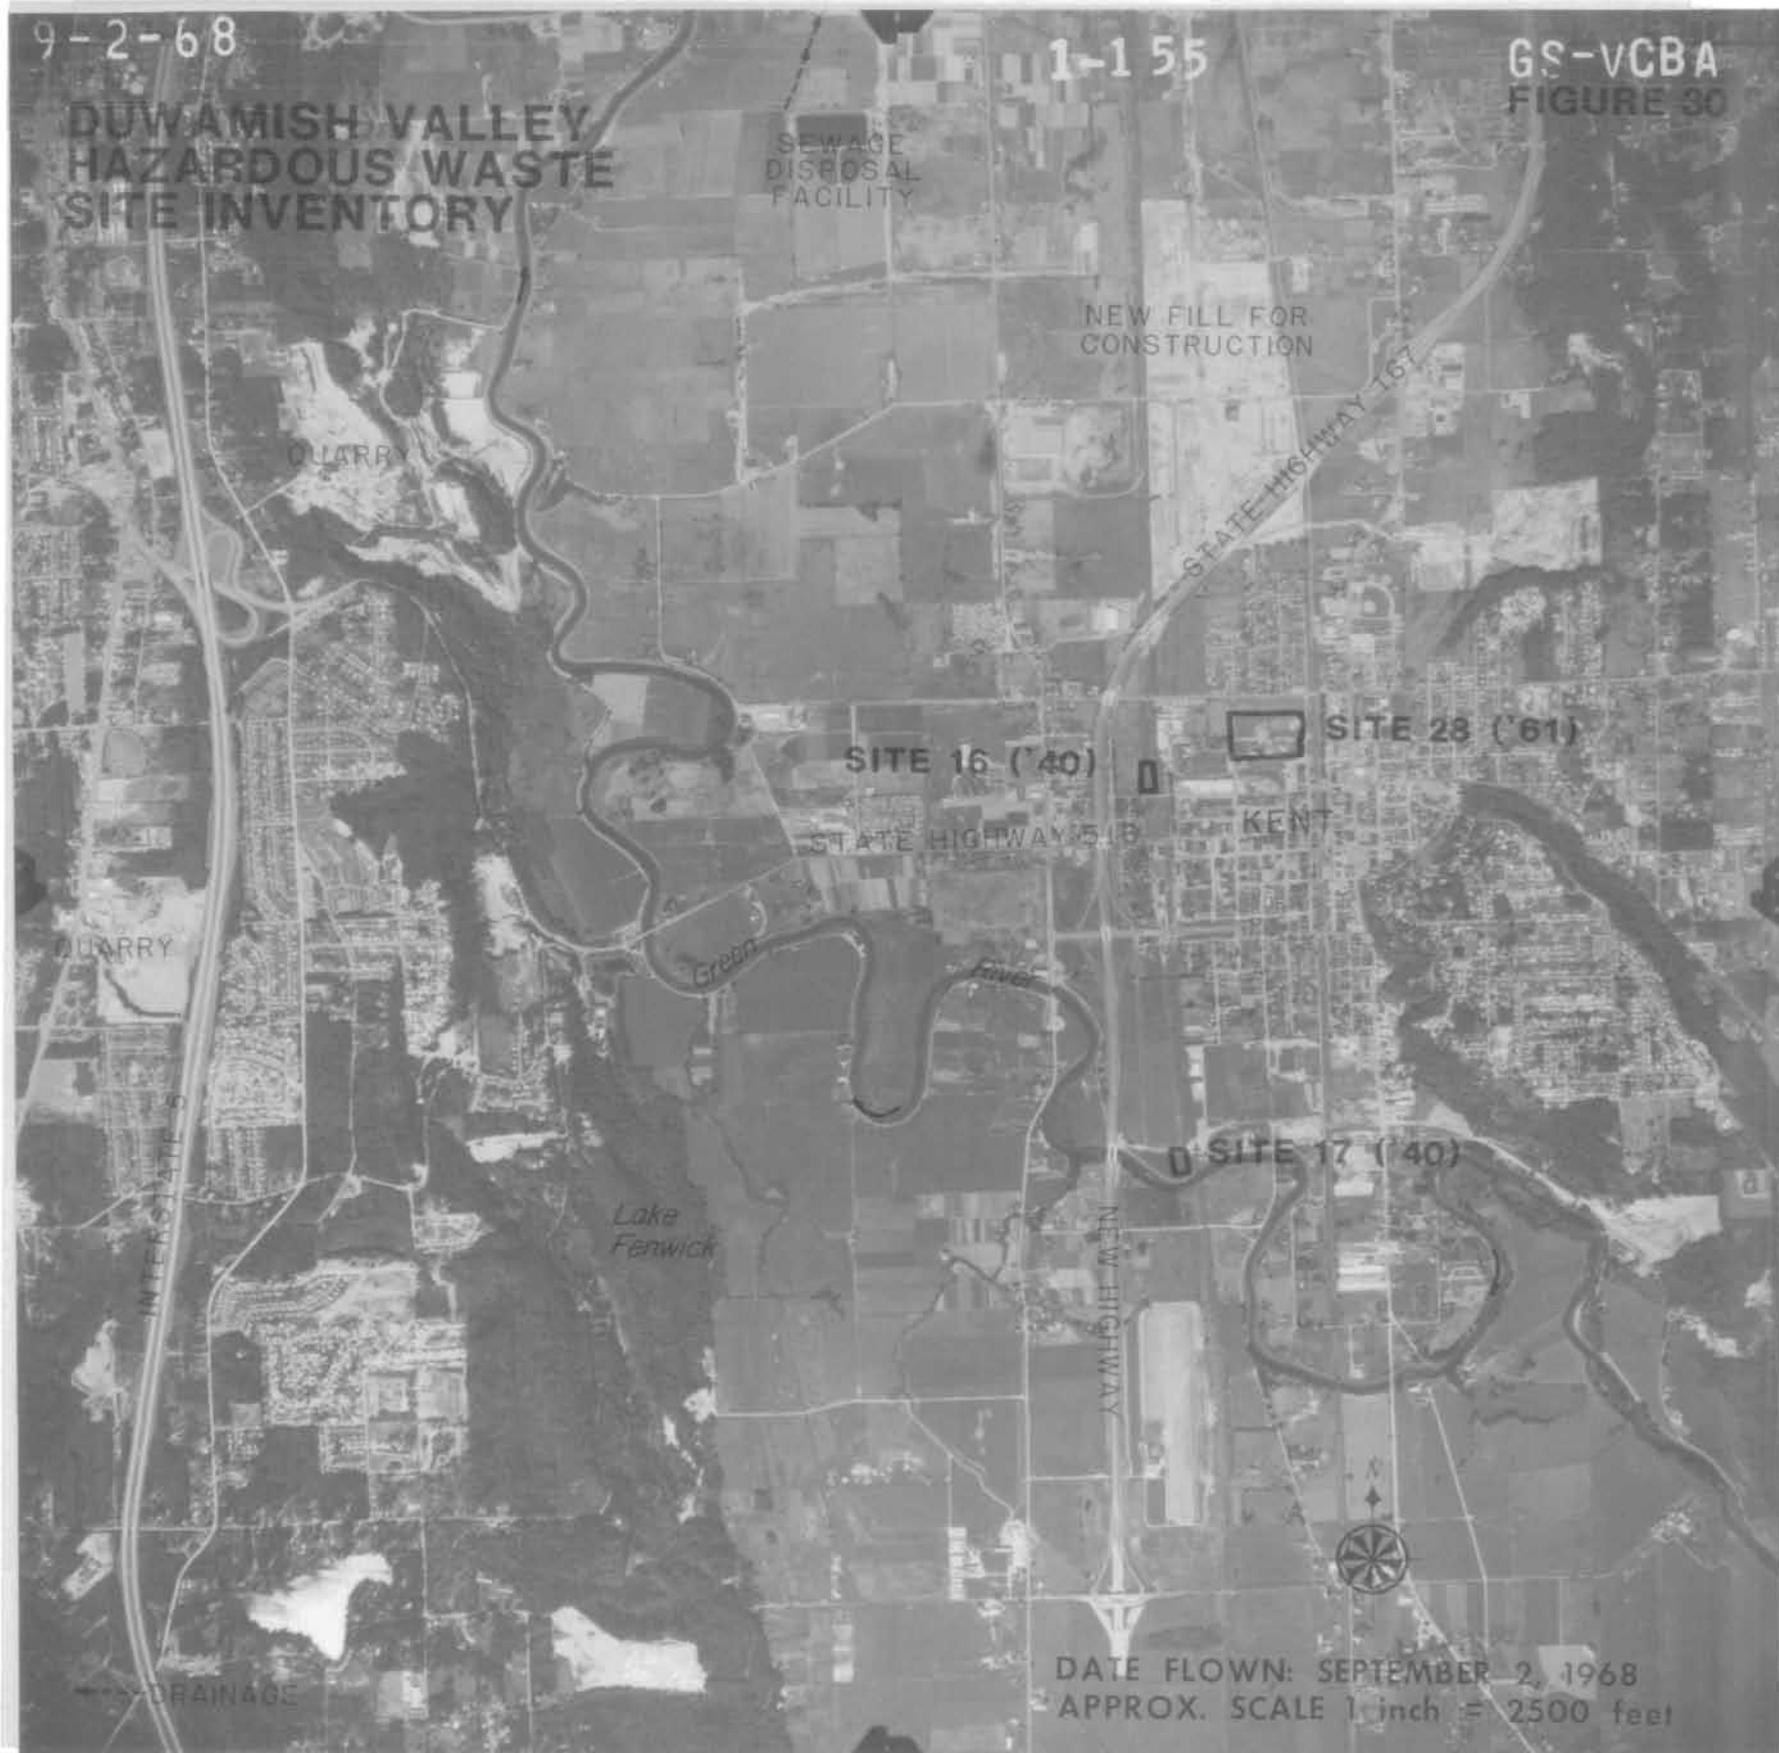
GS-VCBA
FIGURE 30

SITE 28 ('61) - The uncontained tanks appear to have been removed but the two waste ponds remain (Figure 30). A possible dump area is evident east of the waste ponds. There is no evidence of any spills or waste disposal.
