Overview of the Historical Site Assessment For Subarea 5D

April 20, 2011

Santa Susana Field Laboratory
Historical Site Assessment

Draft Technical Memorandum - HSA-5D

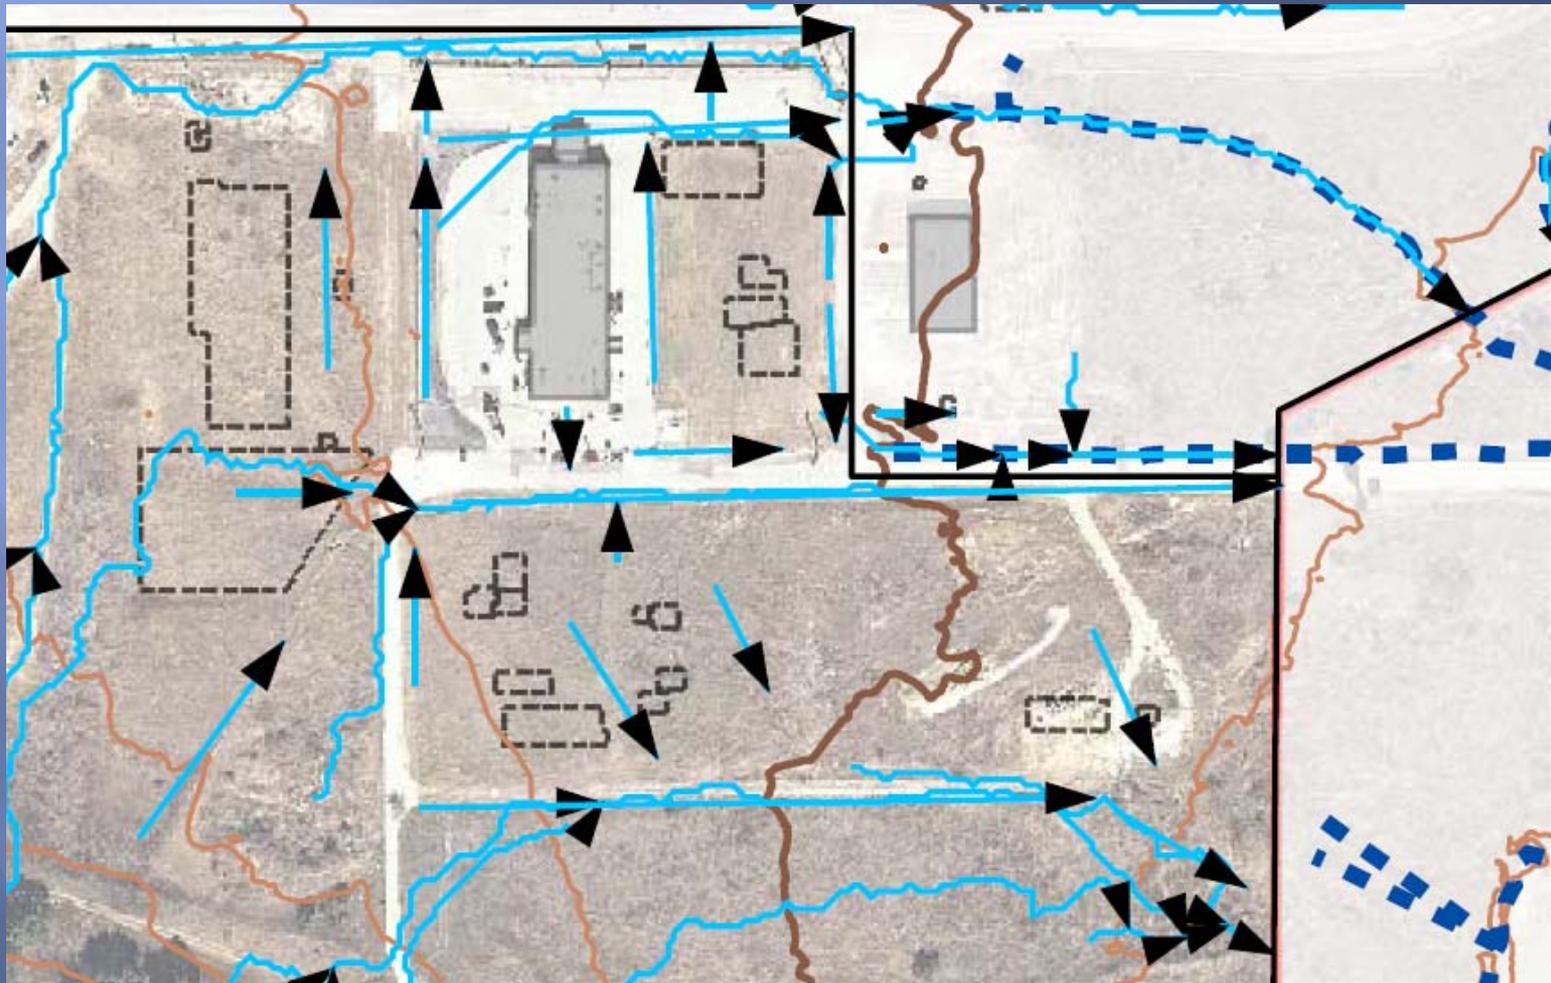
Building 4020 - Migration Pathways

Incident Type	Fire	Air Release	Basement /Other Areas	Spill at Loading Dock	Building Demo	Total # of Incidents
Release to Environment	4	2	5	4	4	19
Personnel Exposure - no evidence of release to environment						112
Total Incidents						131

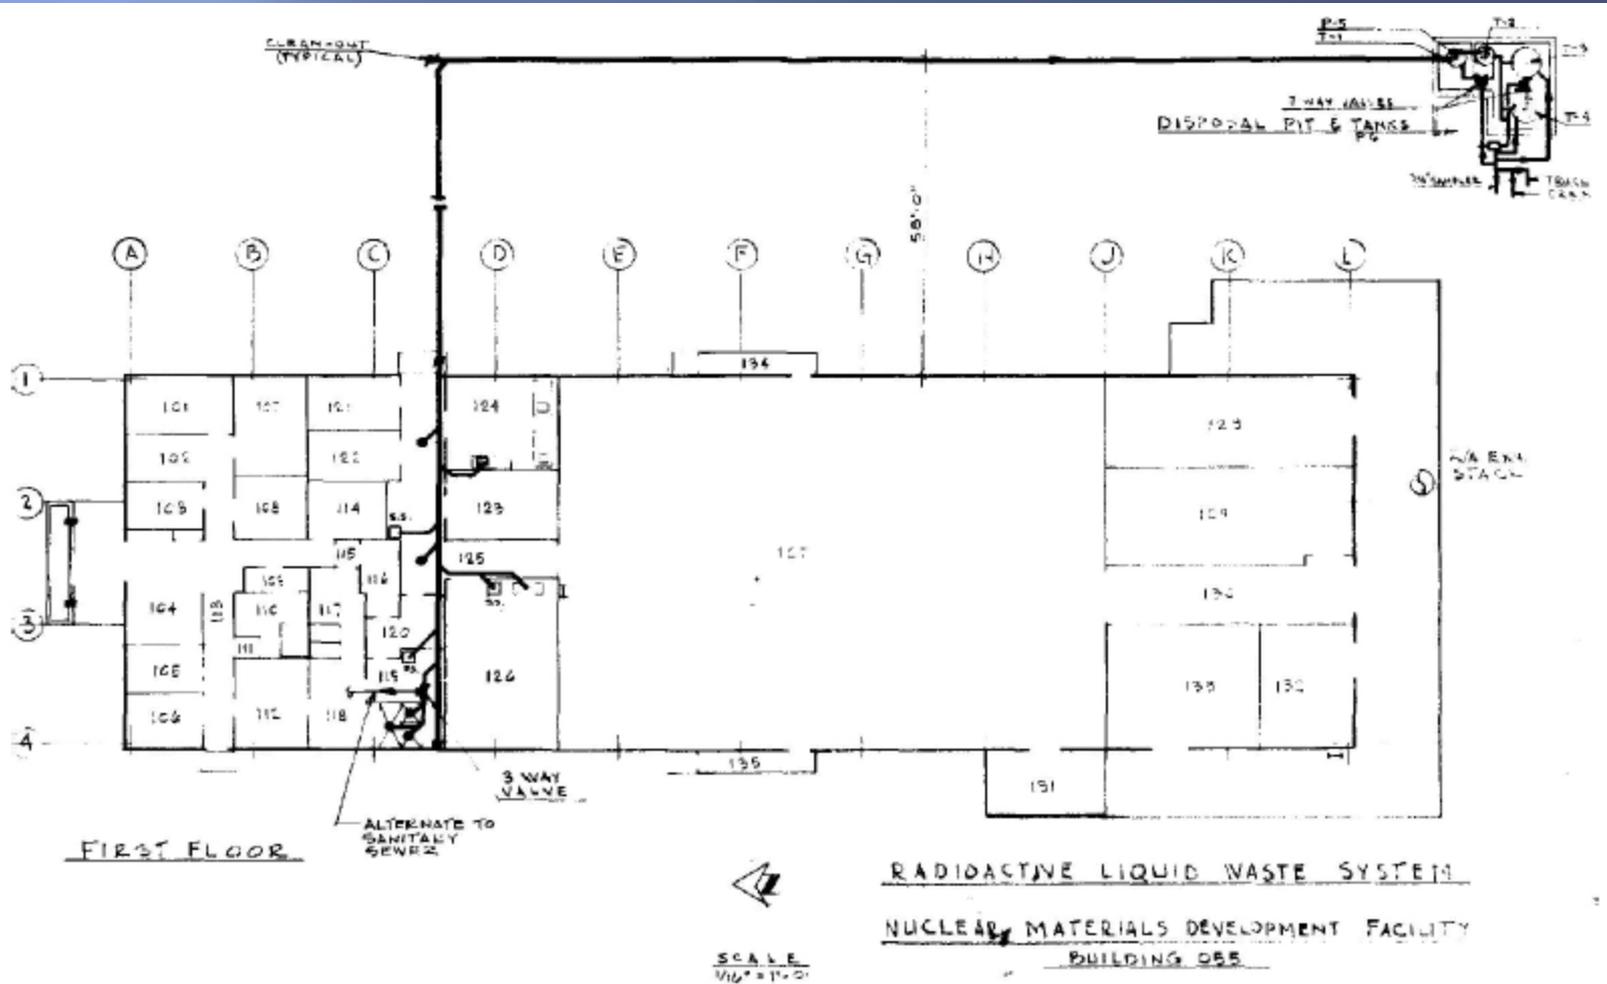
Building 4055 - Liquid Waste Holdup System

Incident Type	Fire	Air Release	Waste Handling Areas	Spill at Loading Dock	Total # of Incidents
Release to Environment	0	3	1	1	5
Personnel Exposure - no evidence of release to environment					15
Total Incidents					20

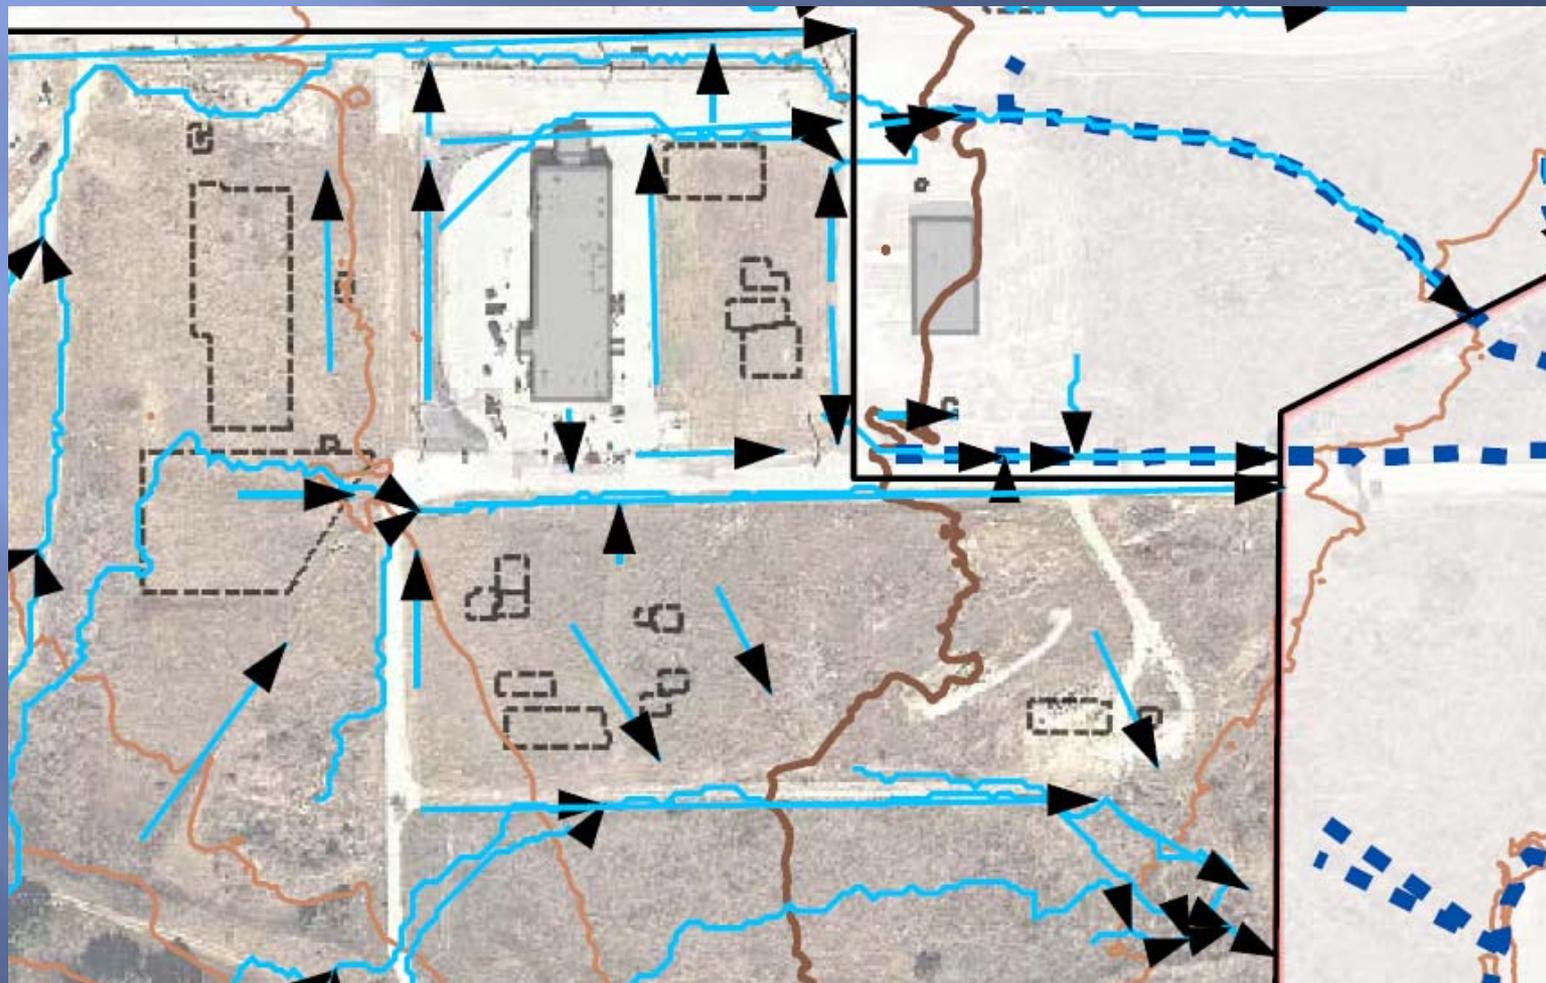
Building 4373 - Migration Pathways

- ▣ SNAP Critical Facility
- ▣ Operations 1956 to 1967
- ▣ Building built for testing and handling of high explosive solid rocket fuels but used for critical assembly research in support of SNAP program
- ▣ No liquid waste holdup system
- ▣ No documented incidents – however, in 1995, contaminated radioactive prefilters found on roof of building
- ▣ 1999 Building demolished

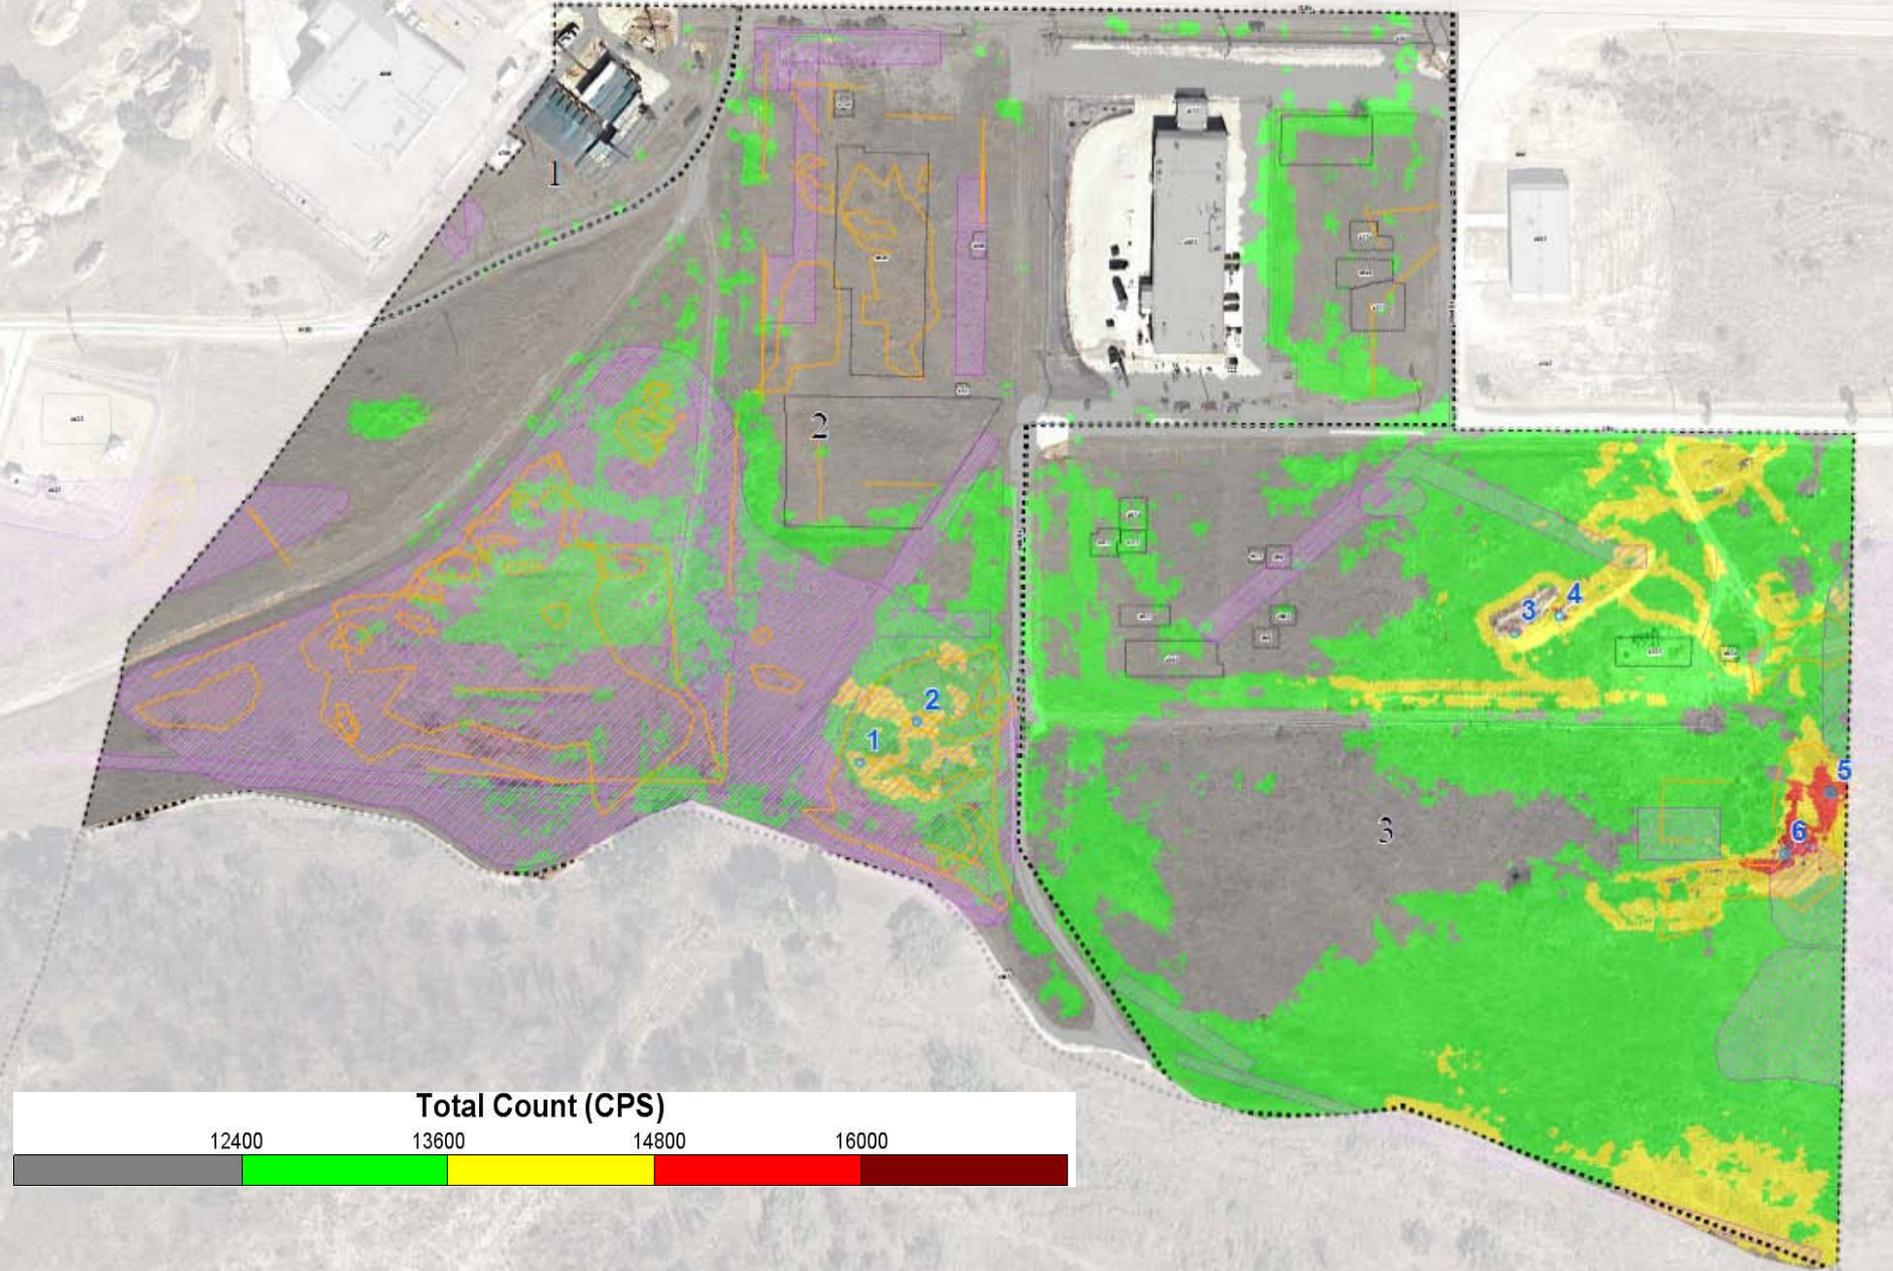
Subarea 5D North Potential GRAYs

Potential GRAY	Evaluation
1, 2, 5, 6	Suspect due to another line of evidence at the location
3, 4	NORM
NORM is Naturally Occurring Radioactive Materials (Uranium, Thorium, and Potassium-40)

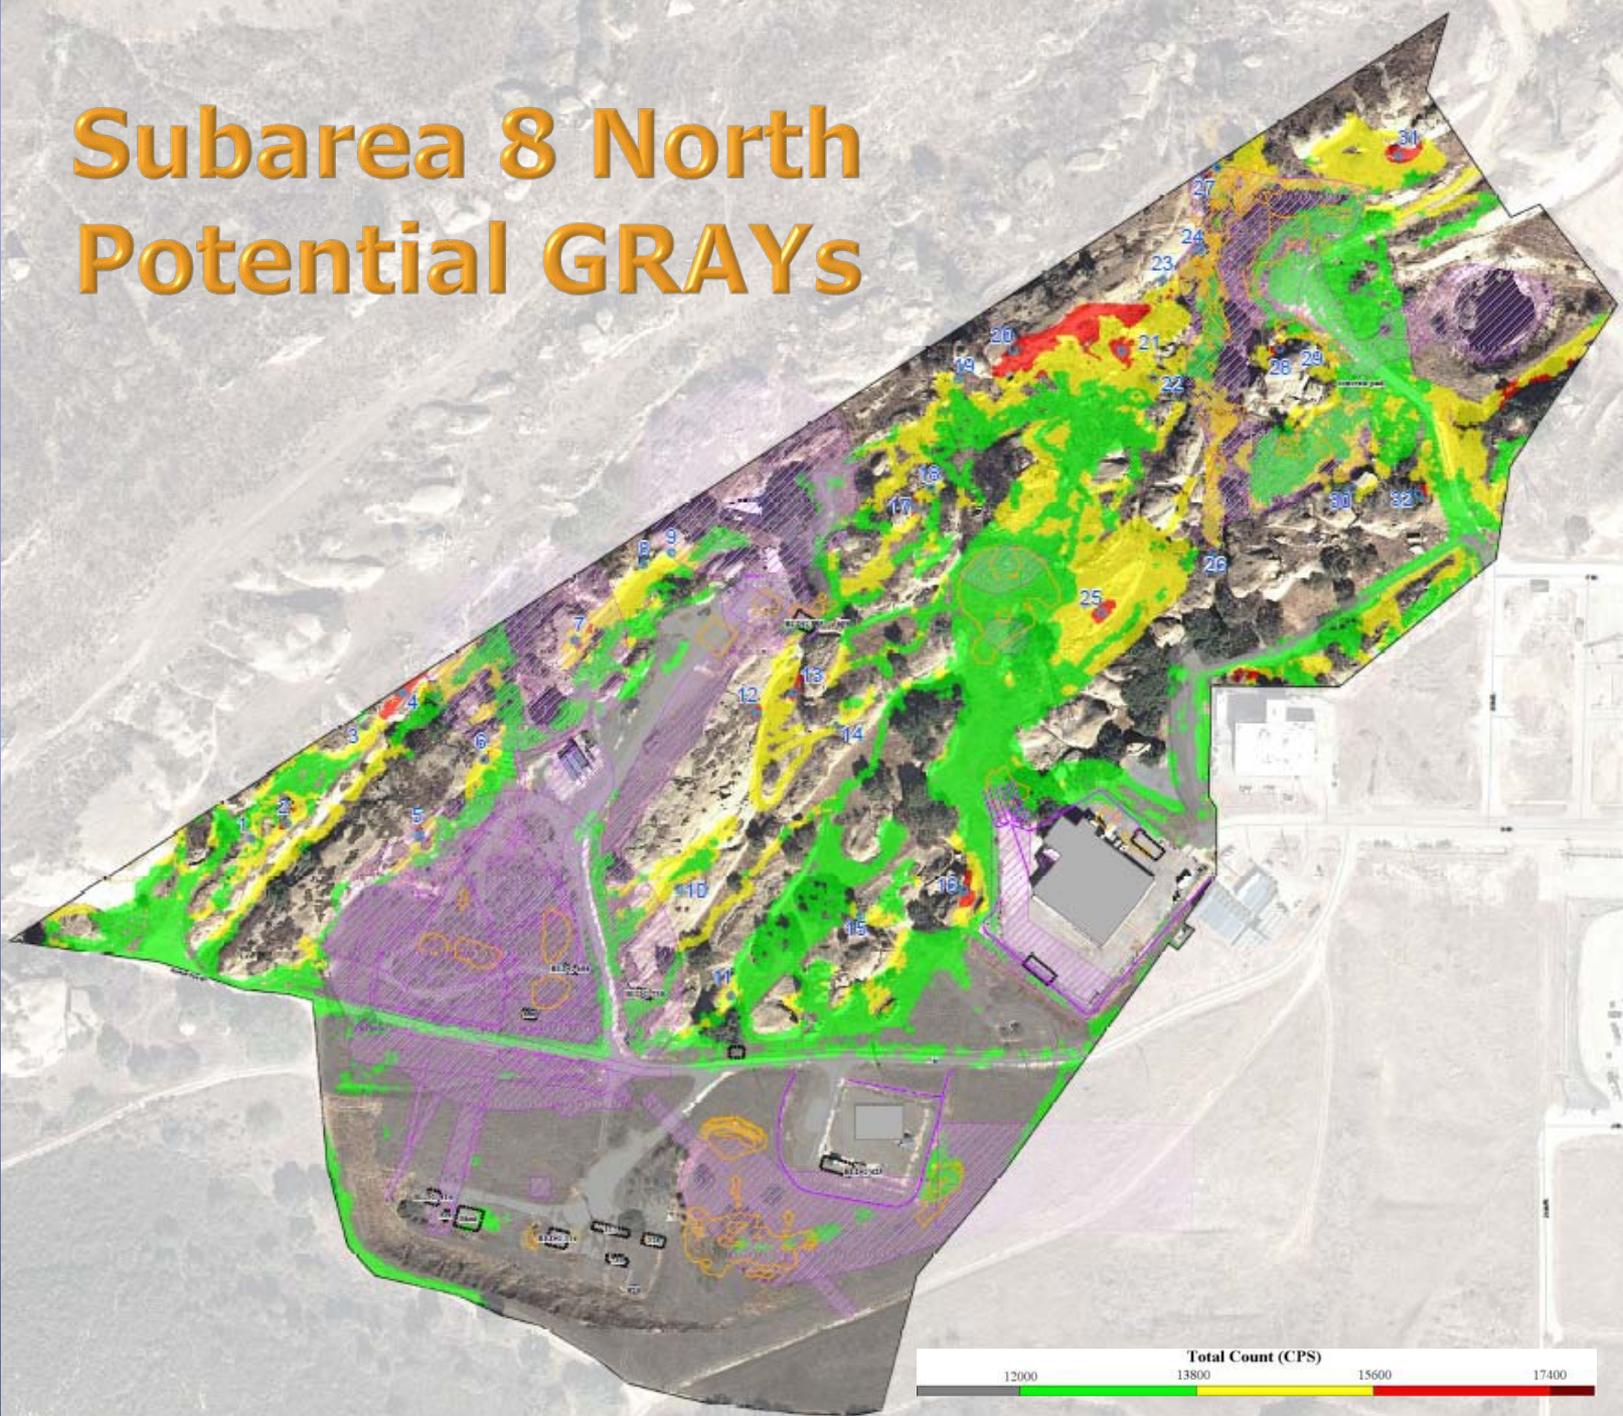
Subarea 8 North Potential GRAYs

Potential GRAY	Evaluation
15 & 30	NORM
11, 18, 26	Sites too wet to verify
5, 7, 9, 24, 26, 27	Suspect due to another line of evidence at the location
NORM is Naturally Occurring Radioactive Materials (Uranium, Thorium, and Potassium-40)
