Attachment 7
Site Inspection Report

Site Inspection Report

Des Moines TCE Site
September 2007

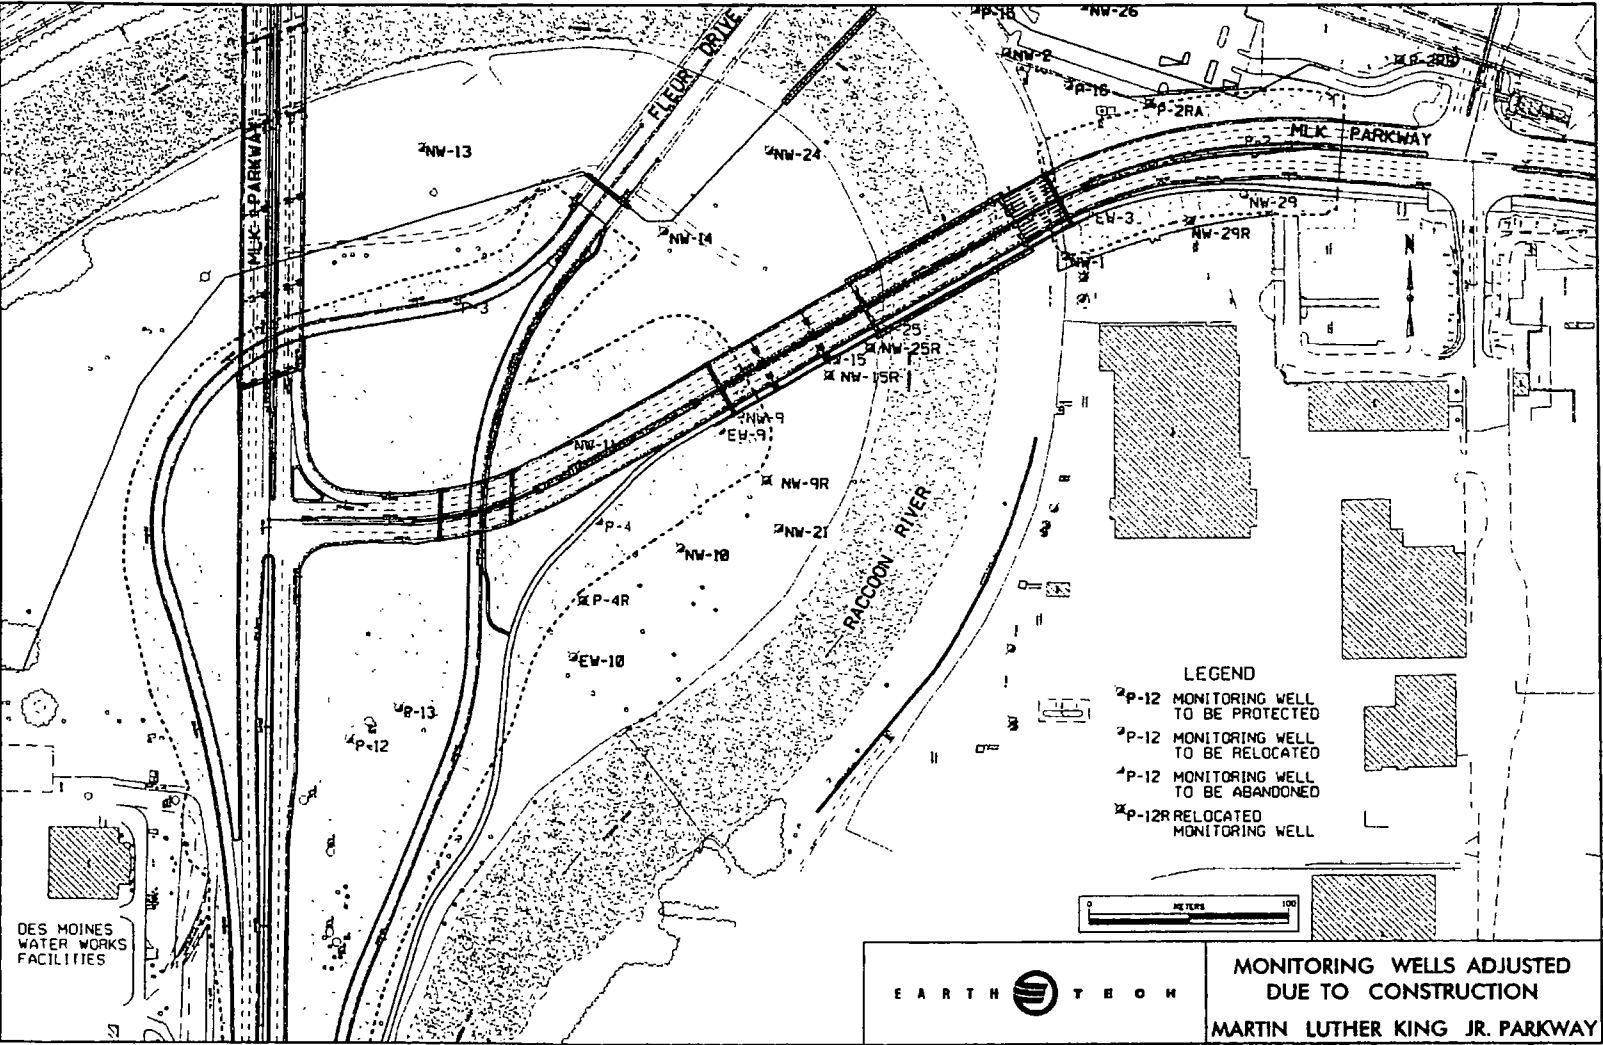
Please find enclosed a location map showing the final monitoring well impacts at the Des Moines TCE Superfund Site caused by the construction of the Martin Luther King, Jr. Parkway Project and the Raw Water Main Relocation Project. In all, seven (7) monitoring wells and four (4) piezometers were impacted. Four (4) wells and two (2) piezometers were replaced during construction as required in the Third Supplement to the Technical Proposal and Plan of Action. (Copy of Attachment 2, Revised Page 1 is attached.) The following list shows the wells and piezometers that were abandoned, as well as those that were replaced.

<u>Wells and Piezometers Abandoned</u>	<u>Replacement Wells and Piezometers</u>
P-2	P-2A, P-2B
P-3	
P-4	P-4R
P-12	
EW-3	
EW-9	
NW-9	NW-9R
NW-11	
NW-15	NW-15R
NW-25	NW-25R
NW-29	NW-29R

Please note that piezometer P-2 was replaced under both construction projects. Both replacement piezometers may be used for testing purposes.
