# DAMAGE TO THE HISTORIC TOWN OF STAUFEN (GERMANY) CAUSED BY GEOTHERMAL DRILLINGS THROUGH ANHYDRITE-BEARING FORMATIONS

## Ingo SASS<sup>1</sup> & Ulrich BURBAUM<sup>2</sup>

ACTA CARSOLOGICA 39/2, 233-245, POSTOJNA 2010

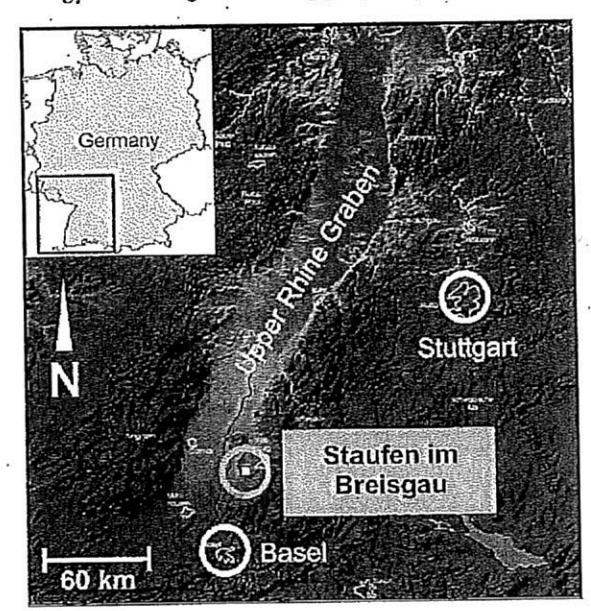
Fig. 1: Staufen im Breisgau.

Staufen im Breisgau (Staufen) is located in the southwestern Germany on the western flank of the Upper Rhine Valley graben (Fig. 1). The drilling of seven shallow borehole heat exchangers (BHE) at the City of Staufen triggered a series of events in completely different domains that have caused a very problematic situation. The complicated process is not completely investigated today. Since the installation of the BHE in September 2007, the subsoil in the inner city shows an uplift of up to approximately 10 mm/month (LGRB 2009). The current cumulative value (as of March 2010) is approximately 26 cm. The geothermal wells were drilled up to 140 m depth, and were intended to supply the town hall with geothermal energy for heating and cooling purposes.

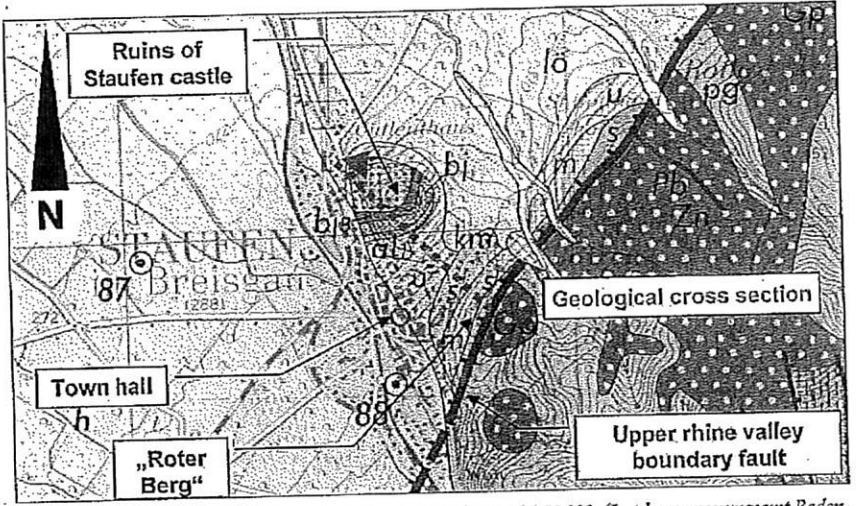
Fig. 6: Modified detail image of the geological map of Freiburg, M 1:50.000. (Landesvermessungsamt Baden Württemberg 1996).

The location of Staufen on the western flank of the Upper Rhine Valley graben (Fig. 6) is affected by complex and partially unexplored tectonic conditions (Landesvermessungsamt Baden-Württemberg 1996). Fig. 7 shows a NW-SE geologic cross-section in the area of the inner city (after Schreiner 1991, as cited in a report by the Landesanstalt für Umweltschutz Baden-Württemberg 2005). Small scale features of shearing, compressive and extensive tectonic movements are typical, and produce multi-phase fracture systems (Geyer & Gwinner 1991).

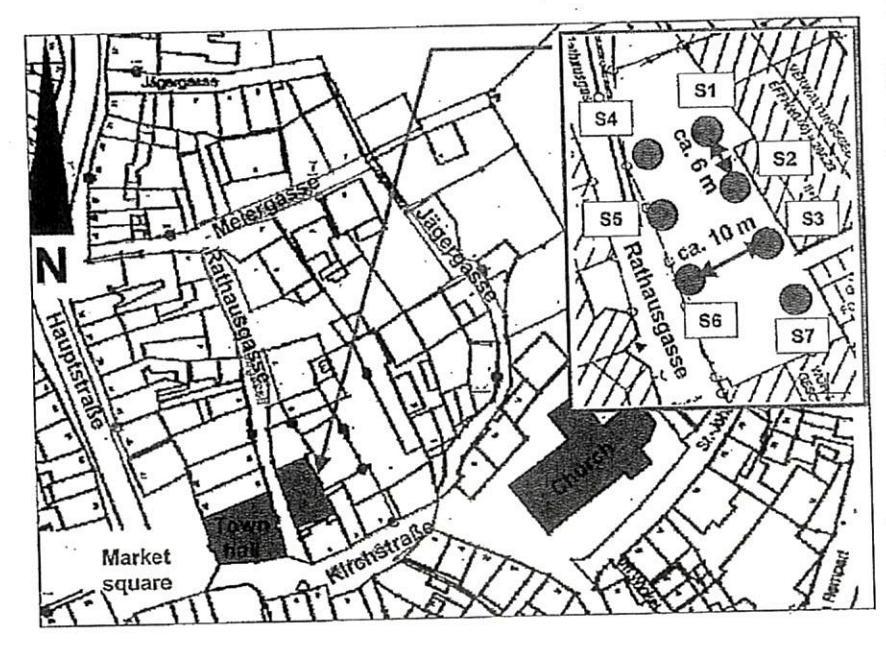
Fig. 11: Site sketch of well locations with interspaces at the city of Staufen town centre.

Well S1 reportedly penetrated artesian groundwater at a depth of 32 m. The piezometric level at the wellhead was at about 0.5 m above ground surface (Report 2007b). All other wells did not encounter artesian conditions (according to residents and the administration of Staufen). It can be concluded that the hydraulic potential of the Muschelkalk karst aquifer was connected

to the borehole S1 via fractures penetrating the Lettenkeuper layers. However, drilling contractor well logs show artesian conditions in all wells. Information on artesian control during drilling operations are missing in the well logs.

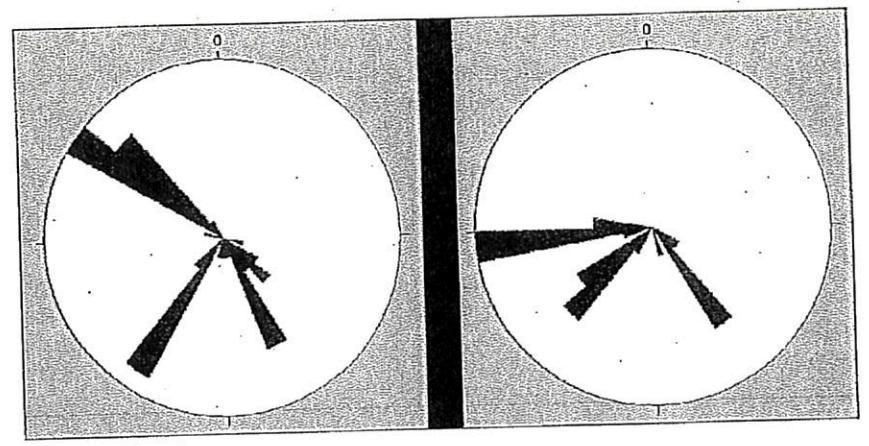
Fig. 19: Rose diagrams of outcrops. Left: Upper Muschelkalk, Right: Hauptrogenstein.

The orientation of building damages corresponds to the orientation of the discontinuities (Figs. 18 and 19) that were obtained by a field study in October 2009. It can be concluded that groundwater not only flows through drillings but now through discontinuities, too. The swelling process therefore cannot be stopped by sealing the BHE-Drillings. A larger area remediation approach must be found.
