**TSCA SECTION 402(c) – RECORDKEEPING / WORK PRACTICE STANDARDS  
INSPECTION REPORT**

**Renovation Firm:** Greenbuild Design & Construction LLC  
**EPA Certification No.:** NAT-F190683-1  
Expired on August 24, 2023

**Renovation Site:** 2208 Turnagain Parkway  
Anchorage, Alaska 99517

**Inspection Date:** July 25, 2018

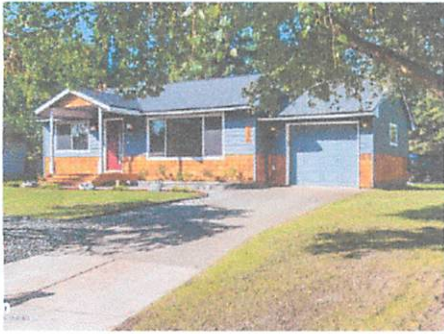
Photo 20180725\_120029.jpg taken July 25, 2018 at 12:00 p.m. shows visible paint chips on bare ground in front of the property to the right of the front porch close to the foundation located at 2208 Turnagain, Anchorage, Alaska. The photograph indicates that no containment was utilized during active renovation work. Photo 20180725\_120057.jpg taken July 25, 2018 at 12:00 p.m. shows visible paint chips on bare ground close to the foundation to the left side of the front porch of the same property. The photograph indicates that no containment was utilized during active renovation work.

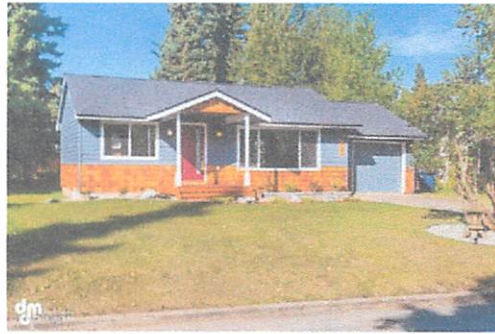
Photo 20180725\_120105.jpg taken July 25, 2018 at 12:01 p.m. shows visible paint chips on bare ground to the left of the house next to the foundation of target property located at 2208 Turnagain, Anchorage, Alaska. The photograph indicates that no containment was utilized
