# Clean Water Act Section 404: Site Visit/Case Development

Site Name: Villegas

Site Name	Villegas	Start Date	May 18, 2022
		End Date	May 18, 2022
Inspection Purpose	Initial site visit		
<b>Opening Conference</b>			
<input checked="" type="checkbox"/> Presentation of Inspector Credentials			
Name and Title (Use N/A if owner/operator not available to join the inspection)			
N/A			
<input checked="" type="checkbox"/> Opening Conference			
Name of person authorizing access if applicable			
Tom Villegas through his attorney Stephen Mossman			
Notes from Opening Conference			
No opening conference took place since Mr. Villegas was unable to be at the site during the inspection.			
<input checked="" type="checkbox"/> Access Issues if Any			
Describe			
Was initially told that Mr. Villegas would be meeting us at the site at 9:00 am on May 18, 2022. When Mr. Simmons and I arrived at the site nobody was present. After waiting for approximately half an hour I called Natasha Goss (assigned EPA Attorney) and asked that she check with Mr. Villega's attorney (Stephen Mossman) to see if Mr. Villegas would be joining us. Mr. Mossman indicated that Mr. Villegas would not be able to join us for the

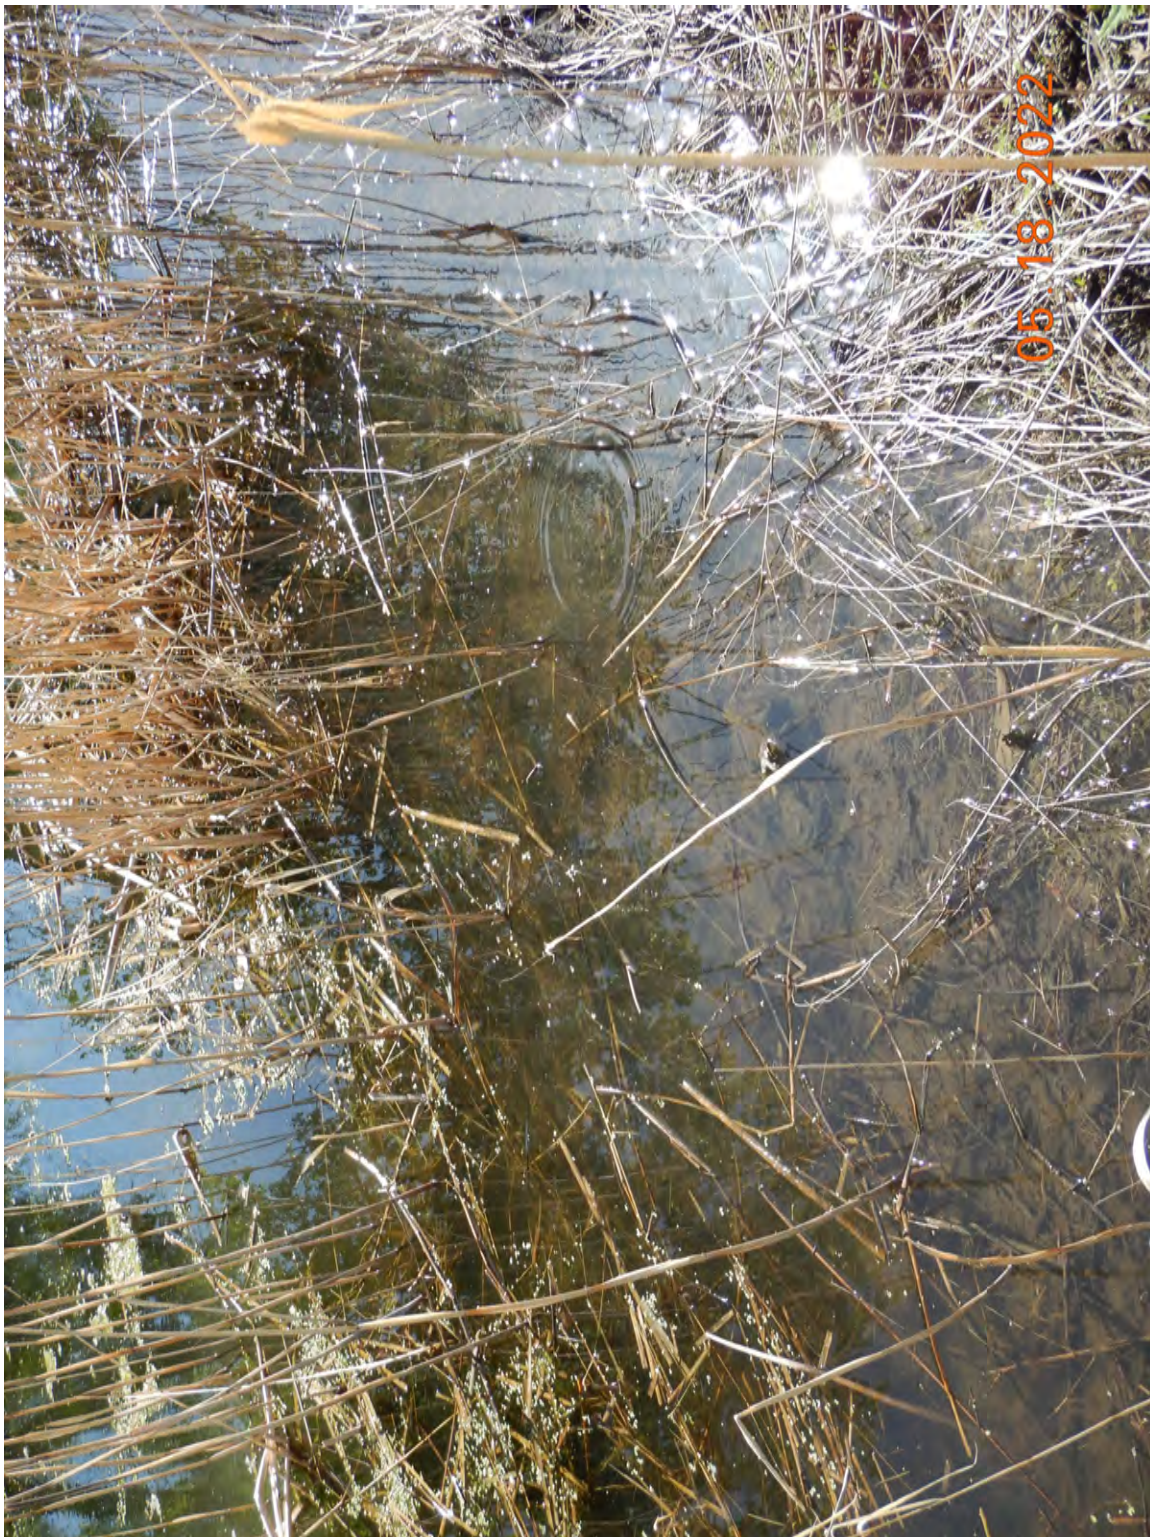
Photo 2

D. Garcia	05/18/22	0951	DSCN013.JPG	2	Frog within channel (bottom center third of photograph).
D. Garcia	05/18/22	0954	DSCN014.JPG	3	Facing berm created from sidecasted material that was excavated from channel.

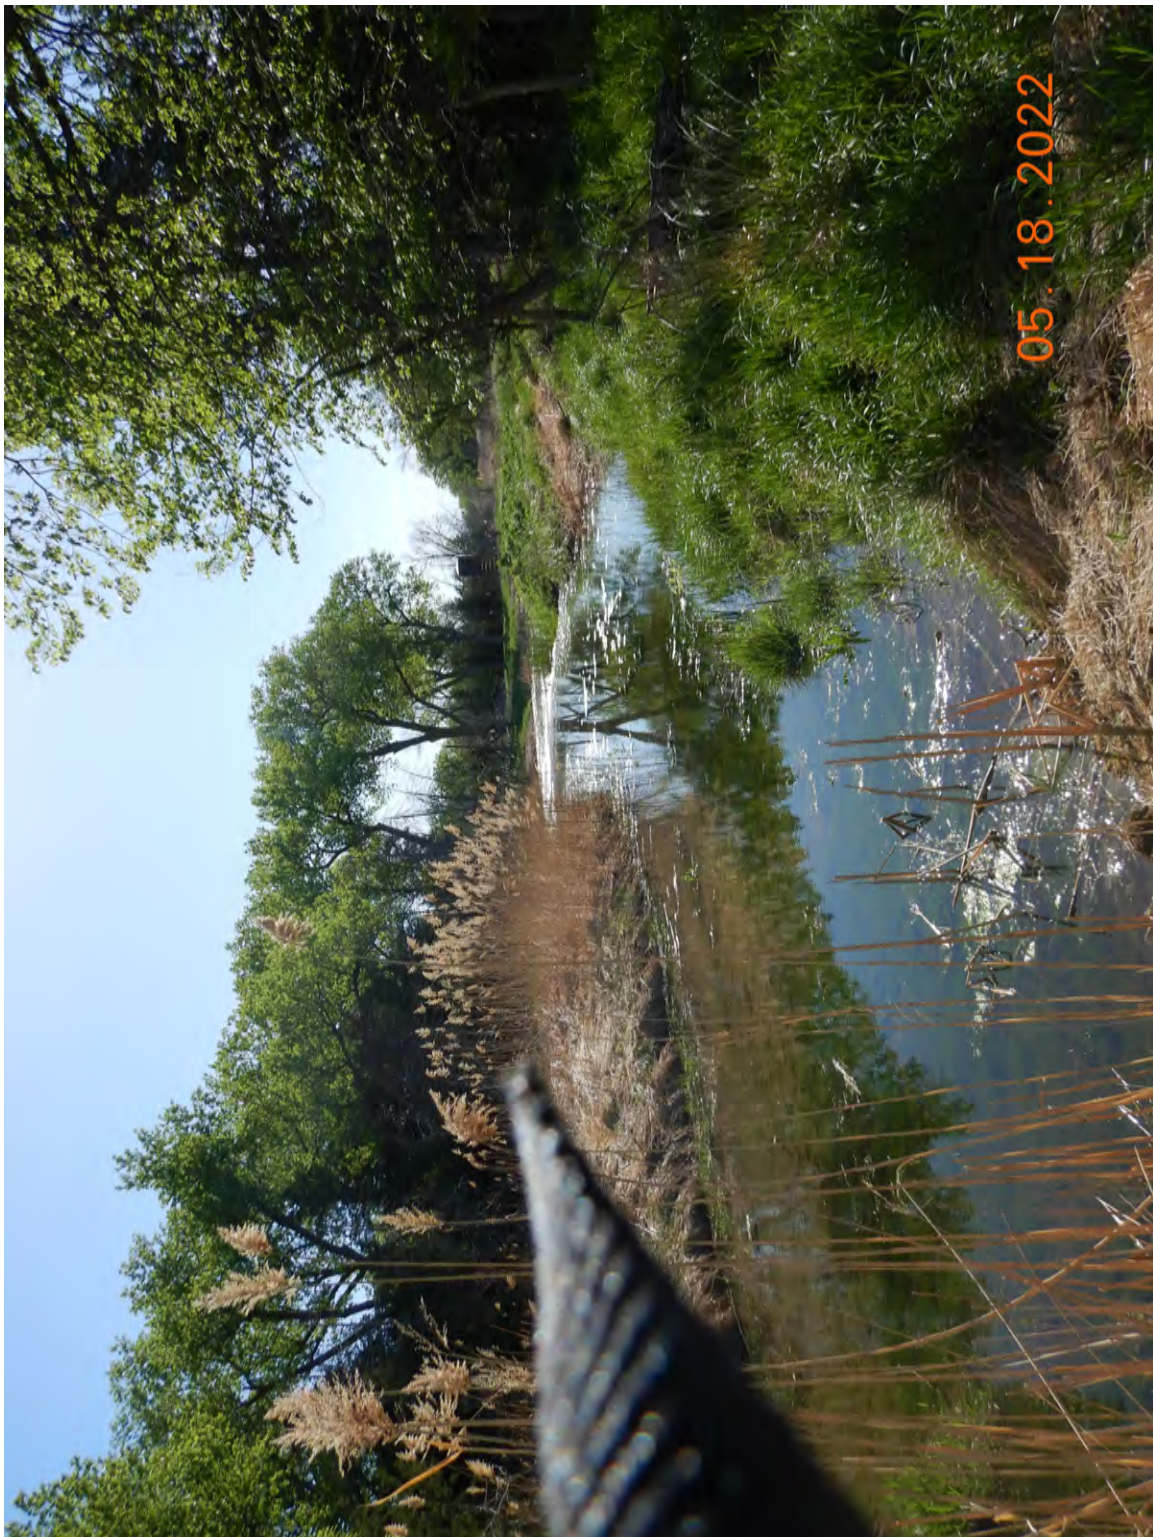
Photo 8

D. Garcia	05/18/22	1000	DSCN0018.JPG	7	Looking at another stream crossing (A4) located to the west of crossing 1
D. Garcia	05/18/22	1002	DSCN0019.JPG	8	Looking at stream channel just west of crossing in Photo 7. There were some minnows present within this channel but photograph did not capture them.

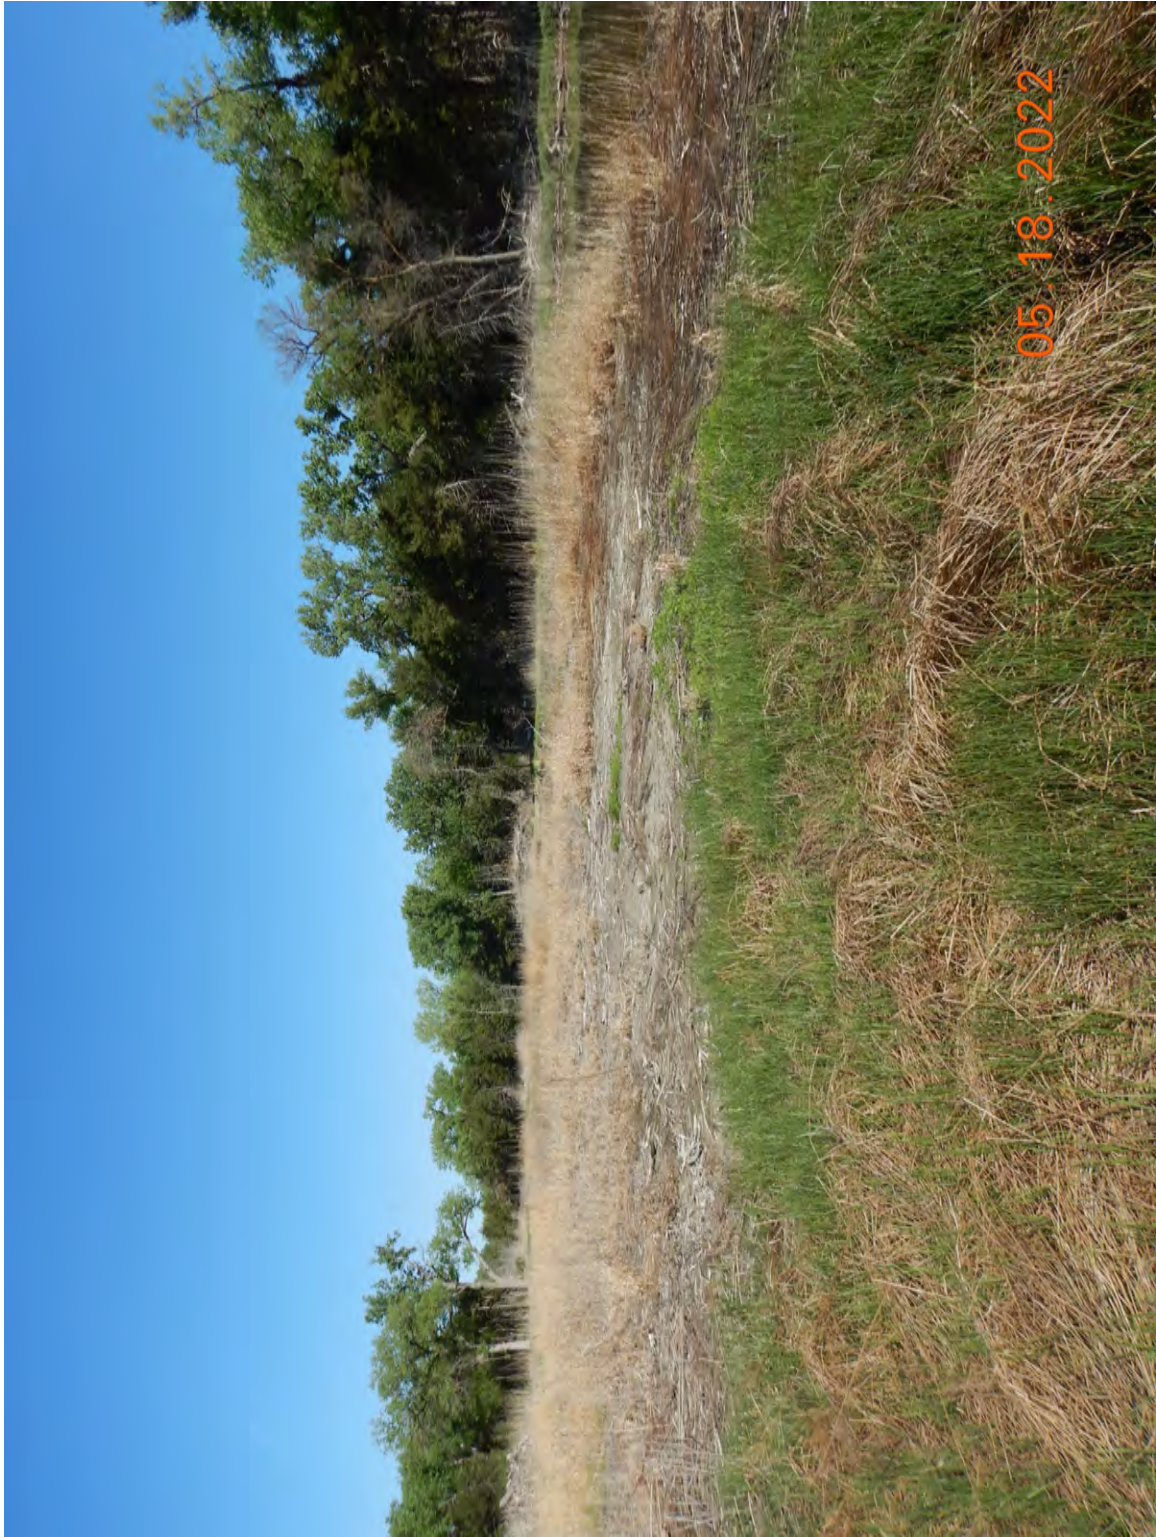
Photo 10

D. Garcia	05/18/22	1013	DSCN0021.JPG	10	Near the edge of the berm, looking at one of the cleared areas.
D. Garcia	05/18/22	1014	DSCN0022.JPG	11	Looking straight down at edge of berm crated from sidcasted excavated material.

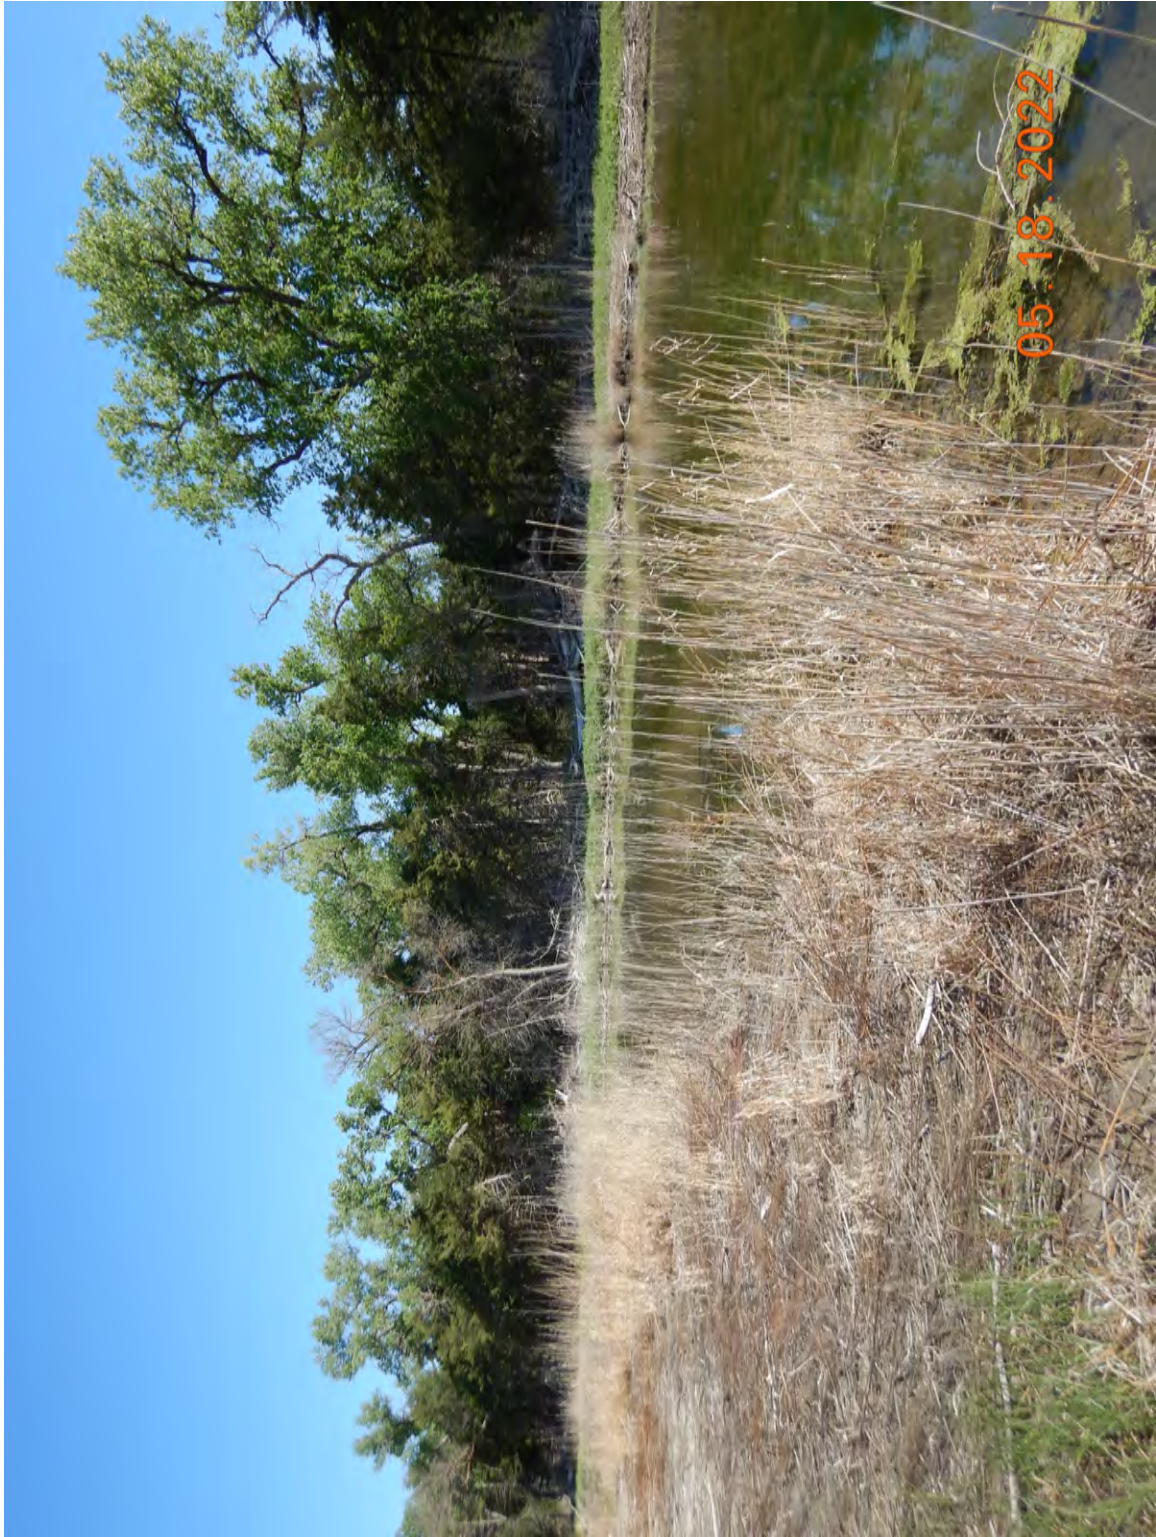
Photo 13

D. Garcia	05/18/22	1014	DSCN0023.JPG	12	Looking at stream channel that was excavated and expanded to create more of a pond.
D. Garcia	05/18/22	1015	DSCN0024.JPG	13	Taken from same location as Photo 12 but facing the other direction.

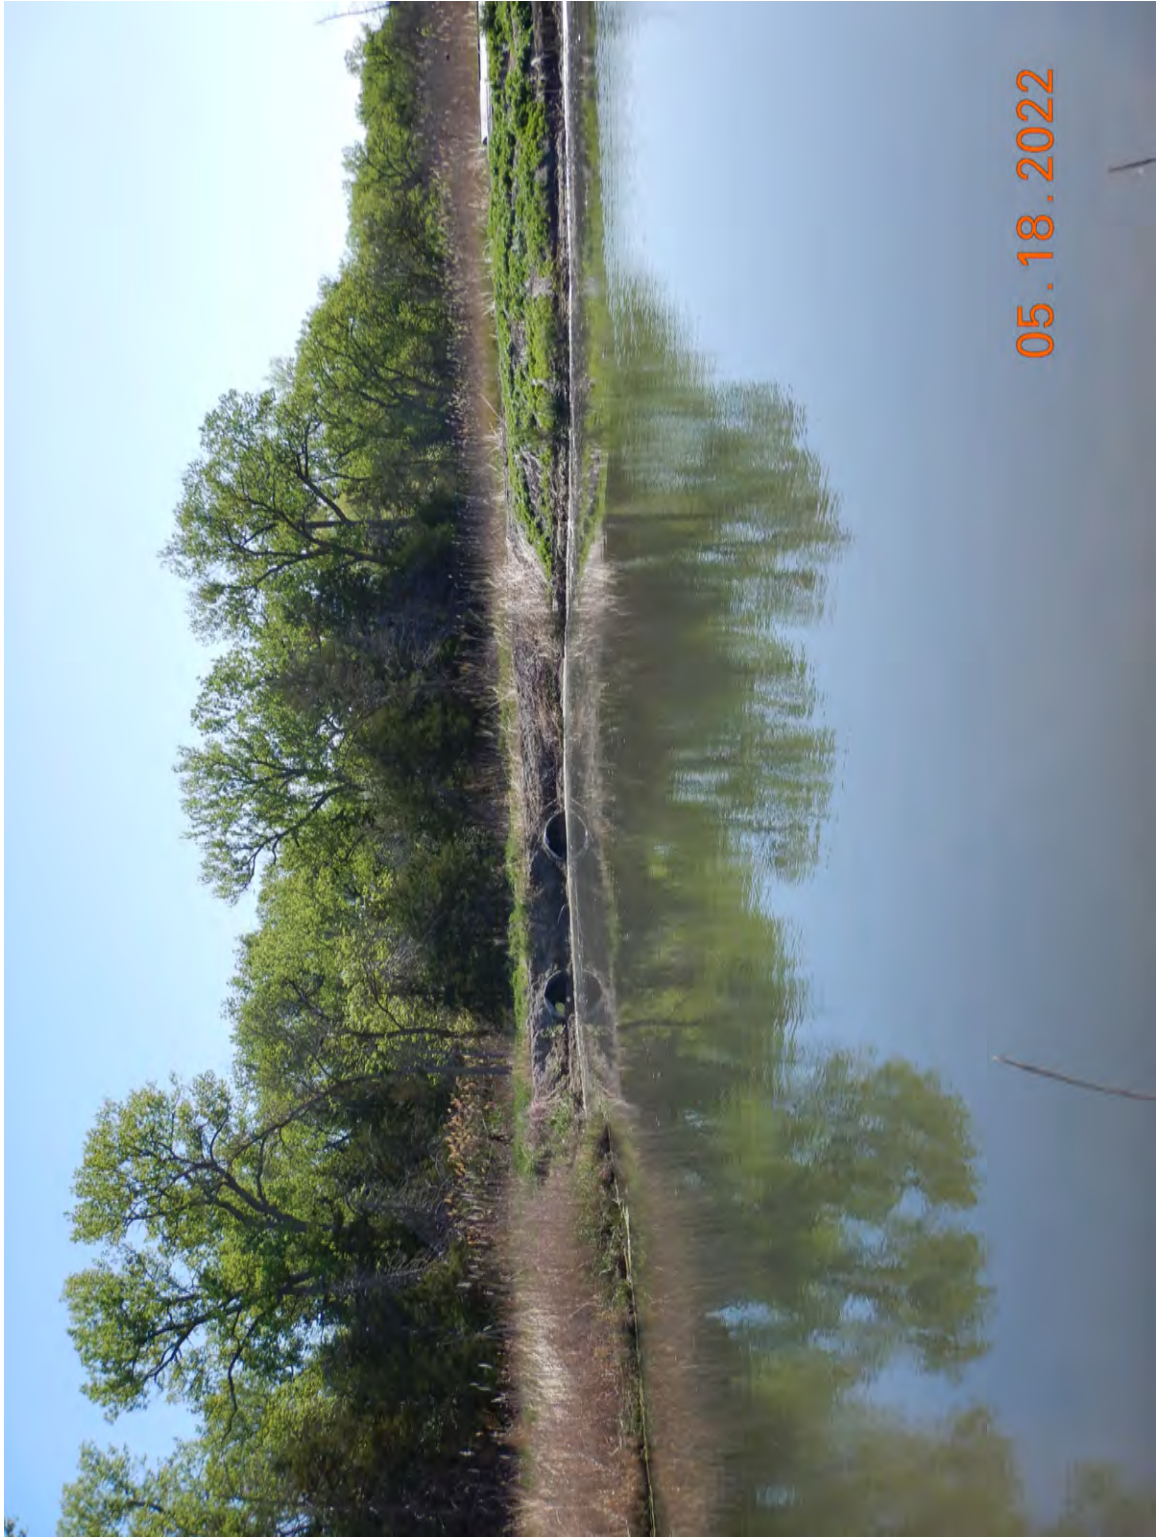
Photo 14

D. Garcia	05/18/22	1017	DSCN0025.JPG	14	Looking at stream crossing 4.
D. Garcia	05/18/22	1017	DSCN0026.JPG	15	Looking at waterfowl blind (metal/white looking object towards center of photograph) in - between stream crossings 3 and 4.

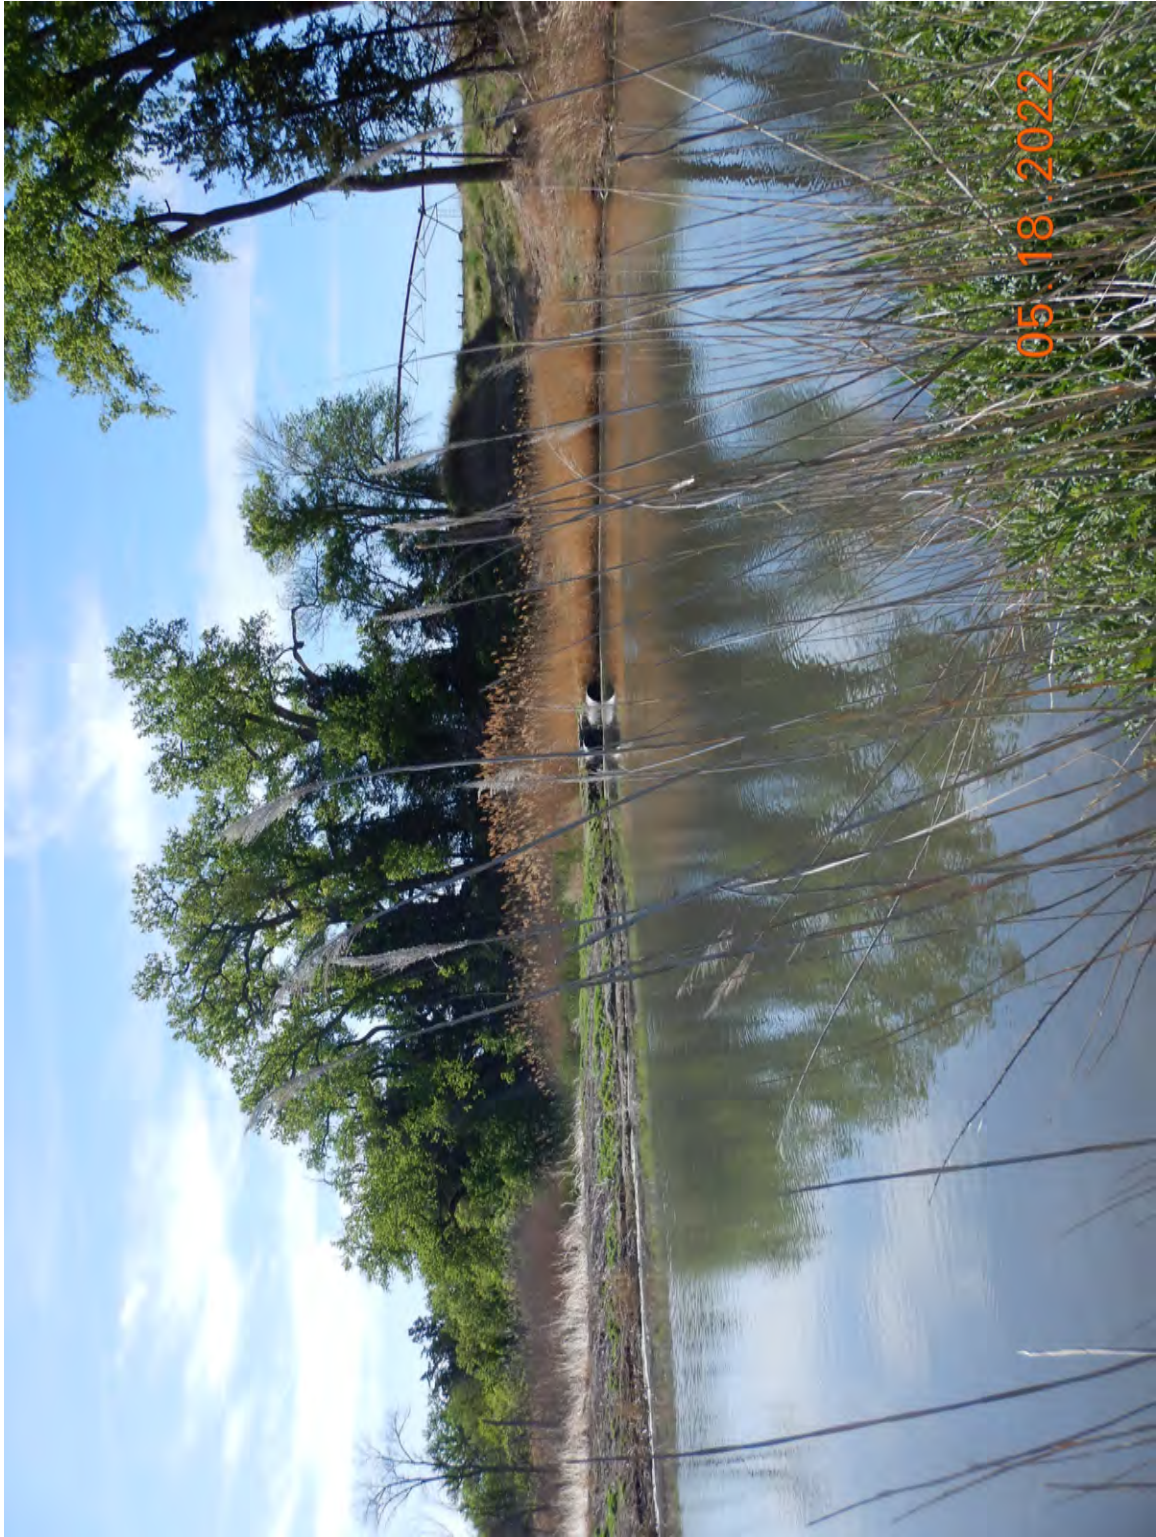
Photo 16

D. Garcia	05/18/22	1017	DSCN0027.JPG	16	Looking at stream crossing 3.
D. Garcia	05/18/22	1022	DSCN0028.JPG	17	Looking down at silt and algae within excavated stream channel.

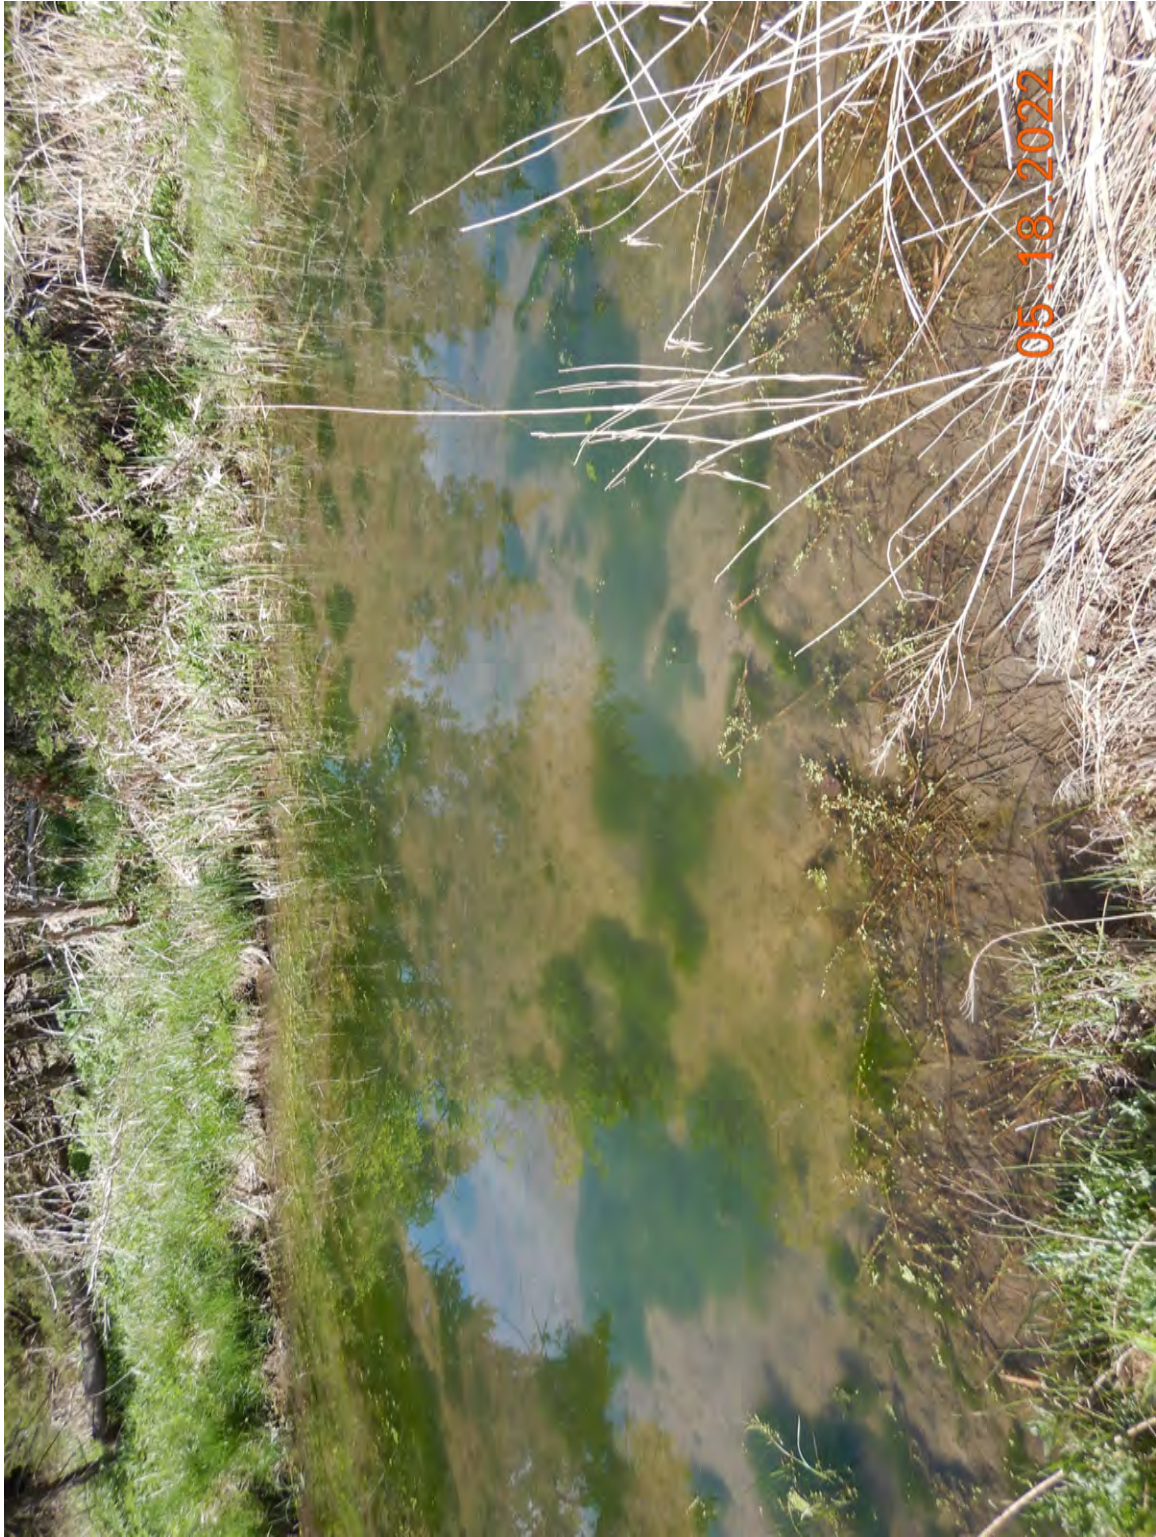
Photo 18

D. Garcia	05/18/22	1022	DSCN0029.JPG	18	Same as photo 18, just slightly different angle.
D. Garcia	05/18/22	1024	DSCN0030.JPG	19	Looking at culvert in stream crossing (A3).

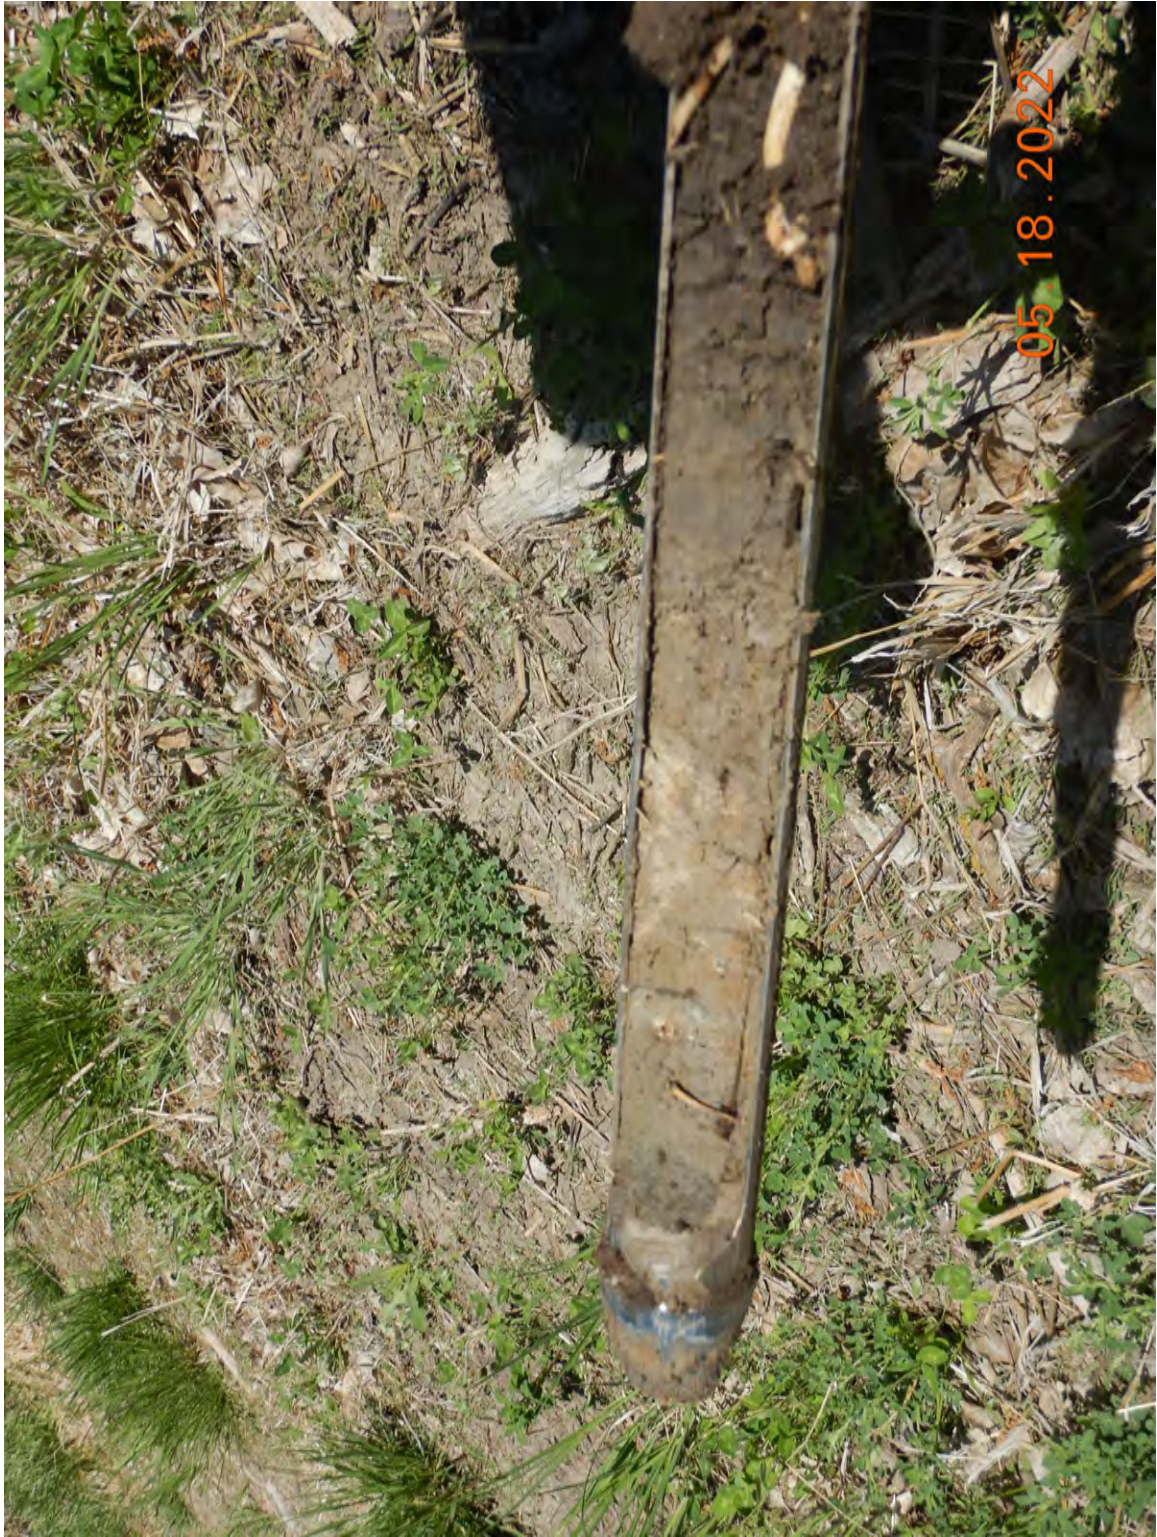
Photo 20

D. Garcia	05/18/22	1027	DSCN0031.JPG	20	Soil core sample, hydric soil present.
D. Garcia	05/18/22	1035	DSCN0032.JPG	21	Pile of cleared trees.
D. Garcia	05/18/22	1039	DSCN0033.JPG	22	Stream crossing 2.

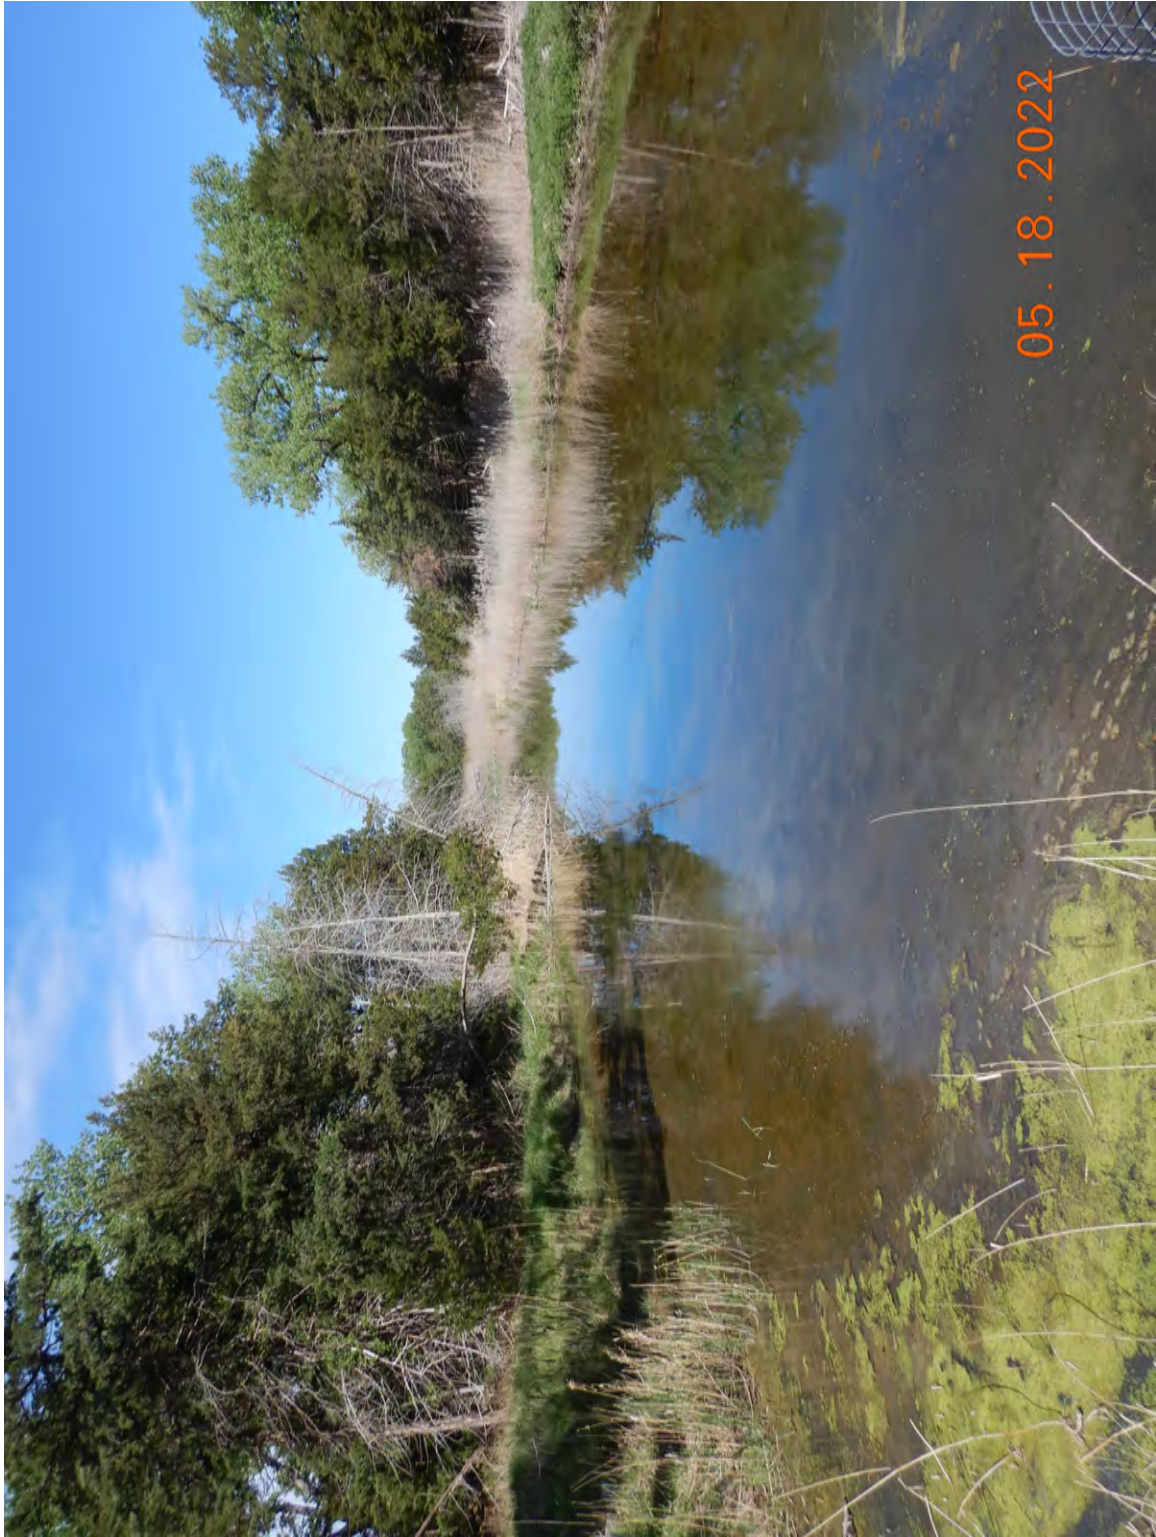
Photo 23

D. Garcia	05/18/22	1039	DSCN0034.JPG	23	Looking at excavated stream channel on which stream crossing 2 was built.
D. Garcia	05/18/22	1039	DSCN0035.JPG	24	Looking at excavated stream channel, opposite view from that shown on Photo 23.

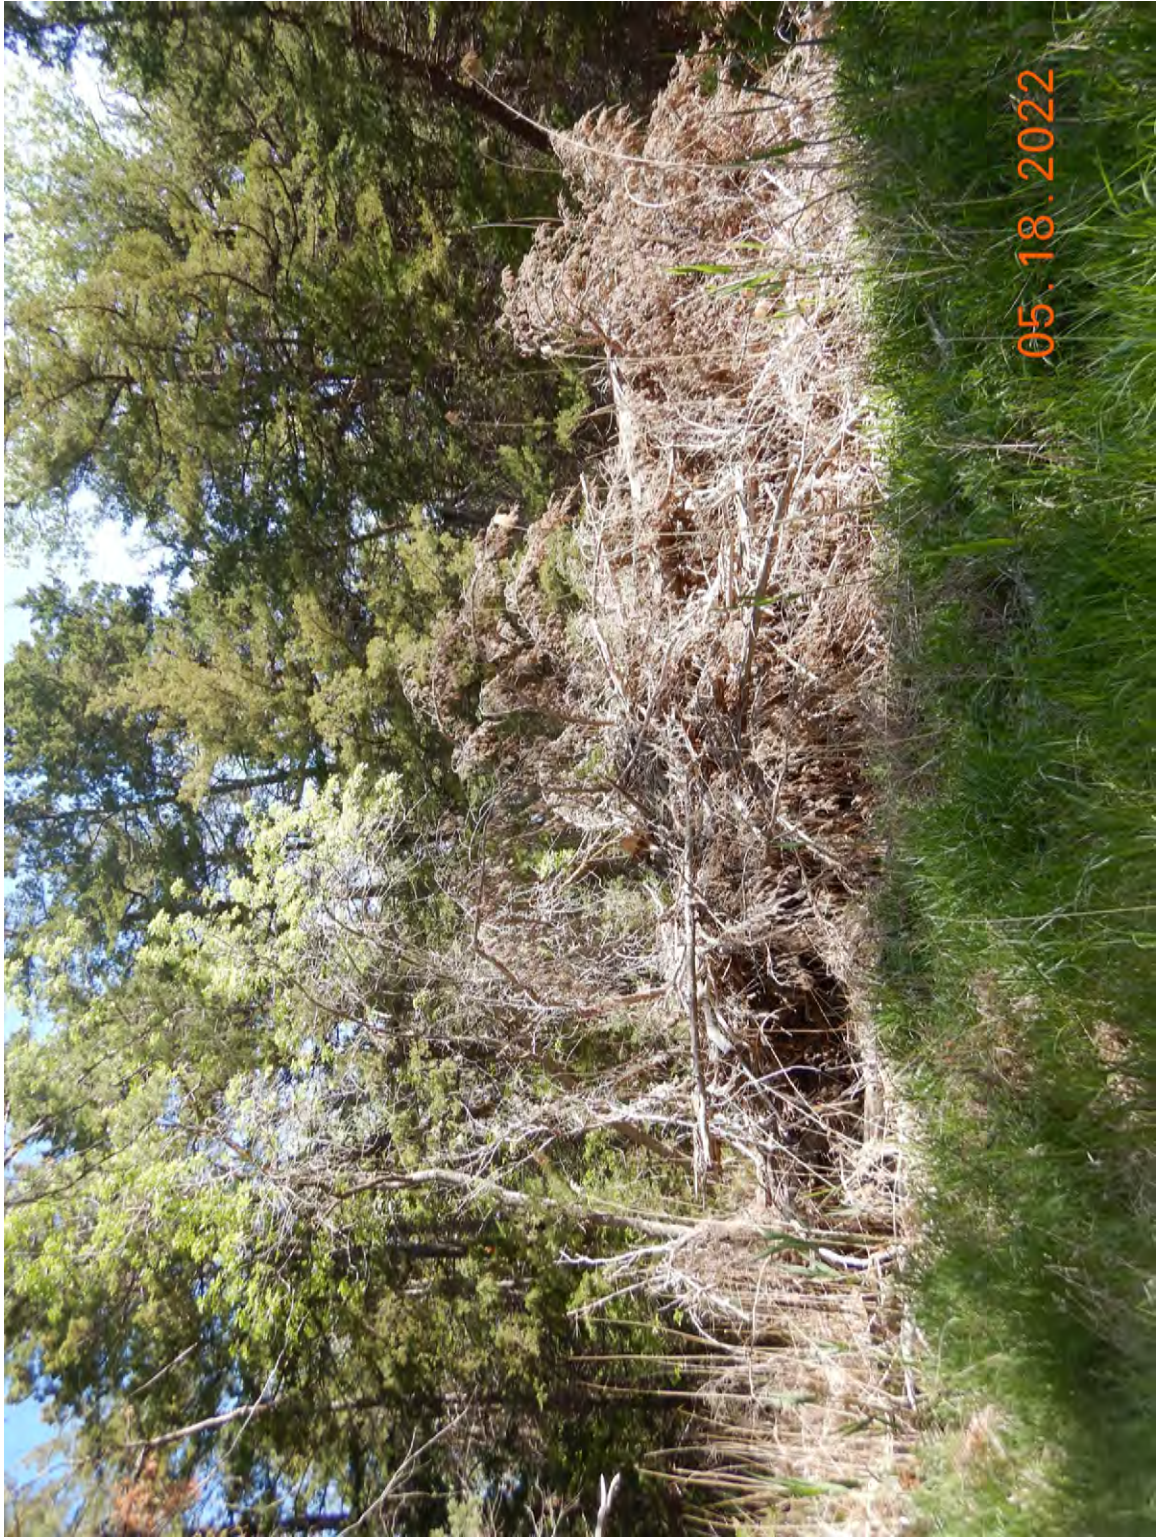
Photo 25

D. Garcia	05/18/22	1042	DSCN0036.JPG	25	Pile of cleared trees.
D. Garcia	05/18/22	1043	DSCN0037.JPG	26	Another pile of cleared trees.

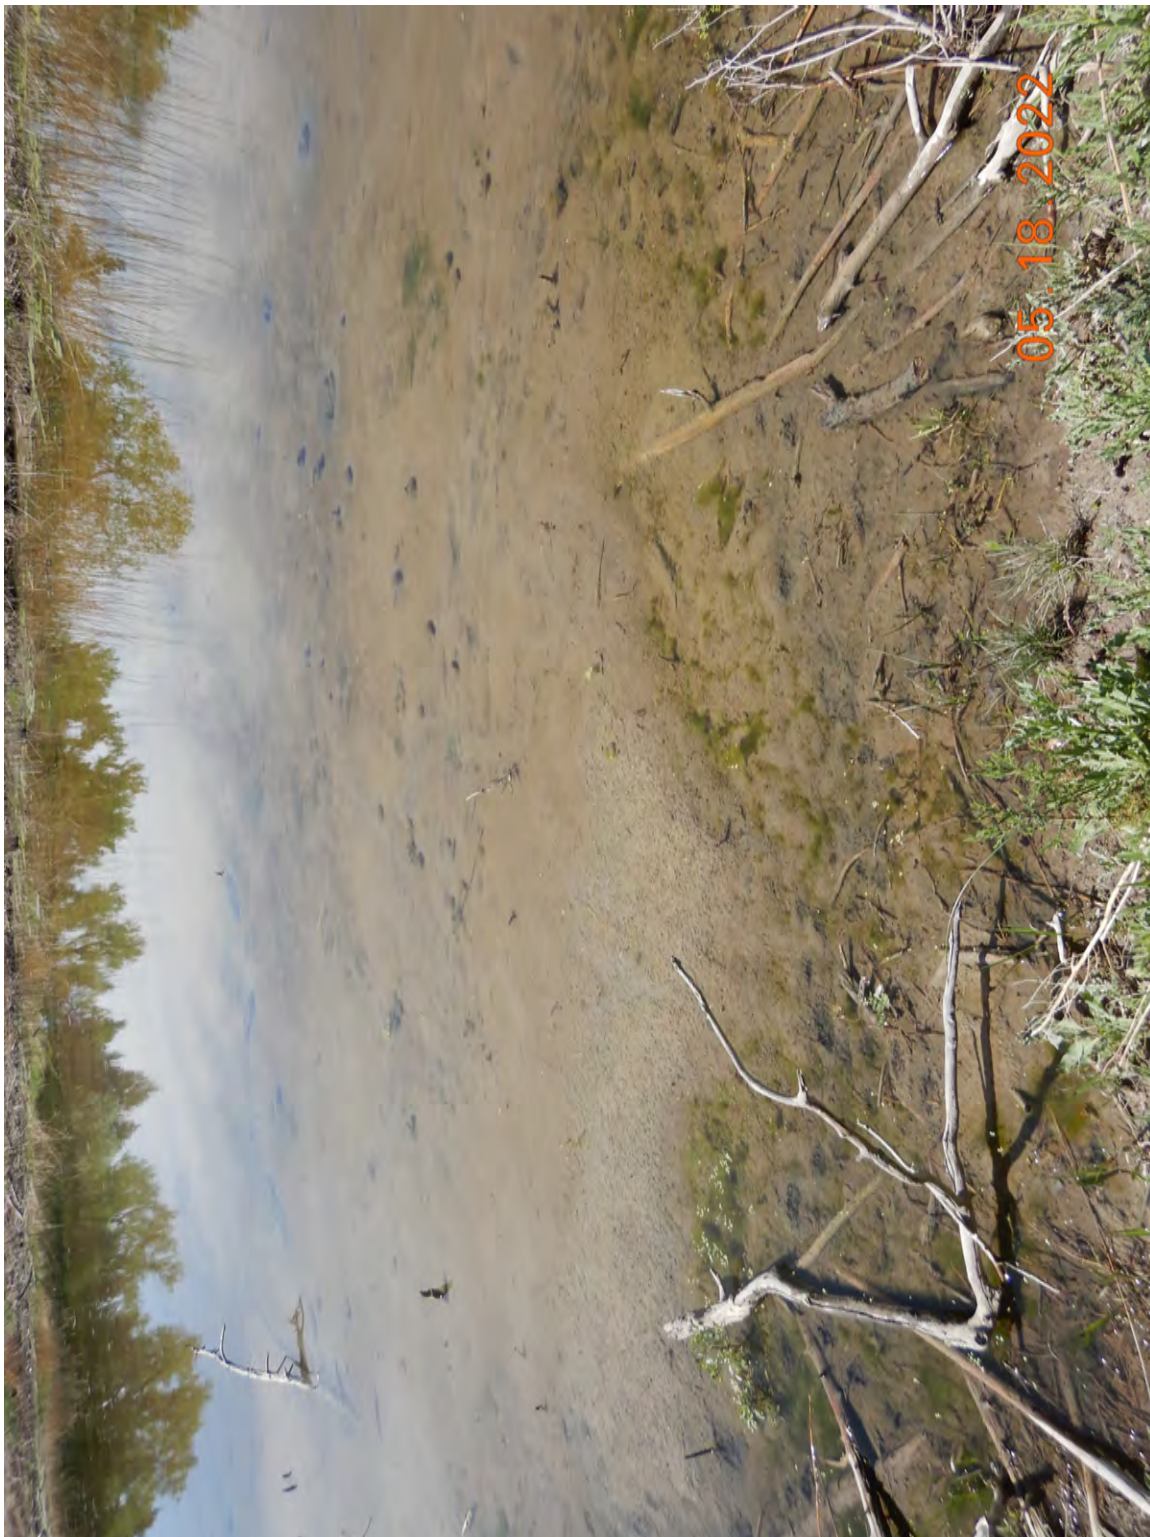
Photo 55

D. Garcia	05/18/22	1146	DSCN0066.JPG	55	Other side of stream channel in Photo 54.
D. Garcia	05/18/22	1153	DSCN0067.JPG	56	Note all sediment/silt deposits in excavated/expanded stream channel.

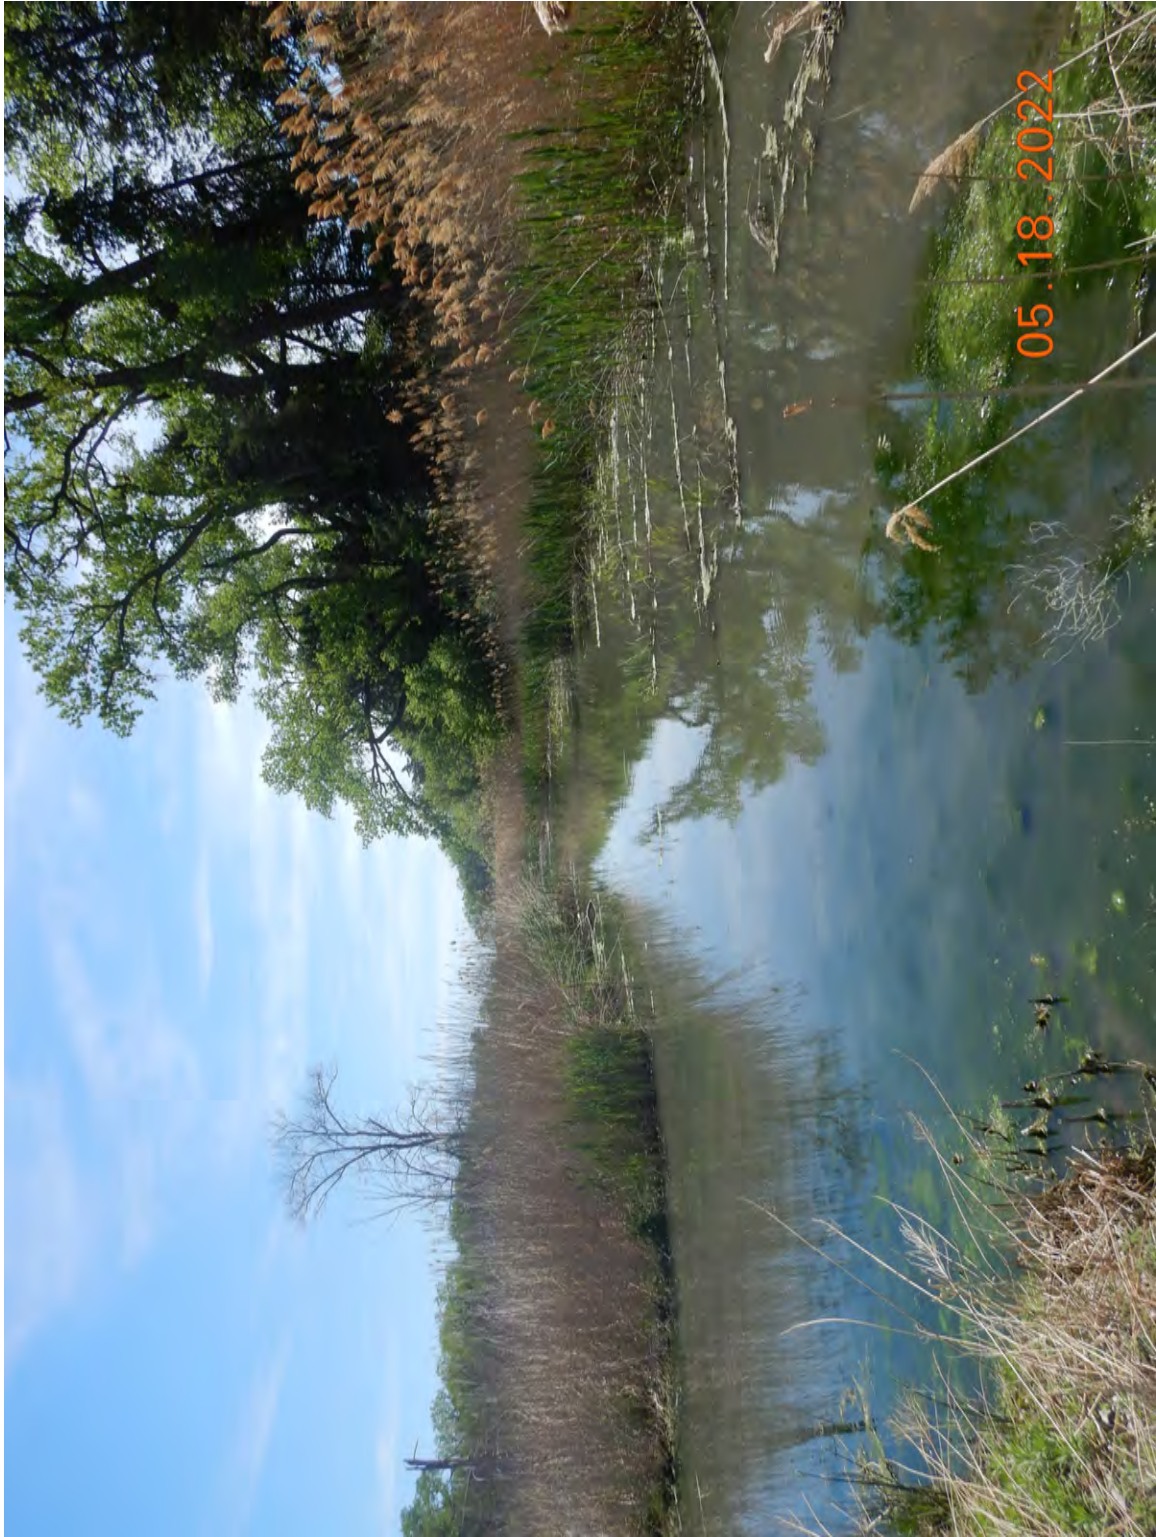
Photo 59

Site Name	Villegas	Start Date	May 18, 2022
		End Date	May 18, 2022
<p>number 20 in GPS Locations Map in Attachment 1) which had been excavated and was located between the A10 and A11 stream crossings. It appeared as though it had served as a borrow area for the material that was utilized for one of those crossings.</p> <p>We continued walking south and stopped once we reached the northern stream channel on the south side of the site. I saw and heard Red-winged blackbirds (<i>Agelaius phoeniceus</i>) in this area, and saw Asian carp (<i>Cyprinus carpio</i>) within the channel . I also saw a considerable amount of silt deposits in the excavated and expanded stream channel (Photo 56 in Attachment 2). A large area has been cleared of vegetation and graded (A13). I walked around both stream crossings (crossings 3 and 4) and the berm that was created just north of the excavated channel (all combined counted as A12). A waterfowl hunting blind was placed in between those two stream crossings (Photo 57 in Attachment 2). A considerable amount of erosion had occurred between the two culverts in crossing 3 (Photos 58 and 64 in Attachment 2). I also noticed that additional fill material had been placed on the north side of the excavated channels in this area but it was not as extensive (see Photo 63 in Attachment 2). As we walked across the two stream crossings we noticed a large area just south of the crossings that might have served as a borrow area for the fill material utilized in the crossings (Photo 59 in Attachment 2)</p>
