**REPORT OF INITIAL FINGERPRINTING
FINDINGS RELATED TO
PUERTO RICO OLEFIN SITE
PEÑUELAS, PUERTO RICO**

Prepared by:
Ady Padan, Ph.D

February, 2015

Analytical Environmental
Services International, Inc.
611 Monserrate Street
2nd Floor, Santurce, P.R. 00907
(787) 722-0220 / Fax (787) 724-5788

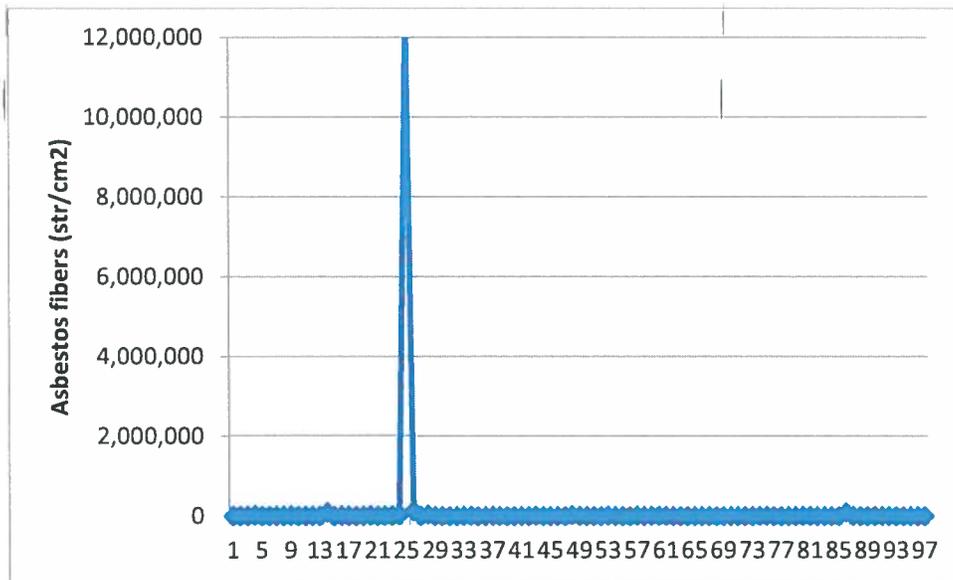
Figure 3. Distribution of asbestos TEM-data (str/cm²) for dust micro-vacuum samples collected from the interior properties (Data from Weston report #IV)

Results of Chrysotile in dust of property P0008 are much higher than the entire area sampled using micro-vacuum method, as the UCL (95%) of all the remaining data is observed to be 4,683 str/cm² (weighted average is 4,610 str/cm² and LCL is 4,555 str/cm²). Therefore, the property is considered as an outlier, as having excessive Chrysotile content. The same property was previously identified as containing levels of Chrysotile above 400,000 str/cm² in dust wipe samples.

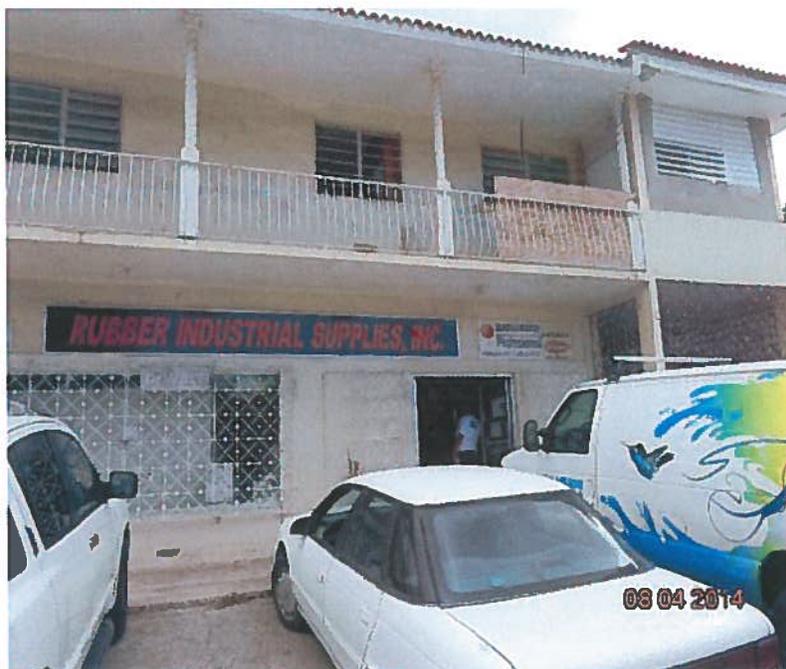
As mentioned, Weston identified ongoing construction activities in the residential part of the P0008 structure. A pile of construction debris is visible in the front of the property. There is a possibility that property P0008 was contaminated during construction activities that perturbed the PACM (popcorn ceiling reported in the commercial part to be present but no analytical data are available, see Figure 4 below). Such contamination may also affect the other properties around. Pictures of the spray on ceiling are shown in Figure 5. Clearly the spray on ceiling appears to be friable, its physical condition is damaged on the exterior of the first floor. There appear to be some residuals left on the ceiling of the second floor.

Figure 4. General view of Commercial (bottom) and Residential (top) Property P0008.

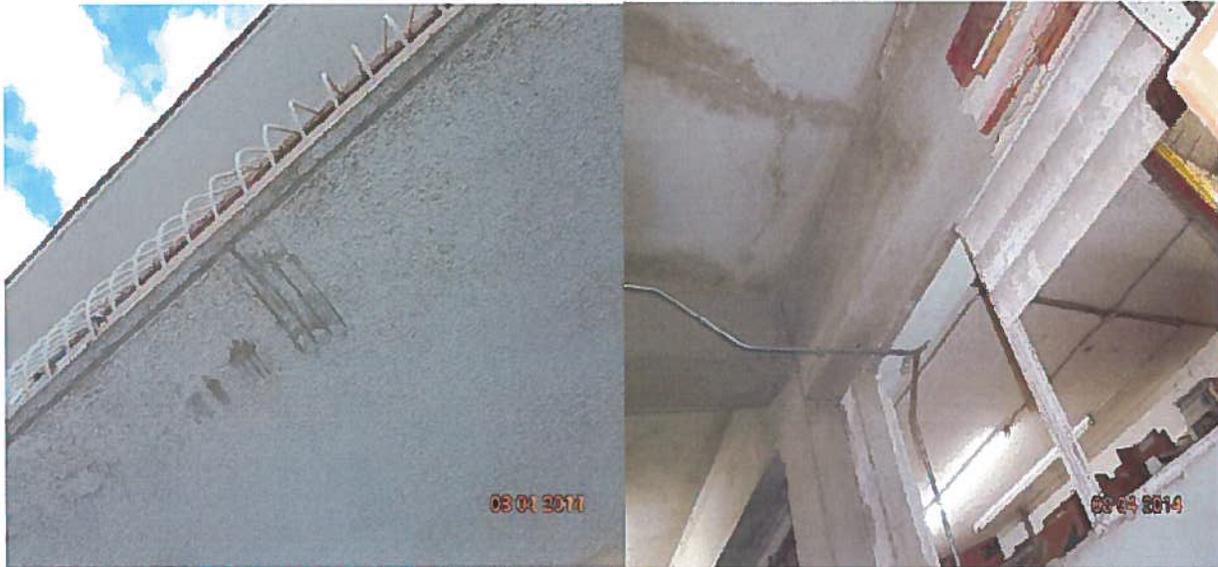
Figure 5. Suspected ACM (spray on) present on ceiling, first floor outside (left) and inside (right)-Commercial part of property P0008.

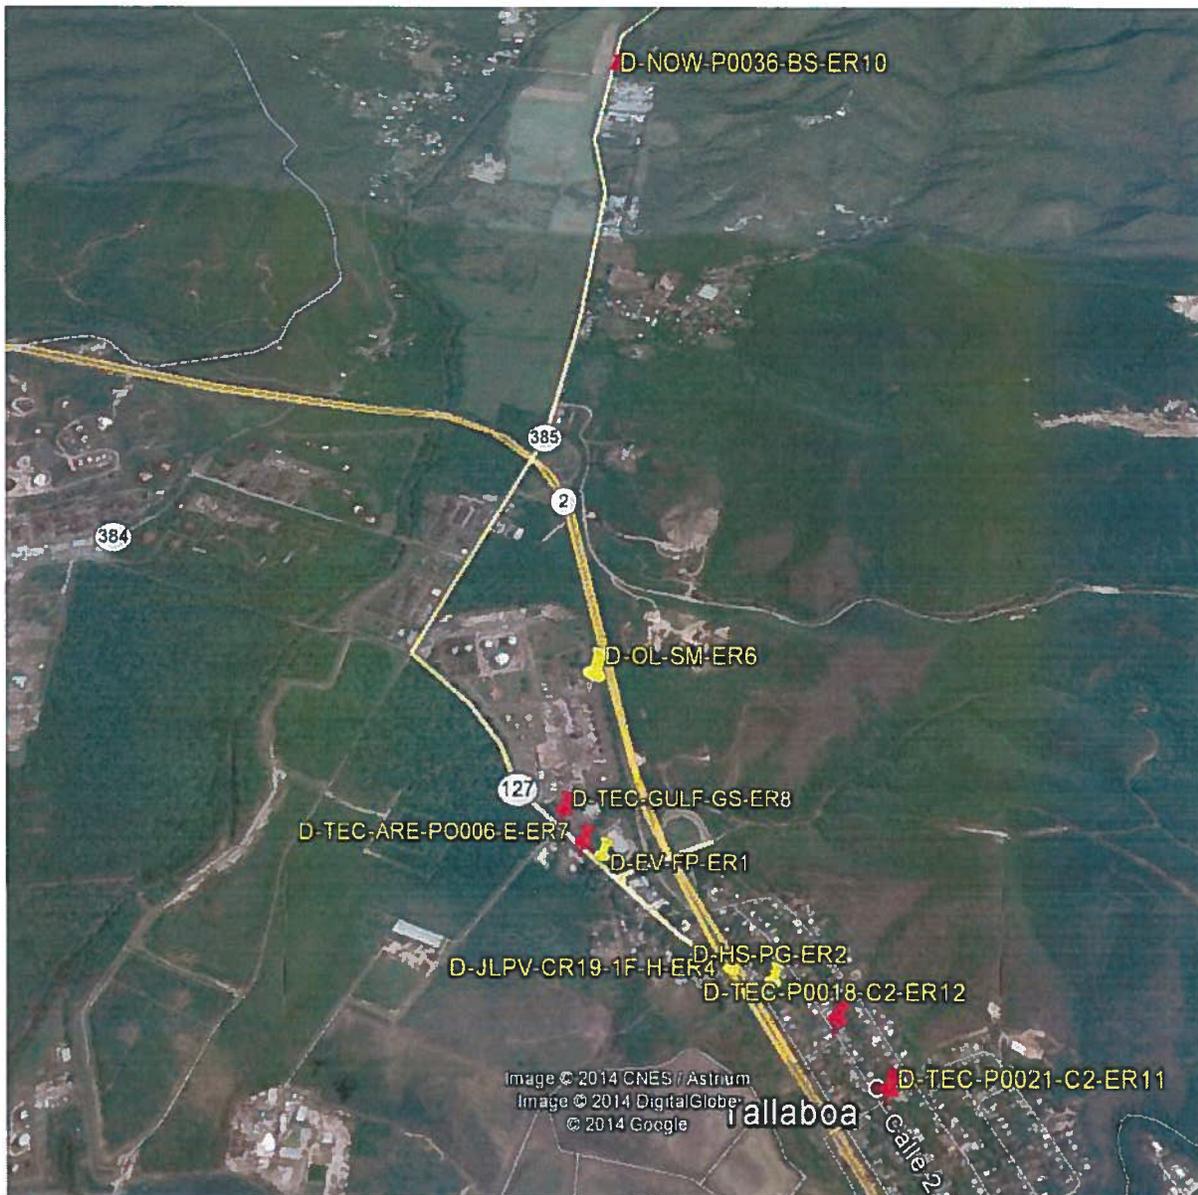
Figure 6. Distribution of Chrysotile and Lizardite in Dust Samples collected Inside/Outside Olefins facility

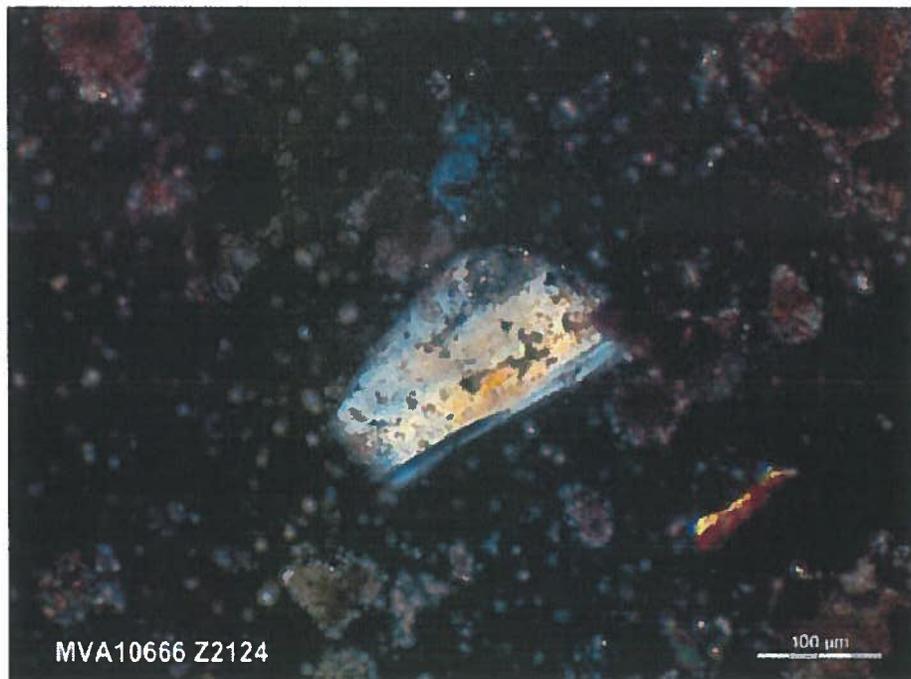
Figure 7. PLM image of Chrysotile bundle detected during analysis of sample D-EV-FP-ER1, Dust, floor, front porch entrance stair, El Velorio Bar.

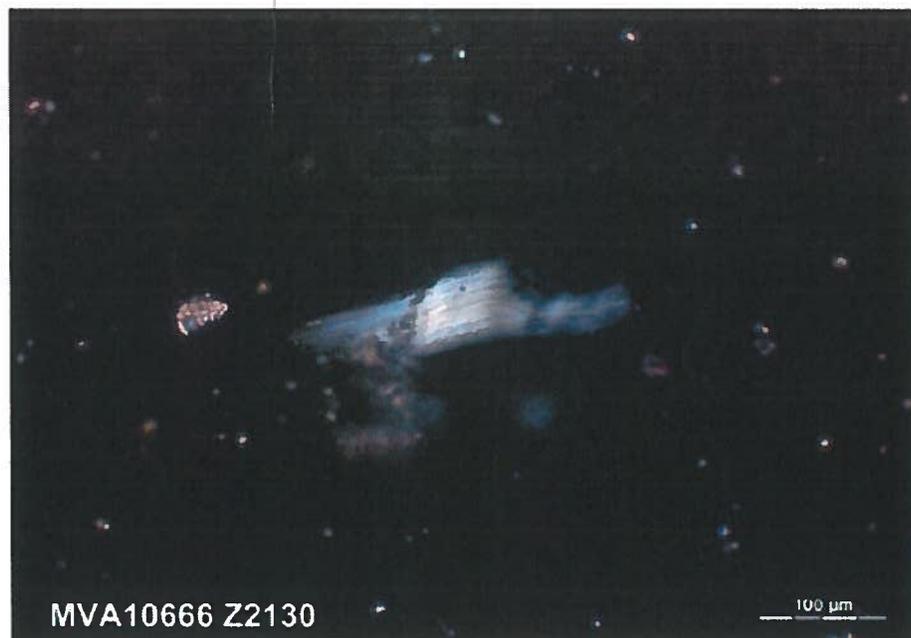
Figure 8. PLM image of Chrysotile bundle detected during analysis of sample D-TEC-ARE-PO006-E-ER7, Dust, floor, AR exchanger boiler specialist exterior Tallaboa Encarnación Community

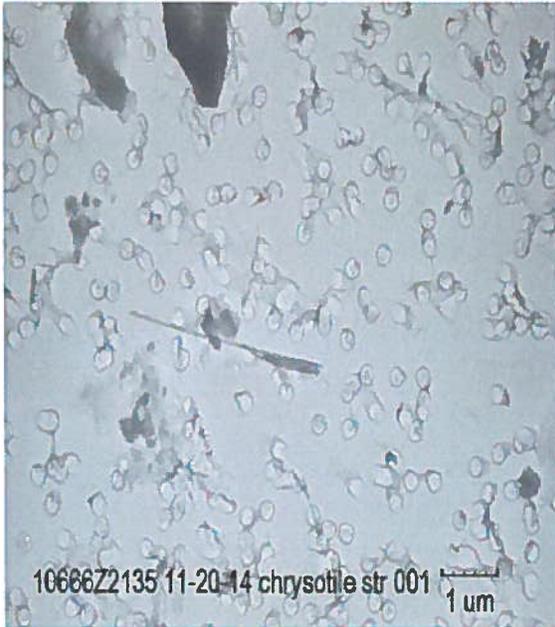
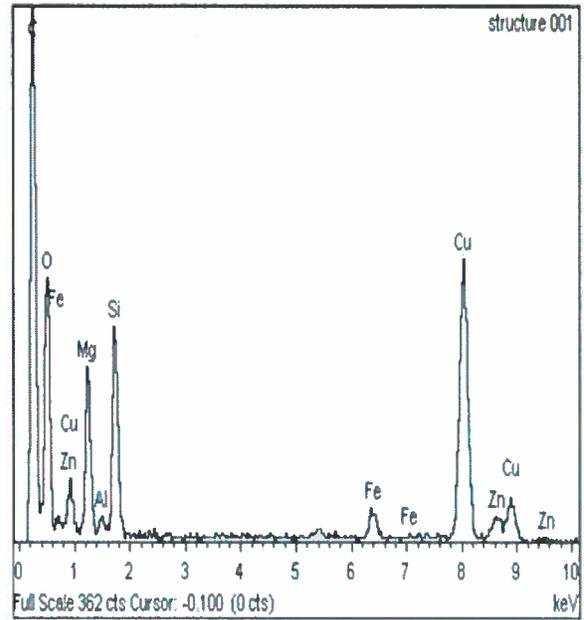
Figures 9a and 9b. TEM image (left) and EDS spectrum (right) of a Chrysotile asbestos bundle detected in sample D-TEC-P0018-C2-ER12, Dust floor, corner street 2, west of street 2, Tallaboa Encarnación Community

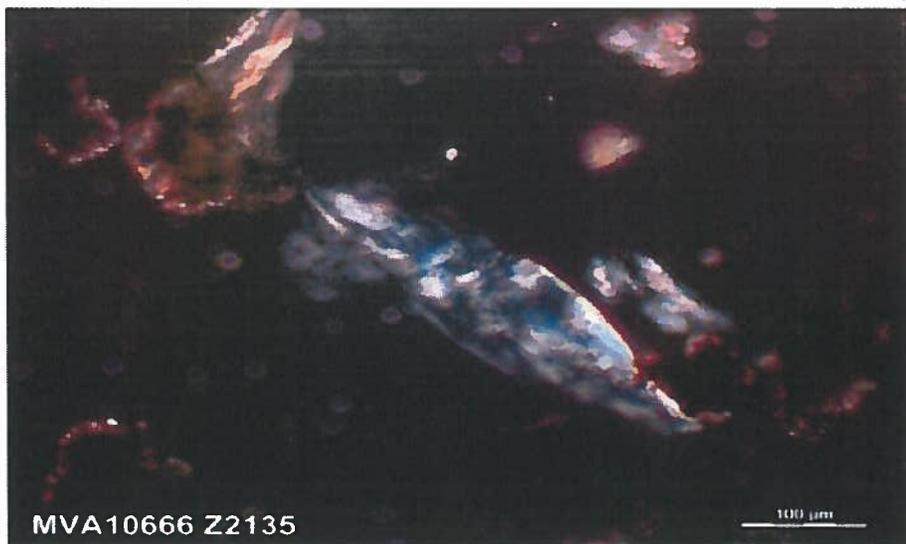
Figure 10a. PLM image of Lizardite particle detected during analysis of sample D-TEC-P0018-CR-ER12, Dust, floor, corner street 2, west of street 2, Tallaboa Encarnación Community

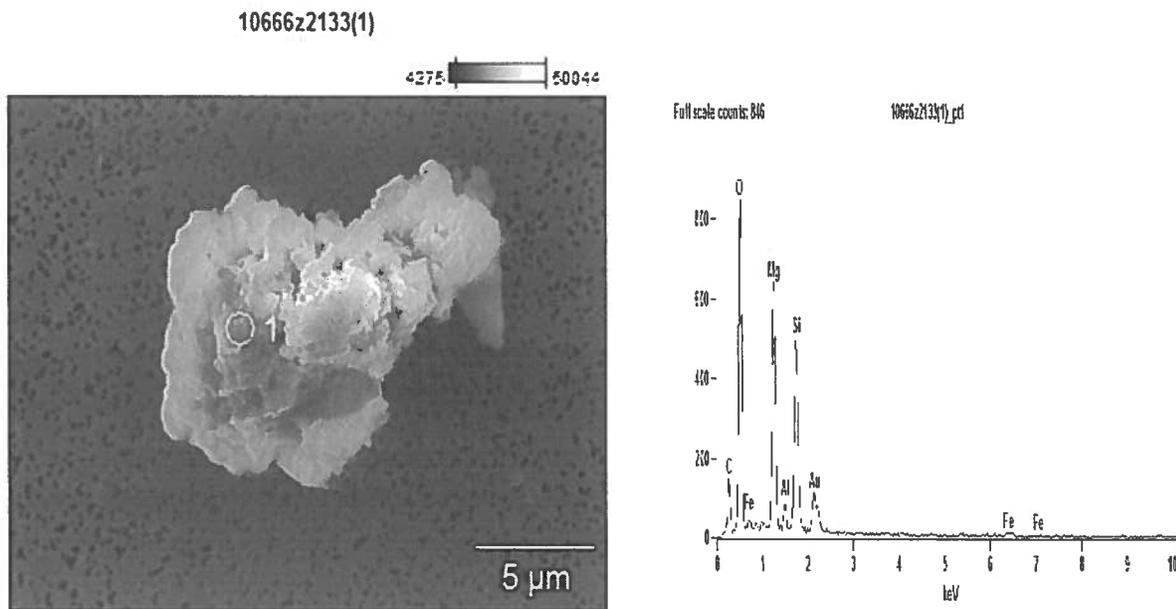
Figure 10b. SEM image of Lizardite particle (left) and EDS spectra (right) detected during analysis of dust sample D-NOW-P0036-BS-ER10 (MVA Z2133) collected from bus stop bench, intersection of state Roads 385 and 384. Note presence of aluminum and iron.

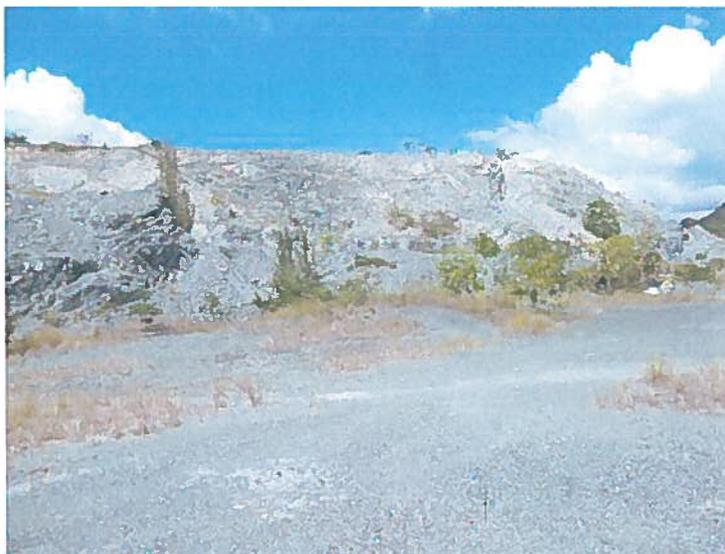
Figure 12. General view of abandoned Quarry 1- Yauco. The quarry is identified as #16 in the quarries inventory list.

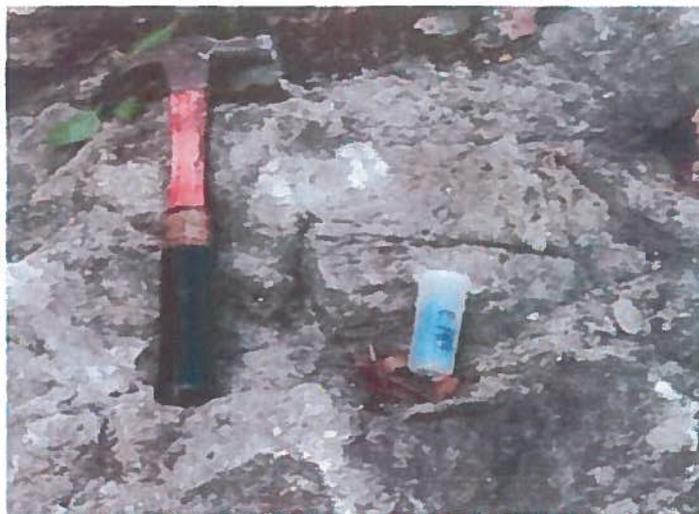
Figure 13. Sample from Serpentinite exposed in Media Quijada

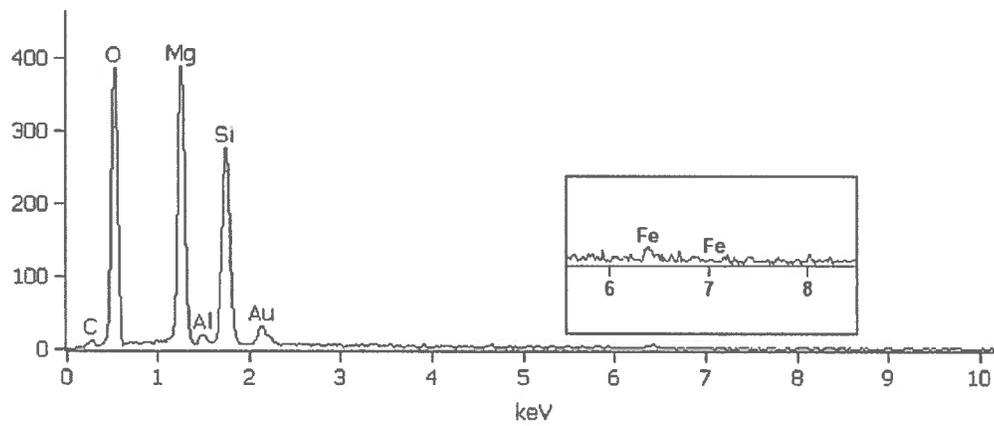
Figure 15a. Area 1 from Figure 14. Lizardite flake. Insert shows an enlarged view of iron peak.

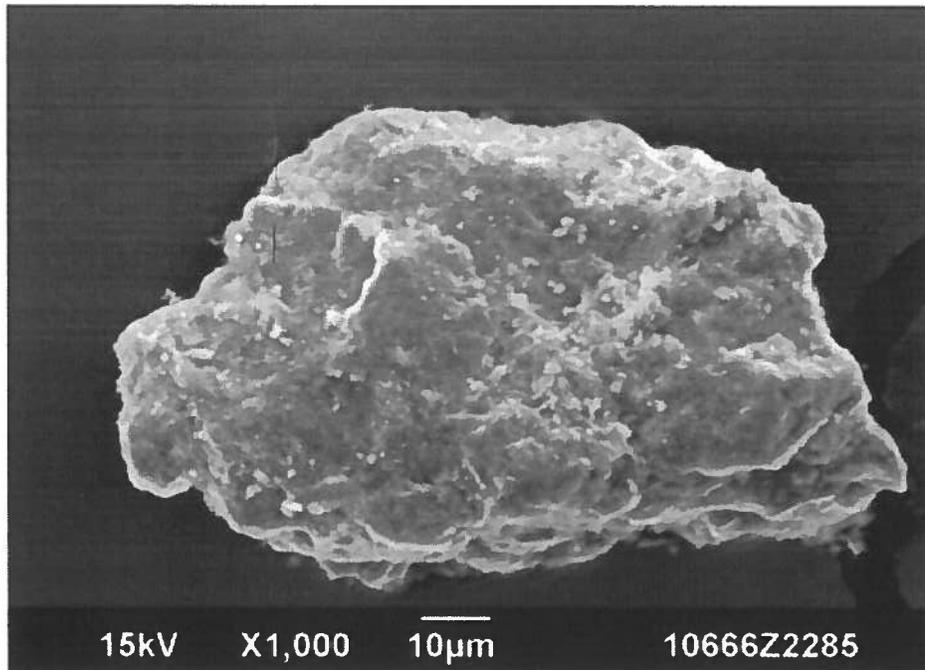
Figure 15b. SEM photo of non-fibrous serpentine (Lizardite) detected during analysis of Quarry 1 sample R-Q1-AP4)

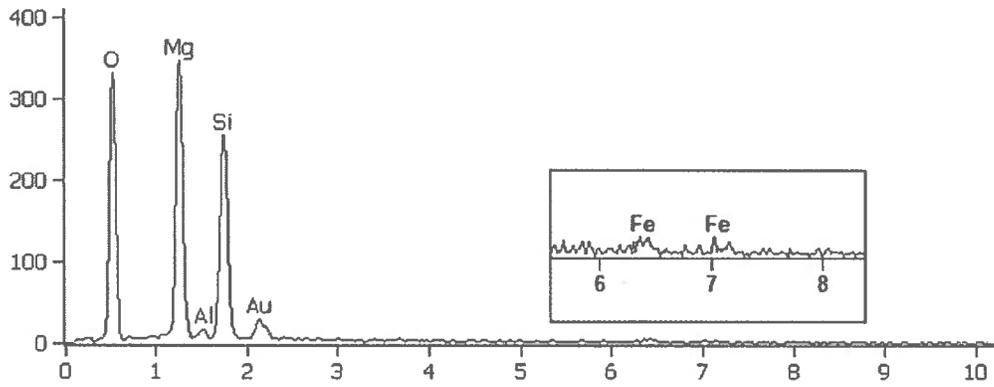
Figure 16a. Area 3 from Figure 14, Fibrous Serpentine (Chrysotile). Insert shows an enlarged view of iron peak.

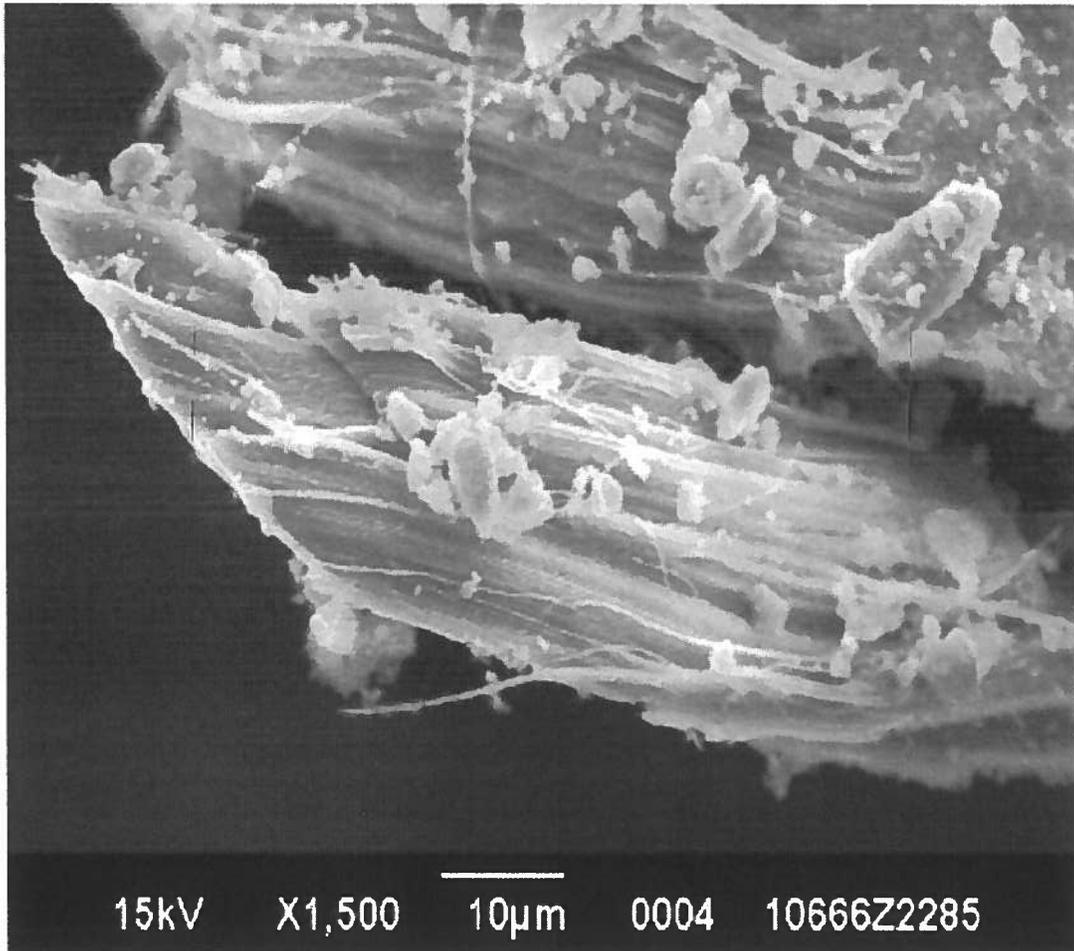
Figure 16b. SEM photo of fibrous serpentine (Chrysotile, confirmed by TEM analysis) detected during analysis of Quarry 1 sample R-Q1-AP4. Chrysotile appears to be a pseudomorph.

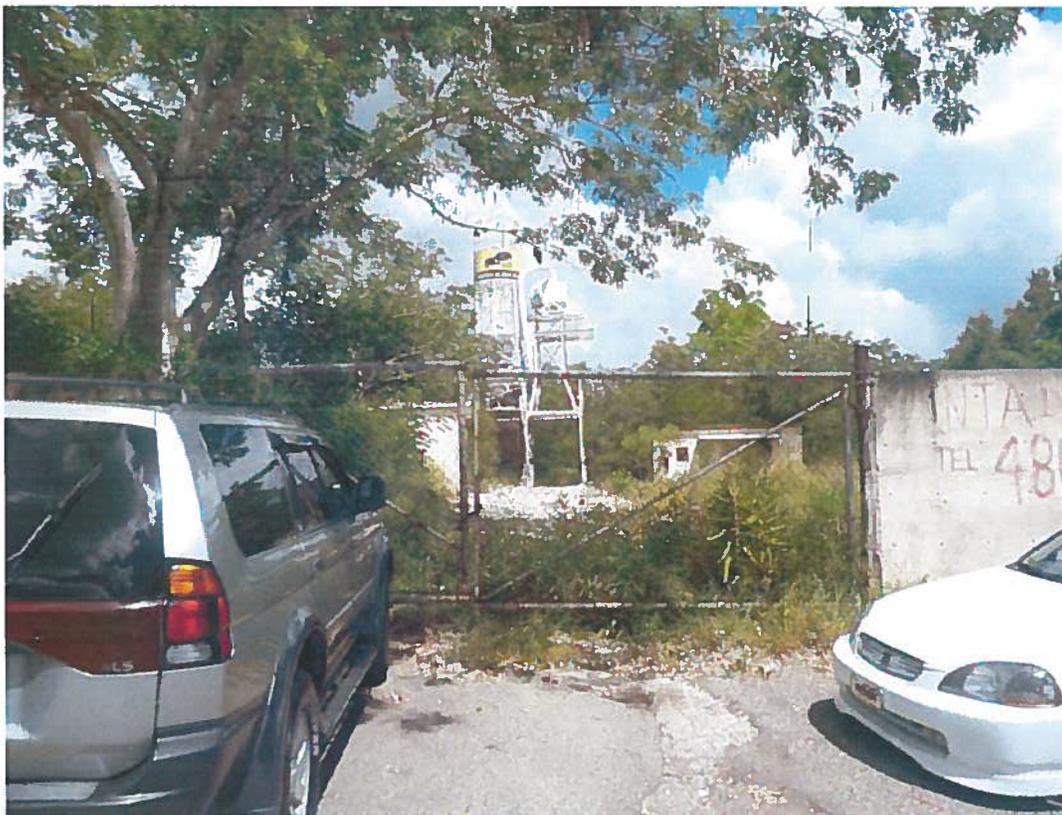
Quarry 16 (identified during the sampling phase as Quarry 1) was used for serpentine minerals characterization presented in section 6.2.2. An abandoned cement plant (Hormigonera Mayaguezana) is present in the vicinity of the quarry suggesting that the extracted material was crushed and used for commercial purposes (see Figure 17).

Figure 17. Abandoned Cement plant located in Yauco. Plant was purchased by Cemex and closed down in 2005.

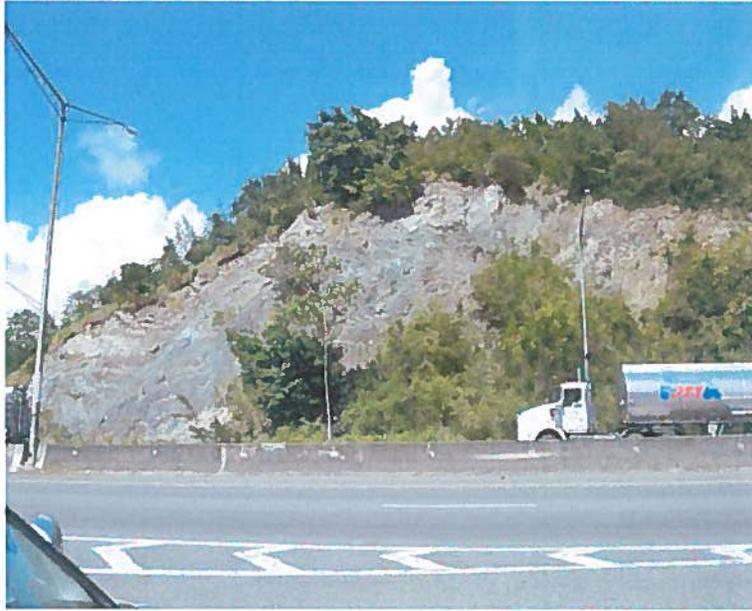
Figure 21-Cut along PR-2 km 172.6. This cut appears to be constructed during the expansion of state road PR-2.

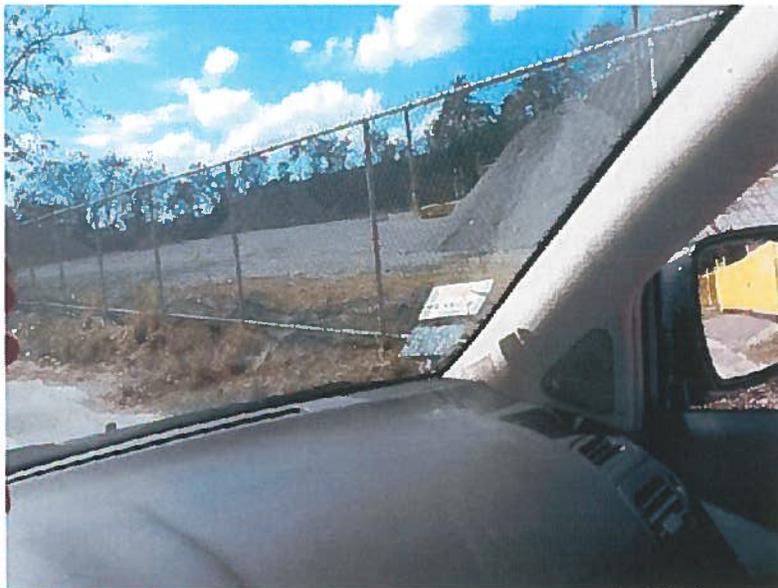
Figure 22. View of piles stored on the facility of Better Roads, State Road PR 3311, Cabo Rojo.

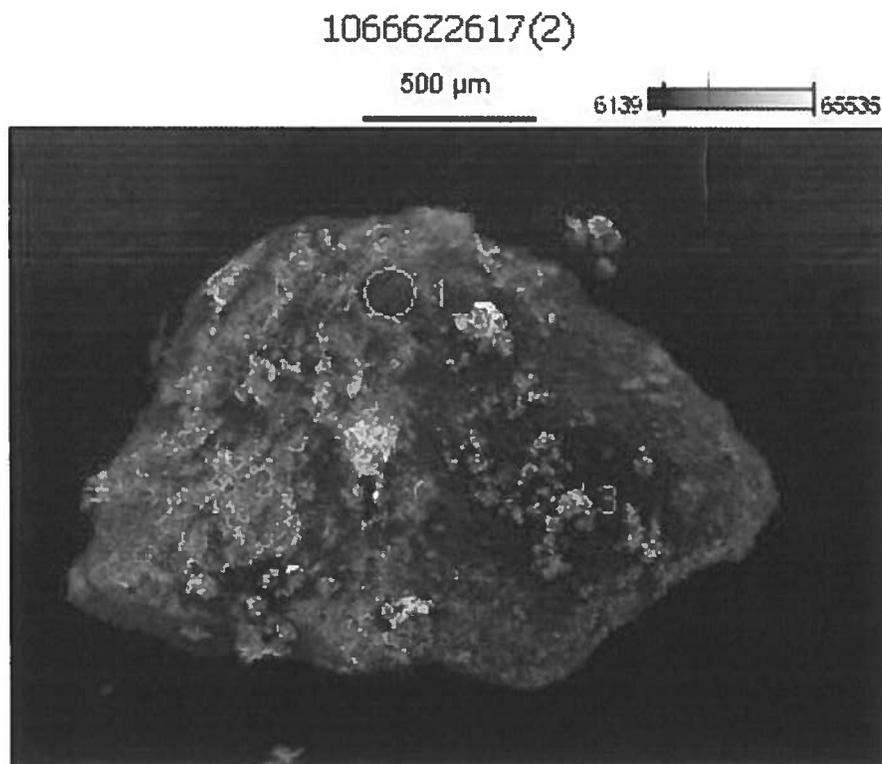
Figure 23d. SEM image of serpentine mineral (Figure 27c). Numbers denote areas where EDS spectra were obtained.

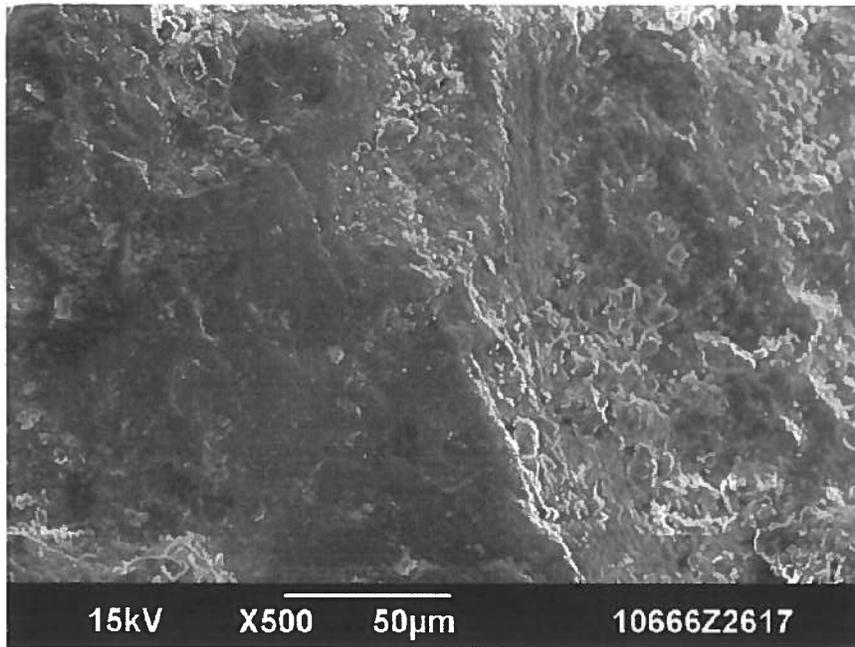
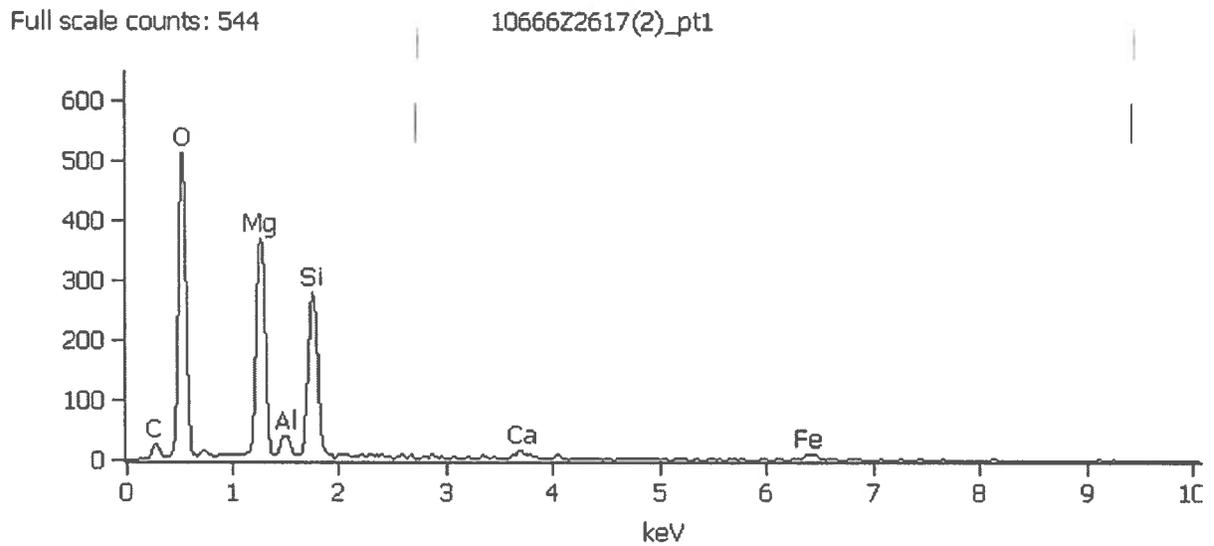
Figure 23e. SEM image (top) and EDS spectra (below) of non-fibrous serpentine (Lizardite) mineral surface (Area 1 in Figure 27d)

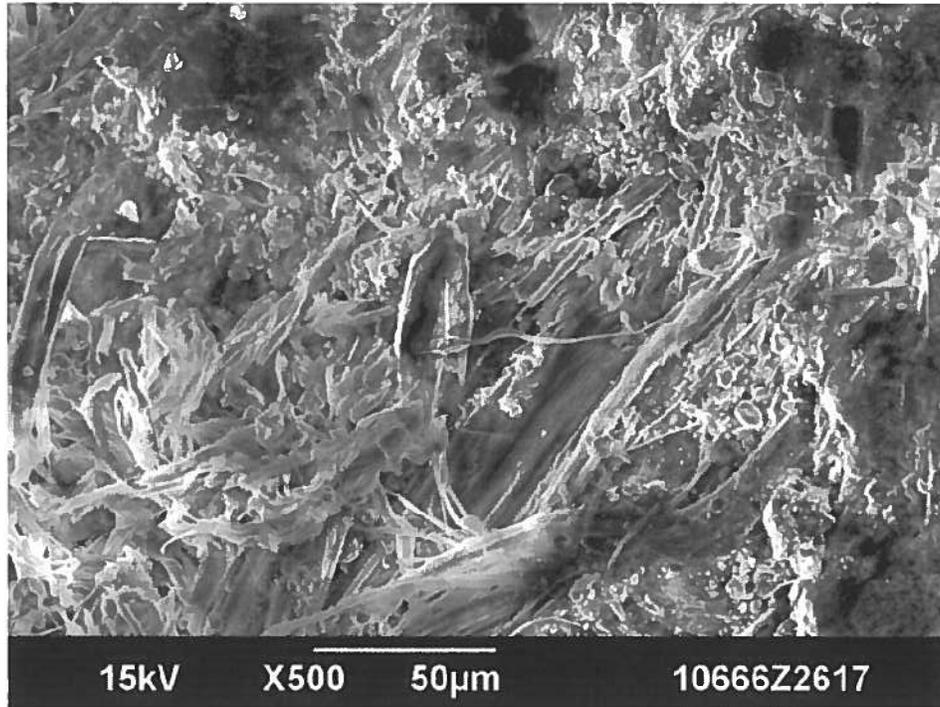
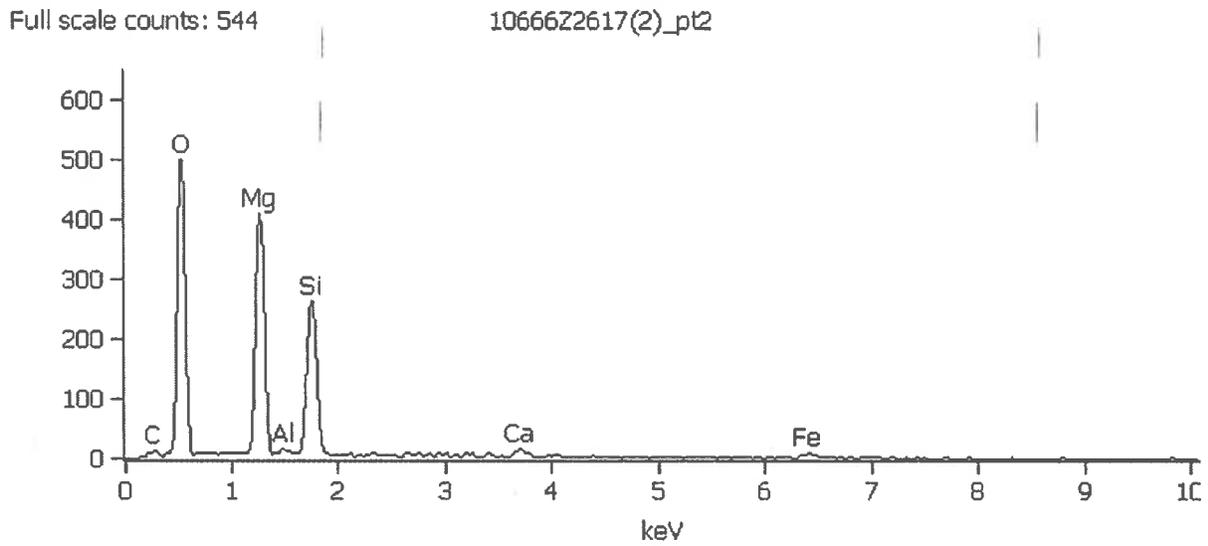
Figure 23f. SEM image (top) and EDS spectra (below) of fibrous serpentine (Chrysotile) mineral surface (Area 2 in Figure 27d)

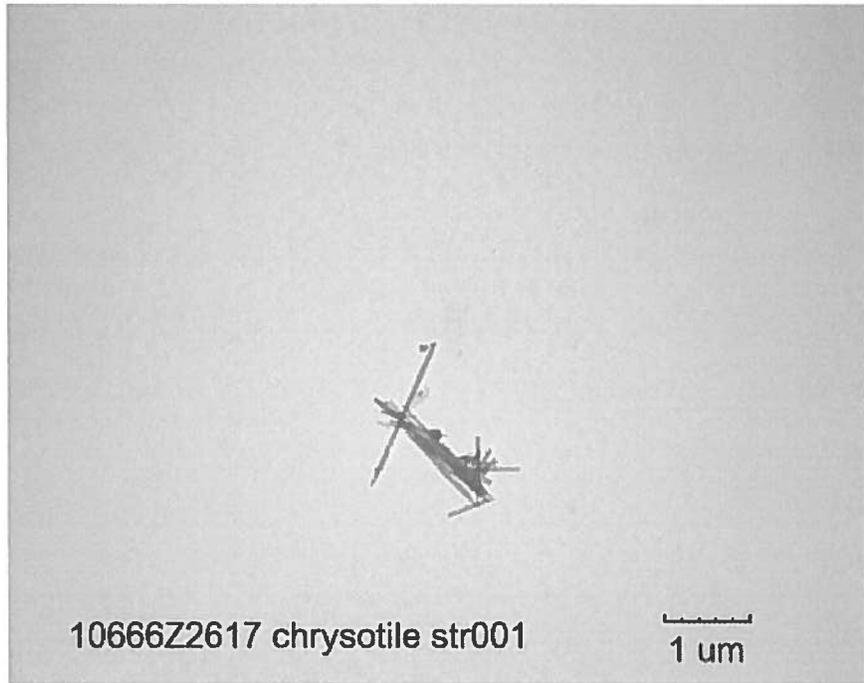
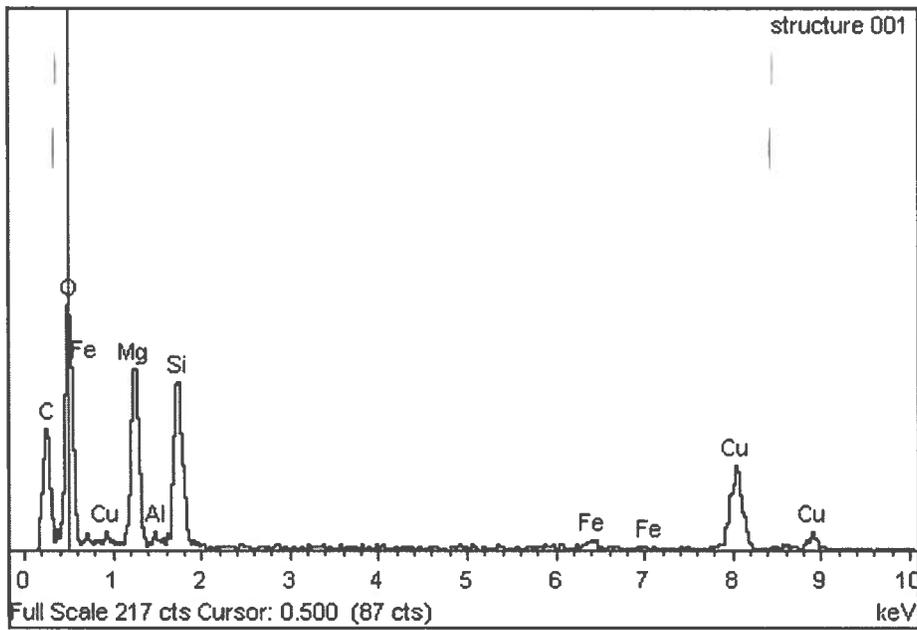
Figure 23g. TEM image (top) and EDS spectrum (bottom) of Chrysotile asbestos fiber observed during analysis of aggregate sample S-TEC-ARE-P0006-ER1

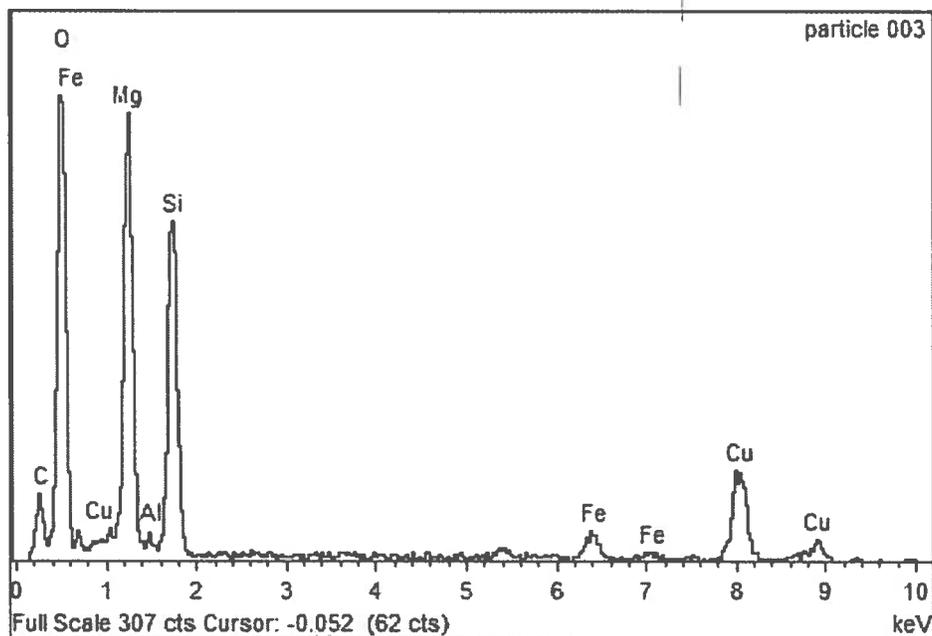
Figure 23h. TEM image (top) and EDS spectrum (bottom) of Lizardite particle observed during analysis of aggregate sample S-TEC-ARE-P0006-ER1.

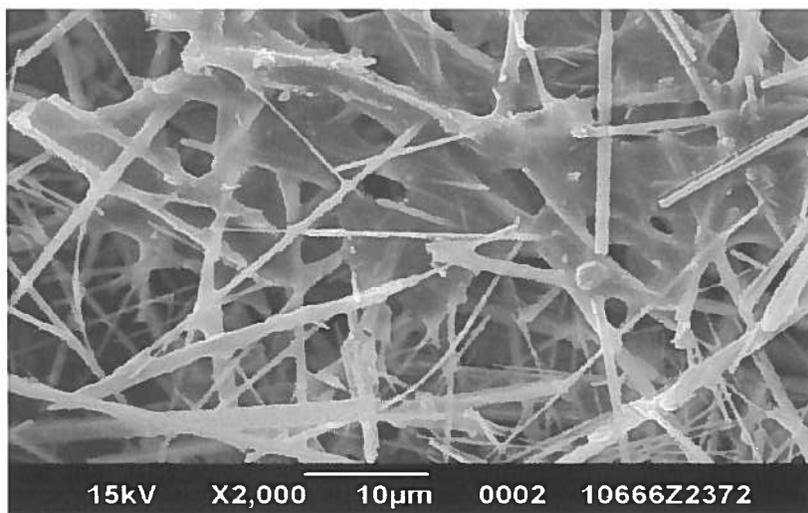
Two of the three samples (Z2369/B-OL-OV-409-ER1) and Z2372/B-OL-OV-PS408-ER5) contained diatoms and a silica binder (see Figure 26). PLM analysis of the soil sample by MVA shows that it is primarily consistent with soil minerals and plant fragments with a minor amount (1 to 10% by volume) of rust/metal flakes and a trace amount (<1% by volume) of insect parts. After ashing, the soil sample was found to contain trace amounts (<1% by volume) of Amosite asbestos.

Figure 26. Scanning electron micrograph of Amosite asbestos fibers and silica binder detected during analysis of bulk insulation debris, Sample Z2372.

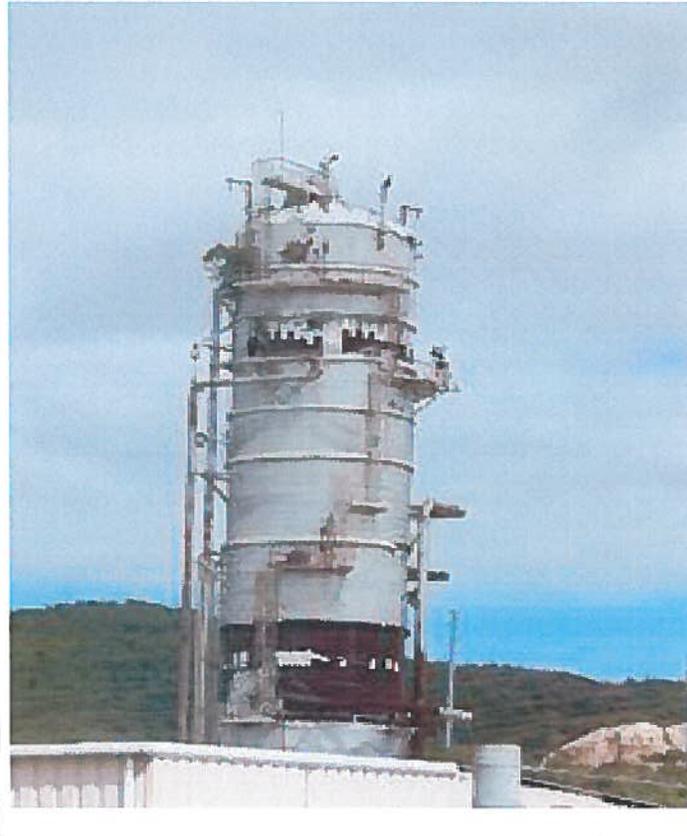
A bulk sample was collected on November 21, 2014 from the insulation of a distillation column in the vicinity of vessel OV-302. Sample was analyzed by PLM and SEM. The TSI on the column appears to be significantly damaged (see Figure 27).

Figure 27, TSI on a distillation column left of platform of vessel OV-302. Note that TSI is in significantly damaged condition.

Forty (40%) to Sixty (60%) Chrysotile was found to be present as determined by MVA PLM analysis (see report in Appendix V-6) in addition to a binder material detected via PLM analysis (See Table 12 for results). Representative photos of the Chrysotile are shown in Figure 29 together with its EDS spectra.

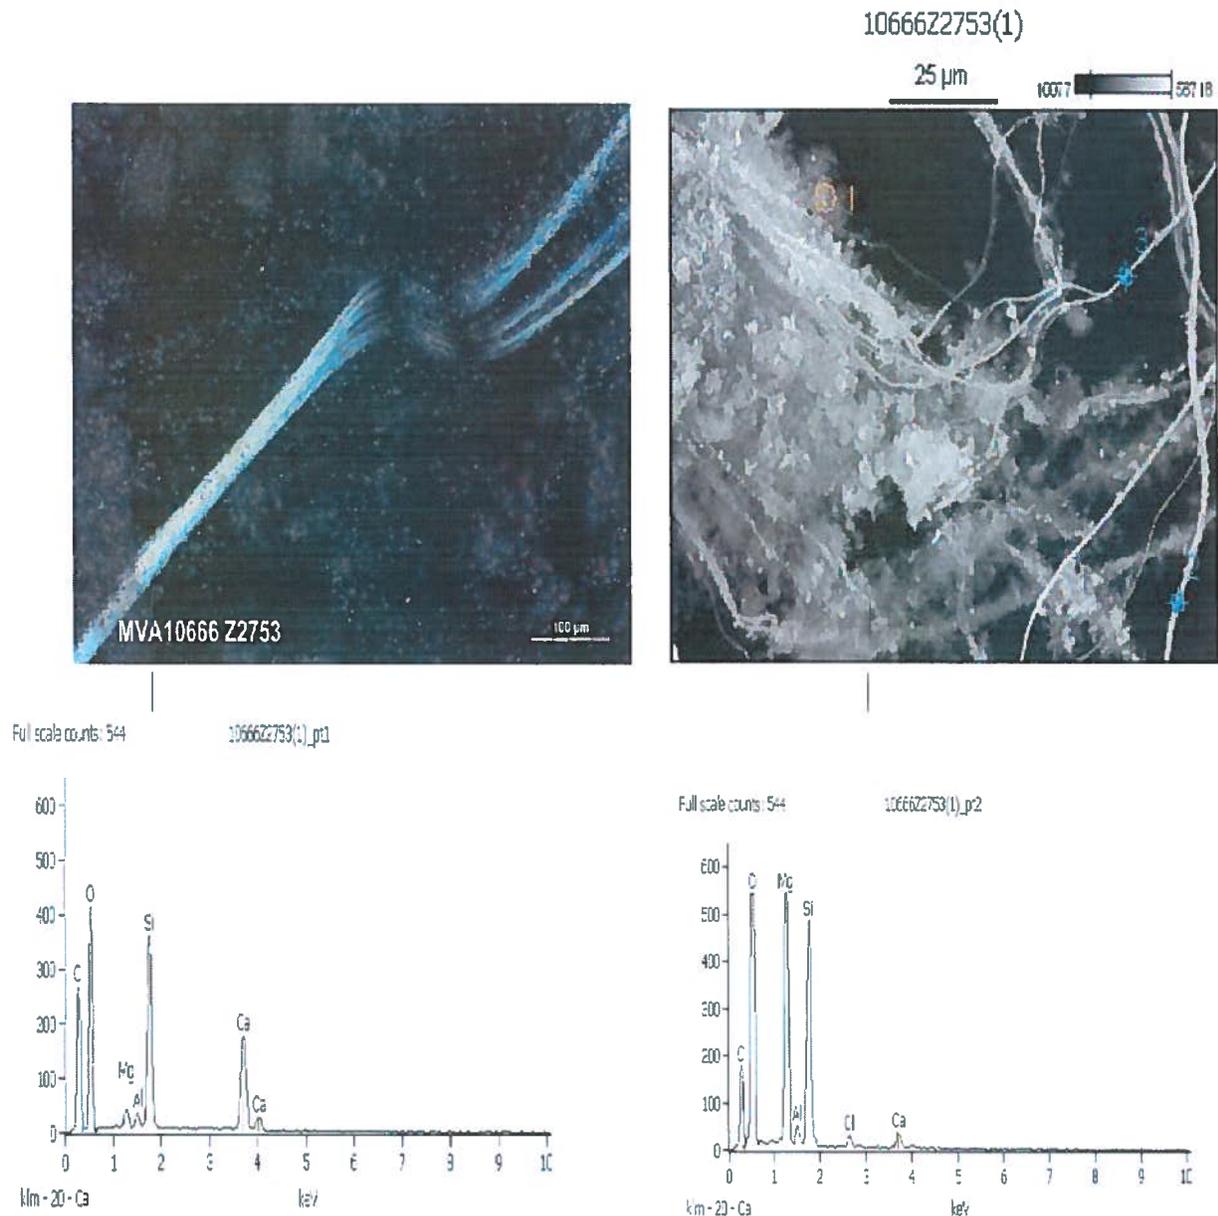
Figure 28 (top) shows PLM/SEM images of a representative Chrysotile asbestos bundle. Representative Chrysotile asbestos bundle SEM-EDS analysis shows that the fiber bundles consist of long, processed chrysotile bundles (Figures 29) with a calcium silicate binder material (Figure 28, top right). Elemental composition of the fibers via SEM-EDS shows trace amounts of aluminum, chlorine, and calcium (Figure 28 bottom); however, these peaks are likely from adhering binders and particulate material since these elements are not confirmed in the TEM-EDS data.

Figure 28. PLM image (top left), SEM micrograph (top right) of Chrysotile asbestos fibers and binder detected during analysis of insulation sample BULK-OL-CHM4-ER2 (MVA Z2753). Numbers denote areas where EDS spectra was collected: Bottom Left area 1-Calcium silicate binder. Bottom Right area 2-Chrysotile asbestos bundle with particulate material. No Iron peaks are visible.

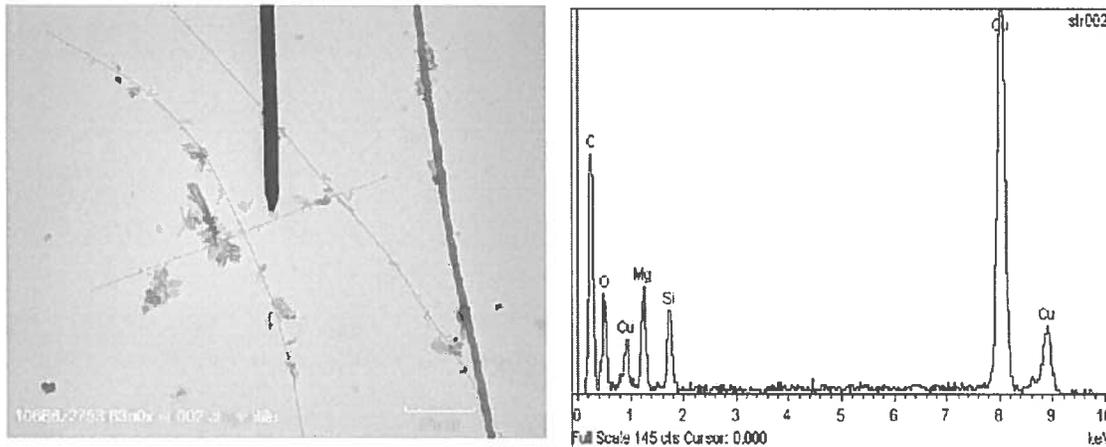
Typical Chrysotile fiber TEM image and EDS spectra are shown in Figure 29. Fifteen random fibers were characterized by TEM-EDS for elemental composition as well as aspect ratios. Based on TEM-EDS, none of the 15 fibers analyzed contained any detectable level of aluminum (see Table 12). The majority of the fibers analyzed contained no detectable level of iron; however, some fibers did contain iron at or below 1.8% (elemental weight percent, Table 12). The average aspect ratio of the 15 fibers analyzed is greater than 100:1 (length:width) with a minimum aspect ratio of 7:1 and a maximum aspect ratio of over 1000:1.

Figure 28. TEM image (left) and EDS spectrum (right) of a representative Chrysotile fiber detected during analysis of insulation sample BULK-OL-CHM4-ER2 (MVA Z2753). No Aluminum or Iron peaks are visible.

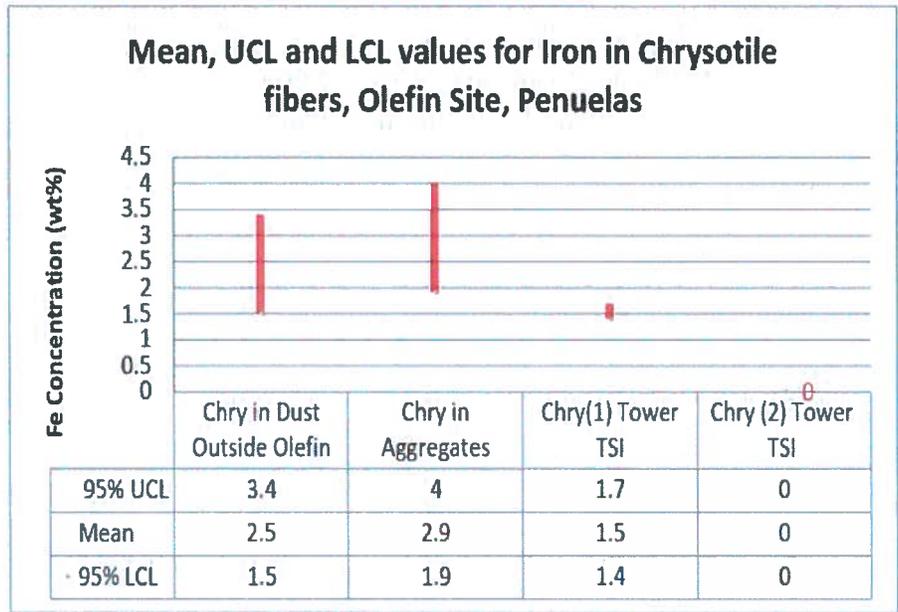
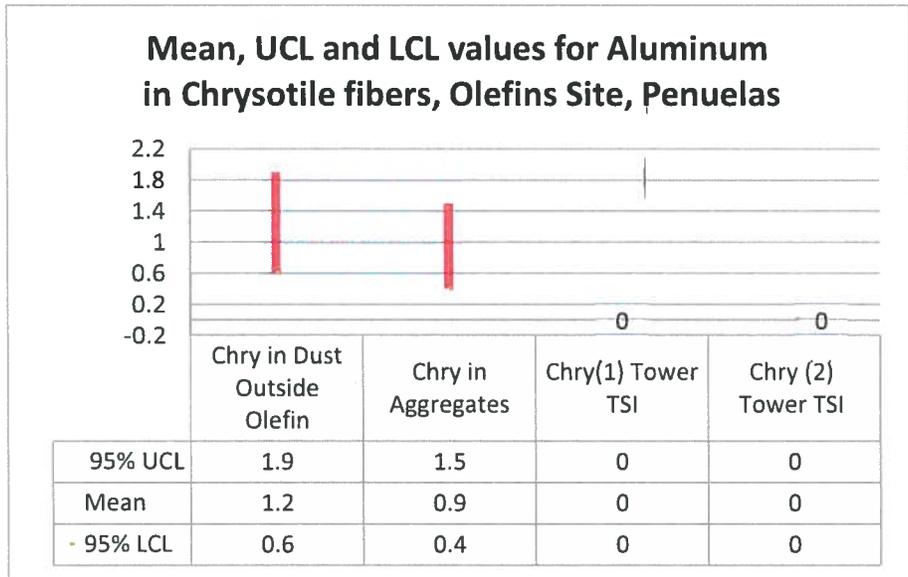
- The direct correlation between the Al-Fe concentrations of Serpentes in aggregates with the Al-Fe content of Chrysotile fibers present in the dust samples (see Figure 31).

- The difference between Iron and Aluminum concentrations of Serpentes from the aggregates and dust samples, versus Chrysotile composition of the insulation sample collected from a deteriorated TSI present on a distillation tower left of platform of vessel OV-302. A statistical comparison between the Fe and Al content of Serpentes present in the dust samples outside Olefins, aggregates samples and the one distillation column TSI sample is shown in Figure 31. Results are presented at 95% confidence using t-distribution. It is noticeable that there are two types of Chrysotile in the TSI that were separated and not averaged together. Clearly Fe and Al Concentration in Serpentes present in aggregates and dust samples almost overlap (Fe averages are 2.9% and 2.5%, respectively and Al averages are 0.9 and 1.2%, respectively), while the sample collected from the TSI insulation has either a much lower average Fe concentration (1.5%), or zero and no aluminum present.

Figure 31. Statistical analysis of Iron (top) and Aluminum (bottom) contents in Chrysotile present in samples collected from aggregates, outside dust and TSI insulation of a distillation tower. Aggregate results include Lizardite and Chrysotile measurements.
