**REPORT OF INITIAL FINGERPRINTING
FINDINGS RELATED TO
PUERTO RICO OLEFIN SITE
PEÑUELAS, PUERTO RICO**

Prepared by:
Ady Padan, Ph.D

February, 2015

Analytical Environmental
Services International, Inc.
611 Monserrate Street
2nd Floor, Santurce, P.R. 00907
(787) 722-0220 / Fax (787) 724-5788

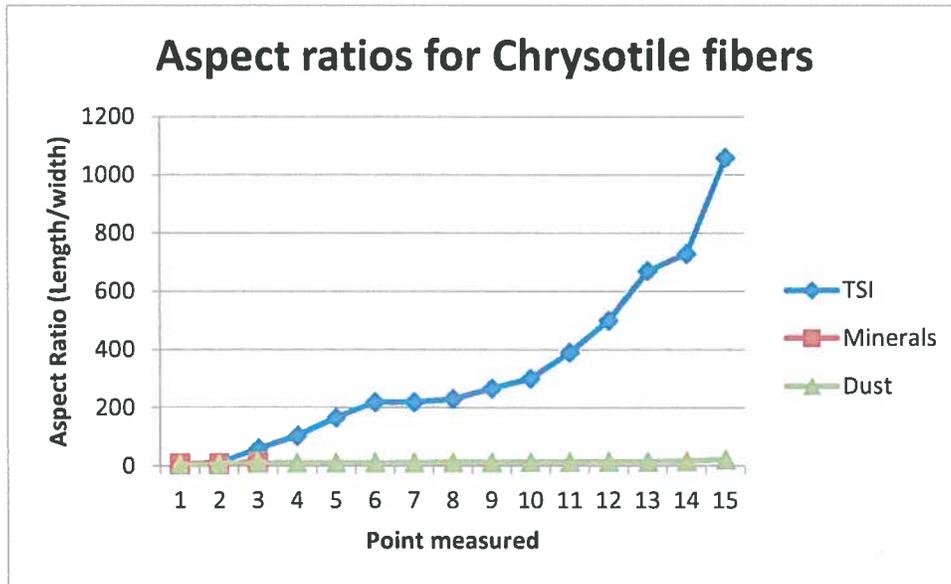
- Initial data related to the aspect ratios (length/width) of the Chrysotile fibers/bundles detected by TEM-EDS, seem to be showing a different aspect ratios of Chrysotile fibers present in the dust samples (aspect ratios were primarily less than 20:1 with two of the fifteen structures tested having aspect ratios of approximately 23:1 and 37:1) and Chrysotile fibers present in the TSI of the distillation tower (see data in Appendix V-8). TSI fibers were found to have a much larger aspect ratios; the average aspect ratio of the fifteen fibers analyzed was greater than 100:1 (329), with a minimum aspect ratio of 7:1 and a maximum aspect ratio of over 1000:1 (see Figure 32).

Figure 32. Aspect ratios for Chrysotile fibers present in TSI, NOA and dust. TSI is from a distillation tower.

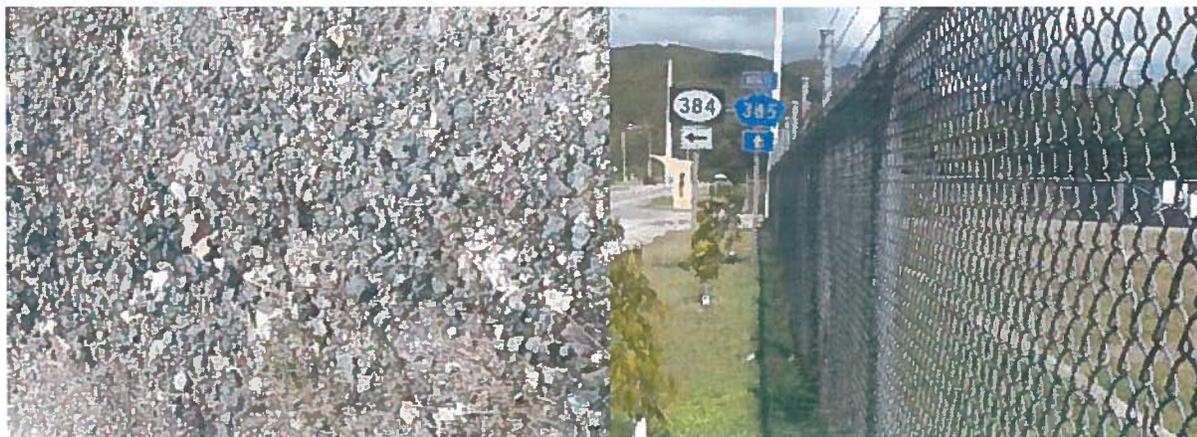
Serpentinite gravel containing Serpentine minerals was used extensively in the roads and parking lots construction. Serpentinite gravel was used for the secondary roads even within the facilities of Olefins, as well as in many surrounding areas (e.g. parking lot south of the bus station at intersection of roads 285 and 384, see Figure 33).

The gravel, subject to daily traffic movements will continuously release Chrysotile containing dust, thus explaining the highest Chrysotile results in dust present on the exterior, in the vicinity

Figure 33. Aggregates containing serpentinite rocks used on the secondary road inside Olefins facility (left) and on a fenced parking lot, south of the bus stop station located at intersection of state Roads 385/384.

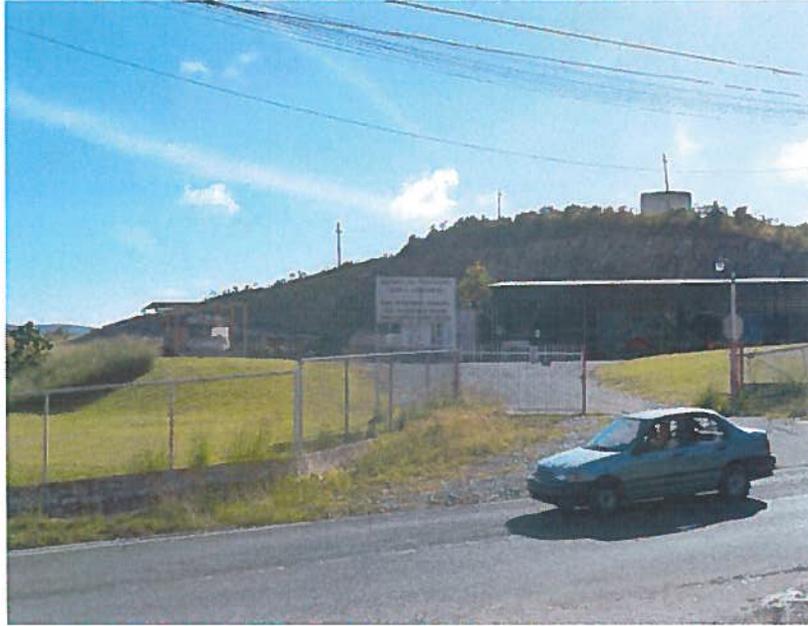
Micro-vacuuming sampling of dust was conducted on the main road, in front on entrance to quarry #17 (quarry Luis A. Gonzalez) located on route PR-121, Sector Cuatro Calles in Yauco (Figure 34). This quarry is active and it has both Environmental Quality Board (JCA) and DRNA permits. Dust sample (D-4-17-ER3) collected from the paved road front of the entrance shows asbestos Chrysotile concentration of approximately 290,000,000 str/cm² (see Appendix V-7 for results).

Figure 34. Front entrance to quarry #17 (Luis A. González) located on route PR-121 Sector Cuatro Calles in Yauco.

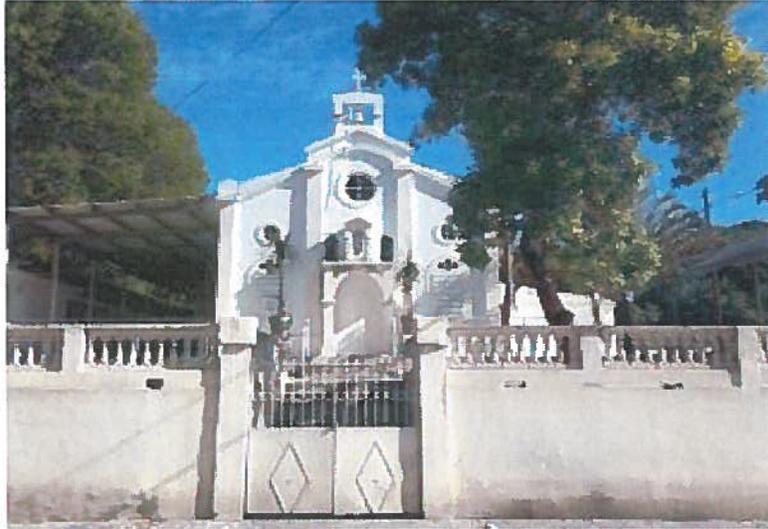
Construction activities were observed on other properties as well. The church next to the school had a part of its roof remodeled and the corrugated roof panels (assumed to contain asbestos fibers) on the back of the church were removed and replaced by new panels (see Figure 35a and 35b). It is not clear how the abatement/disposal of PACM panels was done.

Figure 35a. General view on the Church, Tallaboa Encarnación Community.

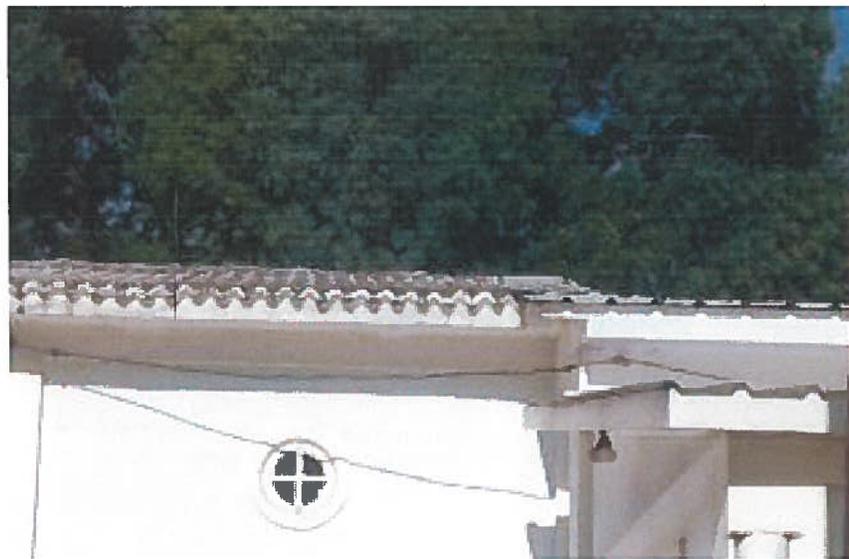
Figure 35b. Side view of Church. Left side the old roof corrugated presumed asbestos containing transite panels are noted. Right side, new metal panels covering the back part of the structure.

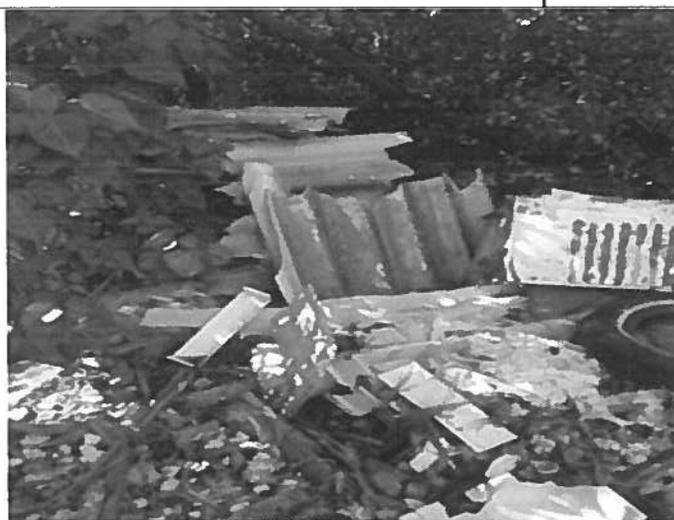
Construction waste containing asbestos containing corrugated panels was found approximately 2.2 miles away, on the beach area (See Appendix II for location and photos). Ten (10) samples were collected. Six (6) of the ten (10) samples collected from construction waste and debris present on the beach area are showing presence of Chrysotile asbestos fibers (see Table 13). All the six (6) samples were collected from corrugated transite panels. There is no certainty that any of the construction waste piles containing ACM debris was generated by the church renovation related activities. However, presence of ACM waste thrown on the beach suggest that some

| Sample ID | Description | Result (Percentage of Asbestos) |
|---|---|---|
| WP-NB-ER9 | Large Pile of Transite Debris Mixed with Trash, Debris #9 | 20% CHR |

Figure 36. General View of waste pile #9 that has transite panels mixed with trash.

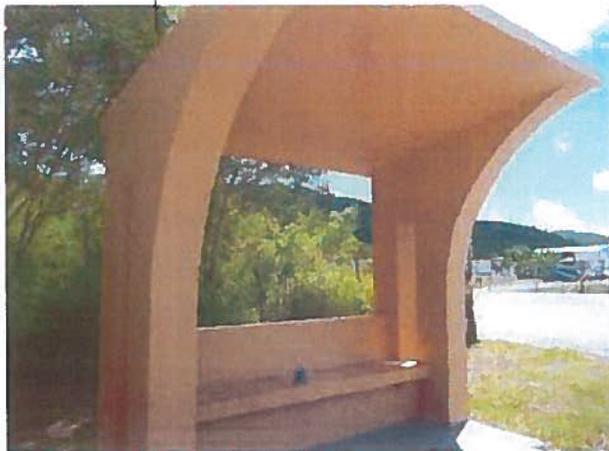
**General View of Sample from Bus Stop
Left Side
D-385-W-ER1**

Figure 1. General view of the bus station, intersection state roads PR-385 and PR-384.

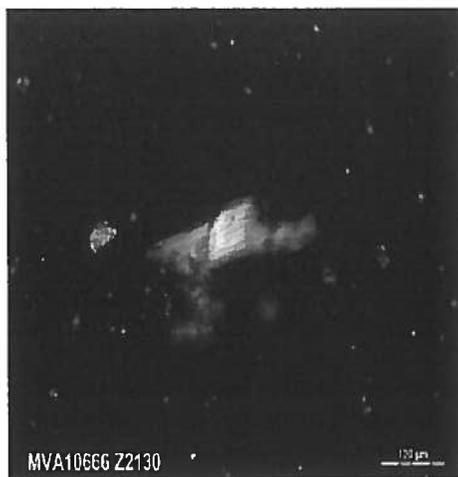
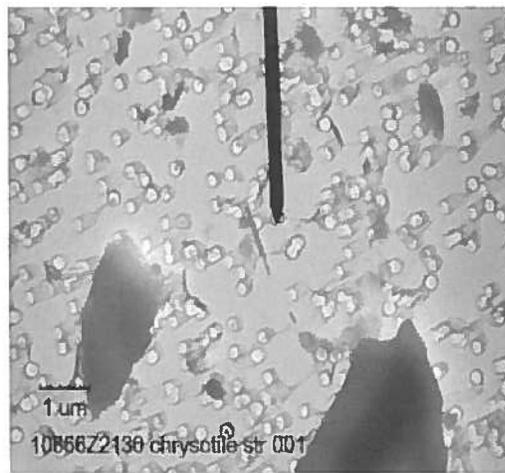
Large bundles of Chrysotile were observed during microscopical investigation of additional samples collected by AESI using micro-vacuuming. As an example below (Figure 3), there is a Chrysotile bundle (left photo) collected from the floor of Exchange Boiler Specialist (MVG sample I.D#-Z2130; AESI sample #D-TEC-ARE-PO006-ER7). The bundle, as seen by Polarized Light Microscopy (PLM) is about 275um long and 50 um wide. As the bundle is made of soft fibers, applied pressure when collecting the wipe sample may convert it to either individual fibers (see right photo below, same sample seeing by TEM), or maybe smaller bundles.

Figure 3. Chrysotile bundles and fibers as viewed by PLM (left and TEM right)

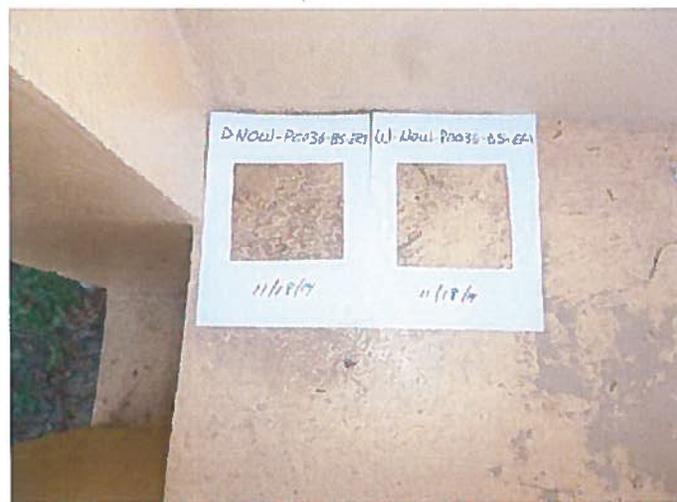
The presence of Chrysotile and Tremolite in the settled dust after the bench clean-up conducted by AESI inspector, suggest that contamination of the area is not related to a single event in the past but it is a dynamic event caused continuously by either daily winds, vehicles passing nearby stirring up the settled dust, or crushing of gravel (present in the parking lot south of the station) subject to daily traffic movement (see Section 7). The fingerprinting of the dust sample collected by AESI in the bus station suggested that not only Chrysotile but also Lizardite are present in one of the bus station samples. The consequences of Lizardite/Chrysotile appearances are discussed in Section 6.2 and are related to Natural Occurring Asbestos (NOA) rocks.

Figure 4. Bus station at intersection of state roads PR-385 and PR-384 prior to wipe/micro-vacuum side by side. Sampling conducted on 11/18/2014.

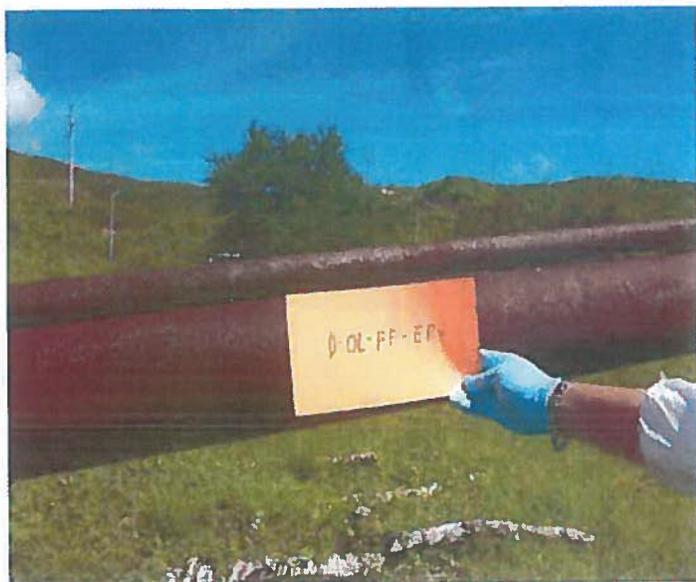
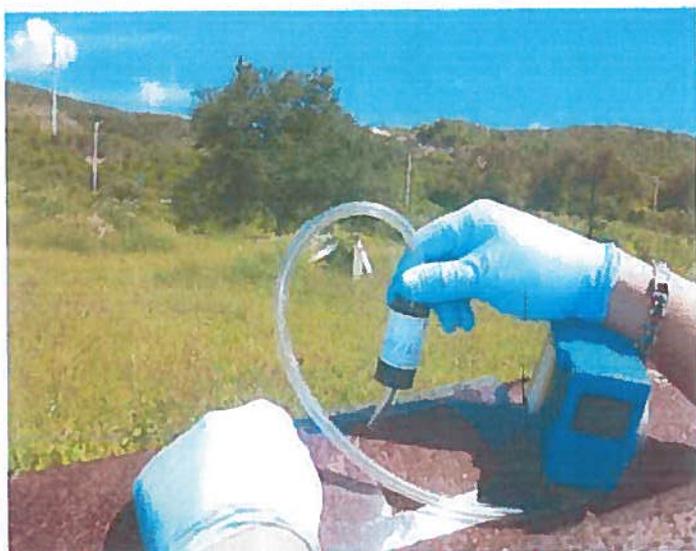
**General View of Sample on Top
of Pipe Surface from Front Flare Area
D-OL-FF-ER2**

**Sample on Top of Pipe Surface
from Front Flare Area
D-OL-FF-ER2**

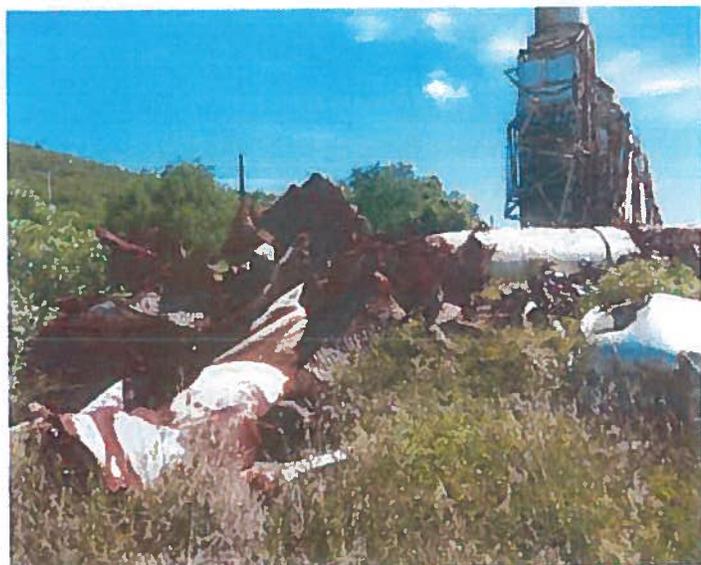
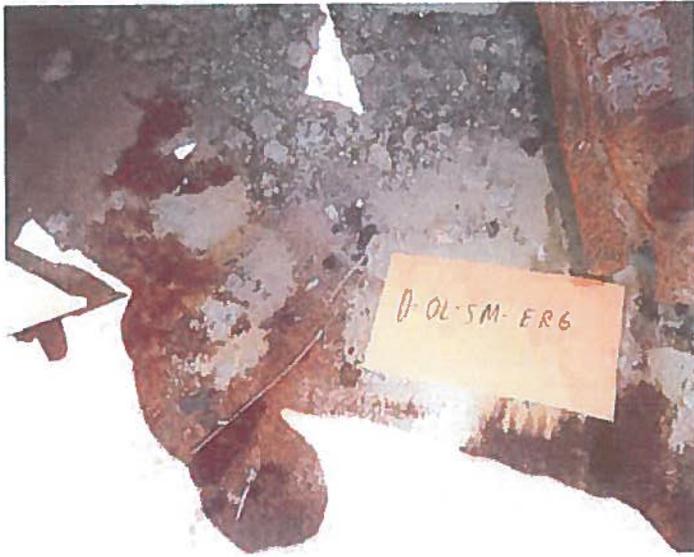
**General View of Sample from Surface
of Metal Scrap in Front of Area
where the Crane was
D-OL-SM-ER6**

**Sample from Surface of Metal Scrap
in Front of Area where the Crane was
D-OL-SM-ER6**

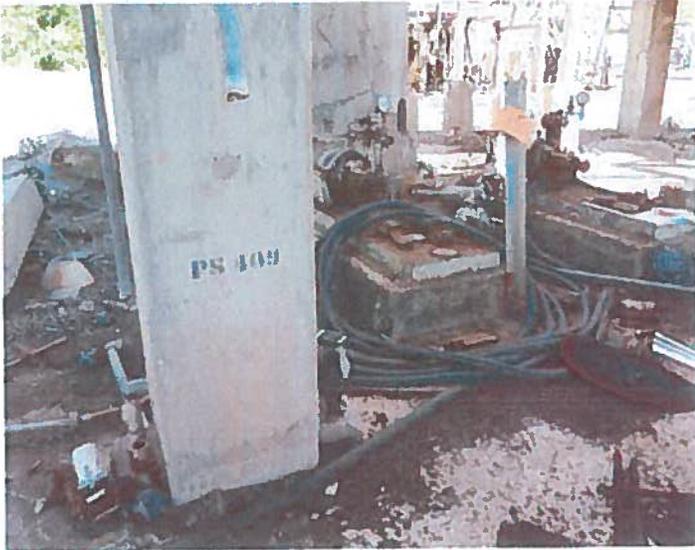
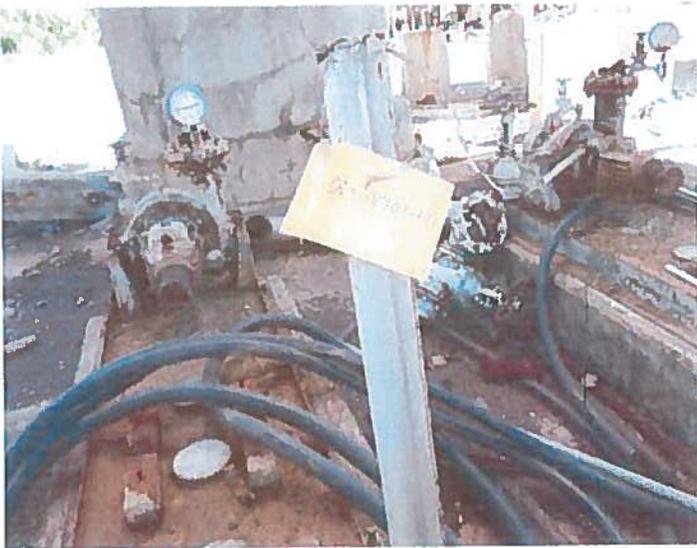
**General View of Sample from Debris
of Pipe Insulation found on Floor
from Area OV409
B-OL-OV-409-ER1**

**Sample from Debris of Pipe Insulation
found on Floor from Area OV409
B-OL-OV-409-ER1**

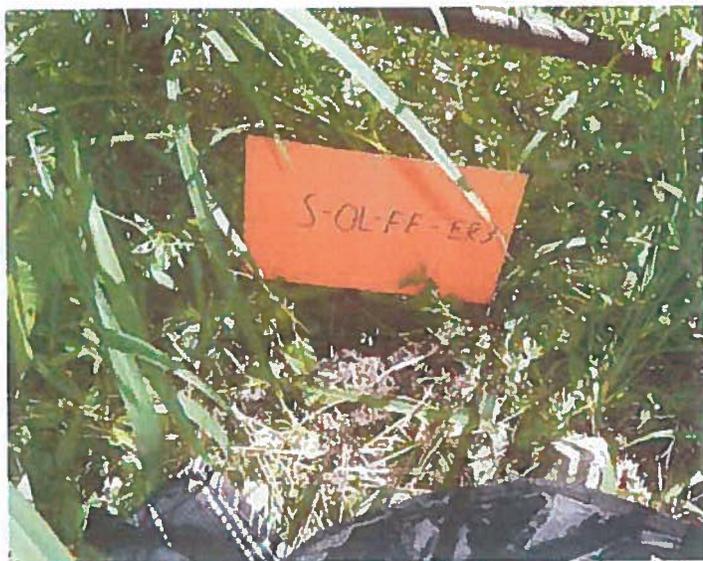
**Soil Sample from Area Covered with Grass,
Area in Front of Flare
S-OL-FF-ER3**

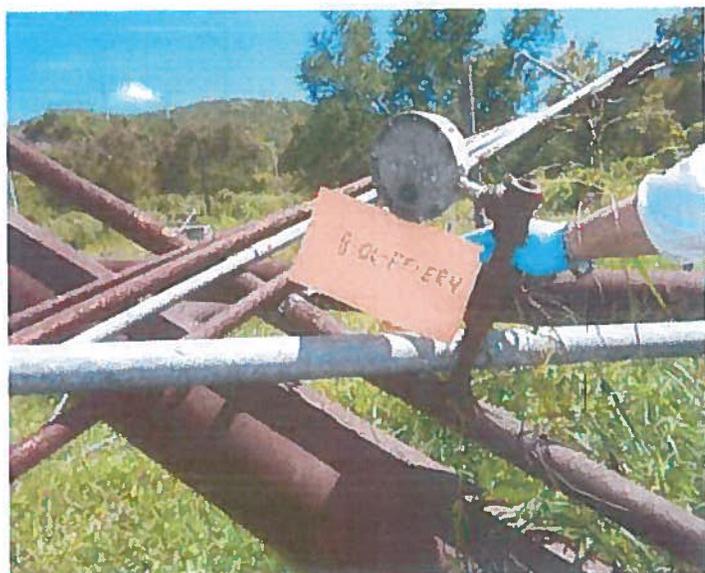
**Sample from Insulation Under Pipe
on the Floor, Area in Front of Flare
B-OL-FF-ER4**

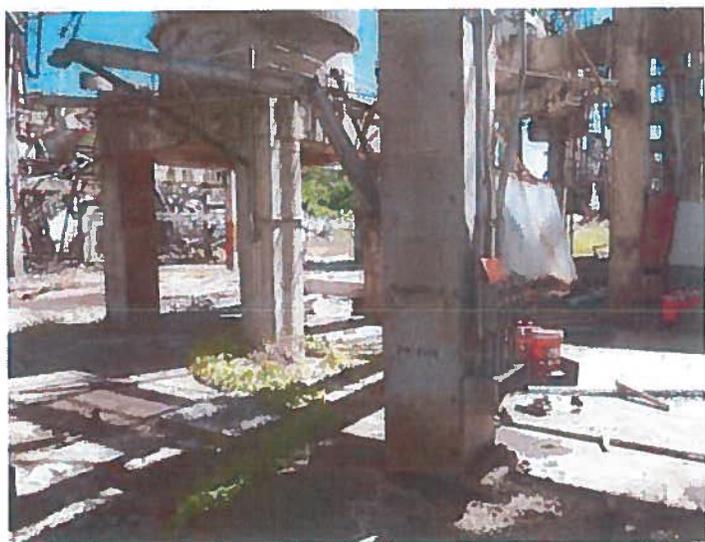
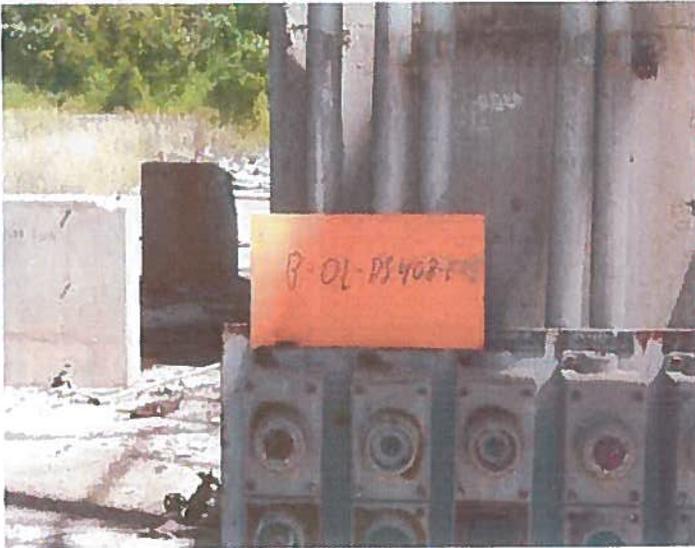
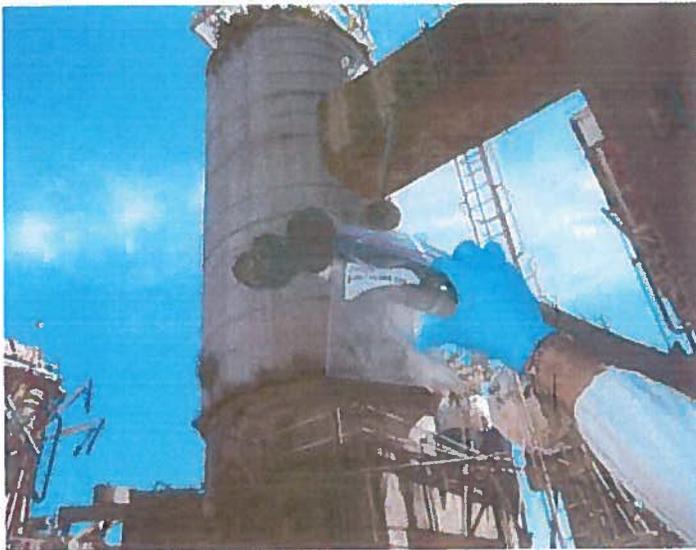
**General View of Sample from Pipe Insulation
on Floor, Debris from Area PS408
B-OL-PS408-ER5**

**Sample from Pipe Insulation on Floor
Debris from Area PS408
B-OL-PS408-ER5**

**Sample from Pipe Insulation seen on Floor
from Area PS408
B-OL-PS408-ER5**

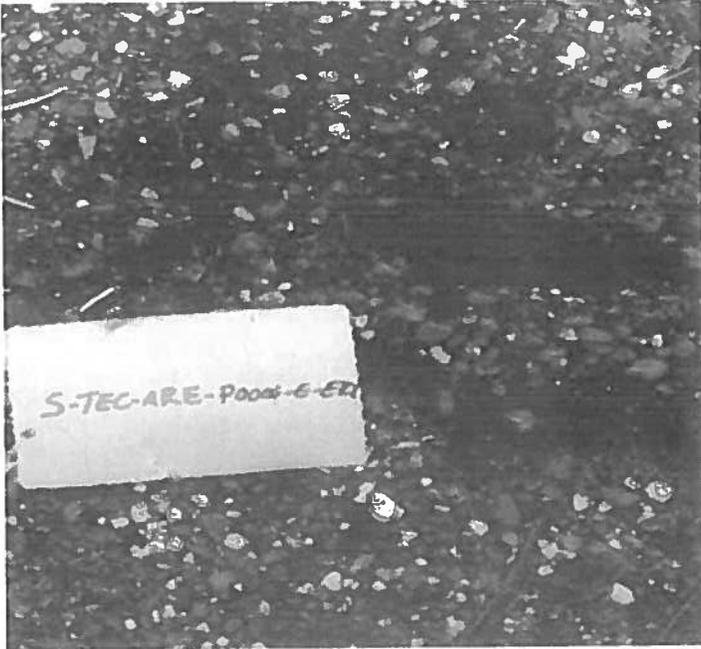
**Gravel from Road Backfill, Entrance to AR
Exchanger Boiler Specialist
S-TEC-ARE-P0006-ER1**

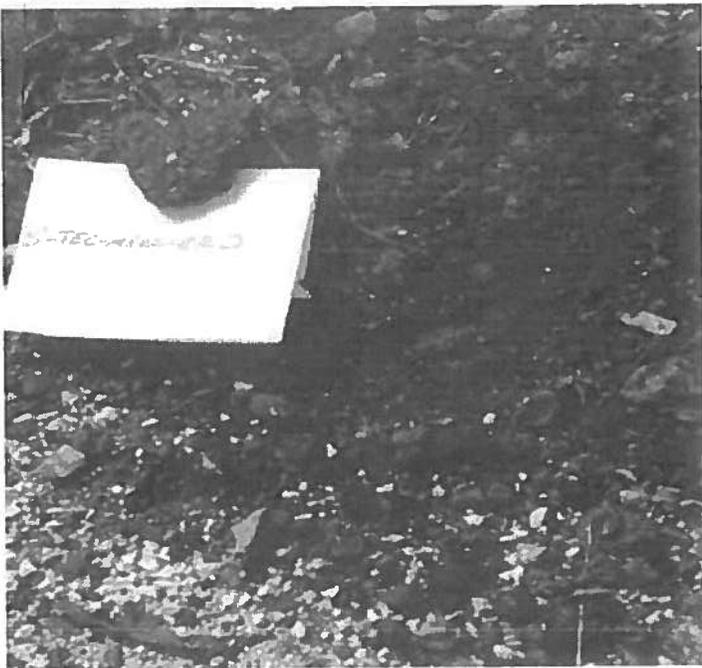
**Gravel from Road Backfill, Entrance to Olefin
S-TEC-MECL-ER2**

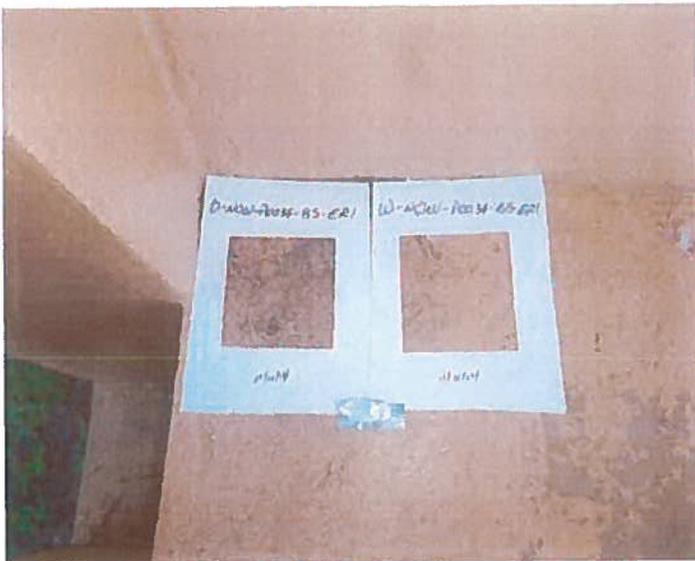
**Dust Sample from Bus Stop Bench
Road. 385, Int. with Road 384
Northwest of Olefin between 1 & 2 miles Radius
D-NOW-P0036-BS-ER1**

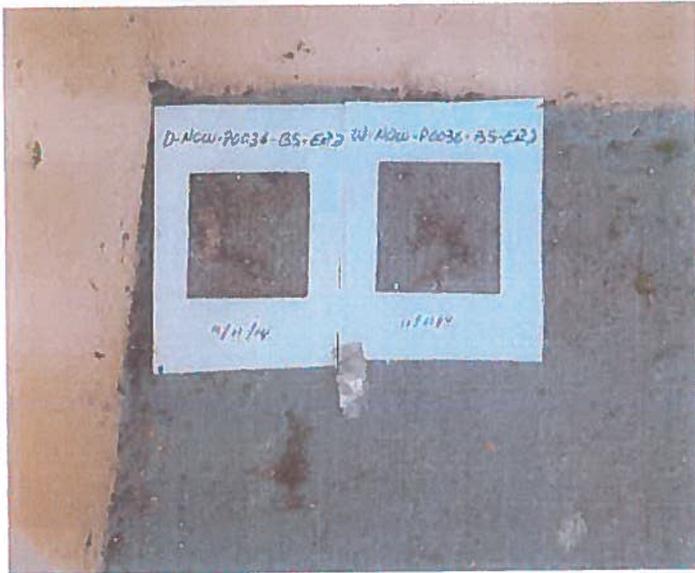
**Dust Sample from under Bus Stop Bench
Road. 385, Int. with Road 384
Northwest of Olefin between 1 & 2 miles Radius
D-NOW-P0036-BS-ER2**

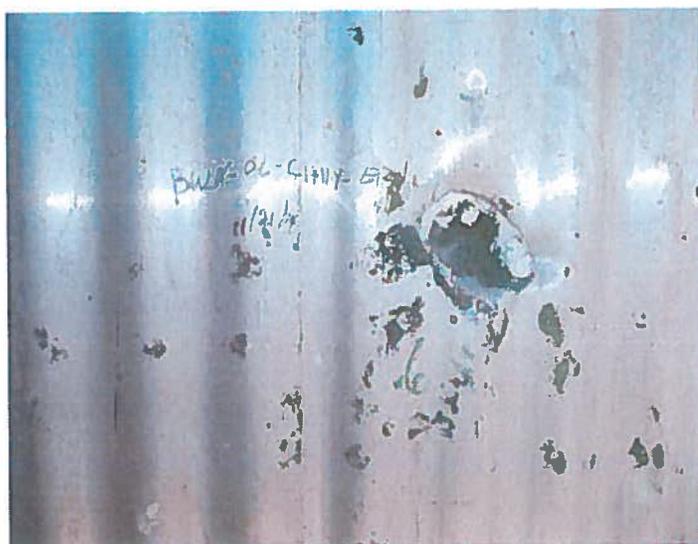
TSI Sample from South Side
Right of Platform of Vessel OV-302
BULK-OL-CHM4-ER1

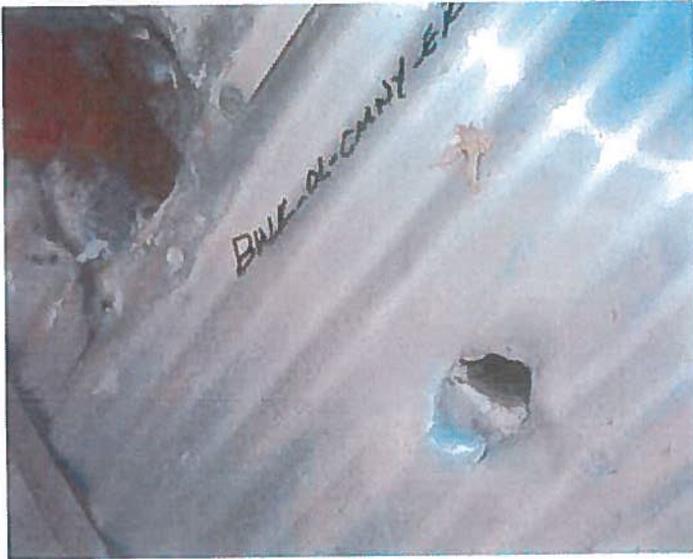
**TSI Sample from South Side
Left of Platform of Vessel OV-302
BULK-OL-CHM4-ER2**

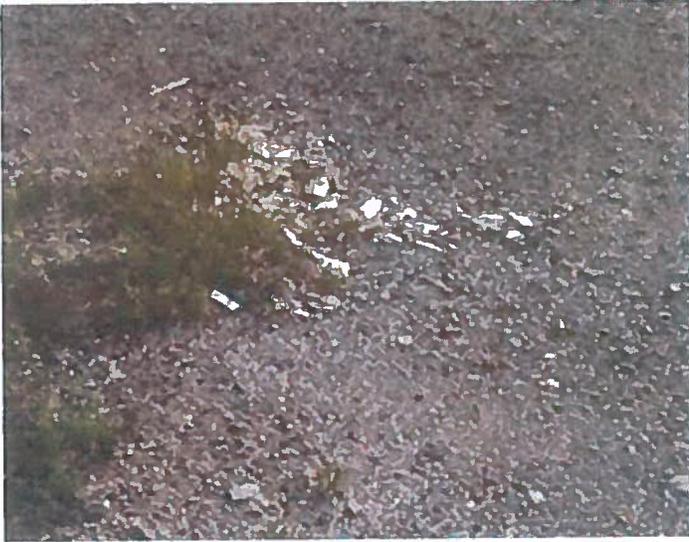
**General View of Debris #1
Transite Debris, Pile 1**

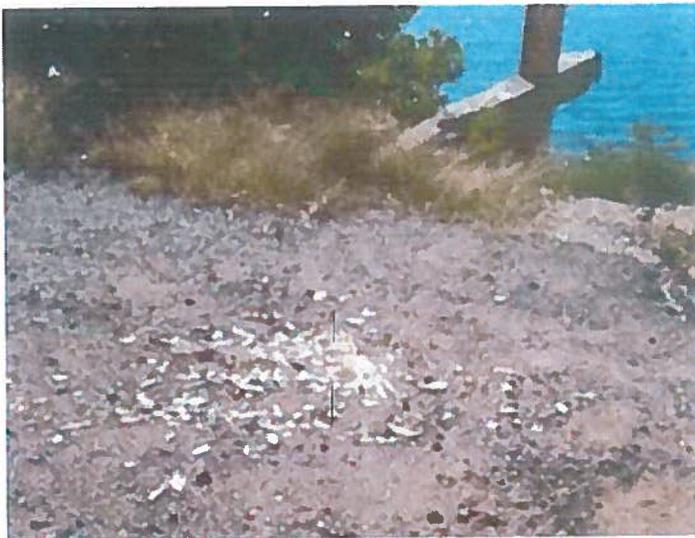
**General View of Debris #1
Transite Debris, Pile 2**

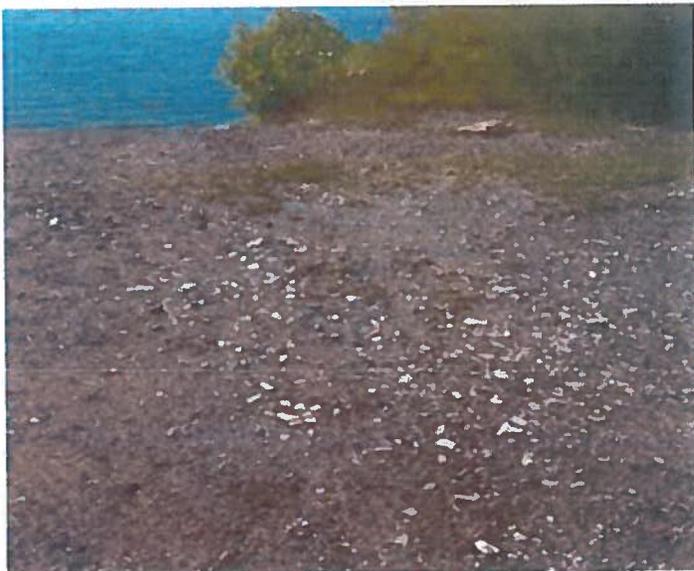
**General View of Debris #1
Transite Debris, Pile 3**

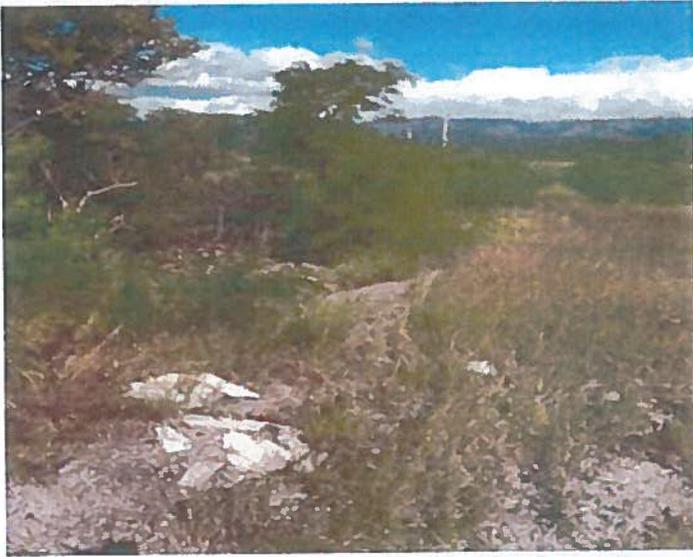
**General View of Debris #2
Transite Debris**

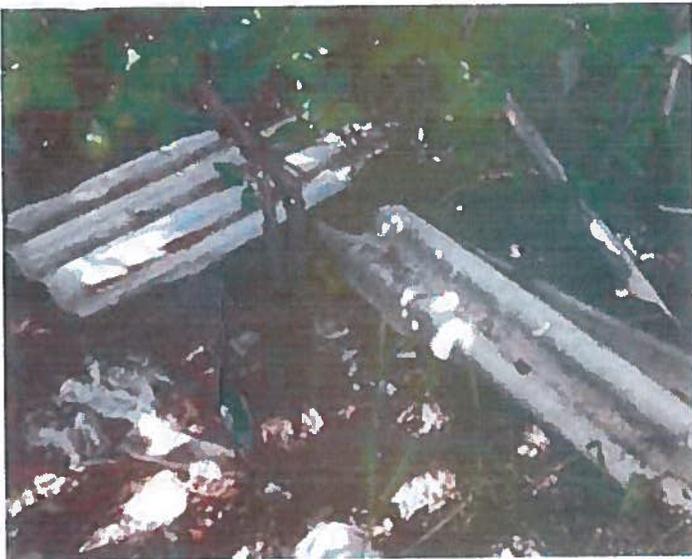
**General View of Debris #3
Transite Debris inside Mangrove**

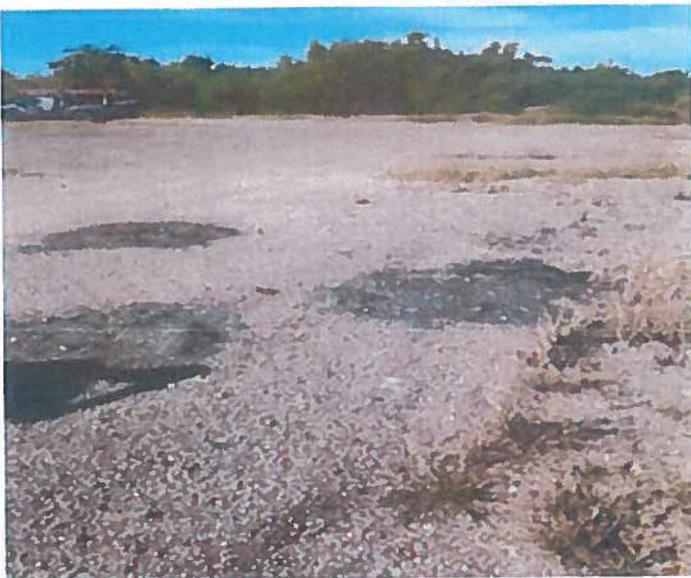
| Sample I. D. | Sample Description (i.e. Location, Name, etc.) | Collected | | Analysis Required | | Comments | Laboratory I.D. |
|---|---|---|---|---|---|---|---|
| WP-NB-ER4 | Bituminous Material found in the Dirt Road, Debris #4 | 12/18/14 | 14:33 | X | | composite | 59435 |

**General View of Debris #4
Bituminous Material found in Dirt Road**

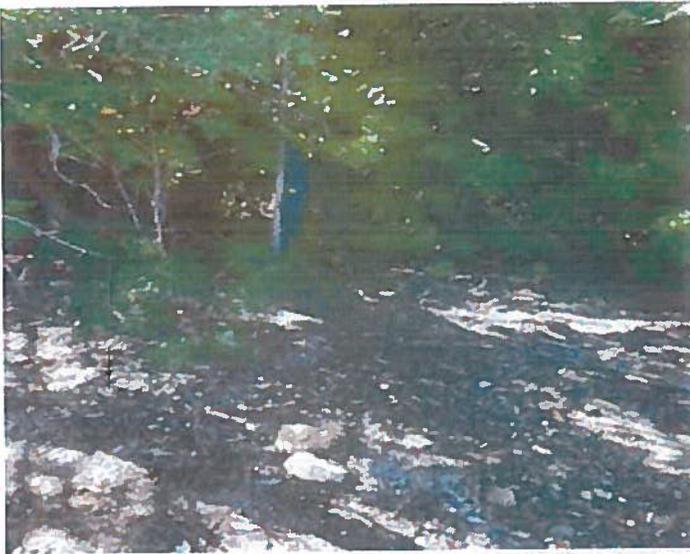
**General View of Debris #6
Black, Hard Material Painted Blue
with Bitumen and Rubber**

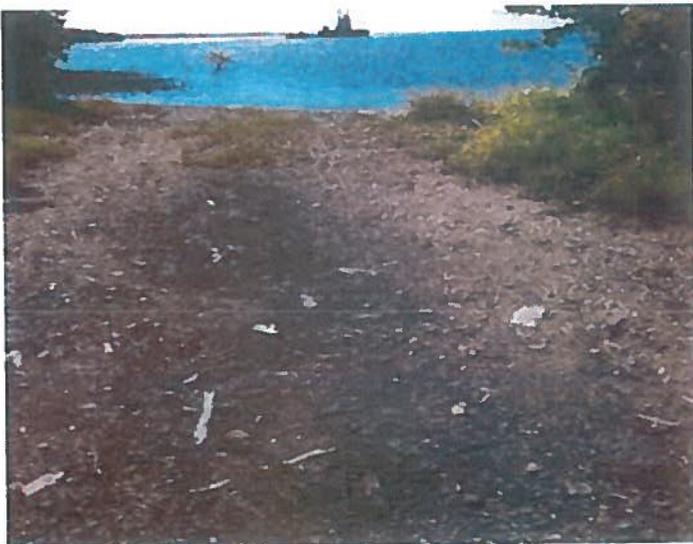
| Sample I. D. | Sample Description (i.e. Location, Name, etc.) | Collected | | Analysis Required | | Comments | Laboratory I.D. |
|---|---|---|---|---|---|---|---|
| WP-NB-ER7 | Bituminous Material found in Gravel close to the Sea, Debris #7 | 12/18/14 | 15:05 | X | | composite | 59438 |

**General View of Debris #7
Bituminous Material found in Gravel
close to Sea**

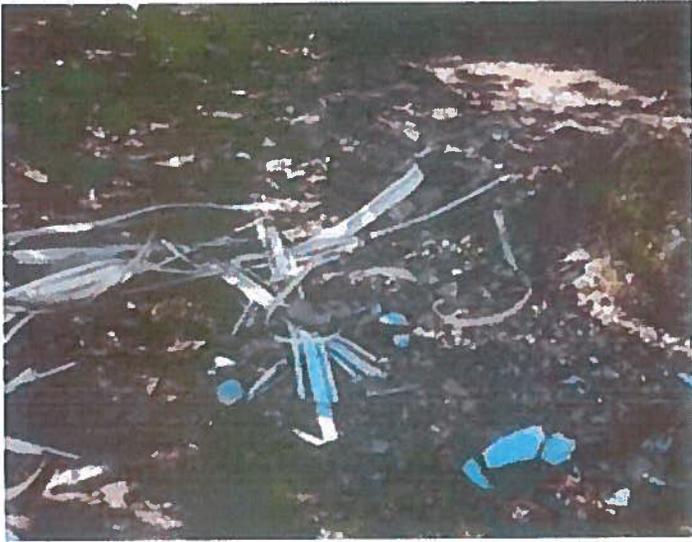
**General View of Debris #8
Transite Panels Debris mixed with
Concrete and Plastic**

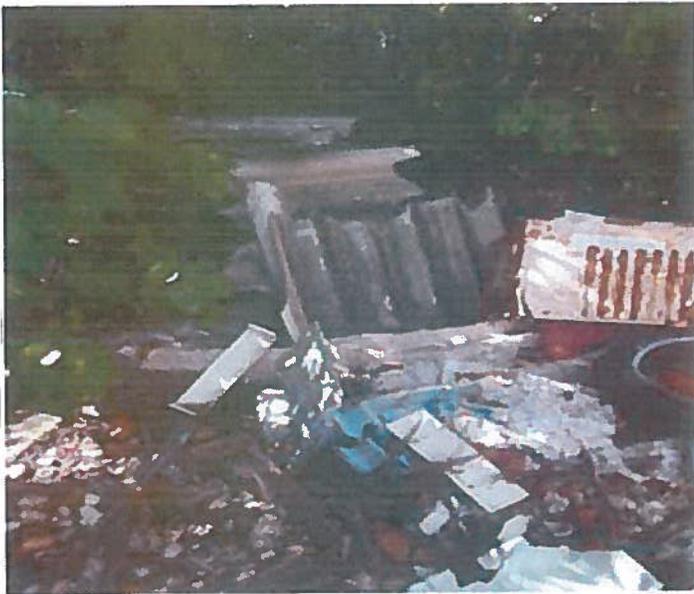
**General View of Debris #9
Large Pile of Transite Debris mixed
with Trash**

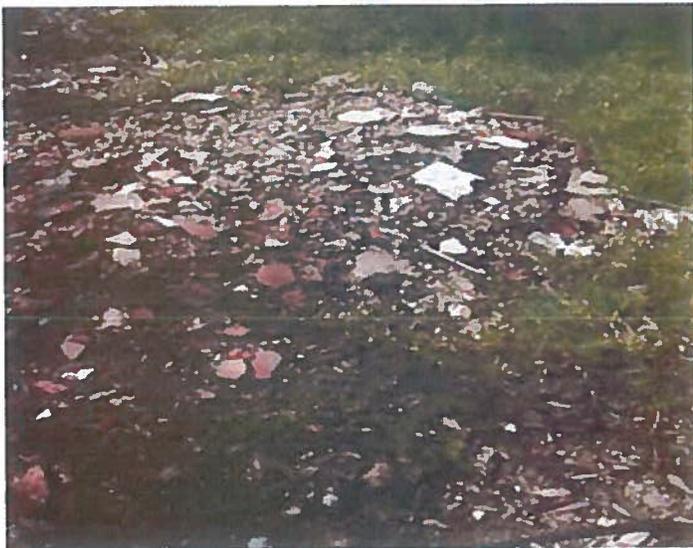
**General View of Debris #10
Bituminous Material mixed with Concrete
and Ceramic Tiles**

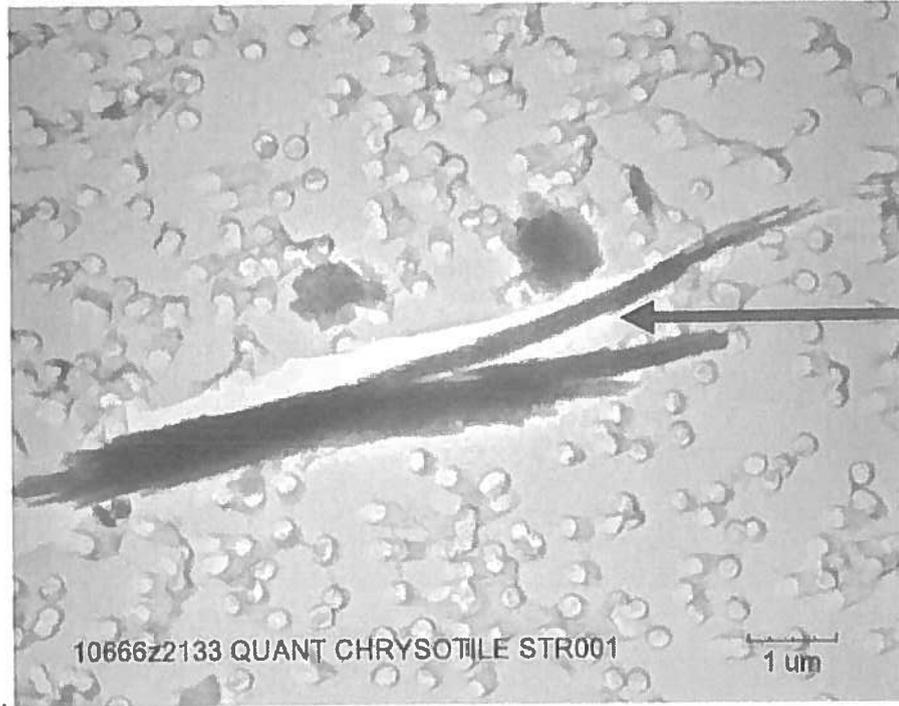
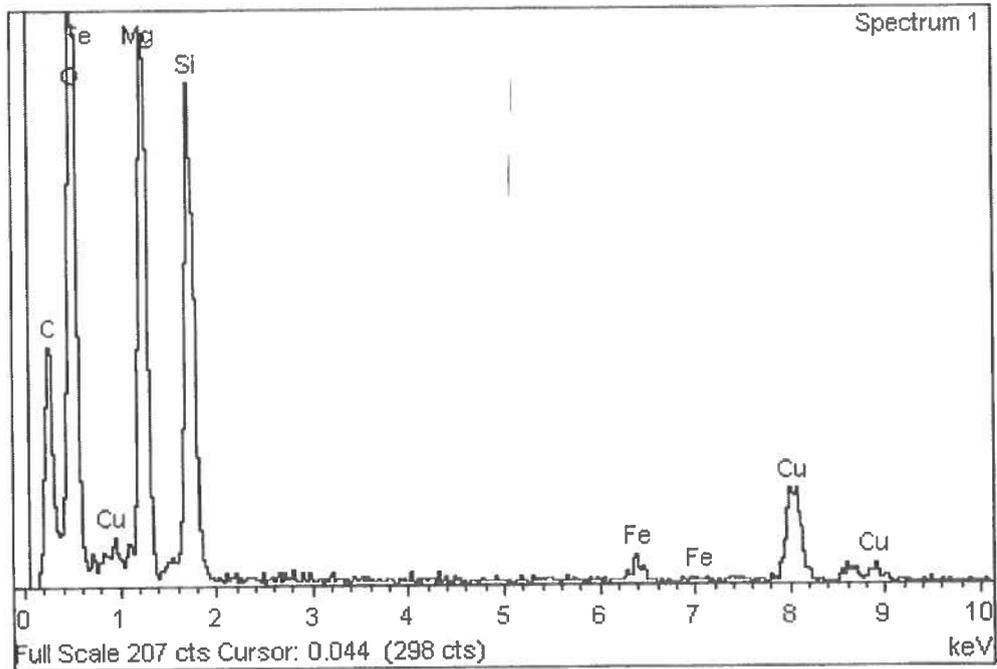
Figure 1. TEM image and EDS spectrum of chrysotile bundle observed in microvac sample D-NOW-P0036-BS-ER10 (MVA Z2133).

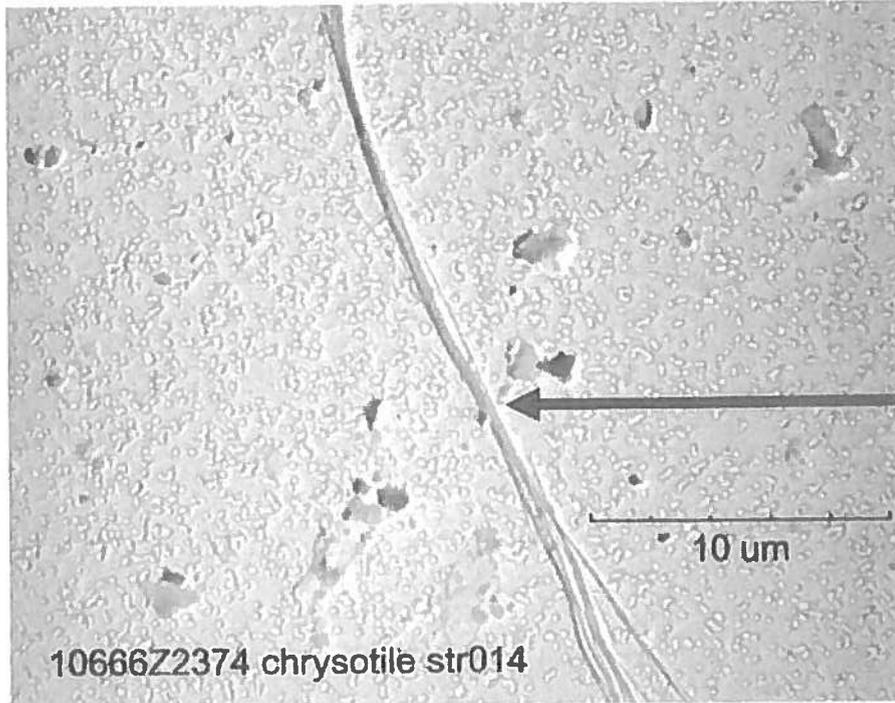
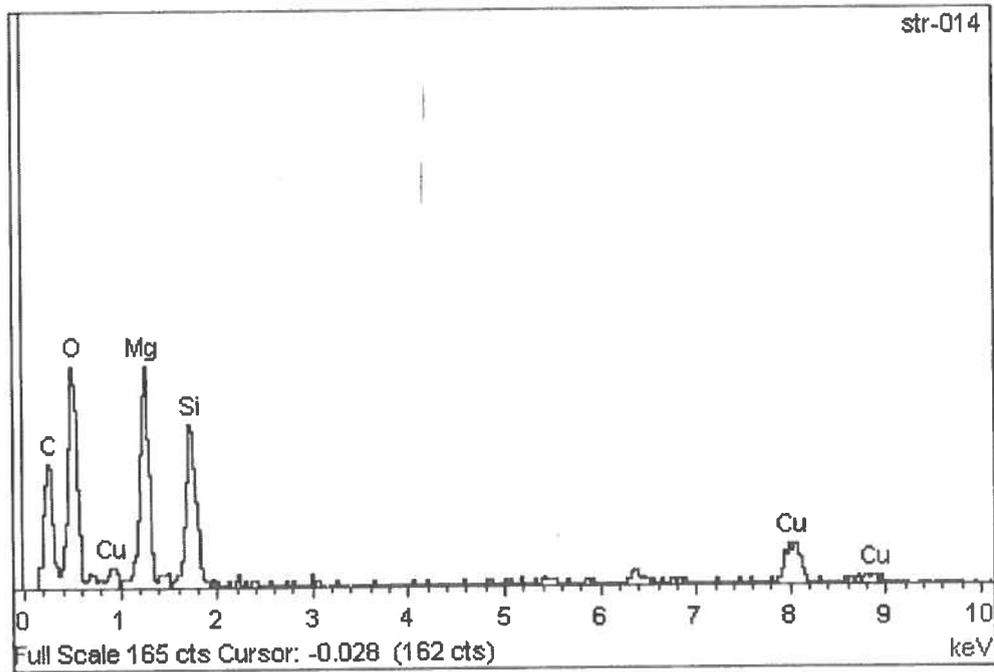
Figure 2. TEM image and EDS spectrum of chrysotile bundle observed in wipe sample D-385-W-ER1 (MVA Z2374).

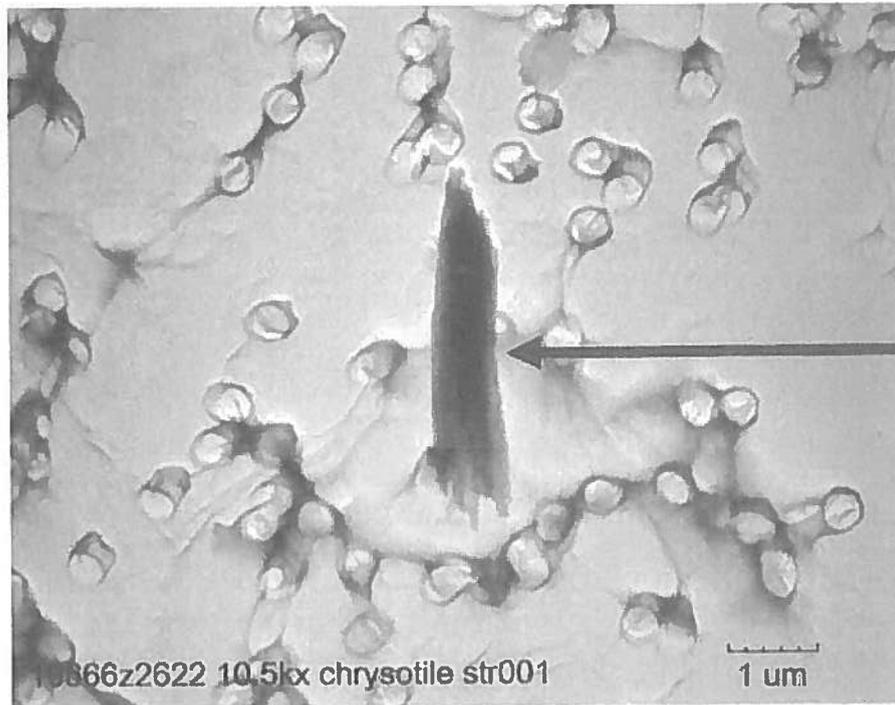
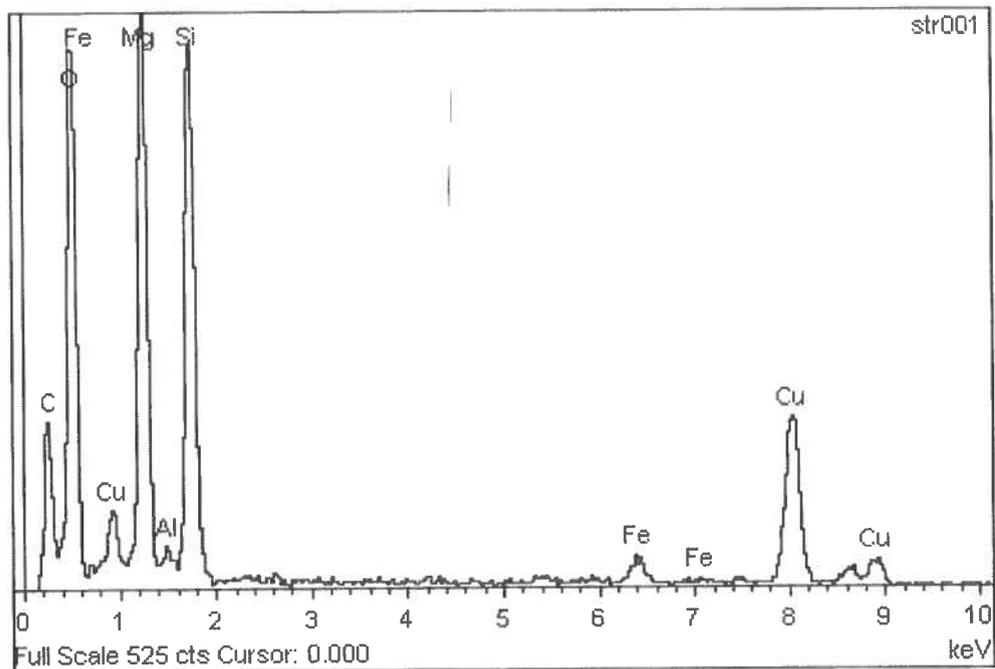
Figure 3. TEM image and EDS spectrum of chrysotile bundle observed in wipe sample W-NOW-P0036-BS-ER1 (MVA Z2622).

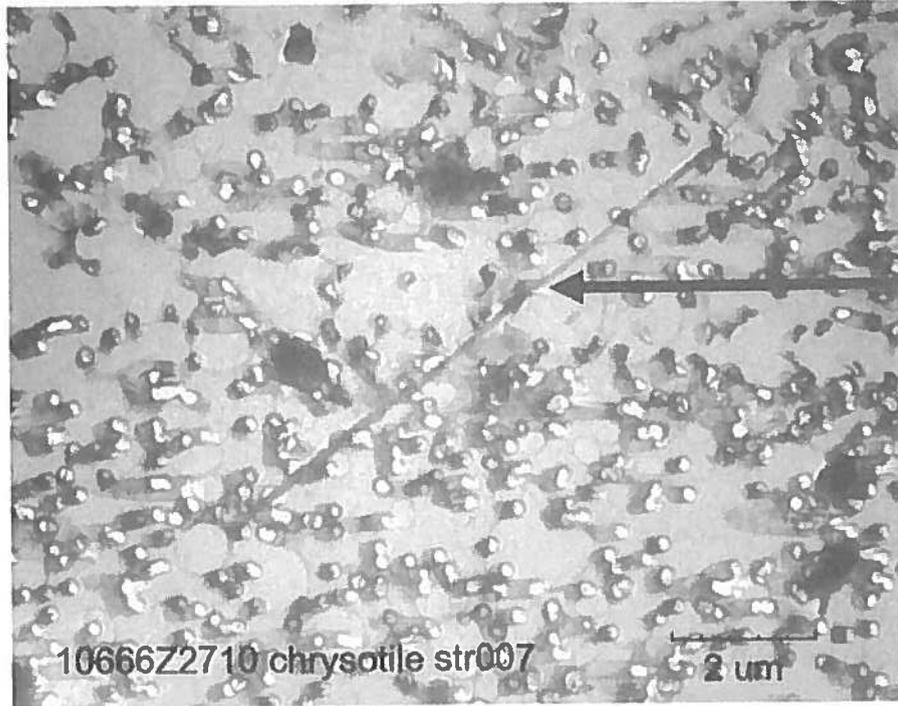
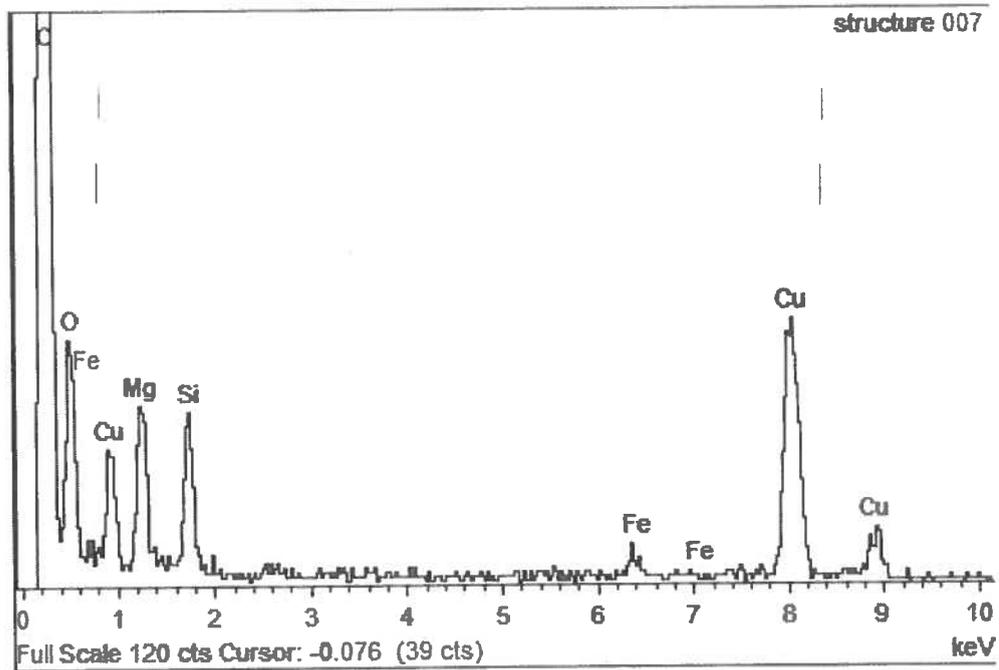
Figure 4. TEM image and EDS spectrum of chrysotile fiber observed in microvac sample D-NOW-P0036-BS-ER1 (MVA Z2710).
