**REPORT OF INITIAL FINGERPRINTING
FINDINGS RELATED TO
PUERTO RICO OLEFIN SITE
PEÑUELAS, PUERTO RICO**

Prepared by:
Ady Padan, Ph.D

February, 2015

Analytical Environmental
Services International, Inc.
611 Monserrate Street
2nd Floor, Santurce, P.R. 00907
(787) 722-0220 / Fax (787) 724-5788

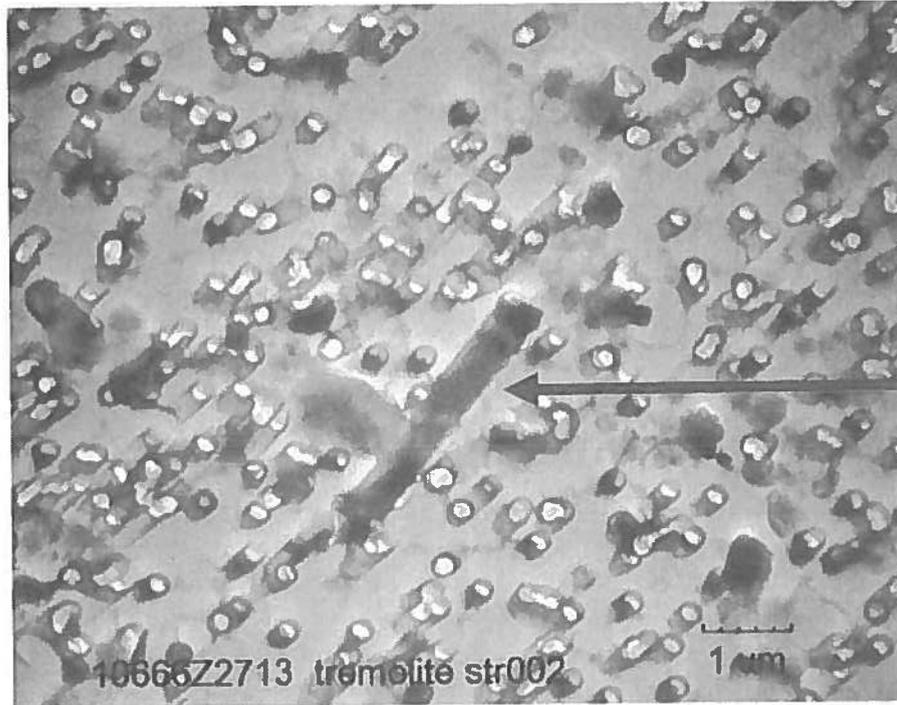
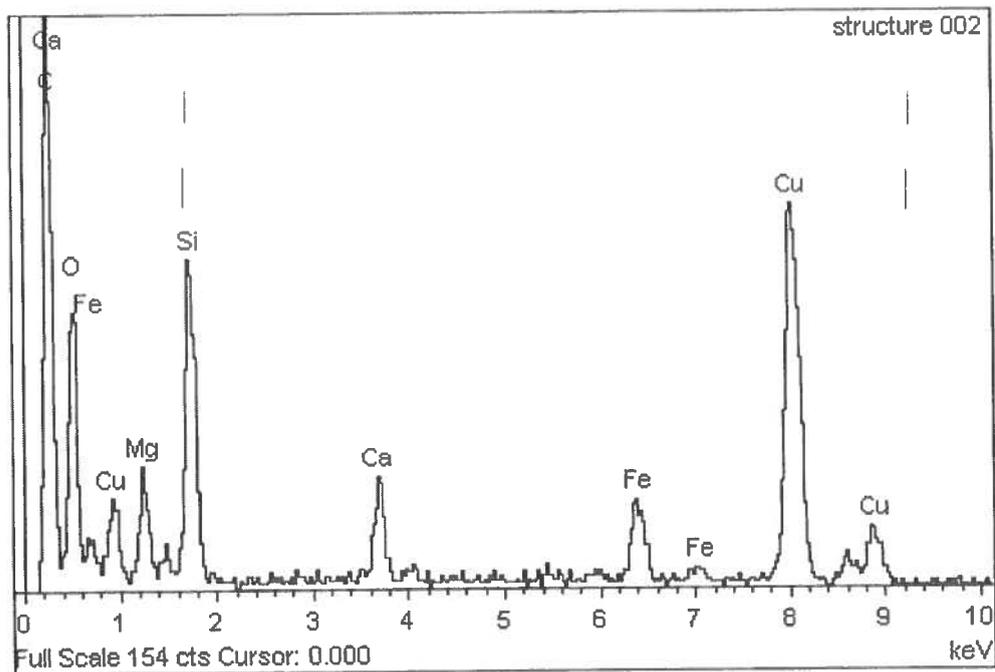
| MVA # | Sample I. D. | Sample Description | Date Collected | TEM results [str/cm ²] |
|---|---|--|---|---|
| Z2713 | W-NOW-P0036-BS-ER1 | Wipe on bench bus stop intersection Road 385/384 | 18 November 2014 | 13,000 total chrysotile-8,400 tremolite-4,200 |

Figure 5. TEM image and EDS spectrum of tremolite fiber observed in wipe sample W-NOW-P0036-BS-ER1 (MVA Z2713).

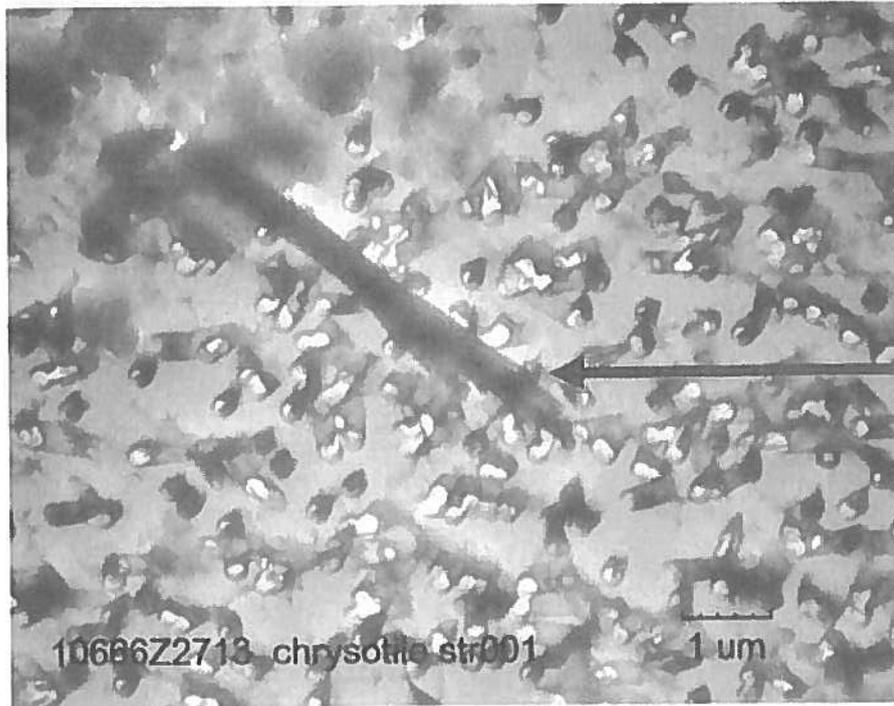
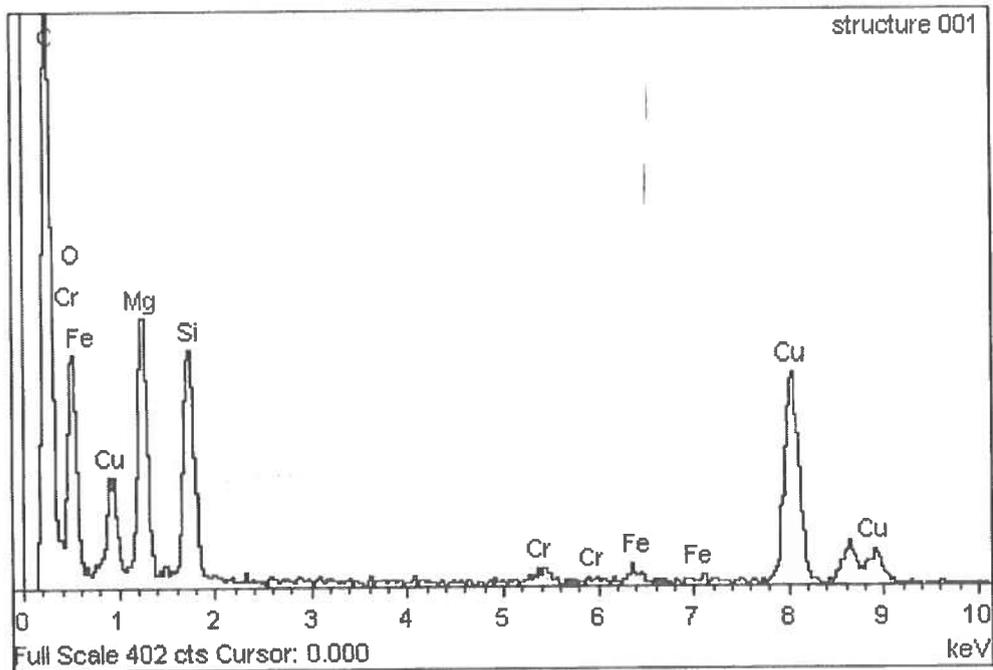
Figure 6. TEM image and EDS spectrum of chrysotile bundle observed in wipe sample W-NOW-P0036-BS-ER1 (MVA Z2713).

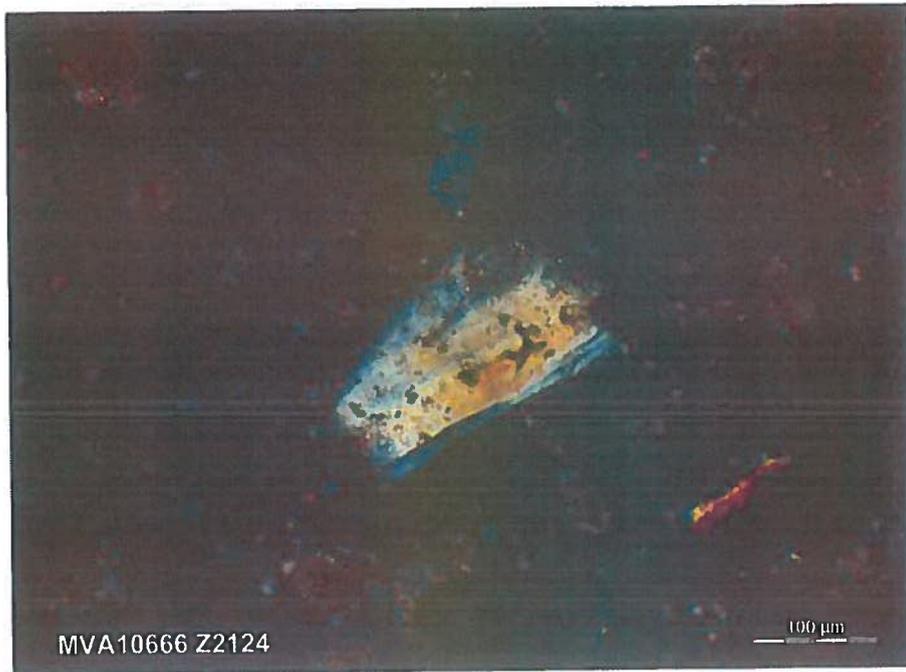
Figure 1. PLM image of chrysotile asbestos bundle detected during analysis of sample D-EV-FP-ER1, "Dust, floor, front porch entrance stair, El Velorio restaurant."

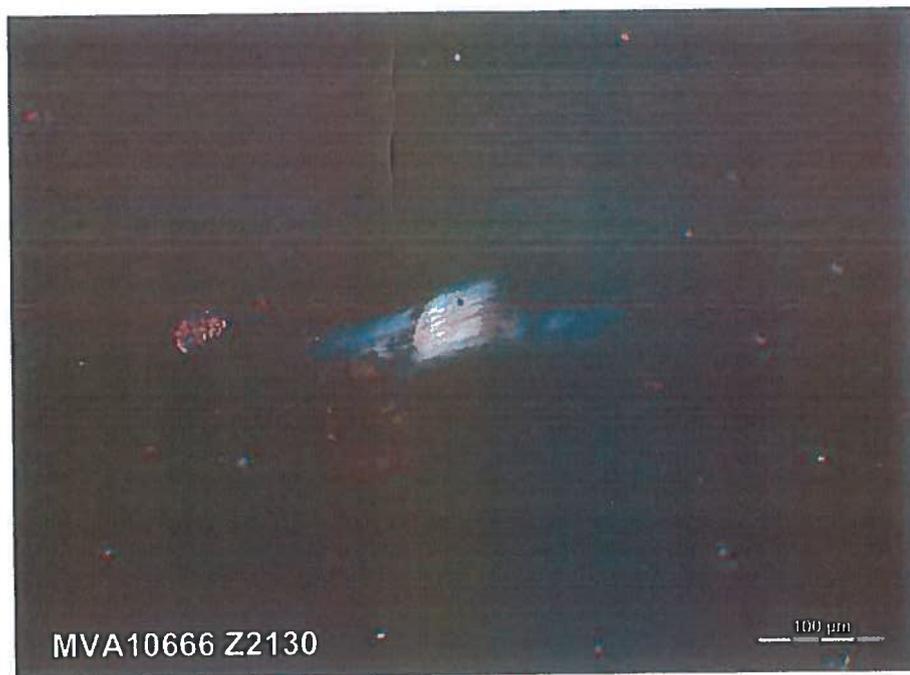
Figure 2. PLM image of chrysotile asbestos bundle detected during analysis of sample D-TEC-ARE-PO006-E-ER7, "Dust, floor, AR exchanger boiler specialist exterior Tallaboa Encarnacion Community."

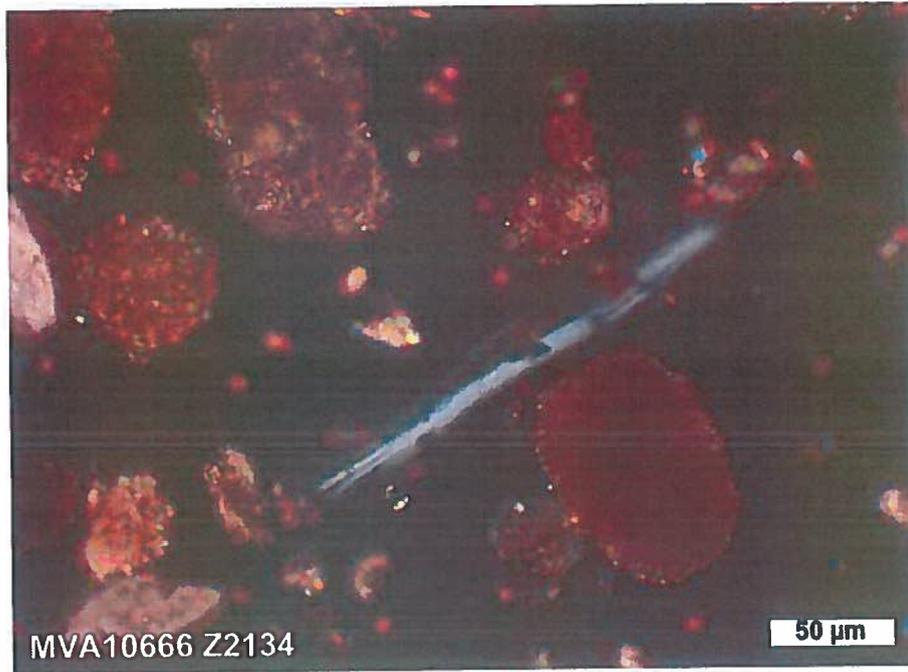
Figure 3. PLM image of chrysotile asbestos bundle detected during analysis of sample D-TEC-P0021-C2-ER11, "Dust, floor, sidewalk front of house corner street 2 intersection street 4, Tallaboa Encarnacion Community."

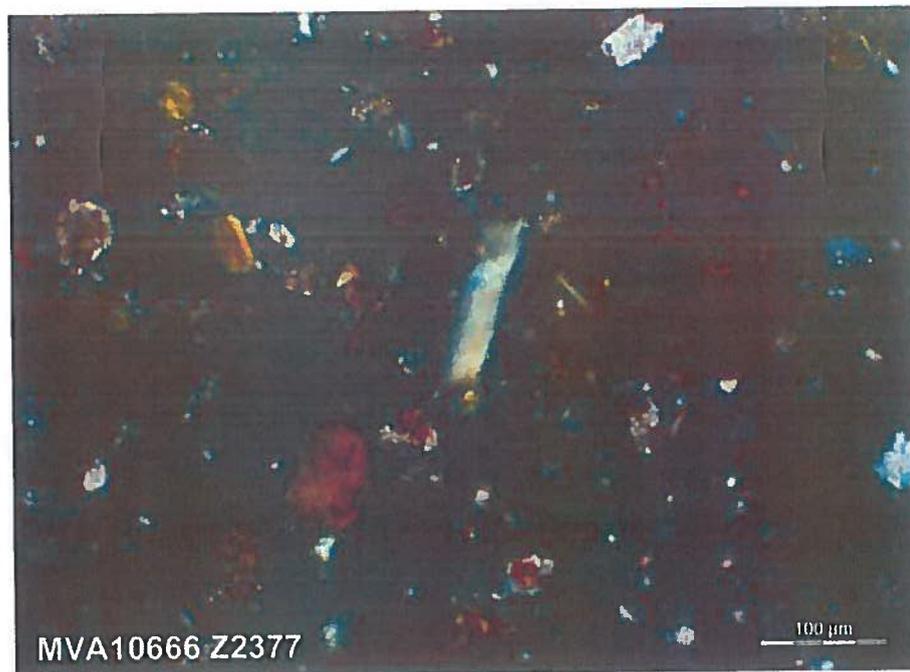
Figure 4. Chrysotile asbestos bundle detected during analysis of sample D-OL-SM-ER6, "Sample from surface of metal scrap in front of area where the crane was."

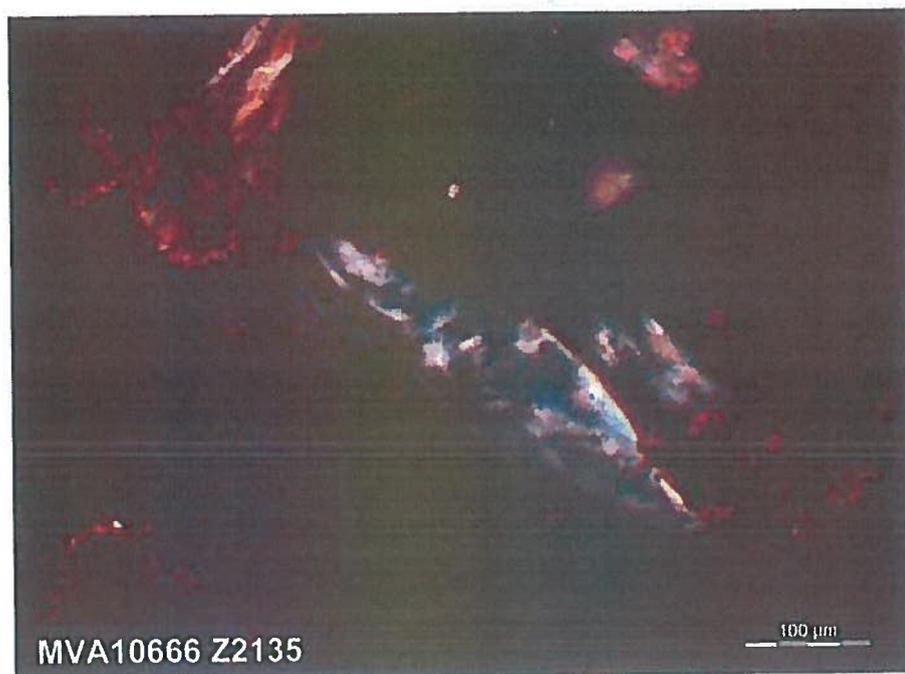
Figure 5. PLM image of lizardite particle detected during analysis of sample D-TEC-P0018-CR-ER12, "Dust, floor, corner street 2, west of street 2 Tallaboa Encarnacion Community."

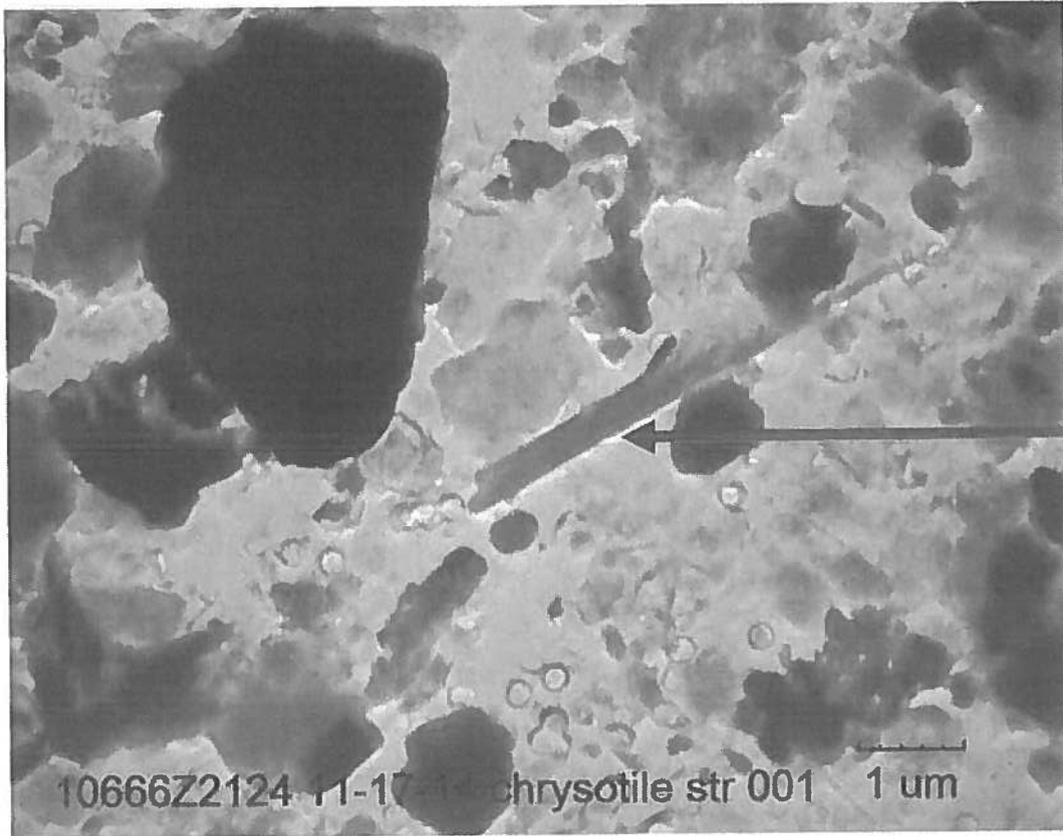
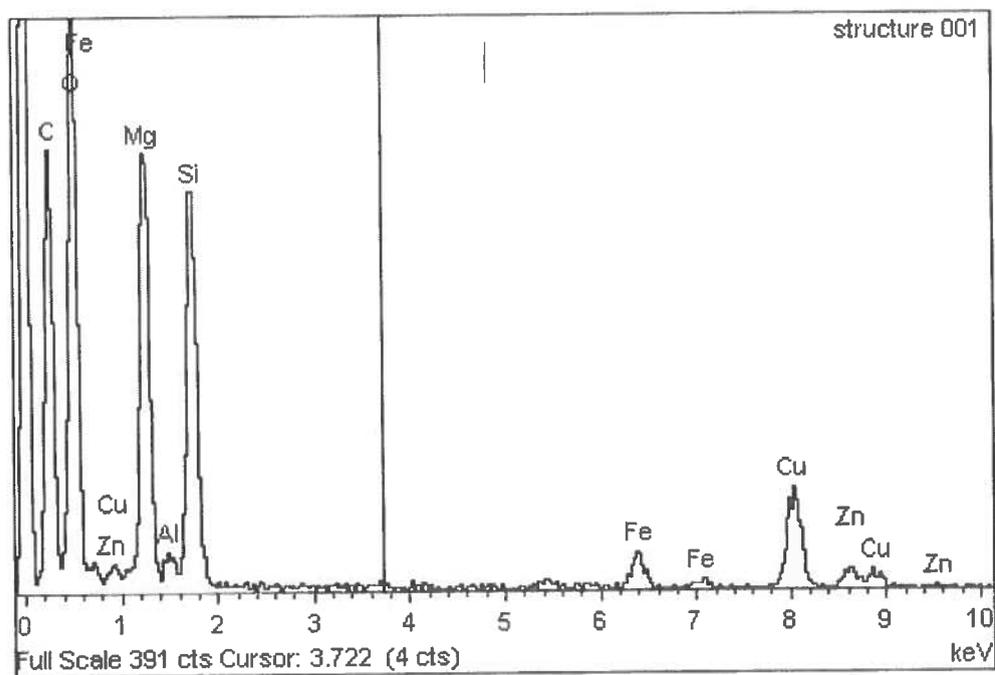
Figure 6. TEM image (above) and EDS spectrum (below) of chrysotile asbestos bundle detected in sample D-EV-FP-ER1, "Dust, floor, front porch entrance stair, El Velorio restaurant."

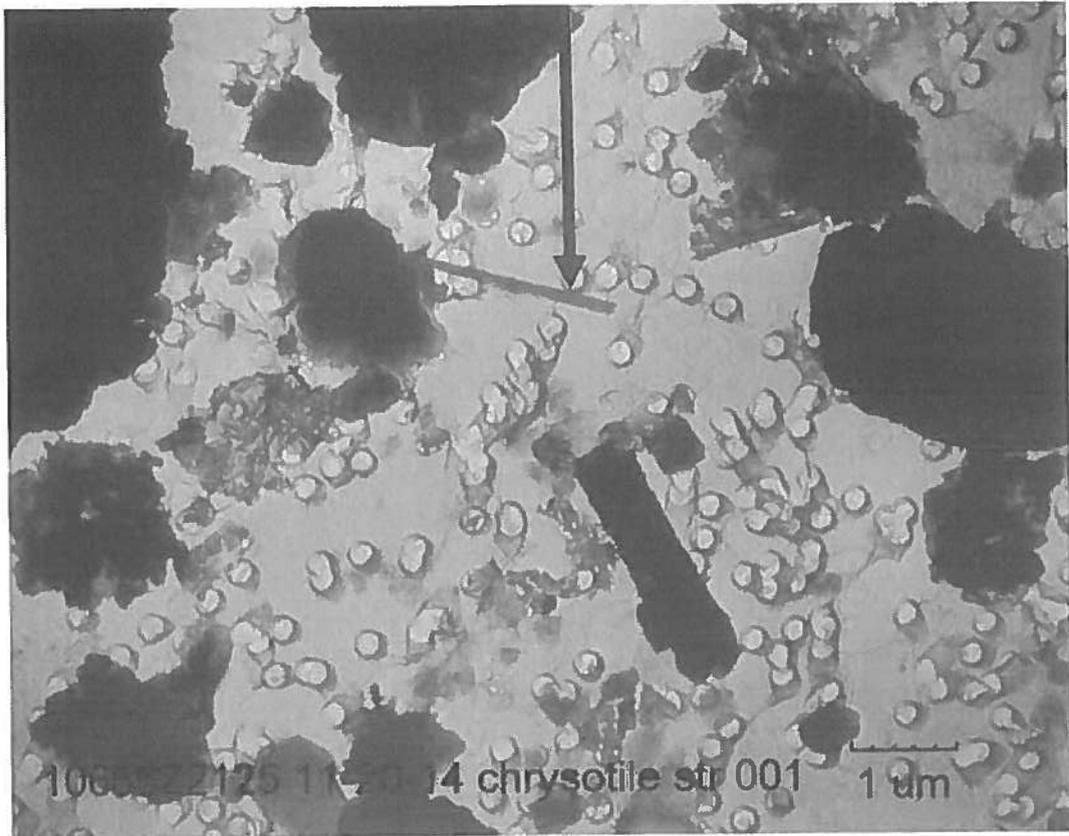
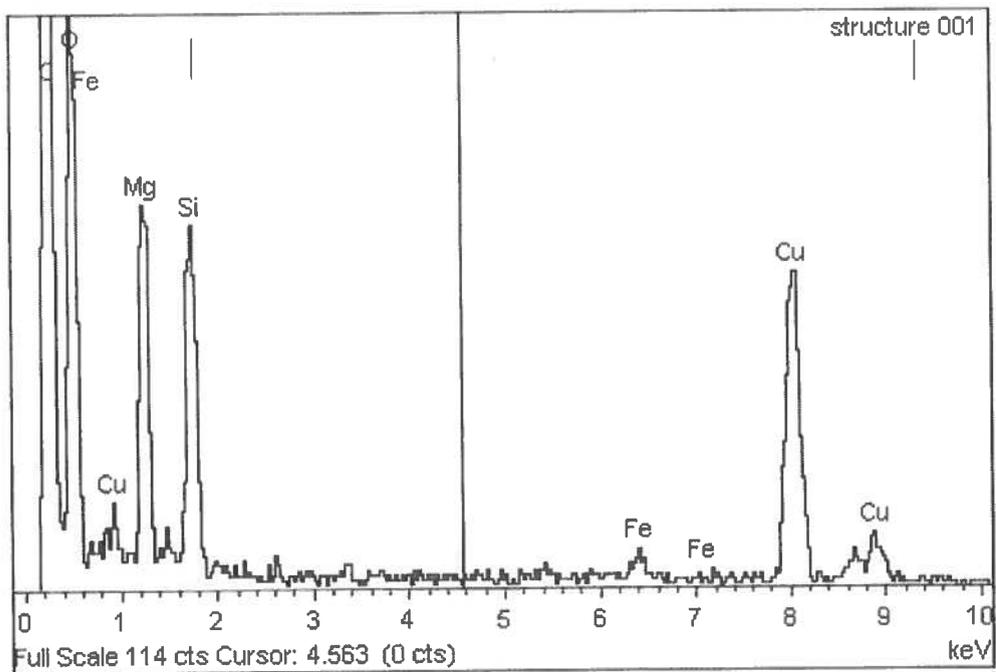
Figure 7. TEM image (above) and EDS spectrum (below) of chrysotile asbestos fiber detected in sample D-HS-PG-ER2, "Dust, floor, exterior next to playground, Head Start."

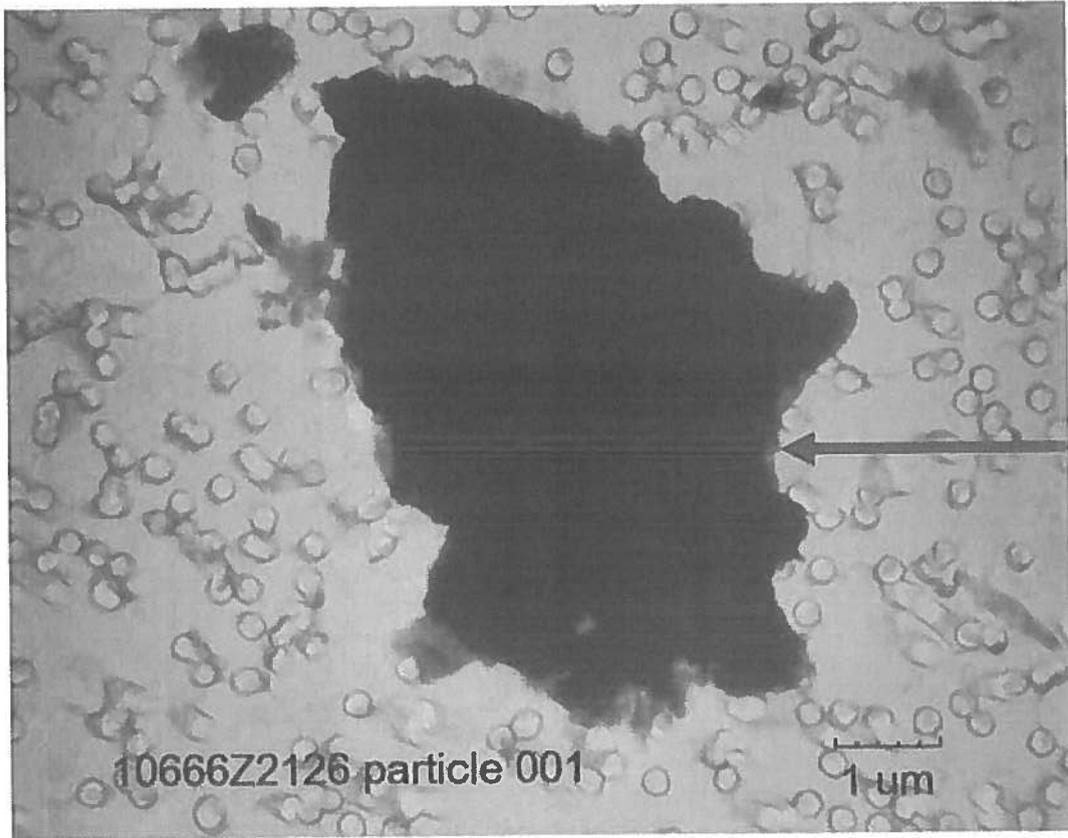
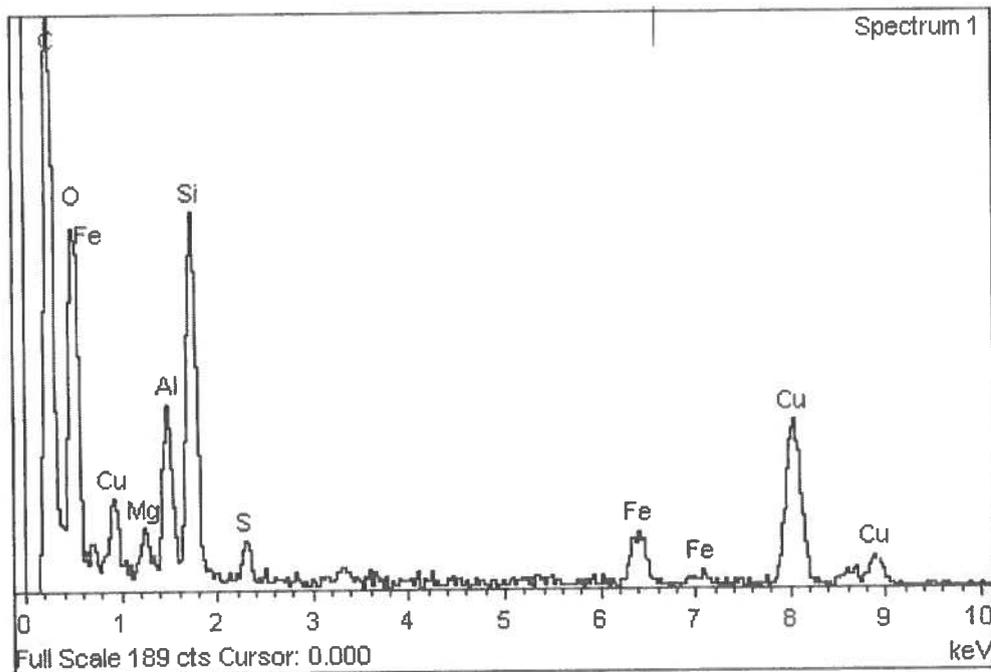
Figure 8. TEM image (above) and EDS spectrum (below) of clay mineral particle detected in sample D-JLPV-CR23-2F-H-ER3, "Dust, floor, hallway 2nd fl., Adm. bldg, JLPV School."

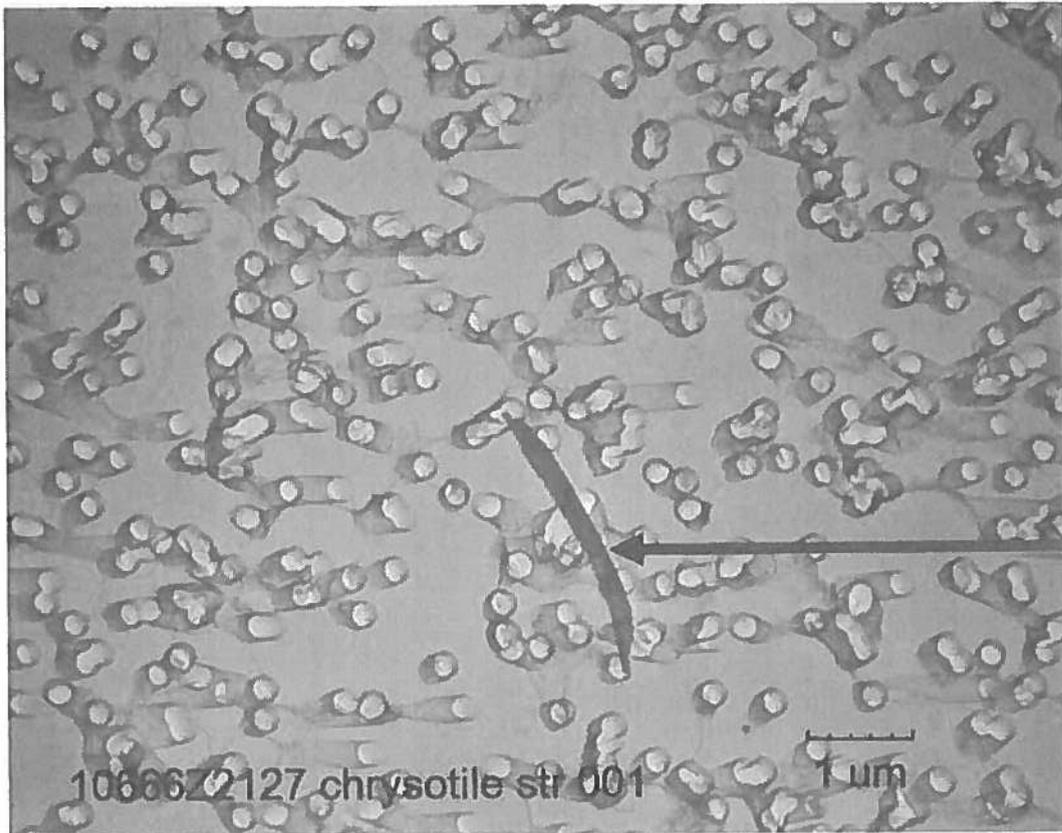
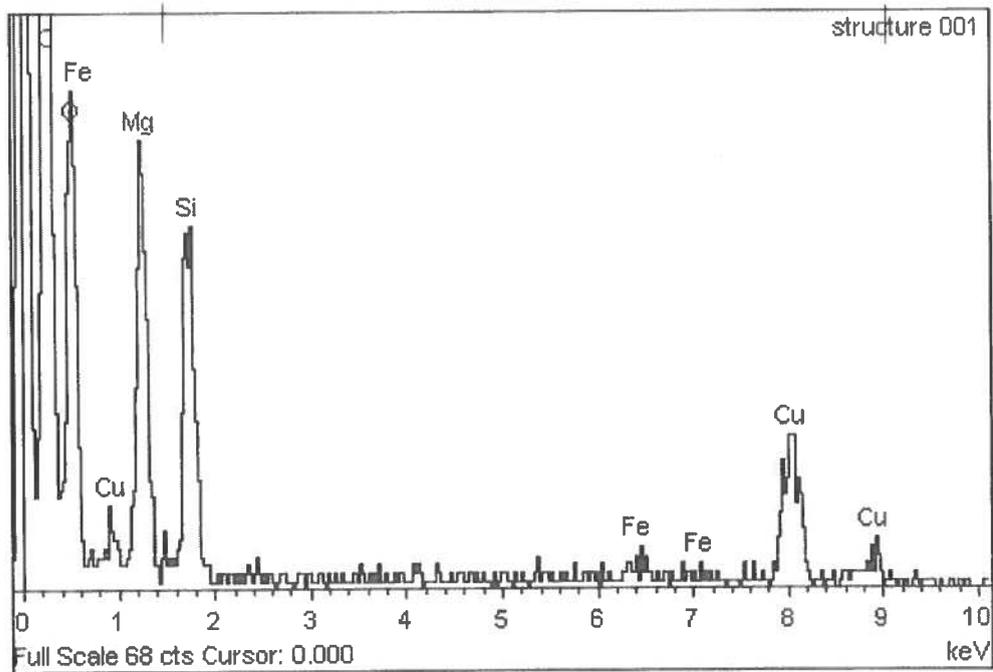
Figure 9. TEM image (above) and EDS spectrum (below) of chrysotile asbestos bundle detected in sample D-JLPV-CR19-1F-H-ER4, "Dust, floor, hallway, bldg. next to basketball ct., JLPV School."

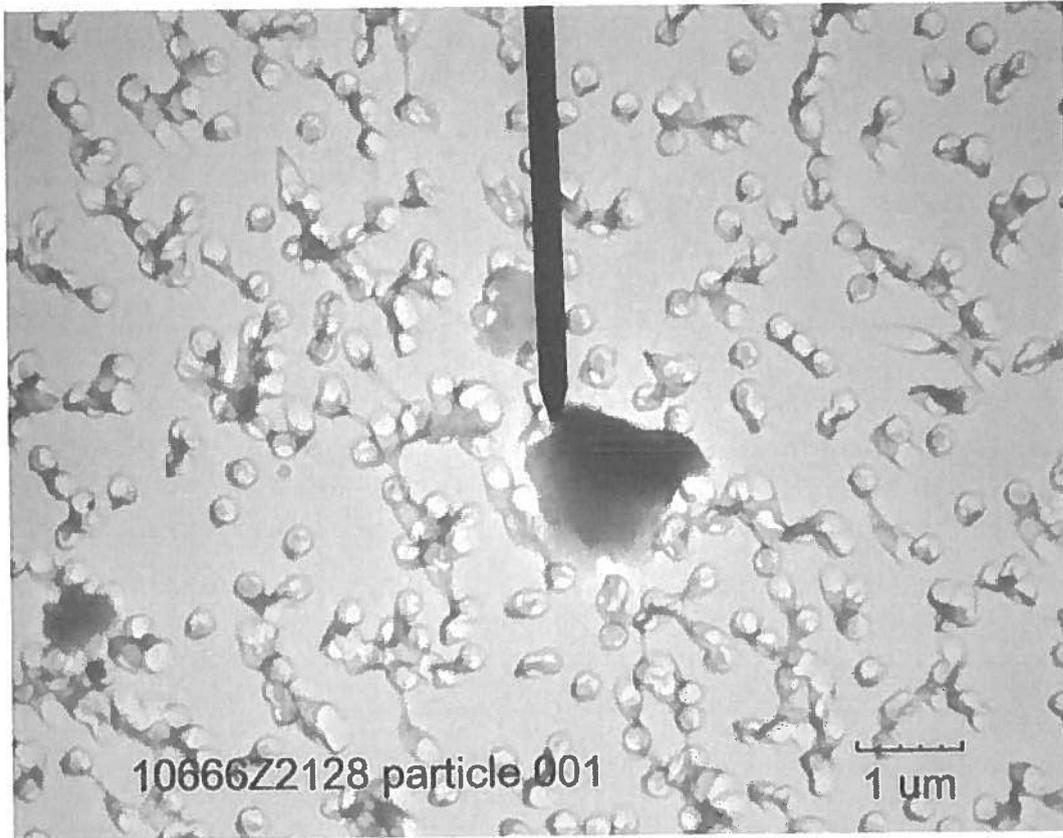
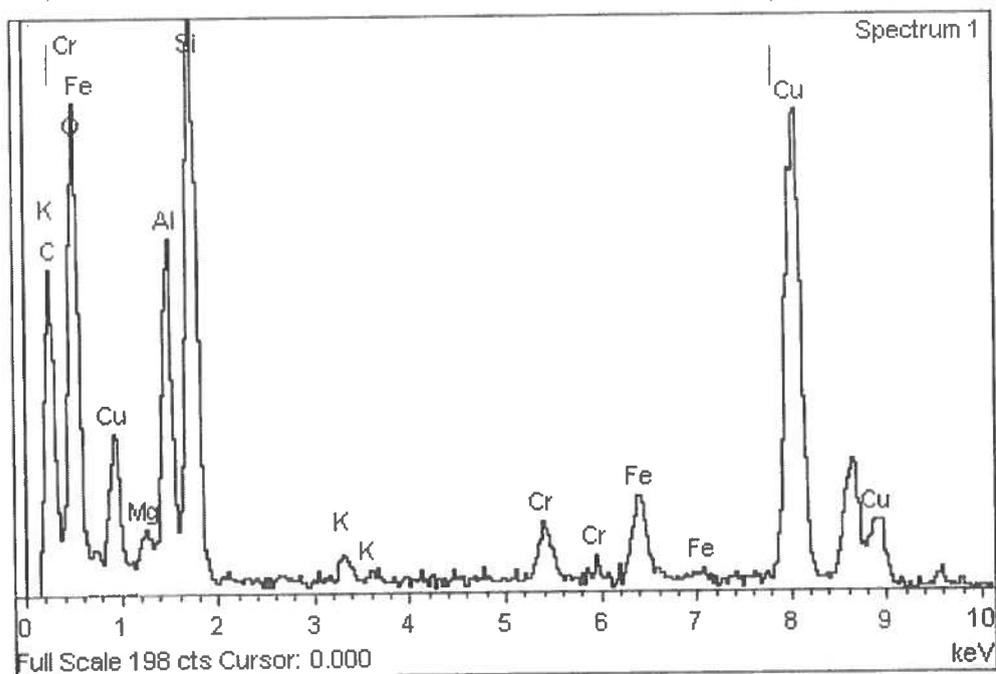
Figure 10. TEM image (above) and EDS spectrum (below) of clay mineral particle detected in sample D-JLPV-CR10-1F-H-ER5, "Dust, floor, hallway, 1st bldg. JLPV School."

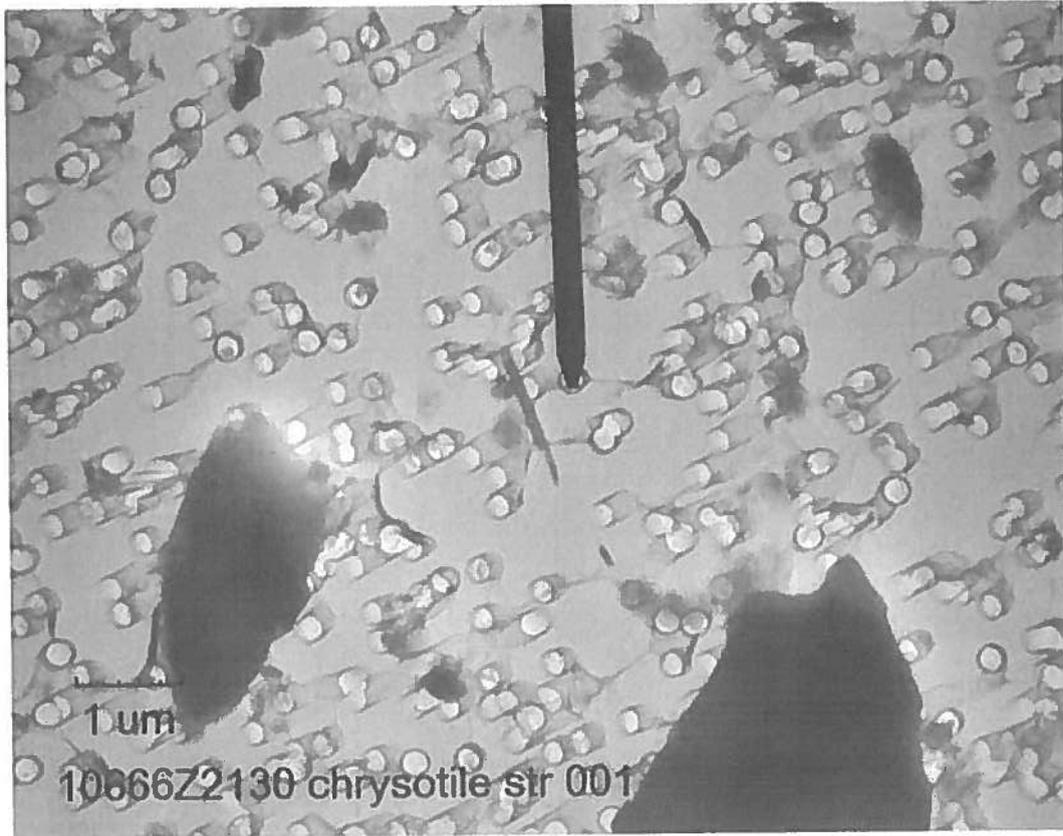
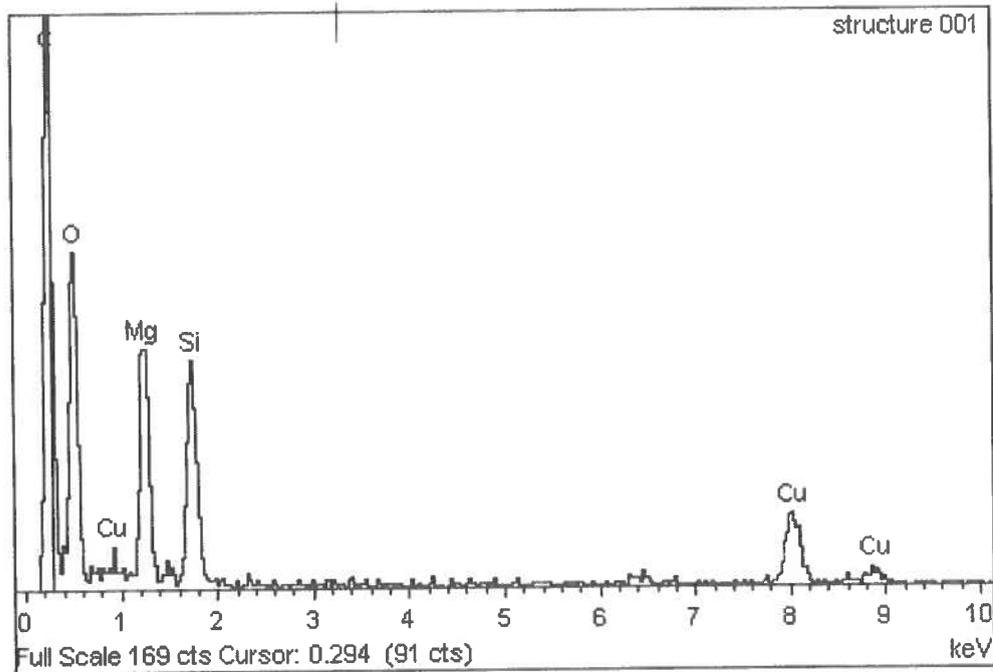
Figure 11. TEM image (above) and EDS spectrum (below) of chrysotile asbestos fiber detected in sample D-TEC-ARE-PO006-E-ER7, "Dust, floor, AR exchanger boiler specialist exterior Tallaboa Encarnacion Community."

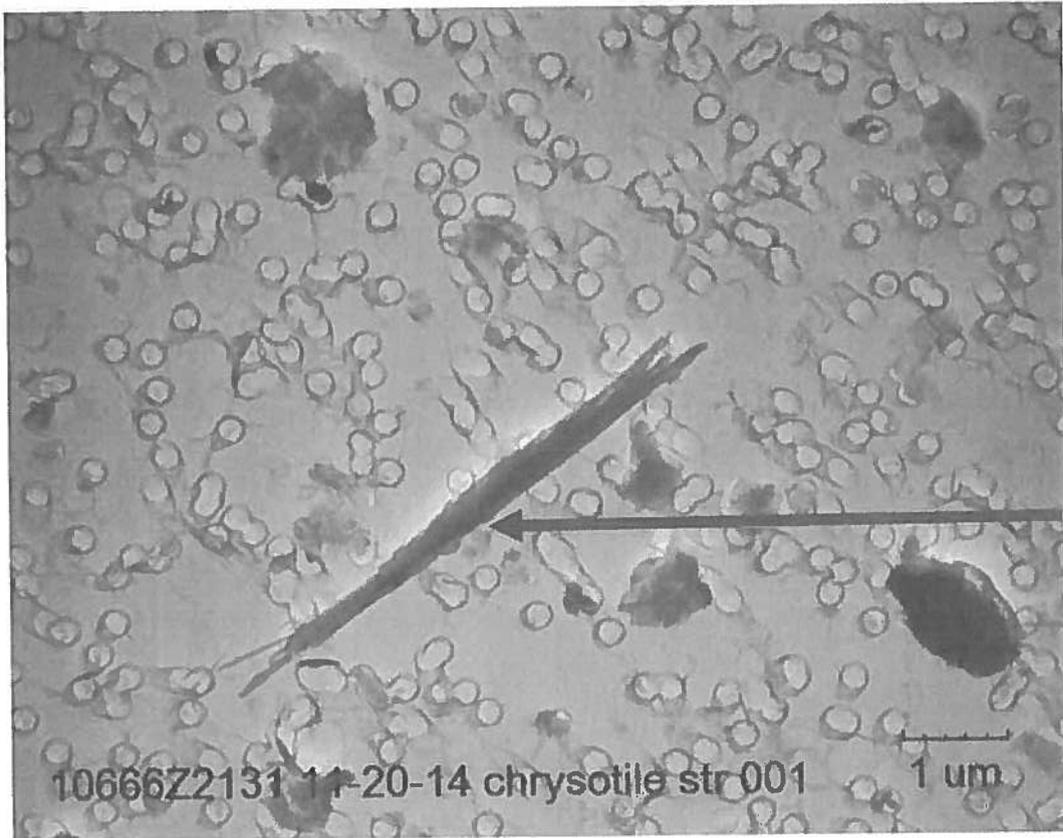
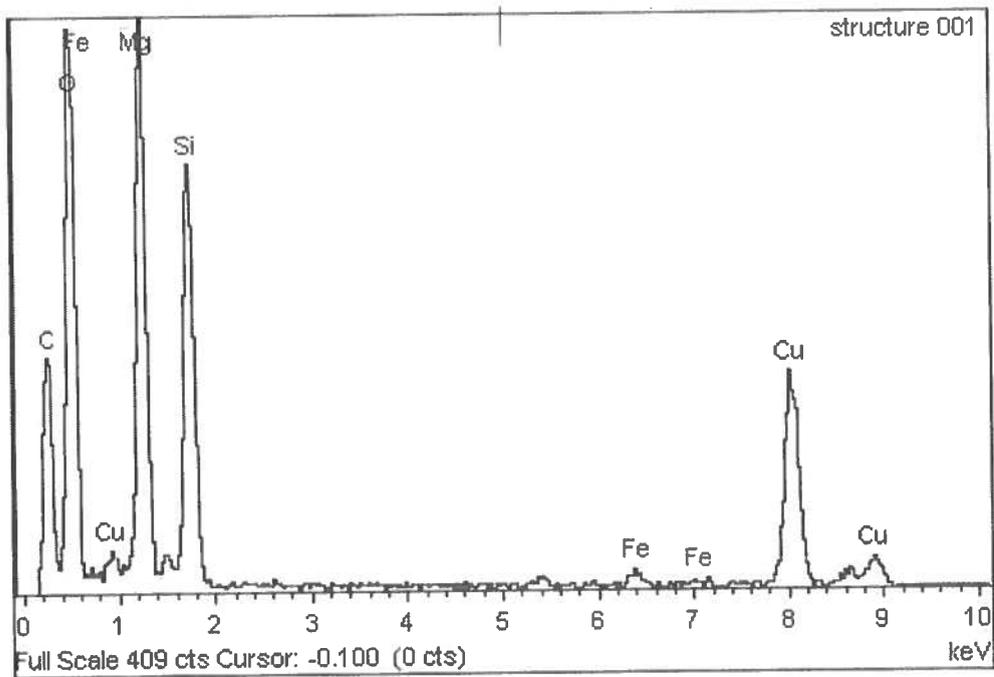
Figure 12. TEM image (above) and EDS spectrum (below) of chrysotile asbestos bundle detected in sample D-TEC-GULF-GS-ER8, "Dust, floor, Gulf Facility entrance, Tallaboa Encarnacion Community."

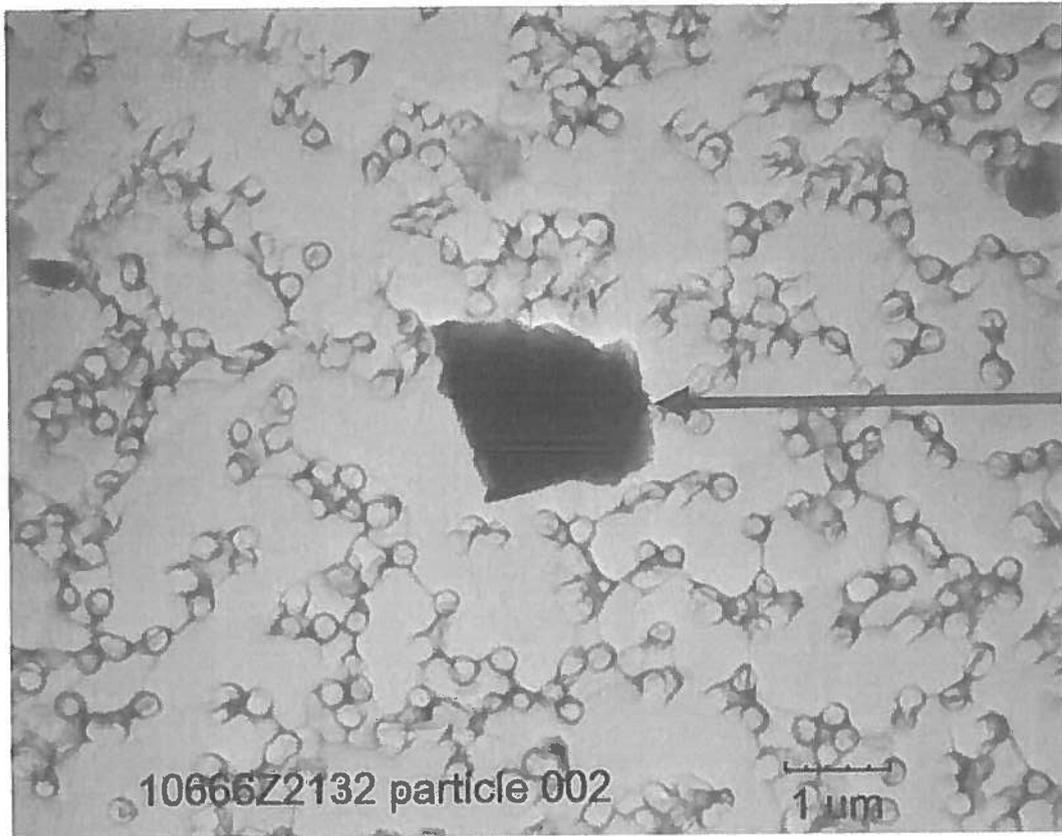
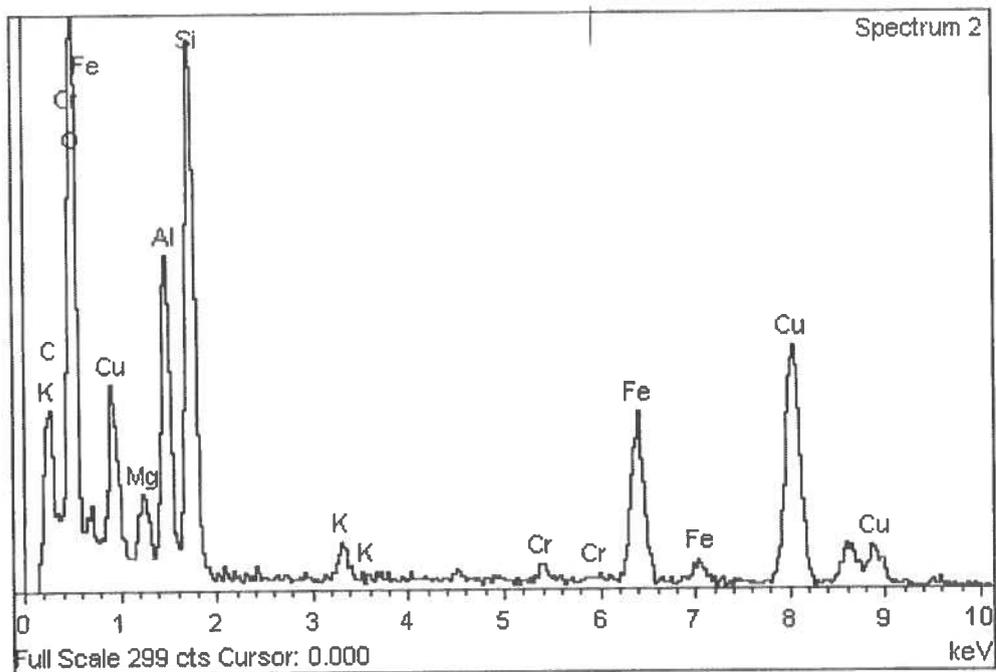
Figure 13. TEM image (above) and EDS spectrum (below) of clay mineral particle detected in sample D-NOW-P0035-TB-ER9, "Dust behind traffic barrier Rd. 384 km 3.2, northwest of Olefin, between 1 and 2 miles radius."

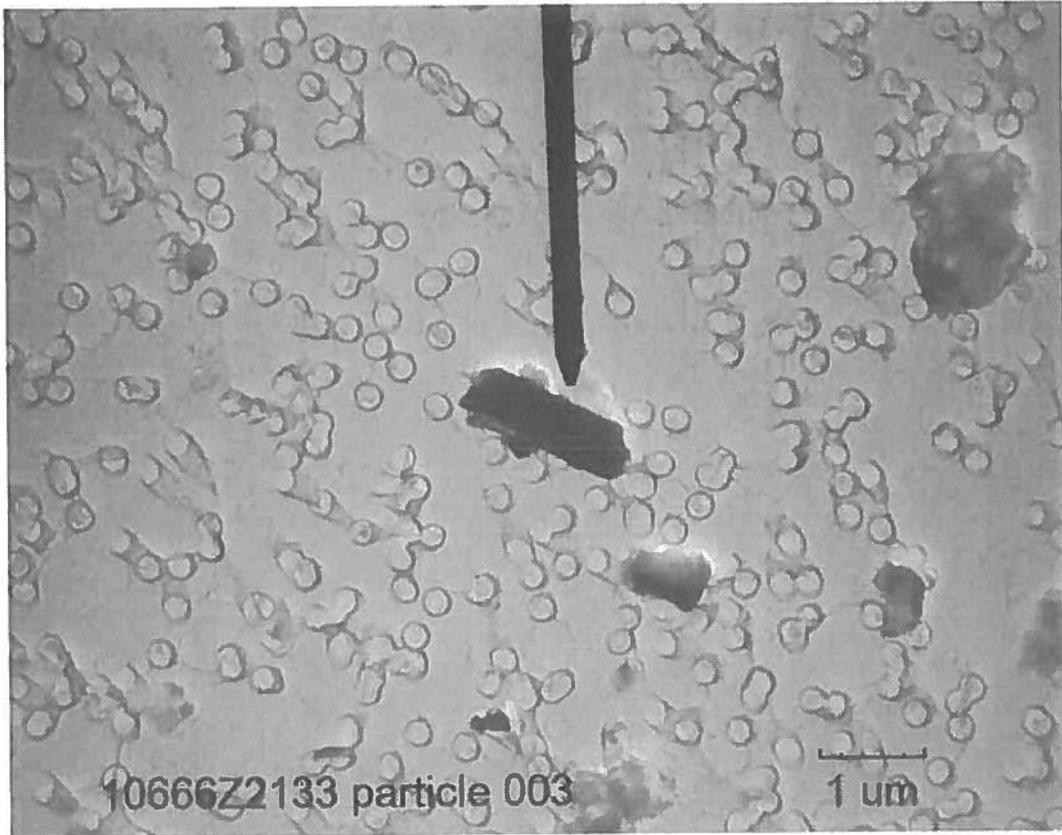
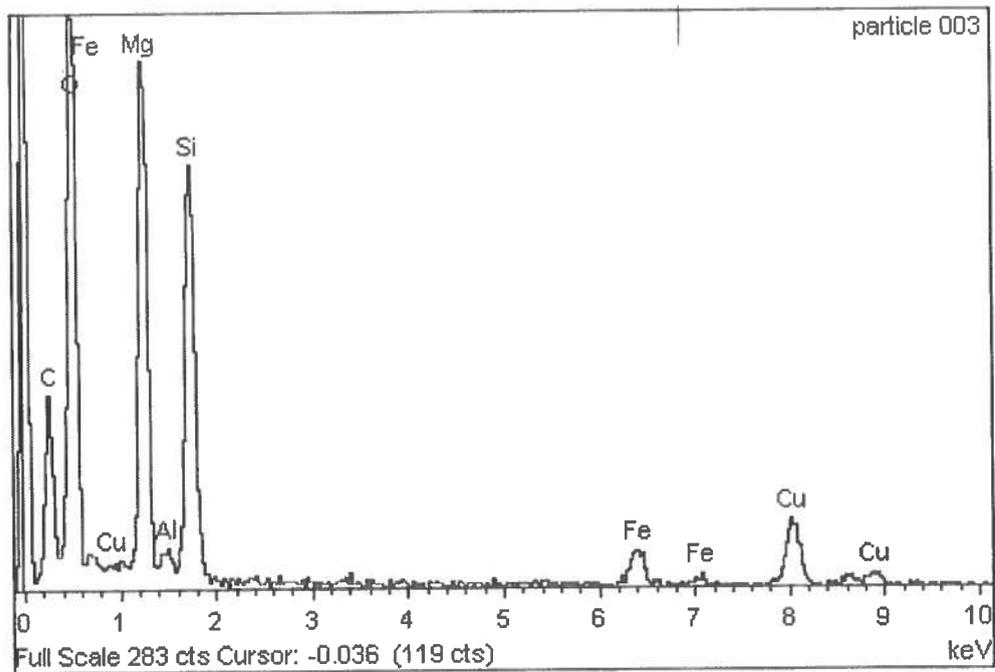
Figure 14. TEM image (above) and EDS spectrum (below) of chrysotile asbestos bundle detected in sample D-NOW-P0036-BS-ER10, "Dust, stop bus bench, rd. 385 int. with rd. 384, northwest of Olefin, between 1 and 2 miles radius."

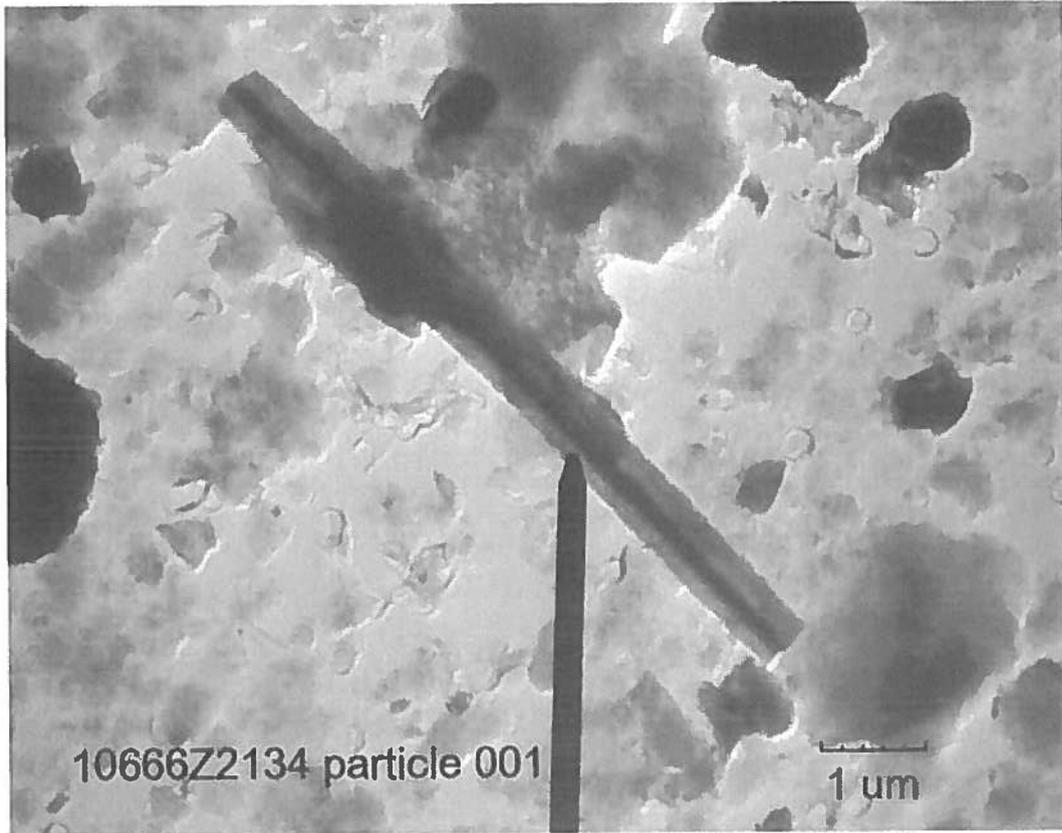
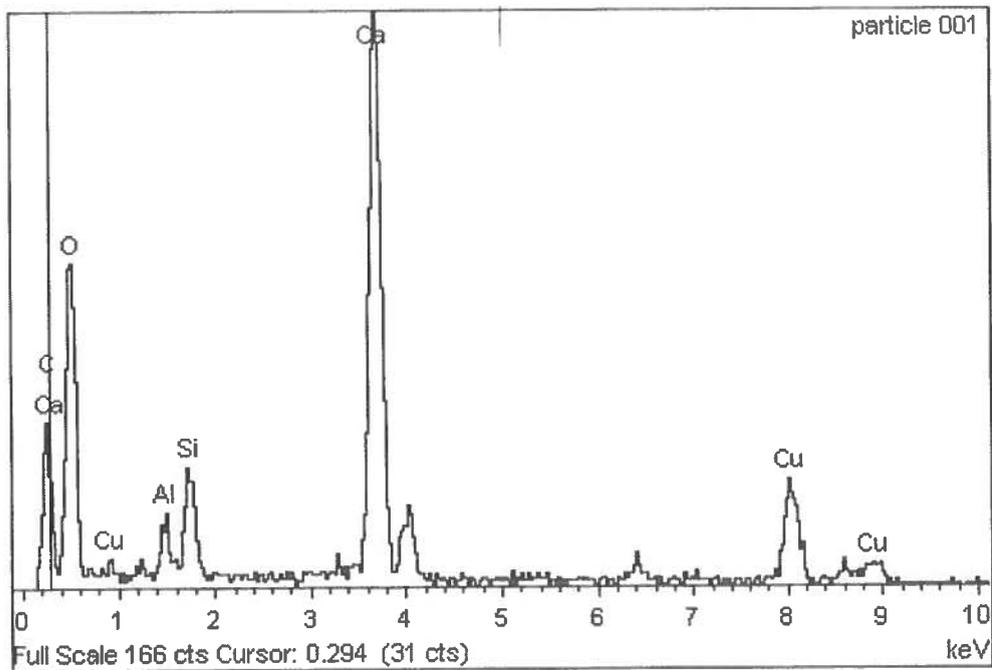
Figure 15. TEM image (above) and EDS spectrum (below) of calcic mineral fiber detected in sample D-TEC-P0021-C2-ER11, "Dust, floor, sidewalk front of house corner street 2 intersection street 4, Tallaboa Encarnacion Community."
