**REPORT OF INITIAL FINGERPRINTING
FINDINGS RELATED TO
PUERTO RICO OLEFIN SITE
PEÑUELAS, PUERTO RICO**

Prepared by:
Ady Padan, Ph.D

February, 2015

Analytical Environmental
Services International, Inc.
611 Monserrate Street
2nd Floor, Santurce, P.R. 00907
(787) 722-0220 / Fax (787) 724-5788

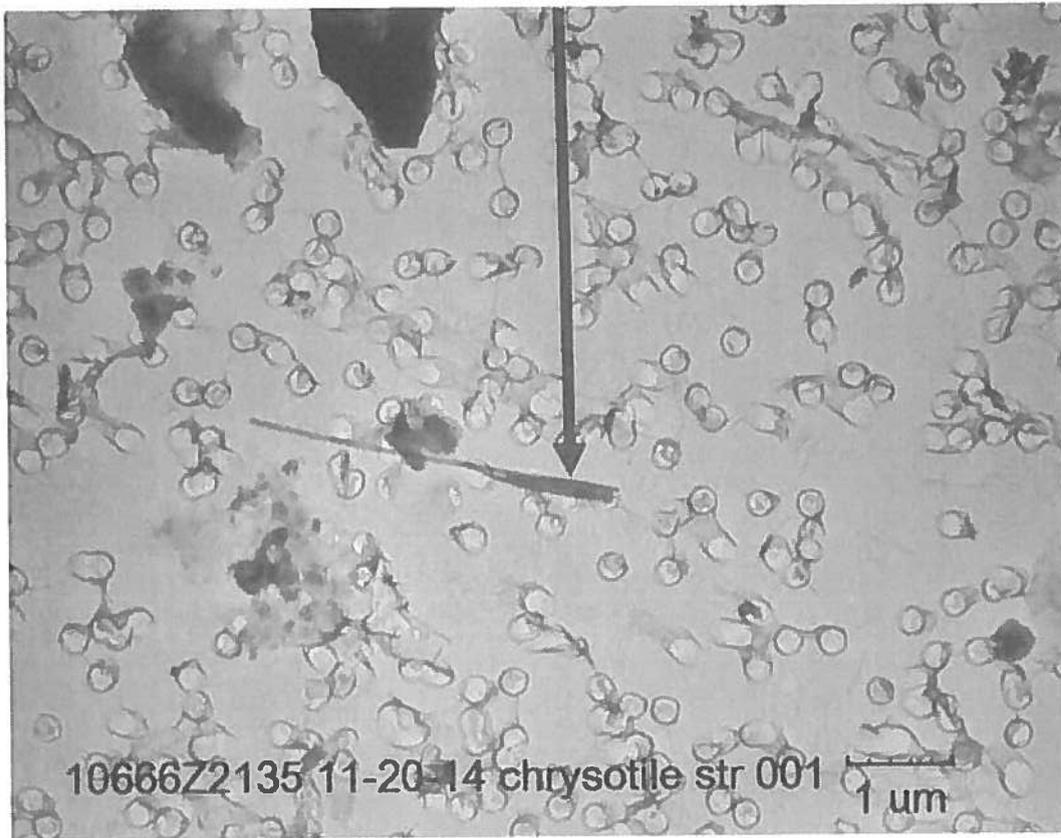
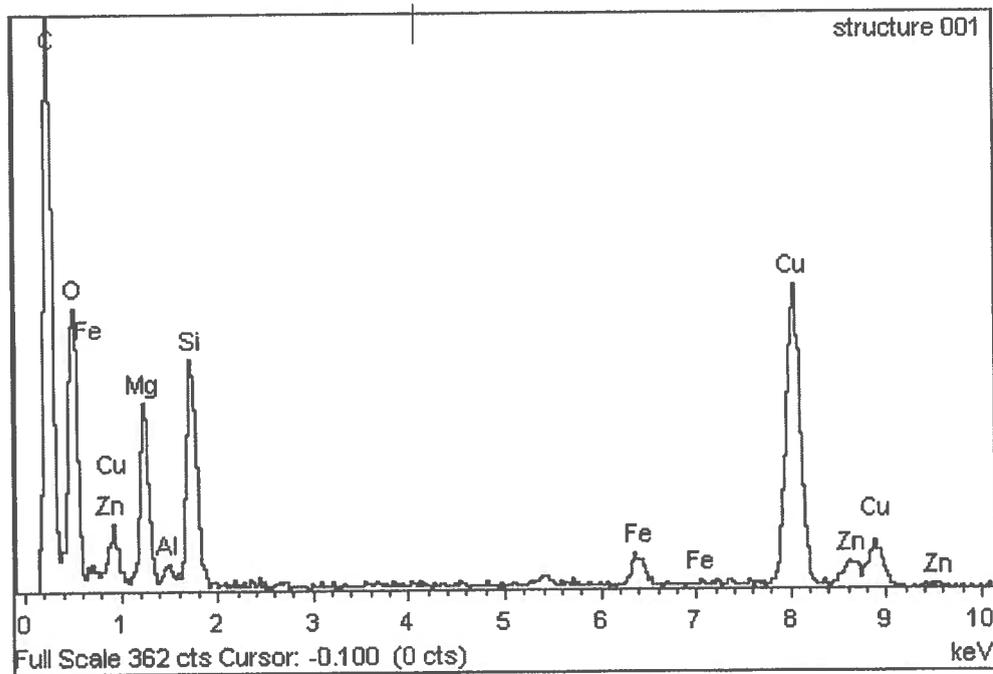
Figure 16. TEM image (above) and EDS spectrum (below) of chrysotile asbestos bundle detected in sample D-TEC-P0018-C2-ER12, "Dust, floor, corner street 2, west of street 2 Tallaboa Encarnacion Community."

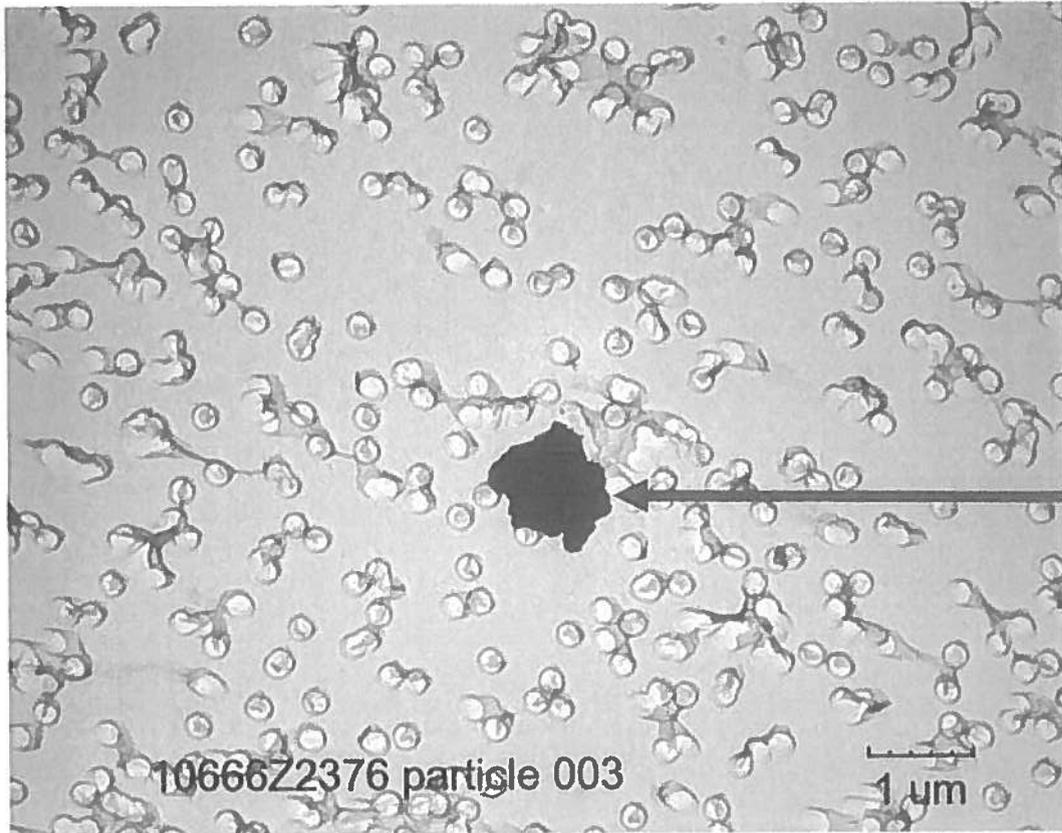
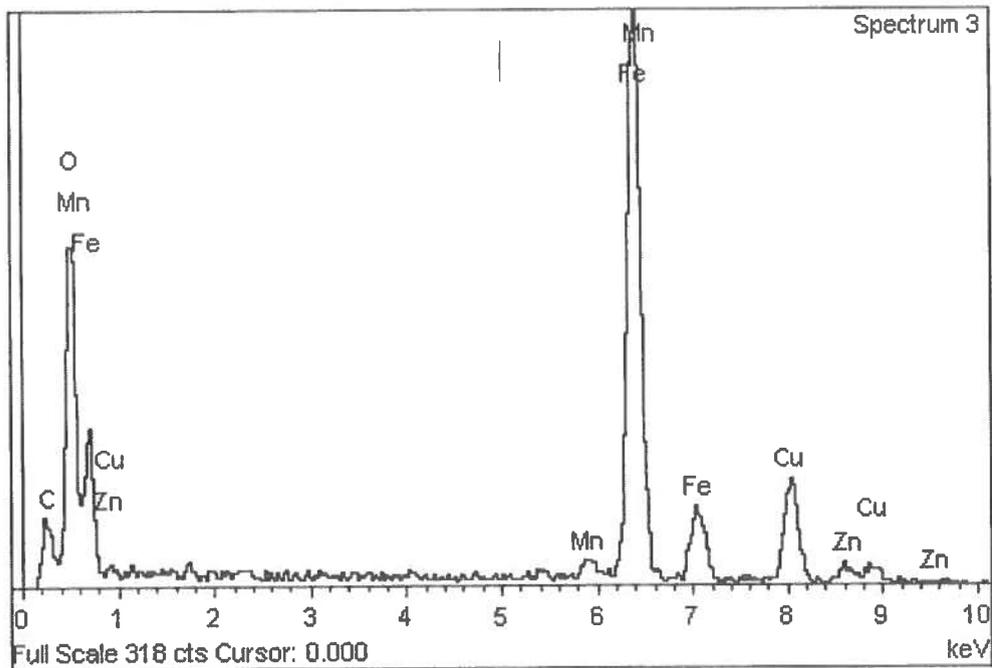
| MVA # | Sample I. D. | PLM Analysis Results % Asbestos | Additional Materials Observed | TEM Analysis Results | Comments |
|---|---|---|---|---|--|
| Z2376 | D-OL-FF-ER2 | NAD | Iron/rust, carbonate, quartz, cellulose | Iron and quartz particles | Small sample volume |

Figure 17. TEM image (above) and EDS spectrum (below) of iron-rich particle detected in sample D-OL-FF-ER2, "Sample on top of pipe surface from front flare area."

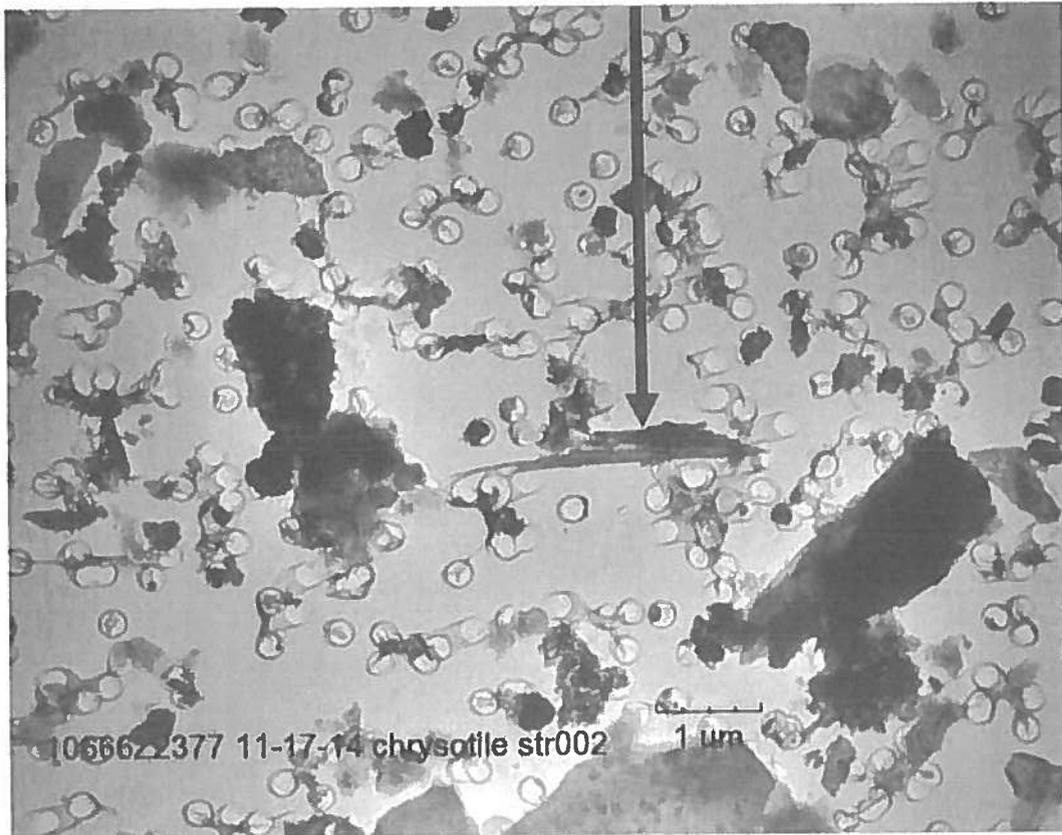
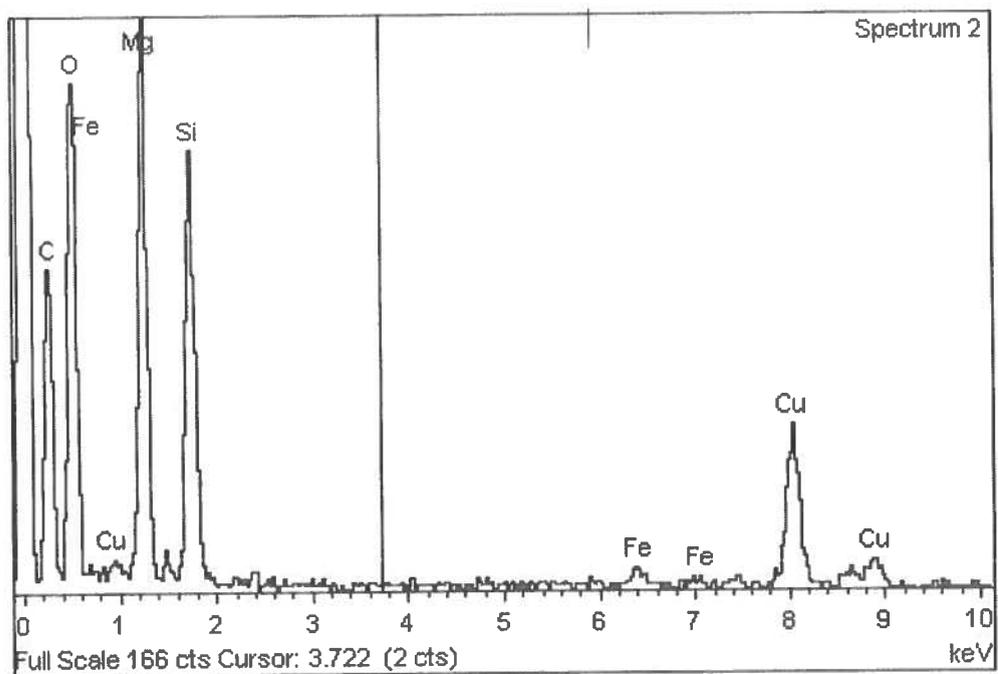
| MVA # | Sample I. D. | PLM Analysis Results % Asbestos | Additional Materials Observed | TEM Analysis Results | Comments |
|---|---|---|---|---|--|
| Z2377 | D-OL-SM-ER6 | Trace amosite Trace chrysotile | Iron/rust, vermiculite, quartz, carbonate, cellulose, glass fibers, fungal material | Iron, aluminum, clay particles, one amosite fiber, two chrysotile bundles | SEM (probable chrysotile) Trace Fe/Al Present in chrysotile (TEM) |

Figure 18. TEM image (above) and EDS spectrum (below) of chrysotile asbestos bundle detected in sample D-OL-SM-ER6, "Sample from surface of metal scrap in front of area where the crane was."

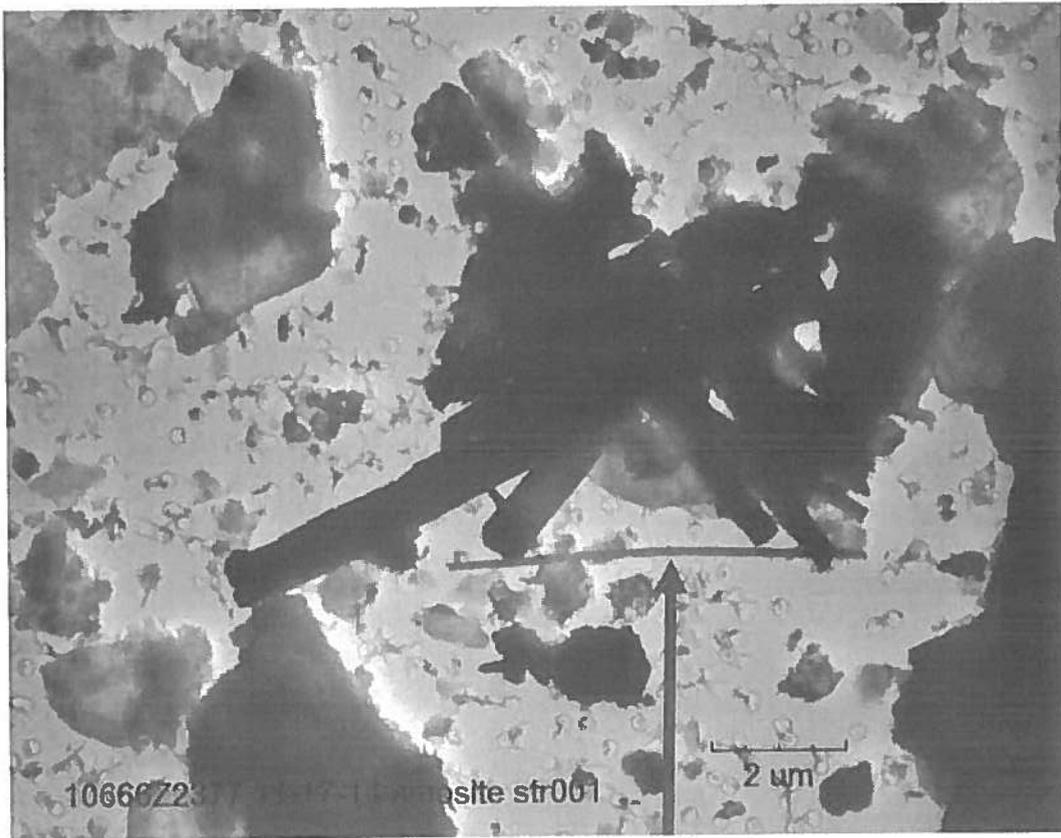
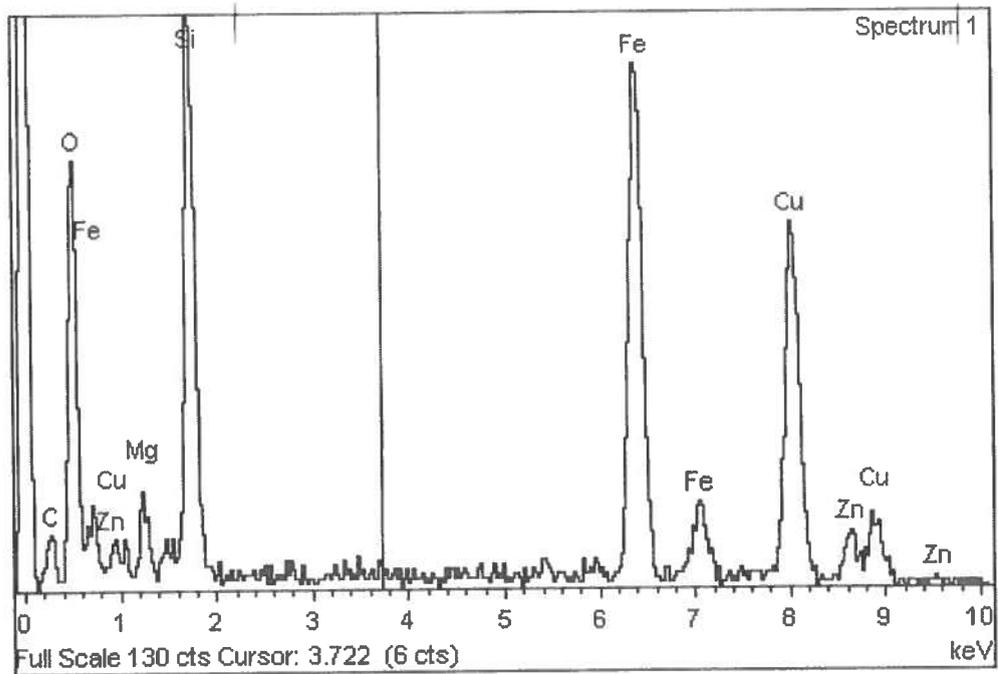
Figure 19. TEM image (above) and EDS spectrum (below) of amosite asbestos fiber detected in sample D-OL-SM-ER6, "Sample from surface of metal scrap in front of area where the crane was."

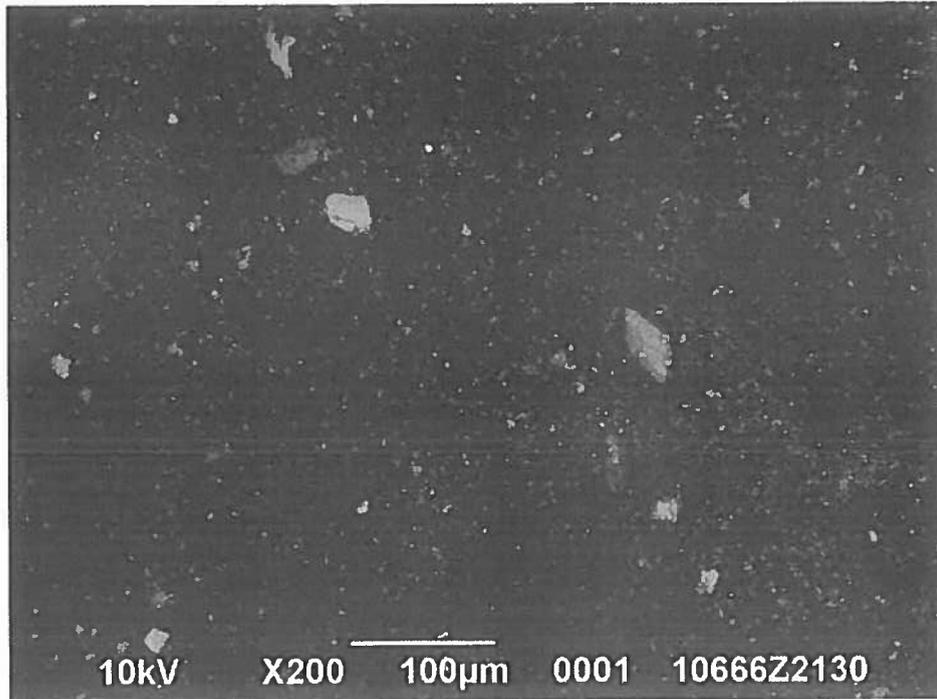
Figure 20. SEM micrograph of dust particles observed during analysis of sample D-TEC-ARE-PO006-E-ER7, "Dust, floor, AR exchanger boiler specialist exterior Tallaboa Encarnacion Community."

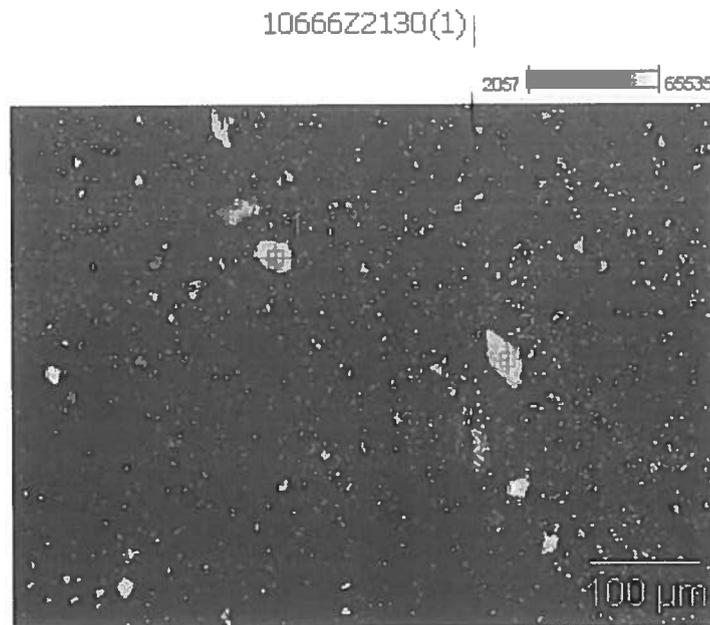
Figure 21. Sample D-TEC-ARE-PO006-E-ER7; same area as Figure 20. Numbers denote areas where EDS spectra were collected.

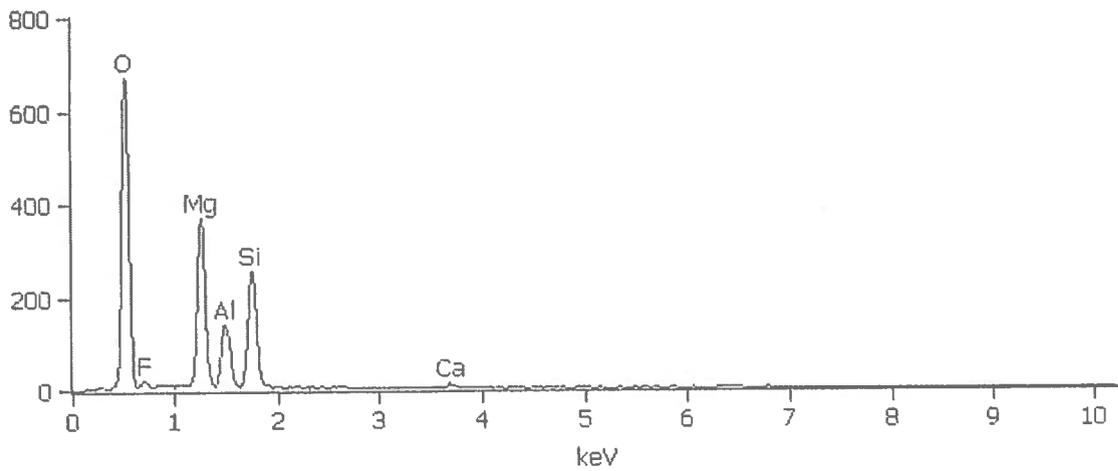
Figure 22. Area 1 from Figure 21. Mineral particle representative of those found throughout sample: O = Oxygen, Mg = Magnesium, Al = Aluminum, Si = Silicon; Ca = Calcium; F = Fluorine. Sample is mounted on adhesive carbon (C).

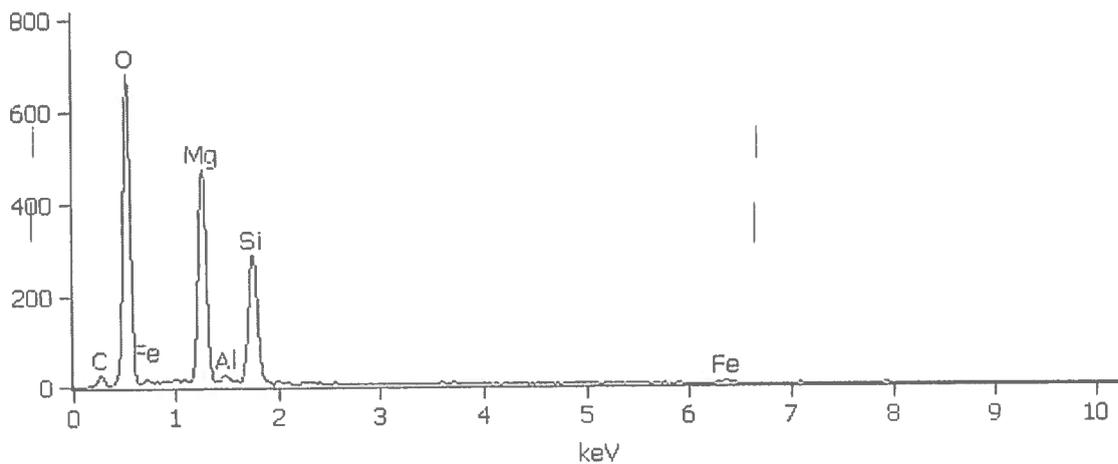
Figure 23. Area 2 from Figure 21. Serpentine mineral particle representative of those found throughout sample: Fe = Iron. Sample is mounted on adhesive carbon (C).

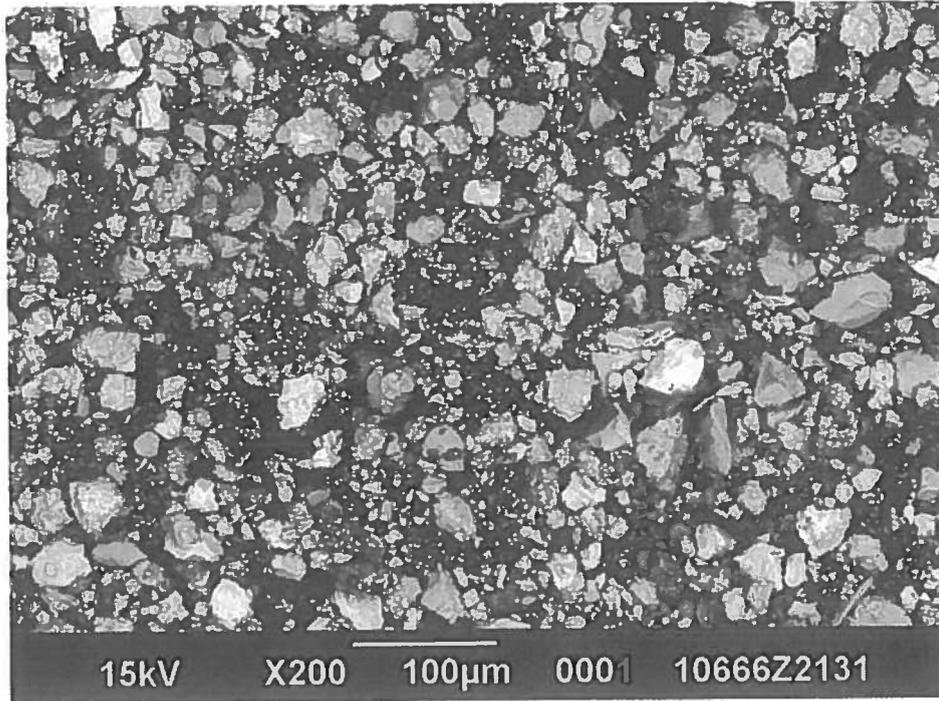
Figure 24. SEM micrograph of dust particles observed during analysis of sample D-TEC-GULF-GS-ER8, "Dust, floor, Gulf Facility entrance, Tallaboa Encarnacion Community."

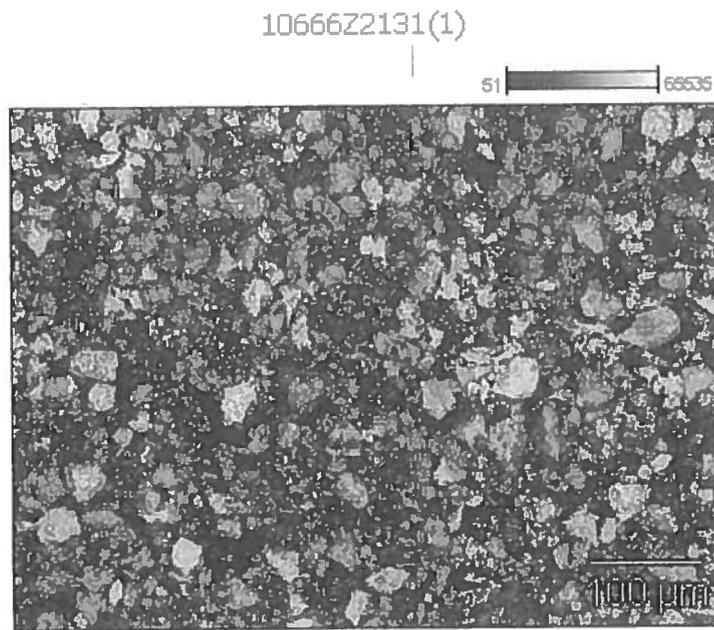
Figure 25. Sample D-TEC-GULF-GS-ER8; same area as Figure 24. Numbers denote areas where EDS spectra were collected.

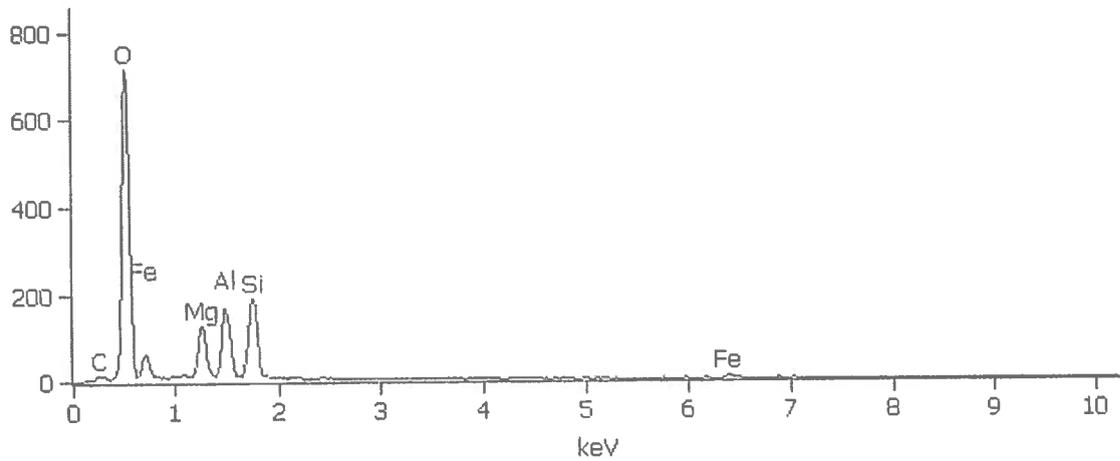
Figure 26. Area 1 from Figure 25. Clay mineral particle representative of those found throughout sample. Sample is mounted on adhesive carbon (C).

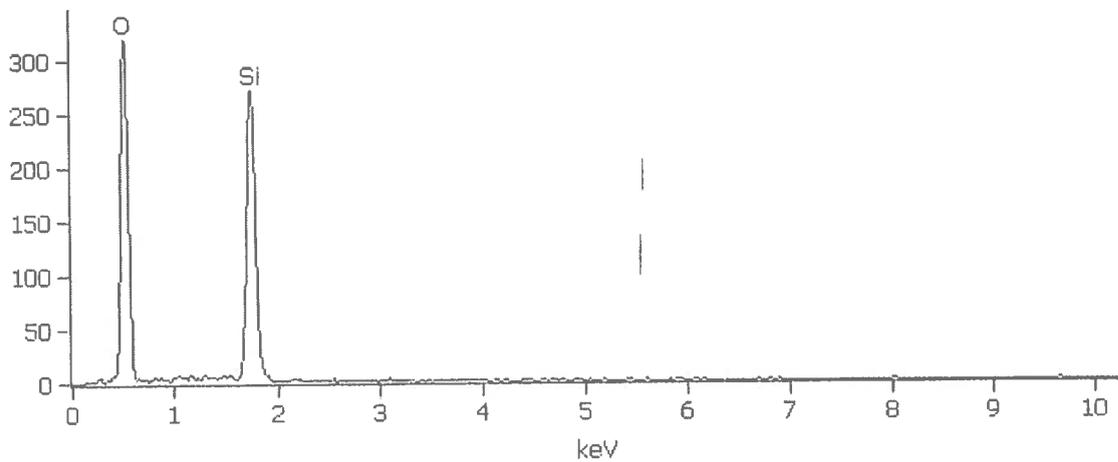
Figure 27. Area 2 from Figure 25. Quartz mineral particle representative of those found throughout sample. Sample is mounted on adhesive carbon (C).

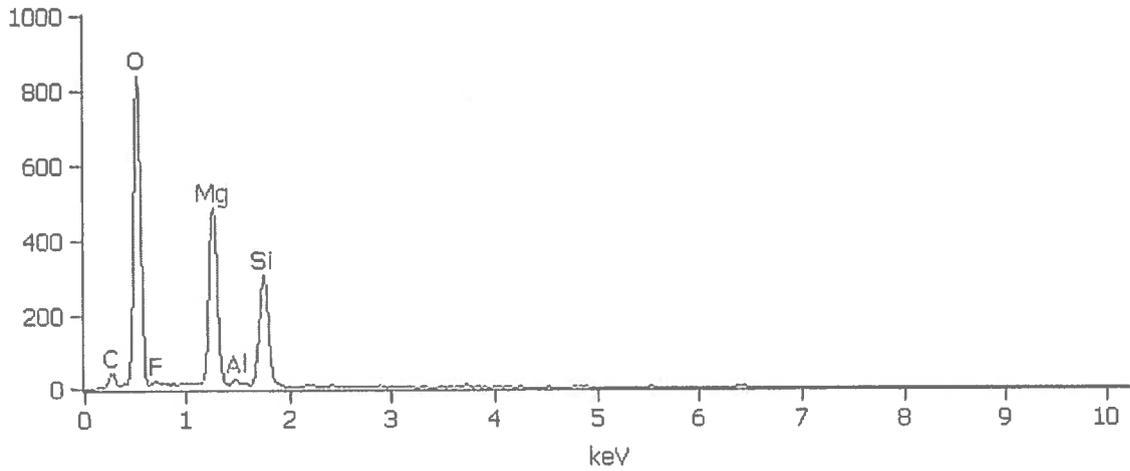
Figure 28. Area 3 from Figure 25. Serpentine mineral particle representative of those found throughout sample. Sample is mounted on adhesive carbon (C).

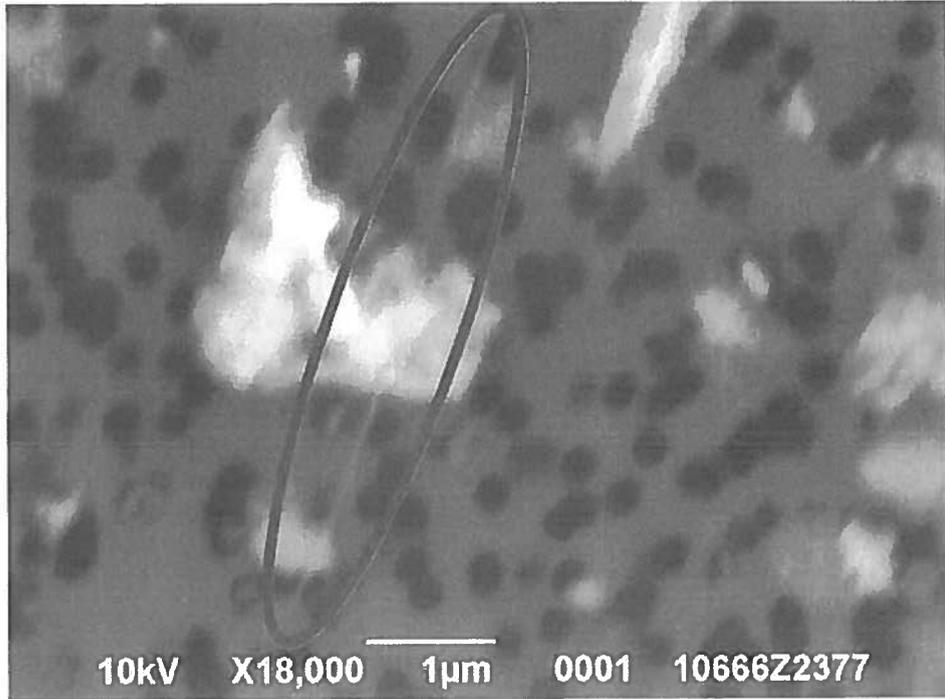
Figure 29. SEM micrograph of mineral fiber, chemically consistent with chrysotile asbestos, observed during analysis of sample D-OL-SM-ER6, "Sample from surface of metal scrap in front of area where the crane was."

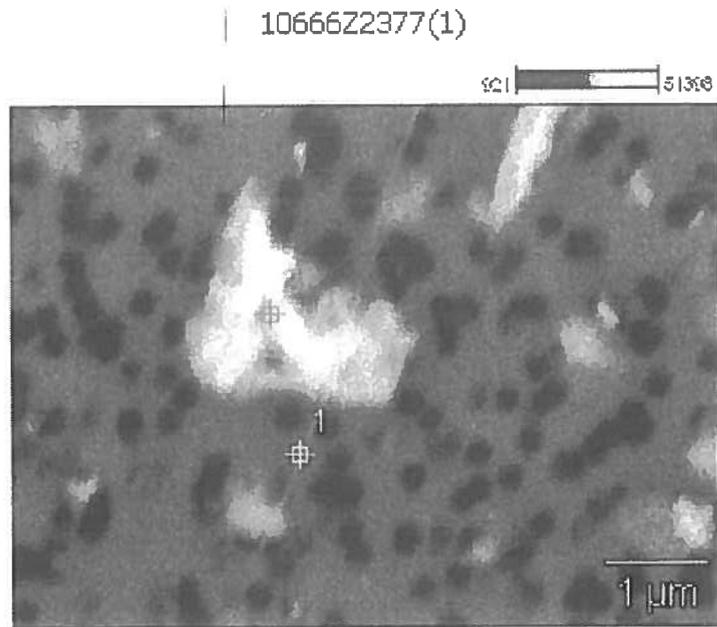
Figure 30. Sample D-OL-SM-ER6; same area as Figure 29. Numbers denote areas where EDS spectra were collected.

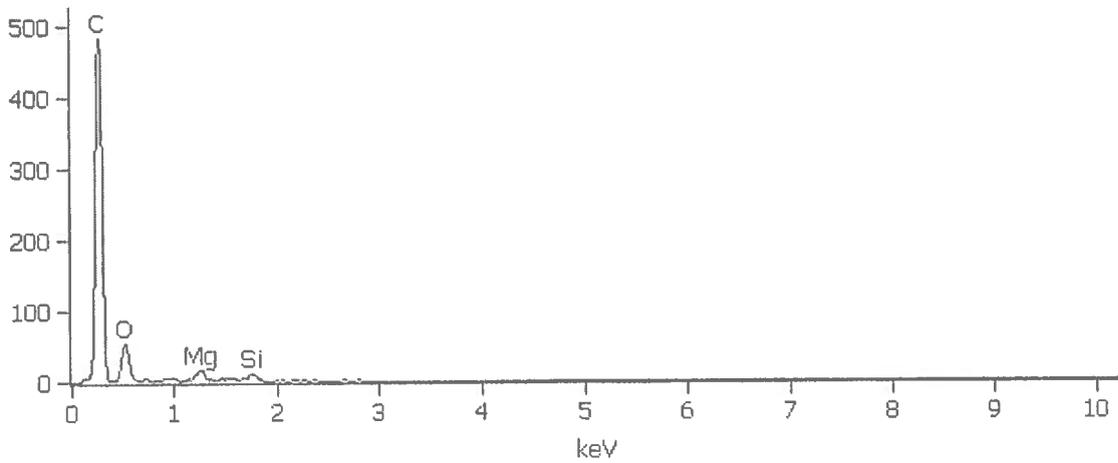
Figure 31. Area 1 from Figure 30. Likely chrysotile asbestos fiber. Sample is mounted on adhesive carbon (C).

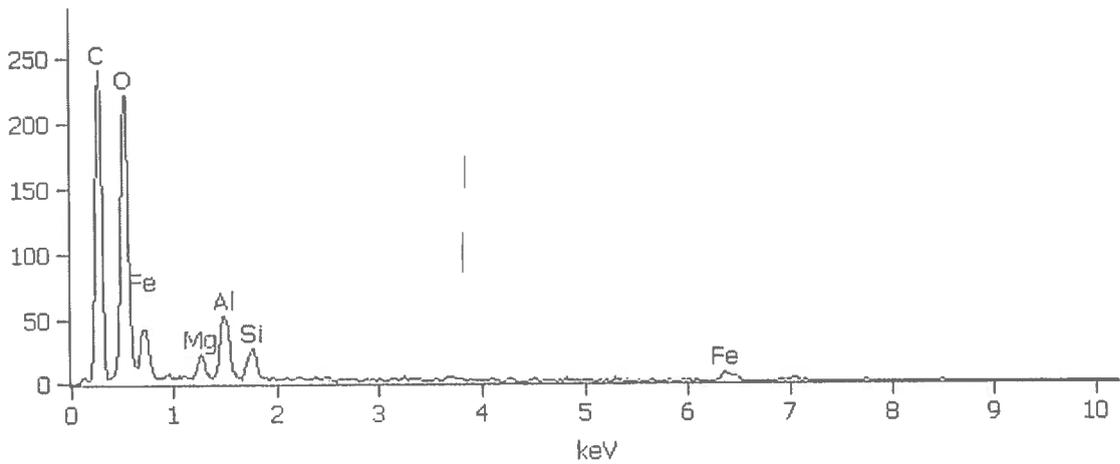
Figure 32. Area 2 from Figure 30. Mineral particle associated with probable chrysotile fiber. Sample is mounted on adhesive carbon (C).

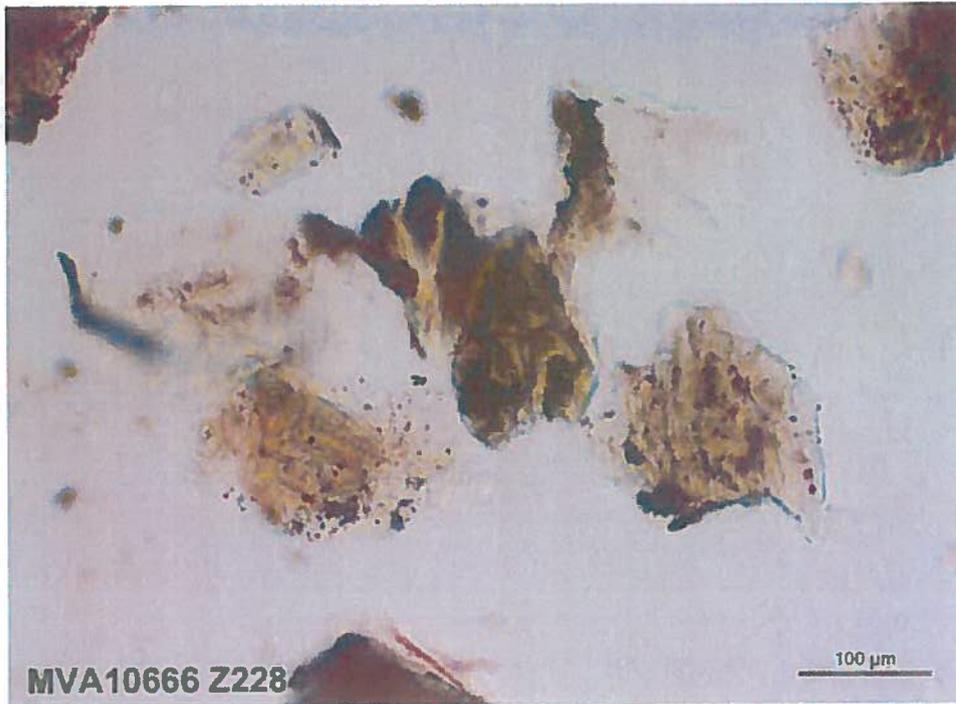
Figure 1. Polarized light microscope image of lizardite mineral particles detected during analysis of Media Quijada sample R-MC-AP3. Plane polarized light illumination.

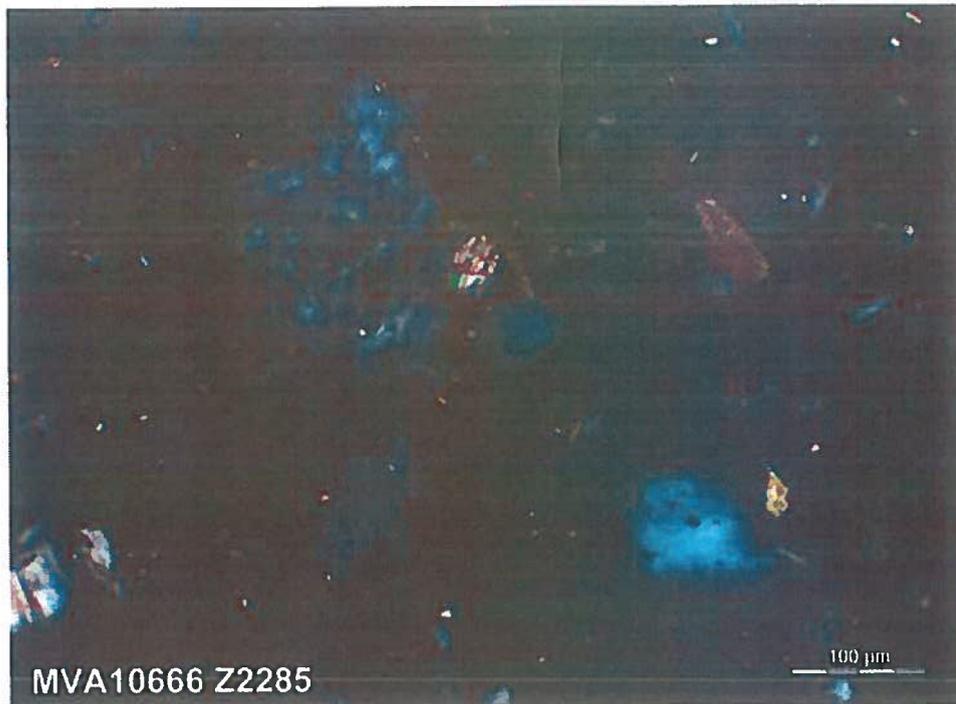
Figure 2. Polarized light microscope image of lizardite mineral particles detected during analysis of Quarry 1 sample R-Q1-AP4. Crossed polars.

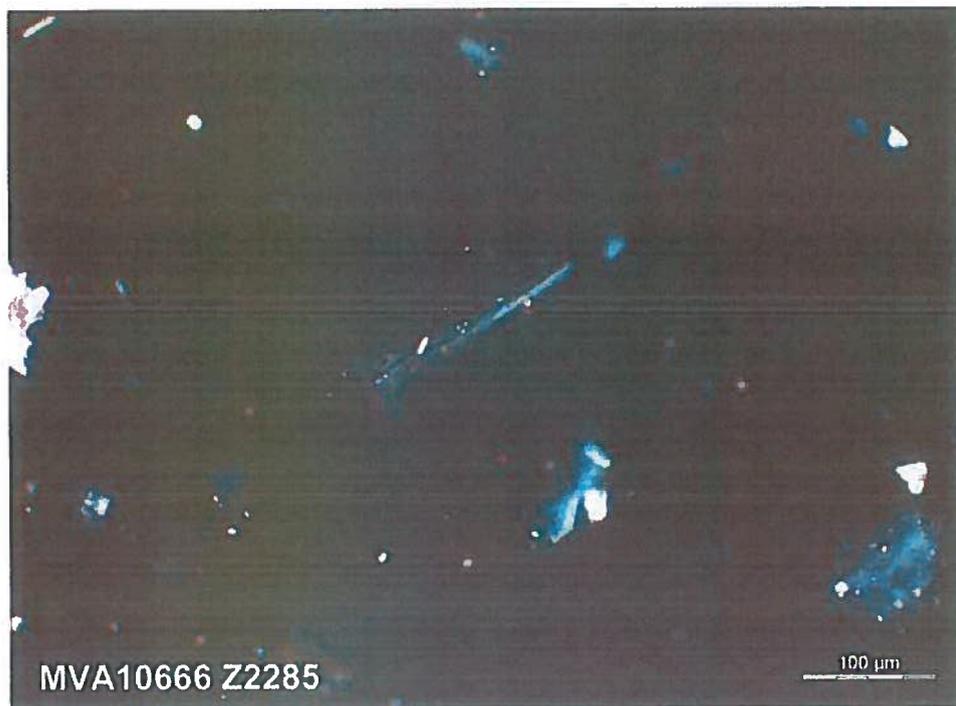
Figure 3. Polarized light microscope image of chrysotile asbestos fibers detected during analysis of Quarry 1 sample R-Q1-AP4. Crossed polars.

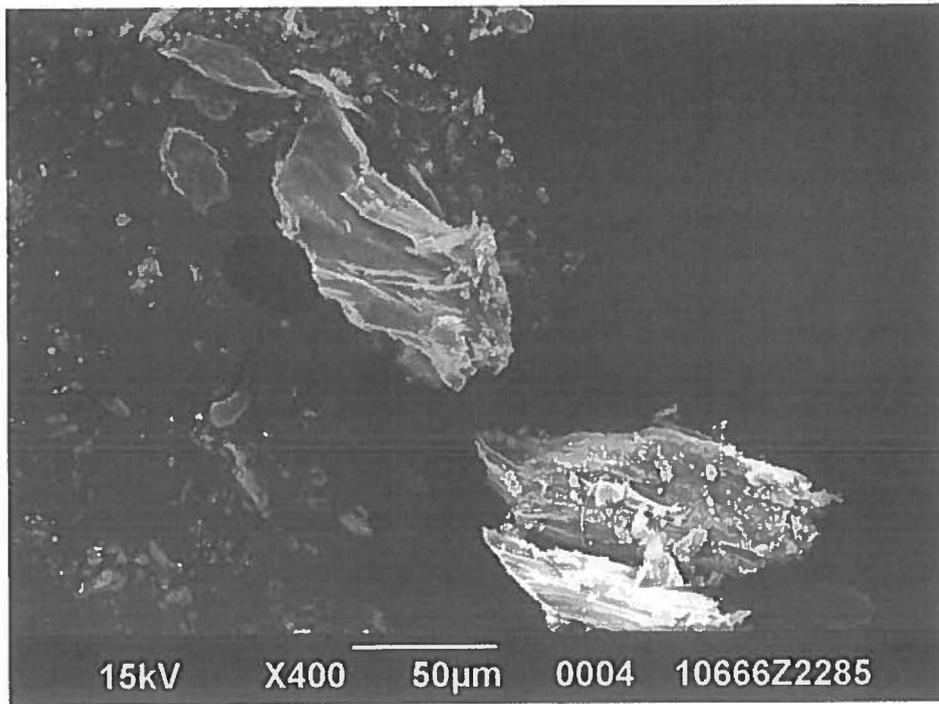
Figure 4. Scanning electron micrograph of fibrous and non-fibrous serpentine (chrysotile and lizardite, respectively) detected during analysis of Quarry 1 sample R-Q1-AP4.

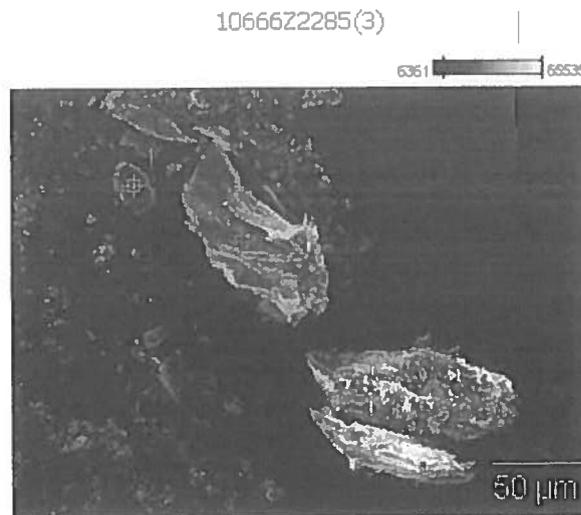
Figure 5. Quarry 1 sample R-Q1-AP4. Same area as Figure 4. Numbers denote areas where EDS spectra were collected.

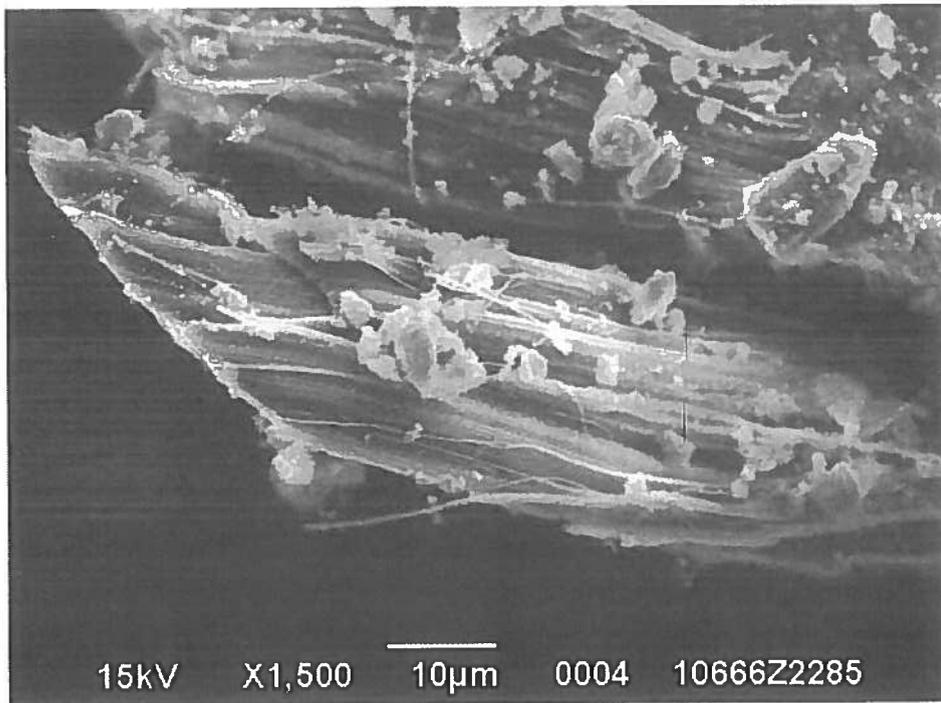
Figure 9. Scanning electron micrograph of fibrous serpentine (chrysotile - confirmed by TEM analysis) detected during analysis of Quarry 1 sample R-Q1-AP4.

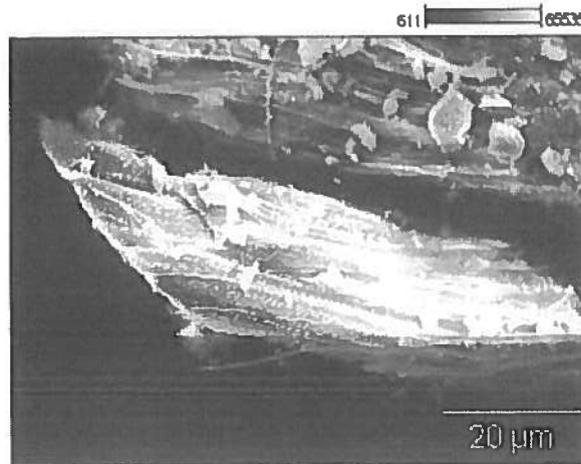
Figure 10. Quarry 1 sample R-Q1-AP4. Same area as Figure 9. Numbers denote areas where EDS spectra were collected.

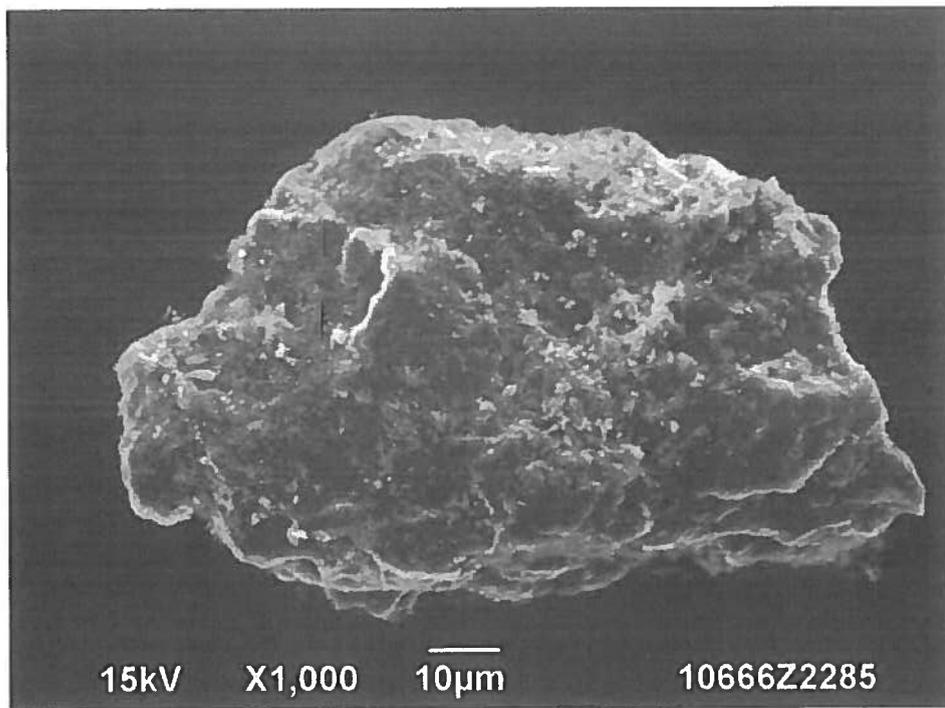
Figure 13. Scanning electron micrograph of non-fibrous serpentine (lizardite) detected during analysis of Quarry 1 sample R-Q1-AP4.

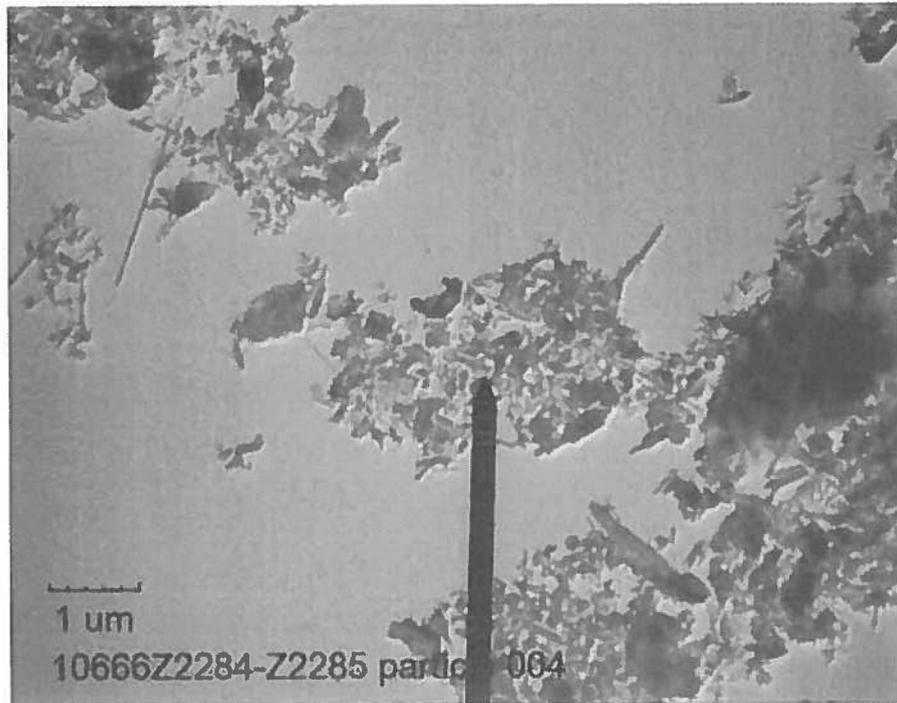
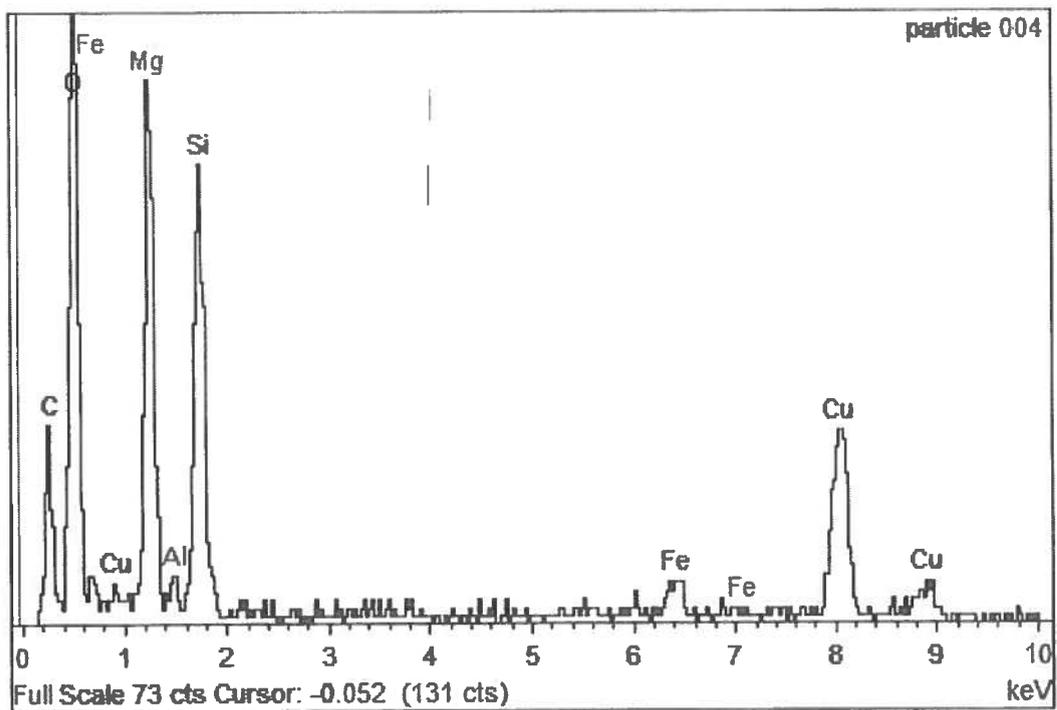
Figure 14. TEM image (above) and EDS spectrum (below) of particles in composite prep of both serpentinite mineral samples.

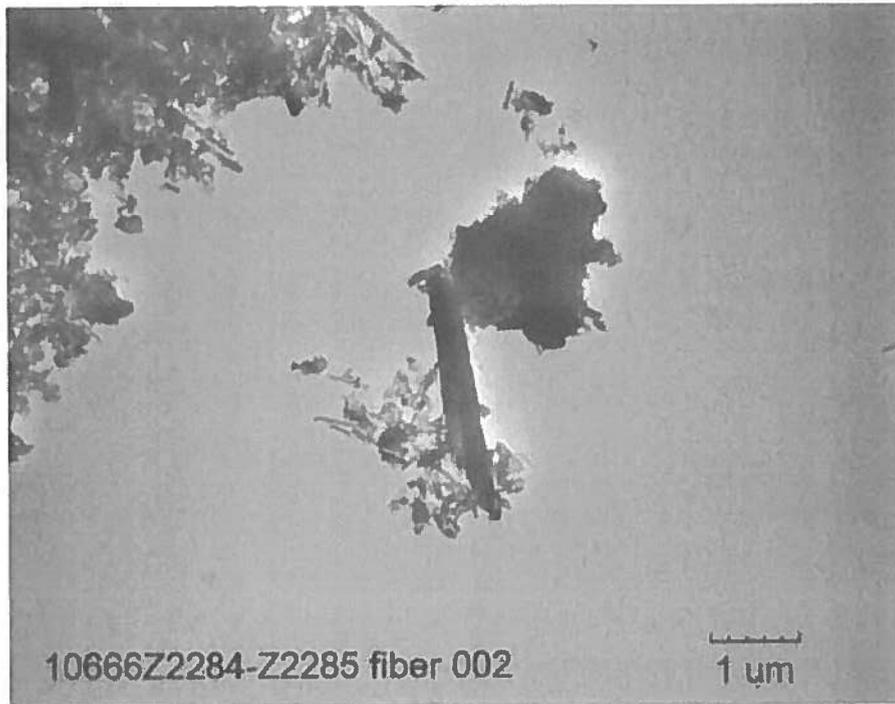
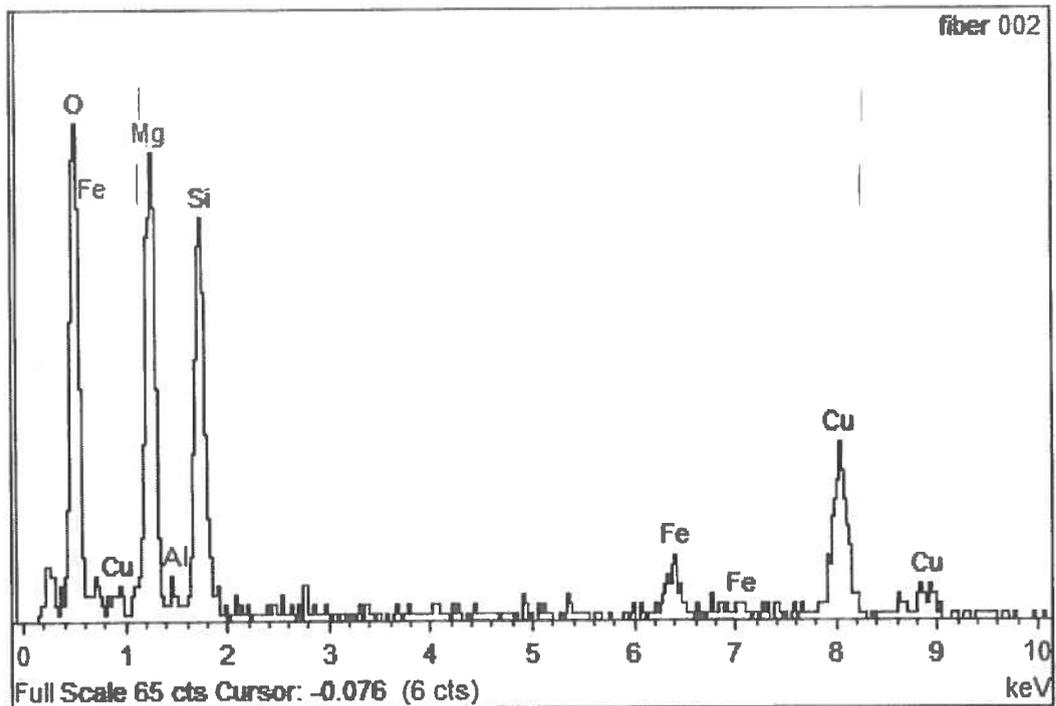
Figure 15. TEM image (above) and EDS spectrum (below) of serpentine fibers (chrysotile asbestos) in composite prep of both serpentinite mineral samples.

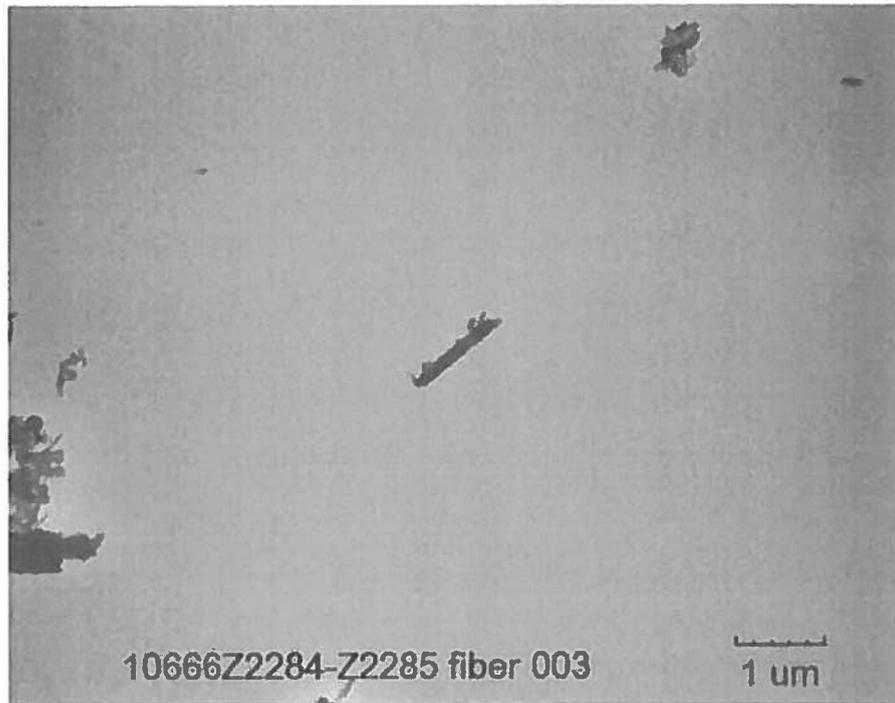
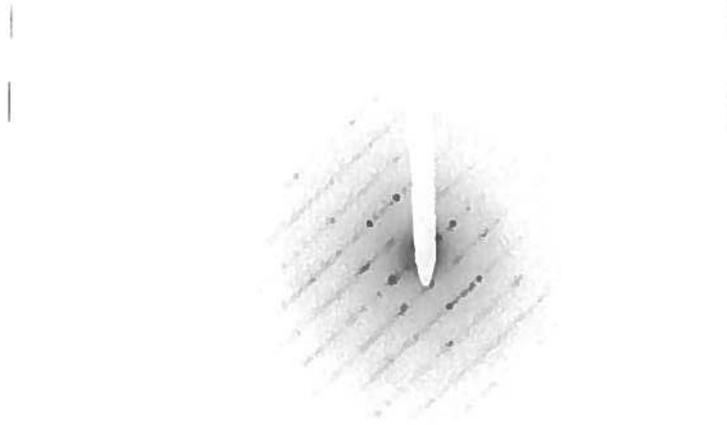
Figure 16. TEM image (above) and electron diffraction pattern (below) of representative chrysotile asbestos fiber observed during analysis of composite prep of both serpentinite mineral samples.
