**REPORT OF INITIAL FINGERPRINTING
FINDINGS RELATED TO
PUERTO RICO OLEFIN SITE
PEÑUELAS, PUERTO RICO**

Prepared by:
Ady Padan, Ph.D

February, 2015

Analytical Environmental
Services International, Inc.
611 Monserrate Street
2nd Floor, Santurce, P.R. 00907
(787) 722-0220 / Fax (787) 724-5788

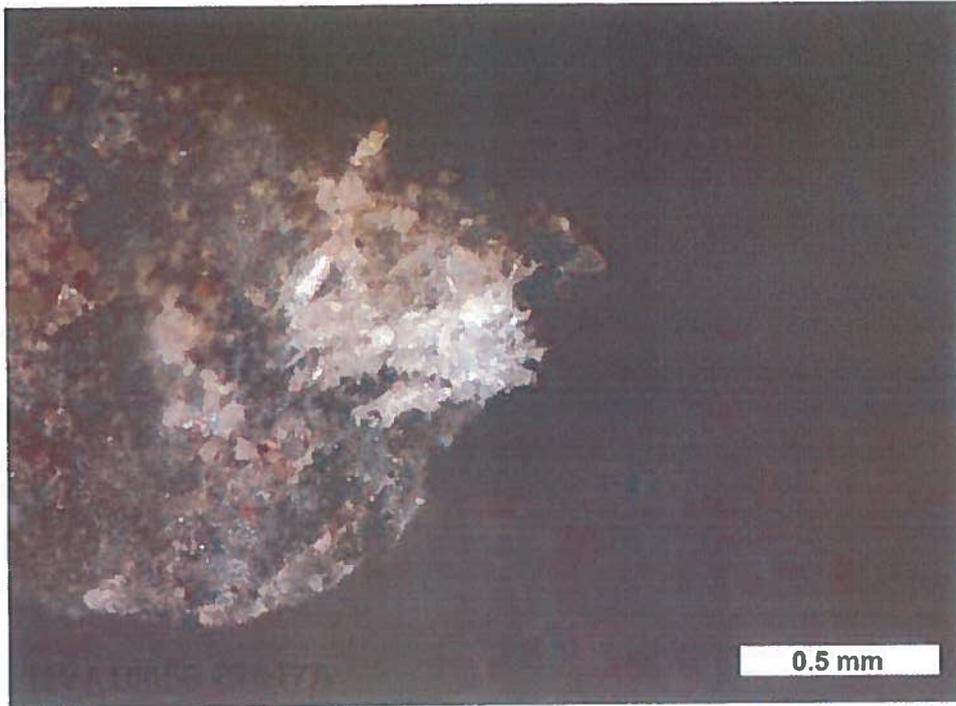
Aggregate sample S-TEC-ARE-P0006-ER1 (MVA Z2617) consisted of a mix of plant debris and soil minerals including major amounts (>10%) of carbonate, non-fibrous serpentine (lizardite) and other soil minerals; minor amounts (1%-10%) of magnetite; and trace amounts (<1%) of fibrous serpentine (chrysotile). Figures 1 through 8 show data regarding the serpentine particles that were observed during analysis of the sample via stereomicroscopy, PLM, SEM-EDS, and TEM-EDS. The serpentine particles present in this sample consistently exhibit trace to minor amounts of aluminum and/or iron. Some particles also contained trace amounts of calcium. The presence of calcium was not confirmed by the analyses of any single particle, therefore it may be present as a result of a surface contaminant carbonate particle.

Figure 1. Stereo-micrograph of non-fibrous serpentine mineral (lizardite) with fibrous serpentine intergrowth (chrysotile) observed in aggregate sample S-TEC-ARE-P0006-ER1.

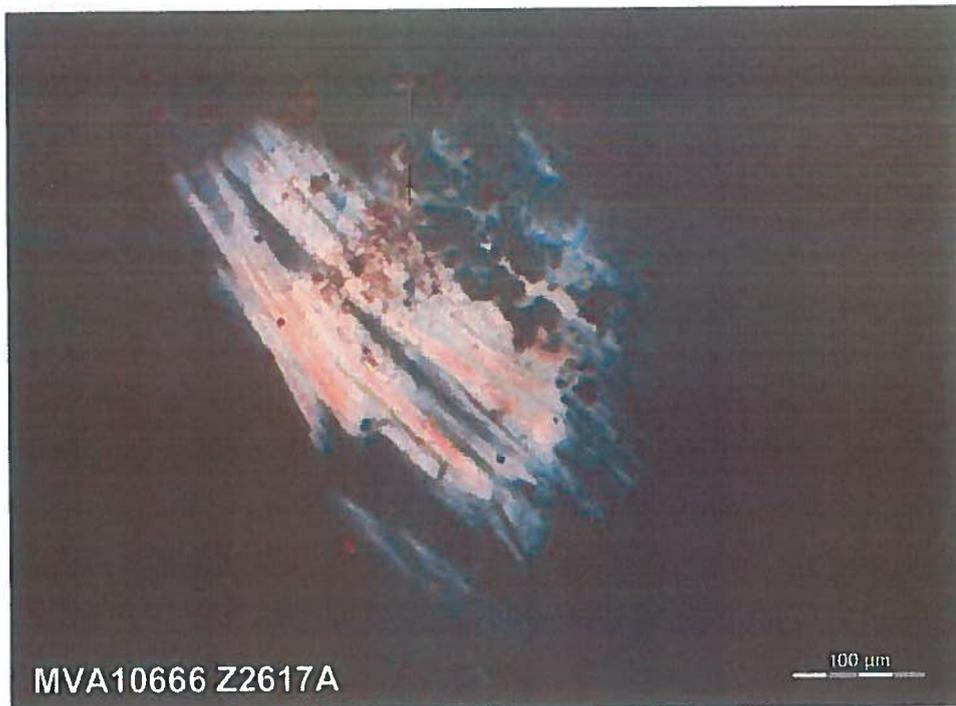
Figure 2. PLM image of chrysotile asbestos observed in aggregate sample S-TEC-ARE-P0006-ER1.

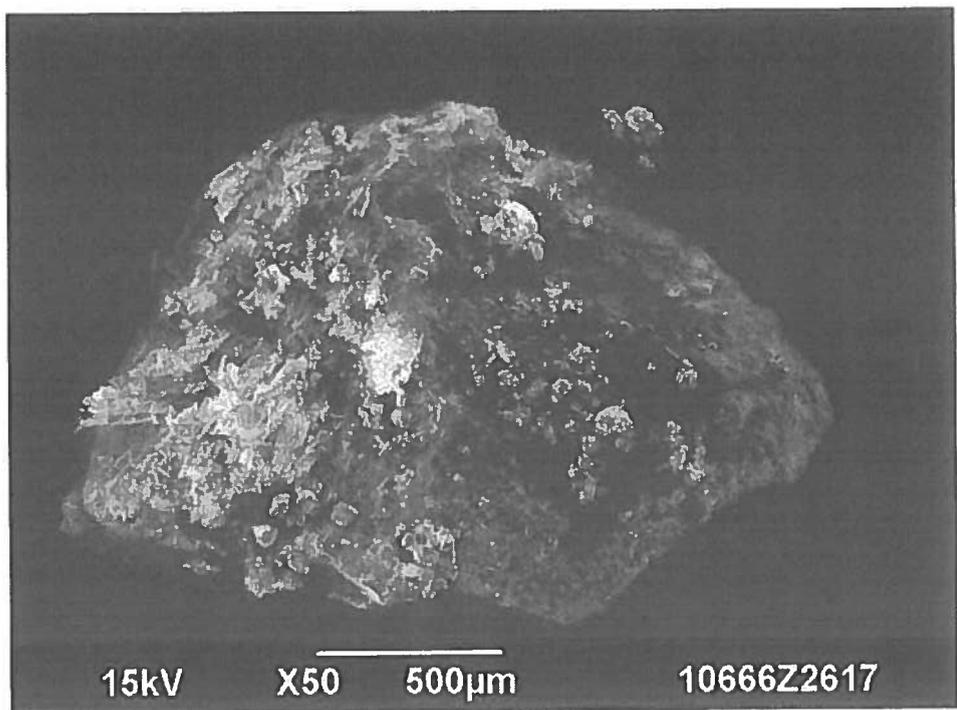
Figure 3. SEM image of serpentine mineral (Figure 1). Note fibrous mineral growth on left side of aggregate particle. Numbers (below) denote areas where EDS spectra were obtained.

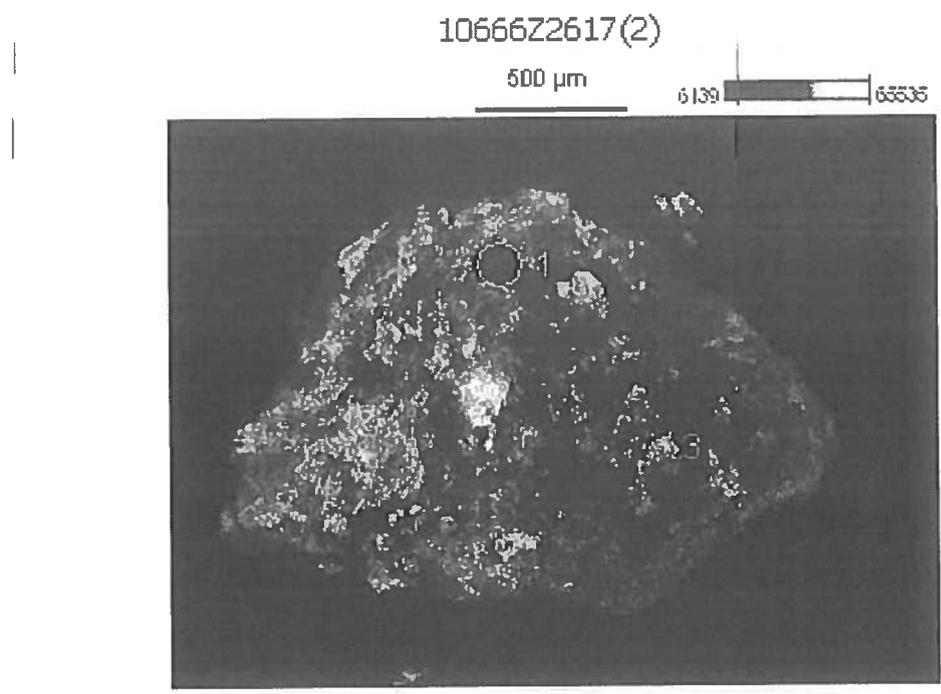
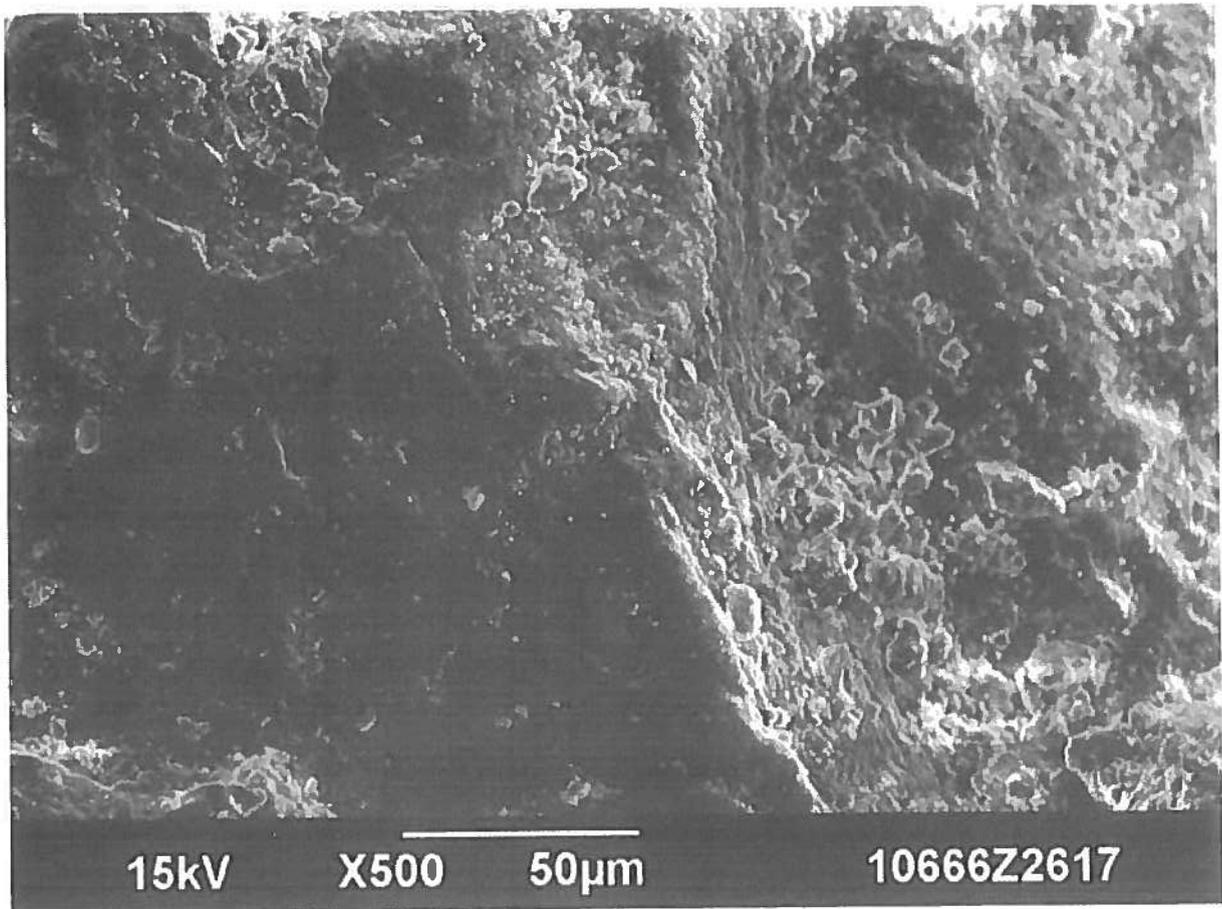
Figure 4. SEM image (above) and EDS spectrum (below) of non-fibrous serpentine (lizardite) mineral surface (Area 1 in Figure 3).

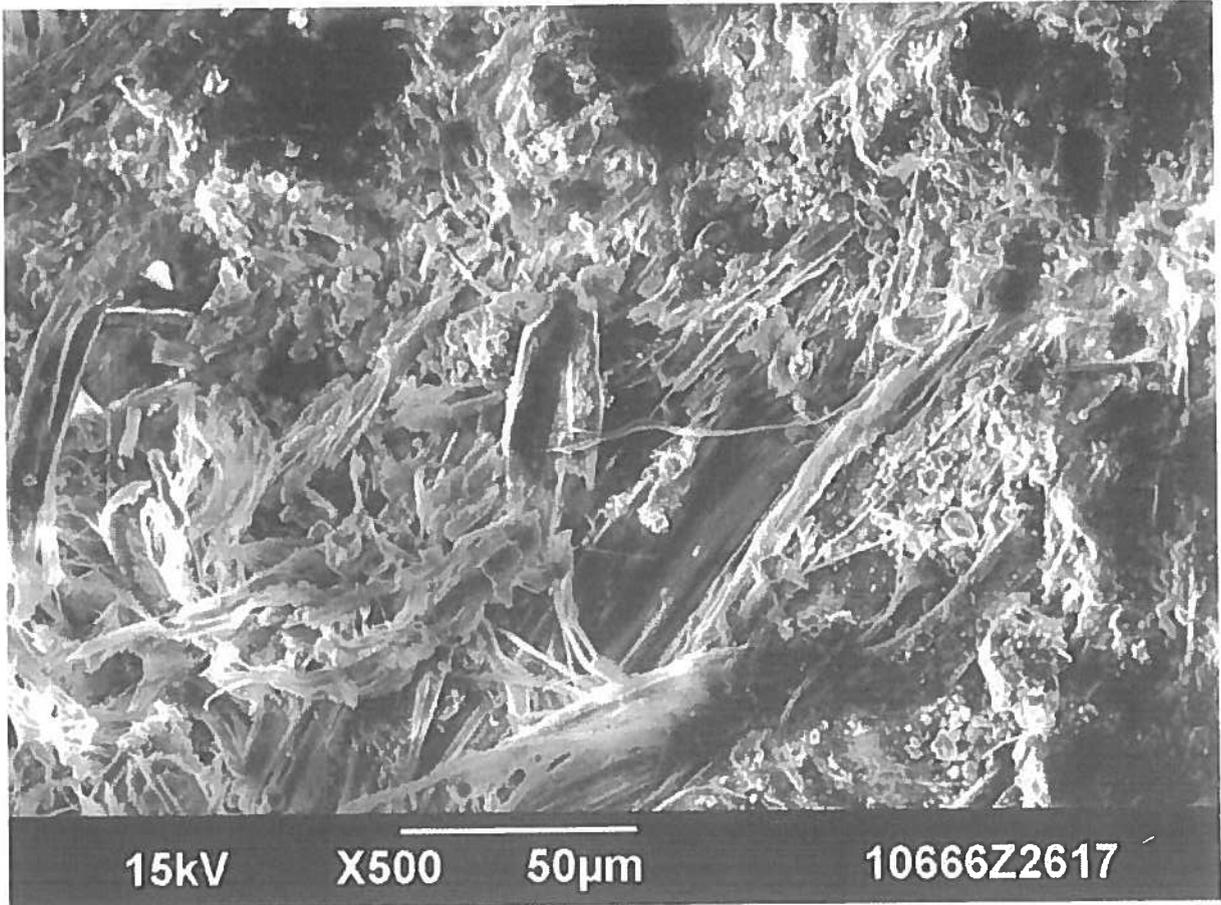
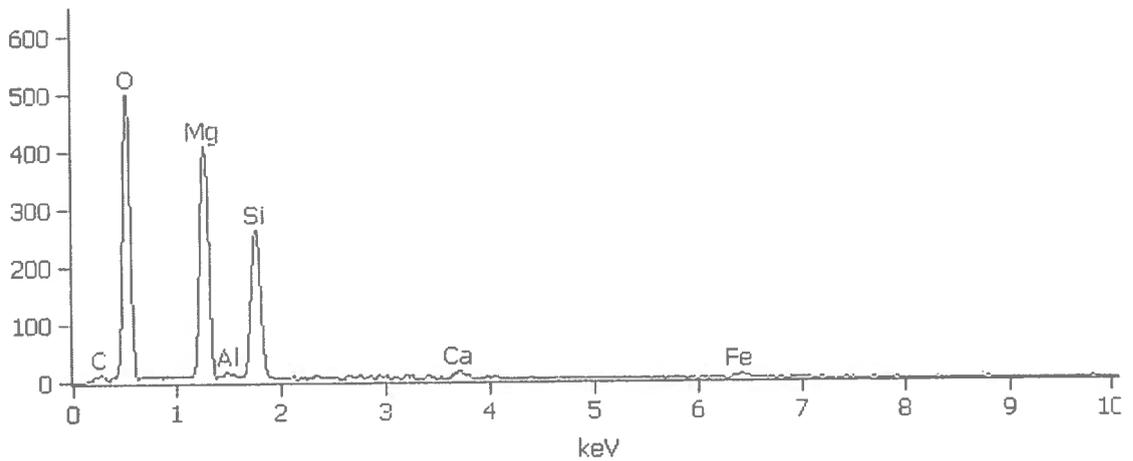
Figure 5. SEM image (above) and EDS spectrum (below) of fibrous serpentine (chrysotile) mineral surface (Area 2 in Figure 3).

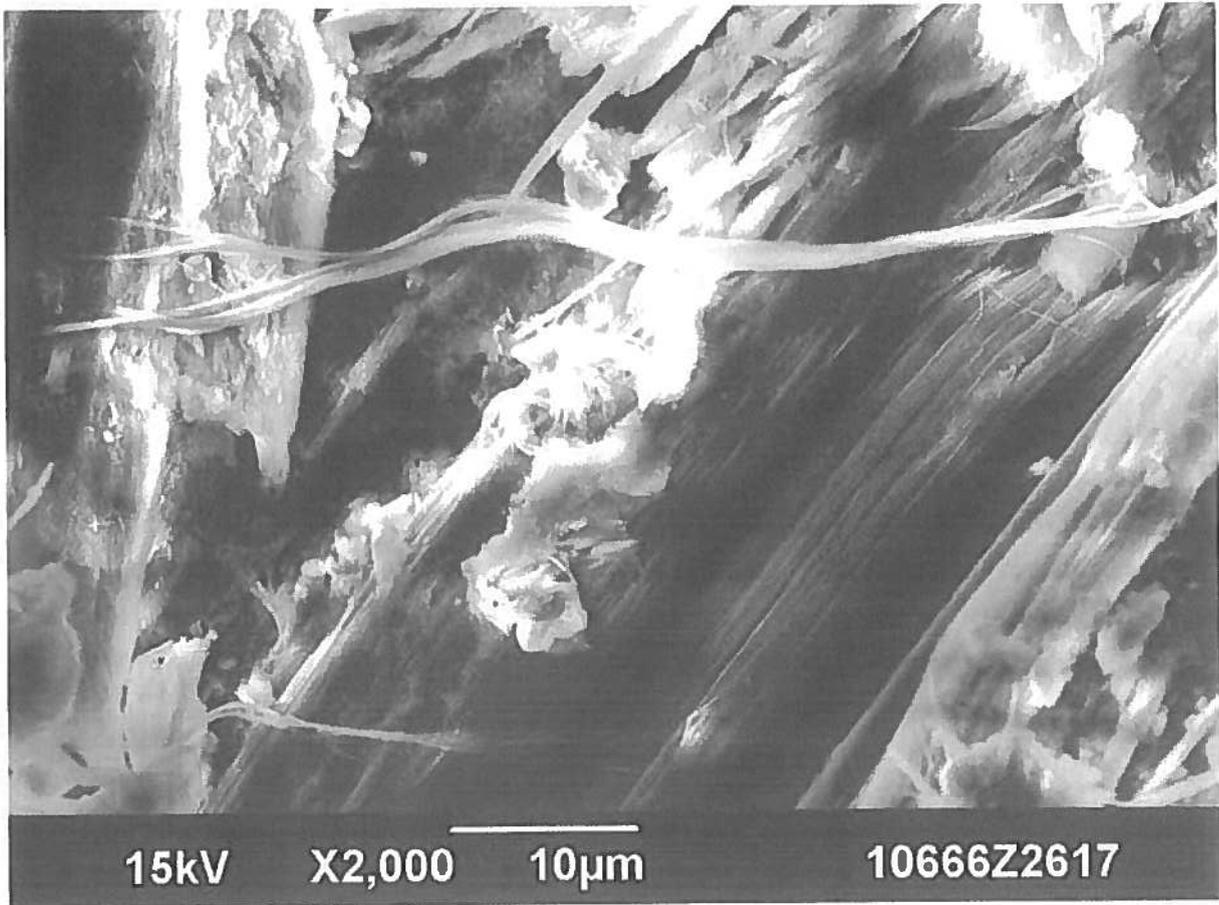
Figure 6. SEM image of chrysotile fibers (Area 2 in Figure 3).

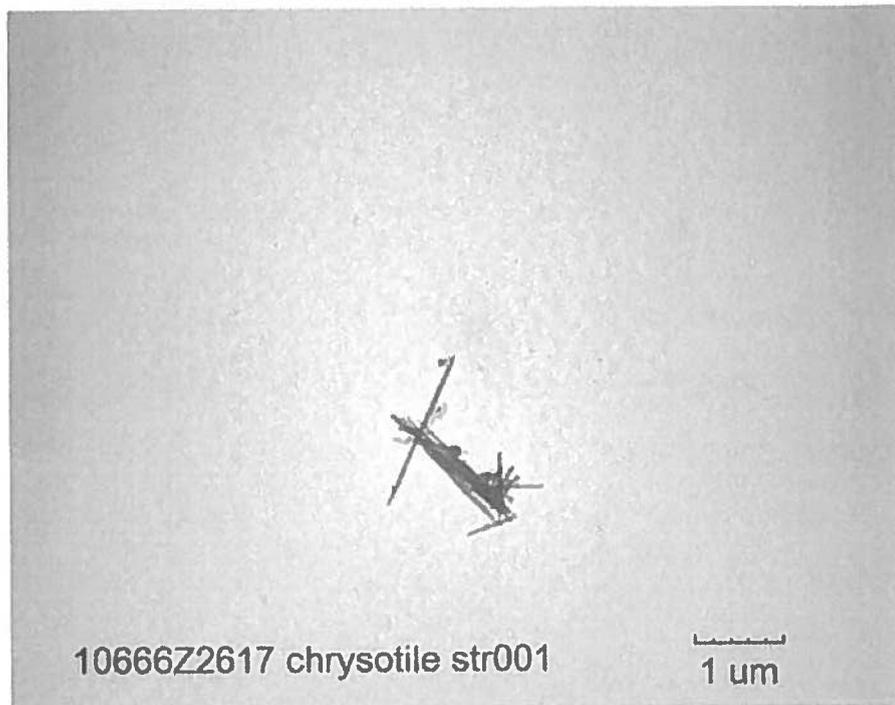
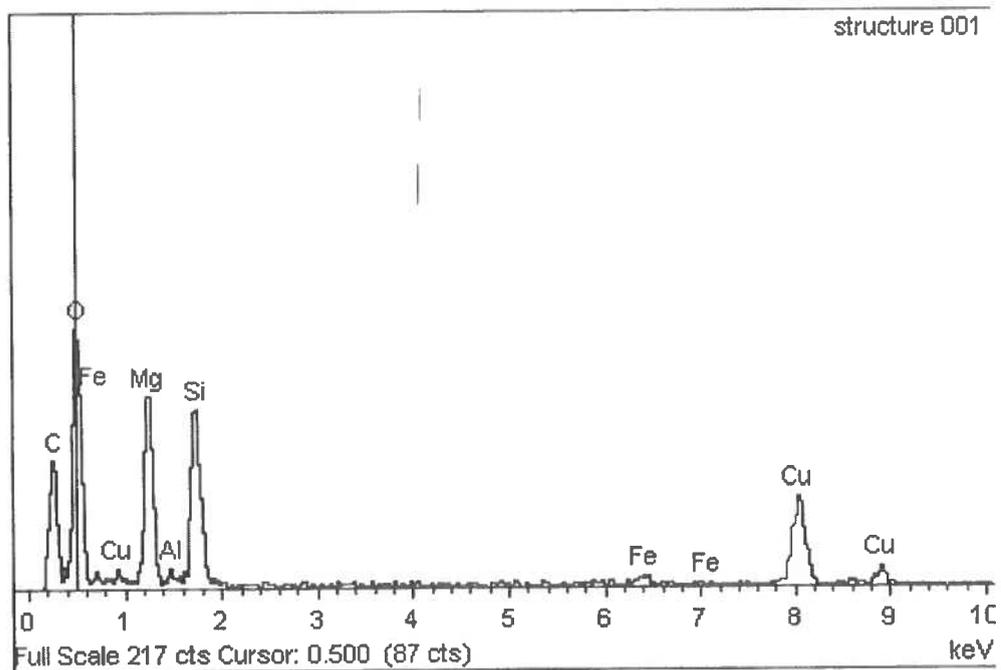
Figure 7. TEM image (above) and EDS spectrum (below) of chrysotile asbestos fiber observed during analysis of aggregate sample S-TEC-ARE-P0006-ER1.

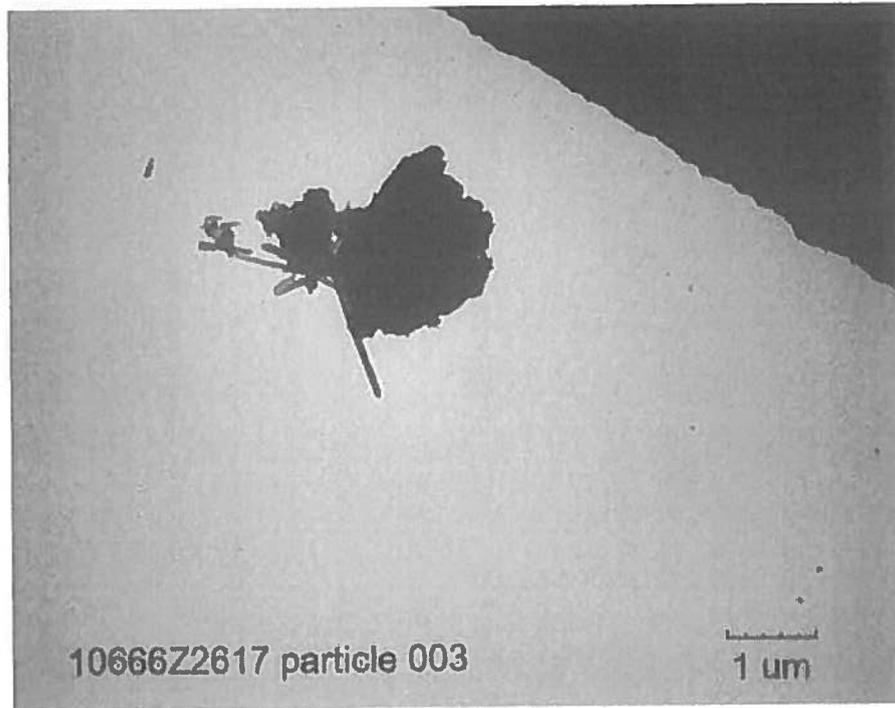
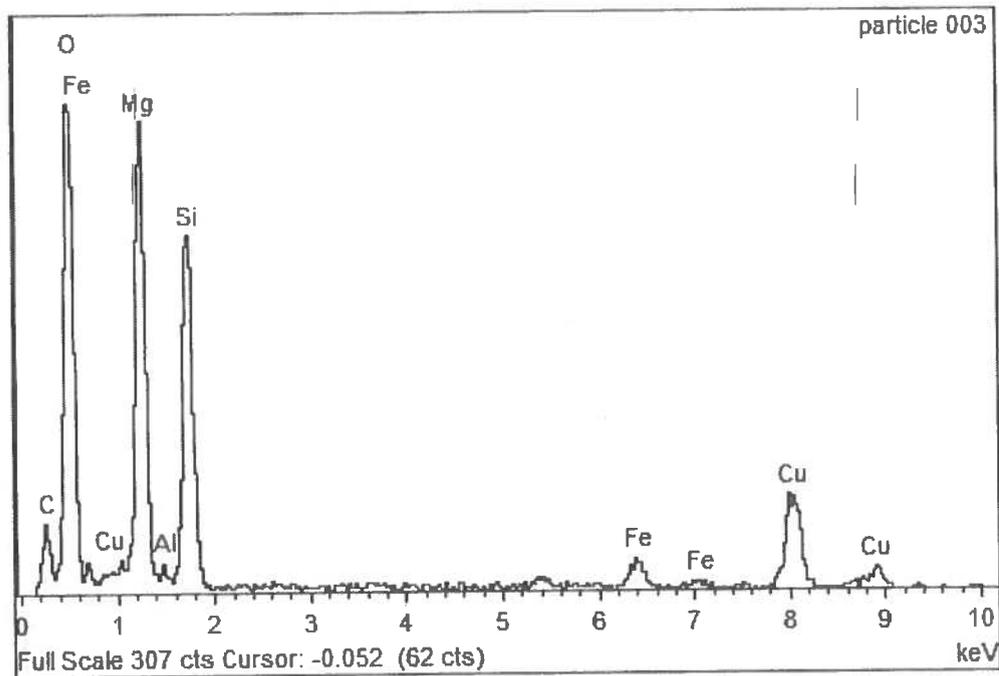
Figure 8. TEM image (above) and EDS spectrum (below) of lizardite particle observed during analysis of aggregate sample S-TEC-ARE-P0006-ER1.

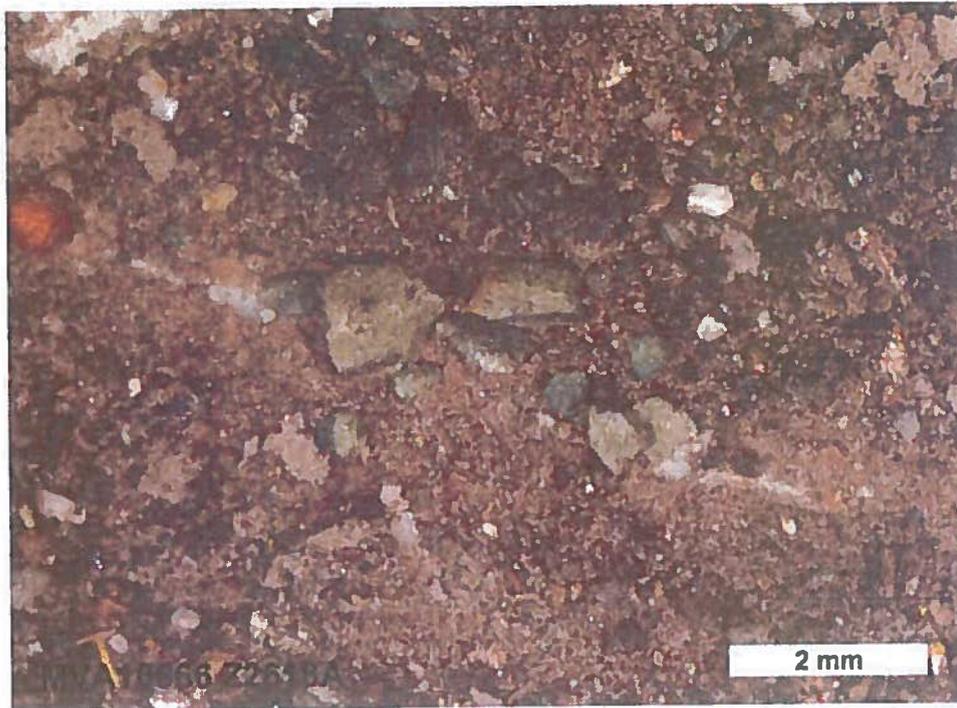
Aggregate sample S-TEC-MEOL-ER2 (MVA Z2618) consisted of a mix of plant debris and soil minerals including major amounts (>10%) of carbonate, non-fibrous serpentine (lizardite), tarry particles (asphalt), and other soil minerals; minor amounts (1%-10%) of magnetite; and trace amounts (<1%) of fibrous serpentine (chrysotile; not detected by PLM). Figures 9 through 12 show data regarding the serpentine particles that were observed during analysis of the sample via stereomicroscopy, PLM, and TEM-EDS. The serpentine particles present in this sample consistently exhibit trace to minor amounts of aluminum and/or iron. One fiber bundle also contained trace amounts of calcium and sulfur, although the presence of calcium and sulfur was not confirmed by the analyses of any single particle; therefore, it may be present as a contaminant particle.

Figure 9. Stereo-micrograph of non-fibrous serpentine mineral (lizardite) observed in aggregate sample S-TEC-MEOL-ER2.

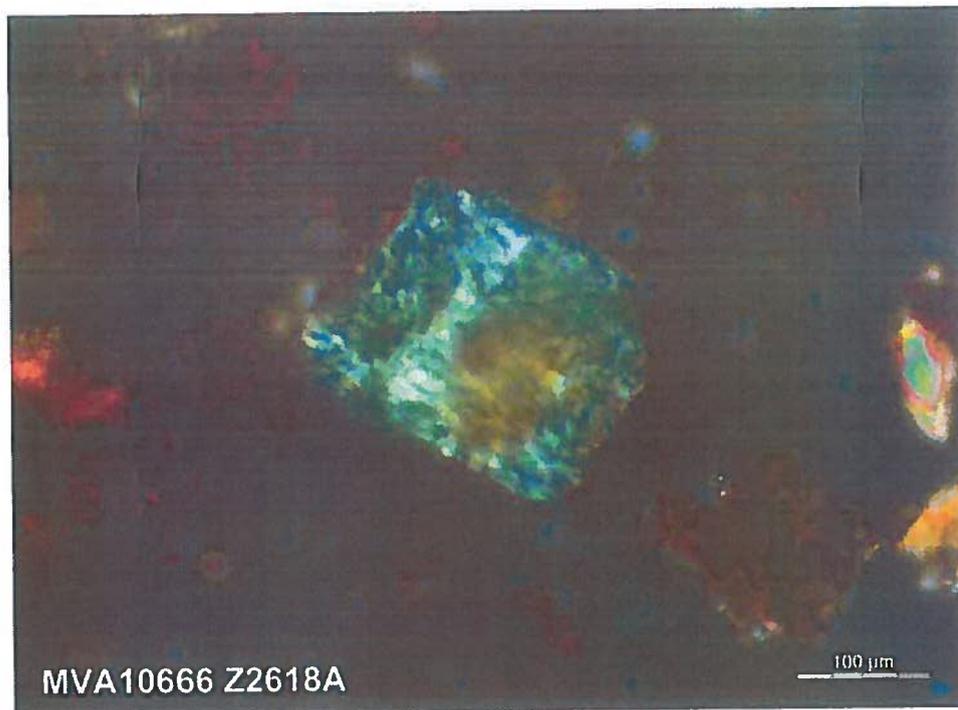
Figure 10. PLM image of non-fibrous serpentine mineral (lizardite) observed in aggregate sample S-TEC-MEOL-ER2.

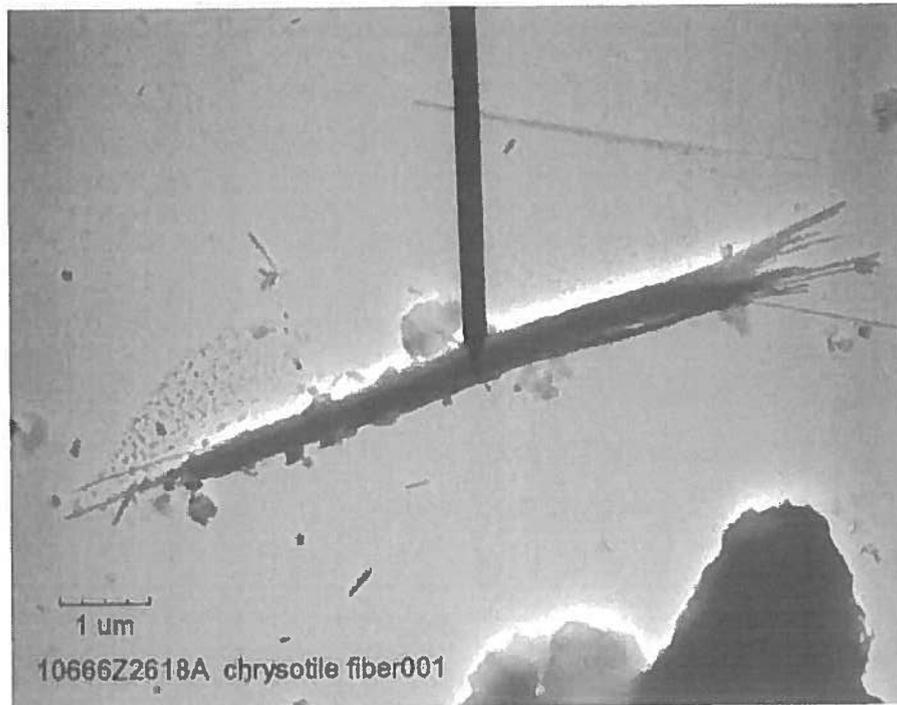
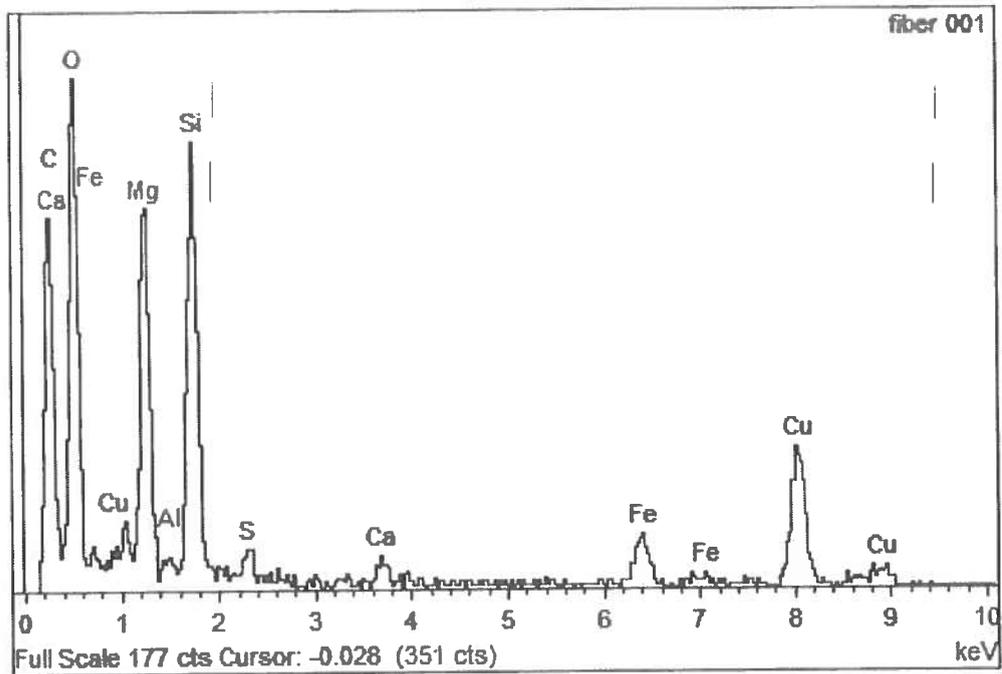
Figure 11. TEM image (above) and EDS spectrum (below) of chrysotile asbestos fiber observed during analysis of aggregate sample S-TEC-MEOL-ER2.

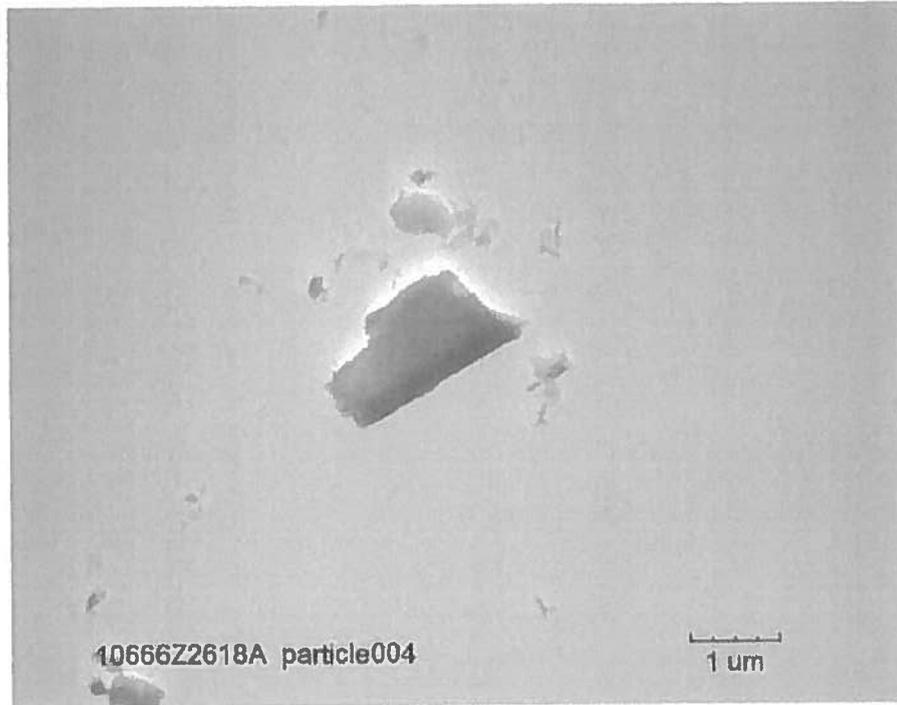
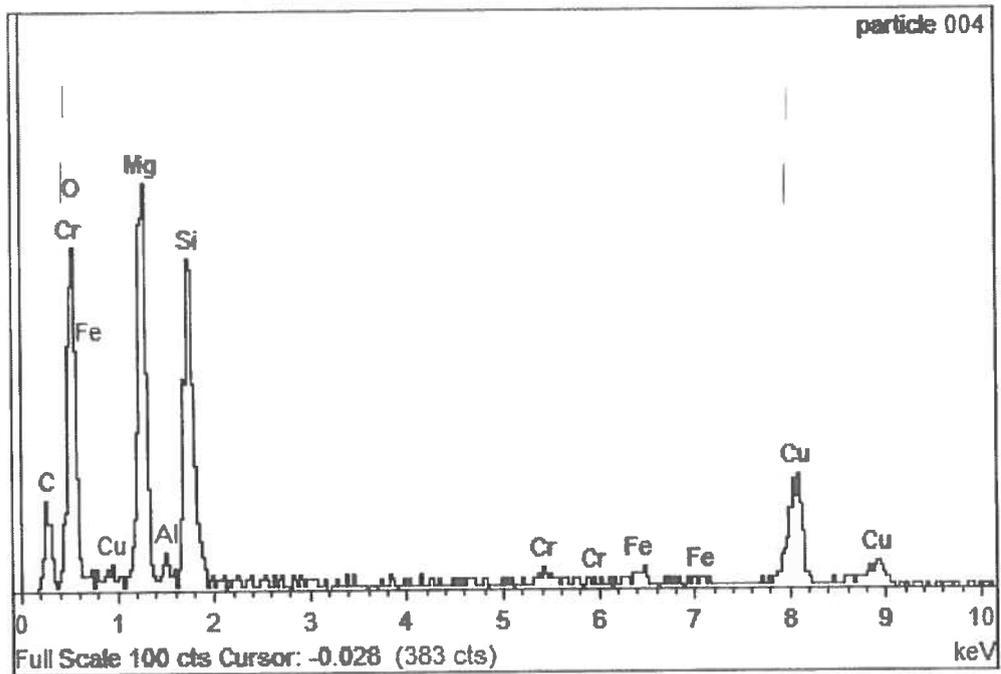
Figure 12. TEM image (above) and EDS spectrum (below) of lizardite particle observed during analysis of aggregate sample S-TEC-MEOL-ER2.

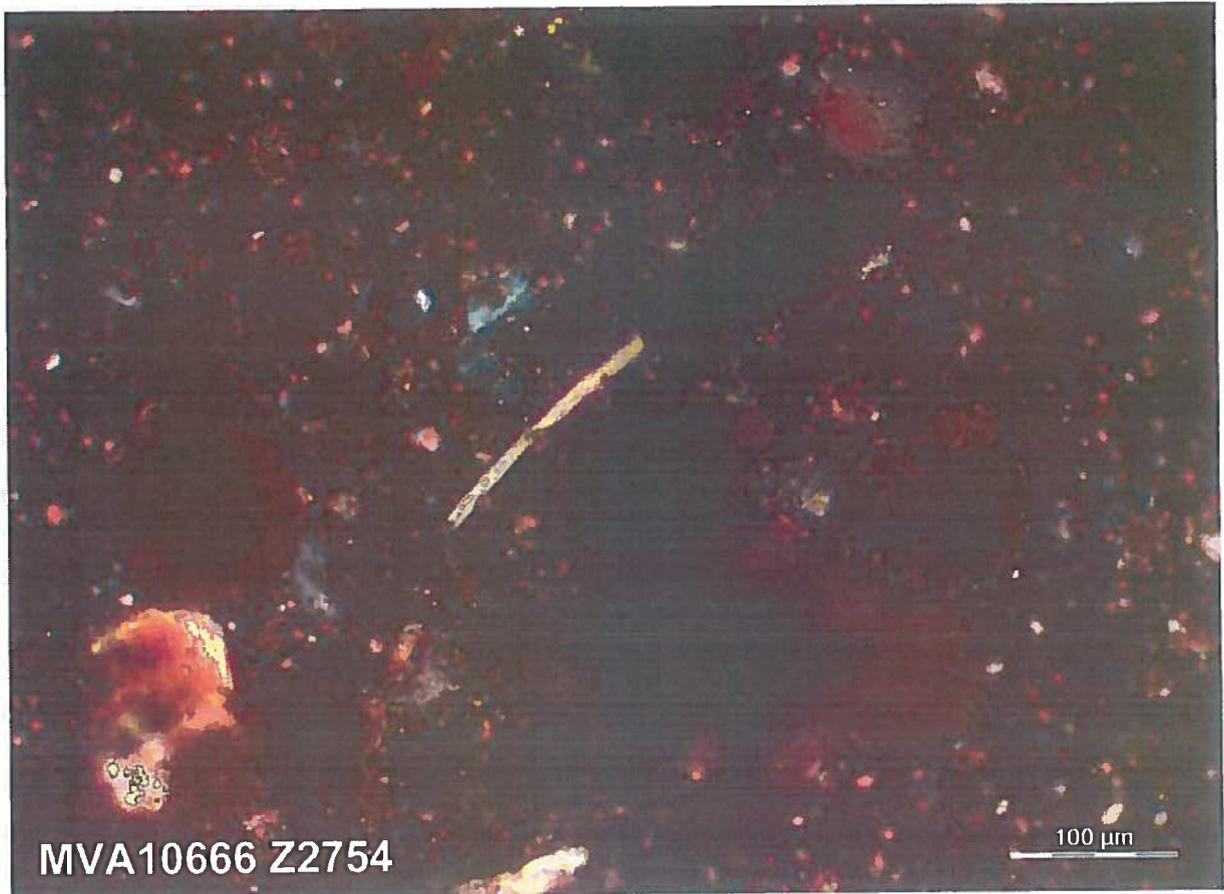
Aggregate sample S-TEC-TNT-S-ER1 (MVA Z2754) consisted of a mix of plant debris and soil minerals including major amounts (>10%) of carbonate, non-fibrous serpentine (lizardite) and other soil minerals; minor amounts (1%-10%) of magnetite; and trace amounts (<1%) of fibrous serpentine (chrysotile). Figures 13 through 17 show data regarding the particles that were observed during analysis of the sample via PLM, SEM-EDS, and TEM-EDS. The serpentine particles present in this sample consistently exhibit trace to minor amounts of aluminum and/or iron.

Figure 13. PLM image of chrysotile asbestos observed in aggregate sample S-TEC-TNT-S-ER1.

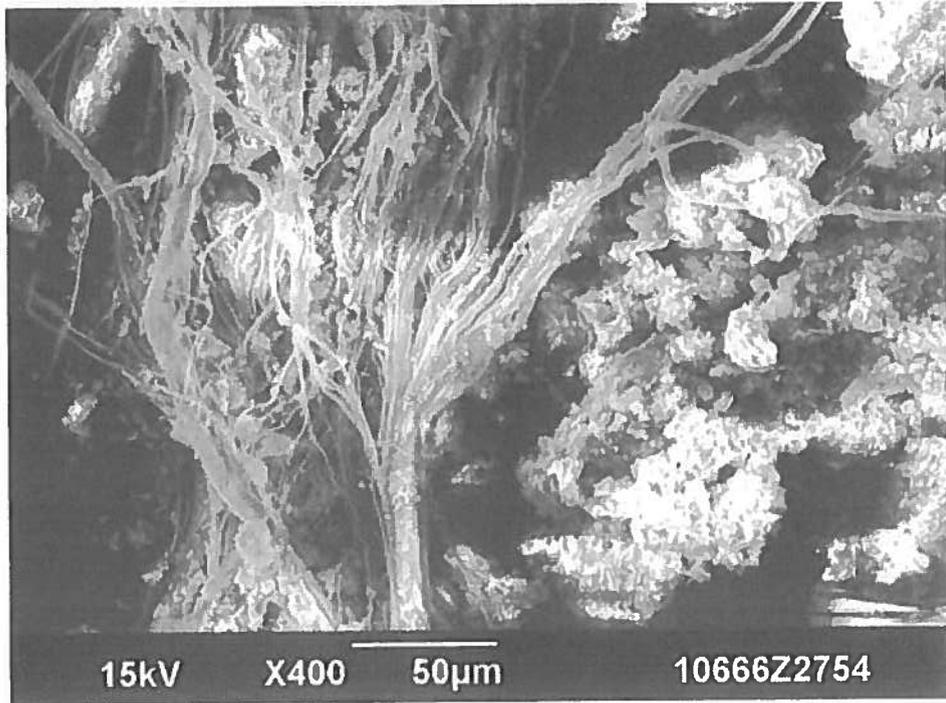
Figure 14. SEM image of debris particles from aggregate sample S-TEC-TNT-S-ER1. Numbers (below) denote areas where EDS spectra were obtained.

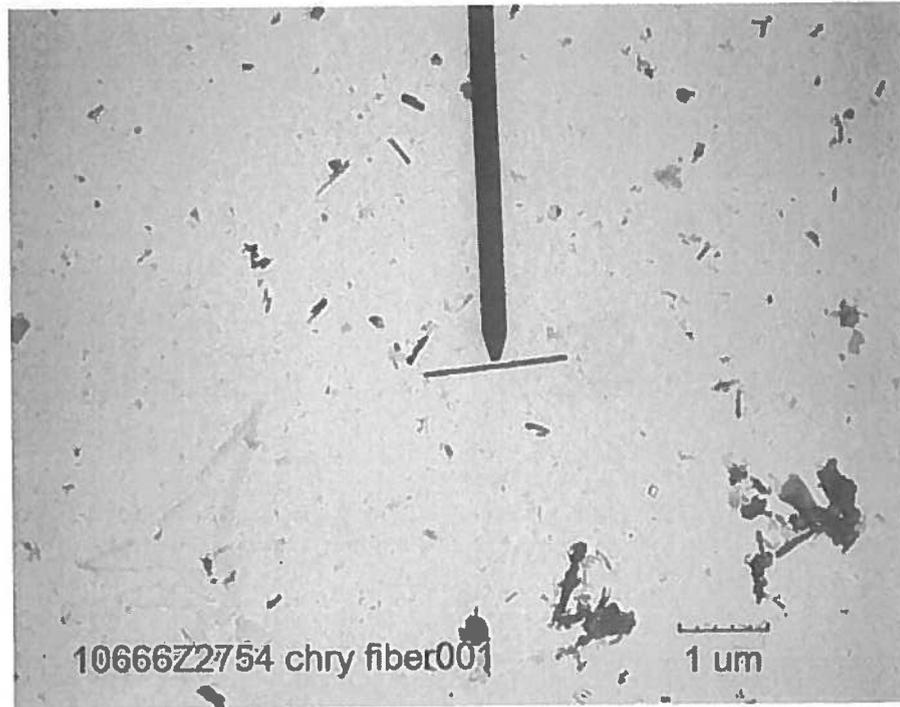
Figure 17. TEM image (above) and EDS spectrum (below) of chrysotile asbestos fiber observed during analysis of aggregate sample S-TEC-TNT-S-ER1.

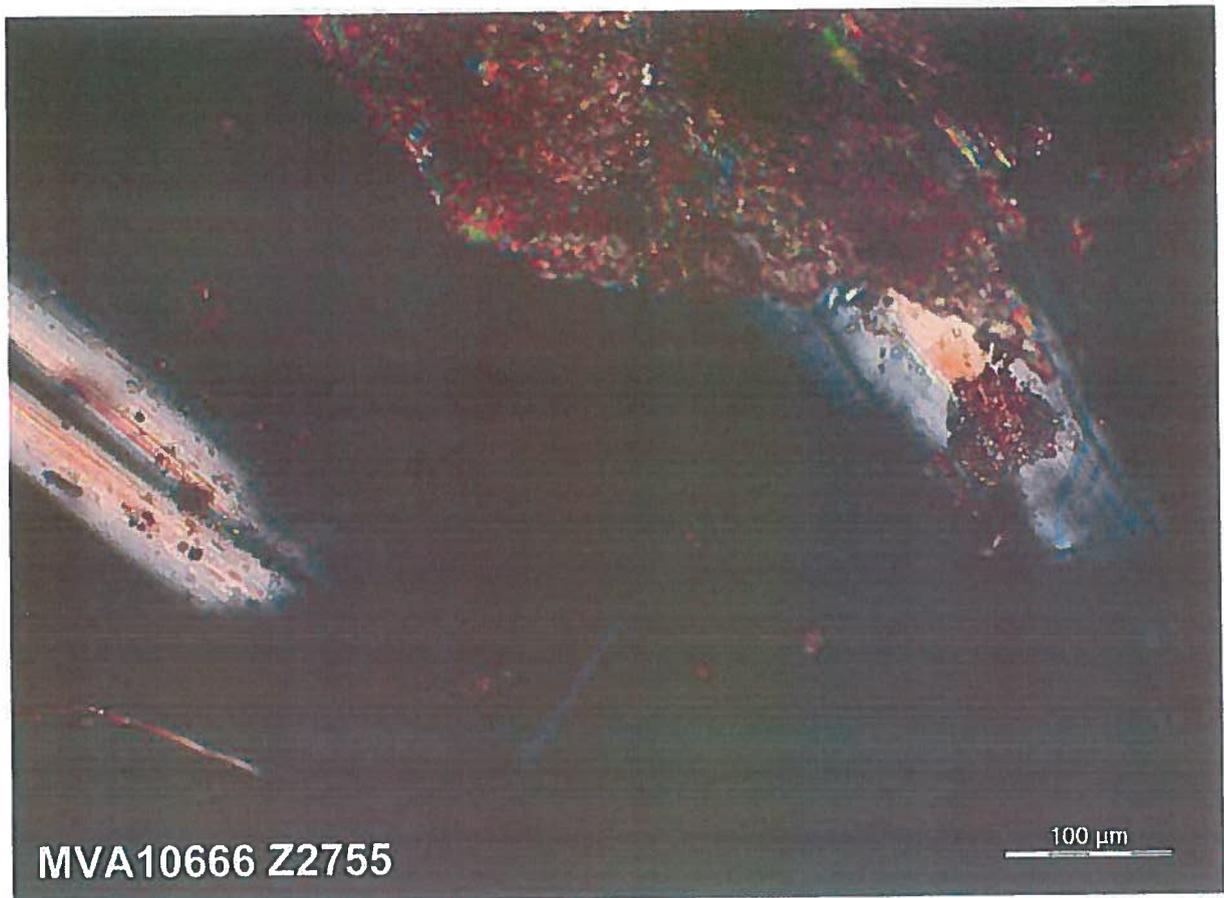
Figure 18. PLM image of chrysotile asbestos (center) observed in aggregate sample S-TEC-BUS-ER2.

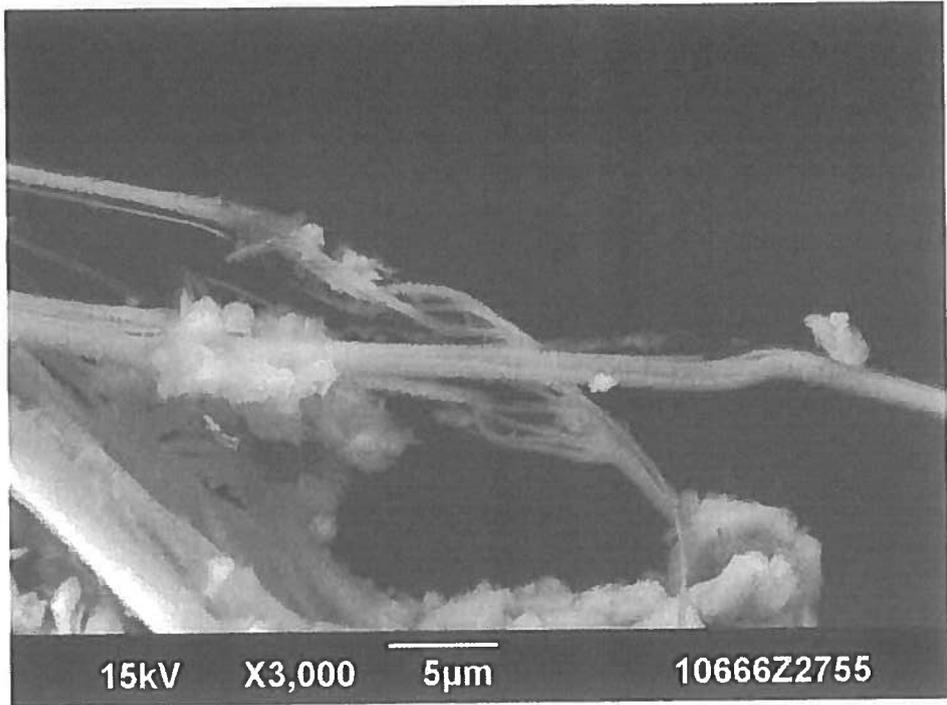
Figure 19. SEM image of debris particles from aggregate sample S-TEC-BUS-ER2. Numbers (below) denote areas where EDS spectra were obtained.

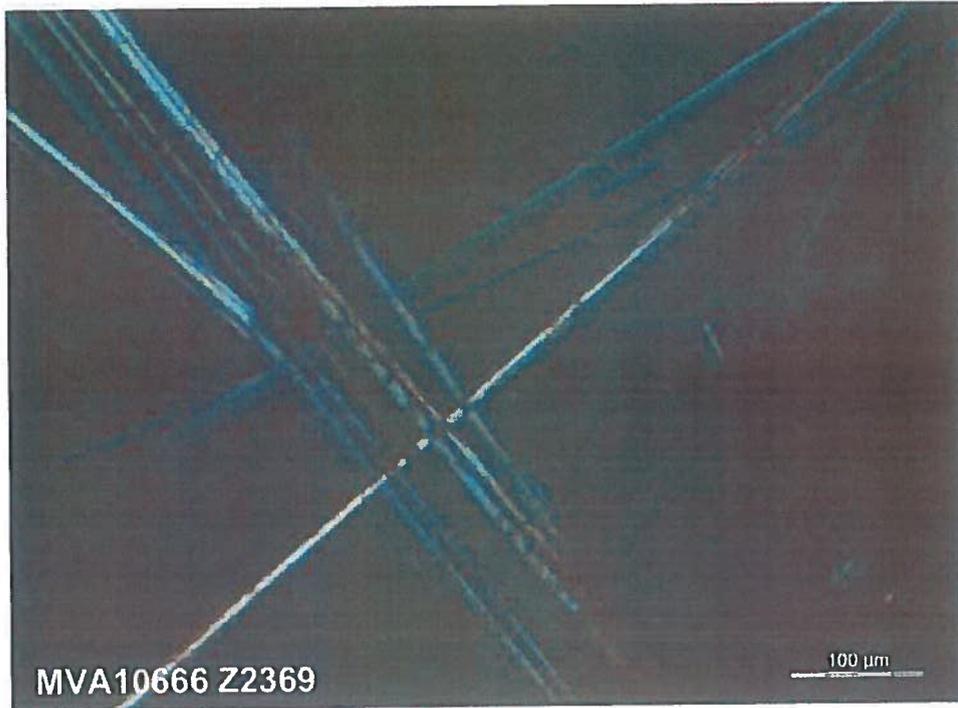
| MVA # | Sample I. D. | Sample Description |
|---|---|---|
| Z2369 | B-OL-OV-409-ER1 | Sample from debris of pipe insulation found on floor from area OV409. |

| MVA # | PLM Analysis Results % Asbestos | Additional Materials Observed | TEM Analysis Results | Comments |
|---|--|--|---|---|
| Z2369 | 60-80% Amosite | Binder, Rust/Metal Particles, Diatoms | NA | --- |

Figure 1. Polarized light microscope image of amosite asbestos fibers detected during analysis of bulk insulation debris, Sample Z2369.

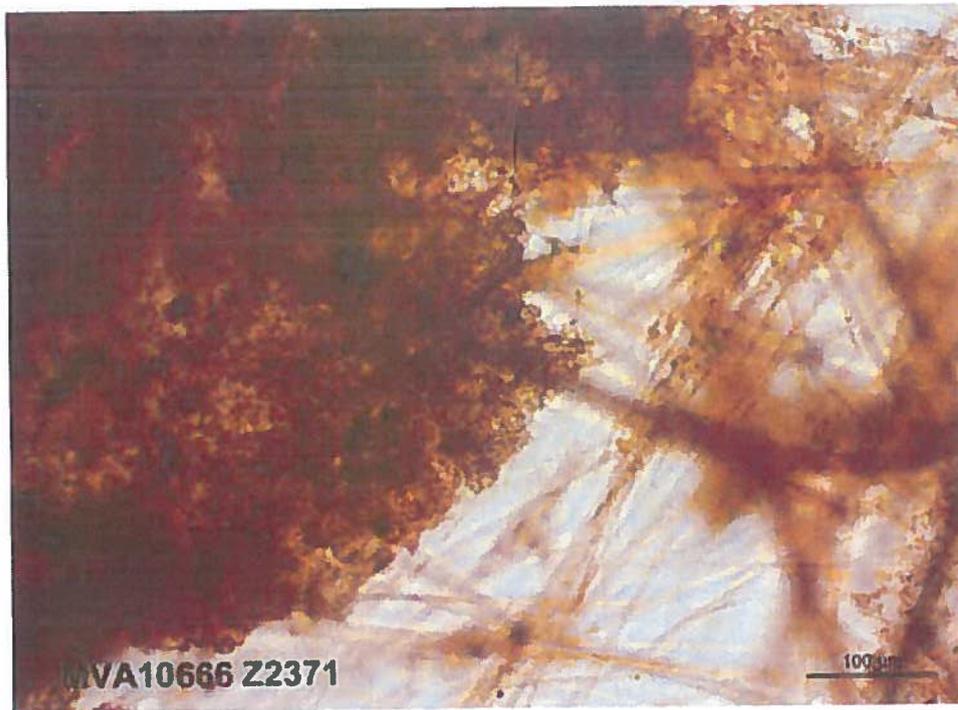
| MVA # | PLM Analysis Results % Asbestos | Additional Materials Observed | TEM Analysis Results | Comments |
|---|--|--|---|---|
| Z2371 | 60-80% Amosite | Binder, Rust/Metal Particles | NA | --- |

Figure 2. Polarized light microscope image of amosite asbestos fibers and binder material detected during analysis of bulk insulation debris, Sample Z2371.

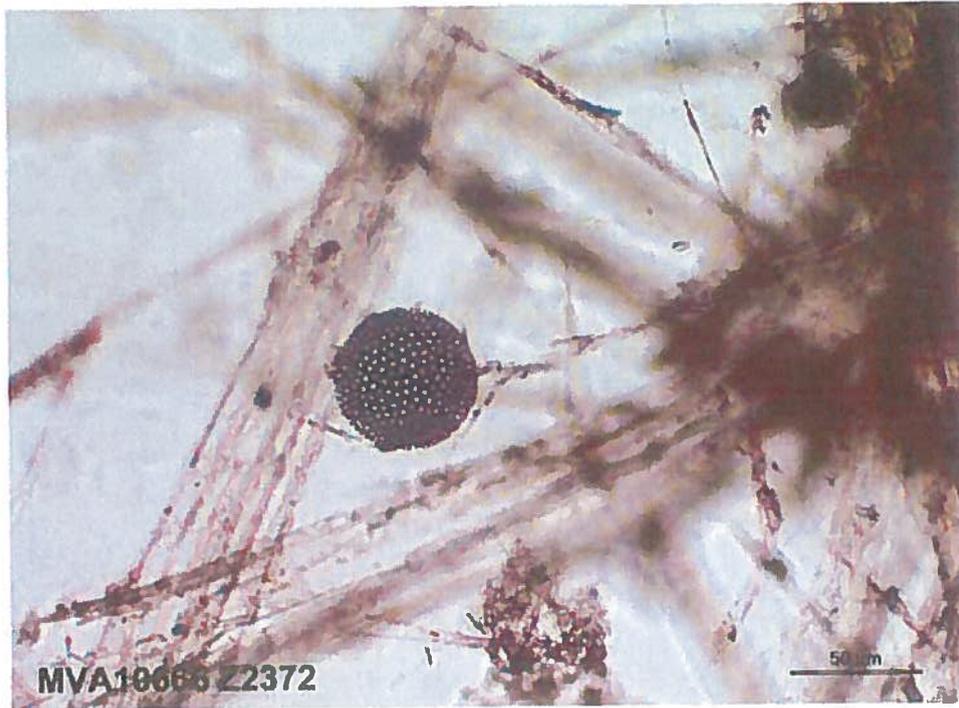
| MVA # | PLM Analysis Results % Asbestos | Additional Materials Observed | TEM Analysis Results | Comments |
|---|--|--|---|---|
| Z2372 | 60-80% Amosite | Binder, Rust/Metal Particles, Diatoms | NA | Amosite with Silicon-rich Binder Confirmed by SEM |

Figure 3. Polarized light microscope image of amosite asbestos fibers and binder material detected during analysis of bulk insulation debris, Sample Z2372.

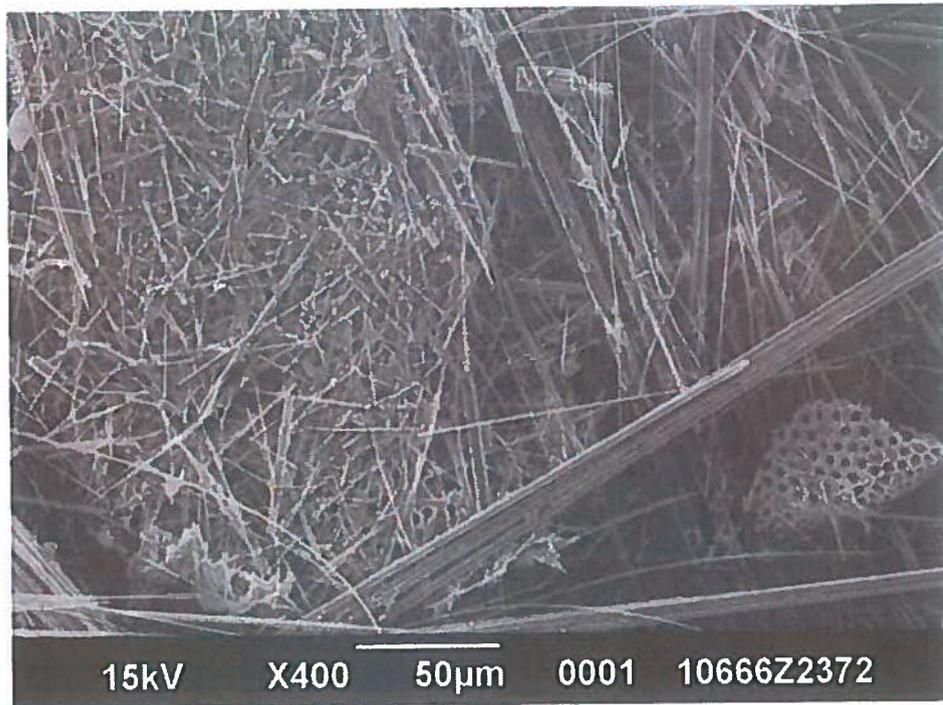
Figure 4. Scanning electron micrograph of amosite asbestos fibers and diatoms detected during analysis of bulk insulation debris, Sample Z2372.

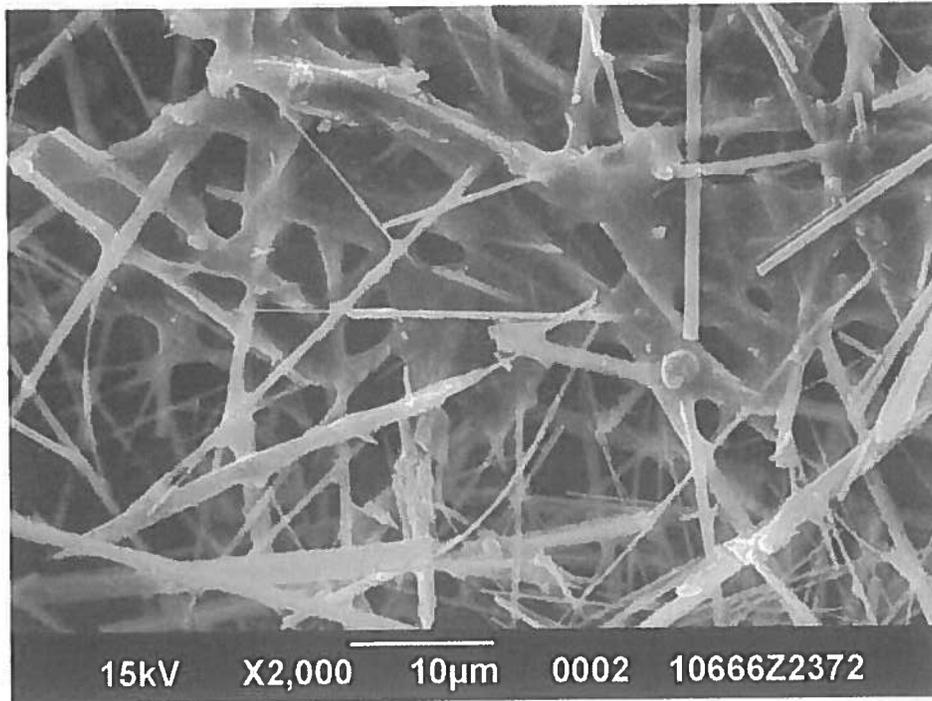
Figure 5. Scanning electron micrograph of amosite asbestos fibers and diatoms detected during analysis of bulk insulation debris, Sample Z2372.

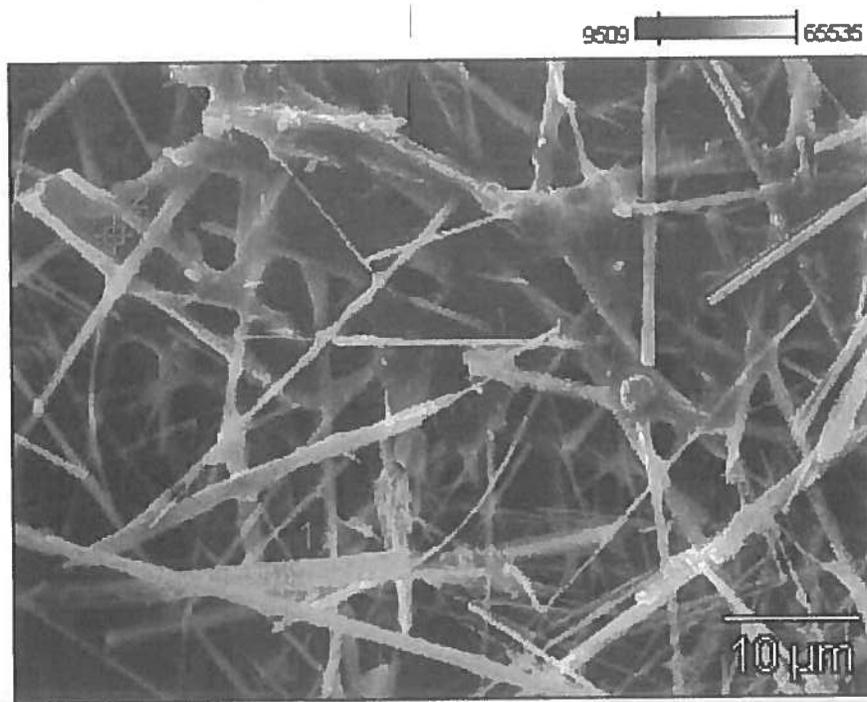
Figure 6. Insulation debris sample Z2372. Same area as Figure 5. Numbers denote areas where EDS spectra were collected.
