**REPORT OF INITIAL FINGERPRINTING
FINDINGS RELATED TO
PUERTO RICO OLEFIN SITE
PEÑUELAS, PUERTO RICO**

Prepared by:
Ady Padan, Ph.D

February, 2015

Analytical Environmental
Services International, Inc.
611 Monserrate Street
2nd Floor, Santurce, P.R. 00907
(787) 722-0220 / Fax (787) 724-5788

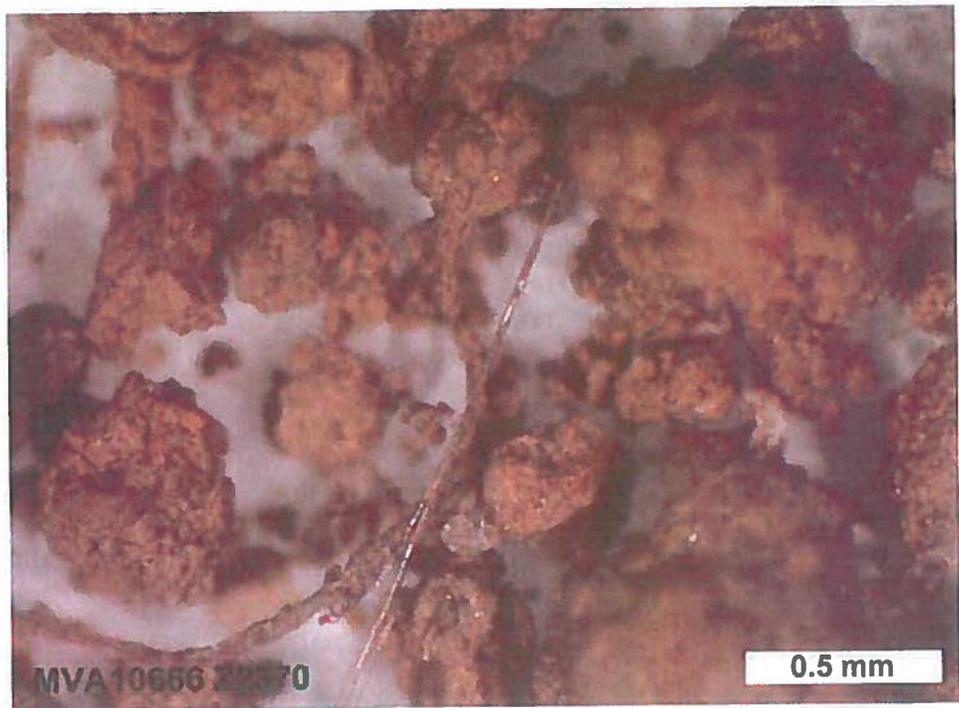
| MVA # | PLM Analysis Results % Asbestos | Additional Materials Observed | TEM Analysis Results | Comments |
|---|--|--|---|---|
| Z2370 | Trace Amosite | Soil Minerals, Plant Fragments, Rust/Metal Particles, Insect Parts | NAD | --- |

Figure 9. Stereomicroscope image of amosite asbestos fibers detected during analysis of soil, Sample Z2370.

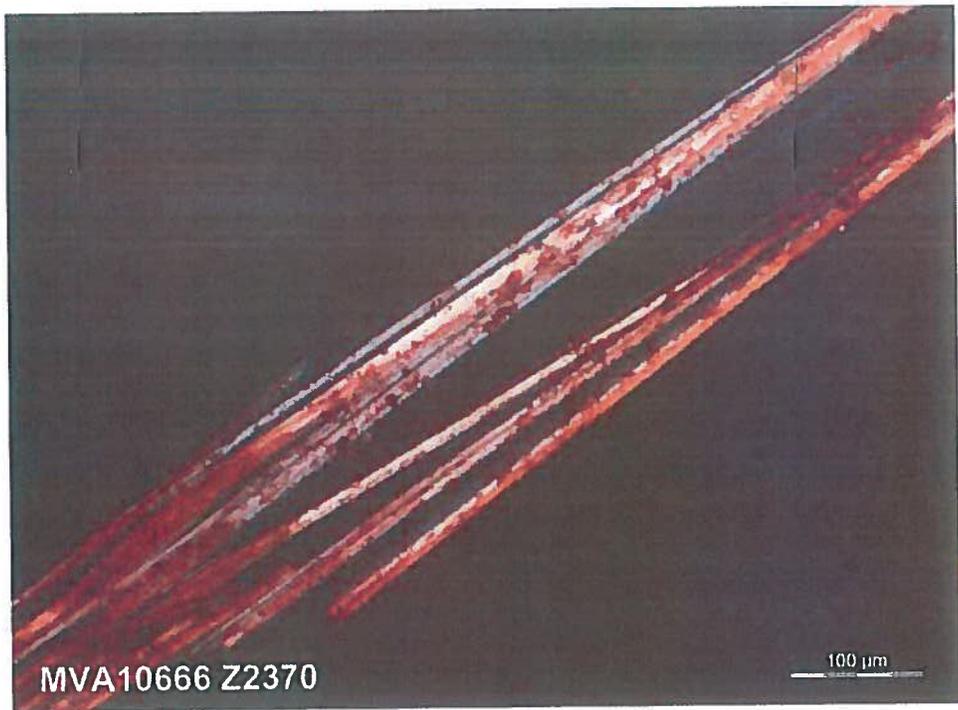
Figure 10. Polarized light microscope image of amosite asbestos fibers detected during analysis of soil, Sample Z2370.

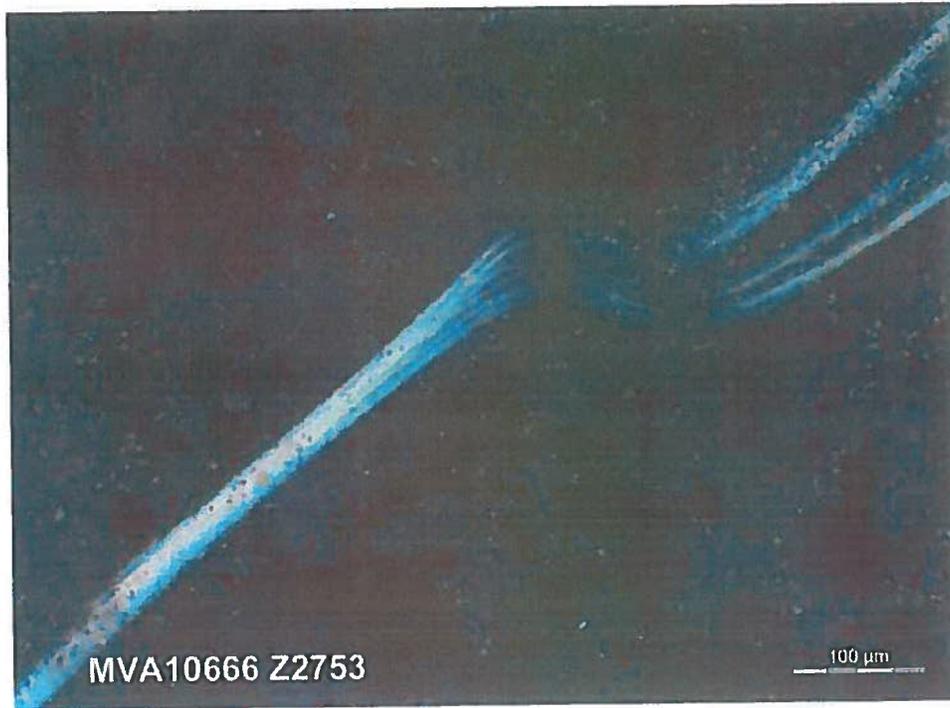
A summary of analytical results for sample "BULK-OL-CHM4-ER2" is provided in Table 2. The insulation sample contained approximately 40 to 60% chrysotile asbestos (by volume) in addition to a binder material detected via PLM analysis. Figure 1 shows a PLM image of a representative chrysotile asbestos bundle. SEM-EDS analysis shows that the fiber bundles consist of long, processed chrysotile bundles (Figures 2 and 3) with a calcium silicate binder material (Figures 4 and 5). Elemental composition of the fibers via SEM-EDS shows trace amounts of aluminum, chlorine, and calcium (Figure 6); however, these peaks are likely from adhering binders and particulate material since these elements are not confirmed in the TEM-EDS data. Based on TEM-EDS, none of the 15 fibers analyzed contained any detectable level of aluminum. The majority of the fibers analyzed contained no detectable level of iron (Figure 7); however, some fibers did contain iron at or below 1.8% (elemental weight percent, Table 3). The average aspect ratio of the 15 fibers analyzed is greater than 100:1 (length:width) with a minimum aspect ratio of 7:1 and a maximum aspect ratio of over 1000:1.

Figure 1. Polarized light microscope image of chrysotile asbestos fibers detected during analysis of insulation sample "BULK-OL-CHM4-ER2" (MVA Z2753).

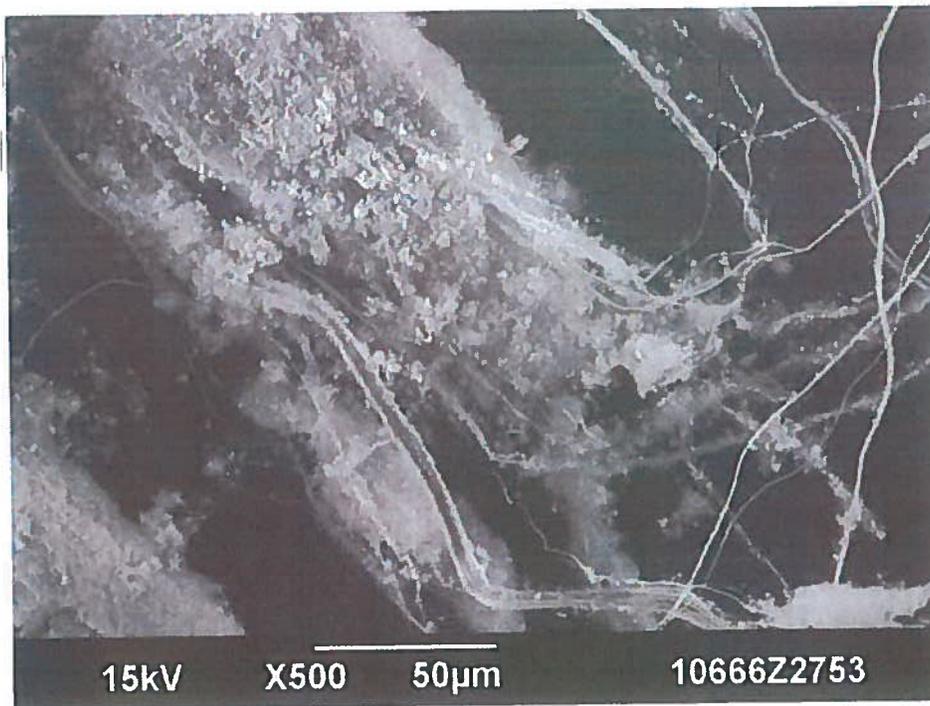
Figure 2. Scanning electron micrograph of chrysotile asbestos fibers and binder detected during analysis of insulation sample "BULK-OL-CHM4-ER2" (MVA Z2753).

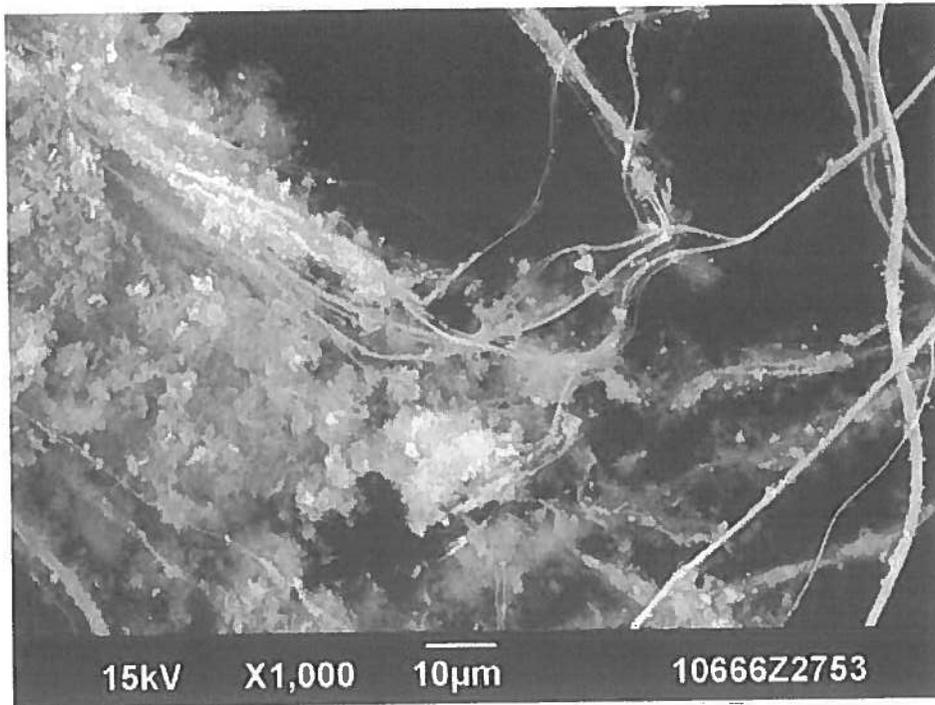
Figure 3. Scanning electron micrograph of chrysotile asbestos fibers and binder detected during analysis of insulation sample "BULK-OL-CHM4-ER2" (MVA Z2753).

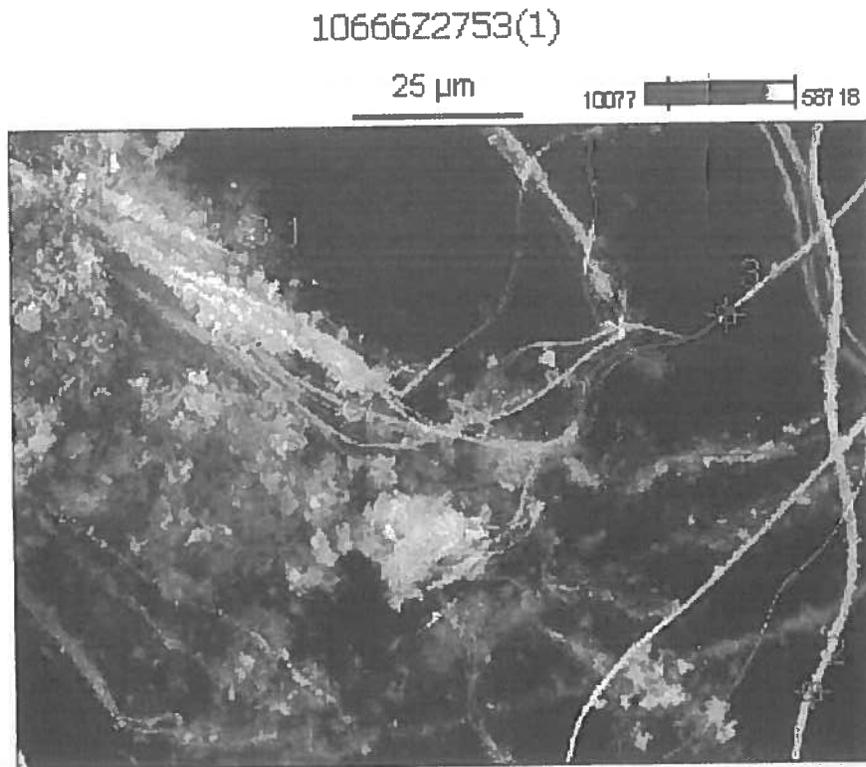
Figure 4. Insulation sample "BULK-OL-CHM4-ER2" (MVA Z2753). Same area as Figure 3. Numbers denote areas where EDS spectra were collected.

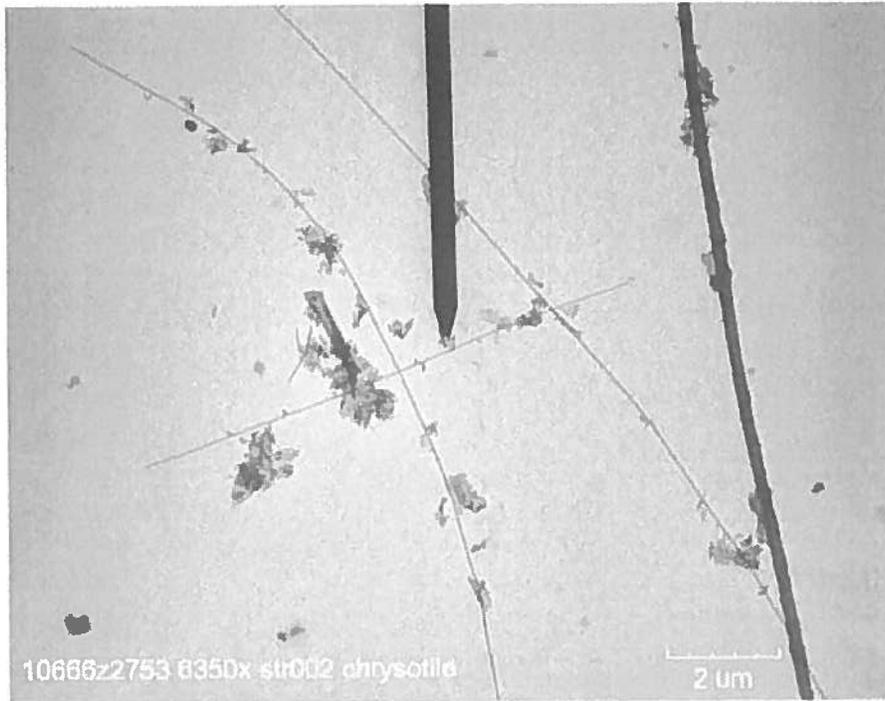
Figure 7. TEM image (above) and EDS spectrum (below) of representative chrysotile asbestos fiber detected during analysis of insulation sample "BULK-OL-CHM4-ER2" (MVA Z2753).

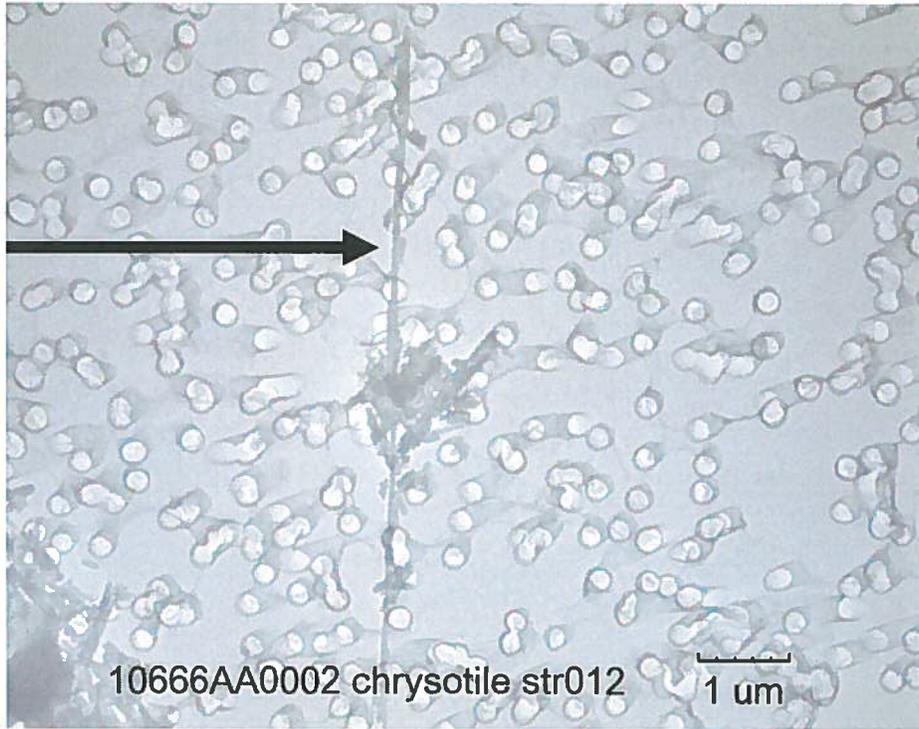
The analytical results of sample D-M-5-ER1 are summarized along with previously reported results in Table 1. Figures 1 and 2 provide a representative TEM image and EDS spectrum of some of the 75,000,000 chrysotile asbestos structures per square centimeter detected during analysis of sample D-M-5-ER1. Figures 3 through 5 show TEM images and EDS spectra representative of the 290,000,000 chrysotile asbestos structures per square centimeter detected during analysis of sample D-4-17-ER3. It was noted during analysis that lizardite particles were also present in both analyzed samples D-M-5-ER1 and D-4-17-ER3 (Figure 6). All of the serpentine particles (lizardite and chrysotile fibers) analyzed by EDS contain minor/trace amounts of iron and/or aluminum. TEM count sheets are included in the Appendix. No asbestos fibers were detected in the laboratory blanks and field blank.

Figure 1. TEM image of chrysotile fiber observed in microvac sample D-M-5-ER1 (MVA AA0002).

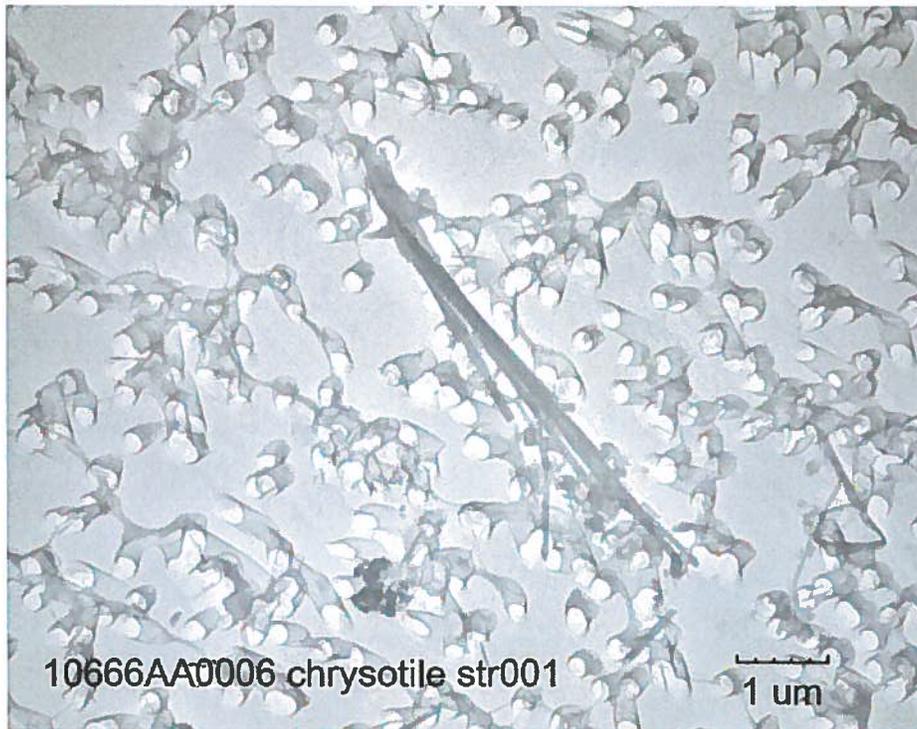
Figure 3. TEM image of chrysotile bundle observed in microvac sample D-4-17-ER3 (MVA AA0006).

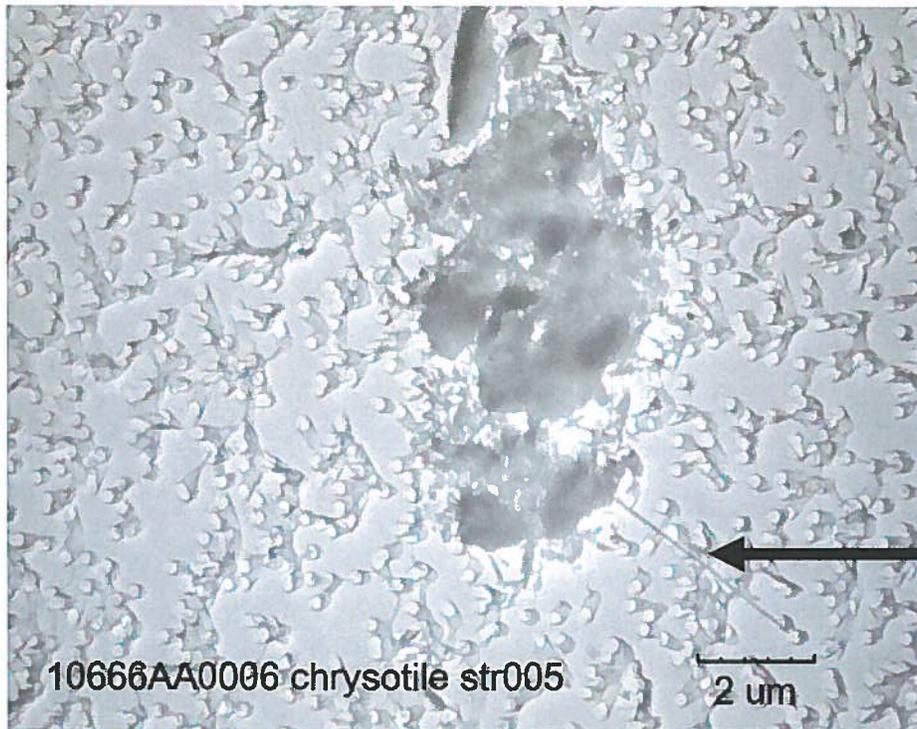
Figure 5. TEM image of chrysotile (indicated by arrow) and matrix (lizardite) observed in microvac sample D-4-17-ER3 (MVA AA0006).

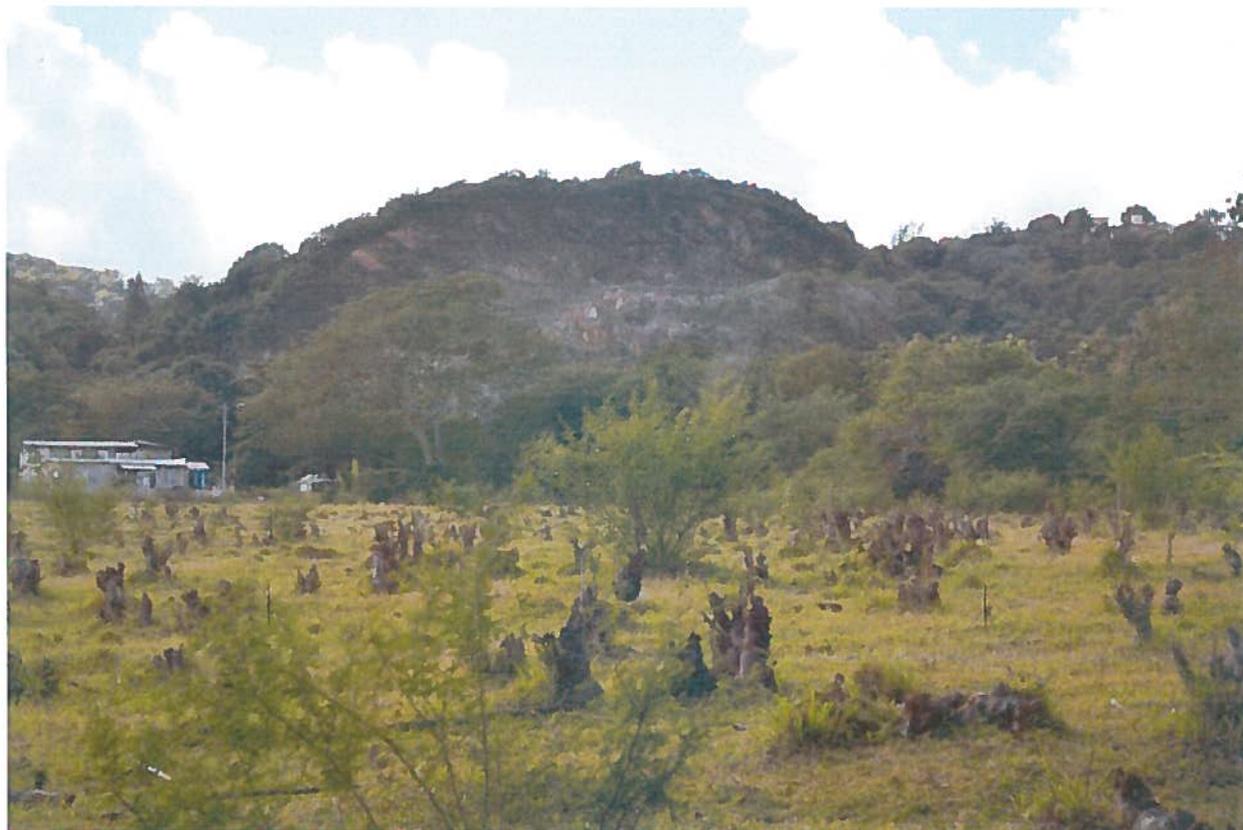
Serpentinite gravel containing Serpentine minerals was used extensively in the roads and parking lots construction. Serpentinite gravel was used for the secondary roads even within the facilities of Olefins, as well as in many surrounding areas (e.g. parking lot south of the bus station at intersection of roads 285 and 384, see Figure 33).

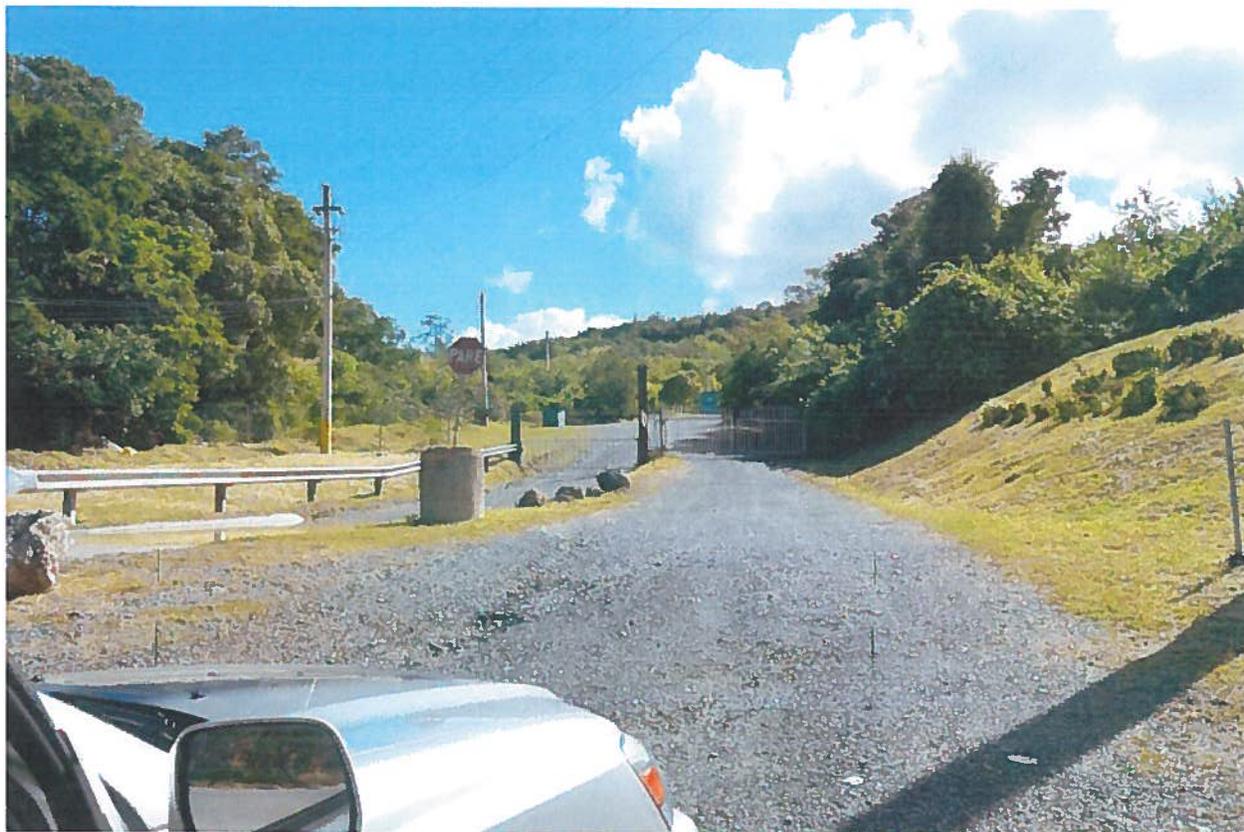
Figure 33. Aggregates containing serpentinite rocks used on the secondary road inside Olefins facility (left) and on a fenced parking lot, south of the bus stop station located at intersection of state Roads 385/384.

Micro-vacuuming sampling of dust was conducted on the main road, in front on entrance to quarry #17 (quarry Luis A. Gonzalez) located on route PR-121, Sector Cuatro Calles in Yauco (Figure 34). This quarry is active and it has both Environmental Quality Board (JCA) and DRNA permits. Dust sample (D-4-17-ER3) collected from the paved road front of the entrance shows asbestos Chrysotile concentration of approximately 290,000,000 str/cm² (see Appendix V-7 for results).

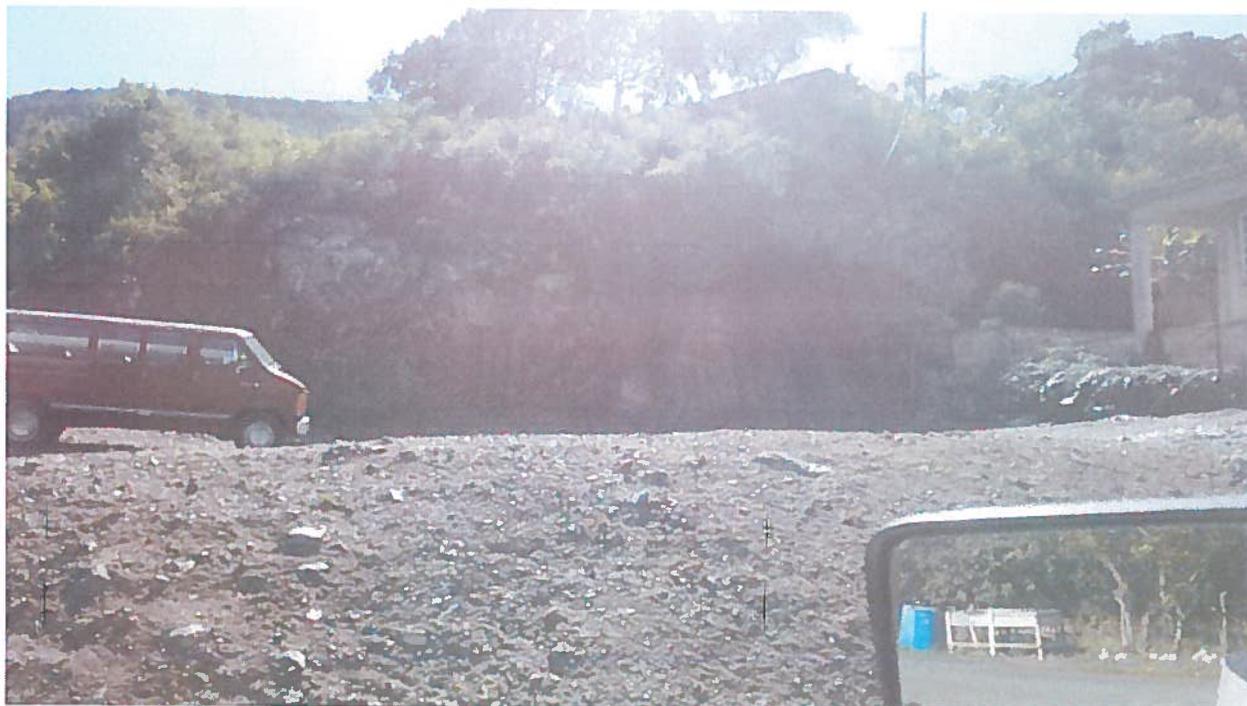
Figure 34. Front entrance to quarry #17 (Luis A. González) located on route PR-121 Sector Cuatro Calles in Yauco.

The composition of Chrysotile in both samples collected in front of quarries 5 and 17 is consistent with the Al-Fe concentrations identified before in the source rock. It was noted during analysis that Lizardite particles were also present in both samples. All of the serpentine particles (Lizardite and Chrysotile fibers) analyzed contain minor/trace amounts of iron and/or aluminum.
