DUST FINGERPRINTS FINDINGS AT OLEFIN SITE PENUELAS PUERTO RICO

Ady Padan, Ph.D, P.G.

Scope of Work

Fingerprint the various types of asbestos containing dust found within and outside the Olefin facility.

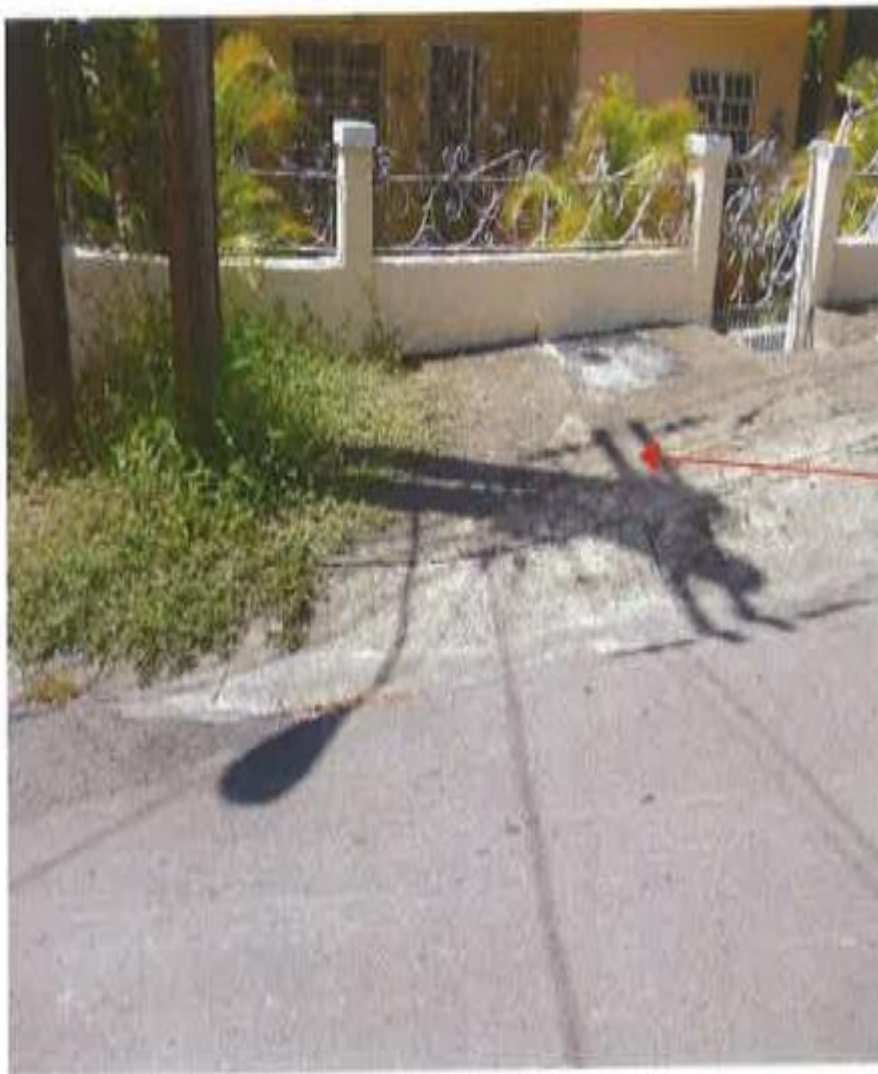
Sampling Point: D-TEC-P0018-C2-ER12

Tallaboa Encarnación Community

West of Street 2

**PLM image of a Lizardite particle detected during analysis of sample
D-TEC-P0018-CR-ER12
Dust, corner street 2, west of street 2, Tallaboa Encarnation Community**

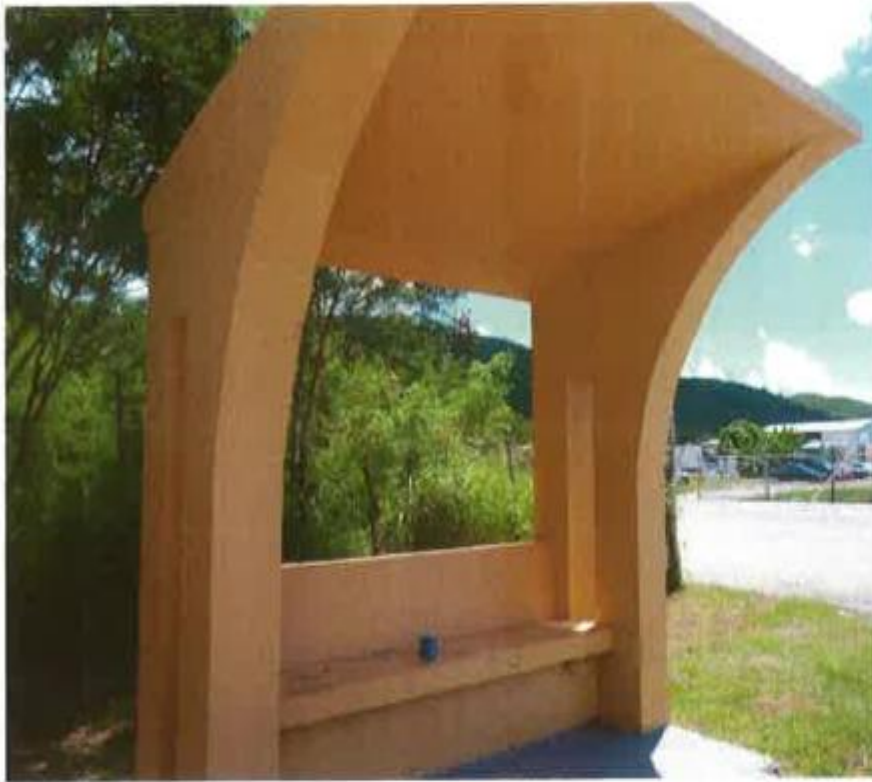
**North Side of Olefin
Intersection of Road 384-385
Bus Stop
General View**

SEM image of a Lizardite particle detected during analysis of sample D-NOW-P0036-BS-ER10 collected from the bus station at the intersection of State roads 384 and 385.

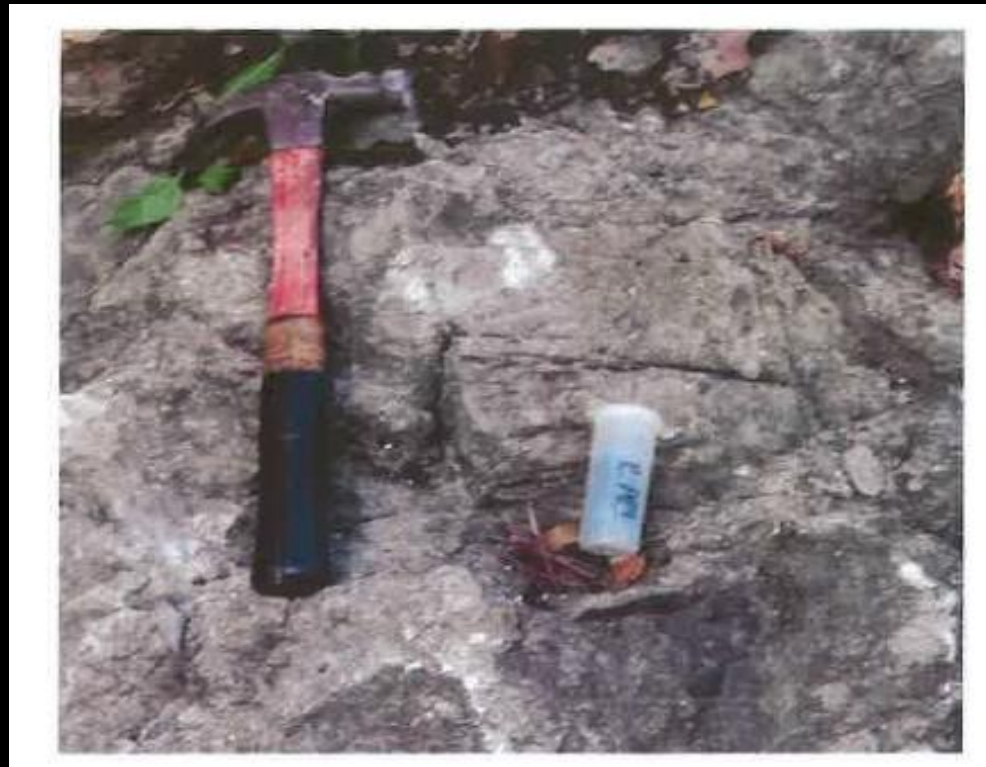
**Sampled area where serpentinite
rocks are exposed on the surface
Media Quijada (cut on the road)**

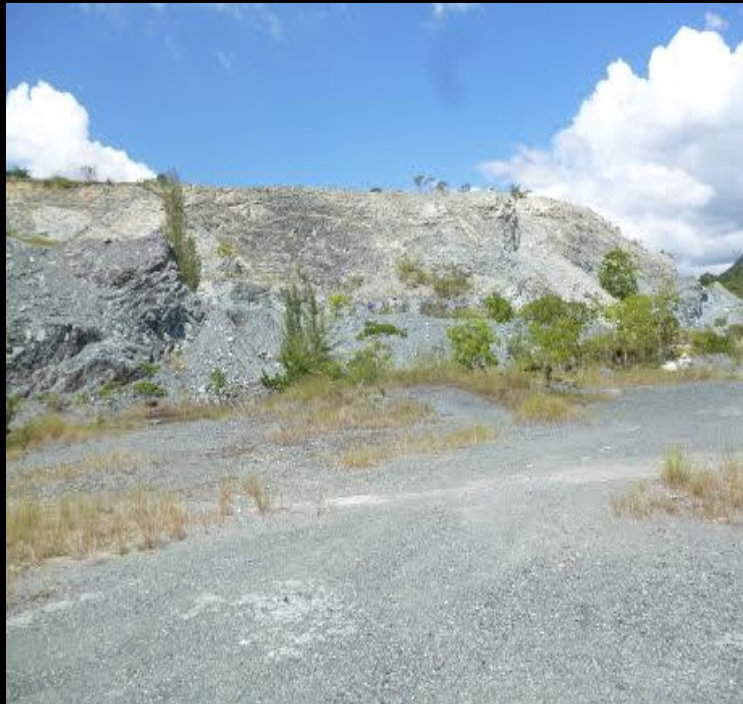
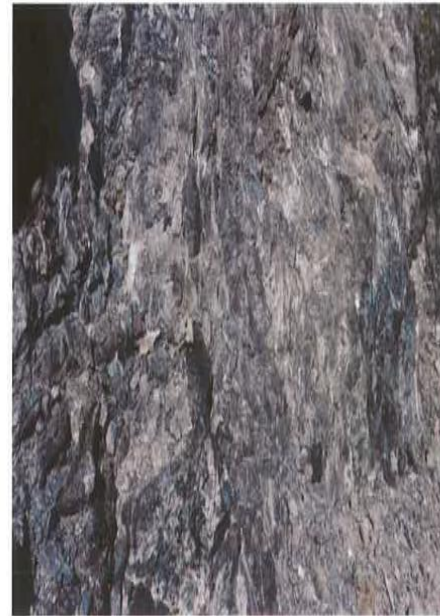
Serpentine from Quarry 1, Yauco
R-Q1-AP4

Sampled area where serpentinite rocks are exposed on the surface Yauco (quarry)

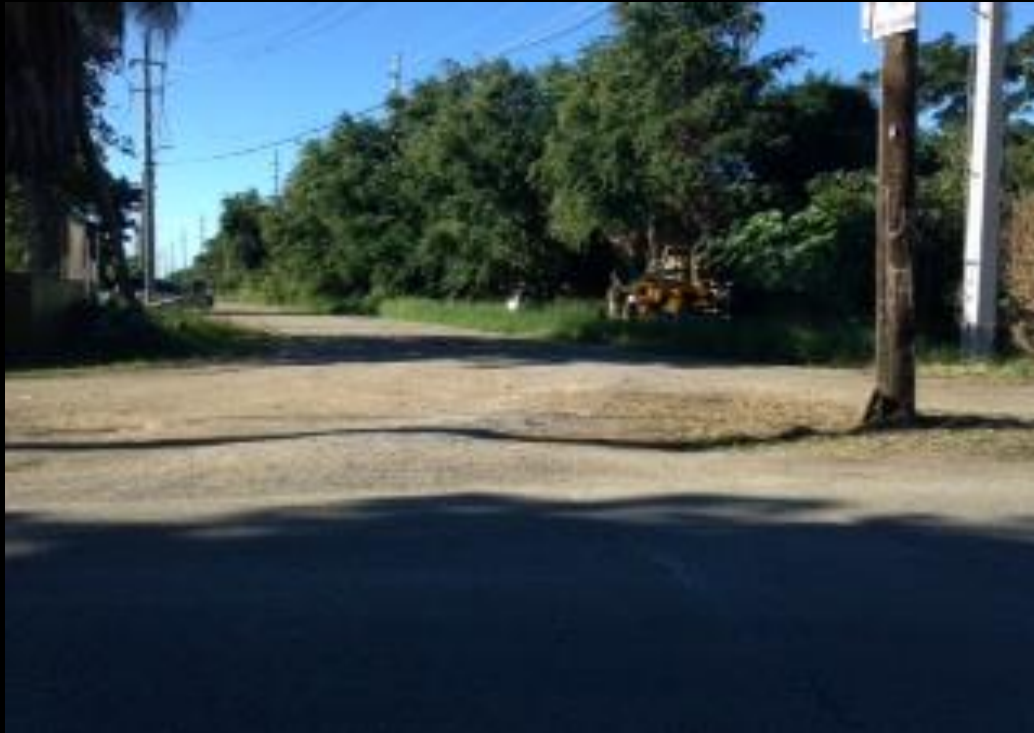
Dirt road south of road PR127

Results of aggregates samples

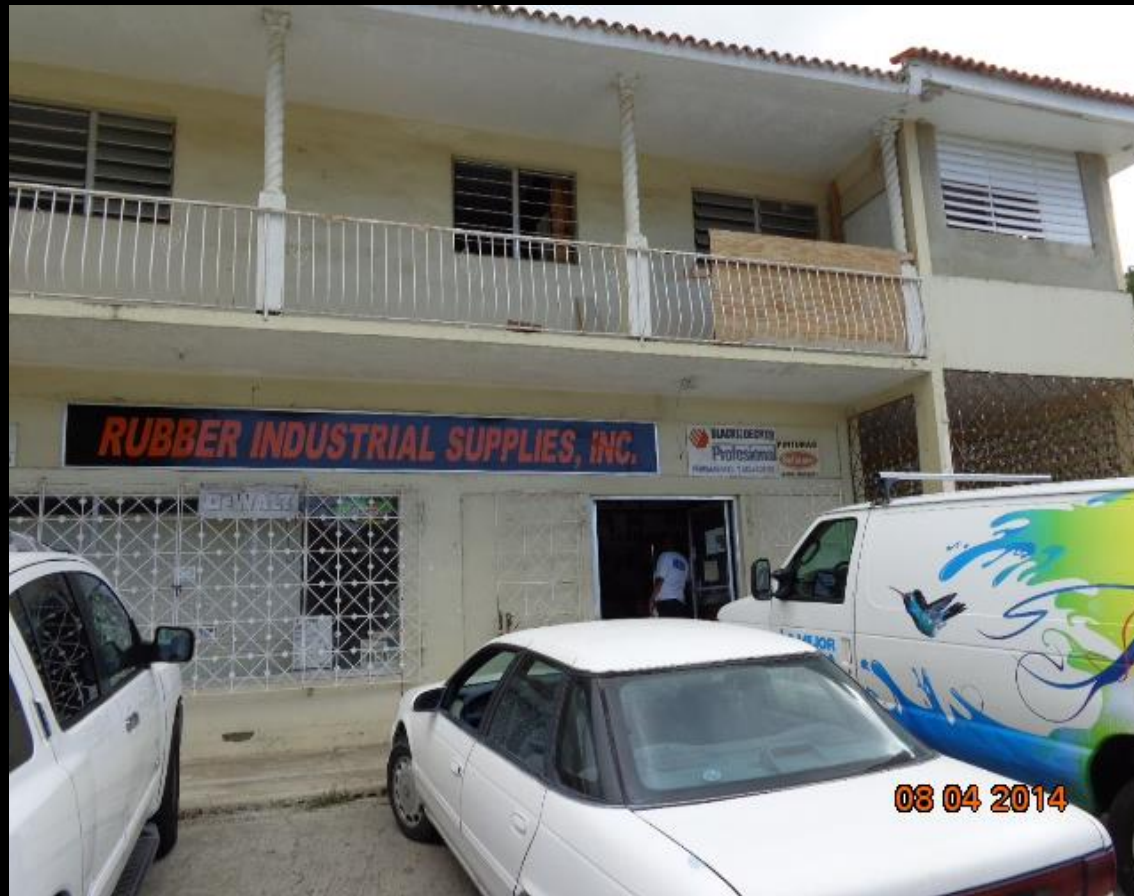
Property 0008-Encarnacion Community Tallaboa.

PACM Spray on Ceiling (stucco) on the first floor (exterior right/interior -left) ceiling-Property P0008 built in 1967. Second floor was under construction (Weston report Phase IV)

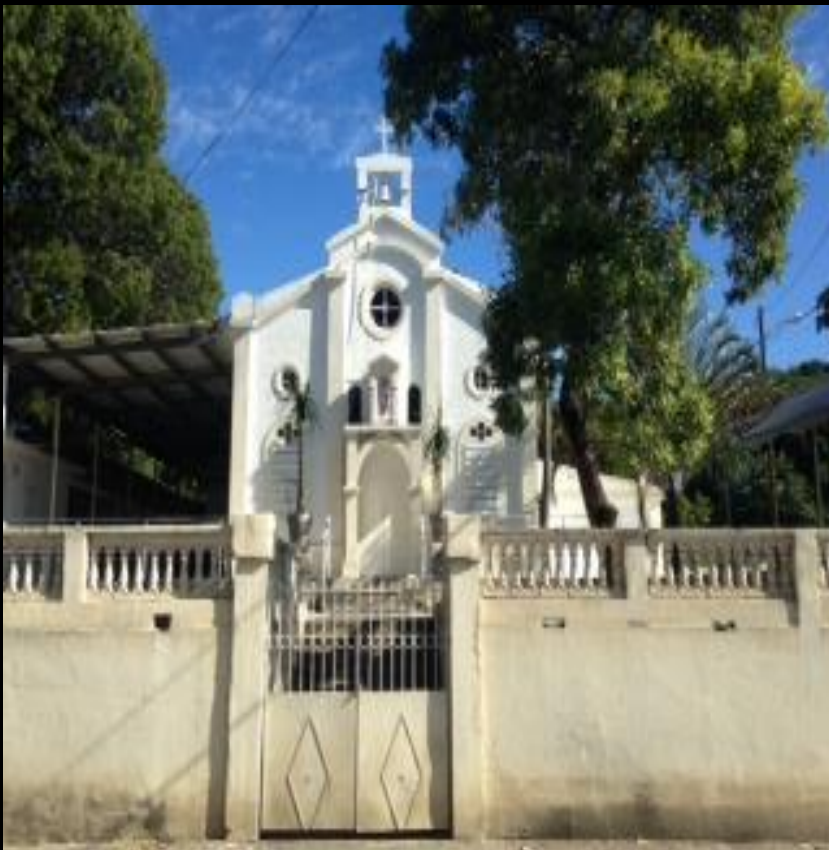
Front View

Church in Tallaboa Community, next to the school

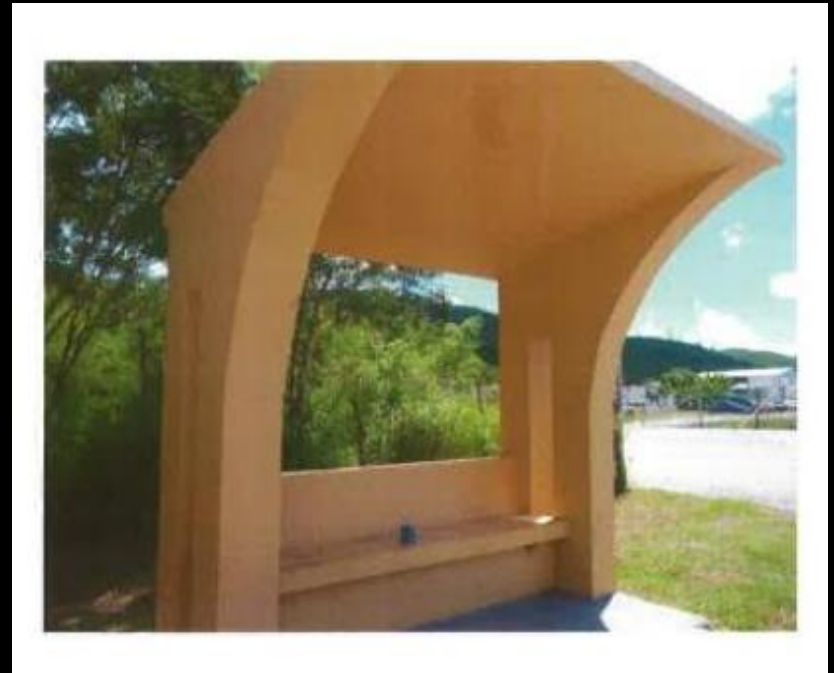
The Bus Stop Bench Sampling Experiment

Bus station is located at the intersection of state roads PR-385 and PR-384, about 1.6 miles north-west of site (see Appendix I for sampling points locations).

Table 1. Summary of Bus Stop Bench Samples. Unless otherwise specified results (str/cm²) are Chrysotile fibers.
