**FIFTH FIVE-YEAR REVIEW REPORT FOR
COAST WOOD PRESERVING SUPERFUND SITE
MENDOCINO COUNTY, CALIFORNIA**

USACE, Seattle District

**U.S. Environmental Protection Agency
Region IX**

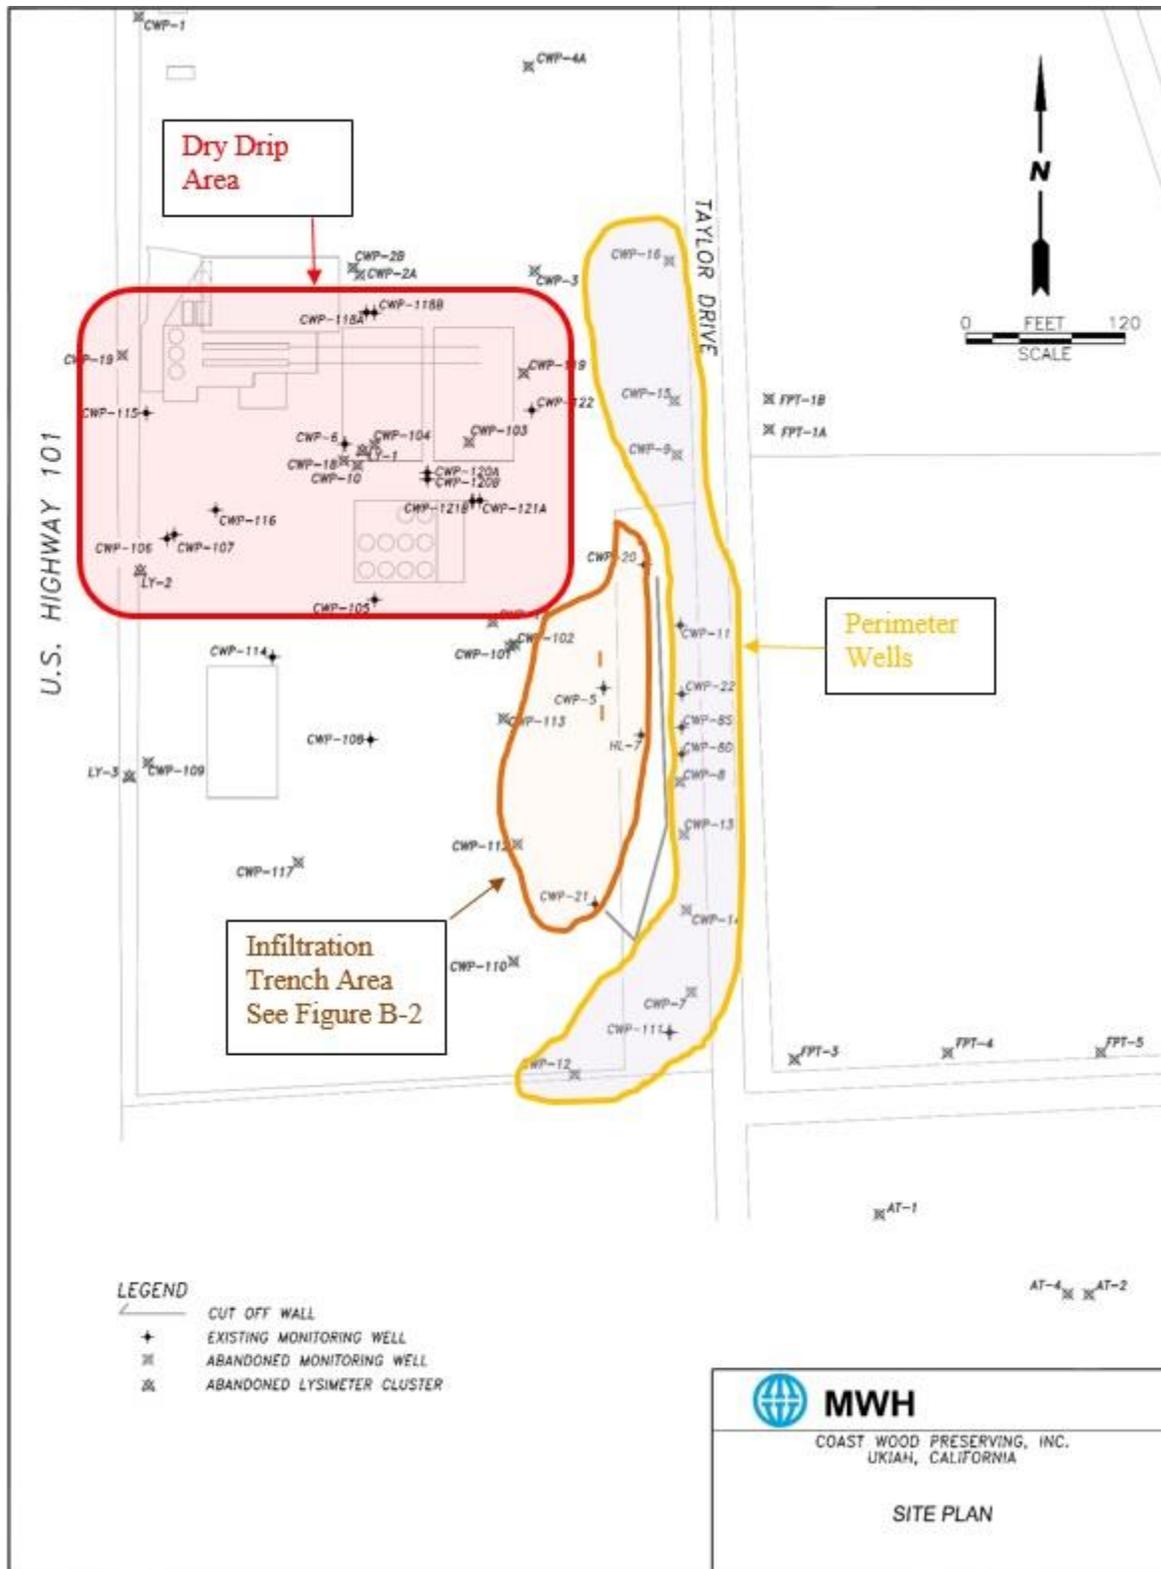
Figure 2: Well Location Map

The Dry Drip Area contains one total chromium plume centered at the southeast area of the Former Tank Farm Area (CWP-116) and one hexavalent chromium plume located near the canopies east of the retort tanks (CWP-118B). Statistical analysis indicate that these plumes are stable in size; however, the concentrations in these wells have fluctuation over the past five years. There are no exceedances above the cleanup level for arsenic in this area within the past five years. However, there were results from several wells with arsenic concentrations above the new MCL (see Table B-1). In the area just south of canopies (CWP-120a), elevated concentrations of arsenic have been noted in the past. Typically, wells with elevated arsenic have been within 20 feet of an injection transect, which most likely has contributed to the elevated concentrations of arsenic. Well CWP-120A is located near the most recent injection which occurred in 2010. It is expected that, in the next 5 years, the concentrations of arsenic will decline and not migrate off site as arsenic precipitates.

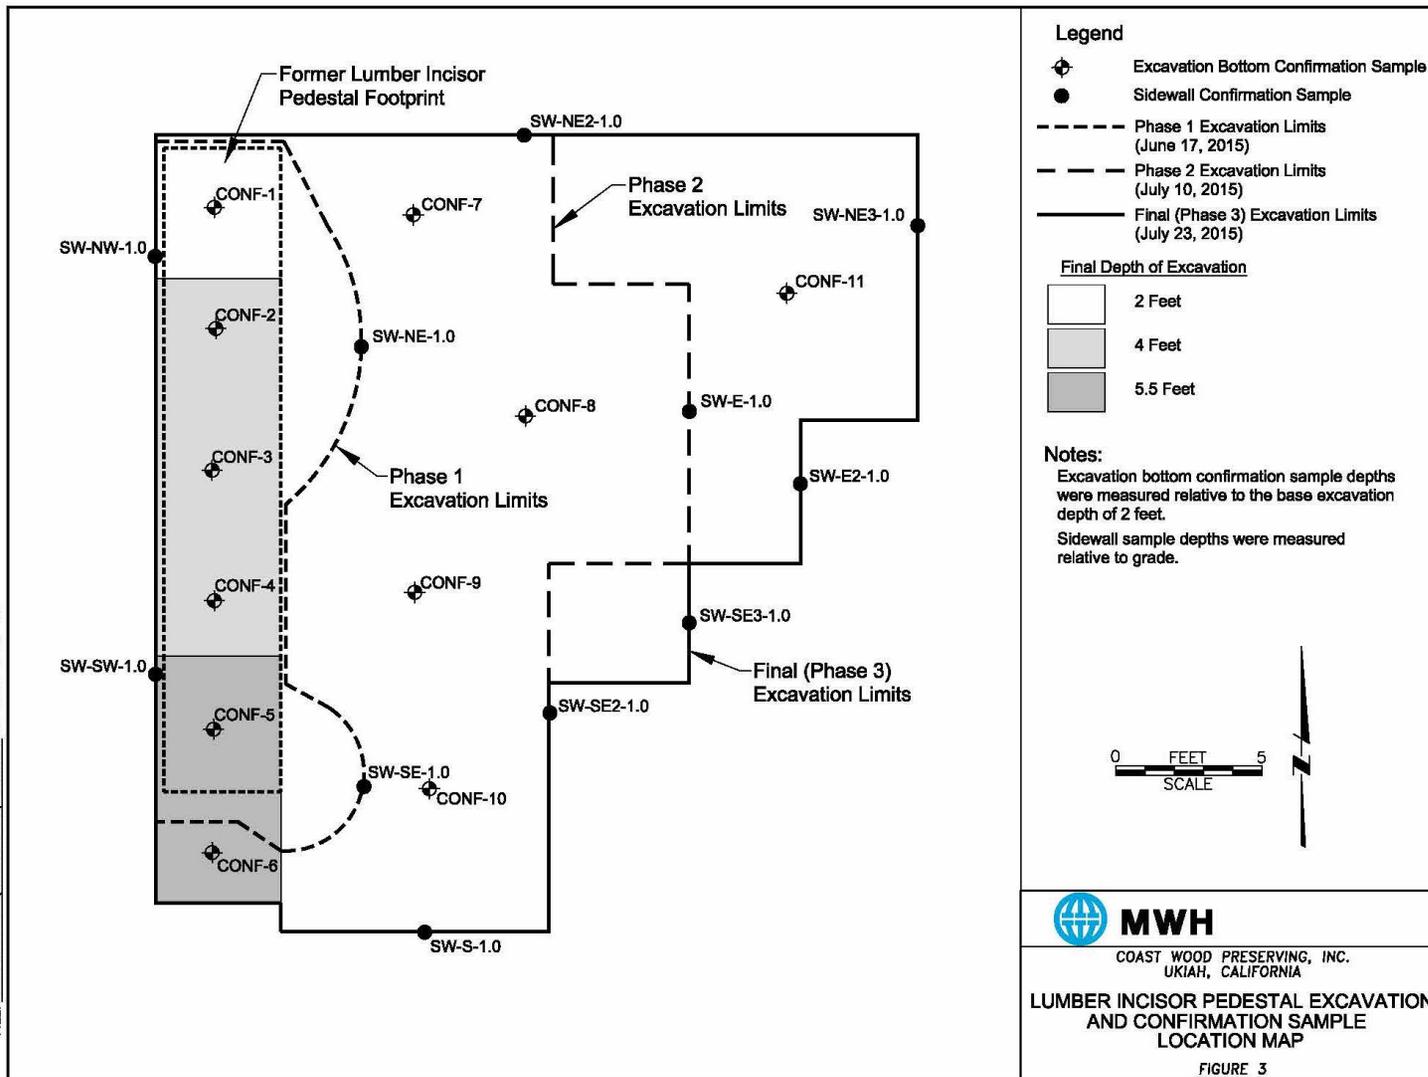
Figure B-17: Excavation Footprint, 2015

In 2015, approximately 42 cubic yards of contaminated soil was removed from the Site during the demolition of a concrete pedestal that once held a lumber incisor (Figure B-16 and Figure B-17). The soil was excavated to soil cleanup goals established for the Site as detailed in the 2003 Explanation of Significant Differences (DTSC, 2003).
