CH2M HILL  
155 Grand Avenue  
Suite 800  
Oakland, CA 94612  
Tel 510.251.2888  
Fax 510.622.9000

October 31, 2014

Subject: Additional Vapor Intrusion Evaluation Report, June/July 2014, Former Synertek Building No. 1, 3050 Coronado Drive, Santa Clara, California, Final Site Cleanup Requirements Order No. 91-051

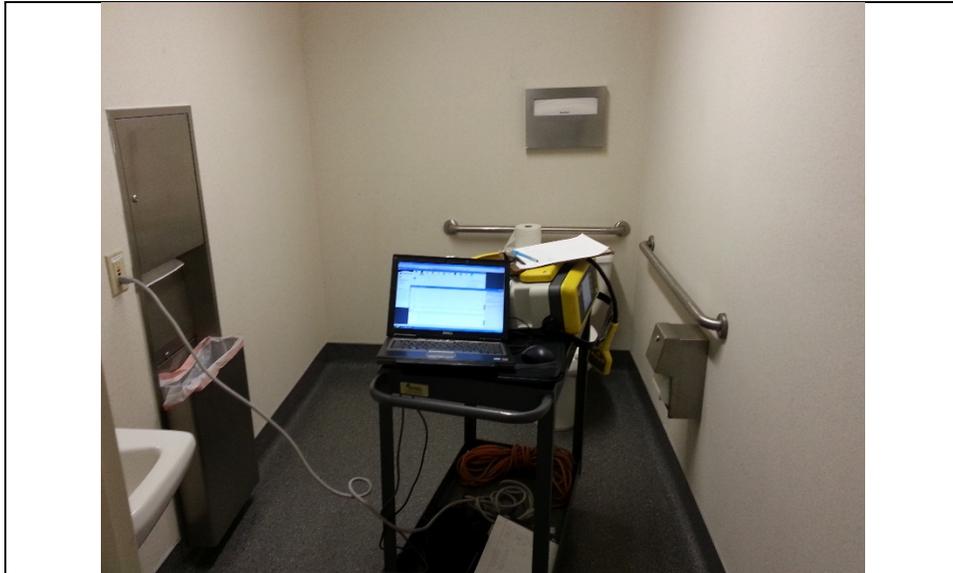
<b>Photo No.</b>	2	<b>Date</b>	07/05/14	<b>View Direction</b>	East
------------------	---	-------------	----------	-----------------------	------

Interior of Crystal Solar men's bathroom at North end of building

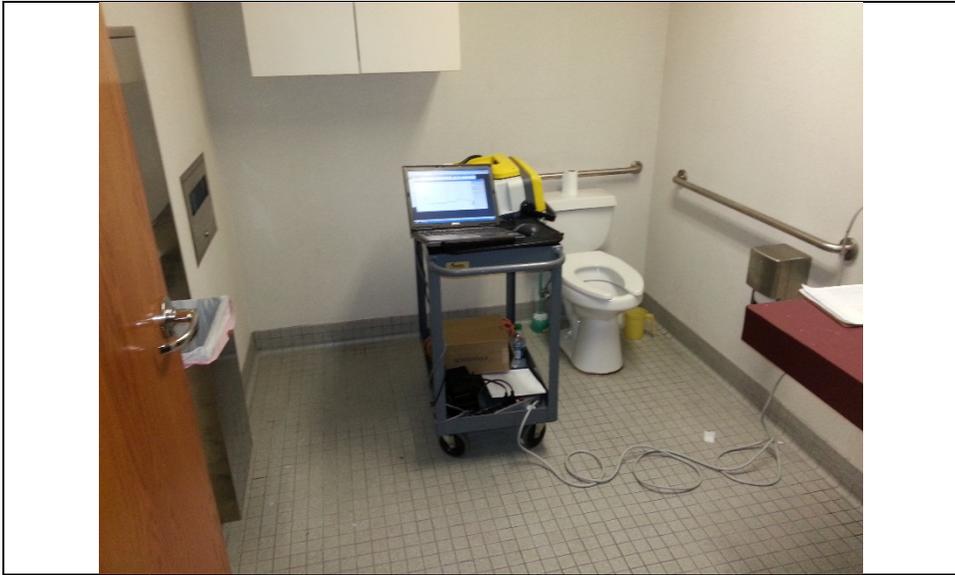
<b>Photo No.</b>	13	<b>Date</b>	07/05/14	<b>View Direction</b>	West
------------------	----	-------------	----------	-----------------------	------

Men's bathroom within Family Prayer House

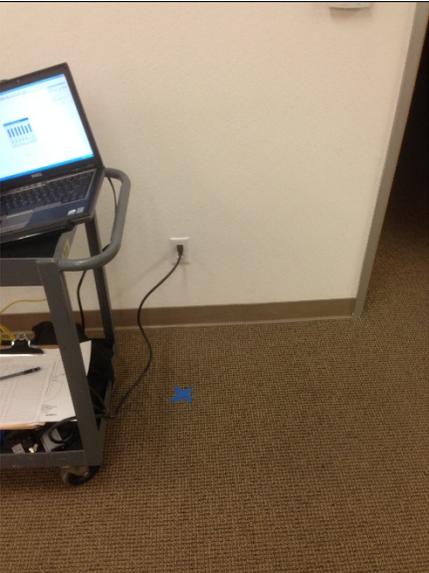
<b>Photo No.</b>	16	<b>Date</b>	07/05/14	<b>View Direction</b>	East
------------------	----	-------------	----------	-----------------------	------

Sanctuary within Family Prayer House

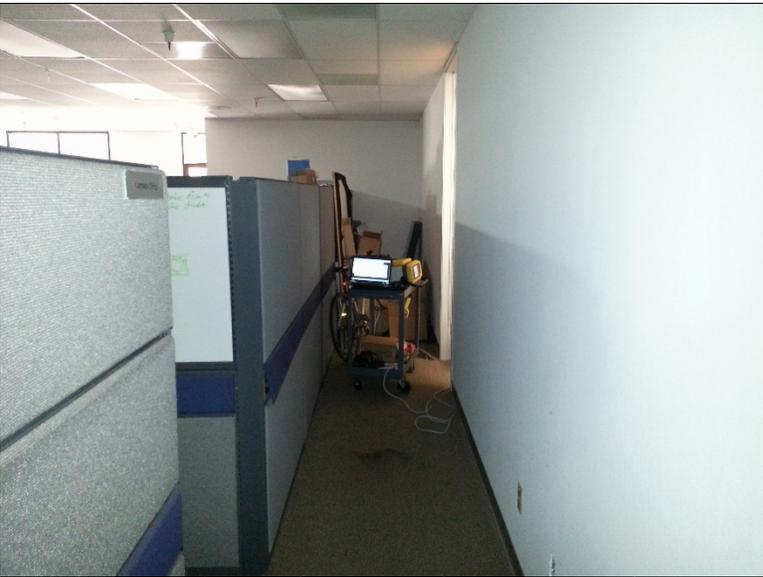
<b>Photo No.</b>	17	<b>Date</b>	07/05/14	<b>View Direction</b>	South
Office area northwest of reception
