**FOURTH FIVE-YEAR REVIEW REPORT FOR**  
**LIQUID GOLD OIL CORPORATION SITE**  
**CONTRA COSTA COUNTY, CALIFORNIA**

U.S. Army Corps of Engineers, Seattle District

U.S. Environmental Protection Agency  
Region IX  
San Francisco, California

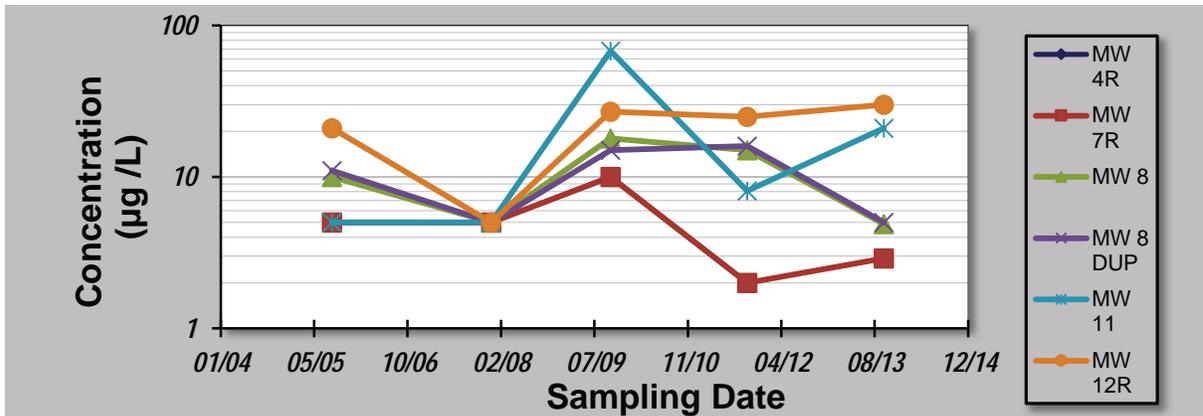
Figure 4: Chromium Trends

Trend analyses (Figure 4 through 9) for dissolved metals were performed using historical data from 2005 onward, including the biennial monitoring events performed in 2011 and 2013. The trend analyses used the Mann-Kendall methodology. The analyses suggested that metal concentrations are either stable or show no increasing or decreasing trend except for mercury at MW 11.
