**FIVE-YEAR REVIEW REPORT FOR
SOUTH BAY ASBESTOS SUPERFUND SITE
SANTA CLARA COUNTY, CALIFORNIA**

U.S. Environmental Protection Agency

Five-Year Review Summary Form

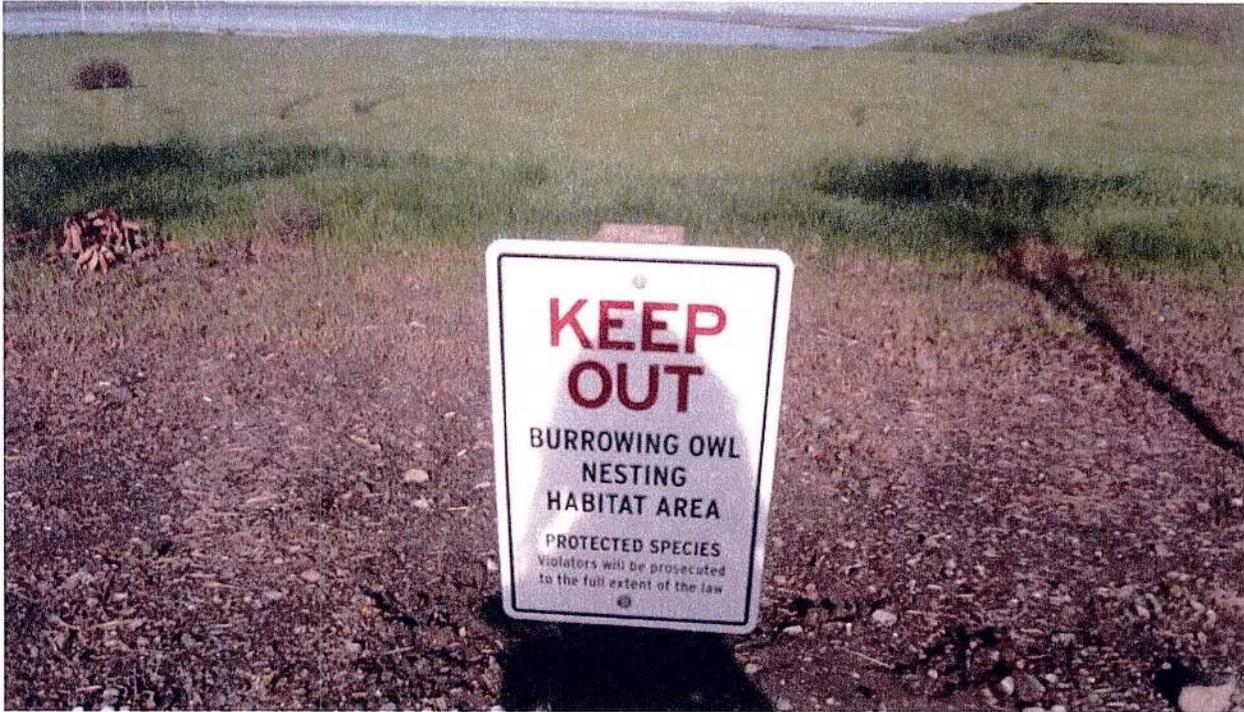
Legacy America Center Photograph 1: Taken facing north/northwest. Most of the signs observed are located in the north and west areas of the site just outside of the parking lot in the open space preserve area.

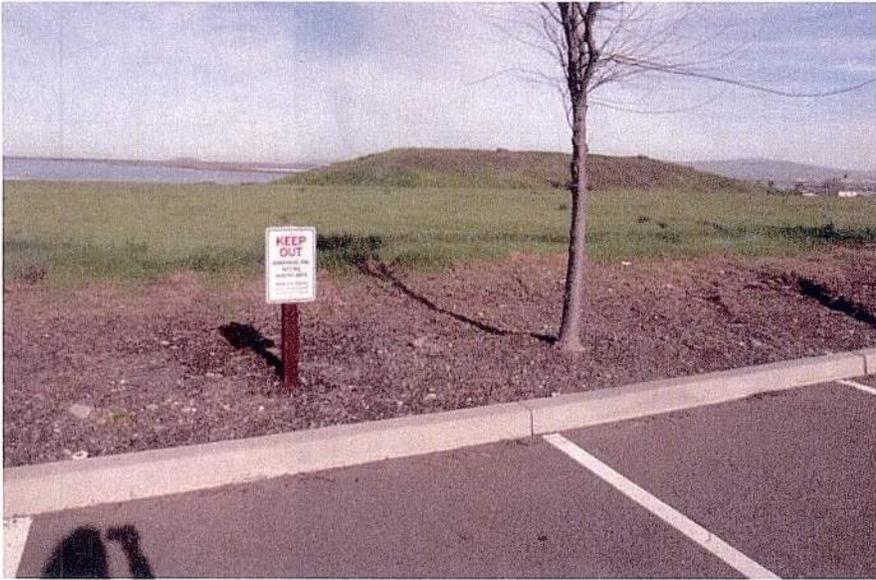
Legacy America Center Photograph 2: Taken facing north/northwest. Vegetated mounds 1 and 2 are landfill features that are located in the open space preserve area in the background.

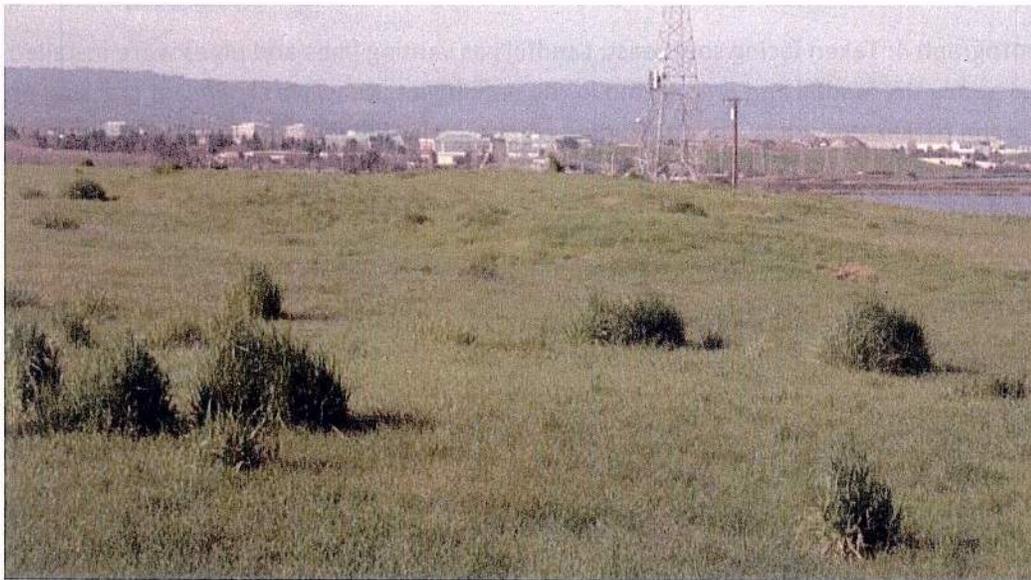
Legacy America Center Photograph 3: Taken facing west. Additional material formed into mounds has been installed on top of the cap in the open space preserve area to provide foraging and nesting habitat for burrowing owls.

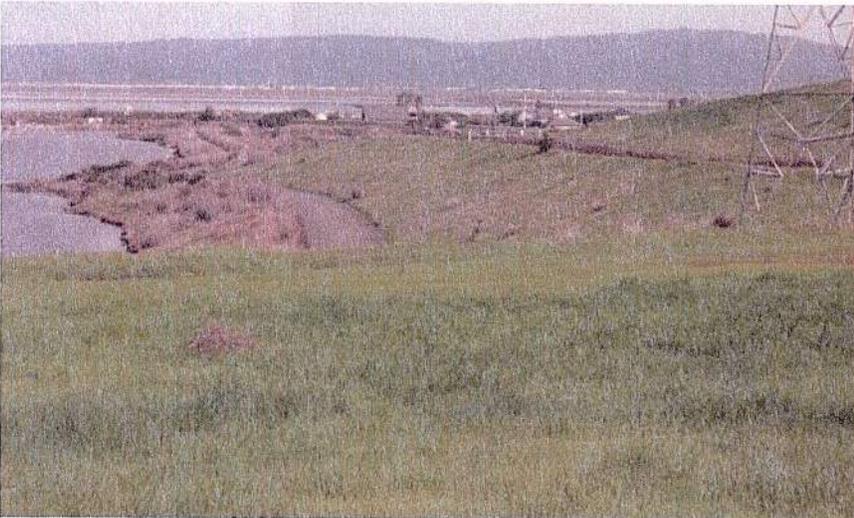
Legacy America Center Photograph 5: Taken facing north. Both gates that provide access to the open space preserve area were locked. This photo also shows the side slopes of the Marshland Landfill that face the salt ponds.

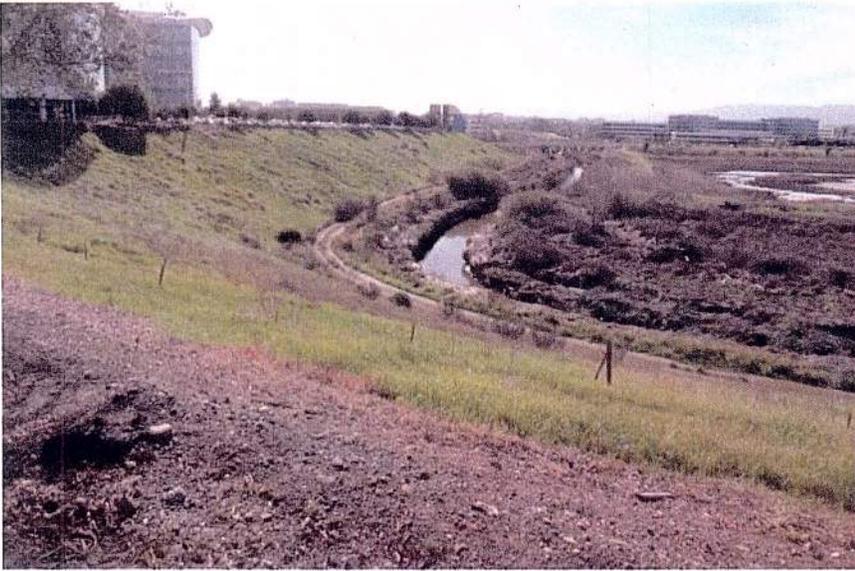
Legacy America Center Photograph 6: Taken facing southwest. This is the side slope of the landfill that faces the San Tomas Aquino Creek behind Buildings 1 and 2.

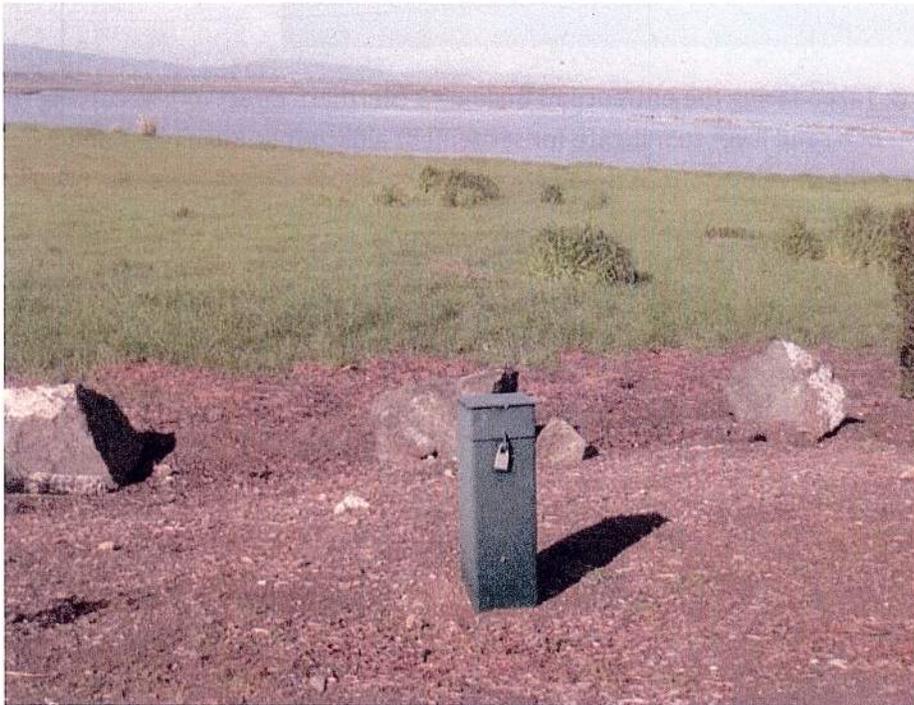
Legacy America Center Photograph 7: Taken facing northwest. This is one example of the locked groundwater monitoring wells observed throughout the property.

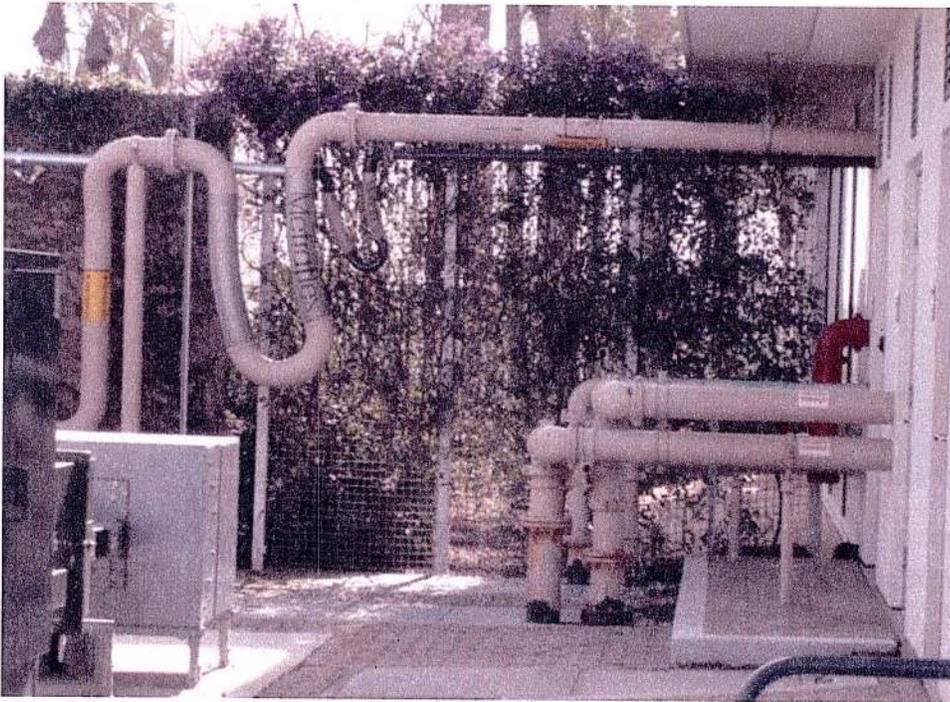
Legacy America Center Photograph 9: Utility connections for Building 2. All utilities vaults, lines, and piping are installed in the overlying material above the landfill. Mark Wheeler indicated that the flexible utility connections to each building prevent negative impacts to utilities due to settlement.

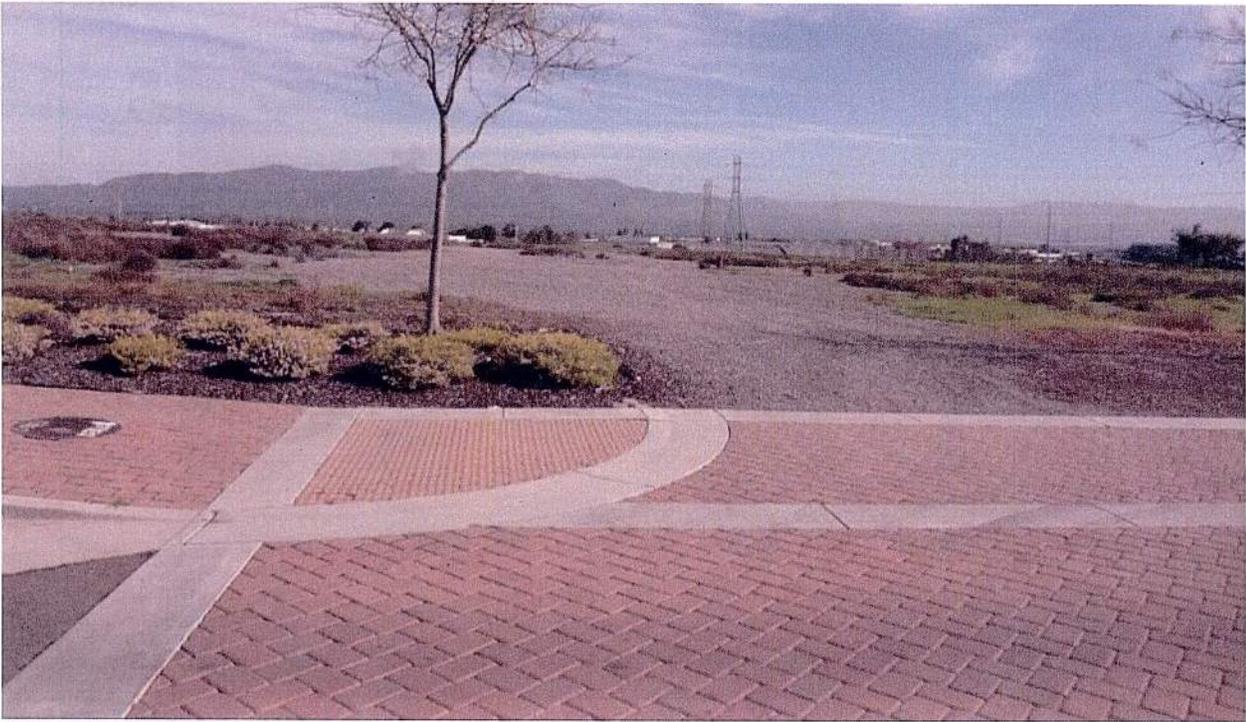
Legacy America Center Photograph 10: Taken facing east. This is an inactive area designated for the Phase II development for the Legacy America Center.

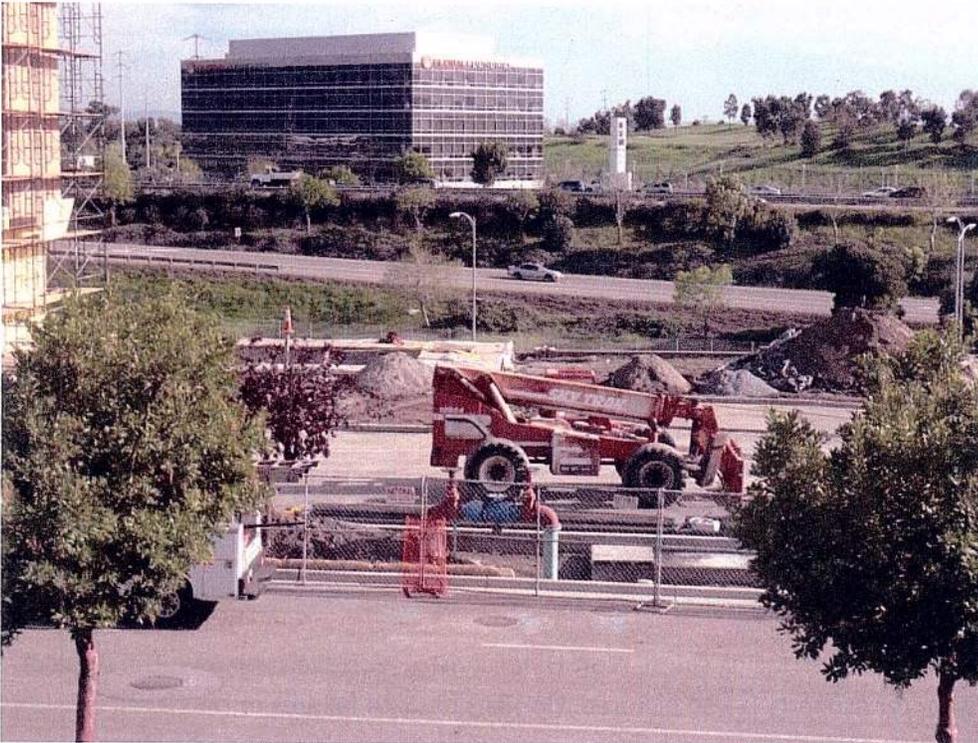
Legacy America Center Photograph 11: Taken facing south. Aloft Hotel construction site overview.

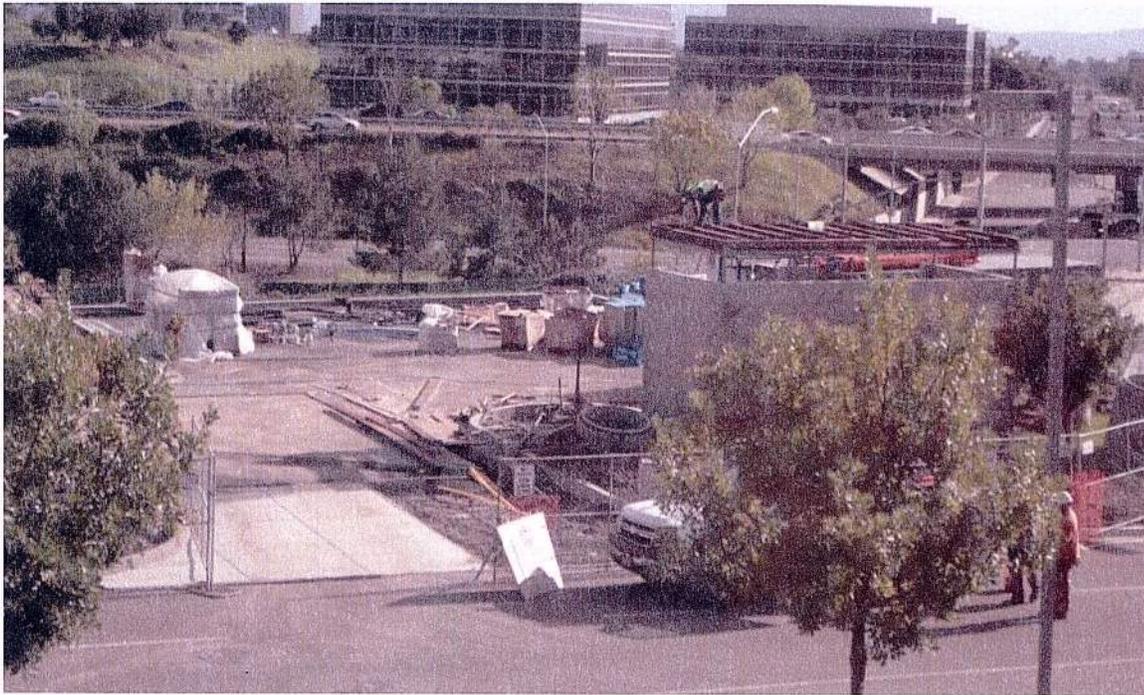
Legacy America Center Photograph 12: Taken facing south. Aloft Hotel construction site overview.

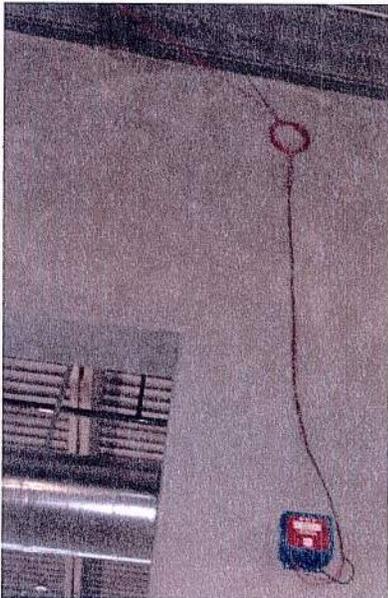
Bixby Technology Center Photograph 2: This is an example of the methane sensors that are equipped with an alarm system installed on the first and second floor of Buildings 2100, 2130, and 2150. This photograph was taken at the first floor of in Building 2100.

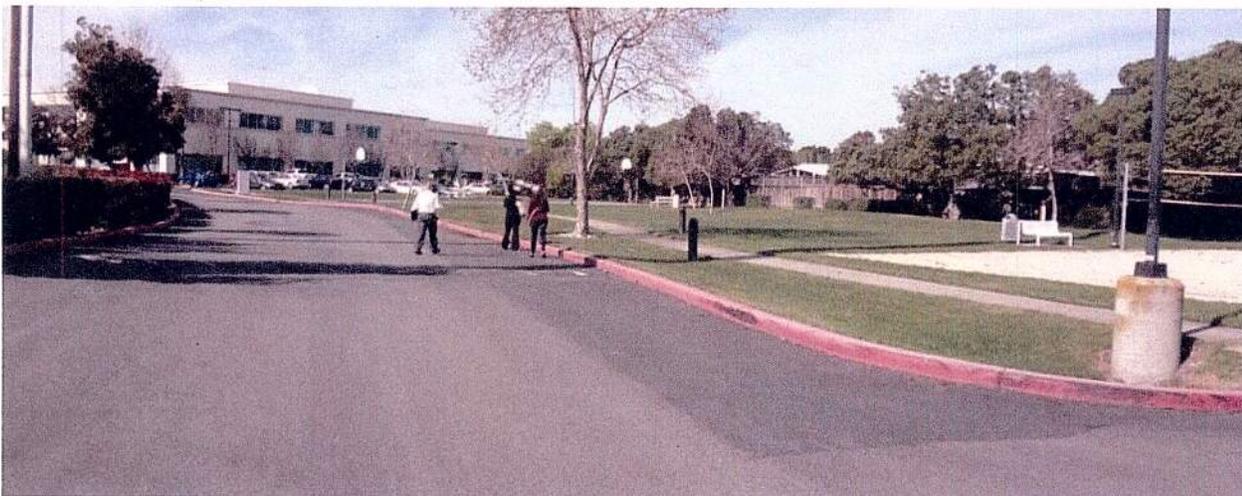
Bixby Technology Center Photograph 4: Taken facing west. The recreation area is located between buildings 2150 and 2160. The recreation area has a sand volleyball court, paved basketball court, and elevated area (resembles a small mound) between the volleyball and basketball courts.

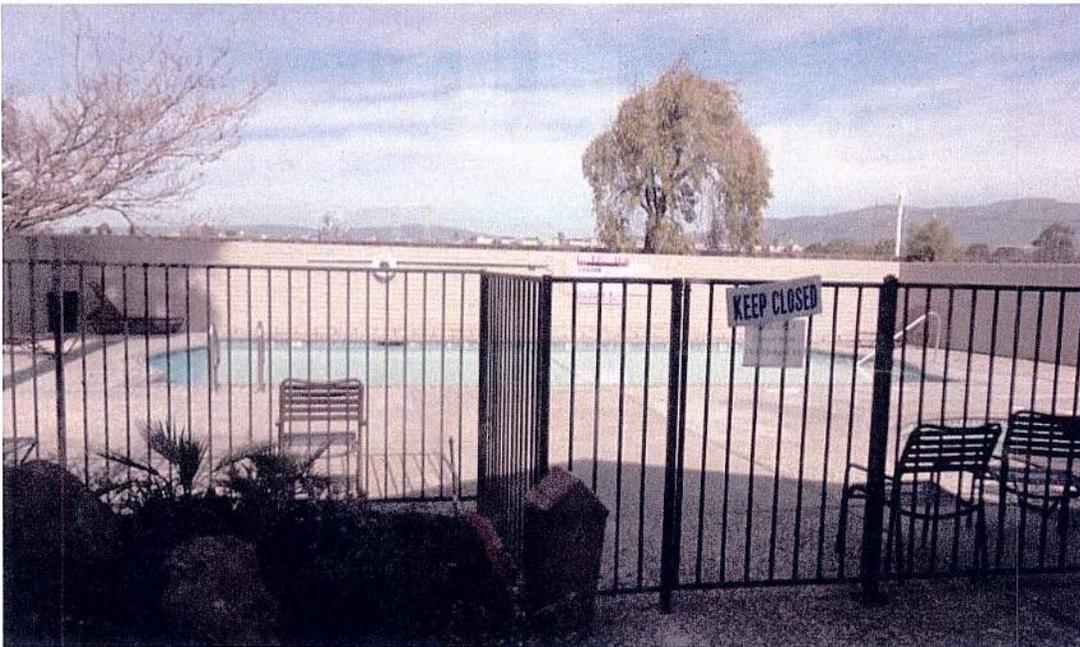
Summerset Mobile Home Estates Photograph 3: Taken facing north. There is a 4-foot deep pool located behind the Summerset Mobile Home Estates office.
