**SUBJECT: Contract Agreement 10-T1114
Cap Repair Summary Report
Brown and Bryant Inc., Site, Arvin, California**

CAP REPAIR SUMMARY REPORT

**BROWN & BRYANT, ARVIN FACILITY
SUPERFUND SITE, FIRST OPERABLE UNIT
REMEDIAL ACTION**

ARVIN, CALIFORNIA

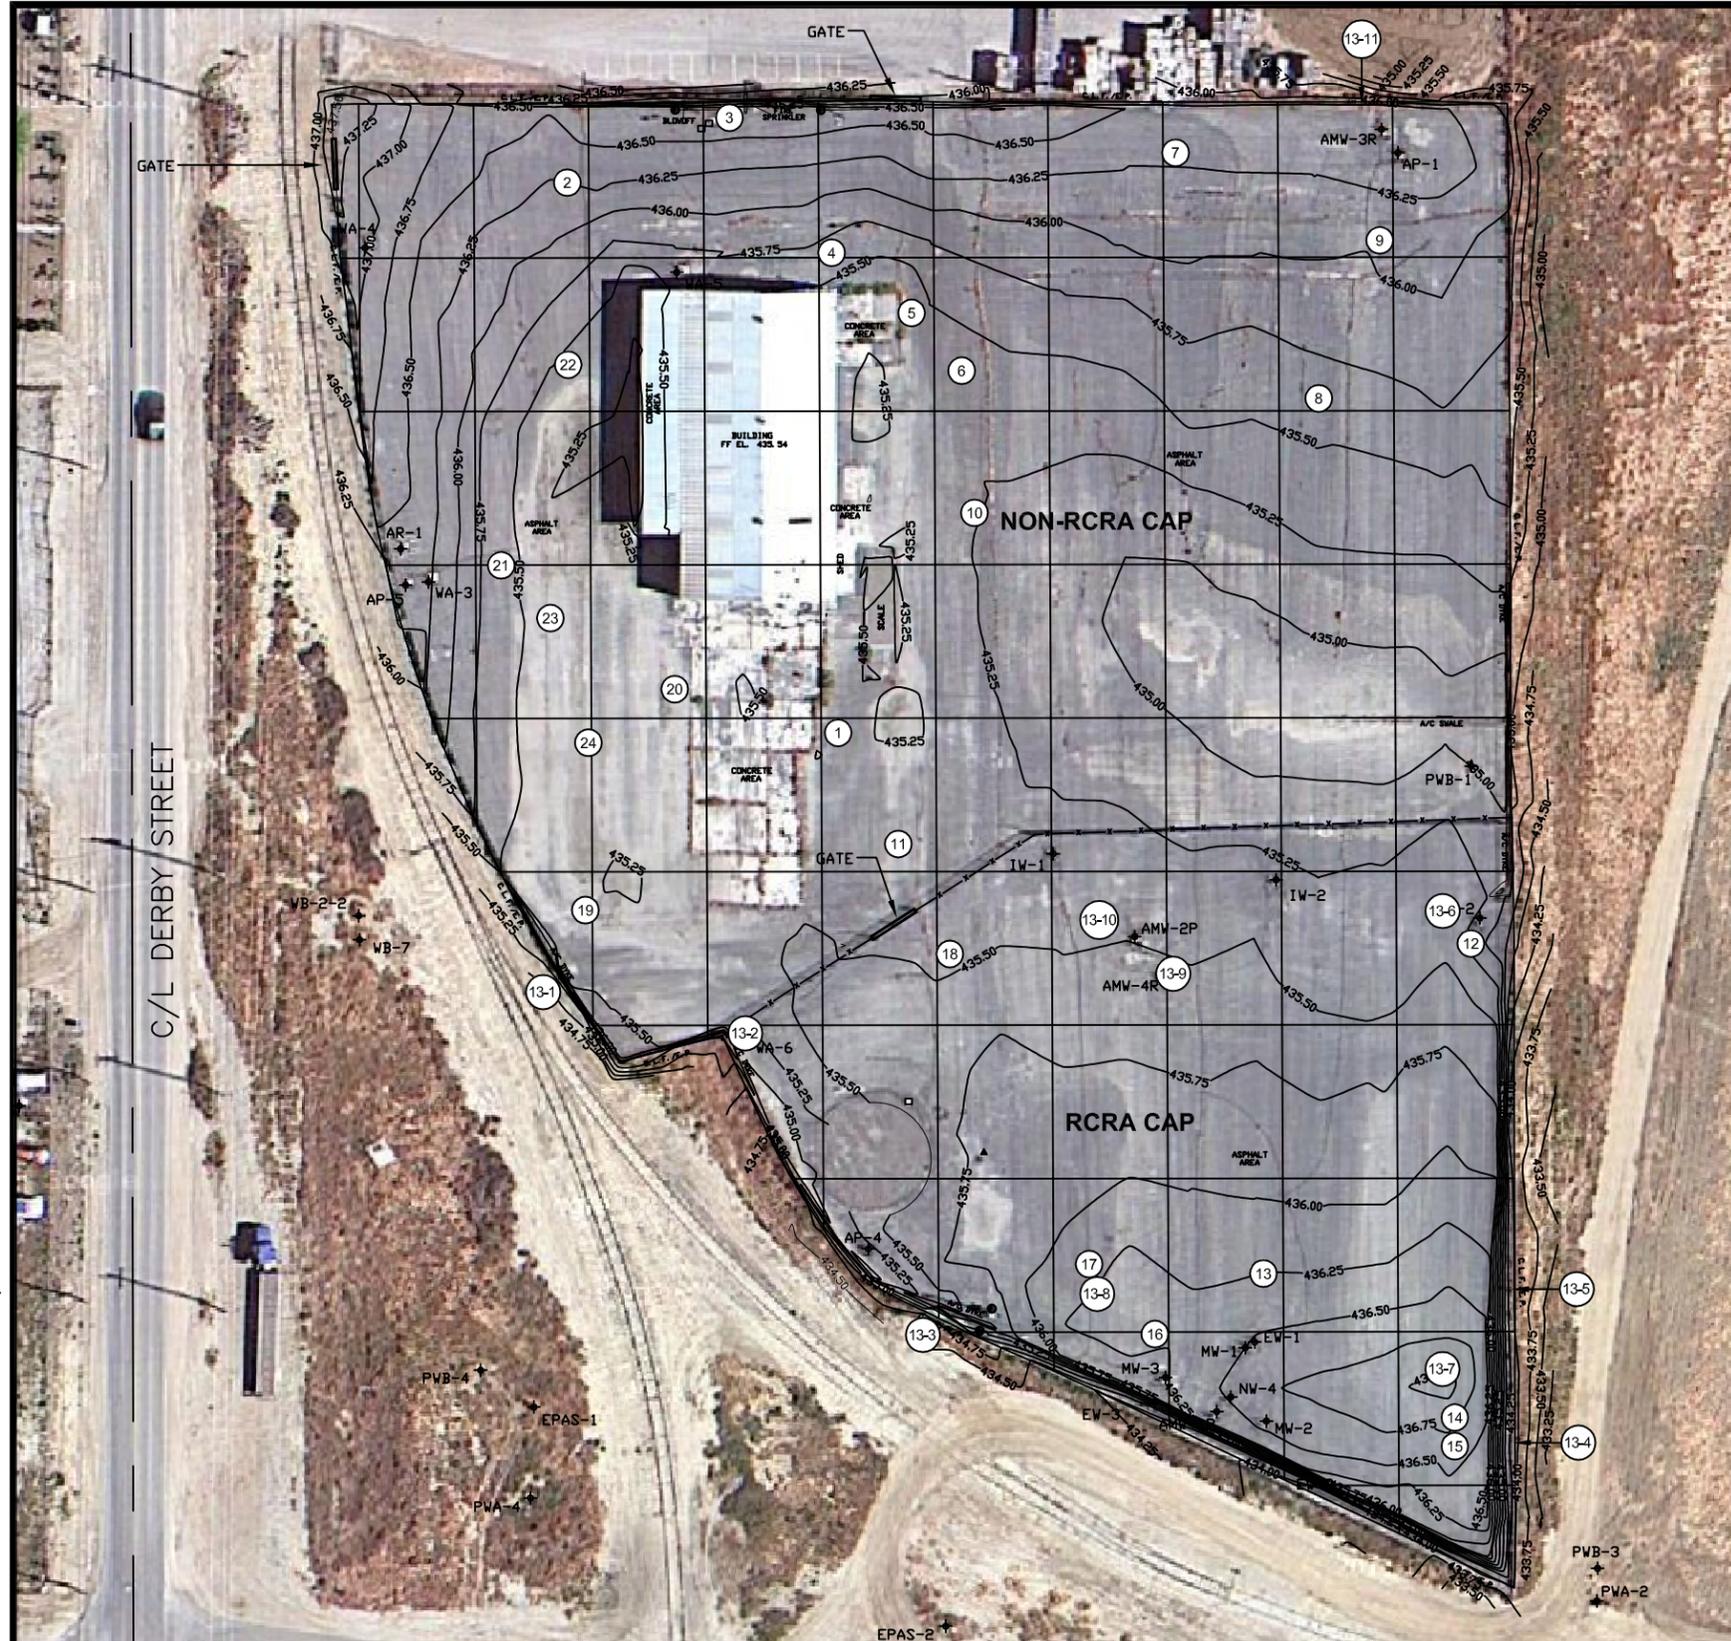
INSPECTION FINDINGS ON 20 MAY 2014

1. WEEDS GROWING THROUGH THE SEPARATION BETWEEN THE CONCRETE SLAB AND ASPHALT, SOUTH OF THE BUILDING ON THE NON-RCRA CAP. WEEDS ALONG EAST FACING FENCE.

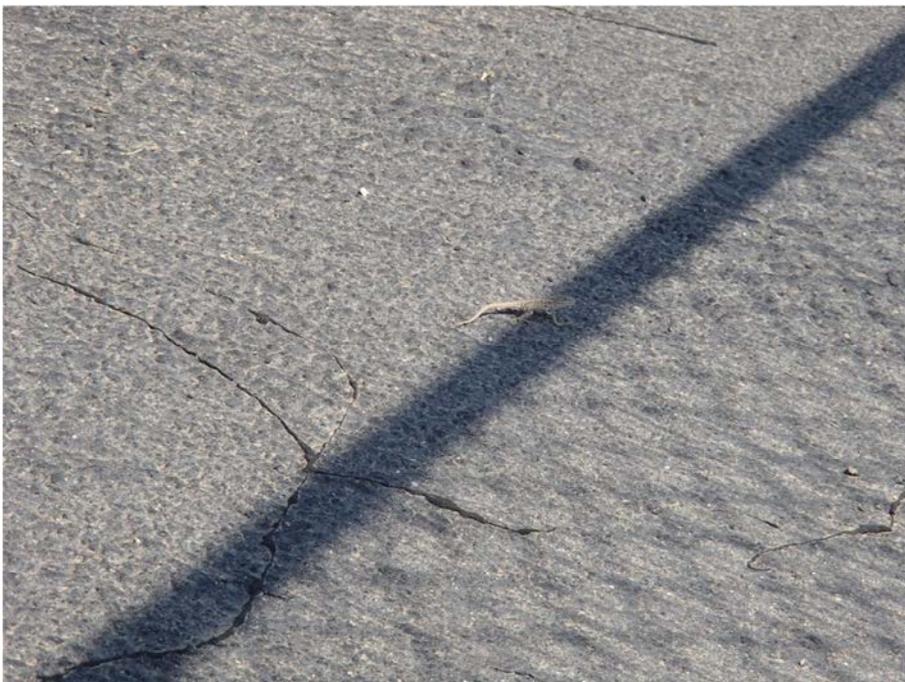
PHOTO: B&B-2014-61

LOCATION:
 RCRA Cap Area
 Map Location Number: Near 13-2
