Five-Year Review Report

Third Five-Year Review

Liquid Gold Oil Corporation Site

Richmond, California

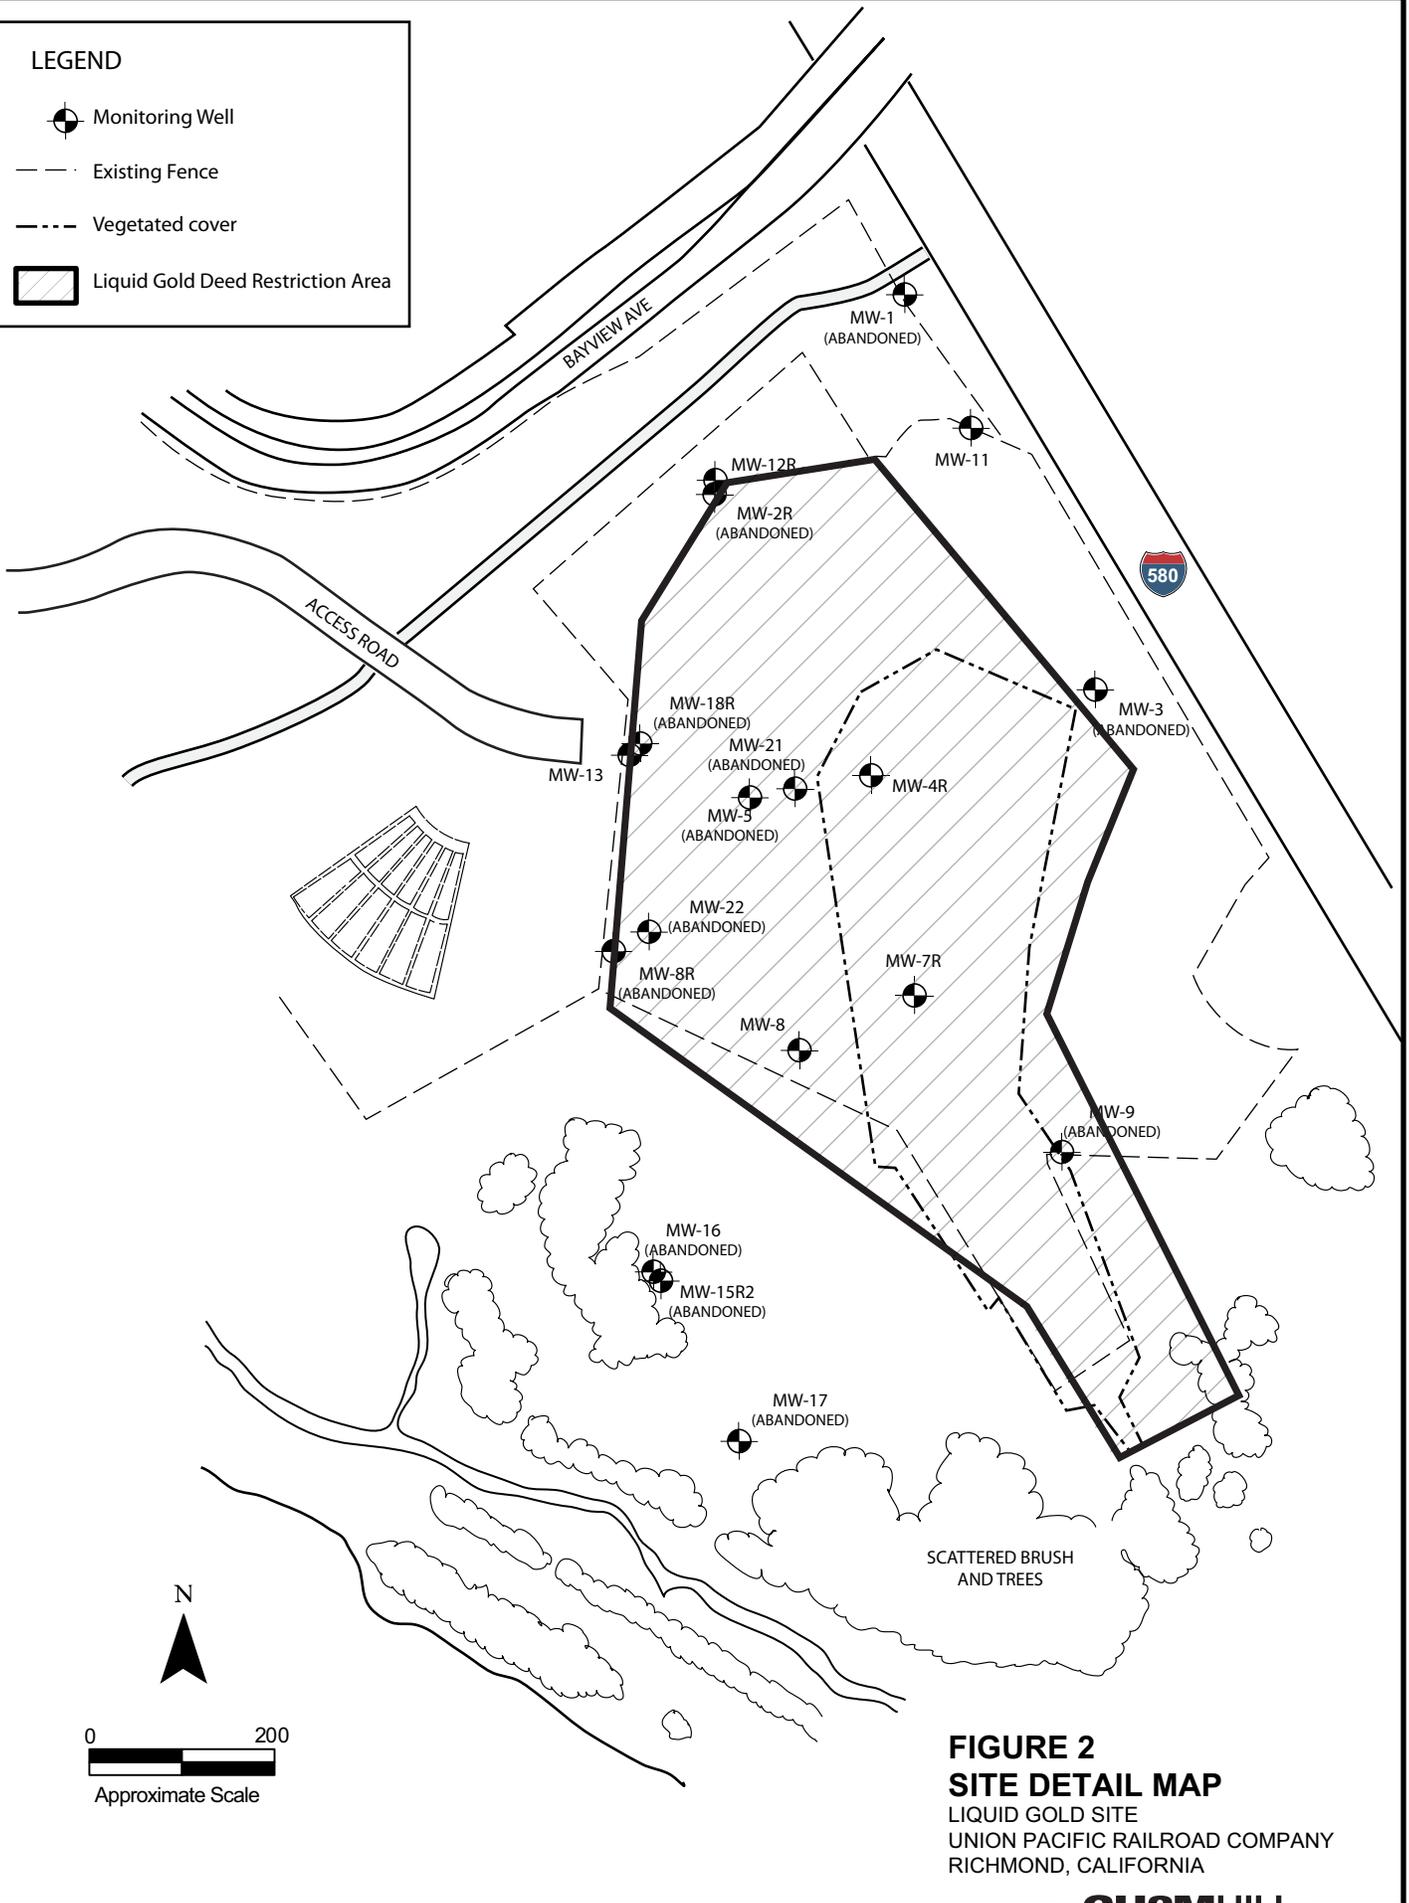
FIGURE 2
SITE DETAIL MAP
LIQUID GOLD SITE
UNION PACIFIC RAILROAD COMPANY
RICHMOND, CALIFORNIA

Sixteen groundwater monitoring wells were installed during or prior to the RI. The monitoring well network at that time consisted of 7 deep wells (MW-1, MW-2, MW-3, MW-6, MW-9, MW-16, and MW-18) and 9 shallow wells (MW-4, MW-5, MW-7, MW-8, MW-11, MW-12, MW-13, MW-15, and MW-17). Locations of these wells are shown on Figure 2.

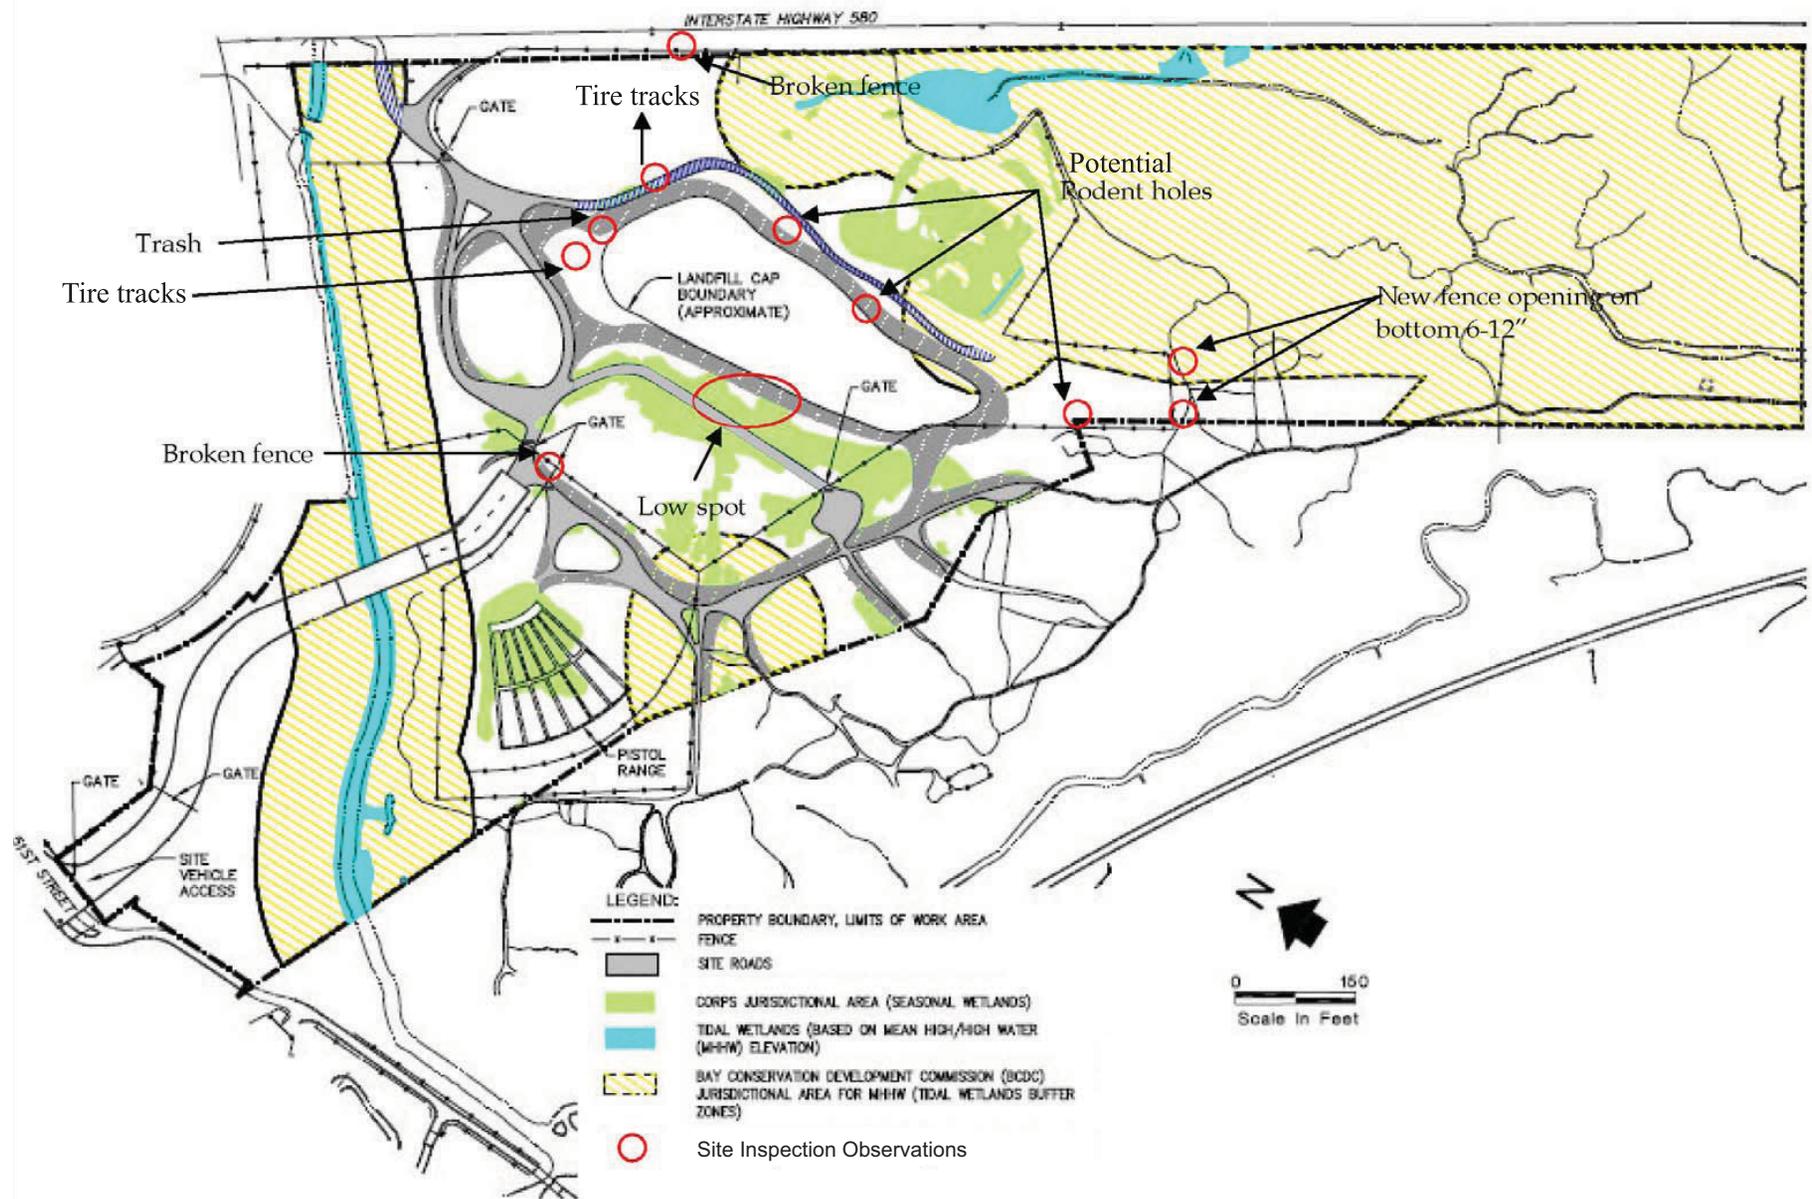
FIGURE C-1
 Liquid Gold Site Inspection
 2007 Biannual Groundwater Monitoring Event
 Former Liquid Gold Site
 Richmond, California

Note: Site inspection at Liquid Gold Site conducted on August 21, 2007.
 Figure edited by CH2M HILL, March 10, 2008.

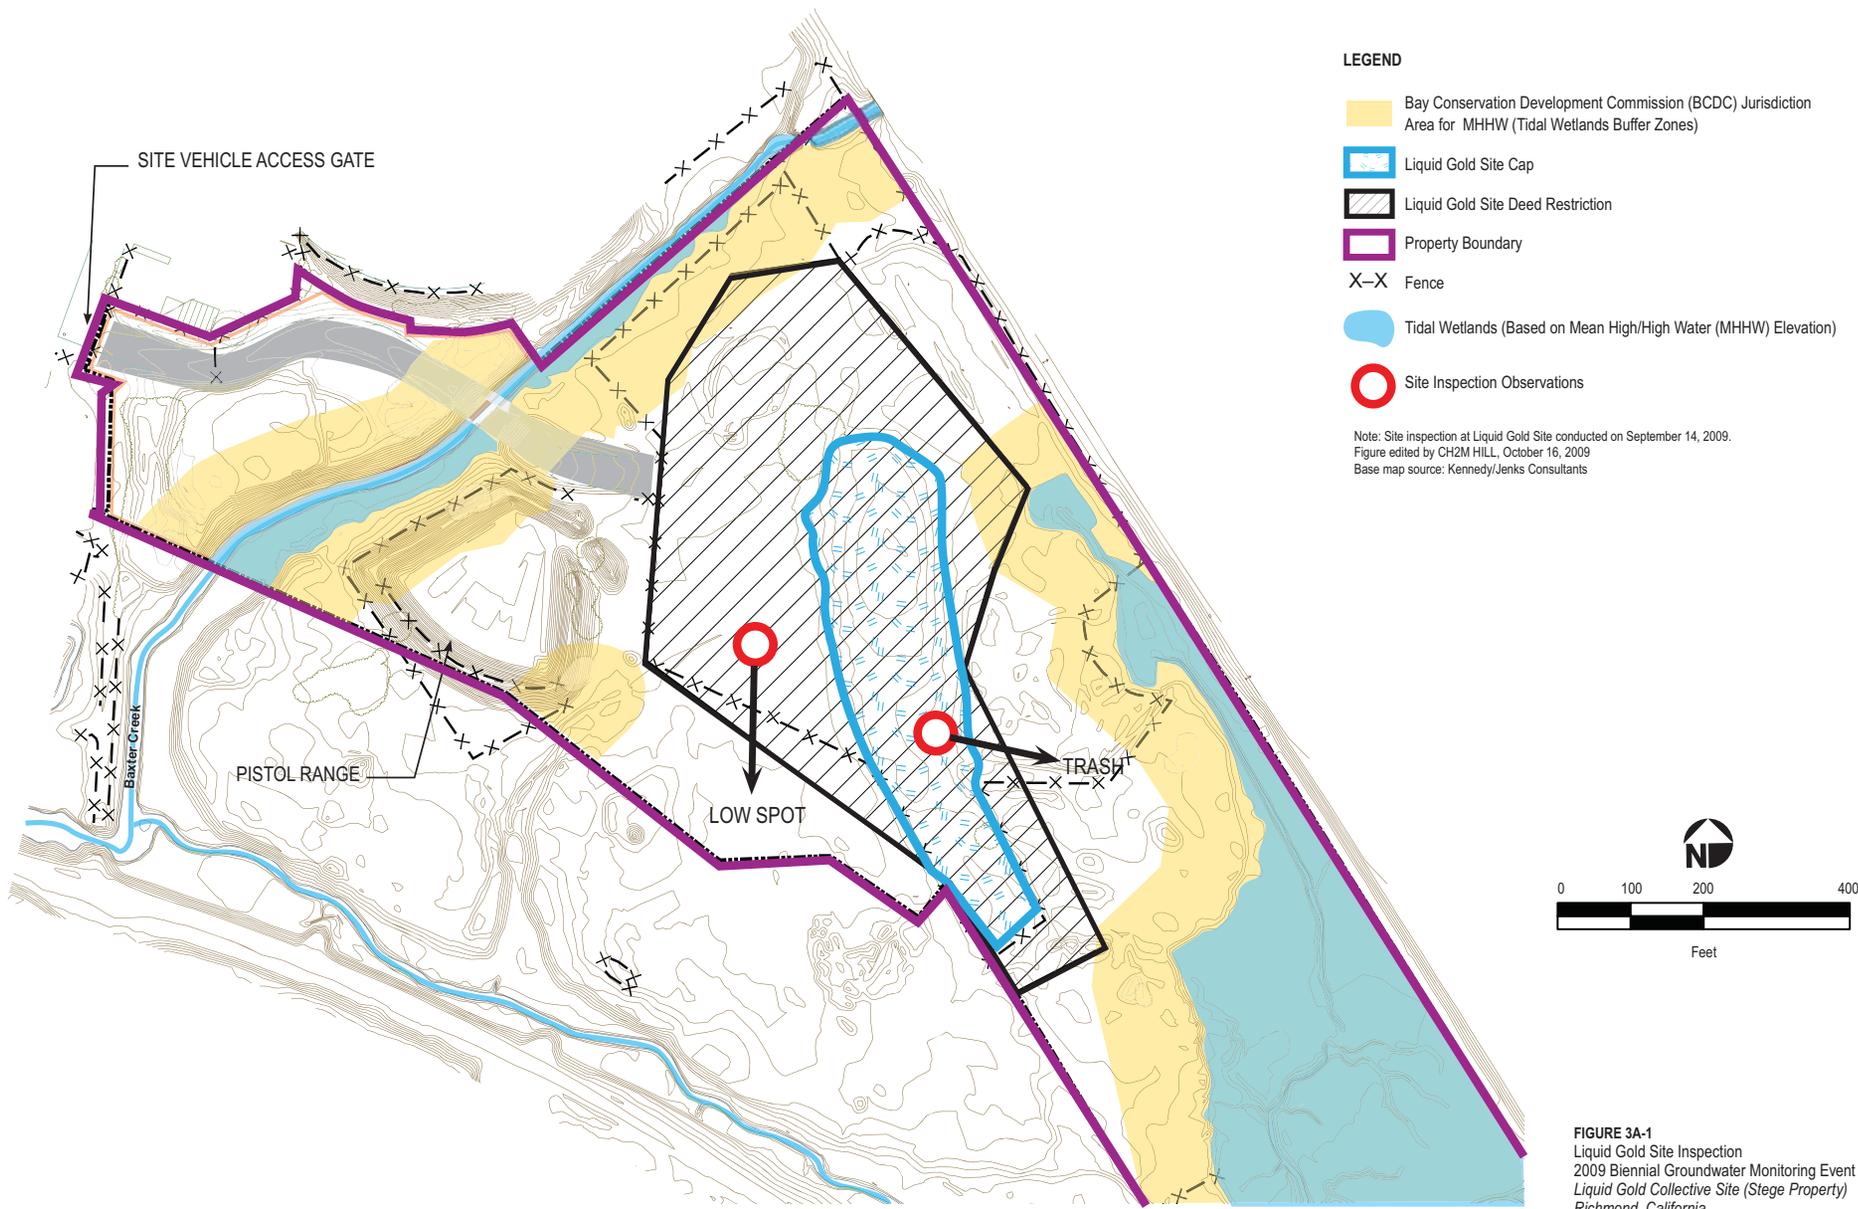
FIGURE 3A-1
 Liquid Gold Site Inspection
 2009 Biennial Groundwater Monitoring Event
 Liquid Gold Collective Site (Stege Property)
 Richmond, California

The observations recorded during the site inspection are presented below. Specific locations where observations were recorded are presented in Figure 3A-1. Table 3A-1 presents the inspection record for the vegetation cover. Table 3A-2 presents the inspection record for the site monitoring wells. A photo log documenting the observations is included in Attachment 3B.

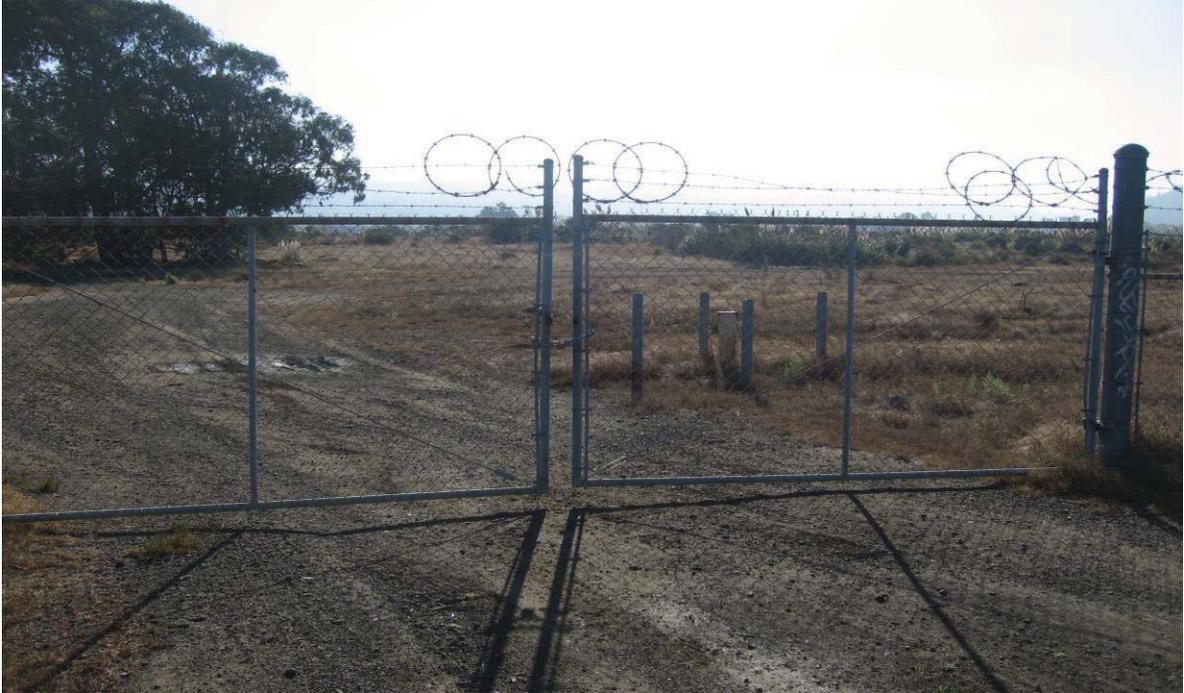
Photo 5: Site Entrance Gate (looking southeast)
