**FOURTH FIVE-YEAR REVIEW REPORT FOR
HEWLETT-PACKARD (620-640 PAGE MILL ROAD) SUPERFUND SITE
PALO ALTO, SANTA CLARA COUNTY, CALIFORNIA**

U.S. Army Corps of Engineers, Seattle District

Executive Summary

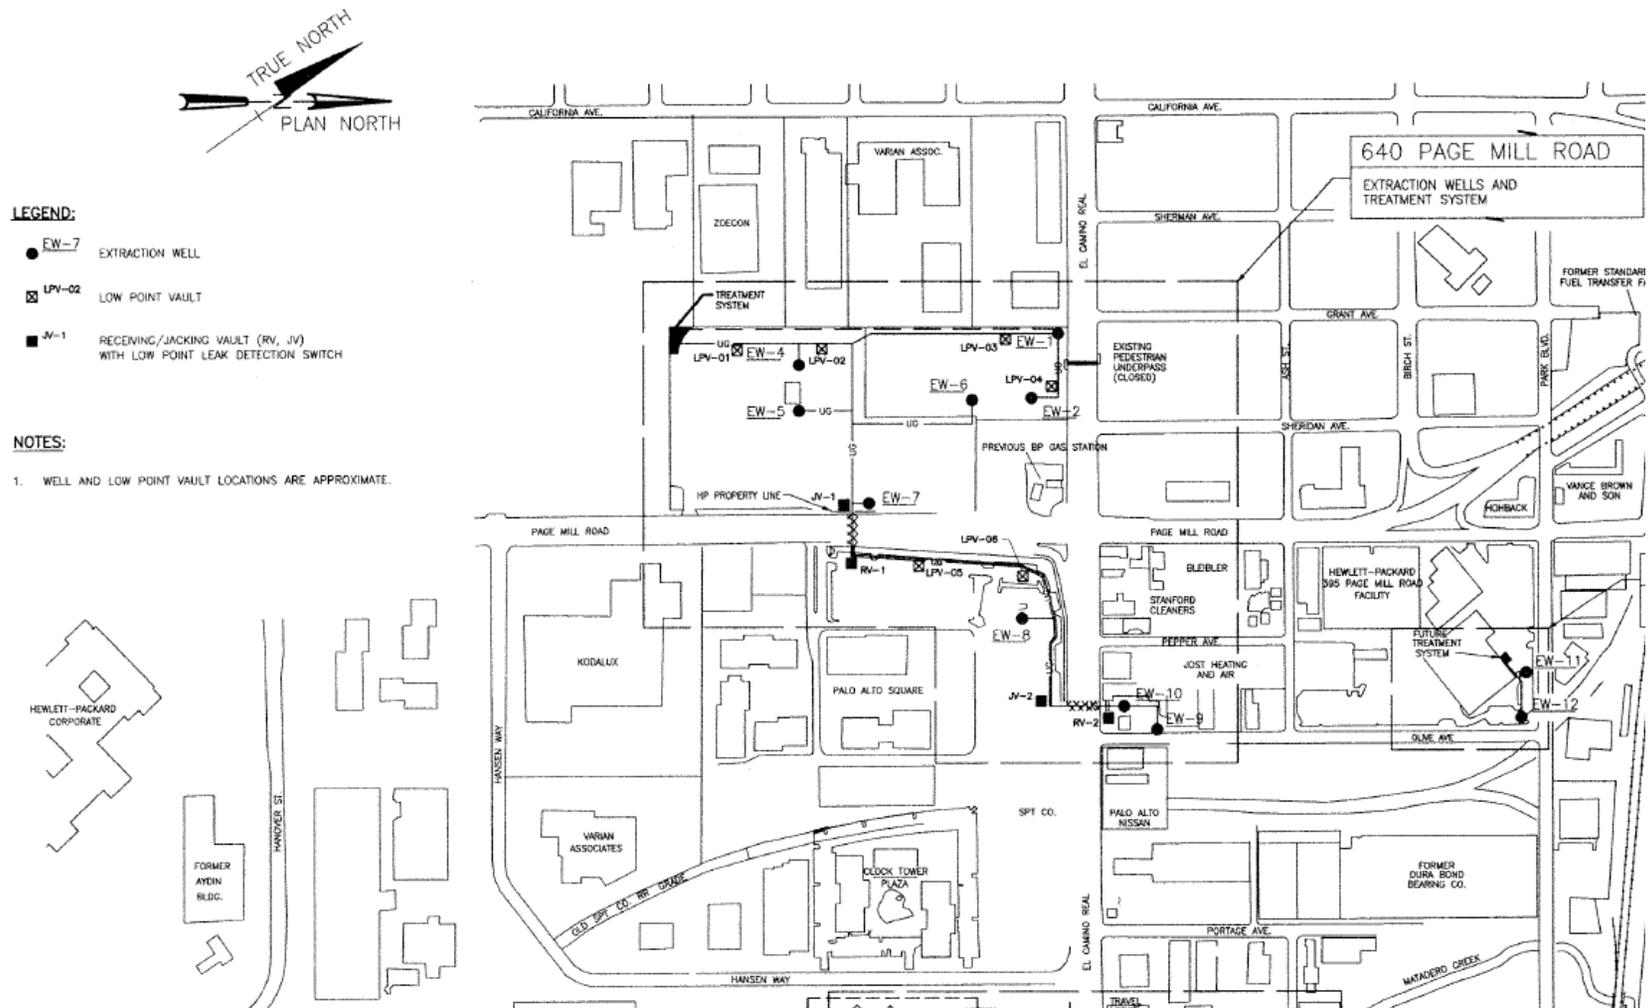
Figure 3. HP 620-640 Page Mill Road Groundwater Extraction and Treatment System

Currently EW-8, EW-10, TW-1 and TW-2 are the only operating extraction wells. Extracted groundwater is pumped through a pipeline from these wells to the northwest corner of the HP 620-640 PMR Site where the treatment system is located (Figure 3).

The treatment system at the HP 620-640 PMR Site is monitored remotely and personnel are on-site at least once per week for inspections and regular maintenance. There were no unexpected operations and maintenance (O&M) difficulties in the last five years, and updates to the O&M procedures were completed when the GWET system was updated in 2013. HP has estimated that O&M expenses are around \$100,000-\$200,000 per year.

NOTE: Wells TW-1 and TW-2 are not shown. They are located just northwest of EW-7.

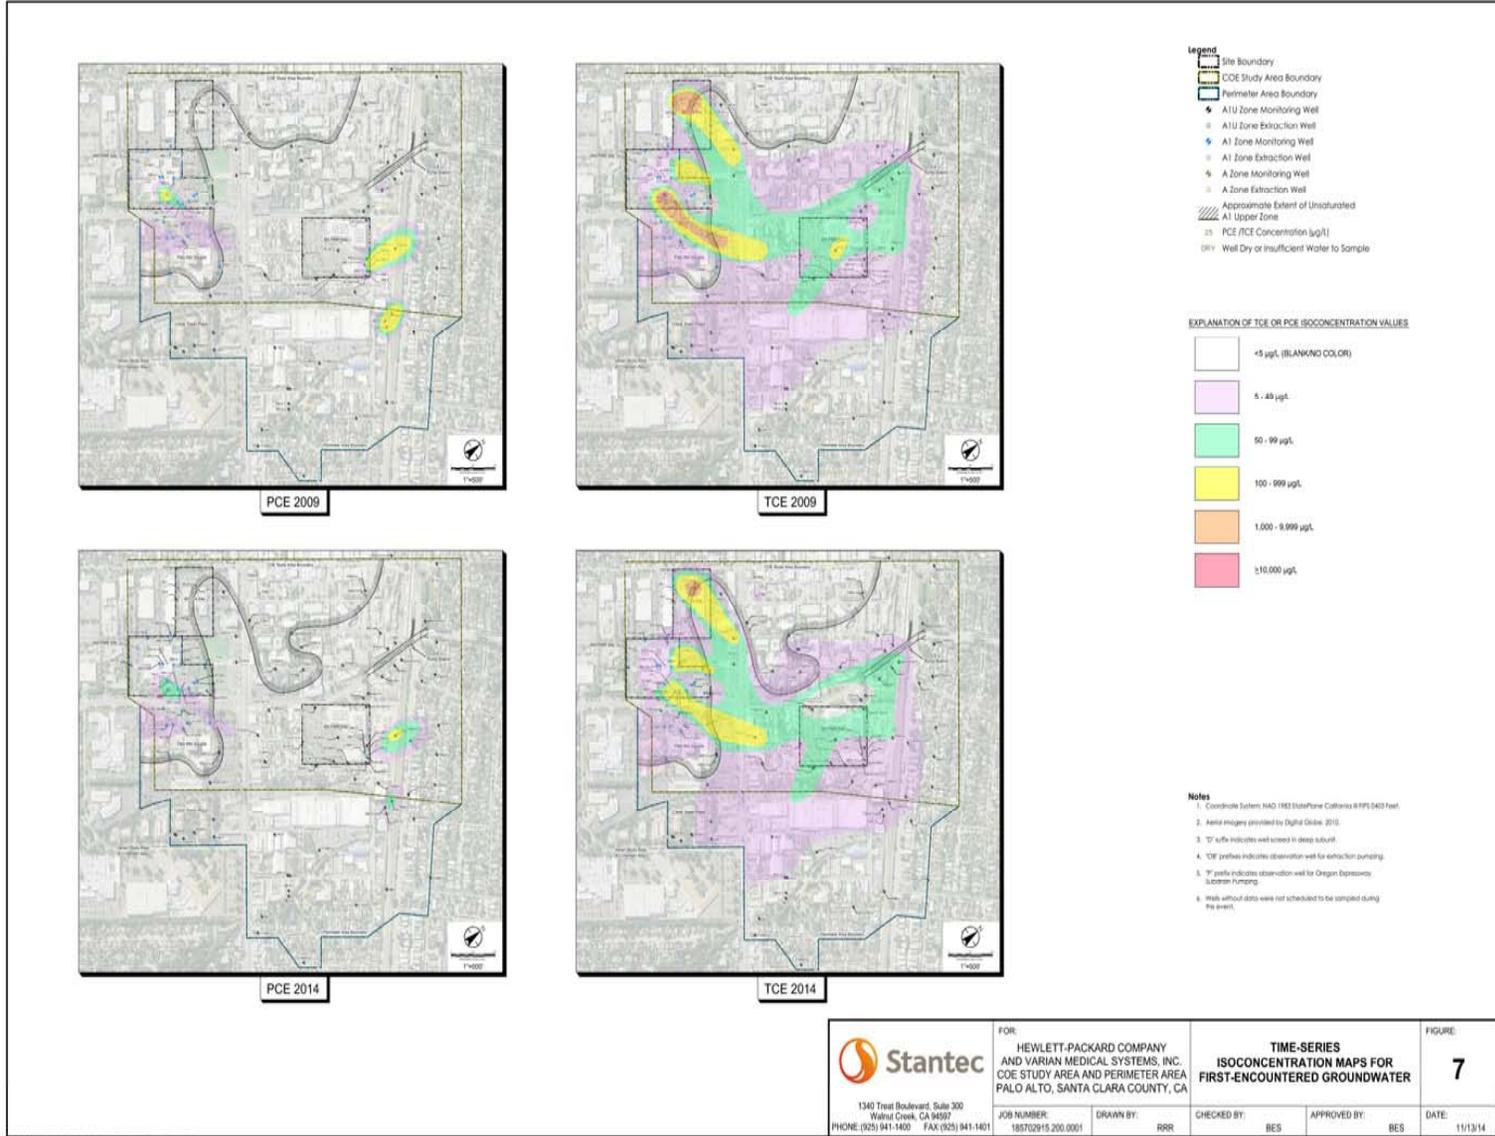
Figure 5. Iso-concentration map of PCE and TCE in first-encountered groundwater

Per the approved groundwater monitoring plan, 26 wells are sampled annually for chlorinated VOCs, and 102 wells are sampled every other year for VOCs (Figure 4 shows the well locations). Figures 5, 6, and 7 present iso-contour maps for PCE and TCE, and compare concentrations from 2009 to concentrations in 2014.
