**DRAFT FINAL**  
**Third Five-Year Review Report**  
**for**  
**Sacramento Army Depot**  
**Sacramento**  
**Sacramento County, California**

**August 2007**

**THE DEPARTMENT OF THE ARMY**  
**ASSISTANT CHIEF OF STAFF FOR INSTALLATION MANAGEMENT**  
**BASE REALIGNMENT AND CLOSURE DIVISION**  
**600 ARMY PENTAGON**  
**WASHINGTON DC 20310-0600**

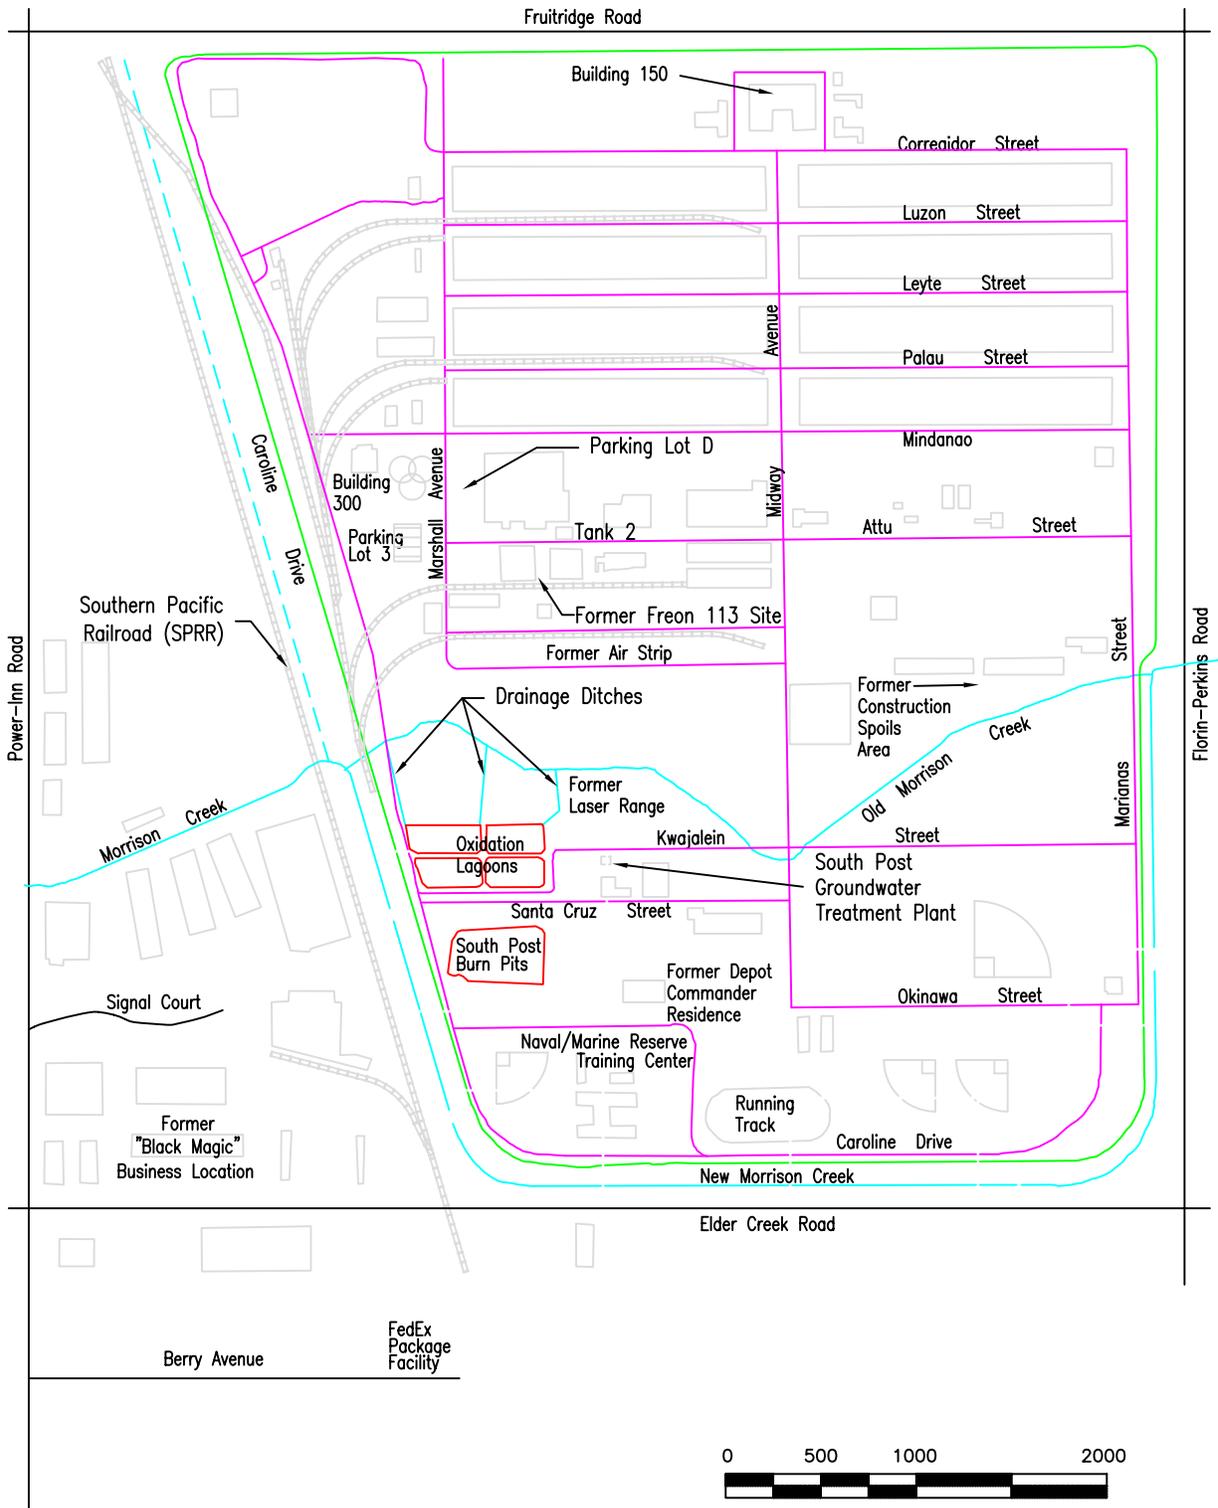
3. **Plate 2, Current Facility Map, Sacramento Army Depot:** It is not clear if Plate 2 has been updated since the drawing date is listed as “09-12-05;” if correct, this date indicates that the plate may not include more current information such as the transfer of Parcel 2B to the City of Sacramento, which (per Table 1) occurred in April 2006, after the date of the drawing. Please review Plate 2 and where appropriate revise the dates and/or information to reflect the current (i.e., late 2006 or early 2007) status of the information, as well as the noted drawing date.

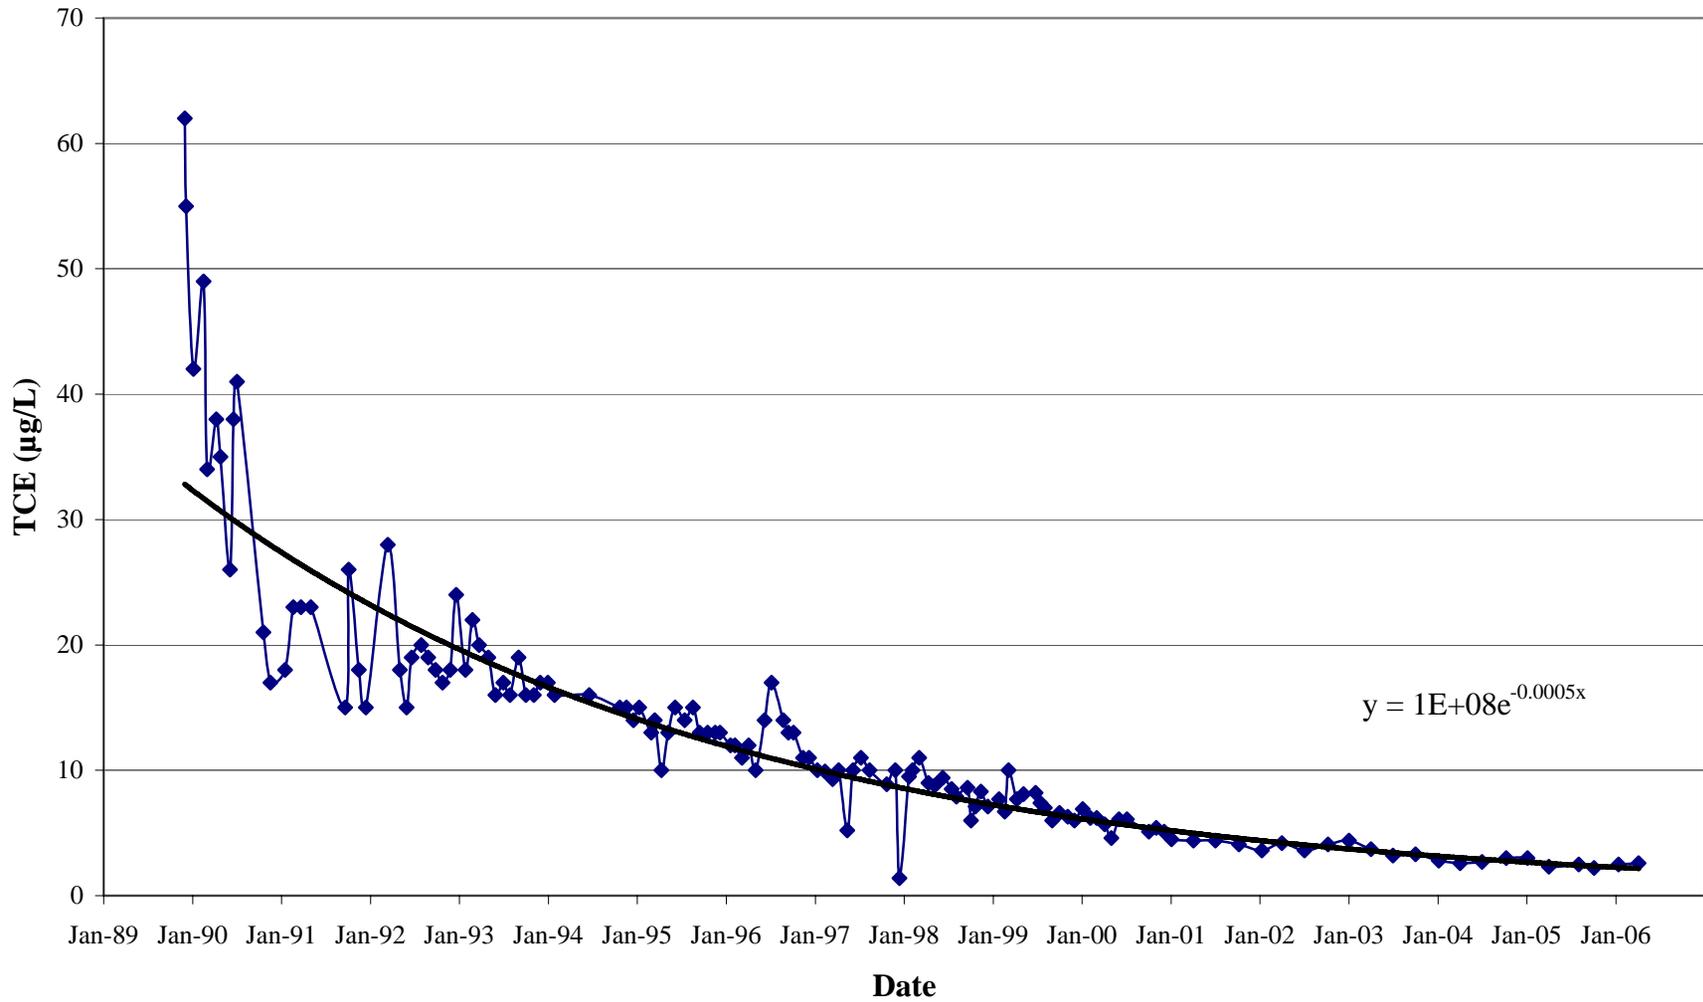
**Plate 10. South Post Treatment Plant Influent TCE Concentrations. Former Sacramento Army Depot, Sacramento, CA. September 2006.**

Extraction well EW-10 is operating at approximately 50% of capacity (of about 100 gpm) due to severe cycling problems caused by suspected well screen fouling. The TCE concentration of extracted groundwater has declined from 62 µg/L (in November 1989) to 2.6 µg/L (in April 2006). Plate 10 shows changes in TCE treatment plant influent concentrations over time. The graph shows an exponentially decreasing trend in TCE concentrations. From January 2001 to August 2006 the rate of TCE concentration decrease has been about 0.4 µg/L per year.
