THIRD FIVE-YEAR REVIEW REPORT

**FOR
KOPPERS COMPANY, INC.
SUPERFUND SITE
OROVILLE, CALIFORNIA**

July 2008

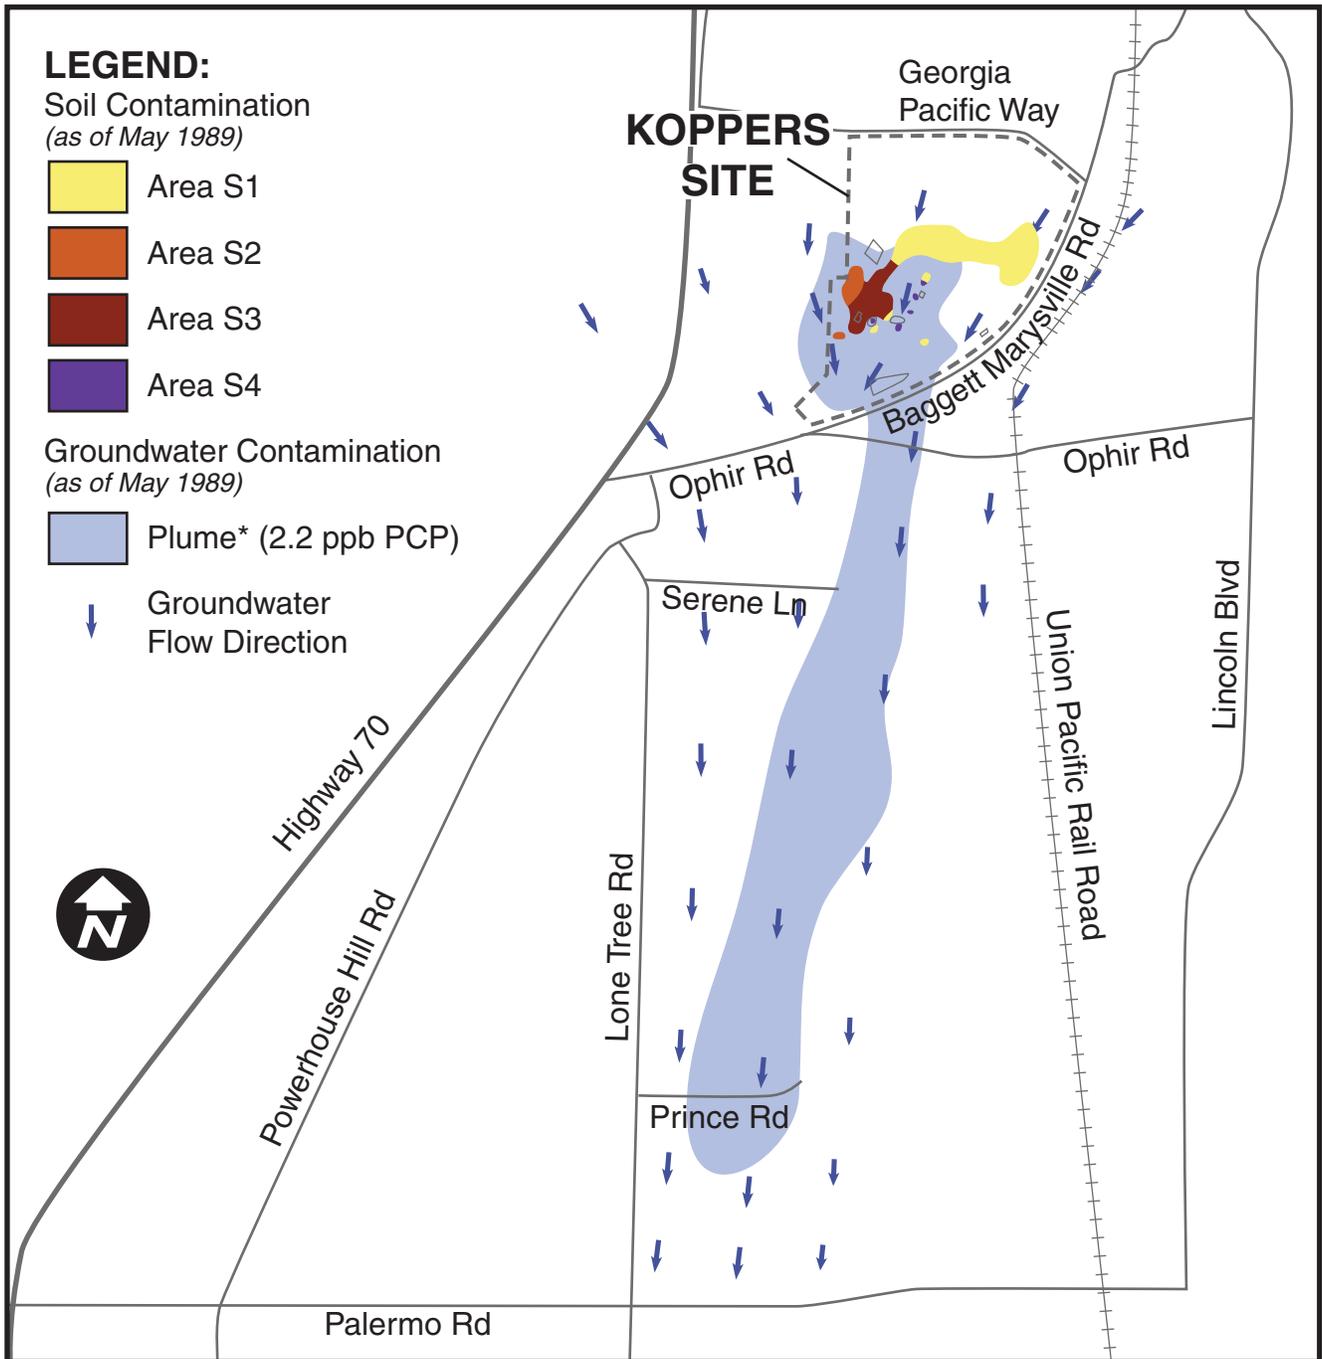
**FIGURE 3-1
SITE MAP**

Well 86 has PCP concentrations above ROD standards and is showing a slow decreasing trend. However, while this well is located off property, based on the plume map in Figure 3-1, it is actually within the capture zone of the on-property extraction well EW-2, and thus contaminated groundwater in the vicinity of Well 86 is currently being captured and treated by the on-property P&T treatment system.

On-property groundwater in situ bioremediation	Concentration trends in the wells overall indicate stabilization in PCP trends. Monitored natural attenuation not yet implemented. Bioremediation ceased at well BW-1 in June 2001 as it resulted in increase in mobility of PAHs.	PCP concentrations are below detection limit except for well MW-8.	The results of the implementation of the On-Property Groundwater In Situ Bioremediation Program indicate that the enhancements have stimulated the aerobic degradation of pentachlorophenol.	Results of the implementation of the On-Property Groundwater In Situ Bioremediation Program indicate that the enhancements have stimulated the aerobic degradation of PCP to less than ROD standards in MW -5 and 7.	Dissolved mobile PAHs have been detected at low concentrations at well MW-24. The steady decrease in pentachlorophenol concentrations at MW-16 indicates that bioremediation of pentachlorophenol was stimulated, and this increased bioactivity appears to be ongoing.	The results of the implementation of the On-Property Groundwater In Situ Bioremediation Program indicate that the enhancements have stimulated the aerobic degradation of pentachlorophenol.	In situ bioremediation has stimulated aerobic degradation of PCP, but the size of the plume (Figure 3-1) has remained more or less the same from 2002 to 2007.

The operation of the On-property In Situ Bioremediation Program continues to enhance the P&T system. However, the plume maps in Figure 3-1 for 2002 and 2007 show little change of the on-property plume. So, the combined treatment system is effective in containing the plume, but not as effective as previous years in reducing it.
