**EXPLANATION OF SIGNIFICANT DIFFERENCES
OPERABLE UNIT 3
FORT WAINWRIGHT, ALASKA**

September 2002

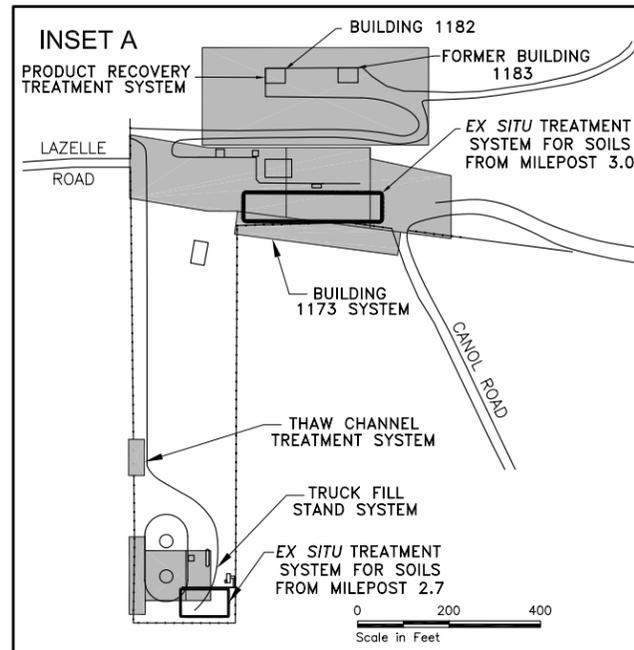
REMEDIAL AREA 1B BIRCH HILL TANK FARM TREATMENT SYSTEMS

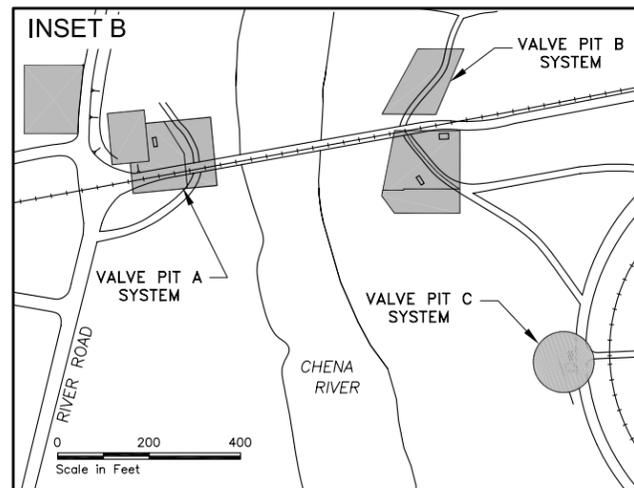
REMEDIAL AREA 2 VALVE PITS A, B, AND C

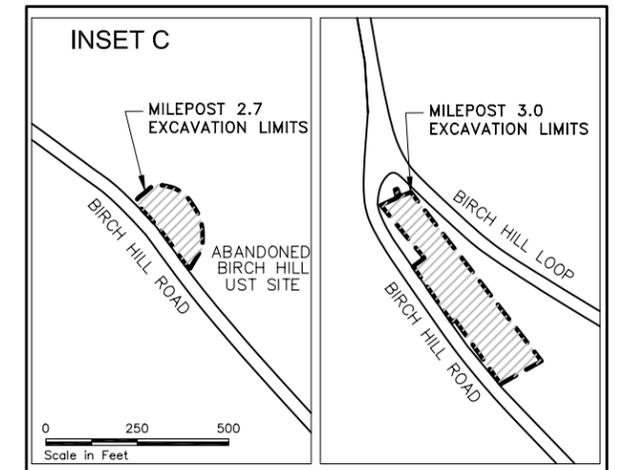
REMEDIAL AREA 3 FAIRBANKS-EIELSON PIPELINE MILEPOST 2.7 AND 3.0

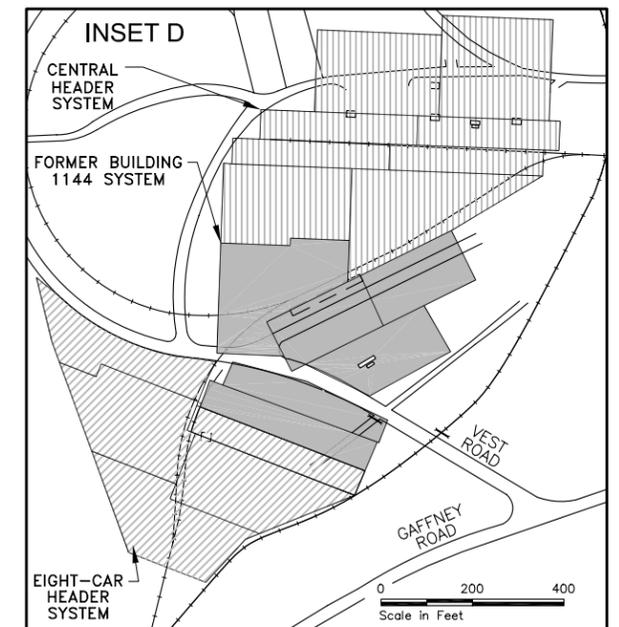
REMEDIAL AREA 2 CENTRAL ROLF: CENTRAL HEADER, FORMER BUILDING 1144, AND EIGHT-CAR HEADER

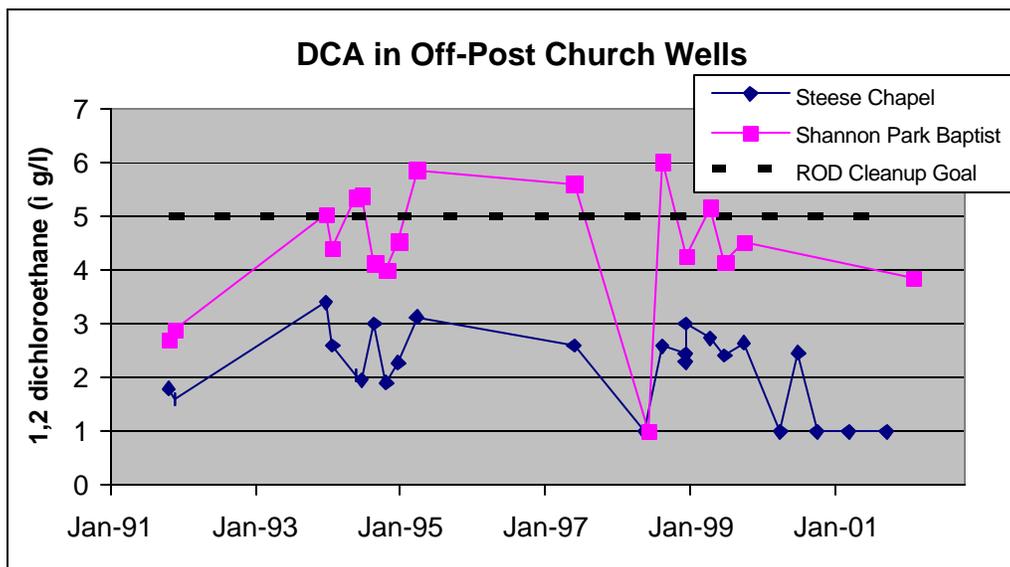
Further investigations indicated that dissolved contaminants measured off-Post are likely migrating in groundwater that comes in contact with free product identified in the fractured bedrock on Birch Hill. A product recovery system was installed on Birch Hill in 2000 and modified in 2001 to recover product and reduce the potential for off-Post migration of contaminants. Contamination still remains in off-Post wells, but at levels below the MCL. Concentrations of DCA in the church wells are presented below.

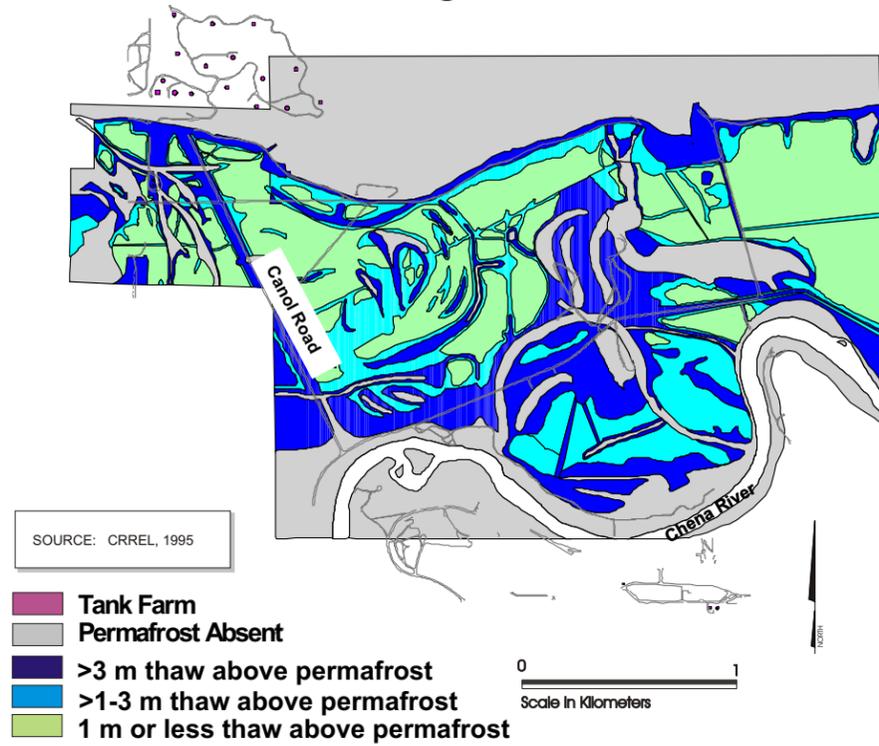
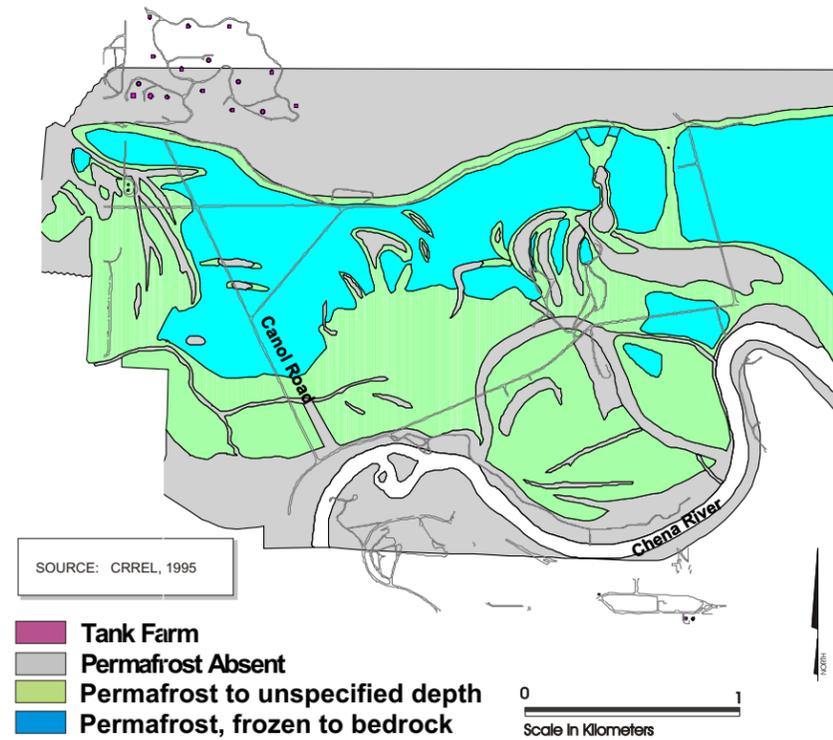
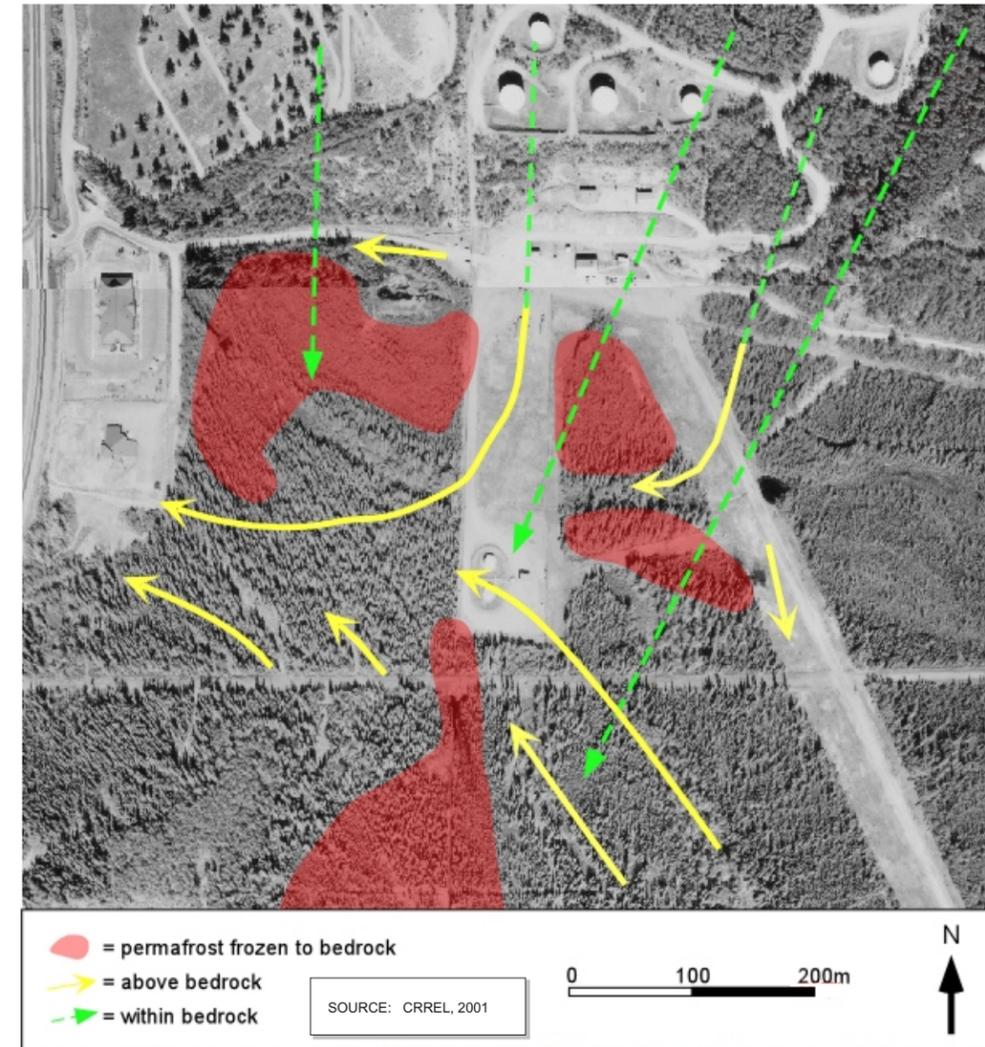
ALASKA DISTRICT CORPS OF ENGINEERS ANCHORAGE, ALASKA	
Permafrost Drawings Birch Hill Tank Farm Explanation of Significant Differences Operable Unit 3 Fort Wainwright, Alaska		
CONTRACT: DAC85-01-C-0018	FIGURE: 2	DATE: 8/02

Pre-ROD Understanding of Permafrost Distribution

(a.) Distribution of permafrost showing characteristic depths of thaw in the shallow permafrost zones.

(b.) Distribution of deep permafrost and aquifer conditions.

Current Understanding of Permafrost Distribution

The characterization of soil and groundwater contamination at the Birch Hill Tank Farm has been complicated by permafrost blocks that partially control groundwater flow in the area. The difficulty of characterizing the soil and groundwater contamination during the RI contributed to an underestimation of the nature and extent of contamination in this area. Prior to the ROD, the permafrost distribution was inferred from limited available borehole geological data, preliminary studies of historical aerial photography, and vegetation and terrain analysis. Since the ROD, numerous geophysical surveys, such as ground penetrating radar and direct current (DC) resistivity, have helped refine the interpretation of permafrost distribution between boreholes. As a result, the permafrost configuration and groundwater flow characteristics are better understood. Figure 2 compares inferred deep and shallow permafrost distributions developed in 1995 to the current understanding of permafrost areas throughout the Tank Farm.

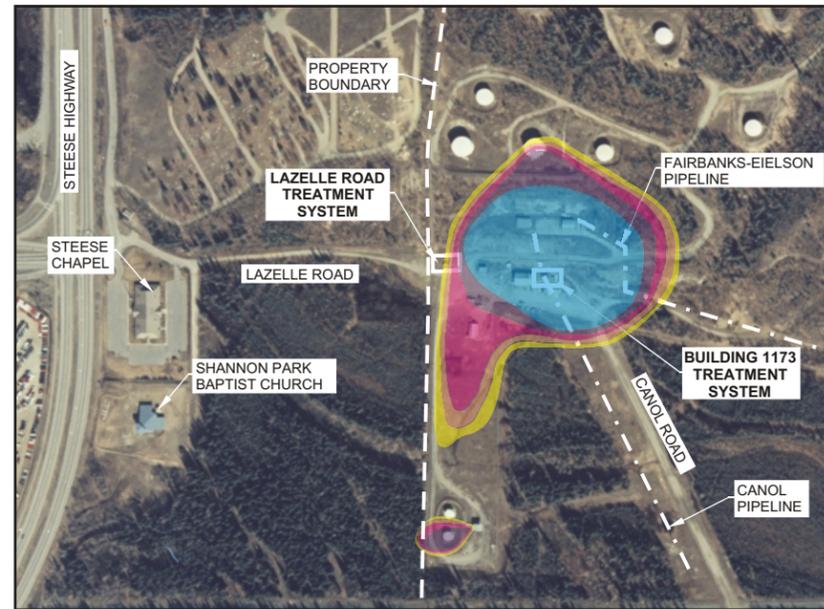
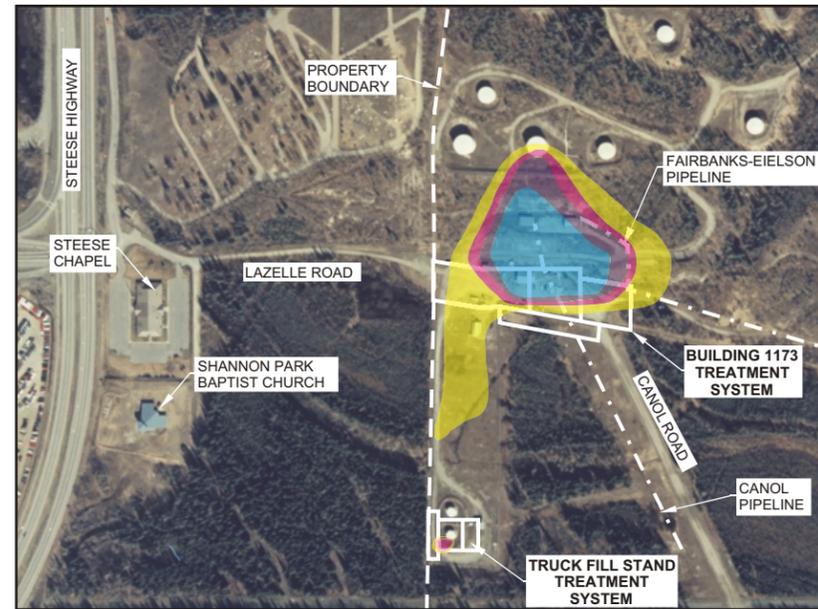
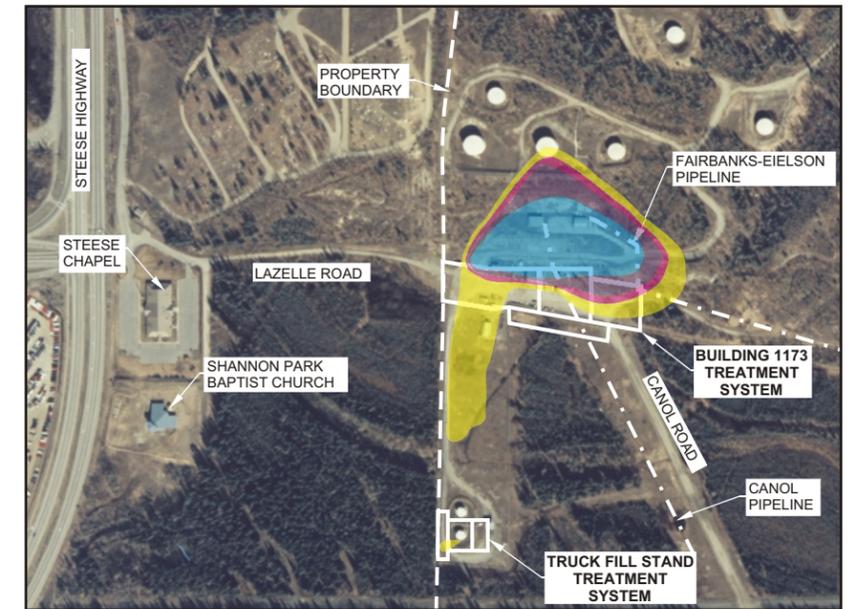
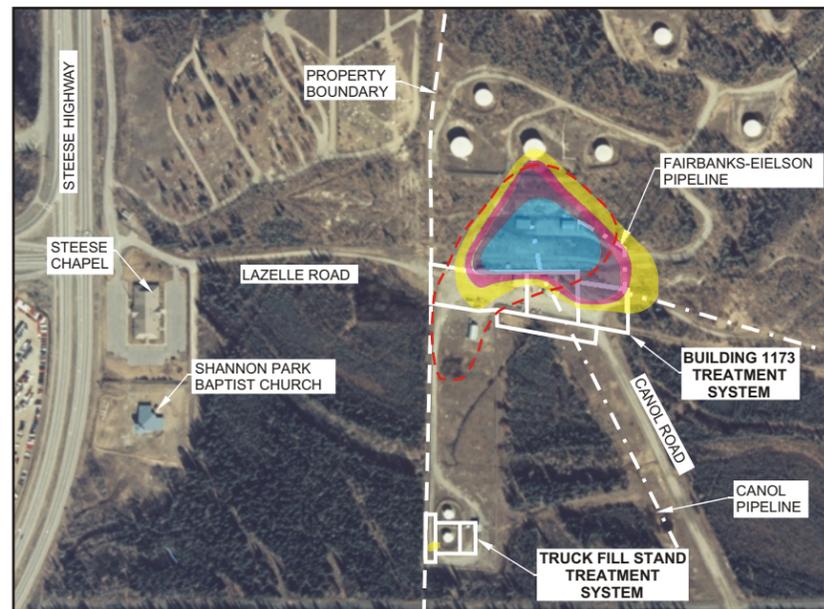
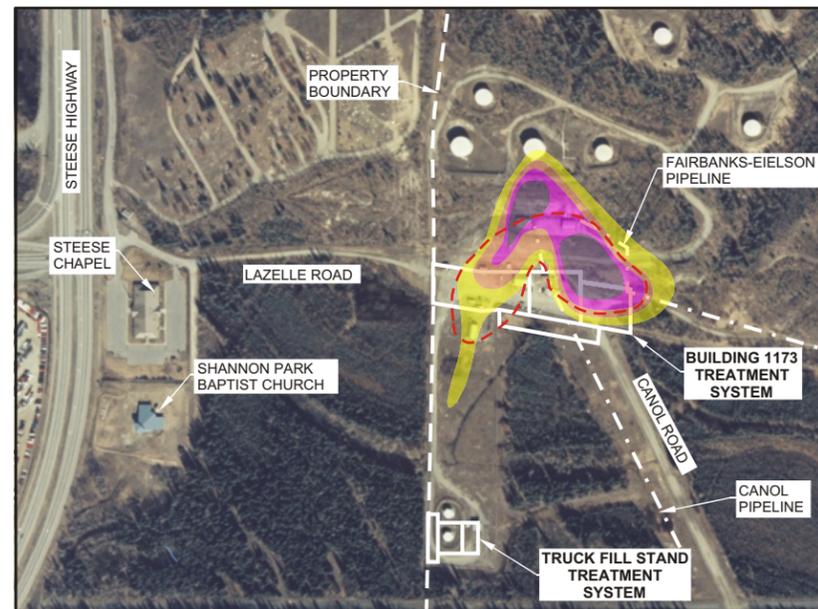
Prior to Treatment 1996-1997

Fall 1998

Fall 1999

Fall 2000

Fall 2001

Figures 3, 4, and 5 show the aerial extent of benzene, EDB, and DCA, respectively, identified (post-ROD) throughout both the alluvial and bedrock aquifers and the reduction in contaminant plume areas since treatment began. Table 3-1 identifies contaminants of concern and their respective concentrations that were detected pre-ROD versus post-ROD and compares the pre-ROD estimated treatment system requirements to the actual installed systems.

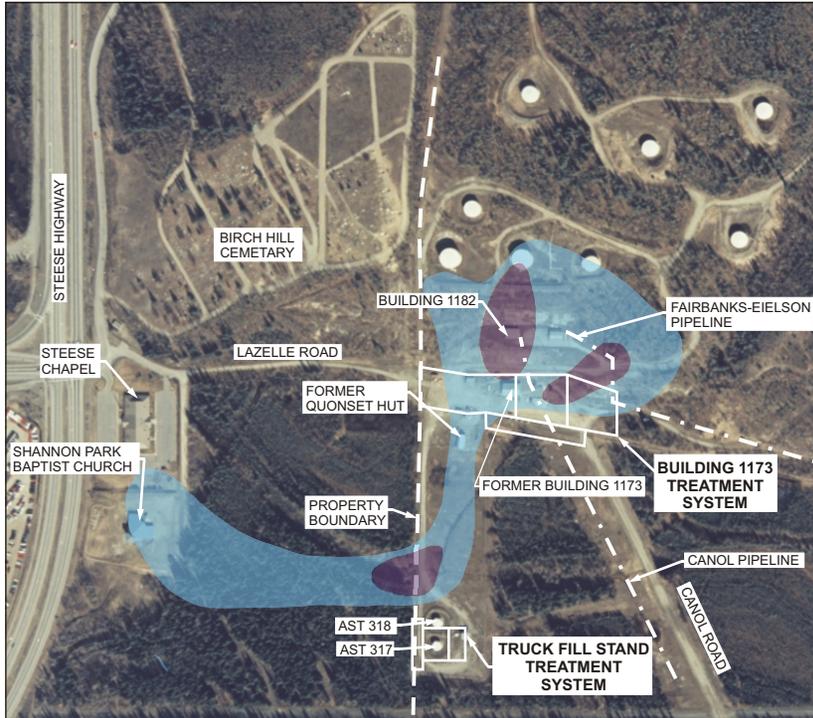
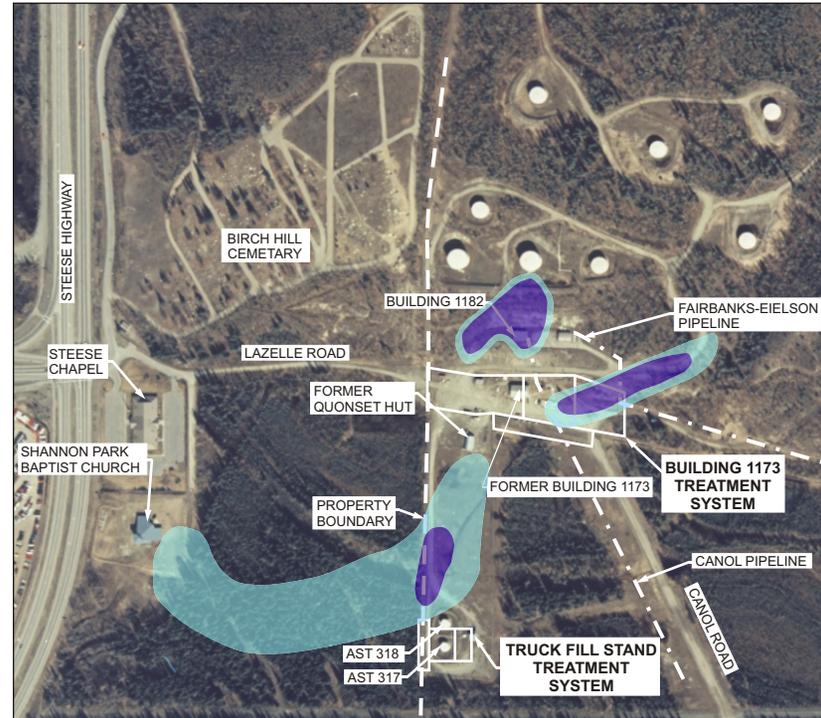
CONTRACT: DACA85-01-C-0018	FIGURE: 4	DATE: 8/02
-------------------------------	--------------	---------------

DCA Plume 2000

DCA Plume 2001

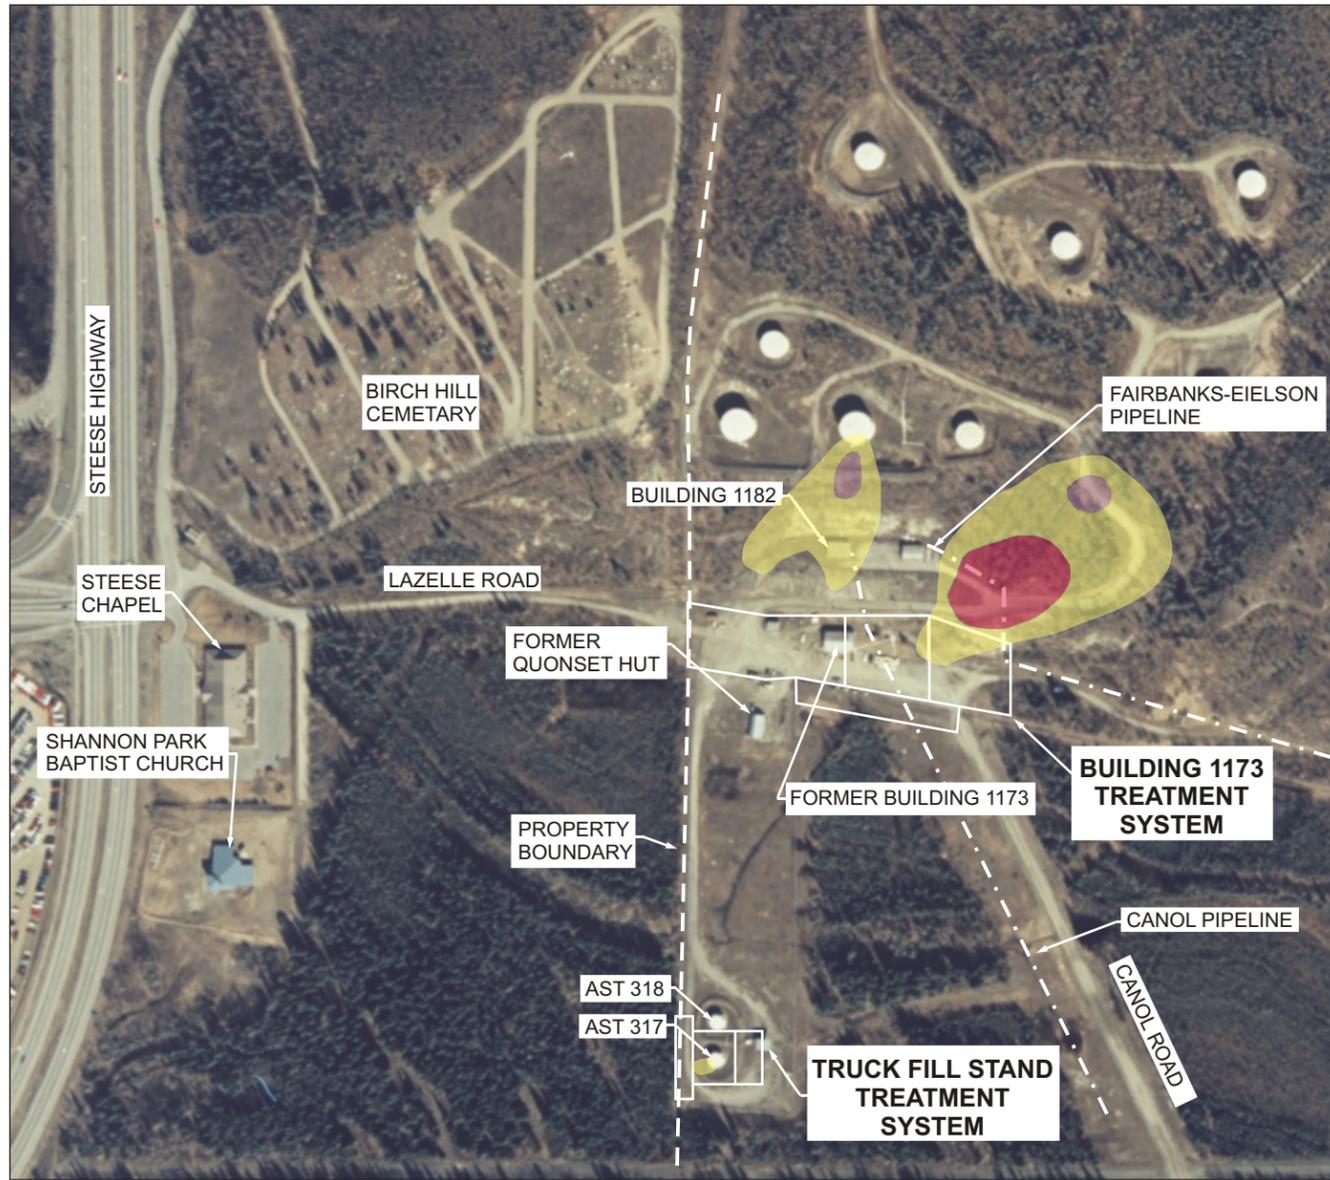
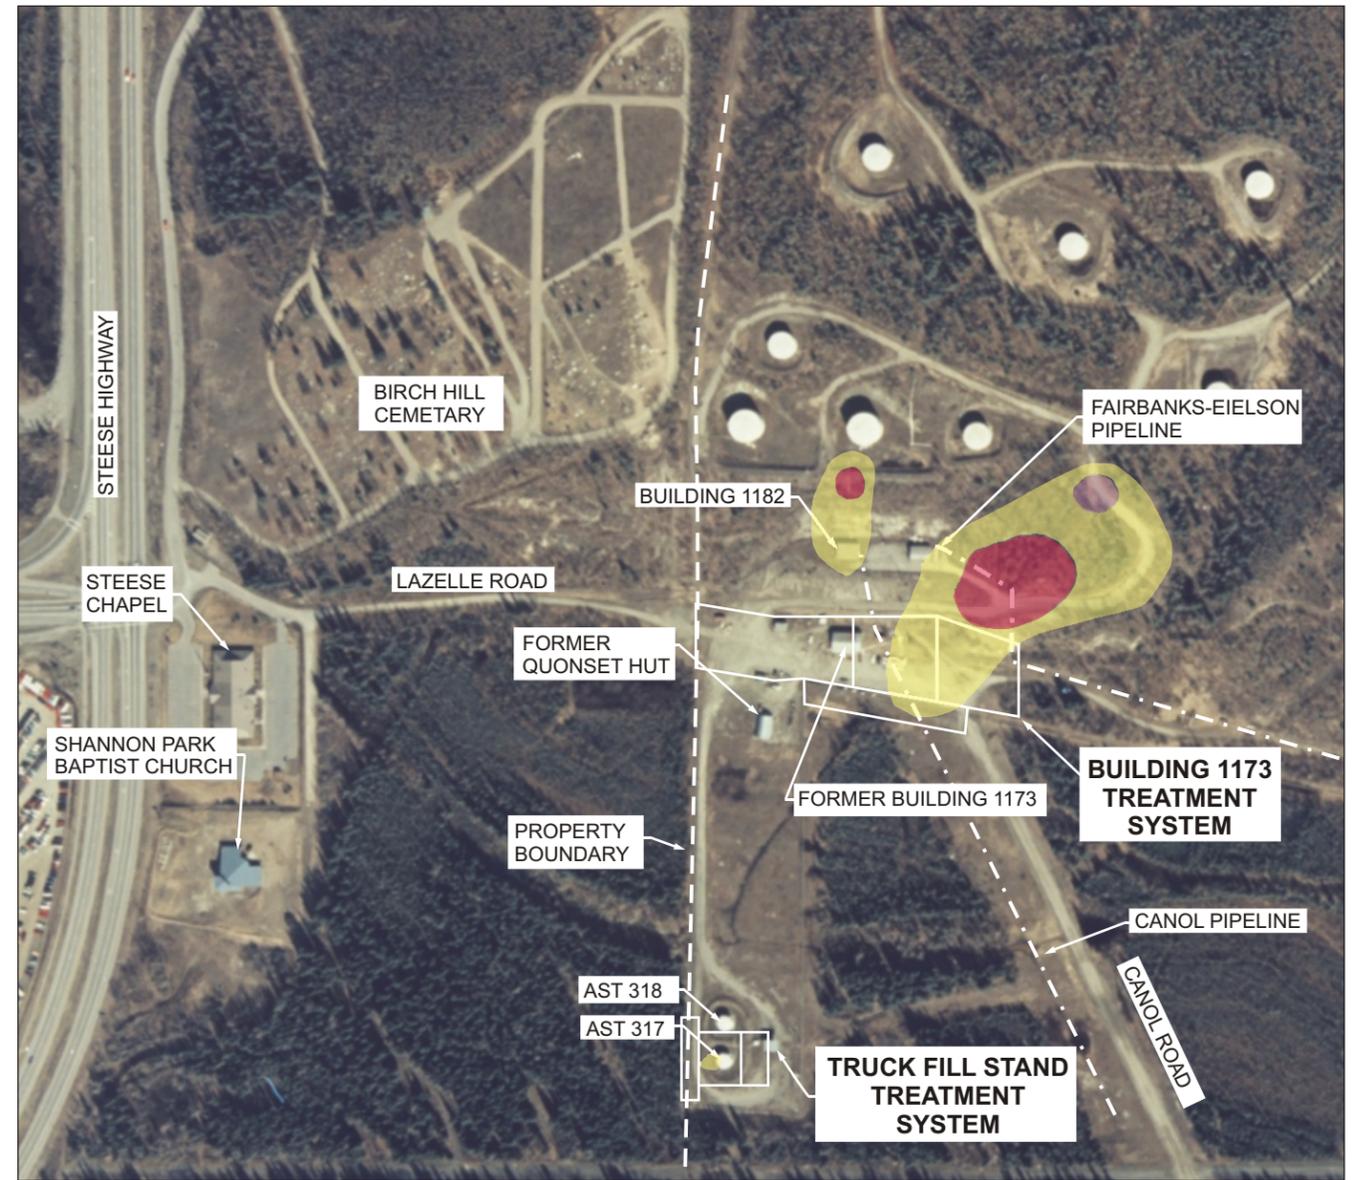
EDB Plume 2000

EDB Plume 2001

LEGEND	
$\mu\text{g/L}$	MICROGRAMS PER LITER
	APPROXIMATE EXTENT OF EDB PLUME ABOVE REMEDIAL ACTION GOALS
	APPROXIMATE EXTENT OF EDB PLUME WITH CONCENTRATIONS ABOVE 10 $\mu\text{g/L}$ (HOT SPOT)
	APPROXIMATE EXTENT OF EDB PLUME WITH CONCENTRATIONS ABOVE 100 $\mu\text{g/L}$ (HOT SPOT)

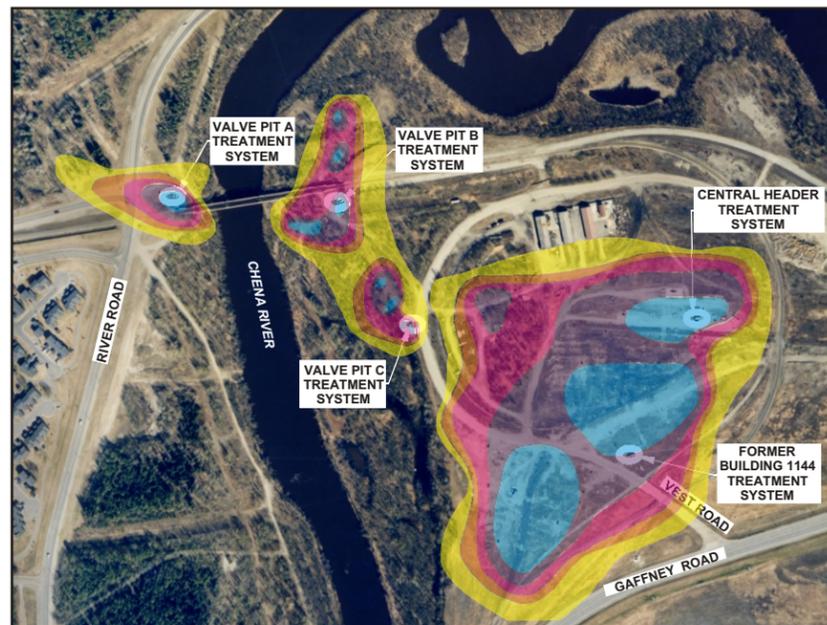
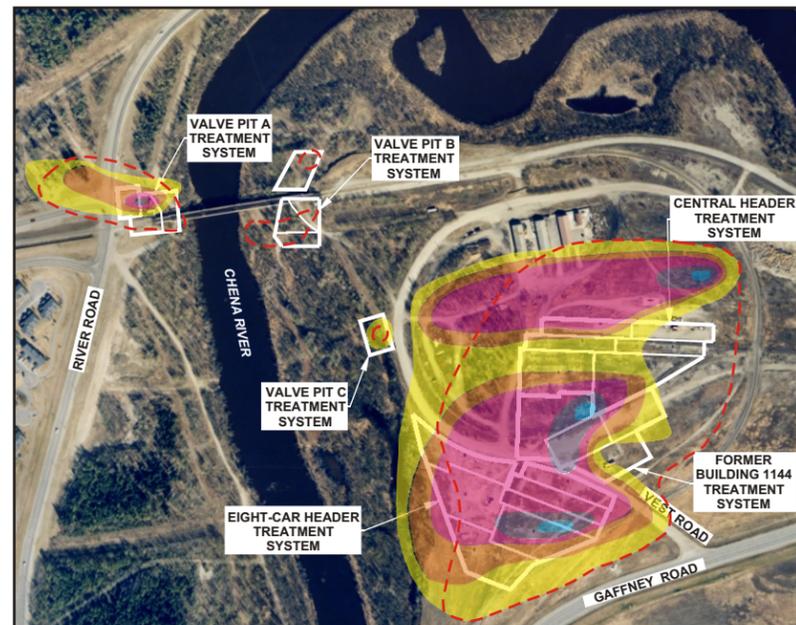
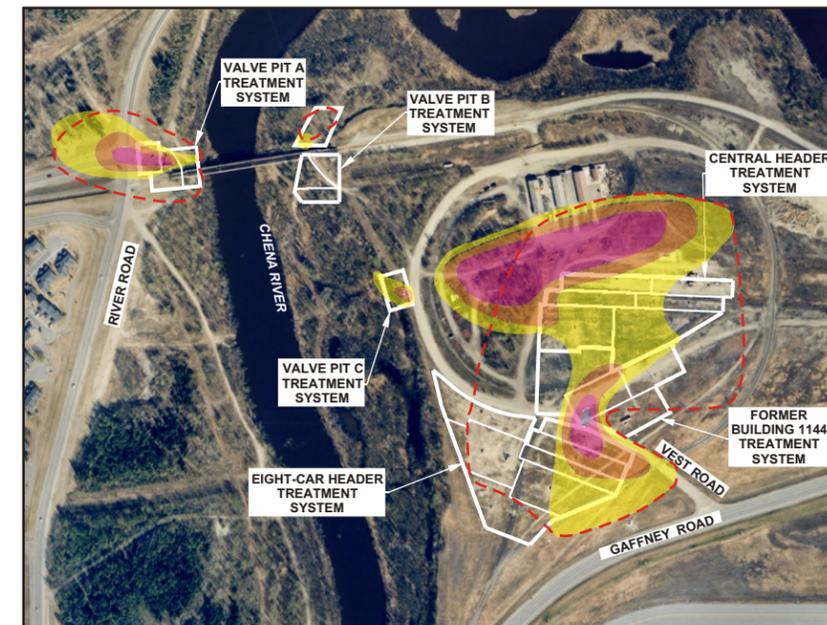
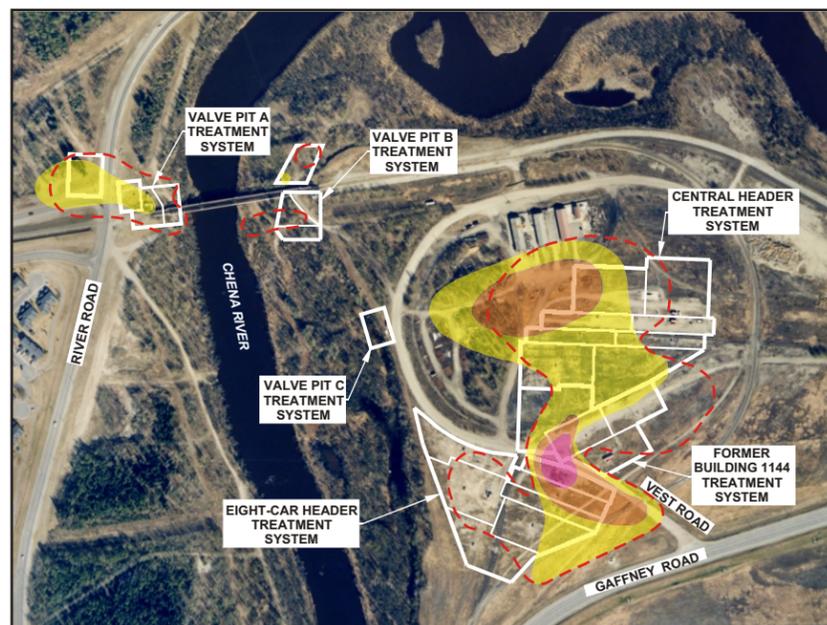
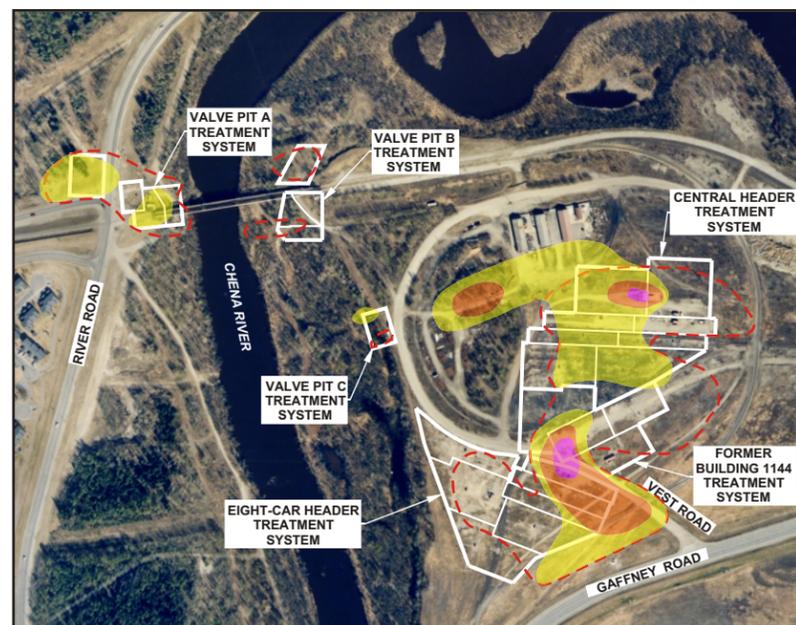
Prior to Treatment 1996-1997

Fall 1998

Fall 1999

Fall 2000

Fall 2001

- APPROXIMATE EXTENT OF 5 $\mu\text{g/L}$ BENZENE PLUME
- APPROXIMATE EXTENT OF 50 $\mu\text{g/L}$ BENZENE PLUME
- APPROXIMATE EXTENT OF 100 $\mu\text{g/L}$ BENZENE PLUME
- APPROXIMATE EXTENT OF 1,000 $\mu\text{g/L}$ BENZENE PLUME
- APPROXIMATE EXTENT OF PRODUCT PLUME
- APPROXIMATE EXTENT OF TRIMETHYLBENZENES

After the AS/SVE systems were initially installed in 1996, sampling results indicated a larger area of contamination existed than originally identified. Expansion of the systems was determined to be

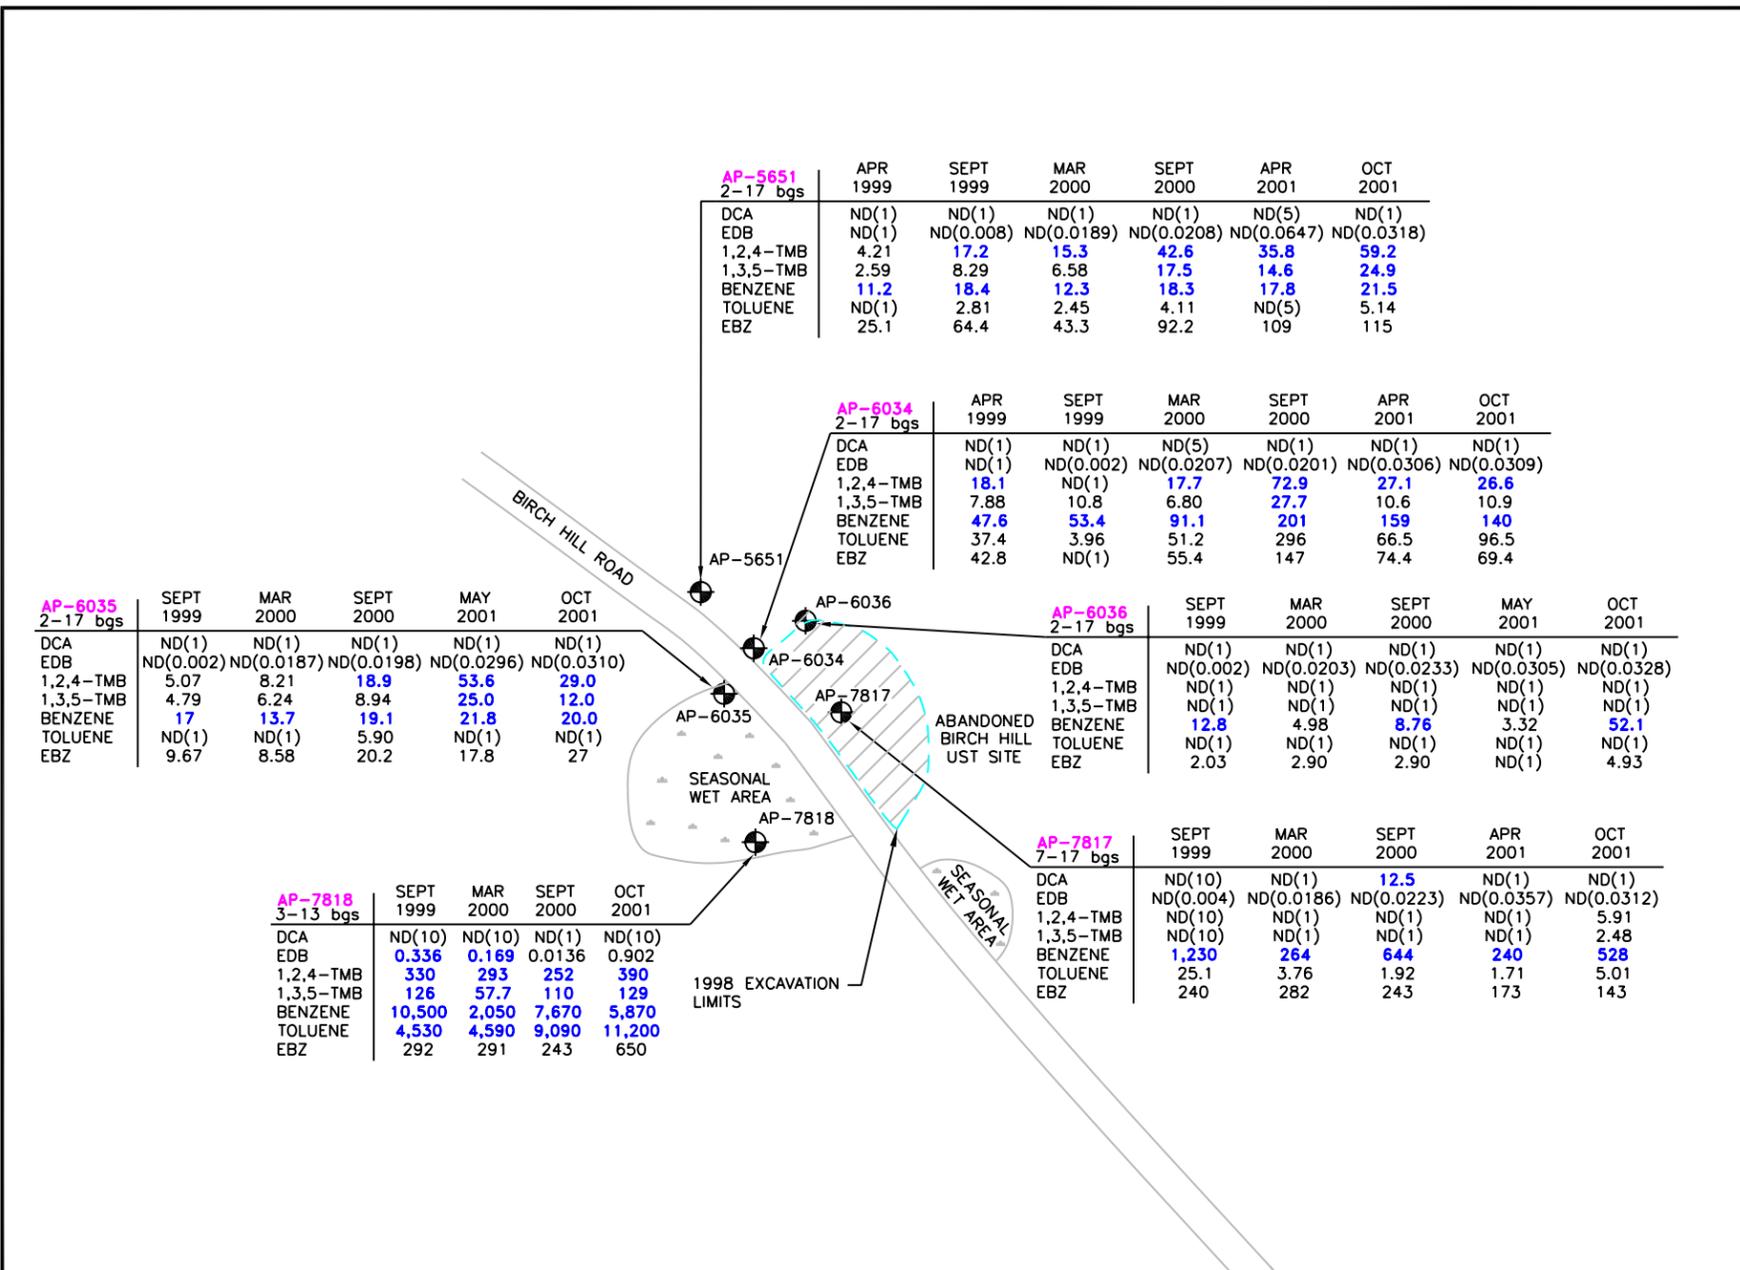
CONTRACT: DAC85-01-C-0018 FIGURE: 8 DATE: 8/02

Concentrations of Analytes in Groundwater - Milepost 2.7
 Explanation of Significant Differences
 Operable Unit 3
 Fort Wainwright, Alaska

Groundwater monitoring has been conducted semi-annually at Milepost 2.7 and 3.0 to evaluate the progress towards achieving RAOs. At Milepost 2.7, benzene concentrations remained above the ROD cleanup levels in each of the six monitoring wells during at least one of the 2001 sampling events. In general, a decreasing trend in groundwater concentrations is not yet evident. Figure 8 presents a summary of groundwater contaminant concentrations in Milepost 2.7 monitoring wells. At Milepost 3.0, the ROD cleanup goal for benzene was also exceeded in samples collected from all monitoring wells during both of the 2001 sampling events. However, significant decreases in benzene concentrations were evident in two downgradient wells, AP-7821 and AP-5850. The decreasing benzene trend in these downgradient wells may be a result of the source removal that was conducted as part of the 2000 pilot study. Figure 9 presents a summary of groundwater contaminant concentrations in Milepost 3.0 monitoring wells.

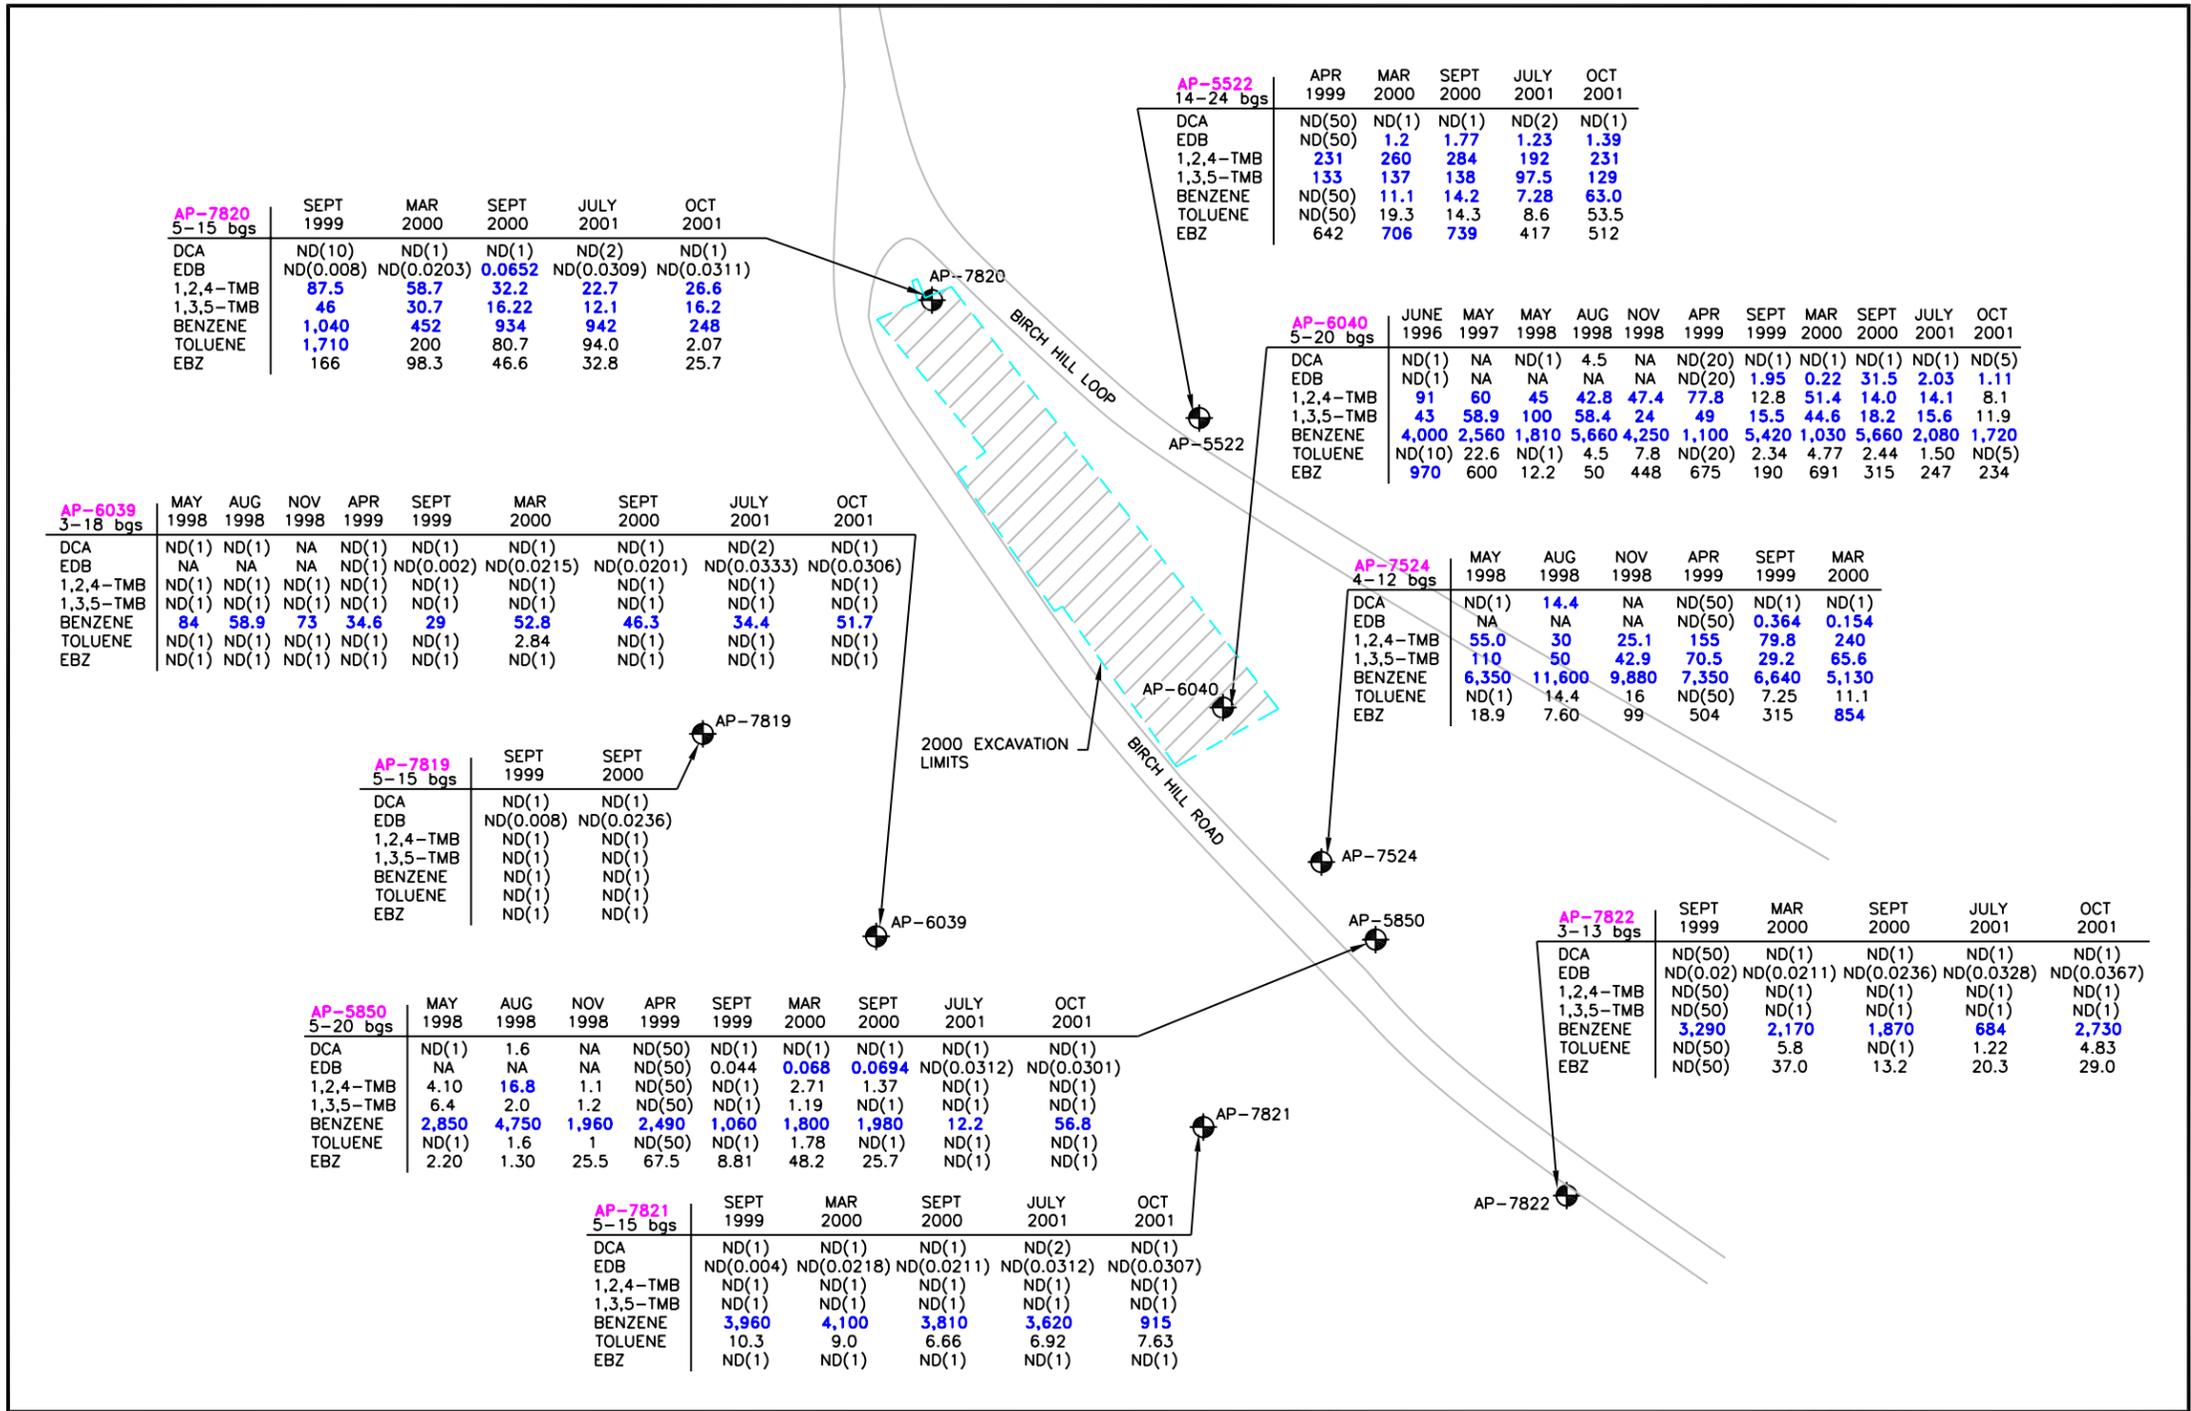
AP-7820
5-15 bgs

SEPT 1999	MAR 2000	SEPT 2000	JULY 2001	OCT 2001
DCA	ND(10)	ND(1)	ND(1)	ND(2)	ND(1)
EDB	ND(0.008)	ND(0.0203)	0.0652	ND(0.0309)	ND(0.0311)
1,2,4-TMB	87.5	58.7	32.2	22.7	26.6
1,3,5-TMB	46	30.7	16.22	12.1	16.2
BENZENE	1,040	452	934	942	248
TOLUENE	1,710	200	80.7	94.0	2.07
EBZ	166	98.3	46.6	32.8	25.7
