# Second Five-Year Review

## **Bremerton Naval Complex**

Bremerton, Washington

**Naval Facilities Engineering Command Northwest**

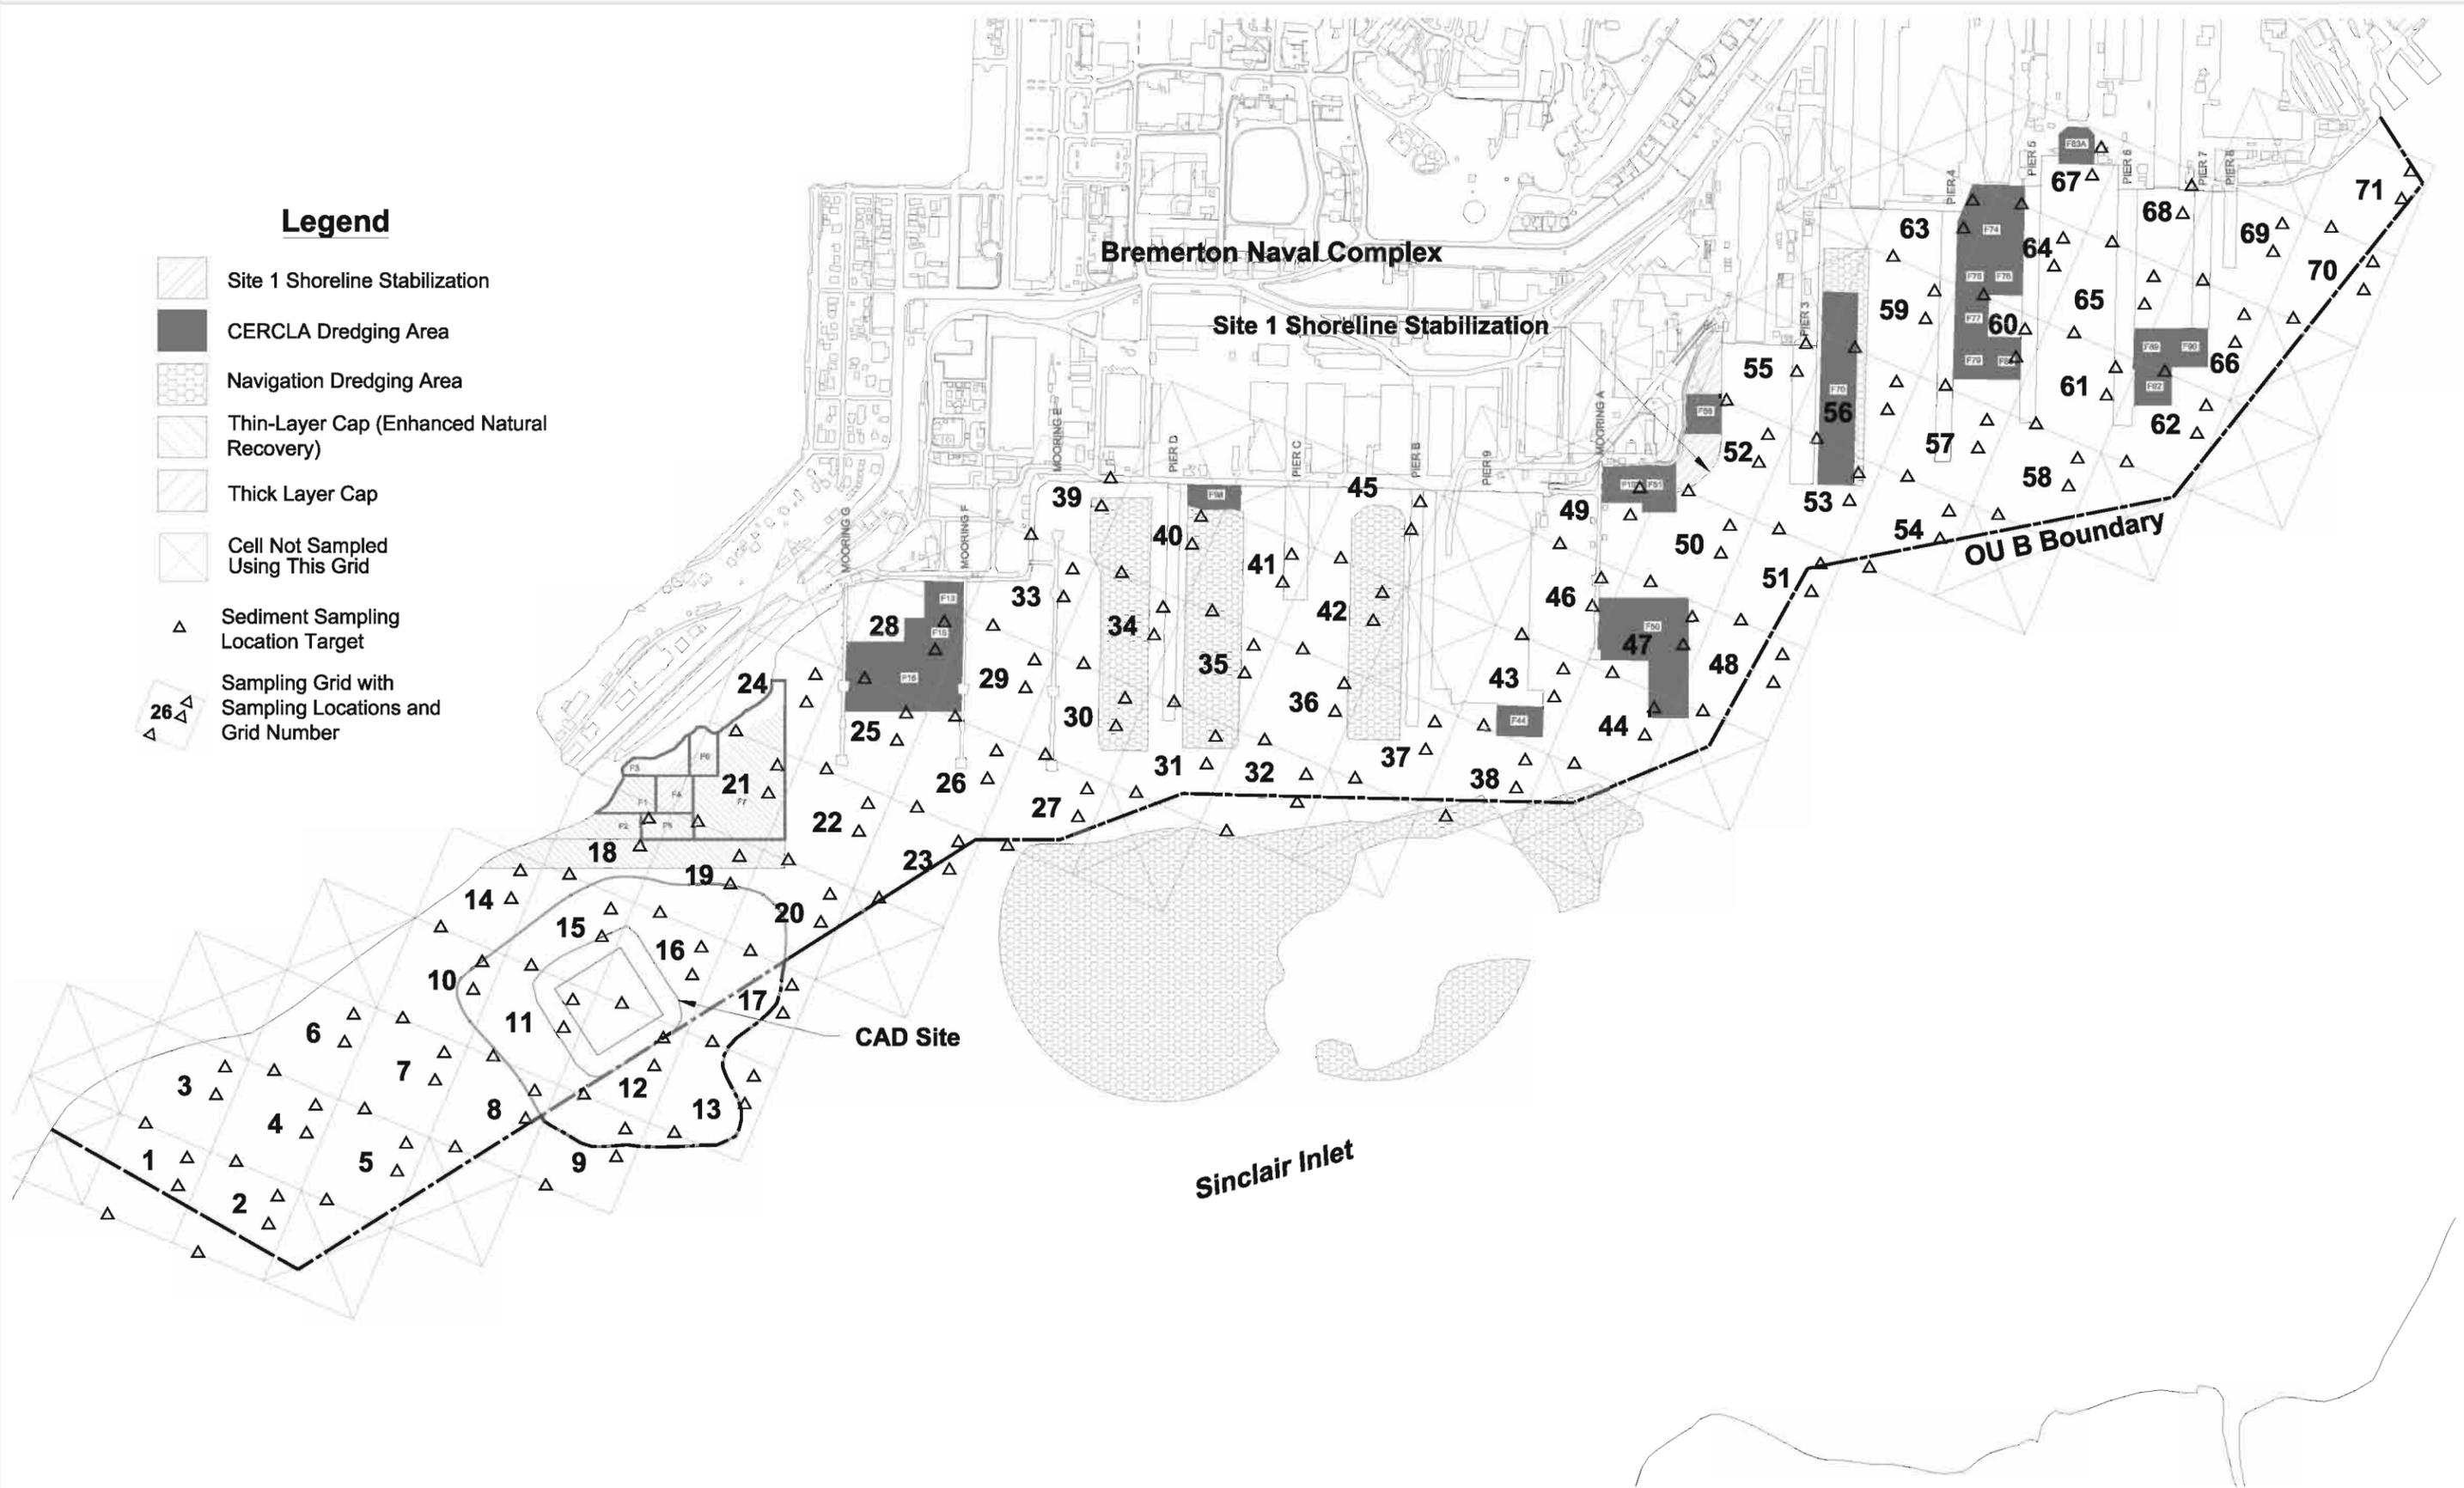
**Figure 6-4**  
**OU B Marine**  
**500-Foot Sampling Grid**

Sampling Grid with Sampling Locations and Grid Number

Figure 6-4 shows the 500-foot square grid used to guide the primary marine sediment sampling within OU B Marine, and Figure 6-5 shows the 1,500-foot grid used to guide sampling in the

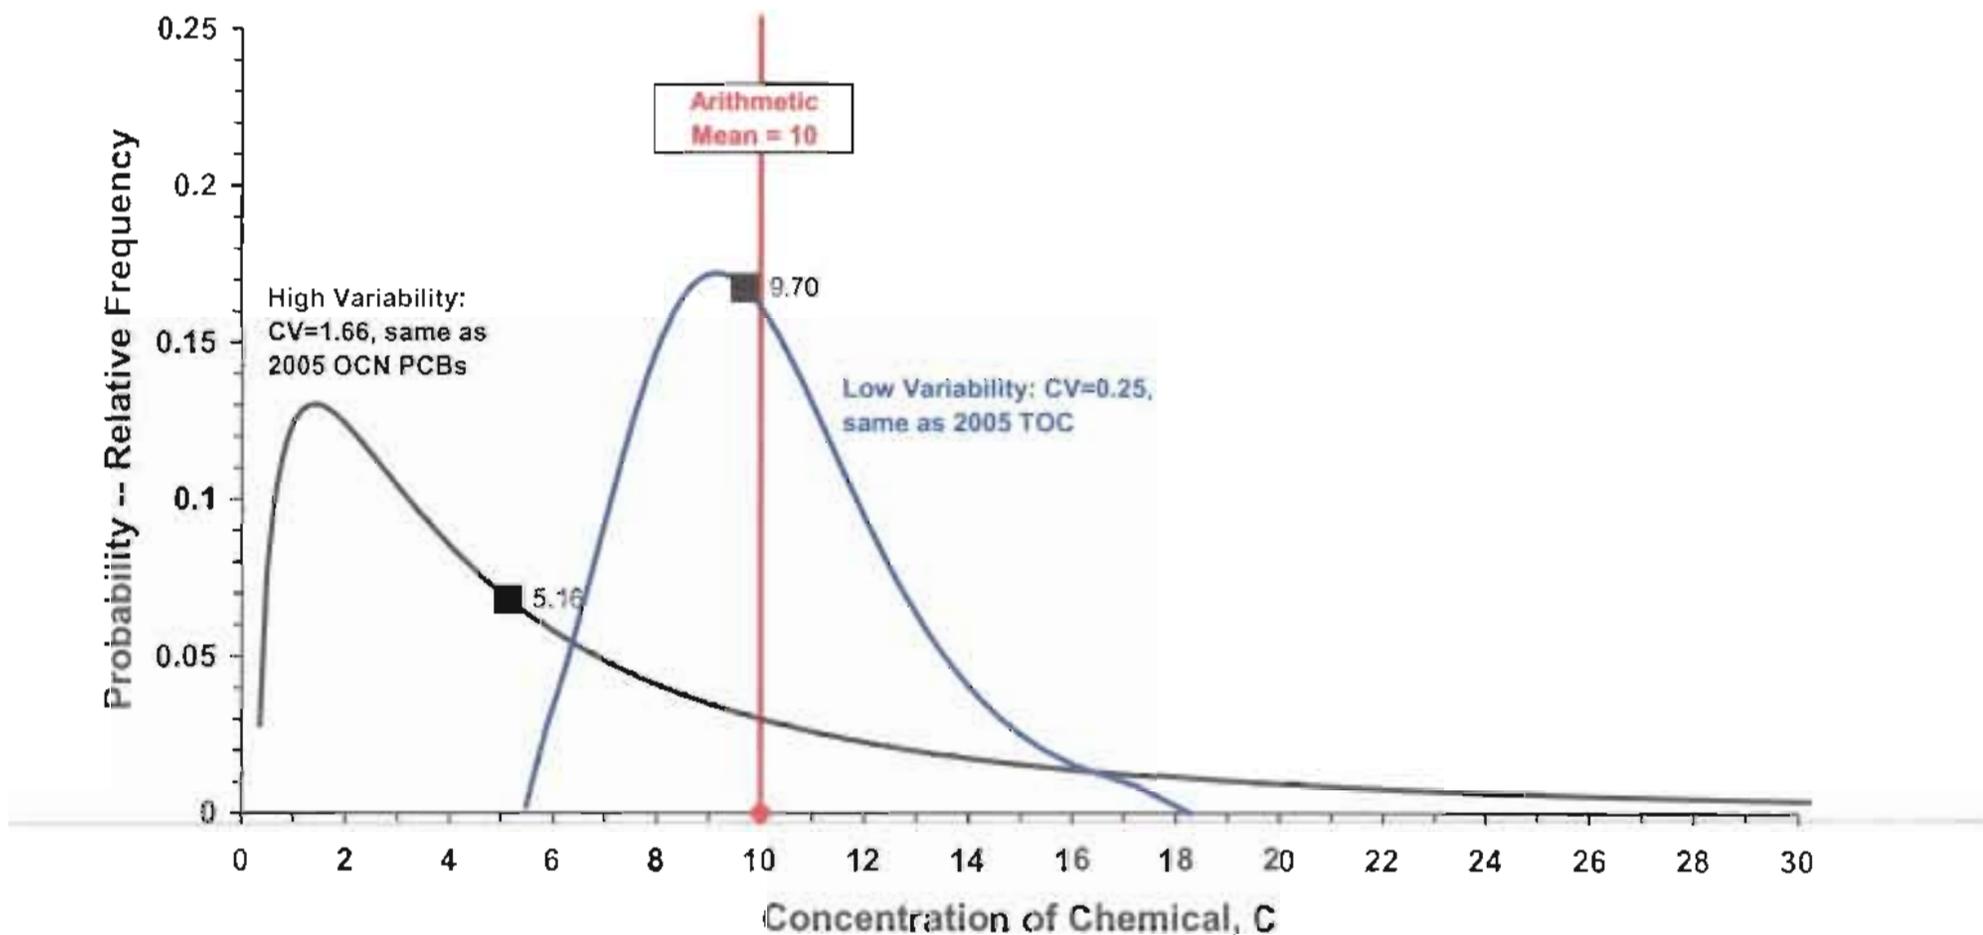
### Illustration of Geomean v. Arithmetic Mean for Two Lognormal Distributions Having The Same Arithmetic Mean

◆ Arithmetic Mean = 10   ■ Geomean   — CV[C] = 1.66   — CV[C] = 0.25

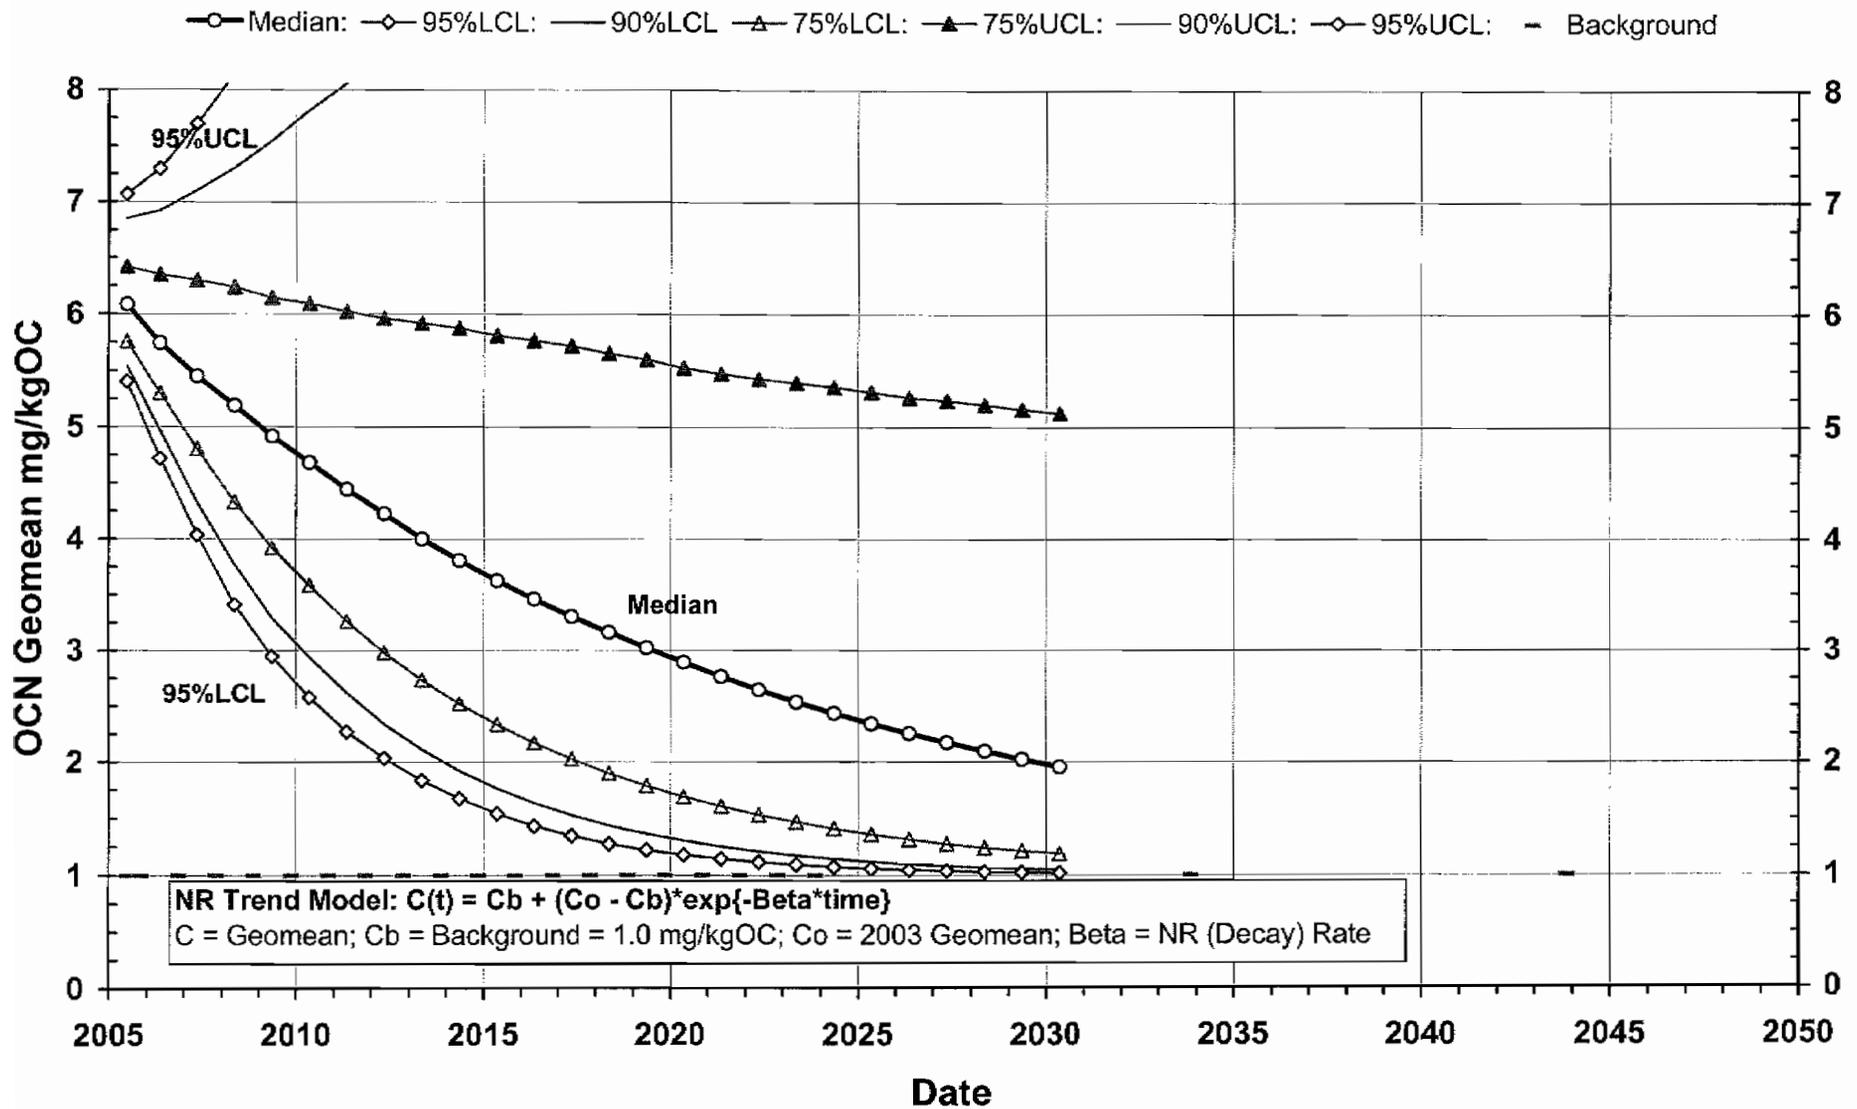
### Natural Recovery Trend Analysis -- 500-ft Grid Cells: Projected OCN Geomean from Bootstrapped 2003 and 2005 Geomeans -- Minimum Assumptions

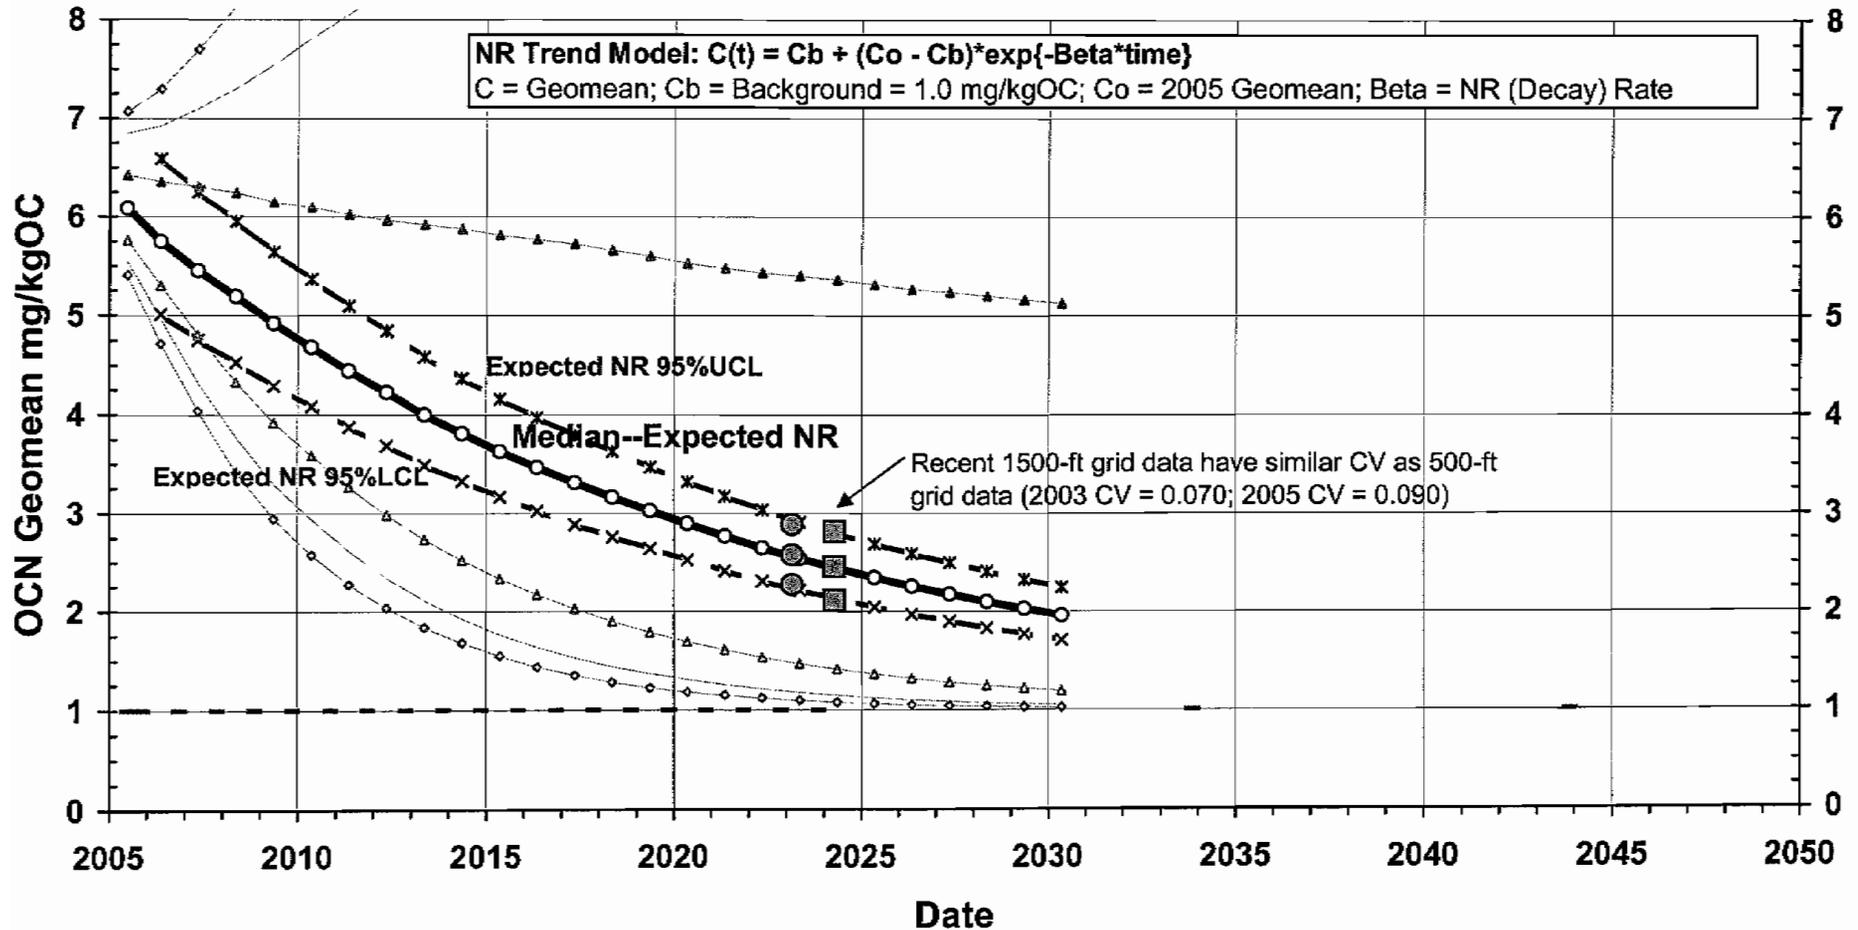
### Expected Natural Recovery 500-ft Grid Cells, OCN PCB Geomean

Estimated from Projected 2003 and 2005 OCN Geomean Sampling Distributions, assuming constant CV equal to 2005 CV of Geomean Sampling Distribution (2005 CV = 0.083; 2003 CV = 0.089)

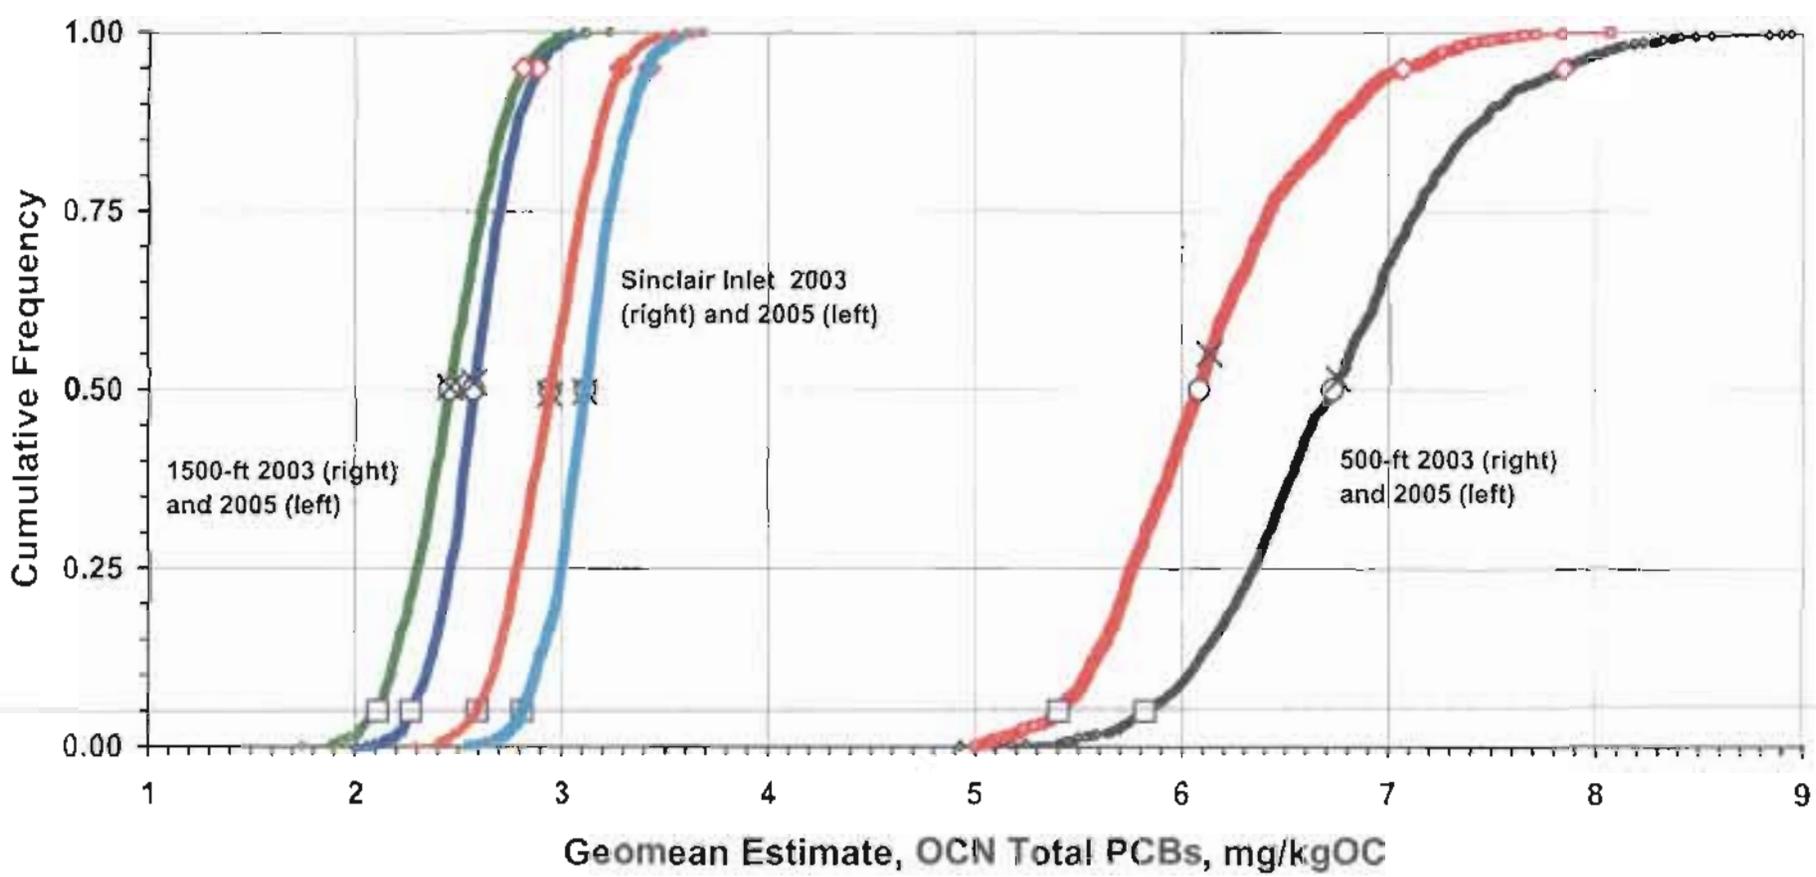
### Bootstrapped Estimate of OCN Total PCBs Geomean Sampling Distribution Cumulative Frequency Represents Estimated Probability True Geomean < Estimate

- 2003 500-ft OCN Geomean
- 2005 500-ft OCN Geomean
- 2003 1500-ft OCN Geomean
- 2005 1500-ft OCN Geomean
- 95%LCL on Geomean:
- Median Estimate:
- ◇ 95%UCL on Geomean:
- × Arithmetic Average:
- 2003 Sinclair Inlet OCN Geomean
- 2005 Sinclair Inlet OCN Geomean

**Bootstrapped Estimate of Geomean Sampling Distribution (B=1,000 resamples of sample data)**  
**Based on OCN Total PCBs Revised Reported-Columns, R2 (Nov 6, 2006)**
