SUBAREA 5B FSP ADDENDUM
REVISION 1
SANTA SUSANA FIELD LABORATORY SITE
AREA IV RADIOLOGICAL STUDY

TO: Craig Cooper, USEPA Region 9 RPM
FROM: Rene R. Rodriguez, P.E., HGL Deputy Project Manager
THROUGH: L. Steven Vaughn, R.G., HGL Project Manager
CC: Mary Aycock, USEPA Region 9 RPM
Nicole Moutoux, USEPA Region 9 RPM
Gregg Dempsey, Technical Advisor
DATE: March 2, 2011
SUBJECT: FSP Addendum for Subarea 5B Revision 1
CONTRACT NO: EP-S7-05-05
TASK ORDER NO: 0038

The purpose of this document is to implement Revision 1 of the Subarea 5B FSP Addendum. The scope of Revision 1 is to document the rationale for Round 1 soil sample locations in Group 8 of Subarea 5B that are located within or near the 17th Street drainage area.

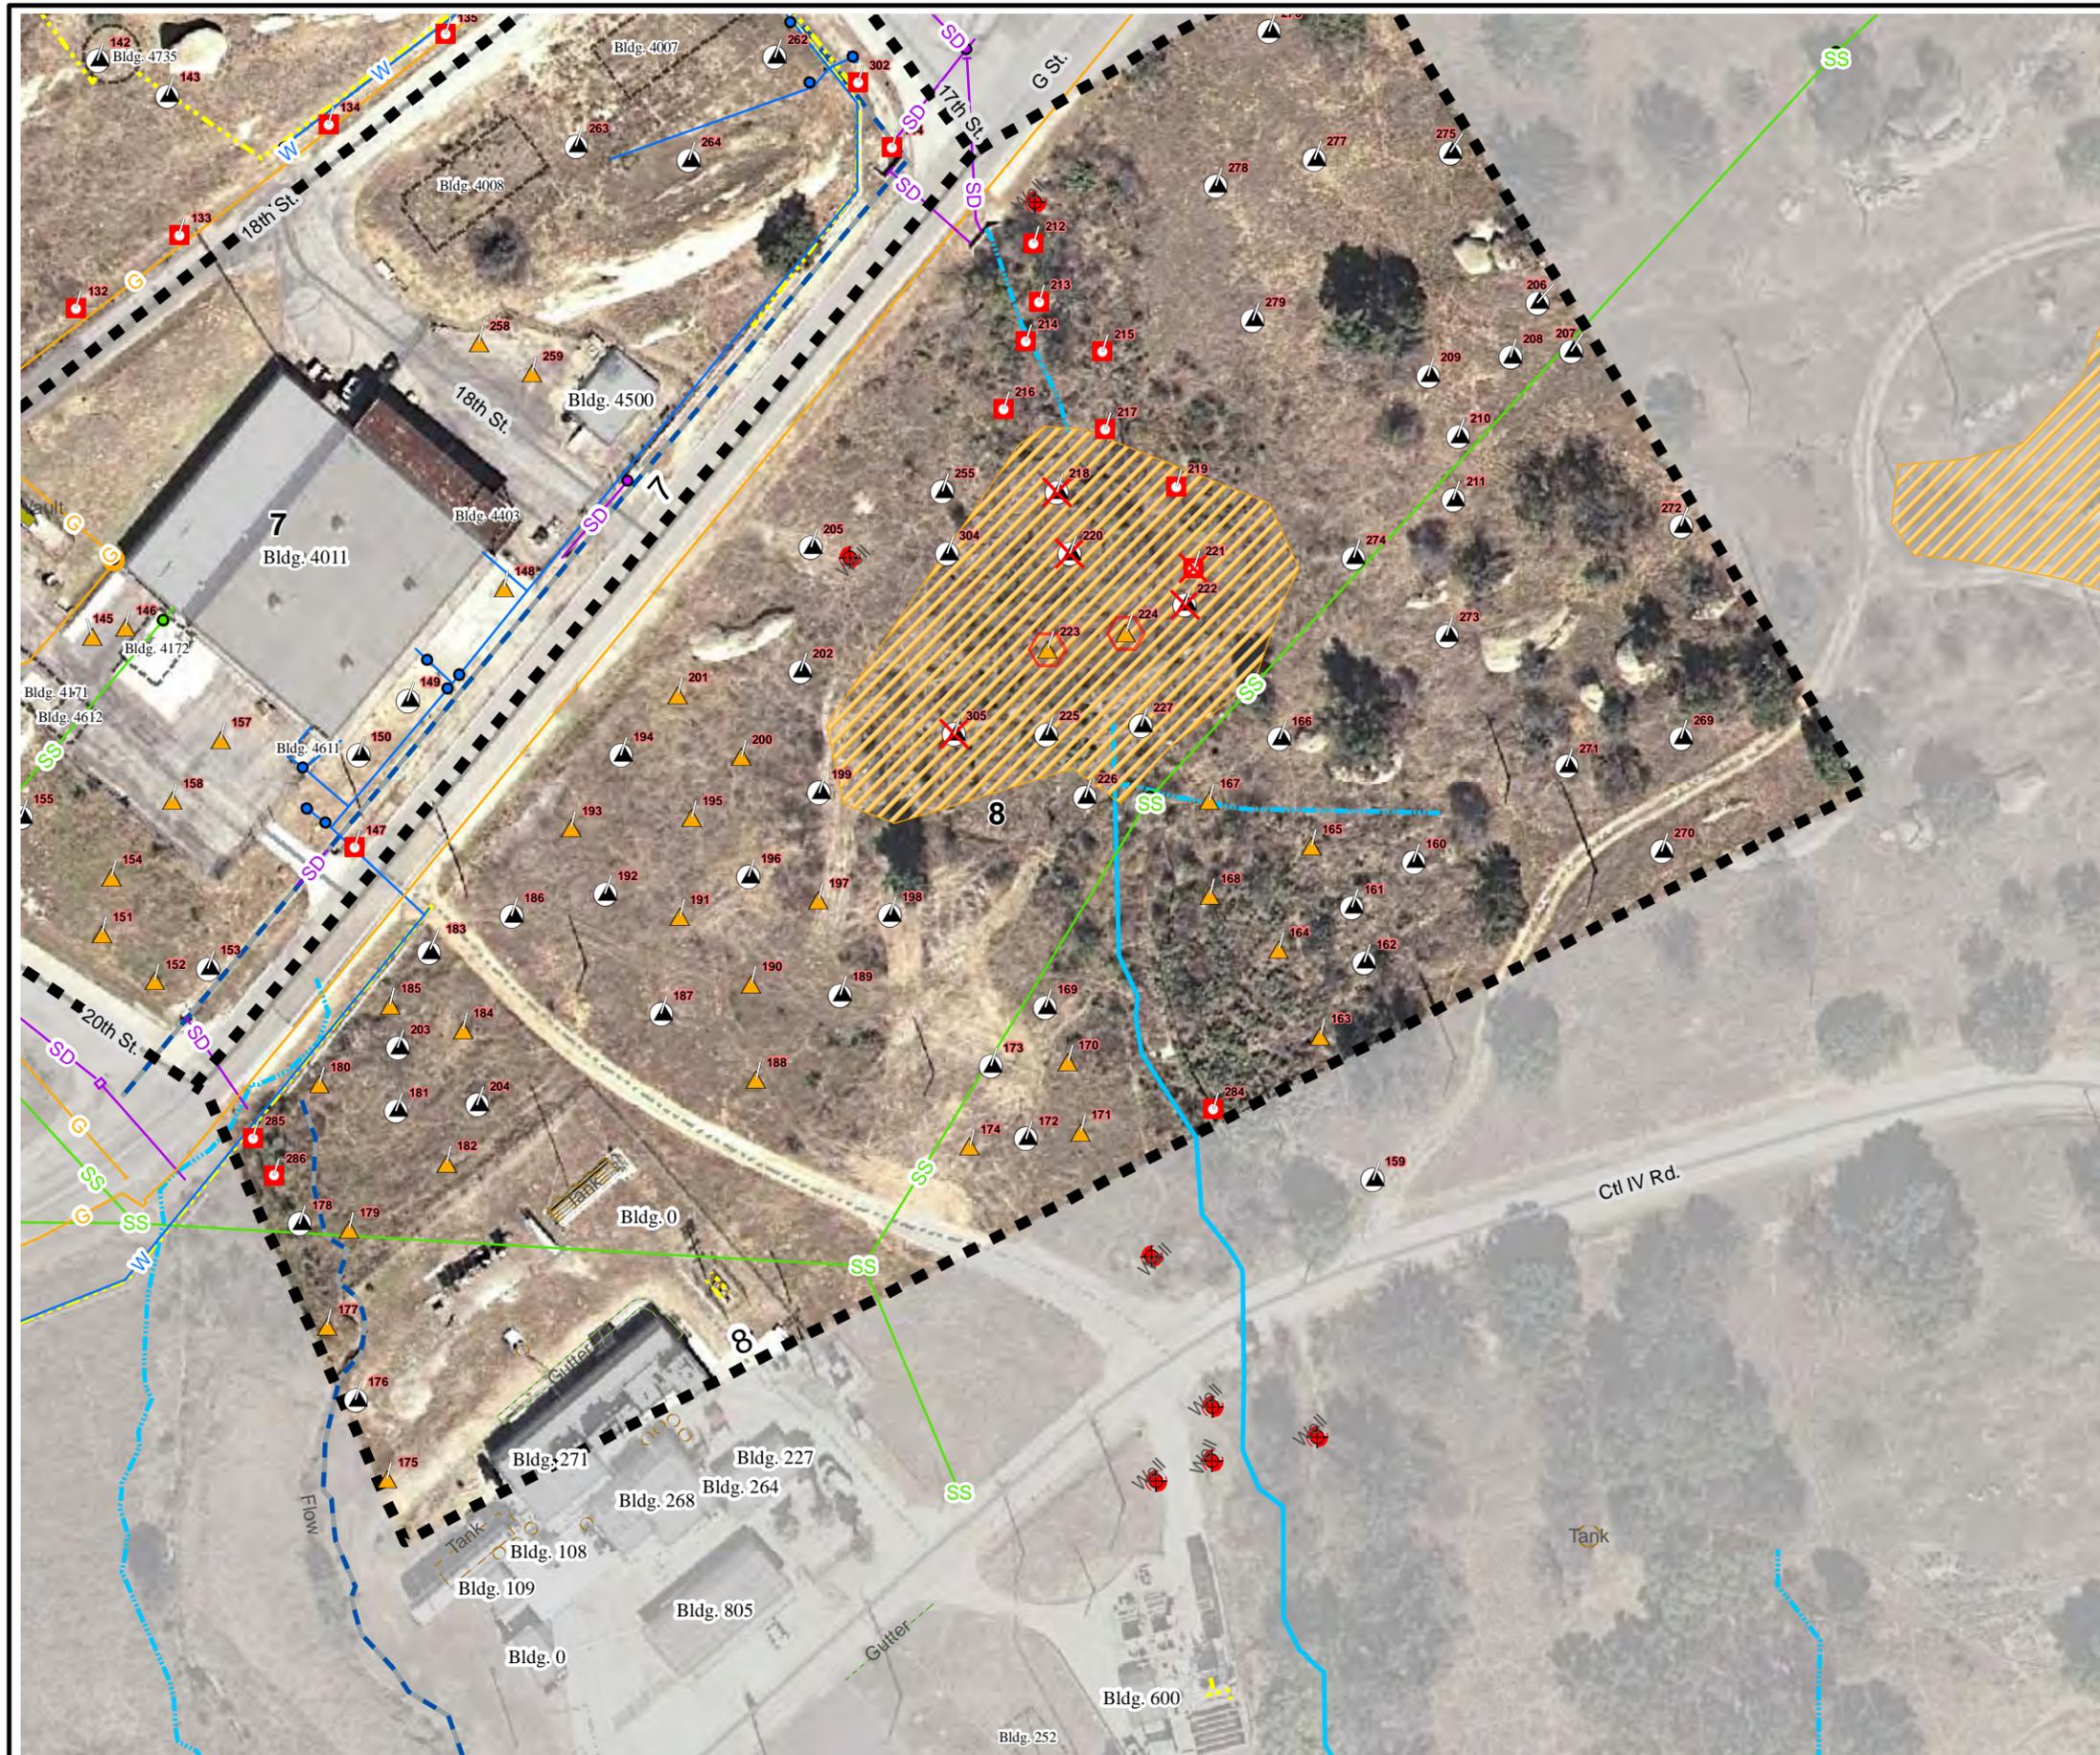
Likely Remediation Zones

(Grayed Symbols Represent Soil Samples from Previous Subareas)

zone. To illustrate this change, Table 1, Table 2 and Figure 9 of the 5B FSP Addendum were revised to reflect this change and are presented below.
