**FIVE-YEAR REVIEW REPORT**  
**FOR**  
**PHOENIX-GOODYEAR AIRPORT (NORTH)**  
**SUPERFUND SITE**  
**GOODYEAR, ARIZONA**

**September 2006**

**Prepared for**  
**Contract No. 68-W-98-225/WA NO. 238**  
**United States Environmental Protection Agency**  
**Region 9**  
**75 Hawthorne Street**  
**San Francisco, California 94105**

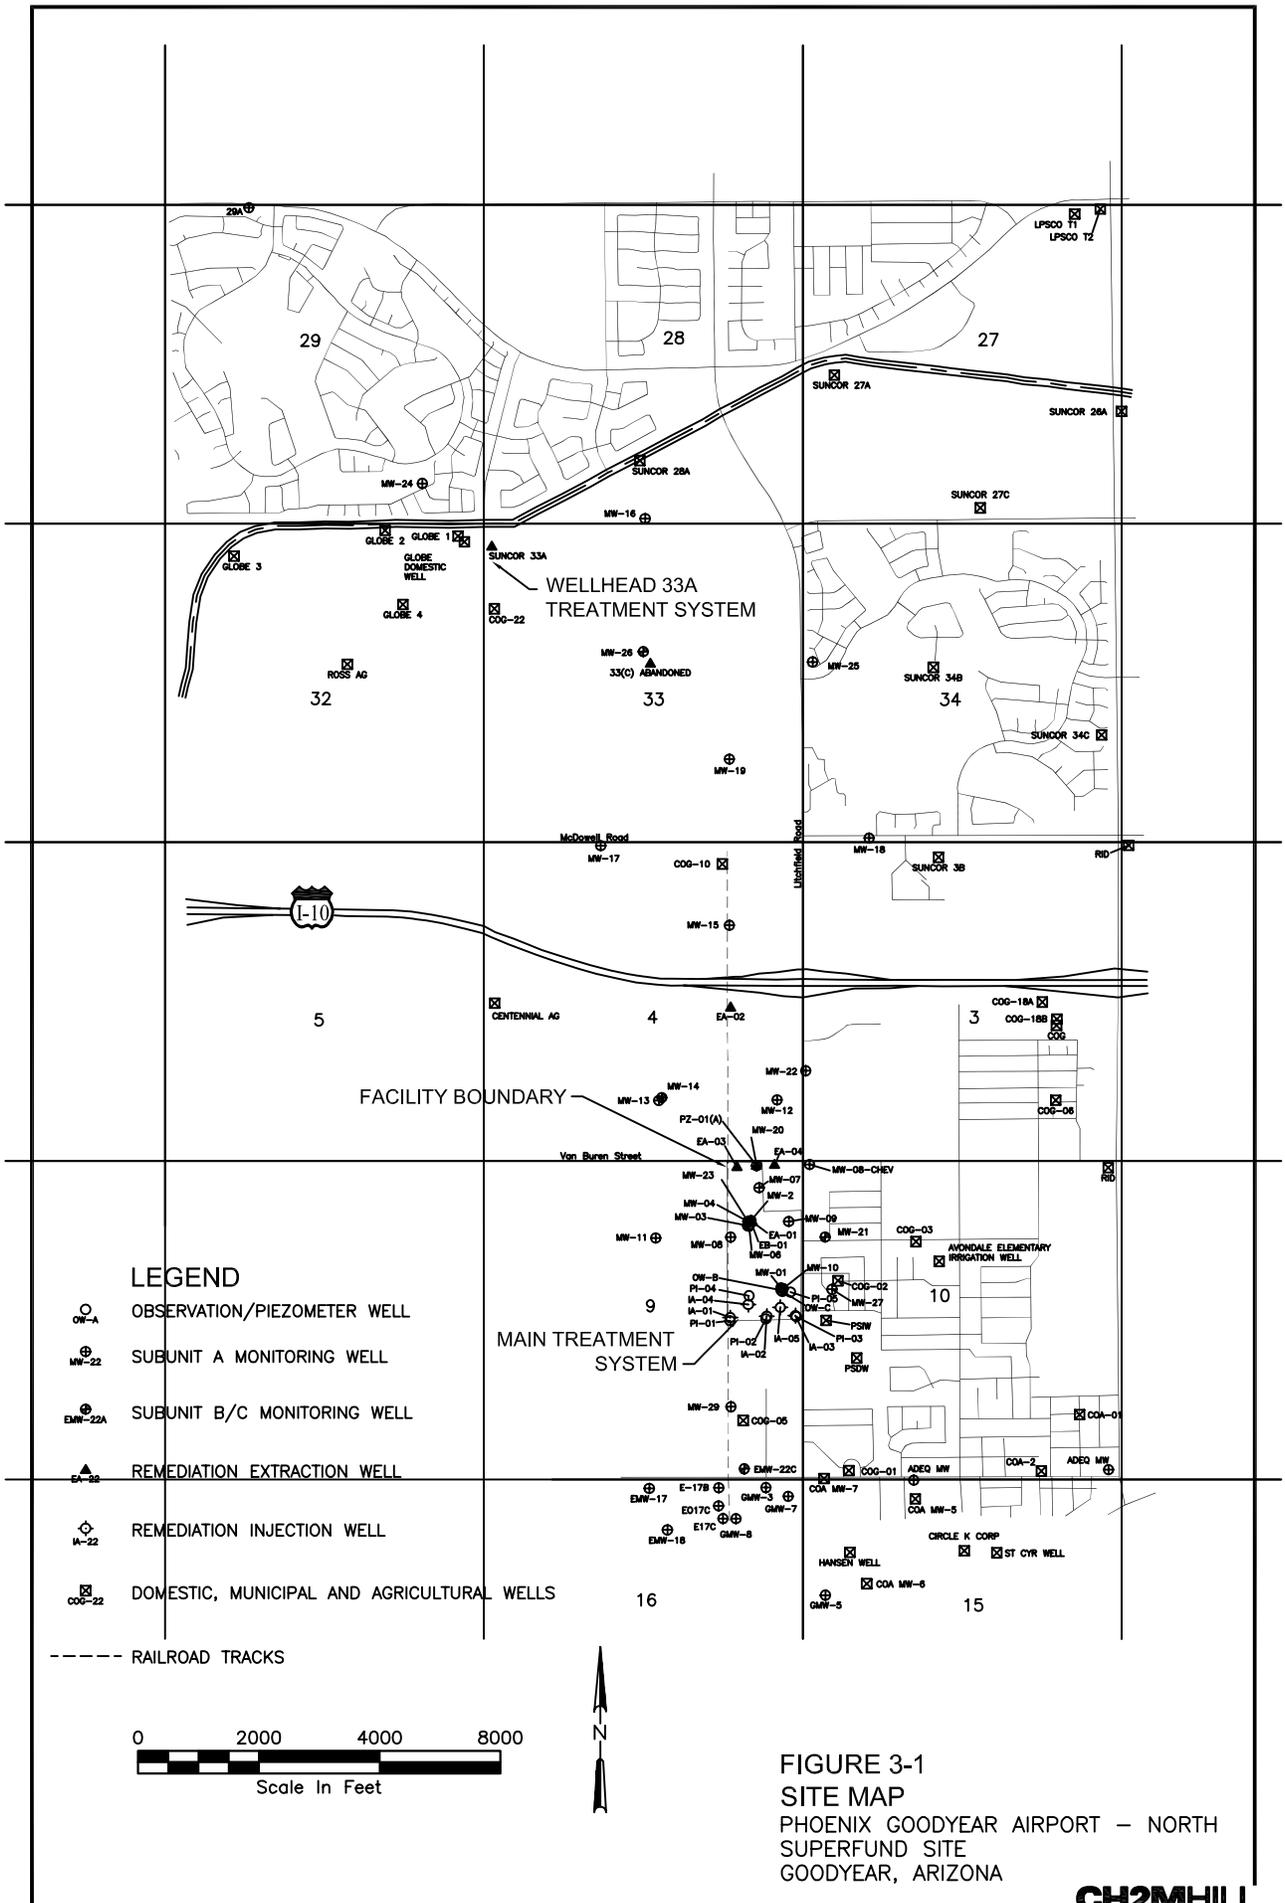
**3-1**      **Area Map Showing Subunit A and C Wells and Treatment Systems**      **Figure**

- OW-A OBSERVATION/PIEZOMETER WELL
- ⊕ MW-22 SUBUNIT A MONITORING WELL
- ⊕ EMW-22A SUBUNIT B/C MONITORING WELL
- ▲ EA-25 REMEDIATION EXTRACTION WELL
- ◇ IA-22 REMEDIATION INJECTION WELL
- ⊠ COG-22 DOMESTIC, MUNICIPAL AND AGRICULTURAL WELLS
- RAILROAD TRACKS
