In the Matter of John Laughter
Docket Number TSCA-01-2010-007

Exhibit 5
First Notice of Violation—92 Benefit Street and attached RWE
Environmental Report

NOTICE OF VIOLATION

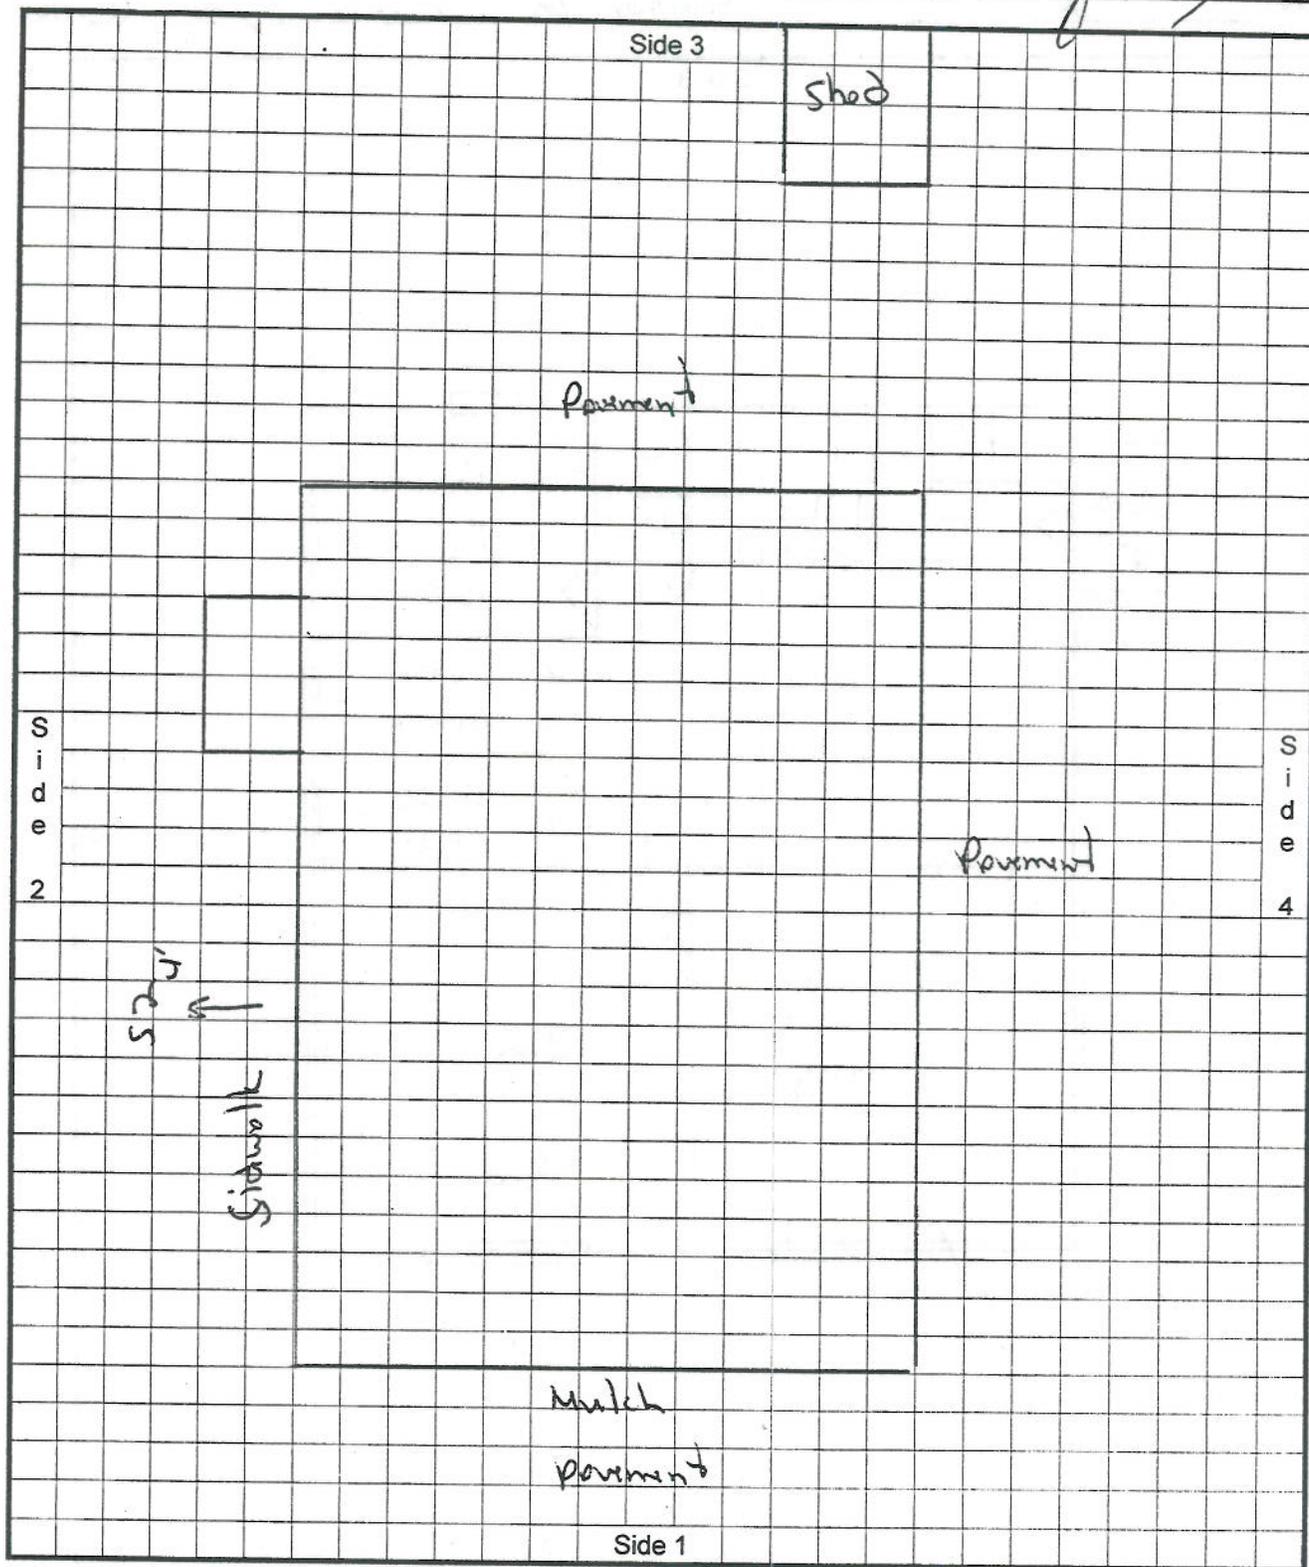
Apt/Floor: Exterior

Street/City: 92 Benefit St. Woon.

Name of Street which 'Side 1' is facing: Benefit St.

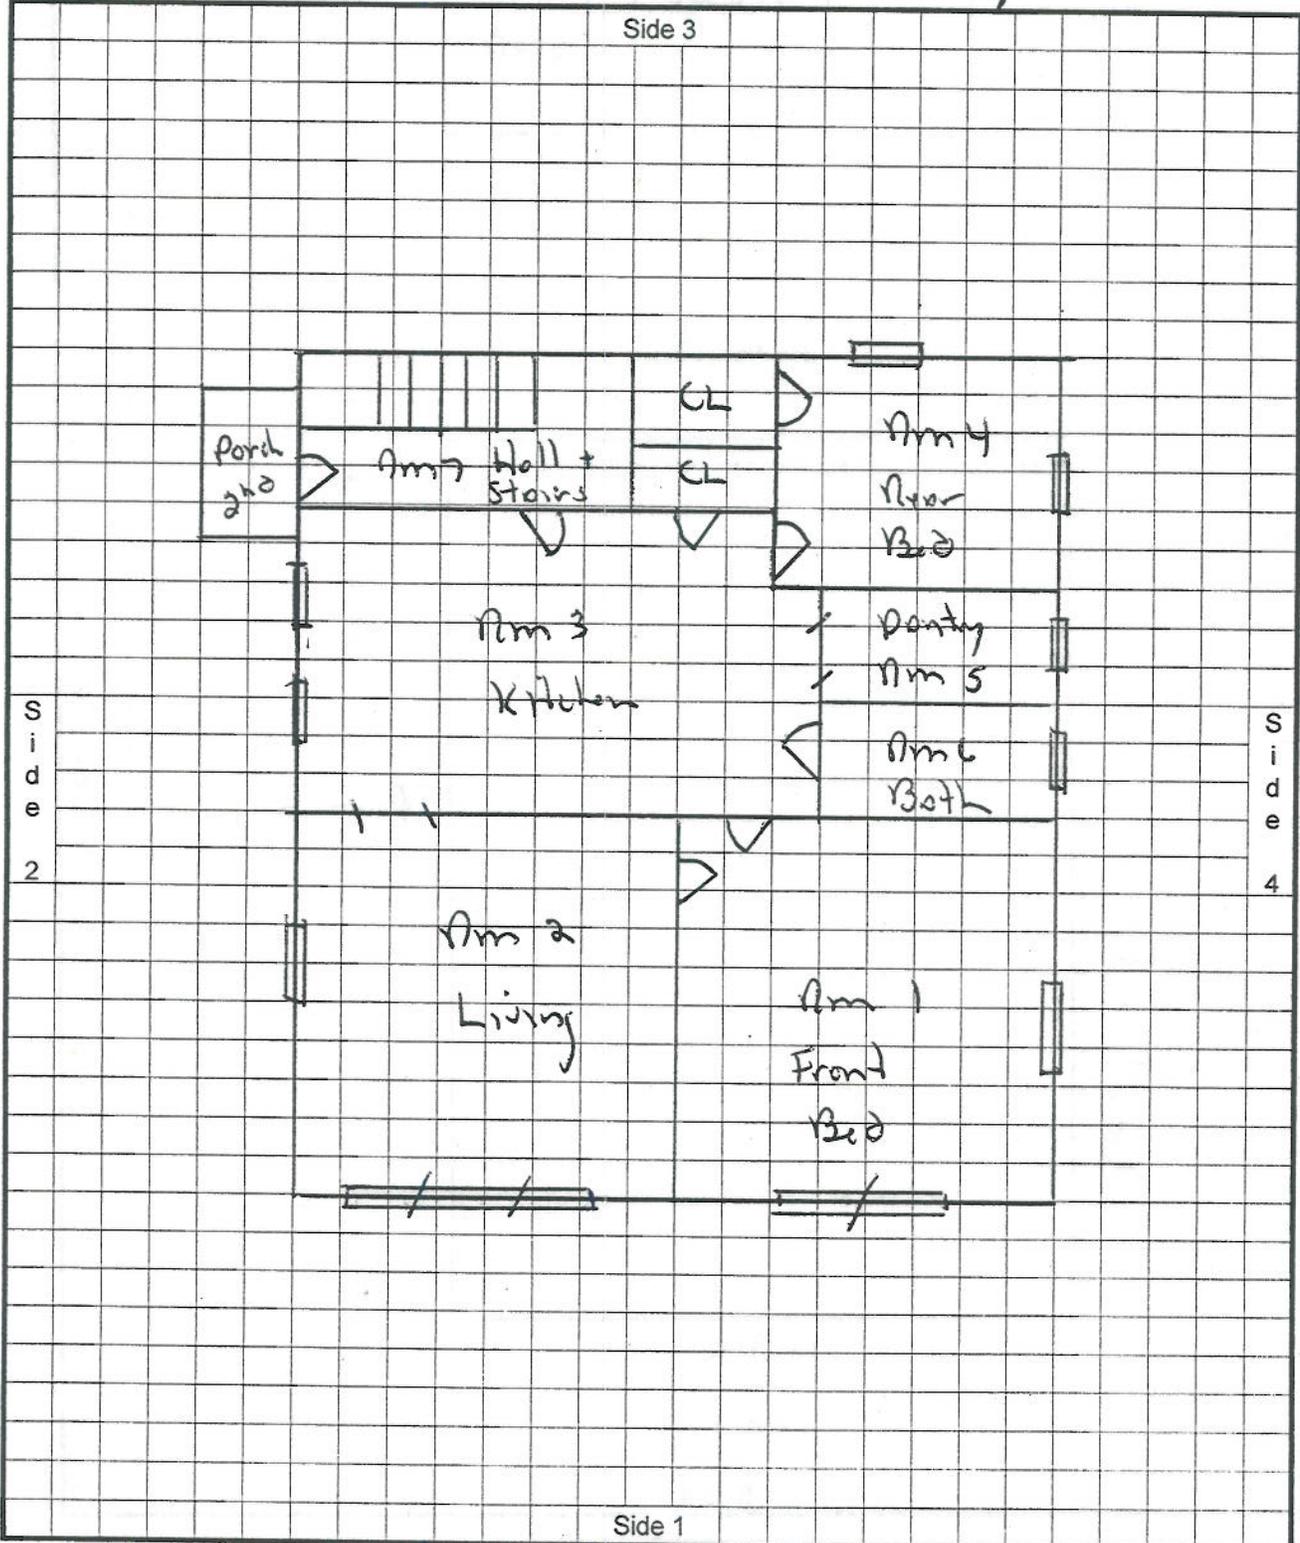
FLOOR PLAN - PROPERTY SKETCH (GRID)

Apt/Floor: 2 Street/City: 92 Benefit St. Woon.

Name of Street which 'Side 1' is facing: Benefit St.
