Engineering Concepts

Reclamation Plan

Church Rock Site
Gallup, New Mexico

UNC Mining and Milling
Gallup, New Mexico

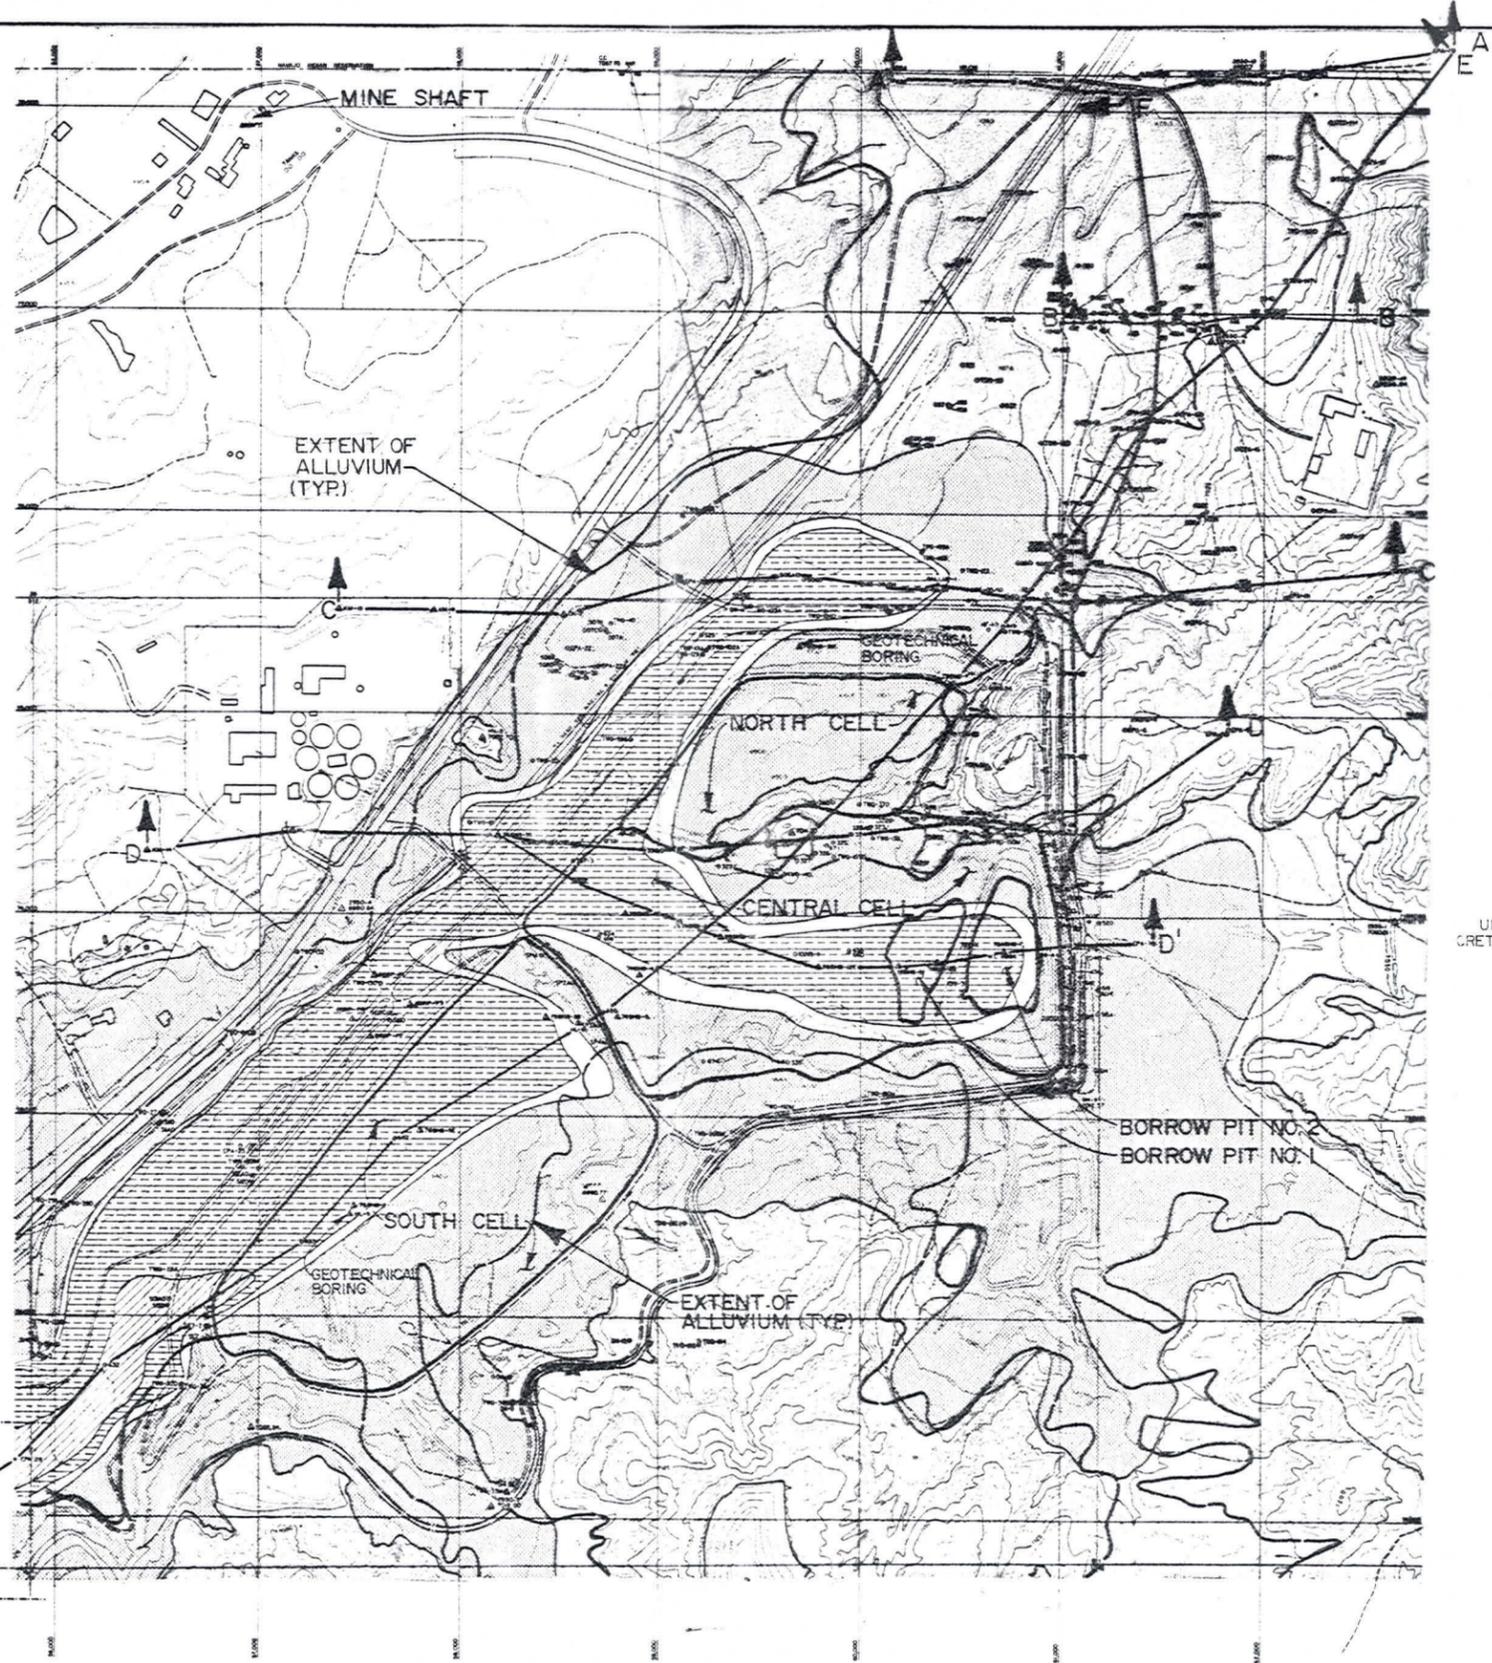
DATE: 2-27-87
 SCALE: AS SHOWN
 FIGURE 2
 DRAWING NUMBER RM86-060-E38

LEGEND:

- WELL
- GEOTECHNICAL BOREHOLE
- DEEP BOREHOLE
- CREVASSE CANYON FORMATION
DILCO COAL MEMBER (Kcdc)
- UPPER GALLUP SANDSTONE - ZONE 3 (KguZ₃)
- UPPER GALLUP SANDSTONE - ZONE 2 (KguZ₂)
- UPPER GALLUP SANDSTONE - ZONE 1 (KguZ₁)
- UPPER CRETACEOUS
- MANCOS SHALE - UPPER D-CROSS TONGUE MEMBER (Kmdu)

1. SEE FIGURE 3 FOR SECTIONS A-A, B-B AND C-C.
2. SEE FIGURE 4 FOR SECTION E-E.

Geology - The geology in the site area consists of Cretaceous age sandstones and shales overlain by Quaternary alluvium. As shown on Figure 2, the tailings area is located primarily on alluvium except in the northeast where bedrock is exposed at the surface. The bedrock present in the tailings area includes, in descending order:

According to the log for the UNC mine shaft sunk in 1968, water was first encountered at an elevation of approximately 6,700 feet. The location of the mine shaft is shown on Figure 2. The tailings disposal area is located at an approximate elevation of 6,980 feet. If a ground water system existed at a corresponding elevation of 6,700 feet under the tailings area, it would lie below the bottom elevation (6,800 feet) of Zone 1 (Figures 3 and 4).

completion of drilling (Figures 2 and 4). This boring was reportedly completed in alluvium. Furthermore, as shown on Section E-E (Figures 2 and 4), the bottom elevation of this borehole is below Zone 1. Borehole No. 76SHB-2W (1976) was drilled through alluvium and ~~Zone 3~~ and completed in the upper part of Zone 1 at an elevation of 6,820 feet (Section C-C, Figures 2 and 3). The borehole was reported to be dry with a possible perched zone at an elevation of about 6,932 feet. Therefore, both the alluvium and the Gallup in the vicinity of the UNC facility were unsaturated prior to the mining activities at the site.

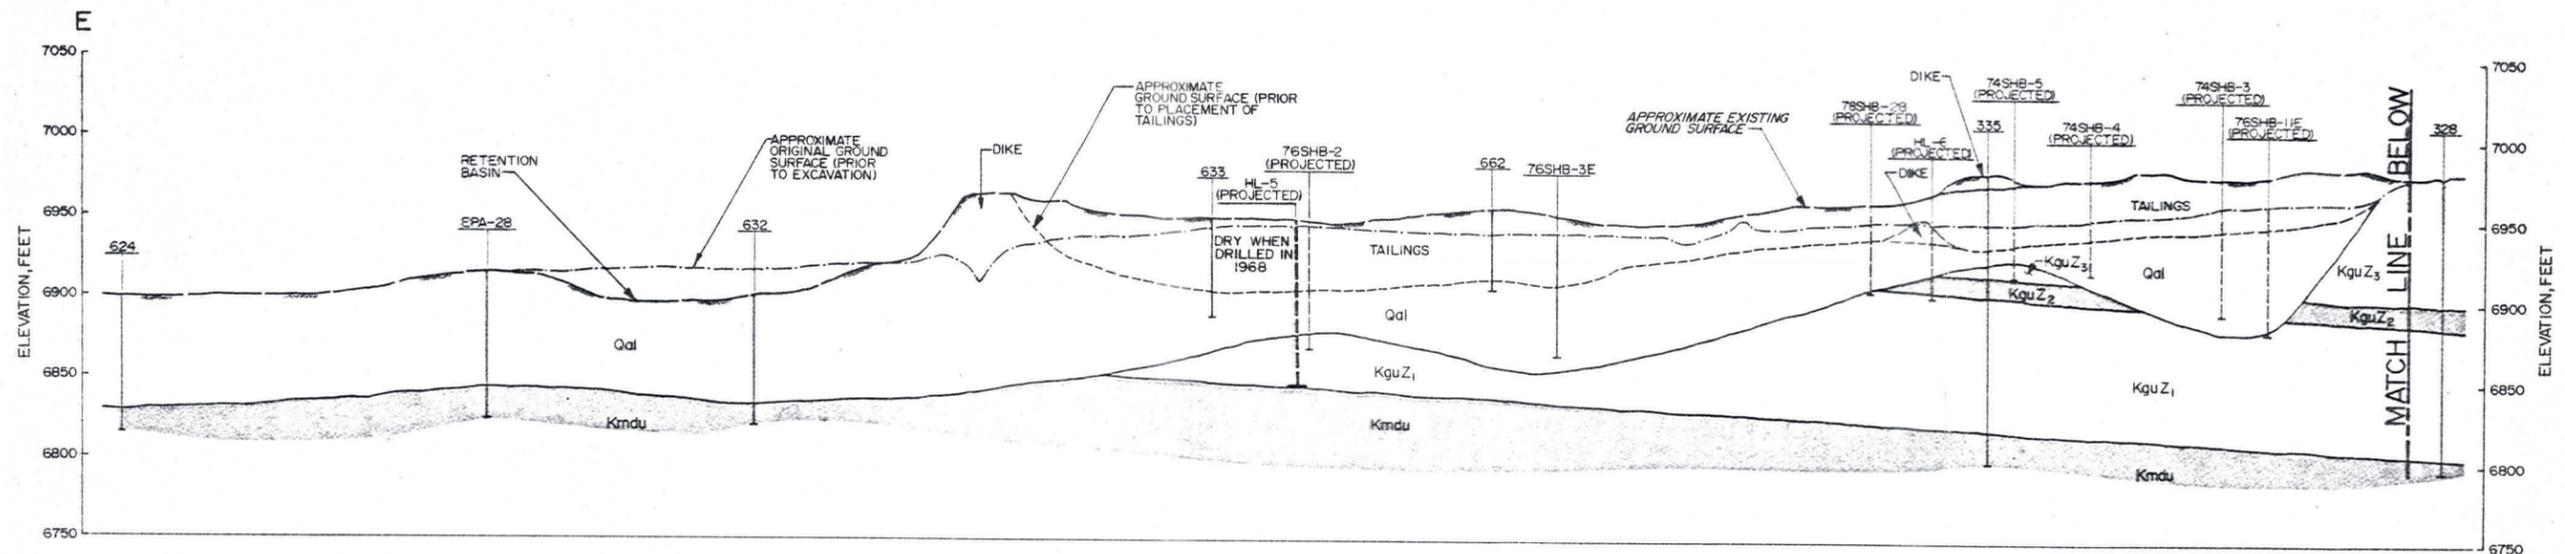
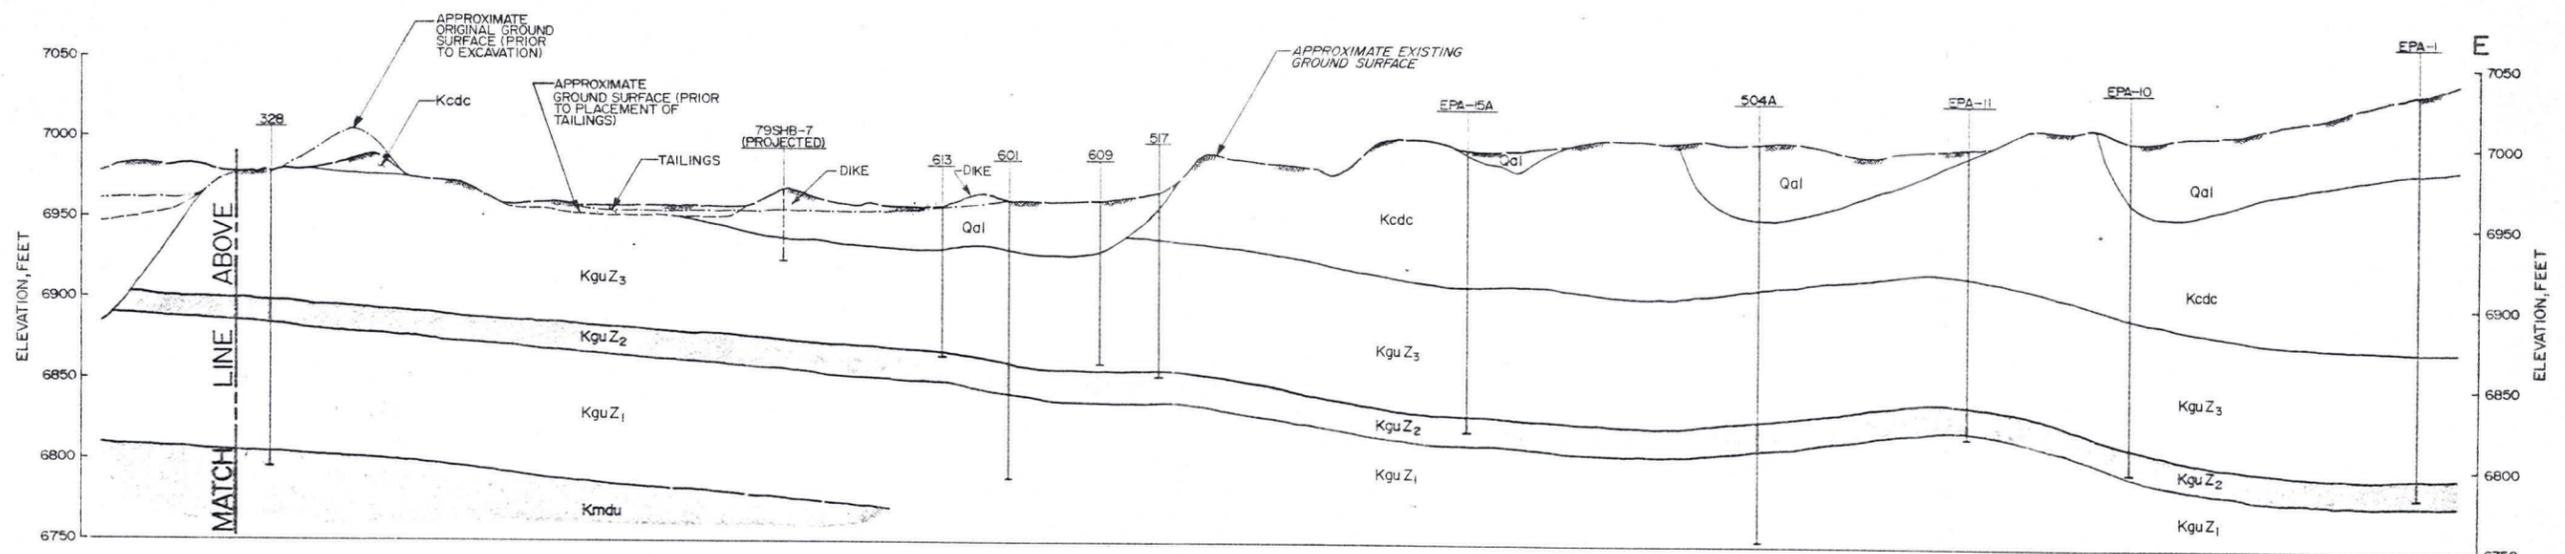
CROSS SECTION E-E
 PREPARED FOR
UNITED NUCLEAR CORPORATION
 GALLUP, NEW MEXICO
Canonie Environmental
 DATE: 1-5-87
 SCALE: AS SHOWN
 FIGURE 4
 DRAWING NUMBER
 RM86-060-E11

SECTION E-E
(LOOKING NORTHWEST)

- LEGEND:**
- QUATERNARY
 - Qal ALLUVIUM
 - Kdc CREVASSE CANYON FORMATION
DILCO COAL MEMBER
 - Kgu Z₃ UPPER GALLUP SANDSTONE-ZONE 3
 - Kgu Z₂ UPPER GALLUP SANDSTONE-ZONE 2
 - Kgu Z₁ UPPER GALLUP SANDSTONE-ZONE 1
 - Kmdu MANCOS SHALE-
UPPER D-CROSS TONGUE MEMBER

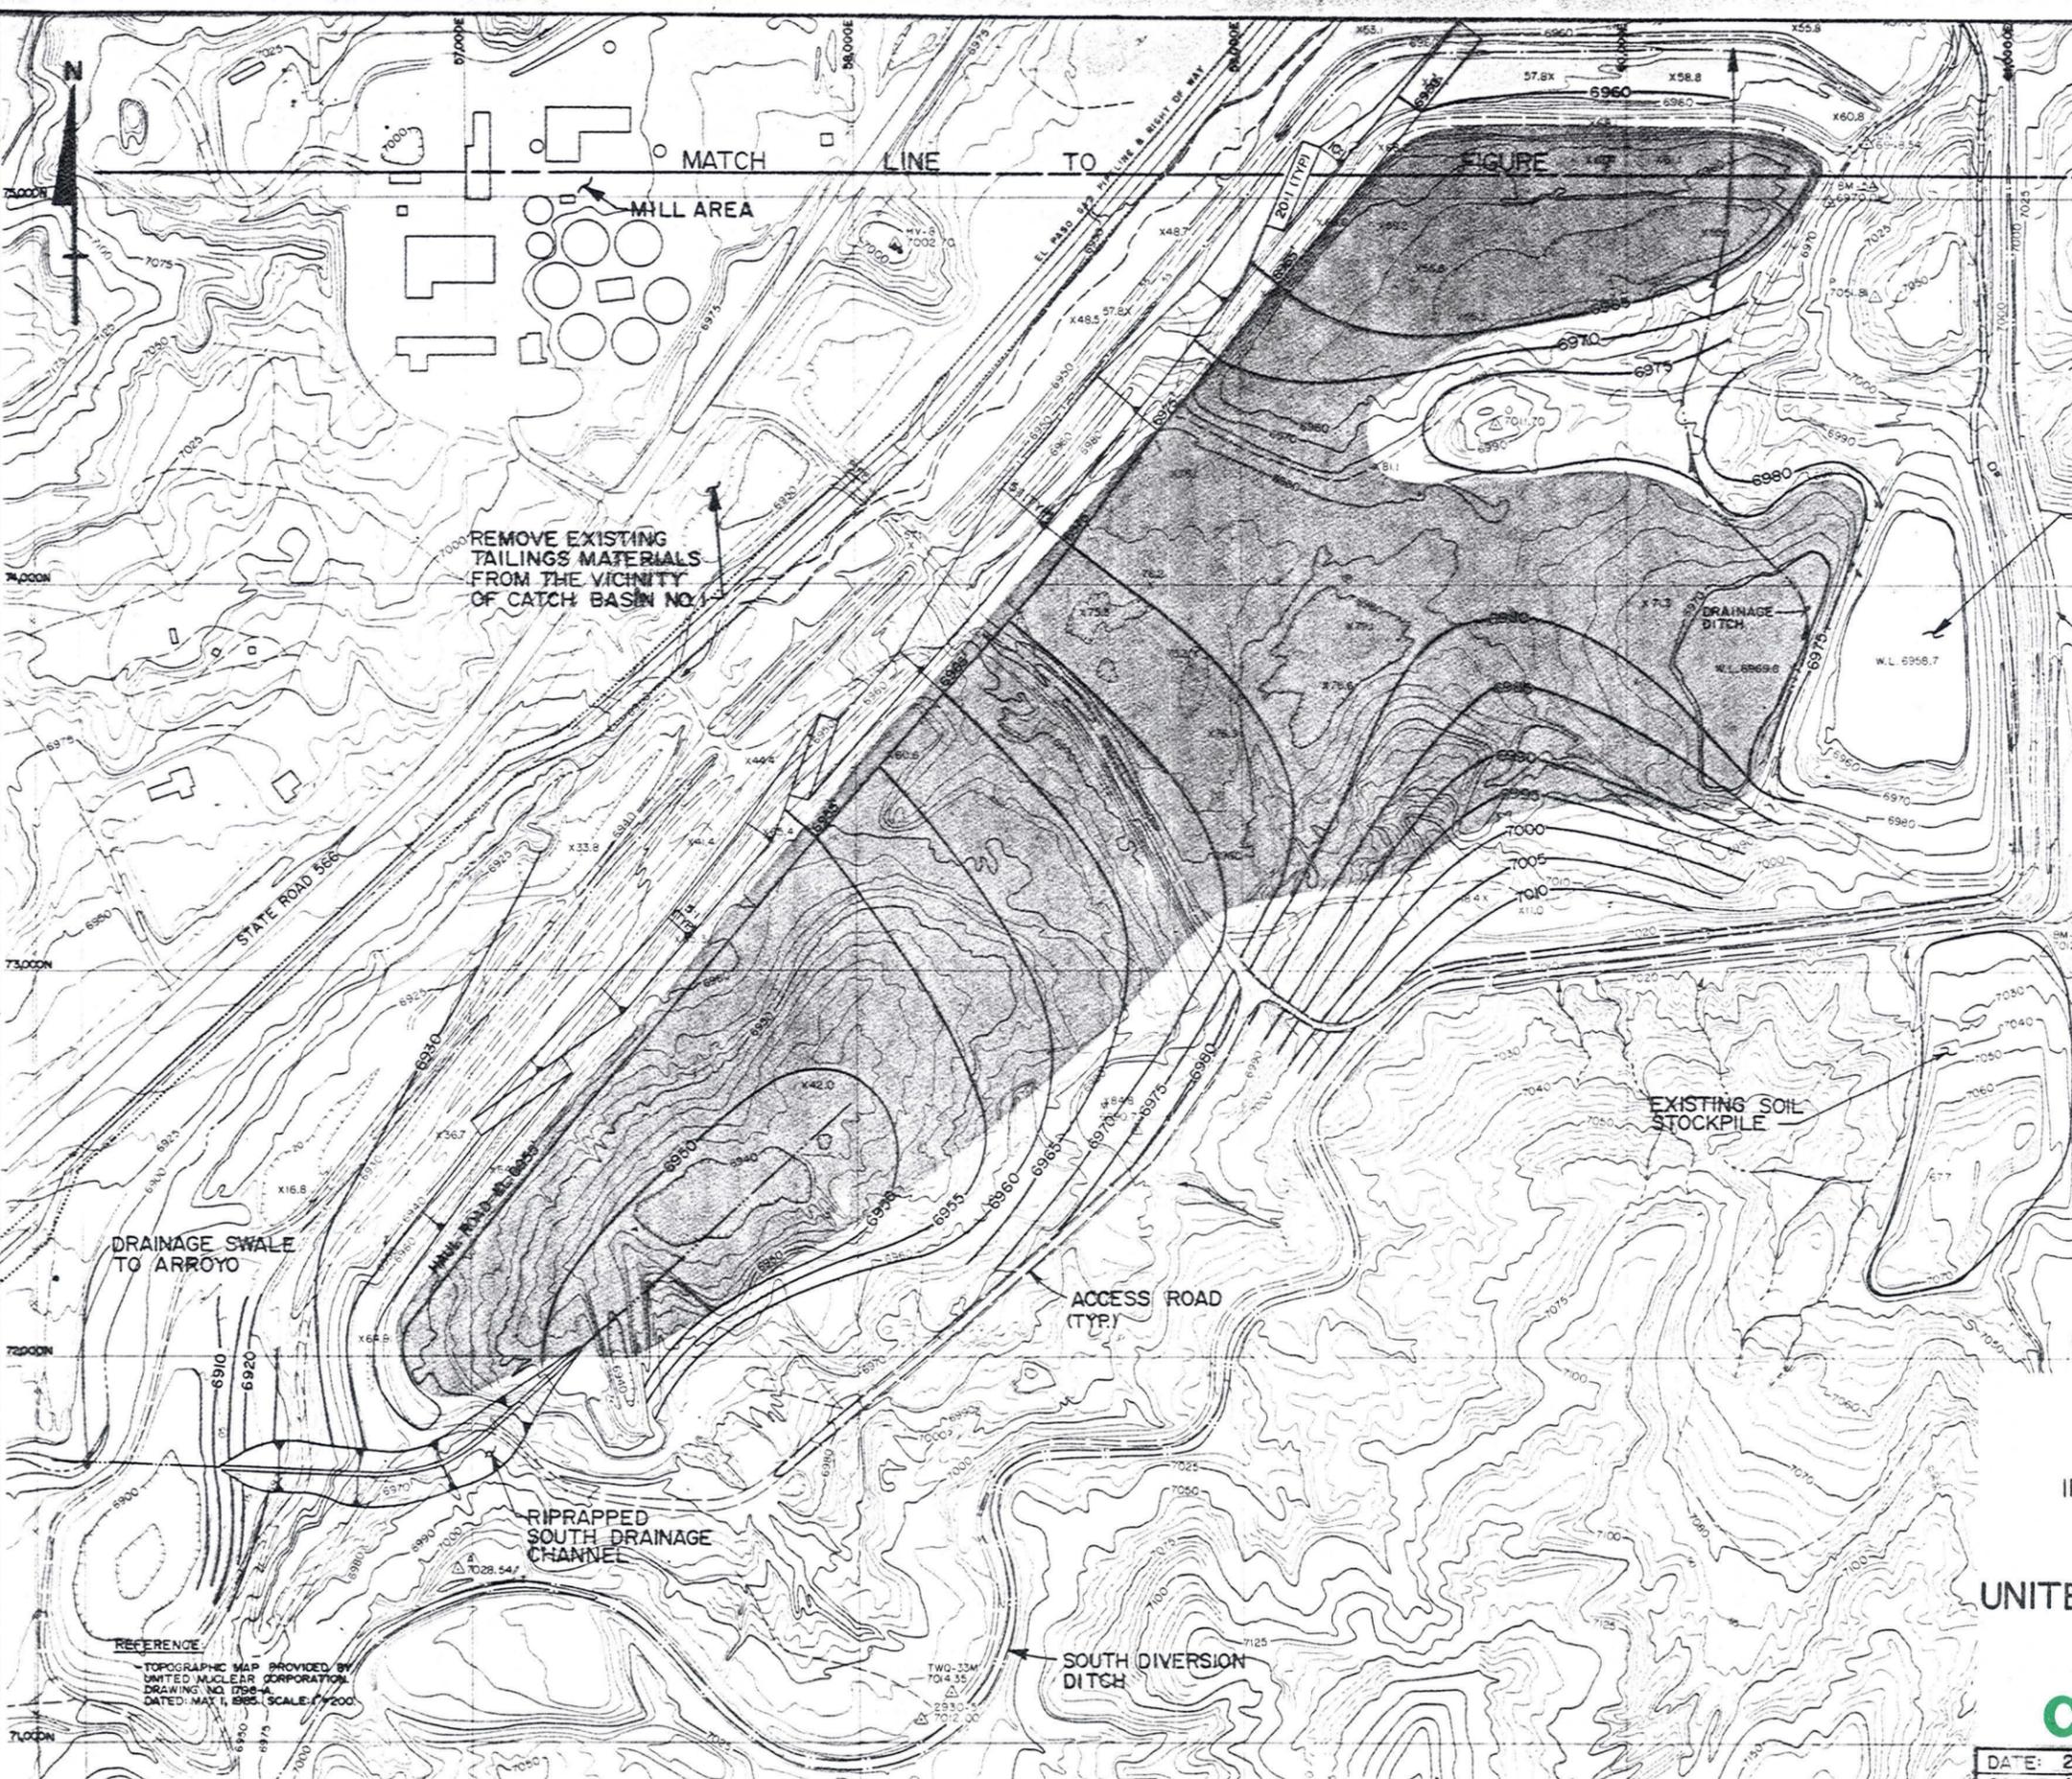
DATE: 2-19-87
 SCALE: AS SHOWN
 FIGURE 6
 DRAWING NUMBER
 RMB6-060-E35

- NOTES:**
1. WINDBLOWN TAILINGS BETWEEN THE CENTRAL AND NORTH CELLS SHALL BE GRADED INTO THE CELLS BEFORE COVER PLACEMENT.
 2. 8-12 INCH SOIL COVER SHALL BE PLACED OVER THE GRADED TAILINGS SHOWN.
 3. BORROW PIT 2 SHALL BE USED FOR DISPOSAL OF MILL FACILITIES DURING FINAL RECLAMATION.
 4. WELLS THAT LIE WITHIN THE AREA TO BE DISTURBED WILL BE PLUGGED FROM THE BASE OF THE WELL TO THE SURFACE WITH PLUG-MIX.

- LEGEND:**
- 6980 — ELEVATION OF GRADED TAILINGS, FEET
 - [Shaded Area] APPROXIMATE LIMITS OF TAILINGS AFTER GRADING

Grade Tailings - Tailings will be graded during interim stabilization as shown on Figures 6 and 7. This grading will provide slopes for the final reclamation and assist in preventing recharge from rain and snow.

grade, and other appurtenances will be demolished and removed. These materials will be buried in Borrow Pit No. 2, as shown on Figure 6. Clean soil from a borrow area will be used, if required, as cover and graded so that the area can be revegetated.

Backfilling and Grading of Borrow Pit No. 2 - Borrow Pit No. 2 will be backfilled with mill debris along with contaminated soils from within Catch Basins I and II. Concurrent with backfilling of the debris, soil from the existing stockpile located adjacent to Borrow Pit No. 2 (Figure 6) or elsewhere on-site will be used to provide access and ultimately as cover to bring the fill to the final grade.

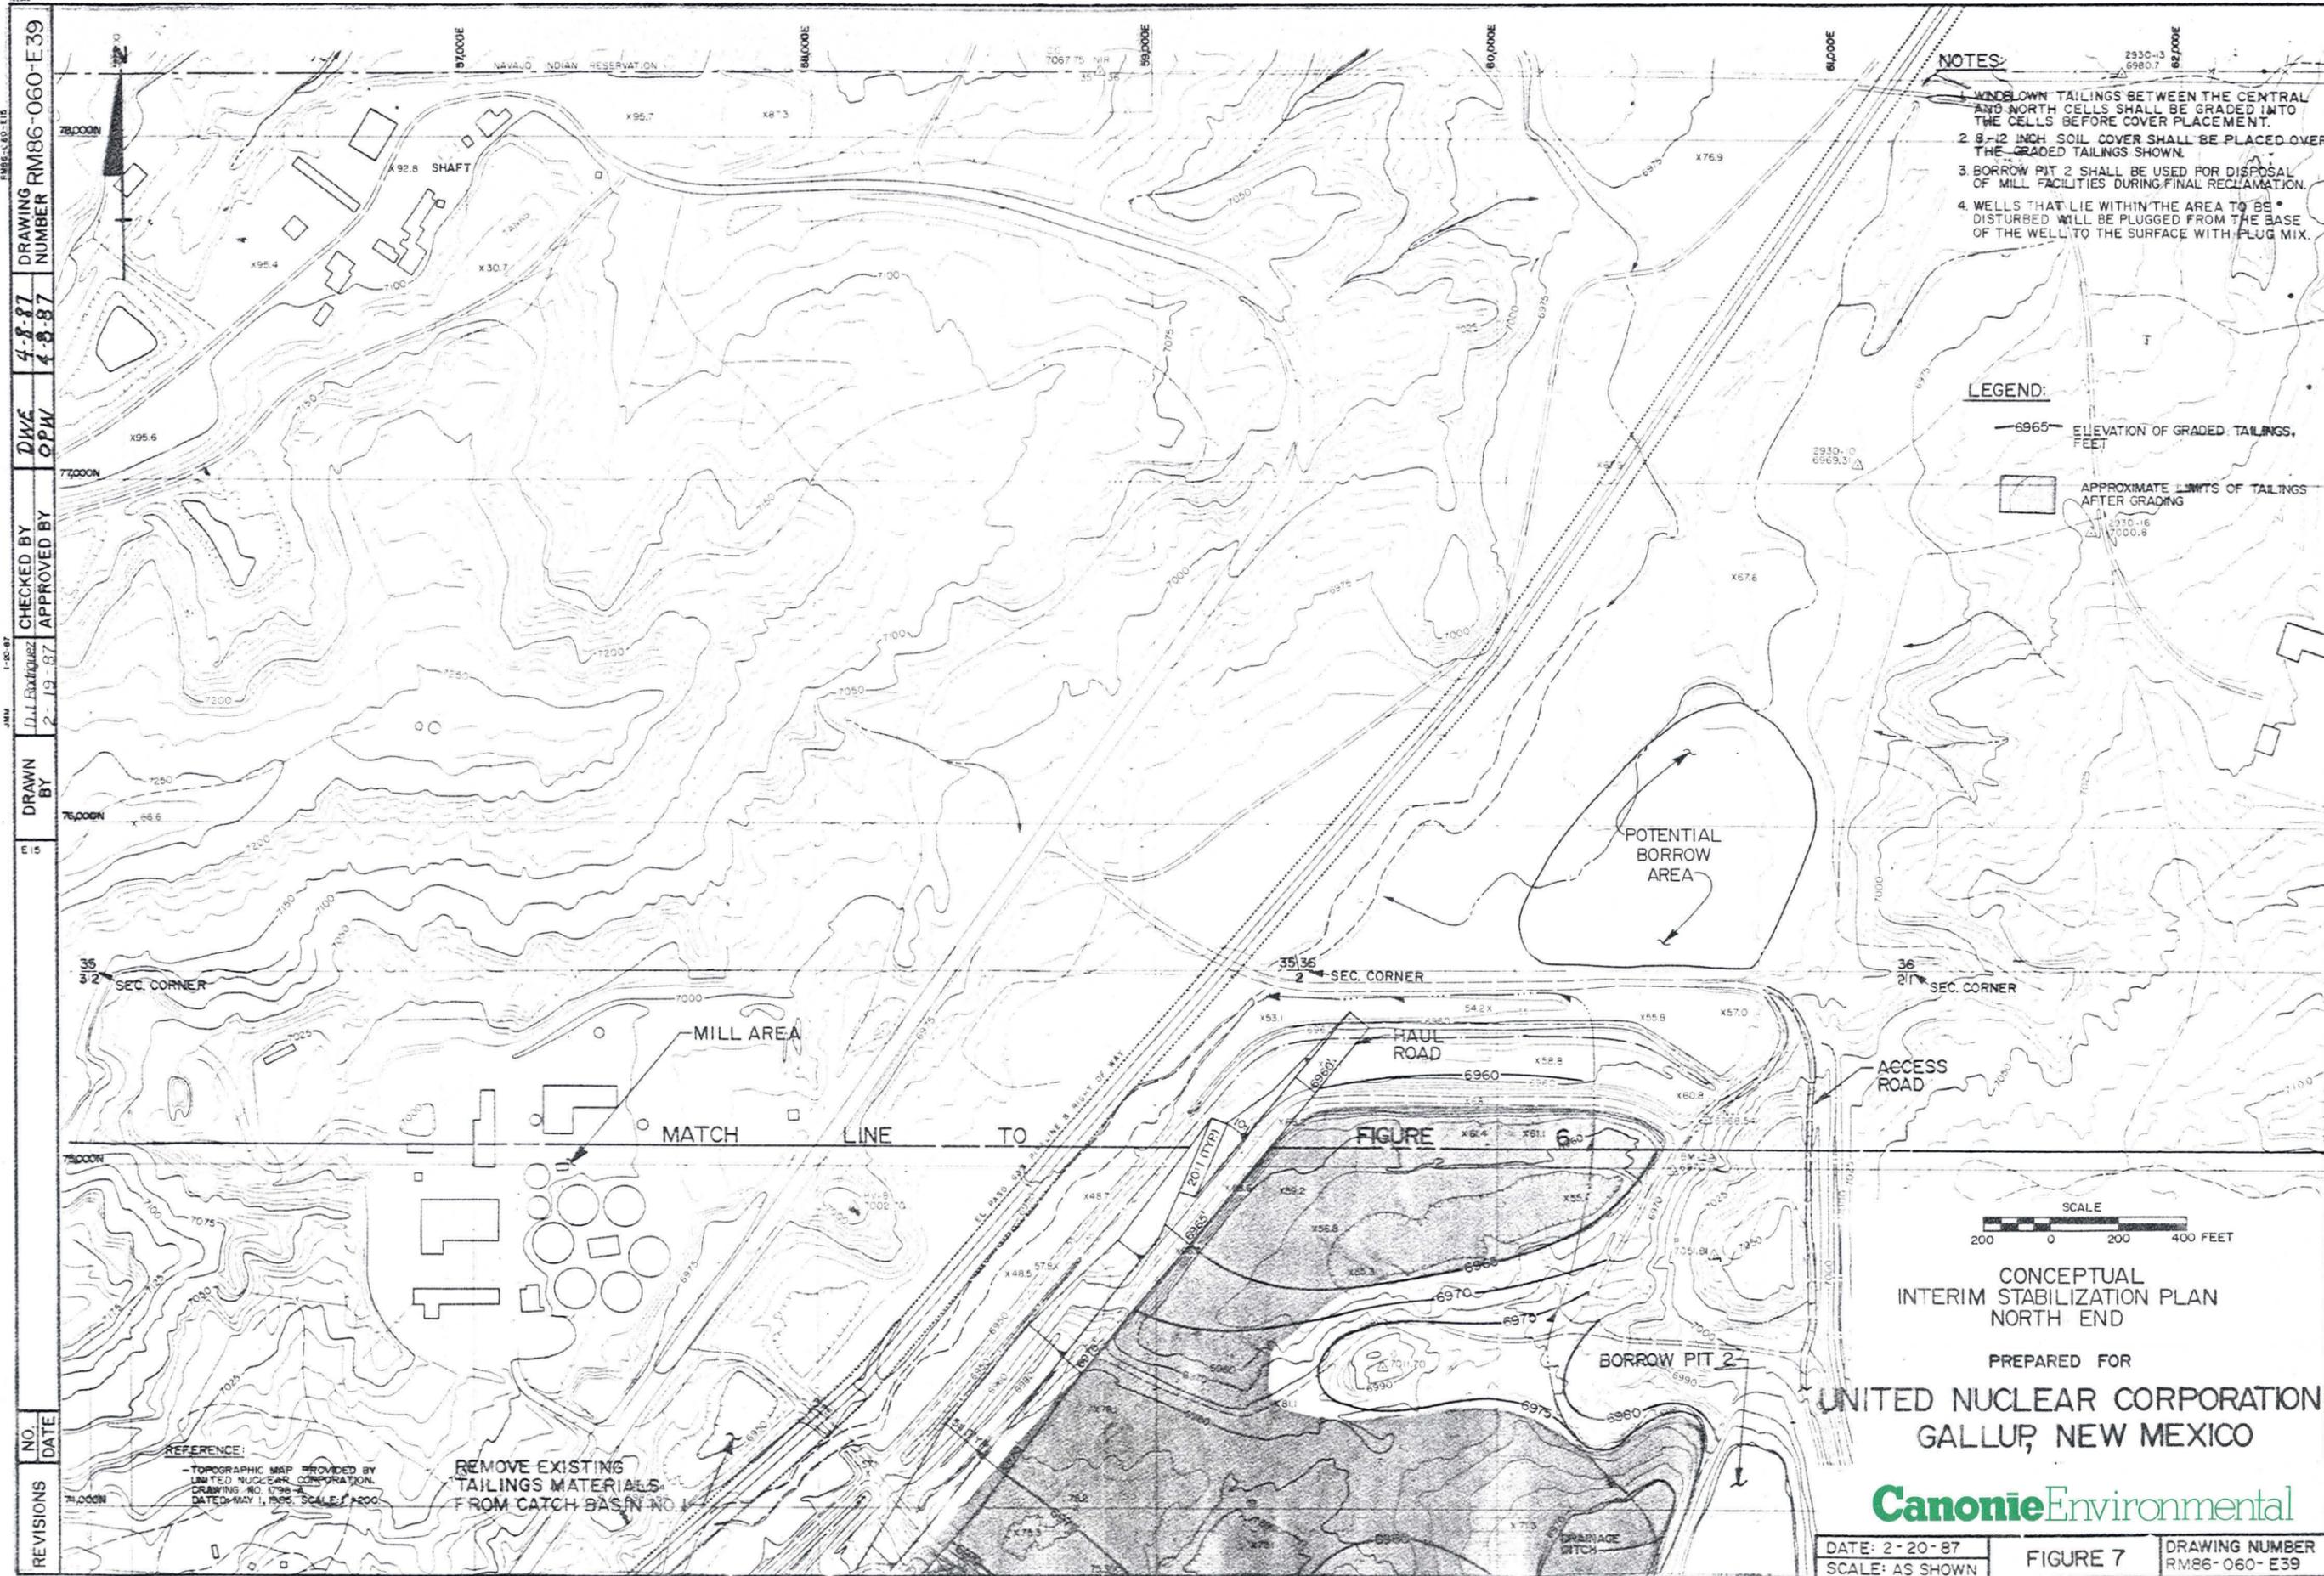
- NOTES:**
1. WINDLOWN TAILINGS BETWEEN THE CENTRAL AND NORTH CELLS SHALL BE GRADED INTO THE CELLS BEFORE COVER PLACEMENT.
 2. 8-12 INCH SOIL COVER SHALL BE PLACED OVER THE GRADED TAILINGS SHOWN.
 3. BORROW PIT 2 SHALL BE USED FOR DISPOSAL OF MILL FACILITIES DURING FINAL RECLAMATION.
 4. WELLS THAT LIE WITHIN THE AREA TO BE DISTURBED WILL BE PLUGGED FROM THE BASE OF THE WELL TO THE SURFACE WITH PLUG MIX.

REMOVE EXISTING
 TAILINGS MATERIALS
 FROM CATCH BASIN NO. 1

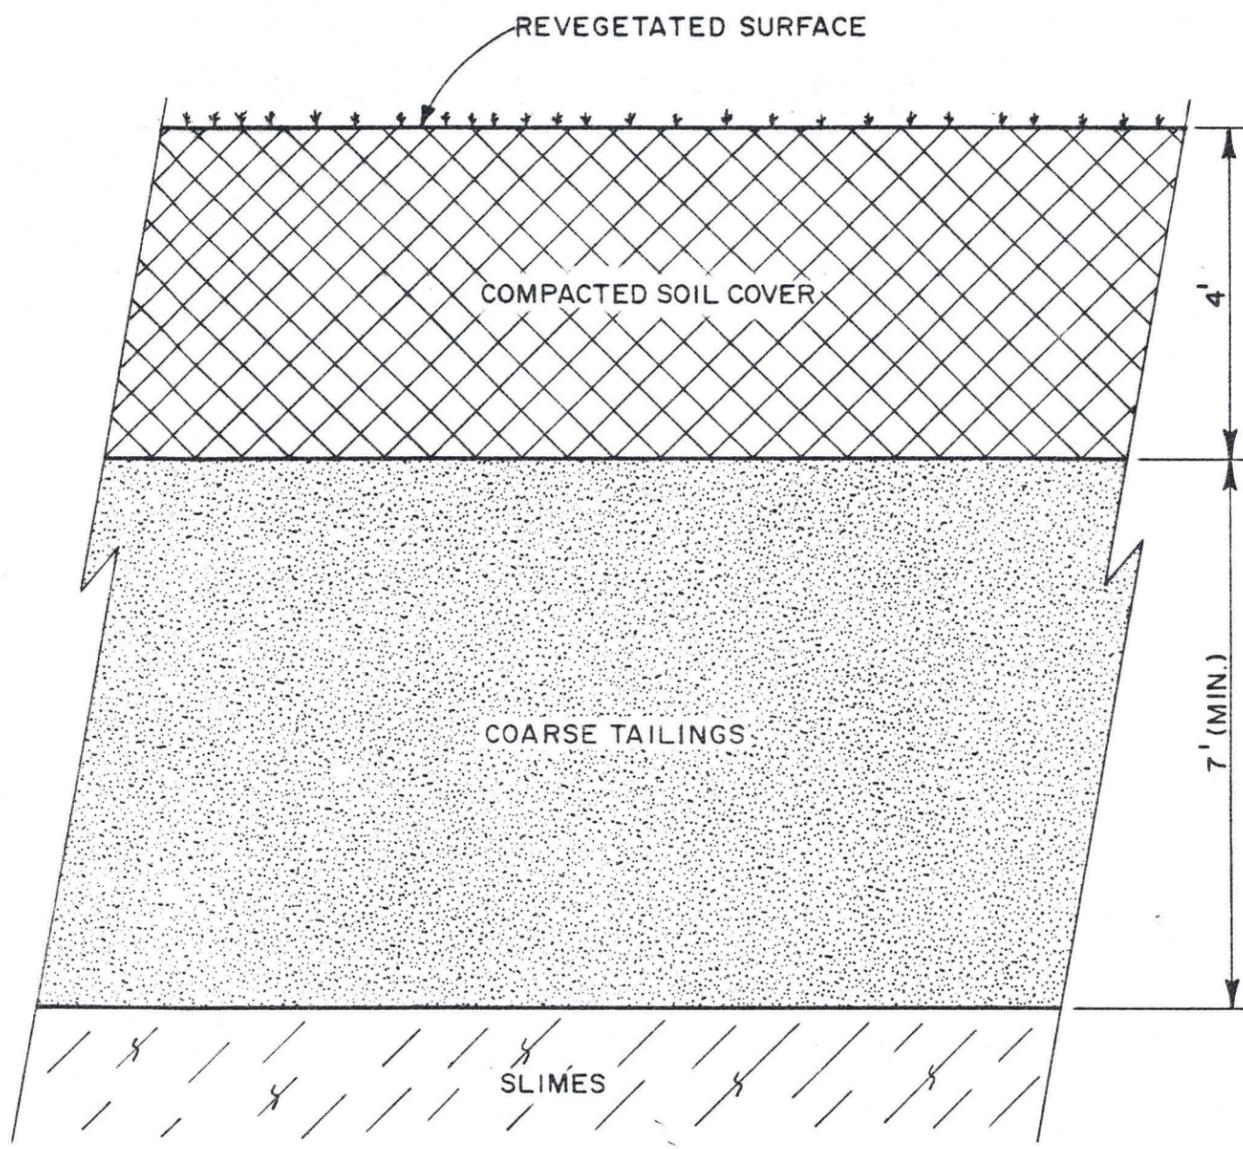
CONCEPTUAL COVER DESIGN
PREPARED FOR
UNITED NUCLEAR CORPORATION
GALLUP, NEW MEXICO

COVER DESIGN PARAMETERS							
MATERIAL	RADIUM CONTENT	EMANATION COEFFICIENT	DRY DENSITY	% MOIST.	% SAT.	POROSITY	DIFFUSION COEFFICIENT (pCi/m ² -sec)
COVER SOIL	0.78 pCi/g	.08	99 pcf	13.6	54	.40	.0095
COARSE TAILINGS	189 pCi/g	.22	105 pcf	10.5	43	.40	.0143
SLIMES	574 pCi/g	.26	76 pcf	35	83	.54	.0031

Placement of a Final Soil Cover - Preliminary calculations of the final soil cover thickness to limit radon emanation were performed using RAECOM as outlined by NUREG CR-3533. The primary input values used in this program are shown on Figure 8. The calculated cover thickness to limit radon emanation is approximately 3.5 feet.

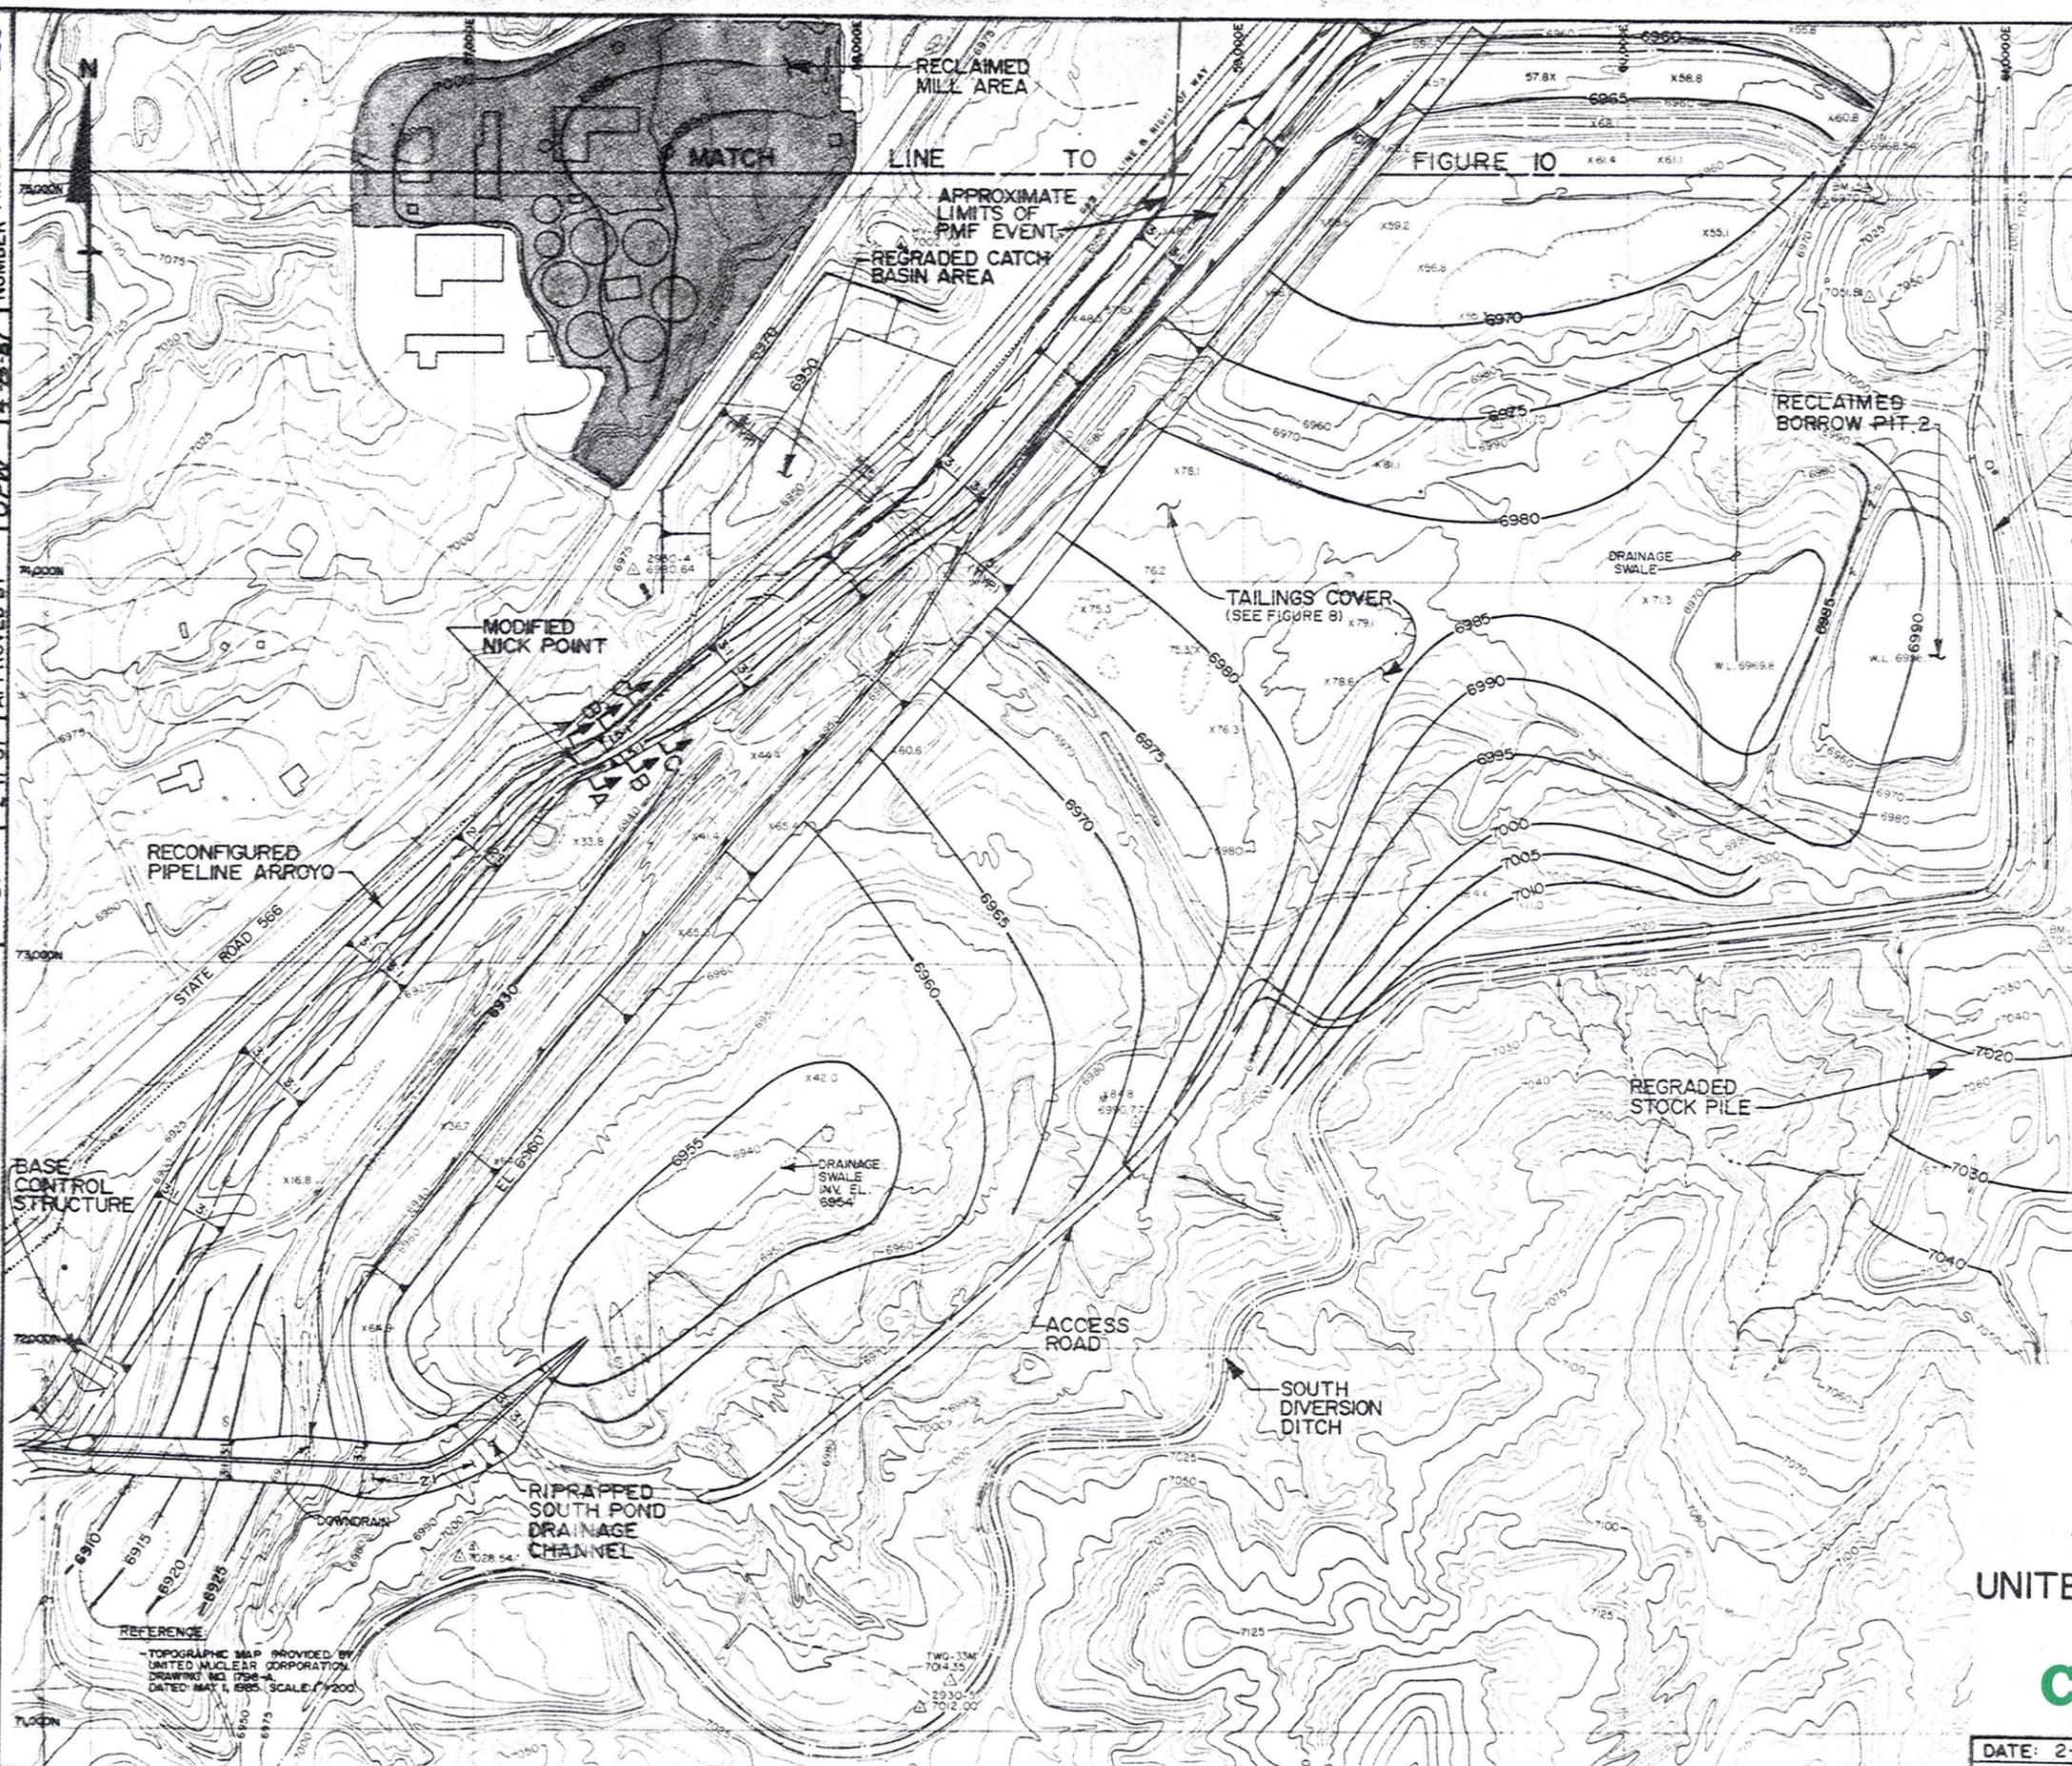
LEGEND:
 — 6985 — ELEVATION OF FINAL GRADE, FT.

NOTE:
 1. FINAL SOIL COVER CONTOURS SHOWN PROVIDE FOR A CONCEPTUAL 5 FOOT SOIL COVER THICKNESS. THE ACTUAL THICKNESS AS CALCULATED USING RAECOM SHALL BE 4 FEET AS SHOWN ON FIGURE 8.

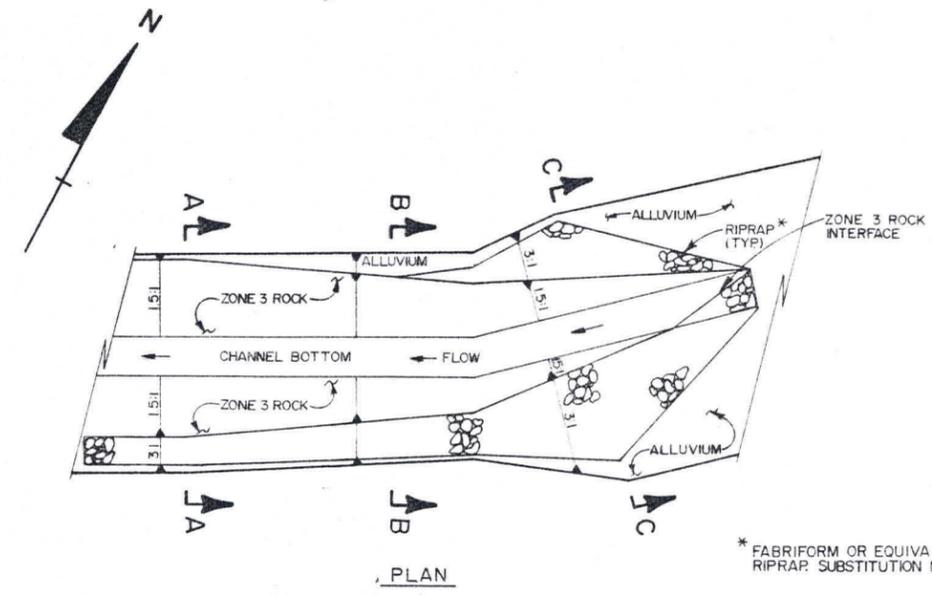
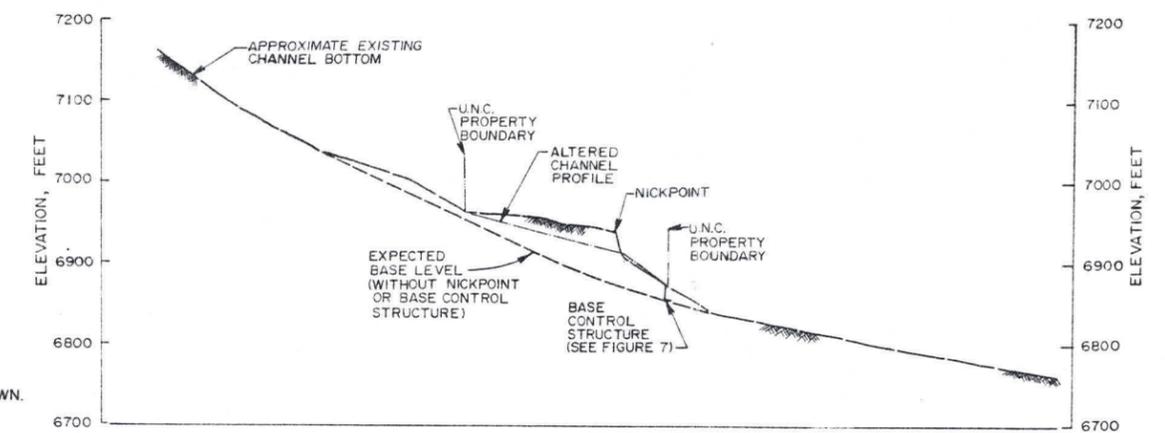
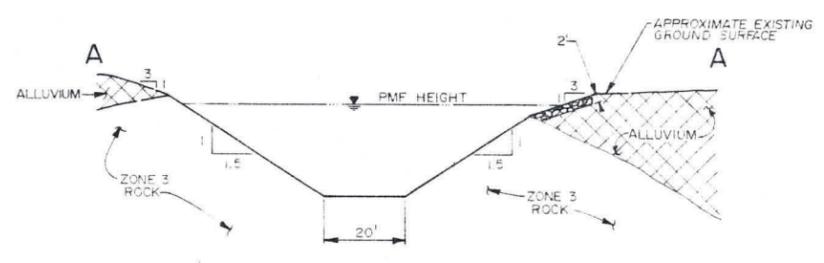
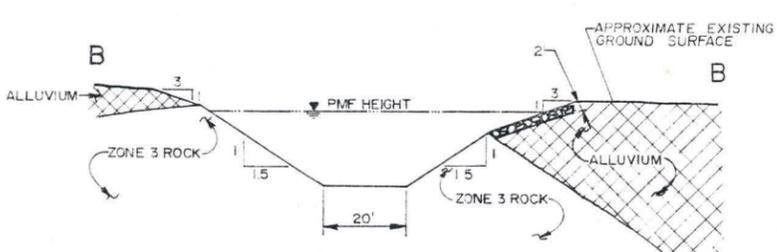
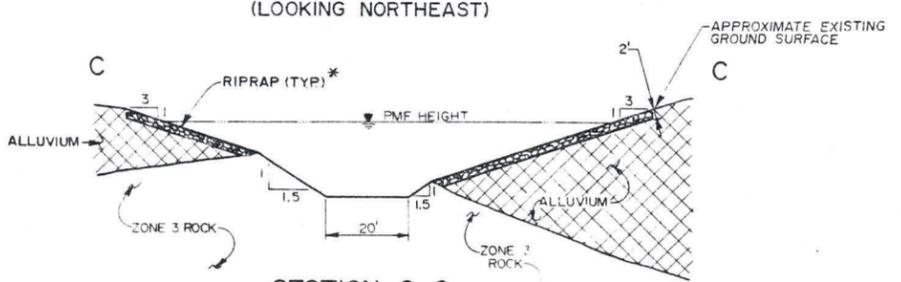
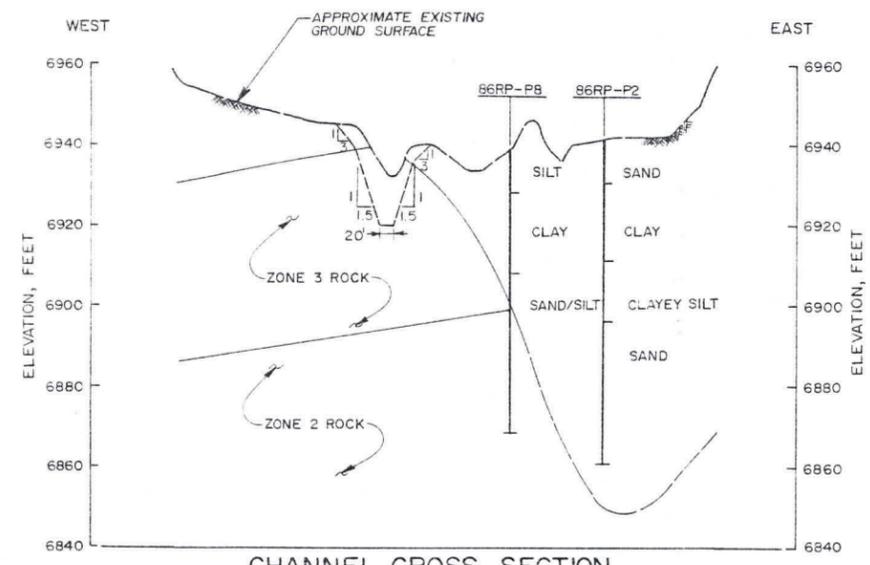
PROPOSED MODIFICATIONS
 PIPELINE ARROYO CHANNEL
 AND NICKPOINT

* FABRIFORM OR EQUIVALENT MAY BE SUBSTITUTED FOR RIPRAP. SUBSTITUTION MAY CHANGE CONFIGURATION SHOWN.

migration of the channel above the nickpoint will be limited to the formation of meanders. The channel profile above the nickpoint, as shown on Figure 9, is steep enough to ensure that no channel sedimentation will occur that would raise the channel bottom and cause significant flows in the overbank area.
