**FINAL  
THIRD FIVE-YEAR REVIEW REPORT**

**PERFORMANCE-BASED REMEDIATION AT  
MARCH AIR RESERVE BASE AND FORMER MARCH  
AIR FORCE BASE, CALIFORNIA**

**Five-Year Review**

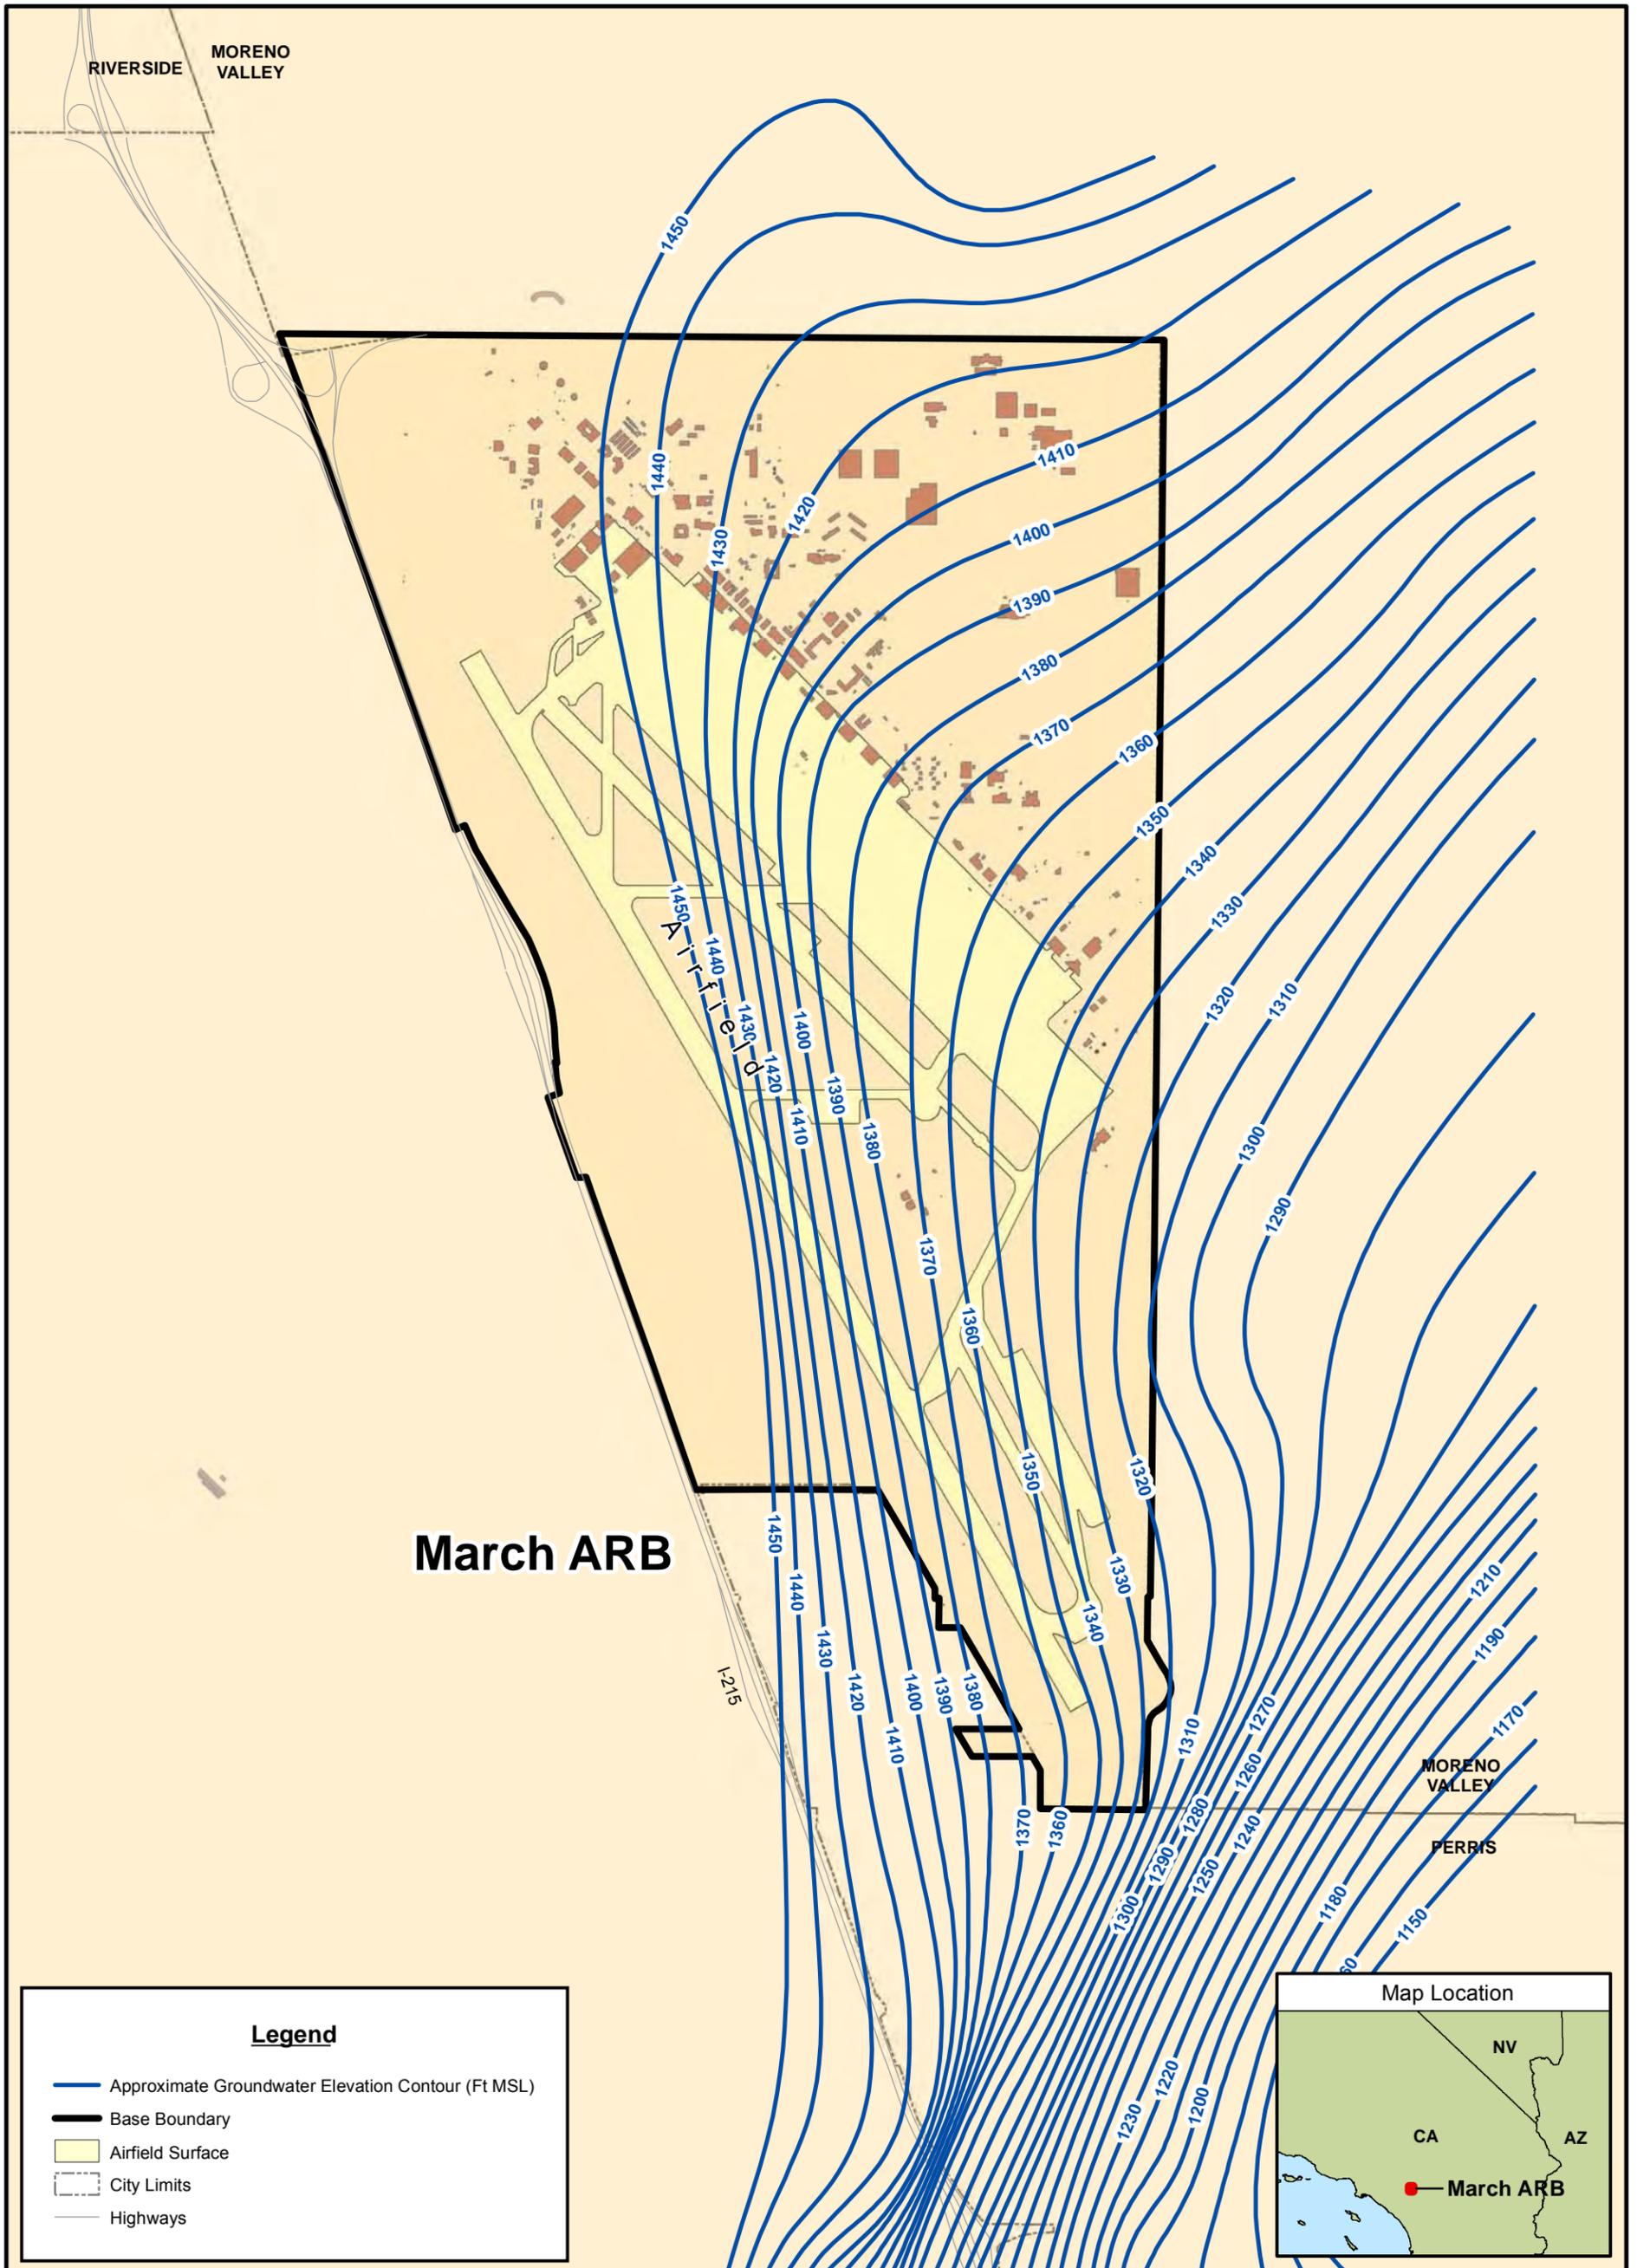
Date	09-14		Figure 3-3
Project No.	60271680

Sources:  
 Spring 1990 groundwater contours were digitized from Figure 9 of the report  
*Installation Restoration Program Records Search for March Air Force Base, California*  
 (CH2M Hill, April 1984).

Figure 3-3 shows the groundwater contours from 1970 and Figure 3-4 presents the three dimensional rendering of the bedrock surface with 1970 water levels. Note that in 1970, the groundwater in the northeast corner of the Base was between 1,400 feet and 1,450 feet above mean sea level. Figure 3-5 shows the groundwater contours in 1993 and Figure 3-6 presents the three dimensional rendering of the bedrock surface with 1993 water levels. In 1993, the groundwater in the northeast corner of the Base was around 1,480 feet above mean sea level in 1993. Figure 3-7 presents the three dimensional rendering of the bedrock surface with 2011 water levels and Figure 3-8 presents the historic three dimensional rendering of the bedrock surface. Figure 3-9 shows the groundwater contours in 2012. The groundwater in the northeast corner is now above 1,515 feet above mean sea level. Note that the direction of groundwater flow has changed somewhat over this period of time. In 1970 and 1993 the direction of flow was generally east to southeast. In the most recent monitoring round groundwater flow was generally more south to southeast.

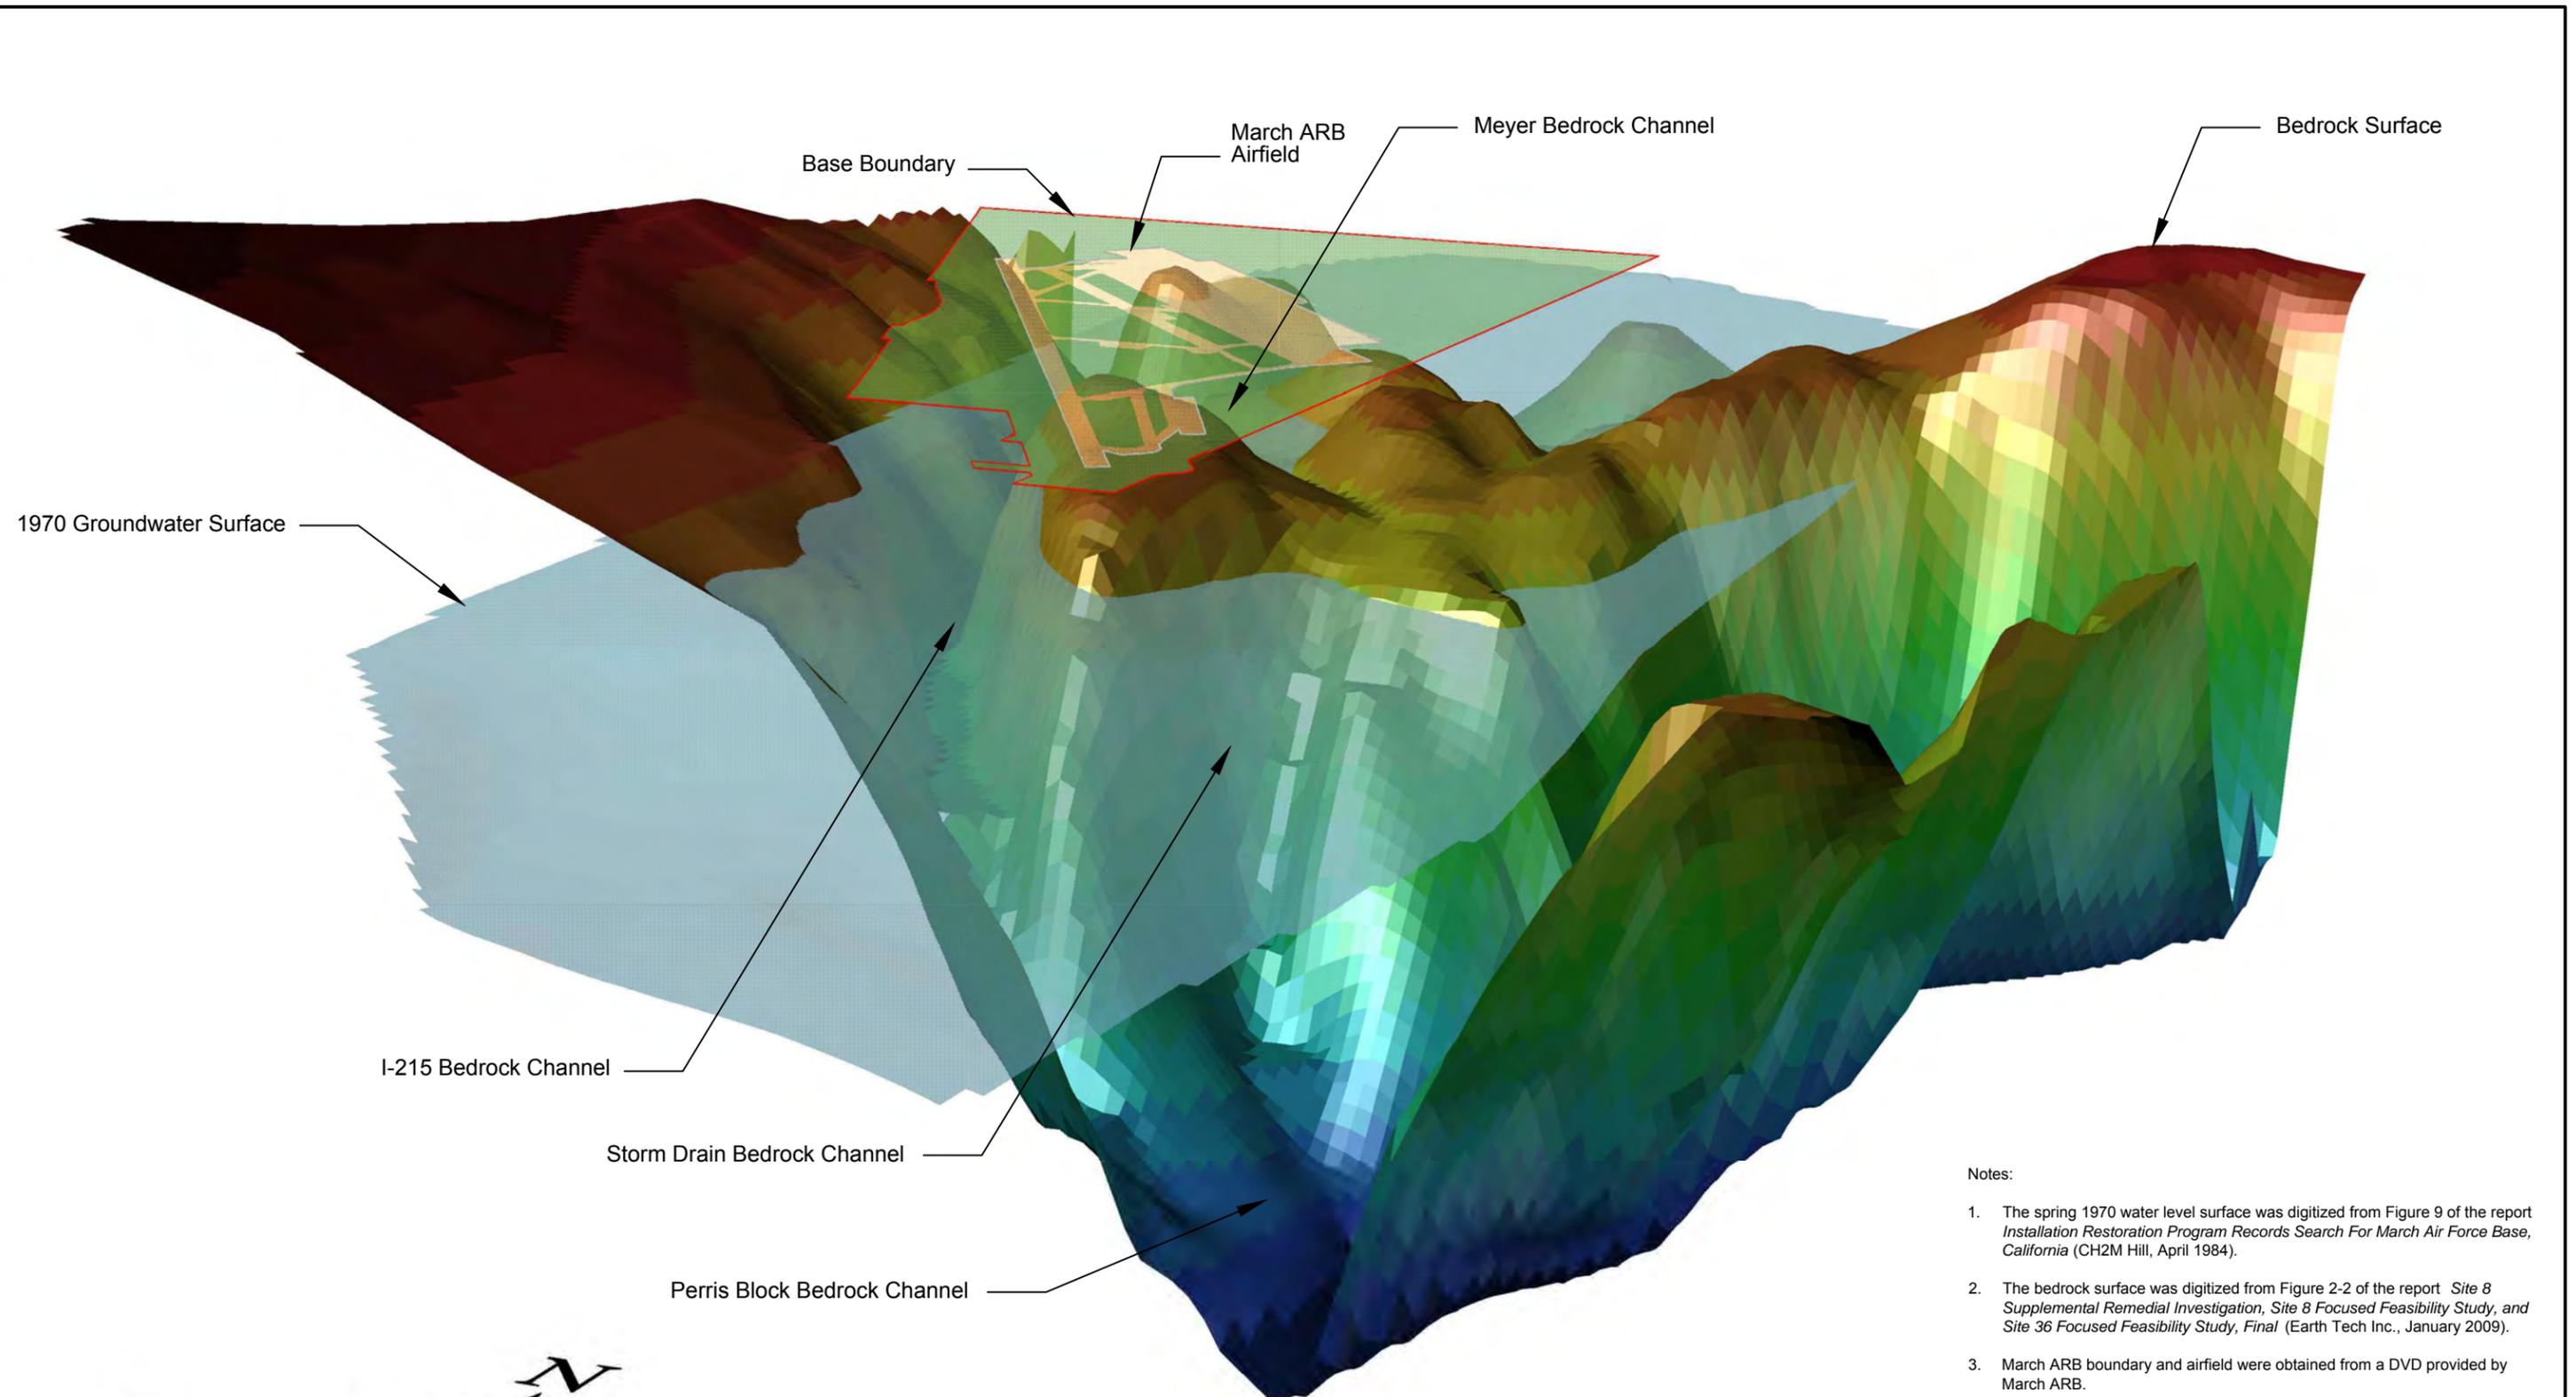
Third Five-Year Review Report		
<b>Three-Dimensional Rendering of the Bedrock Surface with 1970 Water Levels</b>		
Date	09-14	<b>AECOM</b>
Project No.	60271680	
March ARB and Former March AFB, CA		Figure 3-4

1. The spring 1970 water level surface was digitized from Figure 9 of the report *Installation Restoration Program Records Search For March Air Force Base, California* (CH2M Hill, April 1984).
2. The bedrock surface was digitized from Figure 2-2 of the report *Site 8 Supplemental Remedial Investigation, Site 8 Focused Feasibility Study, and Site 36 Focused Feasibility Study, Final* (Earth Tech Inc., January 2009).
3. March ARB boundary and airfield were obtained from a DVD provided by March ARB.

**Perspective View of the Bedrock Surface  
and 1970 Groundwater Surface**  
Southeast looking towards Northwest  
10X Vertical Exaggeration

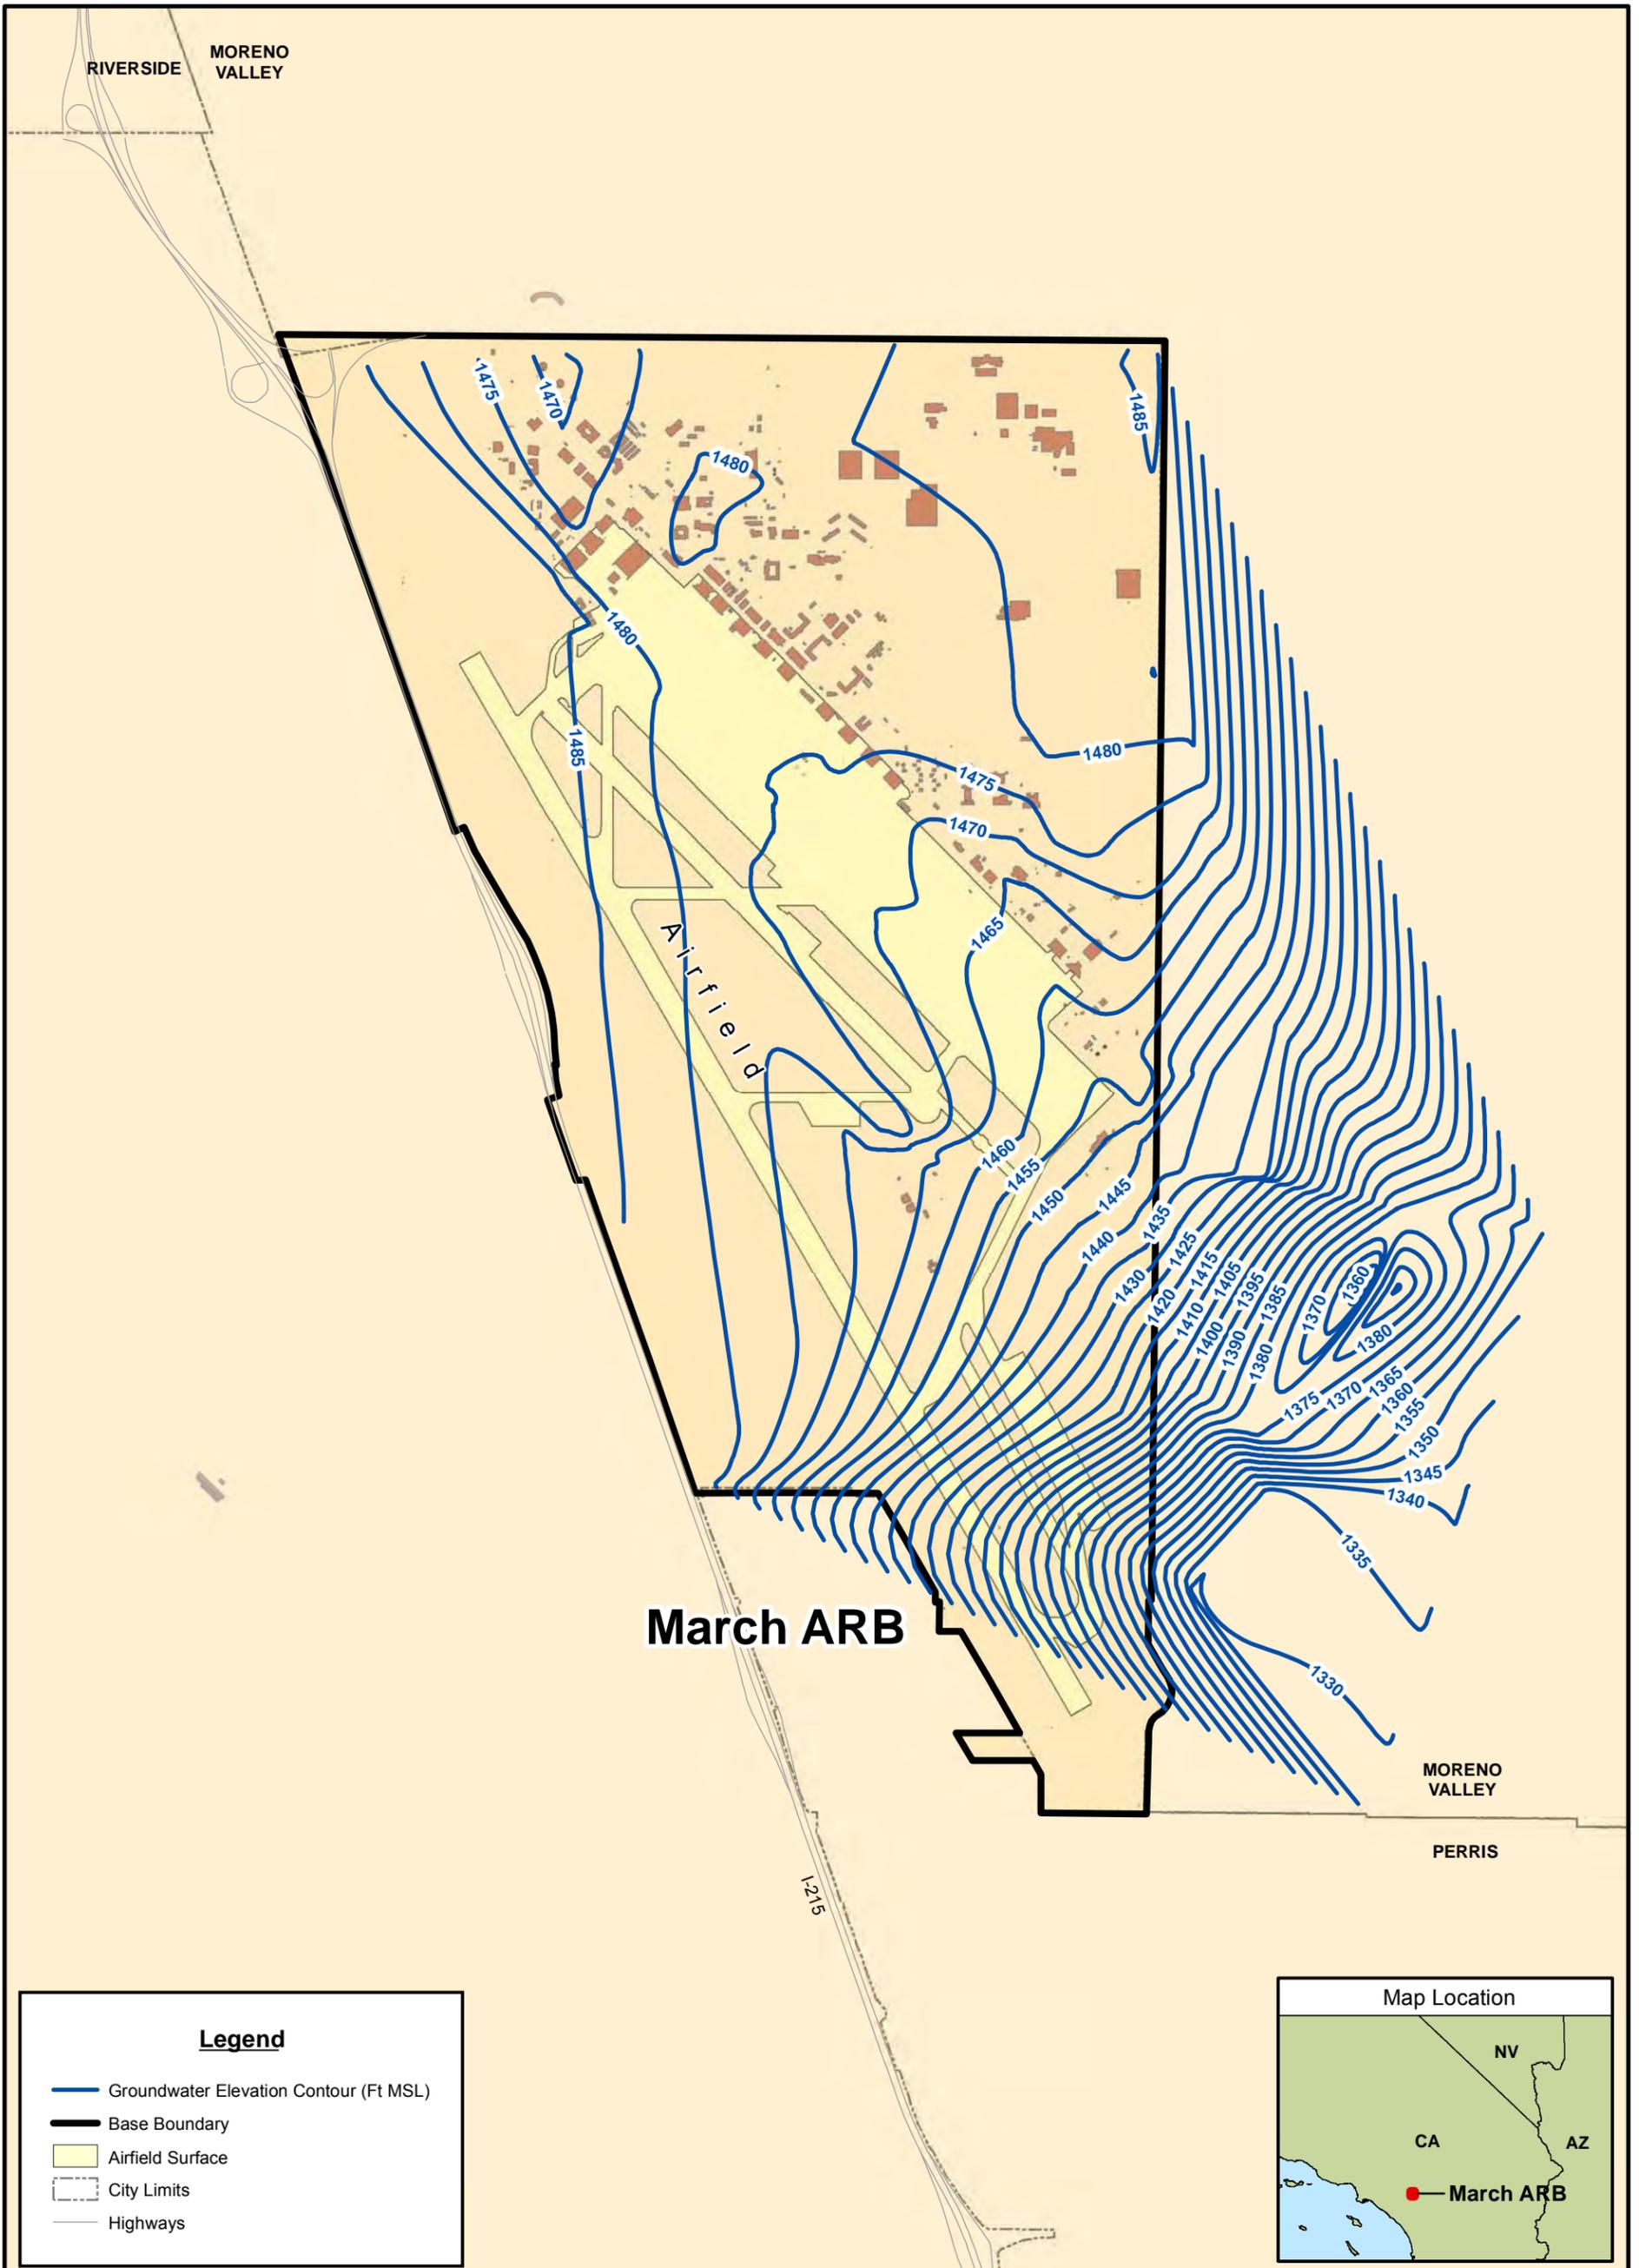
Figure 3-5

Sources:  
Second quarter 1993 water level elevations were obtained from table "2010AMR\_Historical\_GWElev.xlsx" provided on a DVD by March ARB.

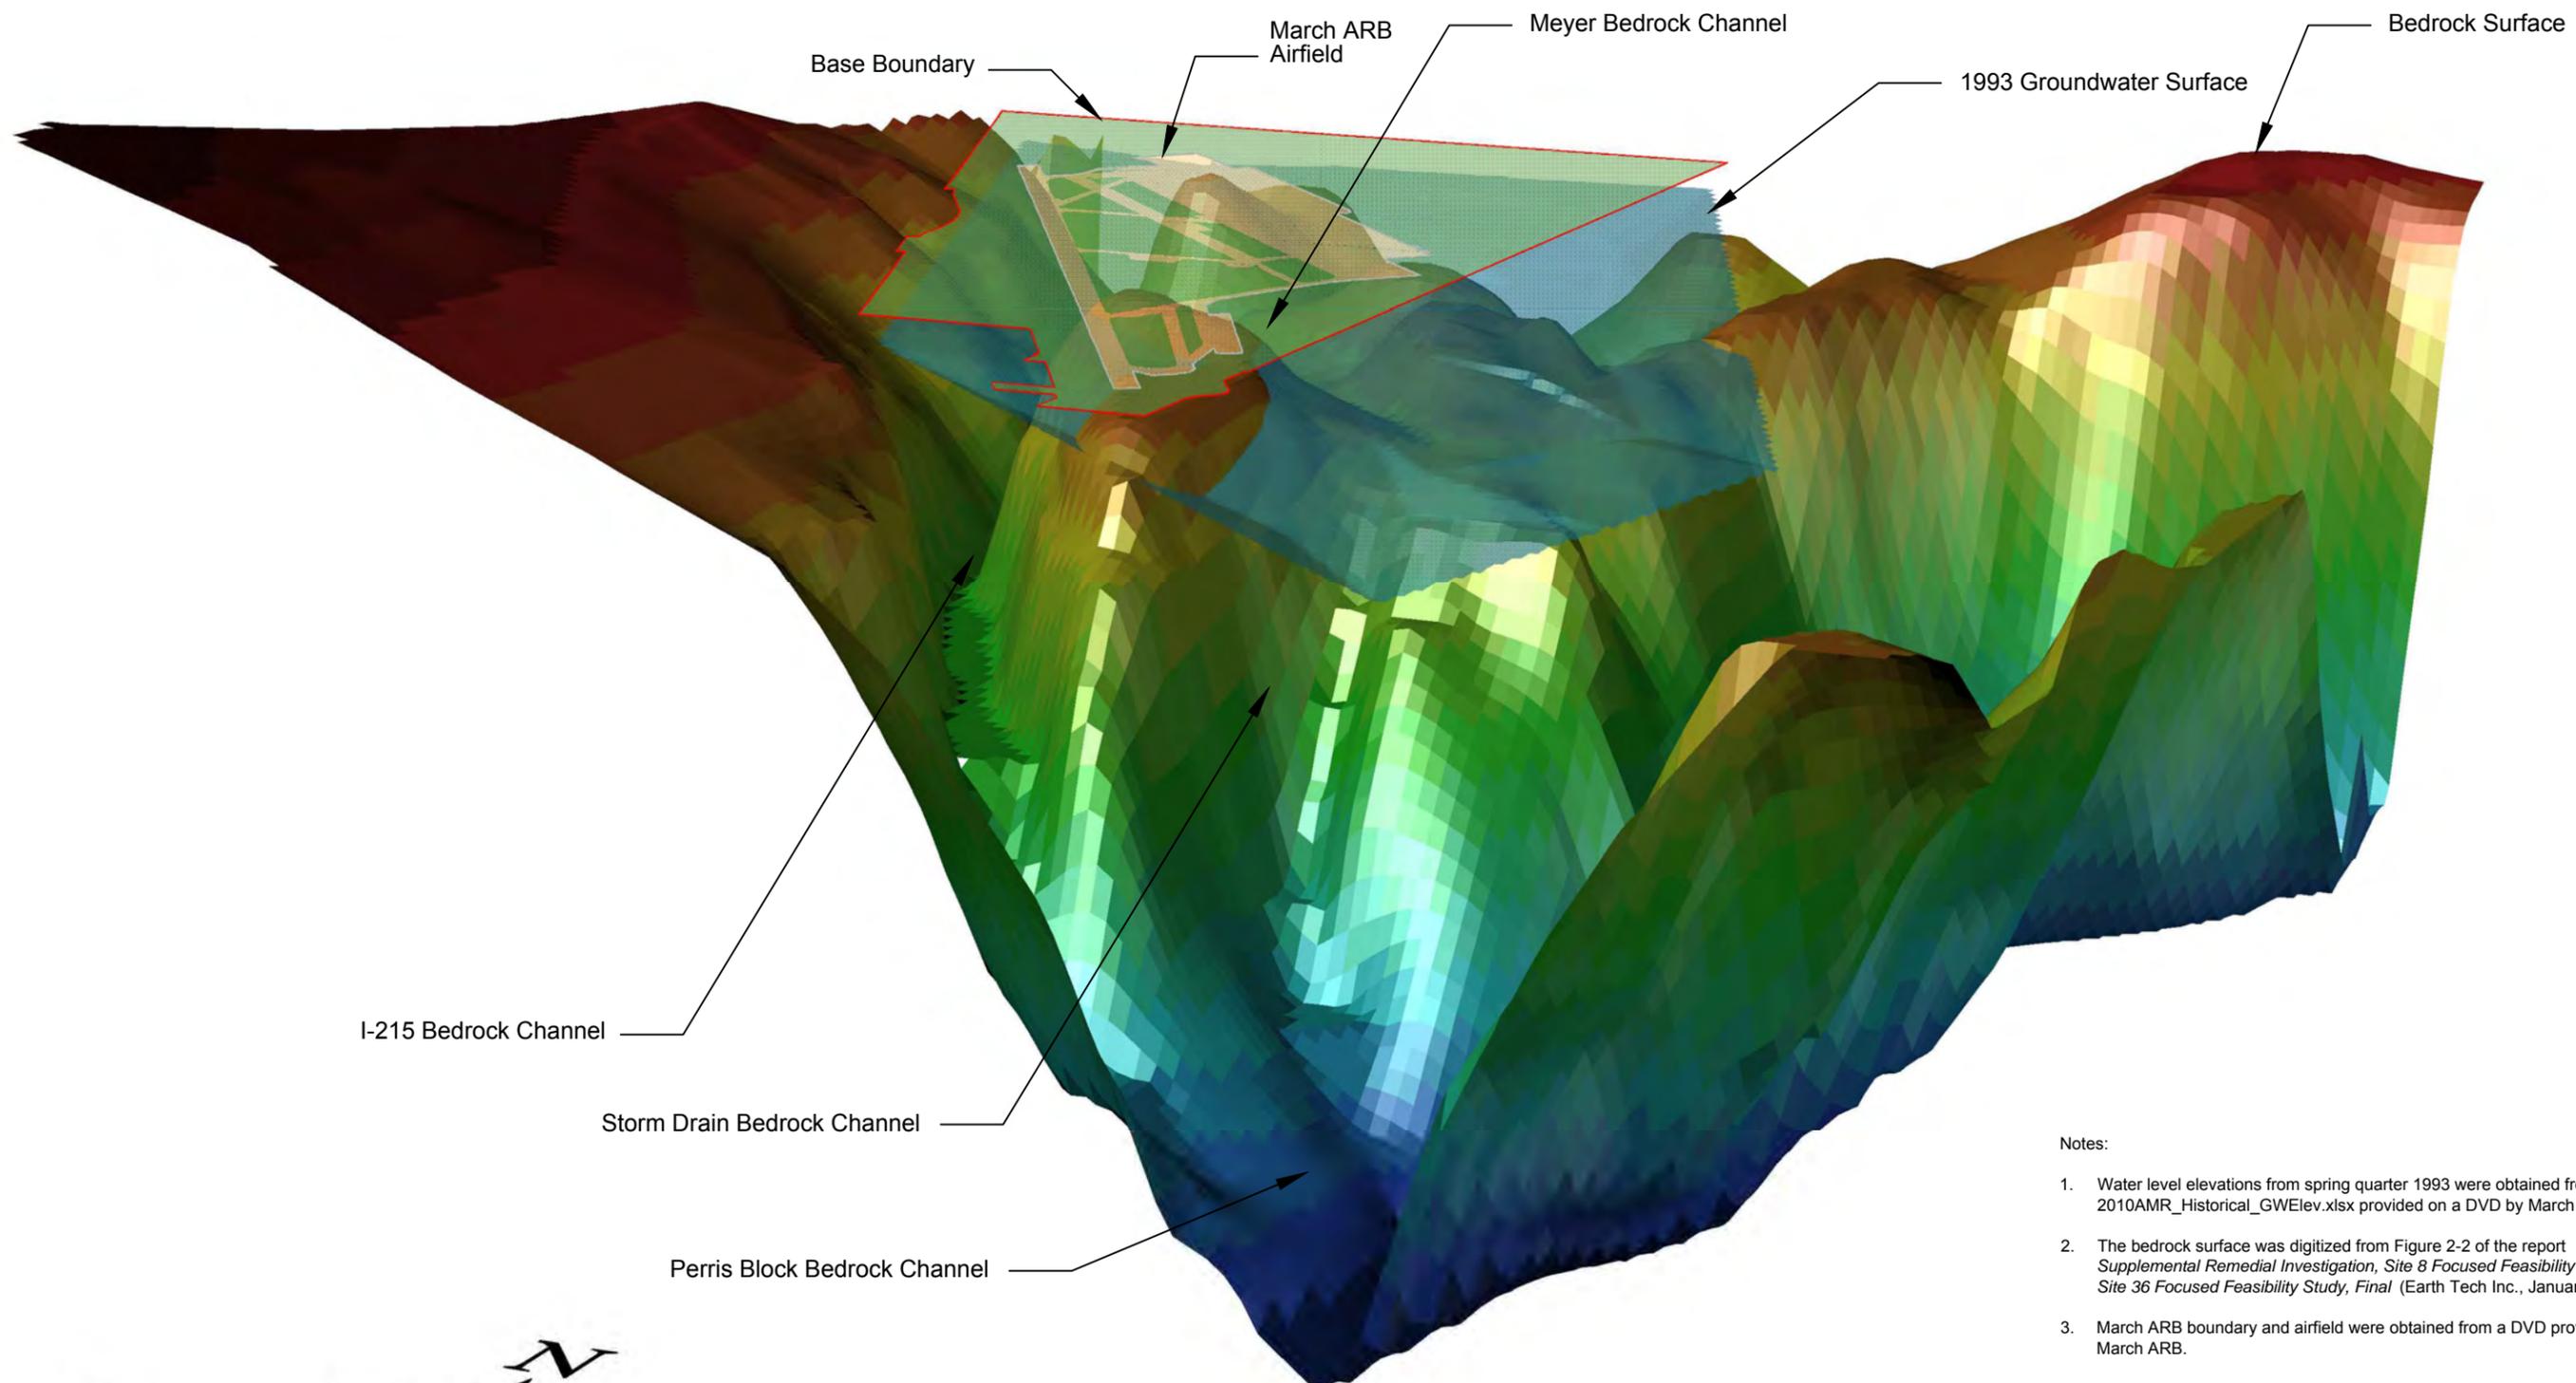
Third Five-Year Review Report		
<b>Three-Dimensional Rendering of the Bedrock Surface with 1993 Water Levels</b>		
Date	09-14	<b>AECOM</b>
Project No.	60271680	
March ARB and Former March AFB, CA		Figure 3-6

1. Water level elevations from spring quarter 1993 were obtained from table 2010AMR\_Historical\_GWElev.xlsx provided on a DVD by March ARB.
2. The bedrock surface was digitized from Figure 2-2 of the report *Site 8 Supplemental Remedial Investigation, Site 8 Focused Feasibility Study, and Site 36 Focused Feasibility Study, Final* (Earth Tech Inc., January 2009).
3. March ARB boundary and airfield were obtained from a DVD provided by March ARB.

Perspective View of the Bedrock Surface  
and 1993 Groundwater Surface  
Southeast looking towards Northwest  
10X Vertical Exaggeration

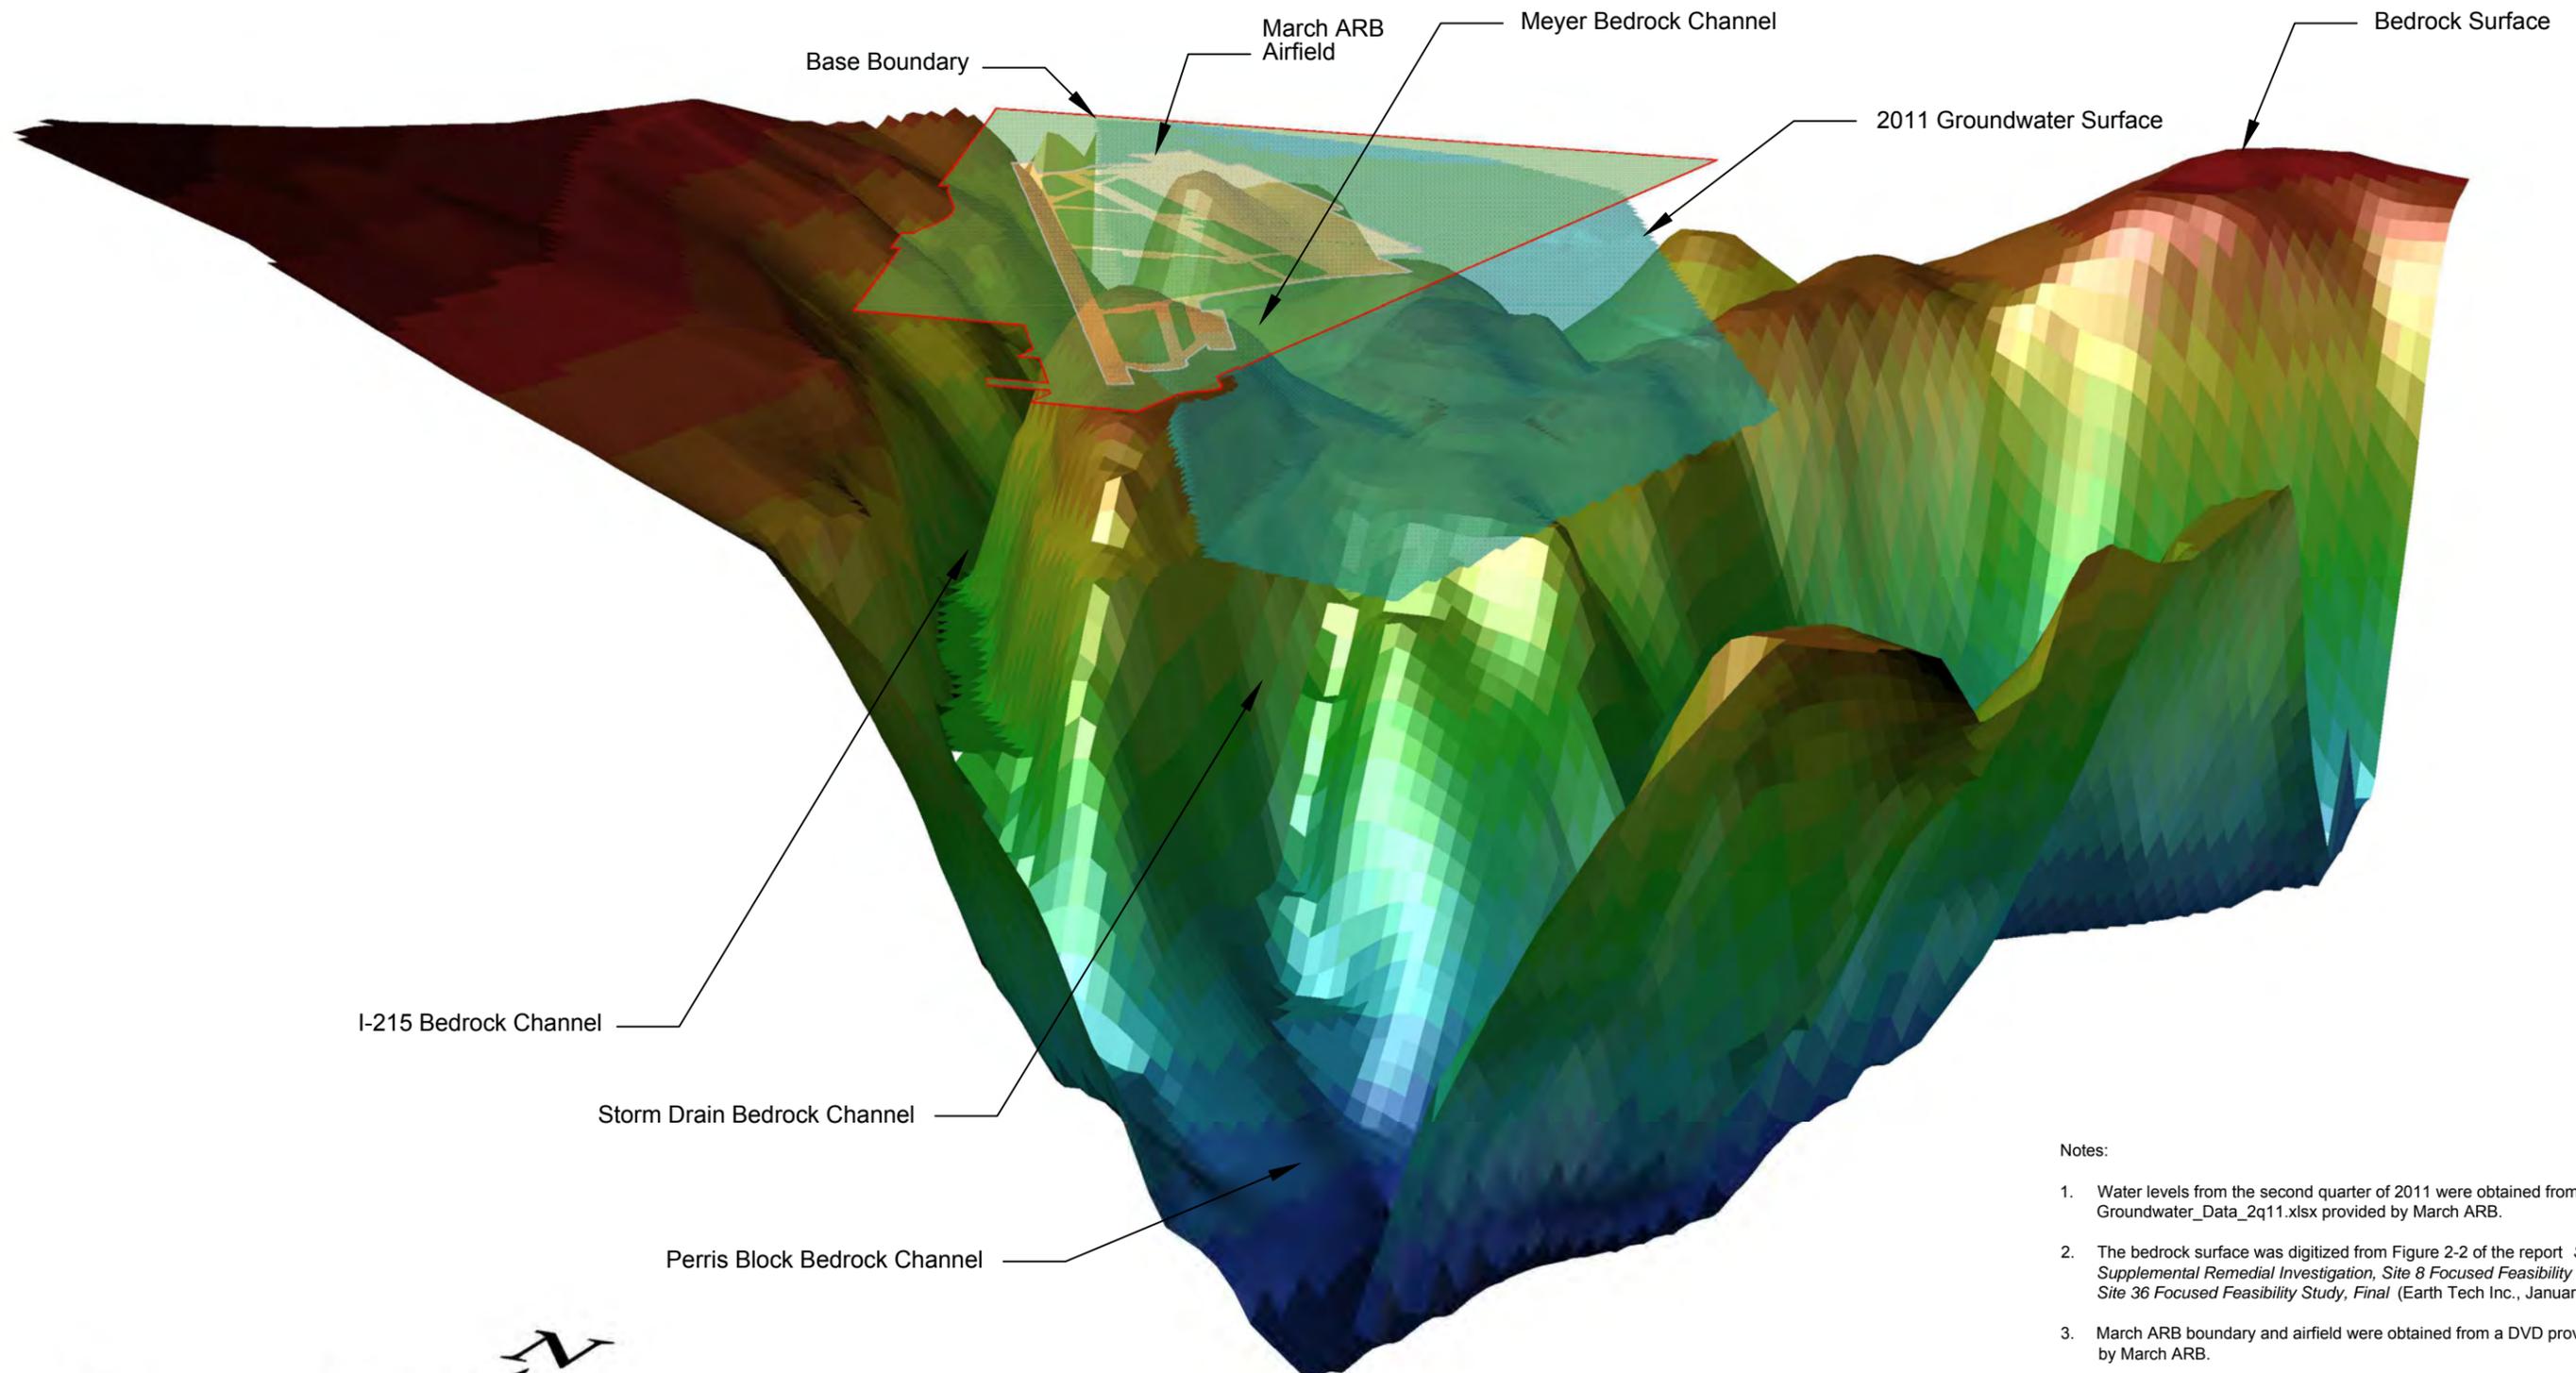
Third Five-Year Review Report		
<b>Three-Dimensional Rendering of the Bedrock Surface with 2011 Water Levels</b>		
Date	09-14	<b>AECOM</b>
Project No.	60271680	
March ARB and Former March AFB, CA		Figure 3-7

1. Water levels from the second quarter of 2011 were obtained from table Groundwater\_Data\_2q11.xlsx provided by March ARB.
2. The bedrock surface was digitized from Figure 2-2 of the report *Site 8 Supplemental Remedial Investigation, Site 8 Focused Feasibility Study, and Site 36 Focused Feasibility Study, Final* (Earth Tech Inc., January 2009).
3. March ARB boundary and airfield were obtained from a DVD provided by March ARB.

**Perspective View of the Bedrock Surface  
and 2011 Groundwater Surface**  
Southeast looking towards Northwest  
10X Vertical Exaggeration

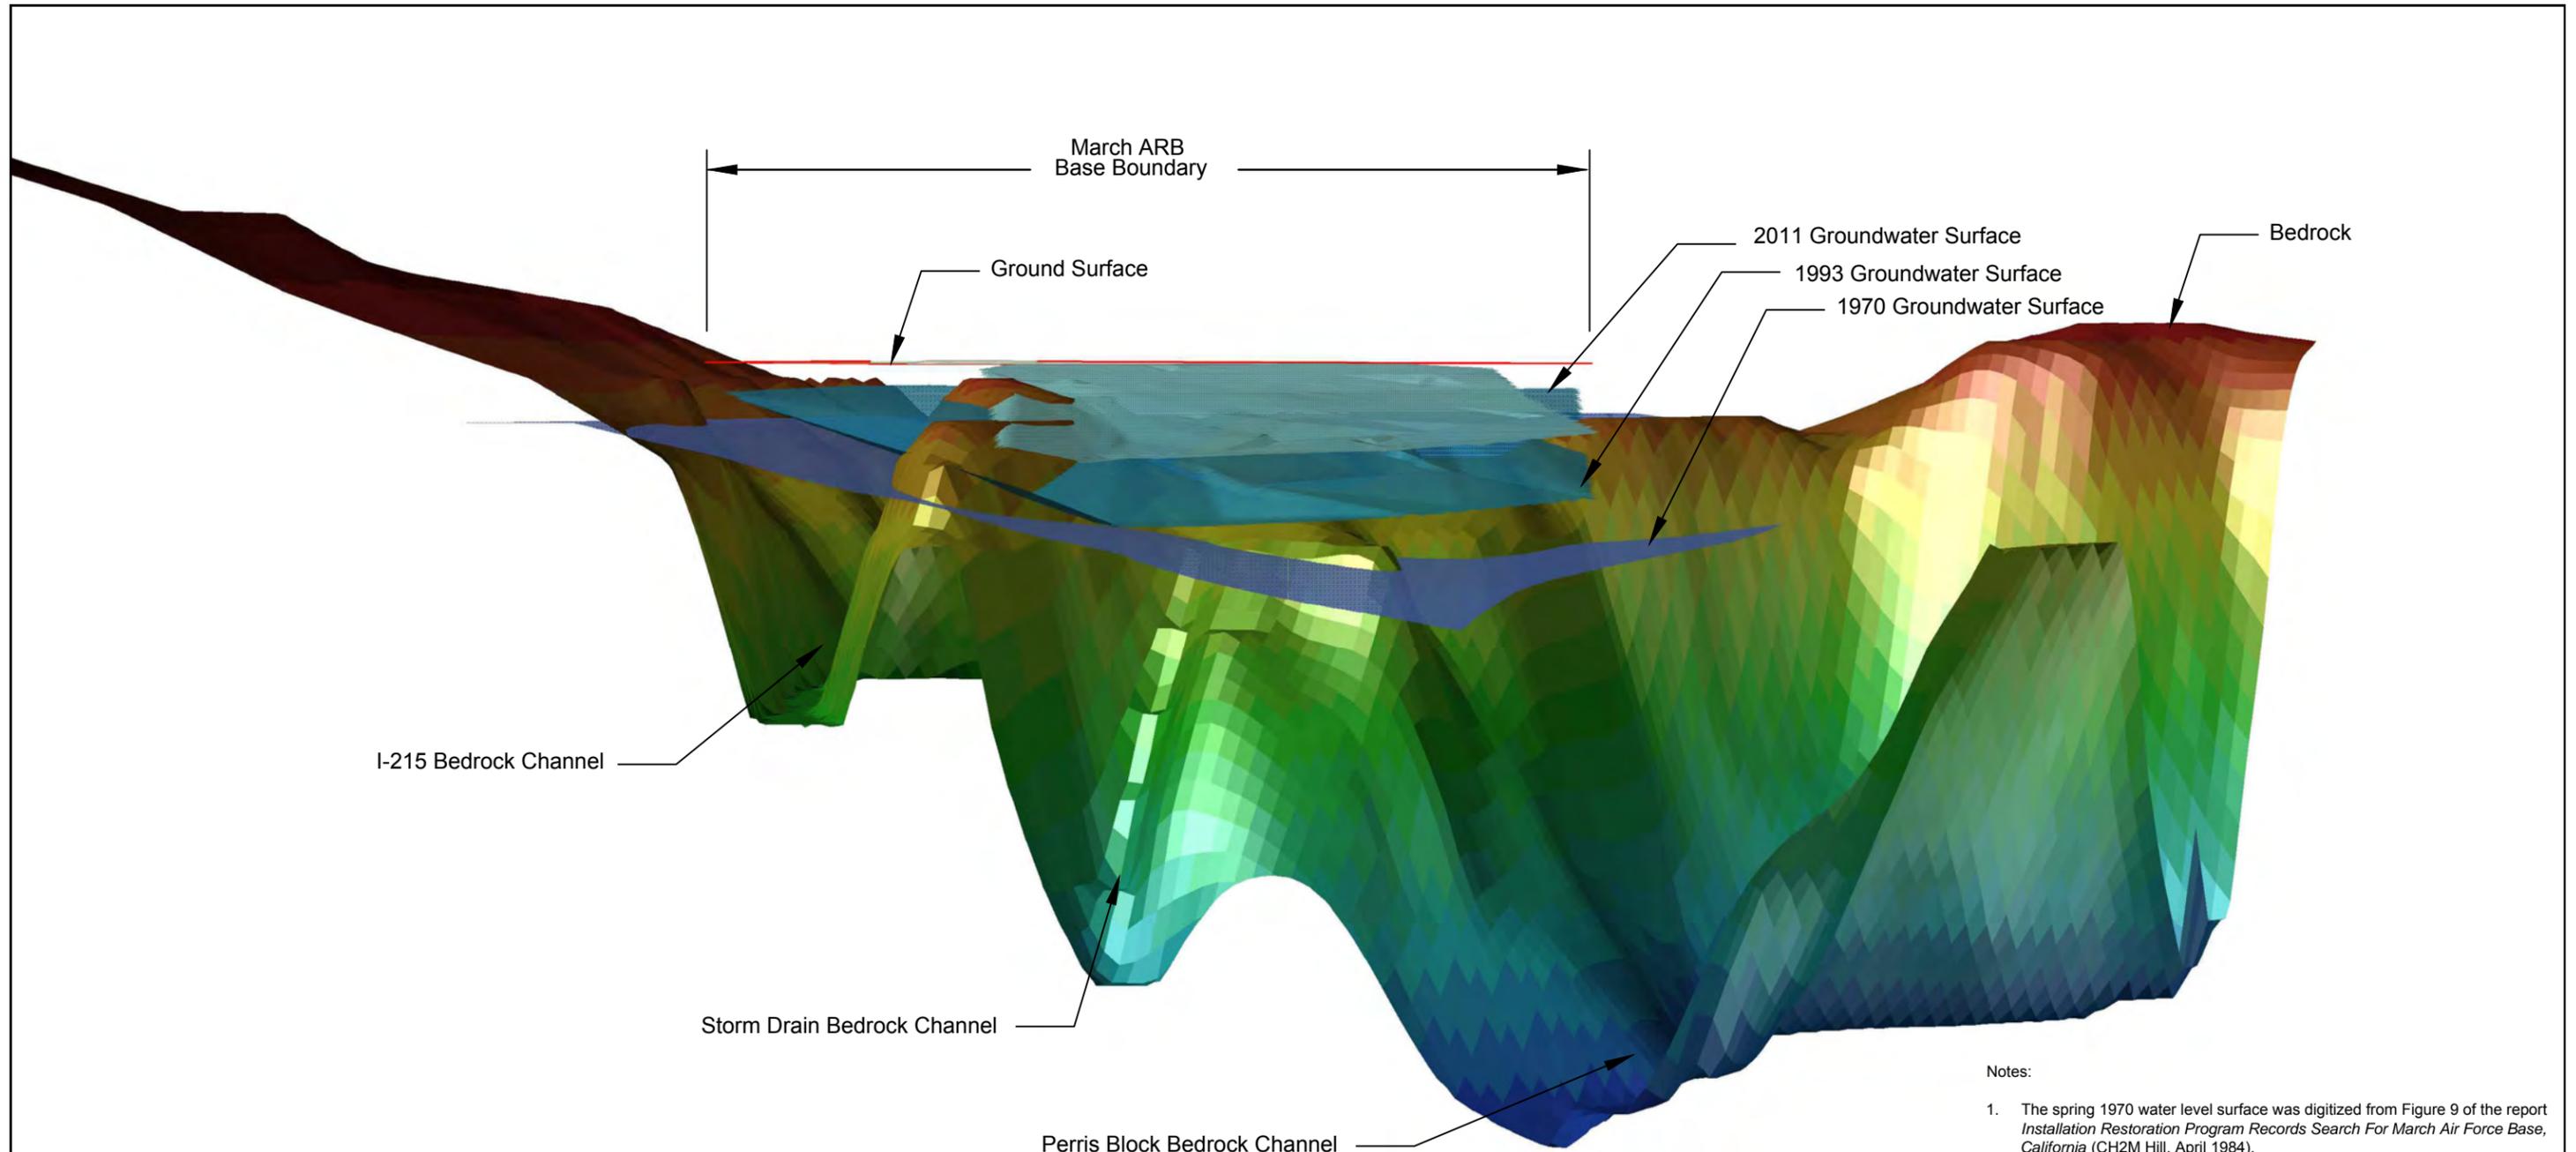
Third Five-Year Review Report		
<b>Three-Dimensional Rendering of the Bedrock Surface with Water Level History</b>		
Date	09-14	
Project No.	60271680	
March ARB and Former March AFB, CA		Figure <b>3-8</b>

1. The spring 1970 water level surface was digitized from Figure 9 of the report *Installation Restoration Program Records Search For March Air Force Base, California* (CH2M Hill, April 1984).
2. Water level elevations from second quarter 1993 were obtained from table 2010AMR\_Historical\_GWElev.xlsx provided on a DVD by March ARB.
3. Water levels from second quarter 2011 were obtained from table Groundwater\_Data\_2q11.xlsx provided by March ARB.
4. The bedrock surface was digitized from Figure 2-2 of the report *Site 8 Supplemental Remedial Investigation, Site 8 Focused Feasibility Study, and Site 36 Focused Feasibility Study, Final* (Earth Tech Inc., January 2009).
5. March ARB boundary and airfield were obtained from a DVD provided by March ARB.
