**FINAL  
THIRD FIVE-YEAR REVIEW REPORT**

**PERFORMANCE-BASED REMEDIATION AT  
MARCH AIR RESERVE BASE AND FORMER MARCH  
AIR FORCE BASE, CALIFORNIA**

**Five-Year Review**

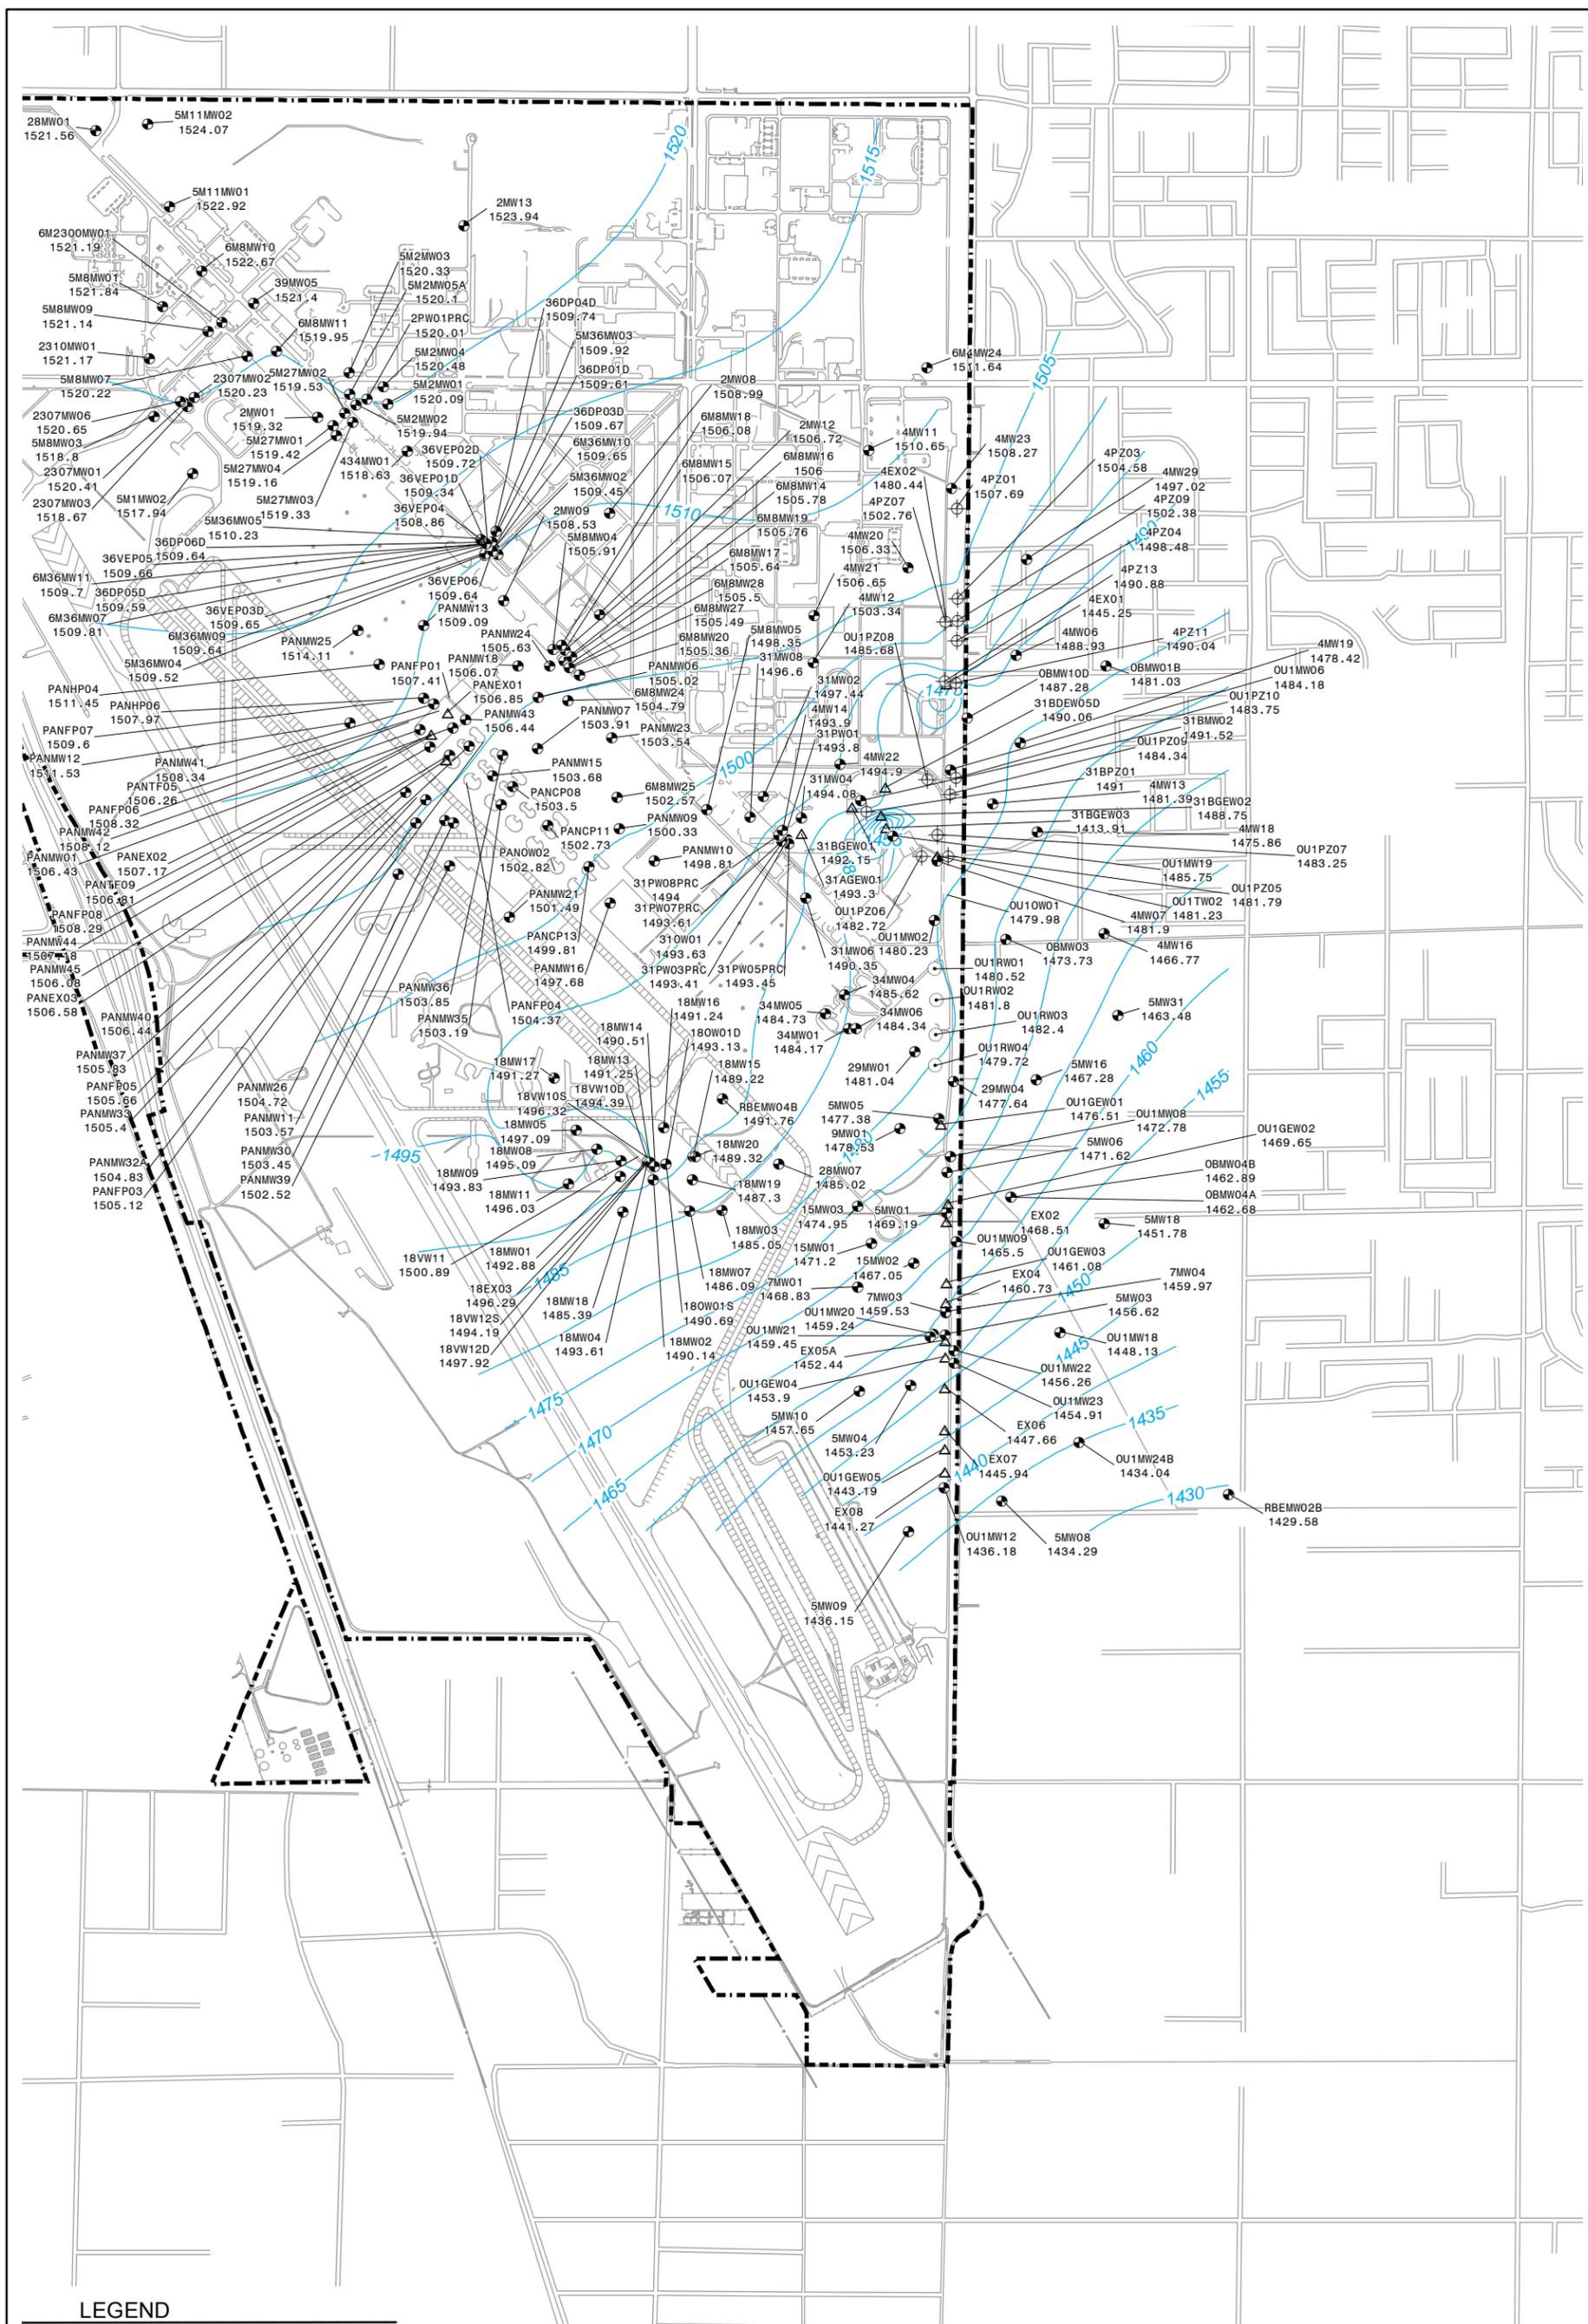
Date	09-14	<b>AECOM</b>	Figure 3-9
Project No.	60271680		
March ARB and Former March AFB, CA

- SECOND QUARTER 2012 GROUNDWATER ELEVATION CONTOURS (FT MSL)
- - - - - BASE PROPERTY LINE
- GROUNDWATER WELLS**
- ▲ EXTRACTION WELL
- △ INJECTION WELL
- MONITORING WELL
- ⊕ PIEZOMETER
- PRIVATE WELL

**Upper Alluvial Basewide Potentiometric Surface Map Second Quarter 2012**

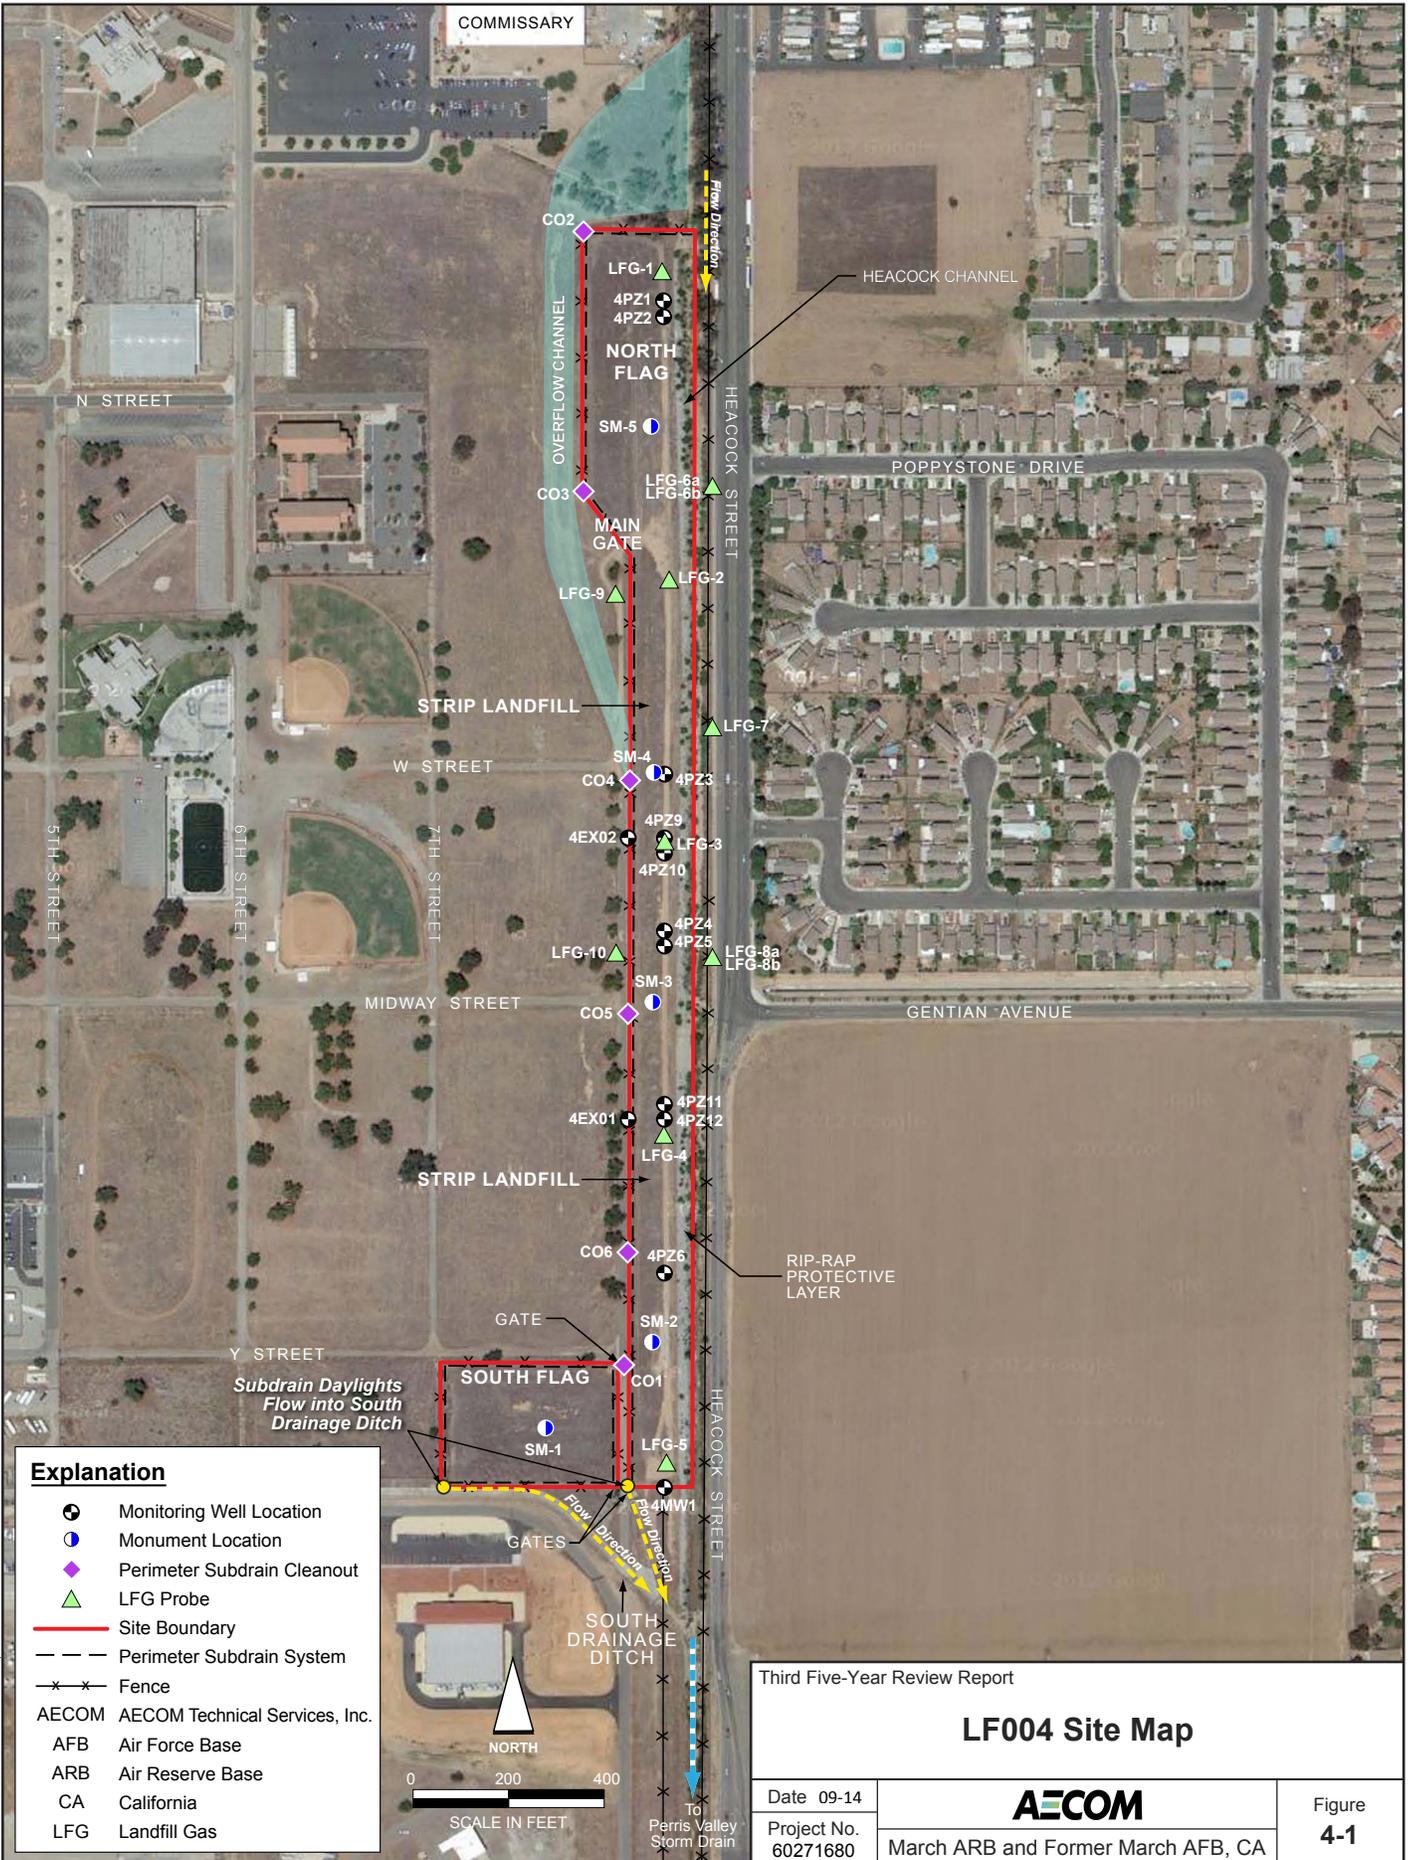
Third Five-Year Review Report		<b>LF004 Site Map</b>	Figure <b>4-1</b>
Date 09-14	<b>AECOM</b>		
Project No. 60271680		March ARB and Former March AFB, CA

- Monitoring Well Location
  - Monument Location
  - Perimeter Subdrain Cleanout
  - LFG Probe
  - Site Boundary
  - Perimeter Subdrain System
  - Fence
- AECOM AECOM Technical Services, Inc.  
 AFB Air Force Base  
 ARB Air Reserve Base  
 CA California  
 LFG Landfill Gas

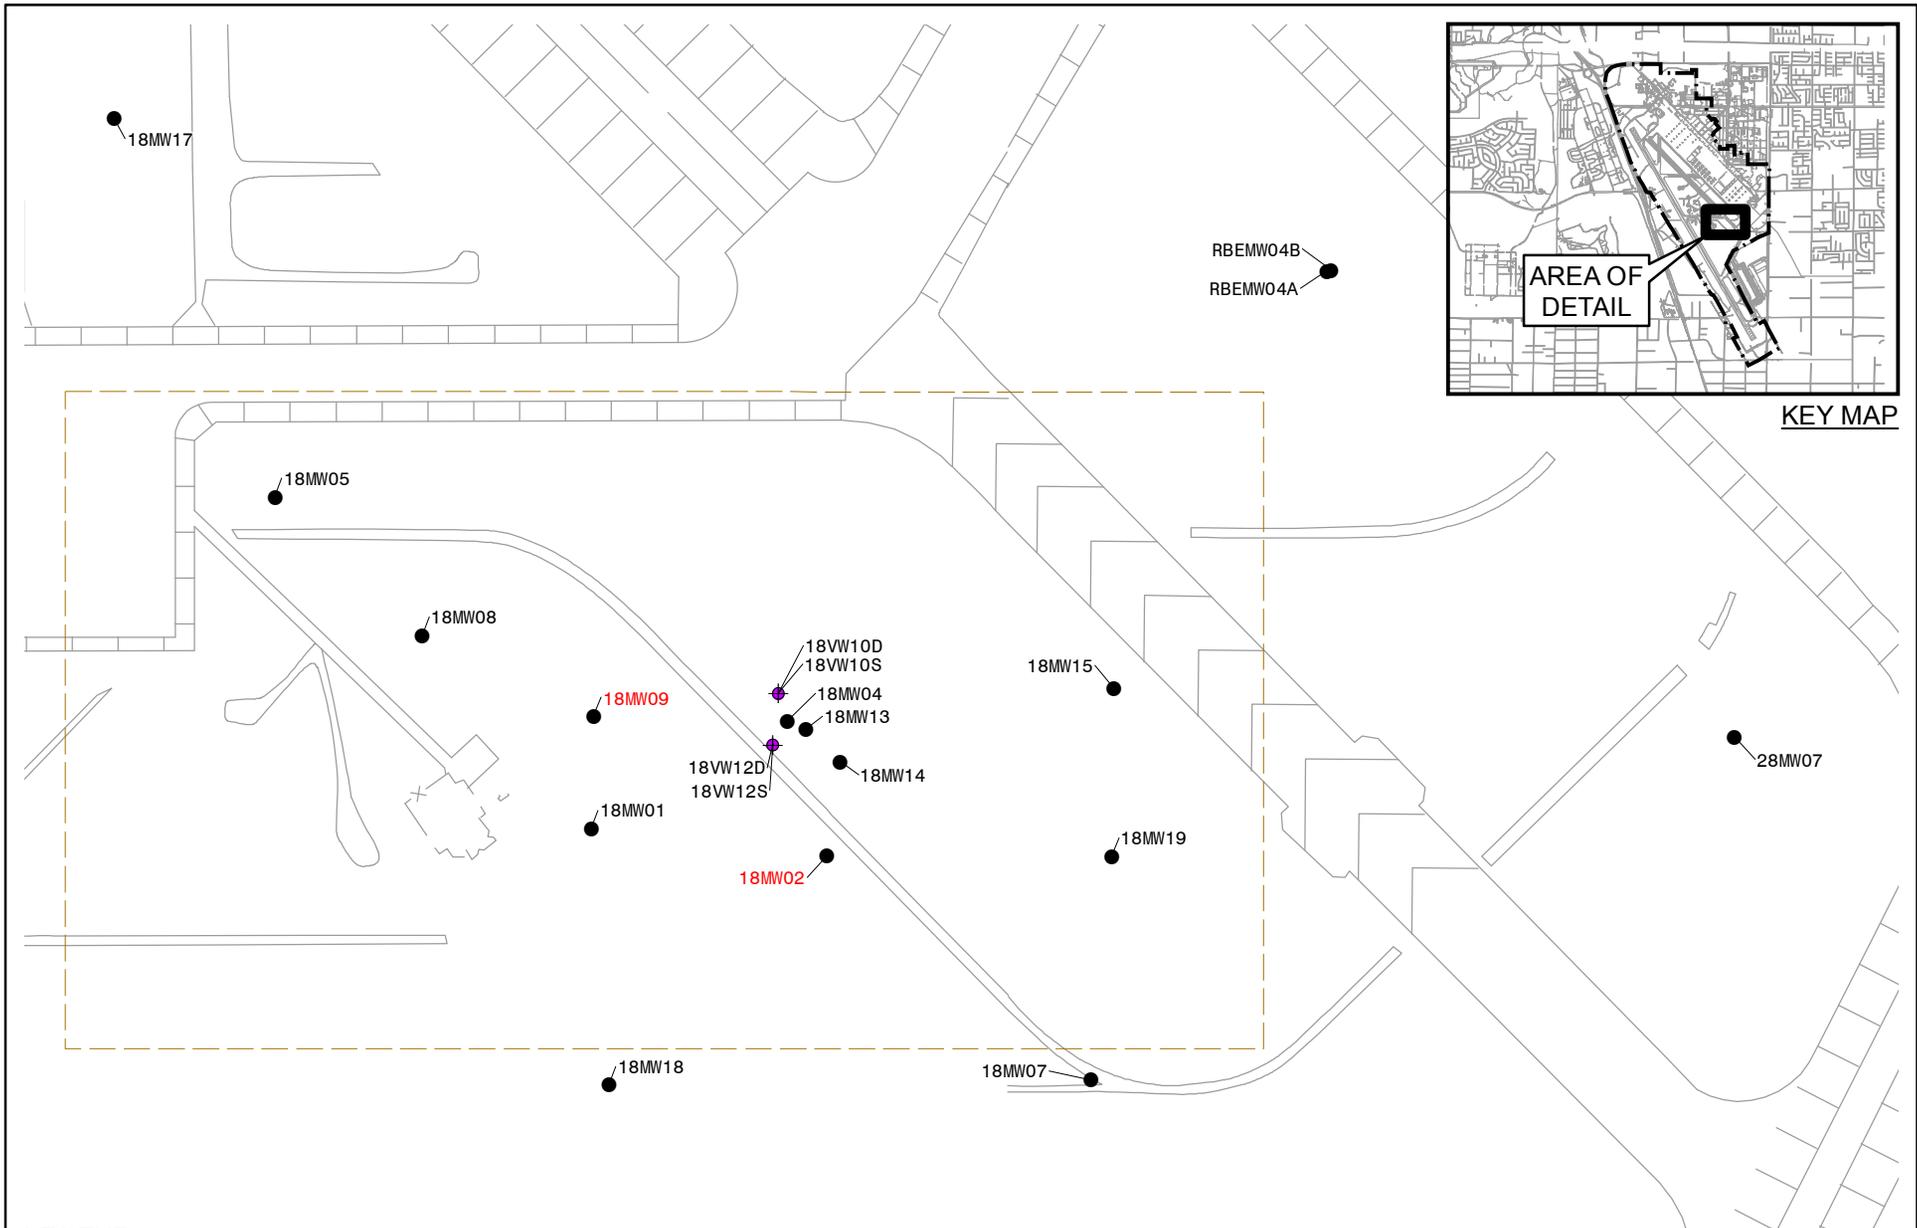
Third Five-Year Review Report		<b>Site 18</b>	
		<b>Site Map and Well Layout</b>	
Date	09-14	<b>AECOM</b>	Figure
Project No.	60271680		4-4
		March ARB and Former March AFB, CA

- MONITORING WELL
- ◆ AIR EXTRACTION WELL
- ▭ SITE BOUNDARY

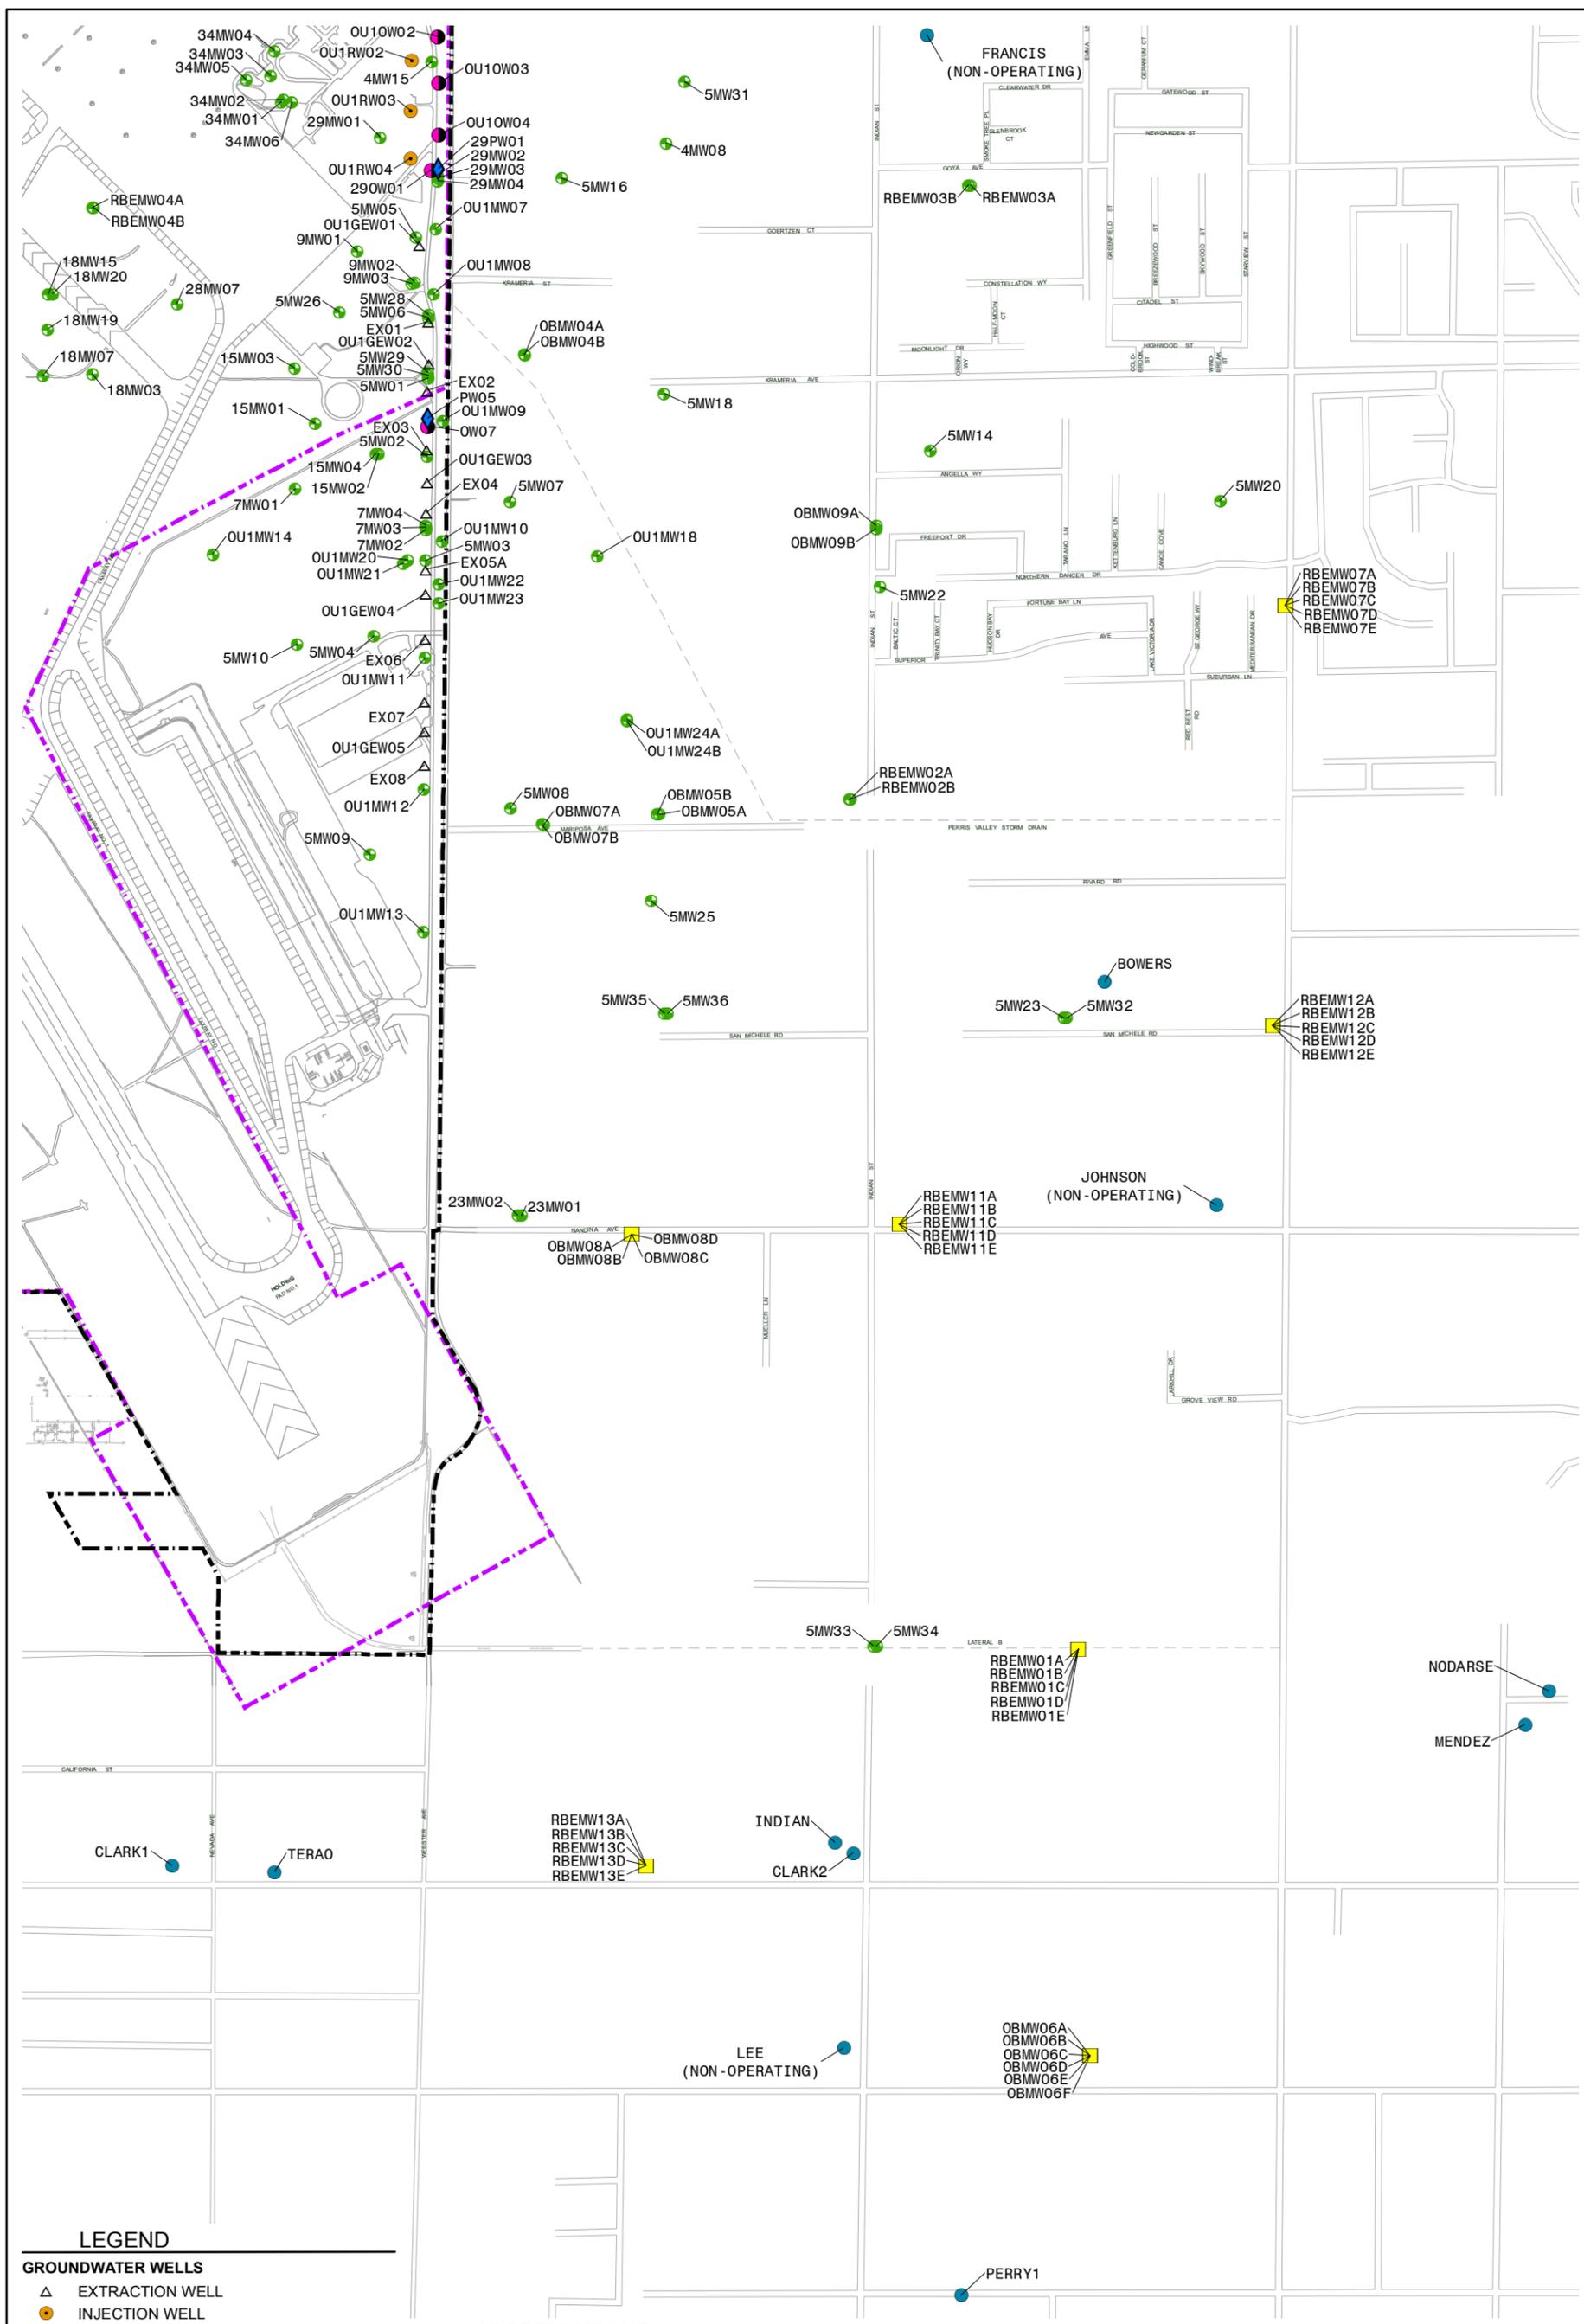
Third Five-Year Review Report		<b>Off-Base Water Supply Well Location Map</b>	
Date	09-14		
Project No.	60271680	<b>AECOM</b>	Figure 4-9
March ARB and Former March AFB, CA

- GROUNDWATER WELLS**
- △ EXTRACTION WELL
  - INJECTION WELL
  - MONITORING WELL
  - PIEZOMETER
  - WATER SUPPLY WELL (NON-OPERATING WHERE NOTED)
  - WESTBAY WELL
  - ◆ PUMPING WELL
  - OBSERVATION WELL
  - FORMER MARCH AFB BASE BOUNDARY
  - MARCH ARB BOUNDARY

Water supply wells exist around March ARB. These wells have been primarily used for agricultural and domestic water supplies. See Section 4.8 for a discussion of water supply well sampling and Figure 4-9 for the location of water supply wells.

The water supply wells are shown in Figure 4-9. A similar analysis was also conducted on the water supply guard wells. No action, other than continued monitoring, was indicated.

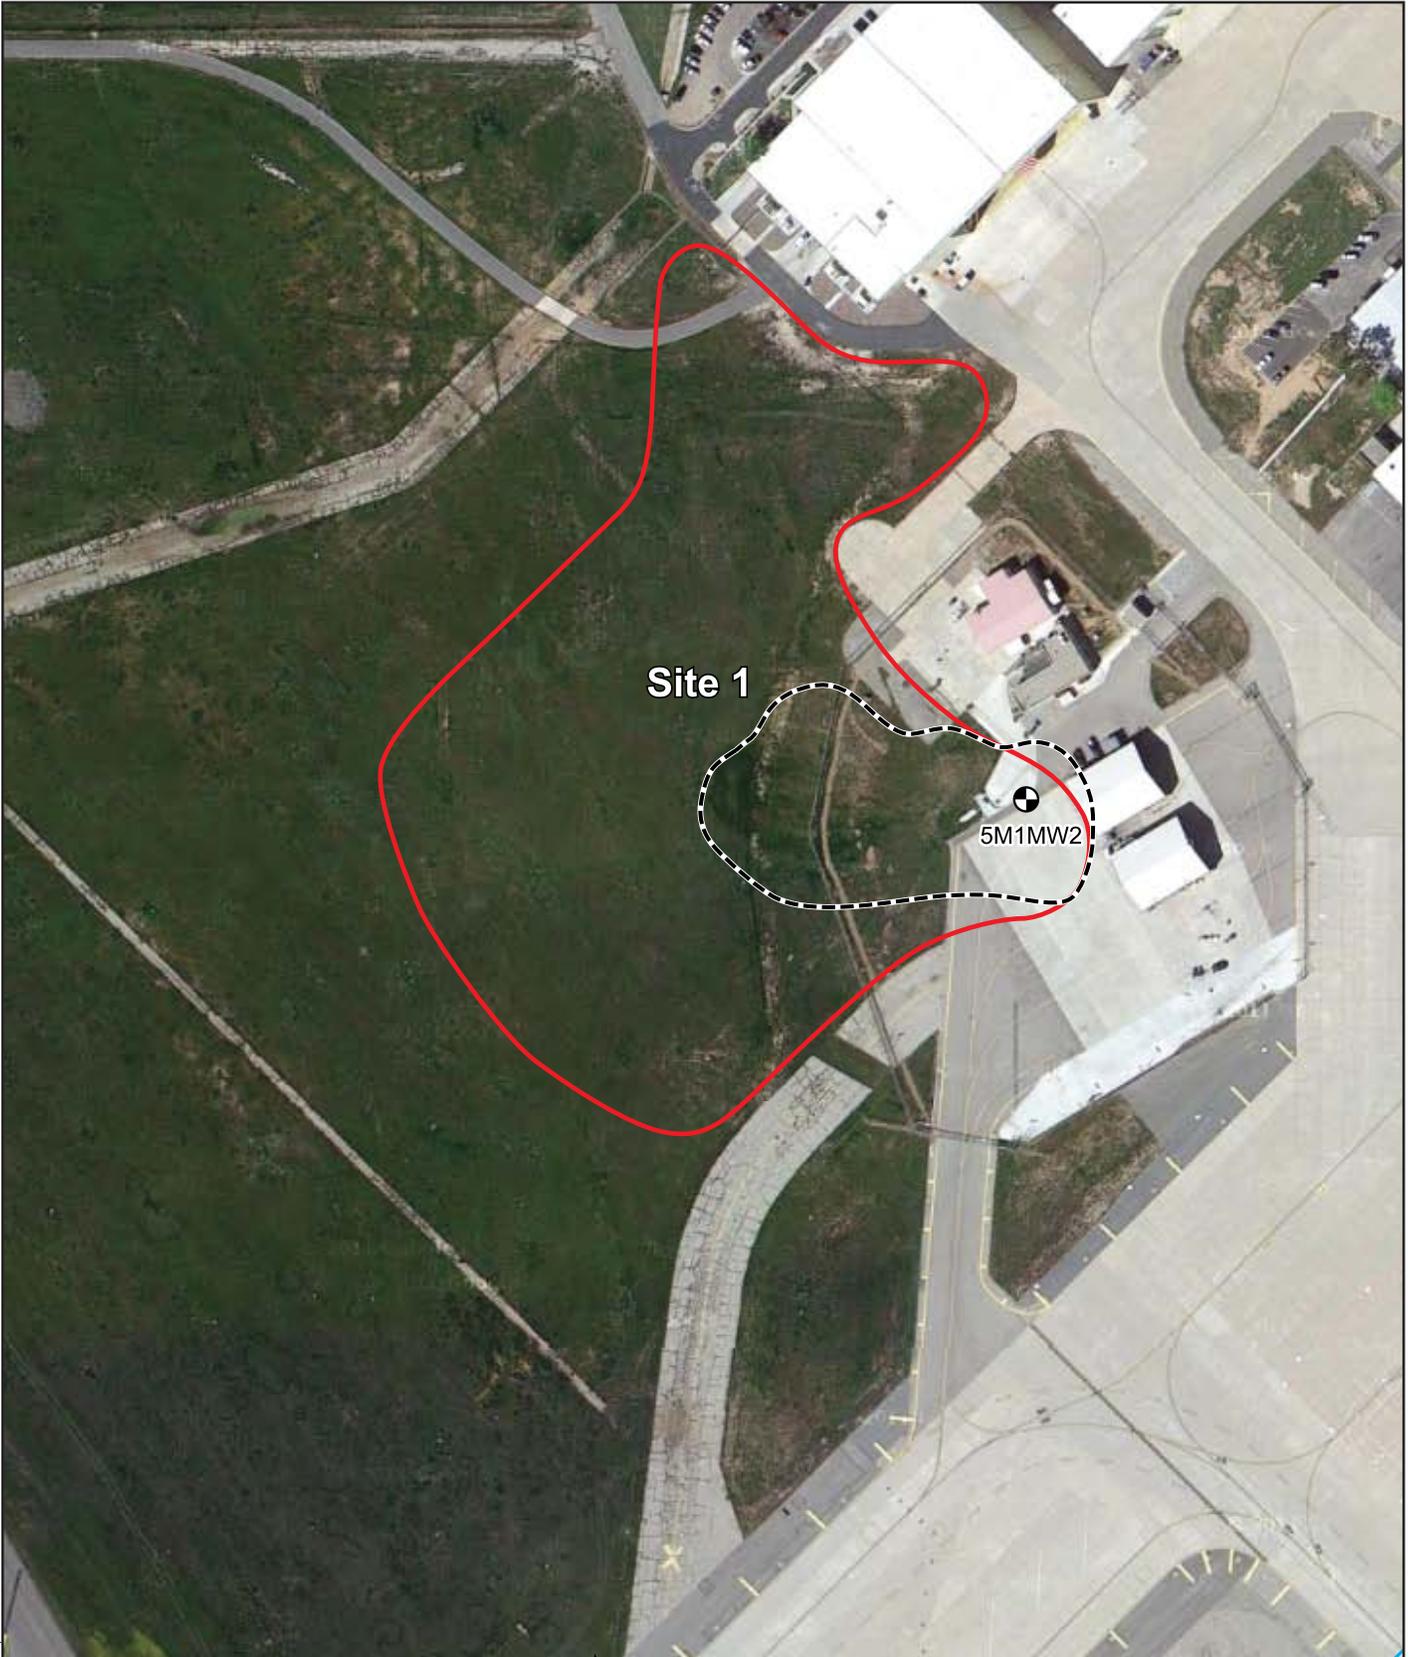
Date 09-14	<b>AECOM</b>	Figure <b>5-1</b>
Project No. 60271680

- Site 1 Boundary
- - - Area of Previous Excavation for PAH-Contaminated Soil
-

**Site 1 Plan**

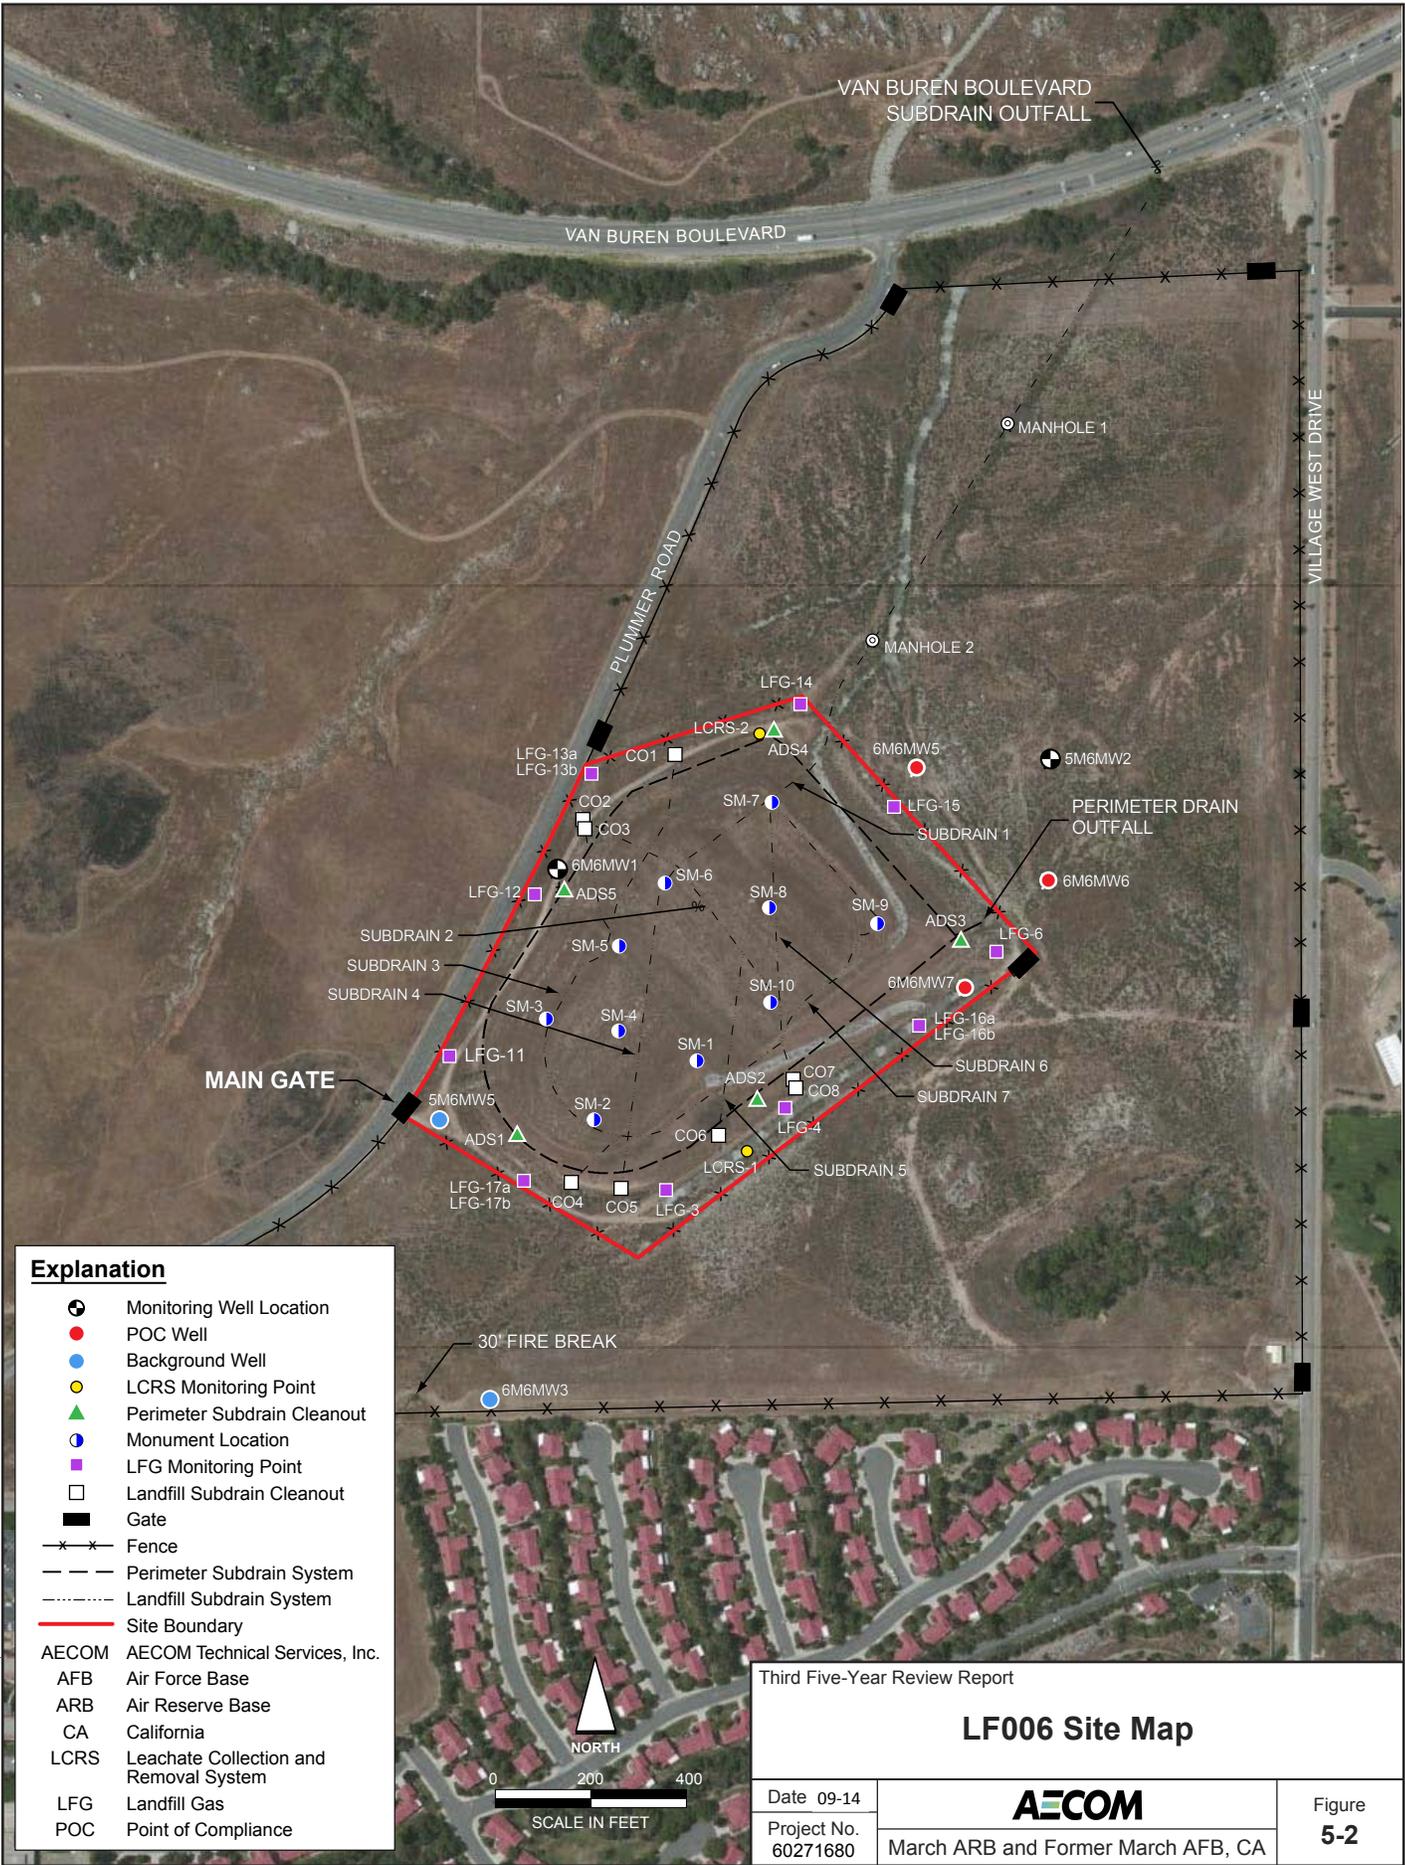
Third Five-Year Review Report		
<b>LF006 Site Map</b>		
Date 09-14	<b>AECOM</b>	Figure
Project No. 60271680	March ARB and Former March AFB, CA	<b>5-2</b>

AECOM AECOM Technical Services, Inc.  
 AFB Air Force Base  
 ARB Air Reserve Base  
 CA California  
 LCRS Leachate Collection and Removal System  
 LFG Landfill Gas  
 POC Point of Compliance

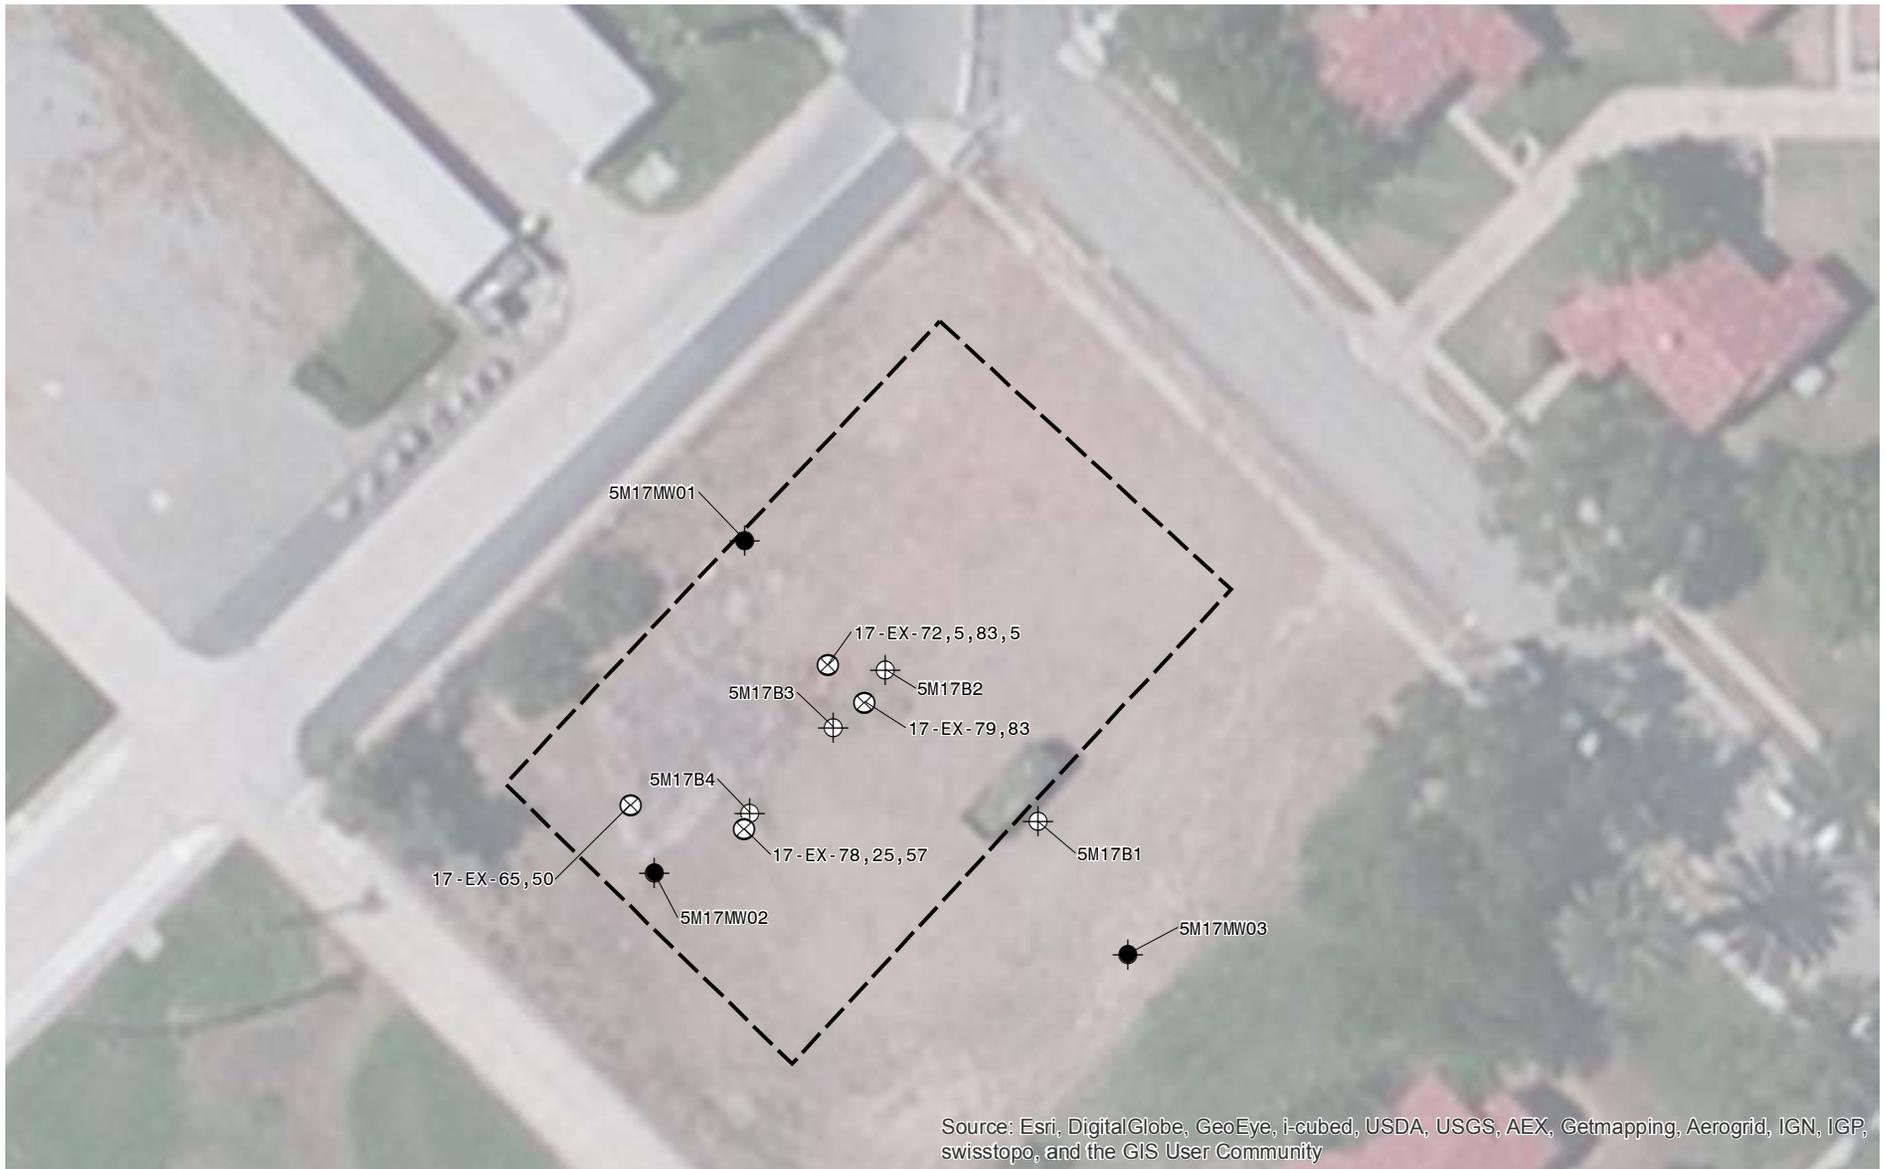
Date	09-14	<b>AECOM</b>	Figure
Project No.	60271680		5-4
March ARB and Former March AFB, CA

- ⊕ STAGE 5 BORING (1994)
- ⊗ CONFIRMATION SAMPLE (1994)
- GROUNDWATER MONITORING WELL (ABANDONED IN 2003)
- ⬡ SOIL EXCAVATION AREA

**Site 17 Layout  
Confirmation Sample Locations**
