**FINAL  
THIRD FIVE-YEAR REVIEW REPORT**

**PERFORMANCE-BASED REMEDIATION AT  
MARCH AIR RESERVE BASE AND FORMER MARCH  
AIR FORCE BASE, CALIFORNIA**

**Five-Year Review**

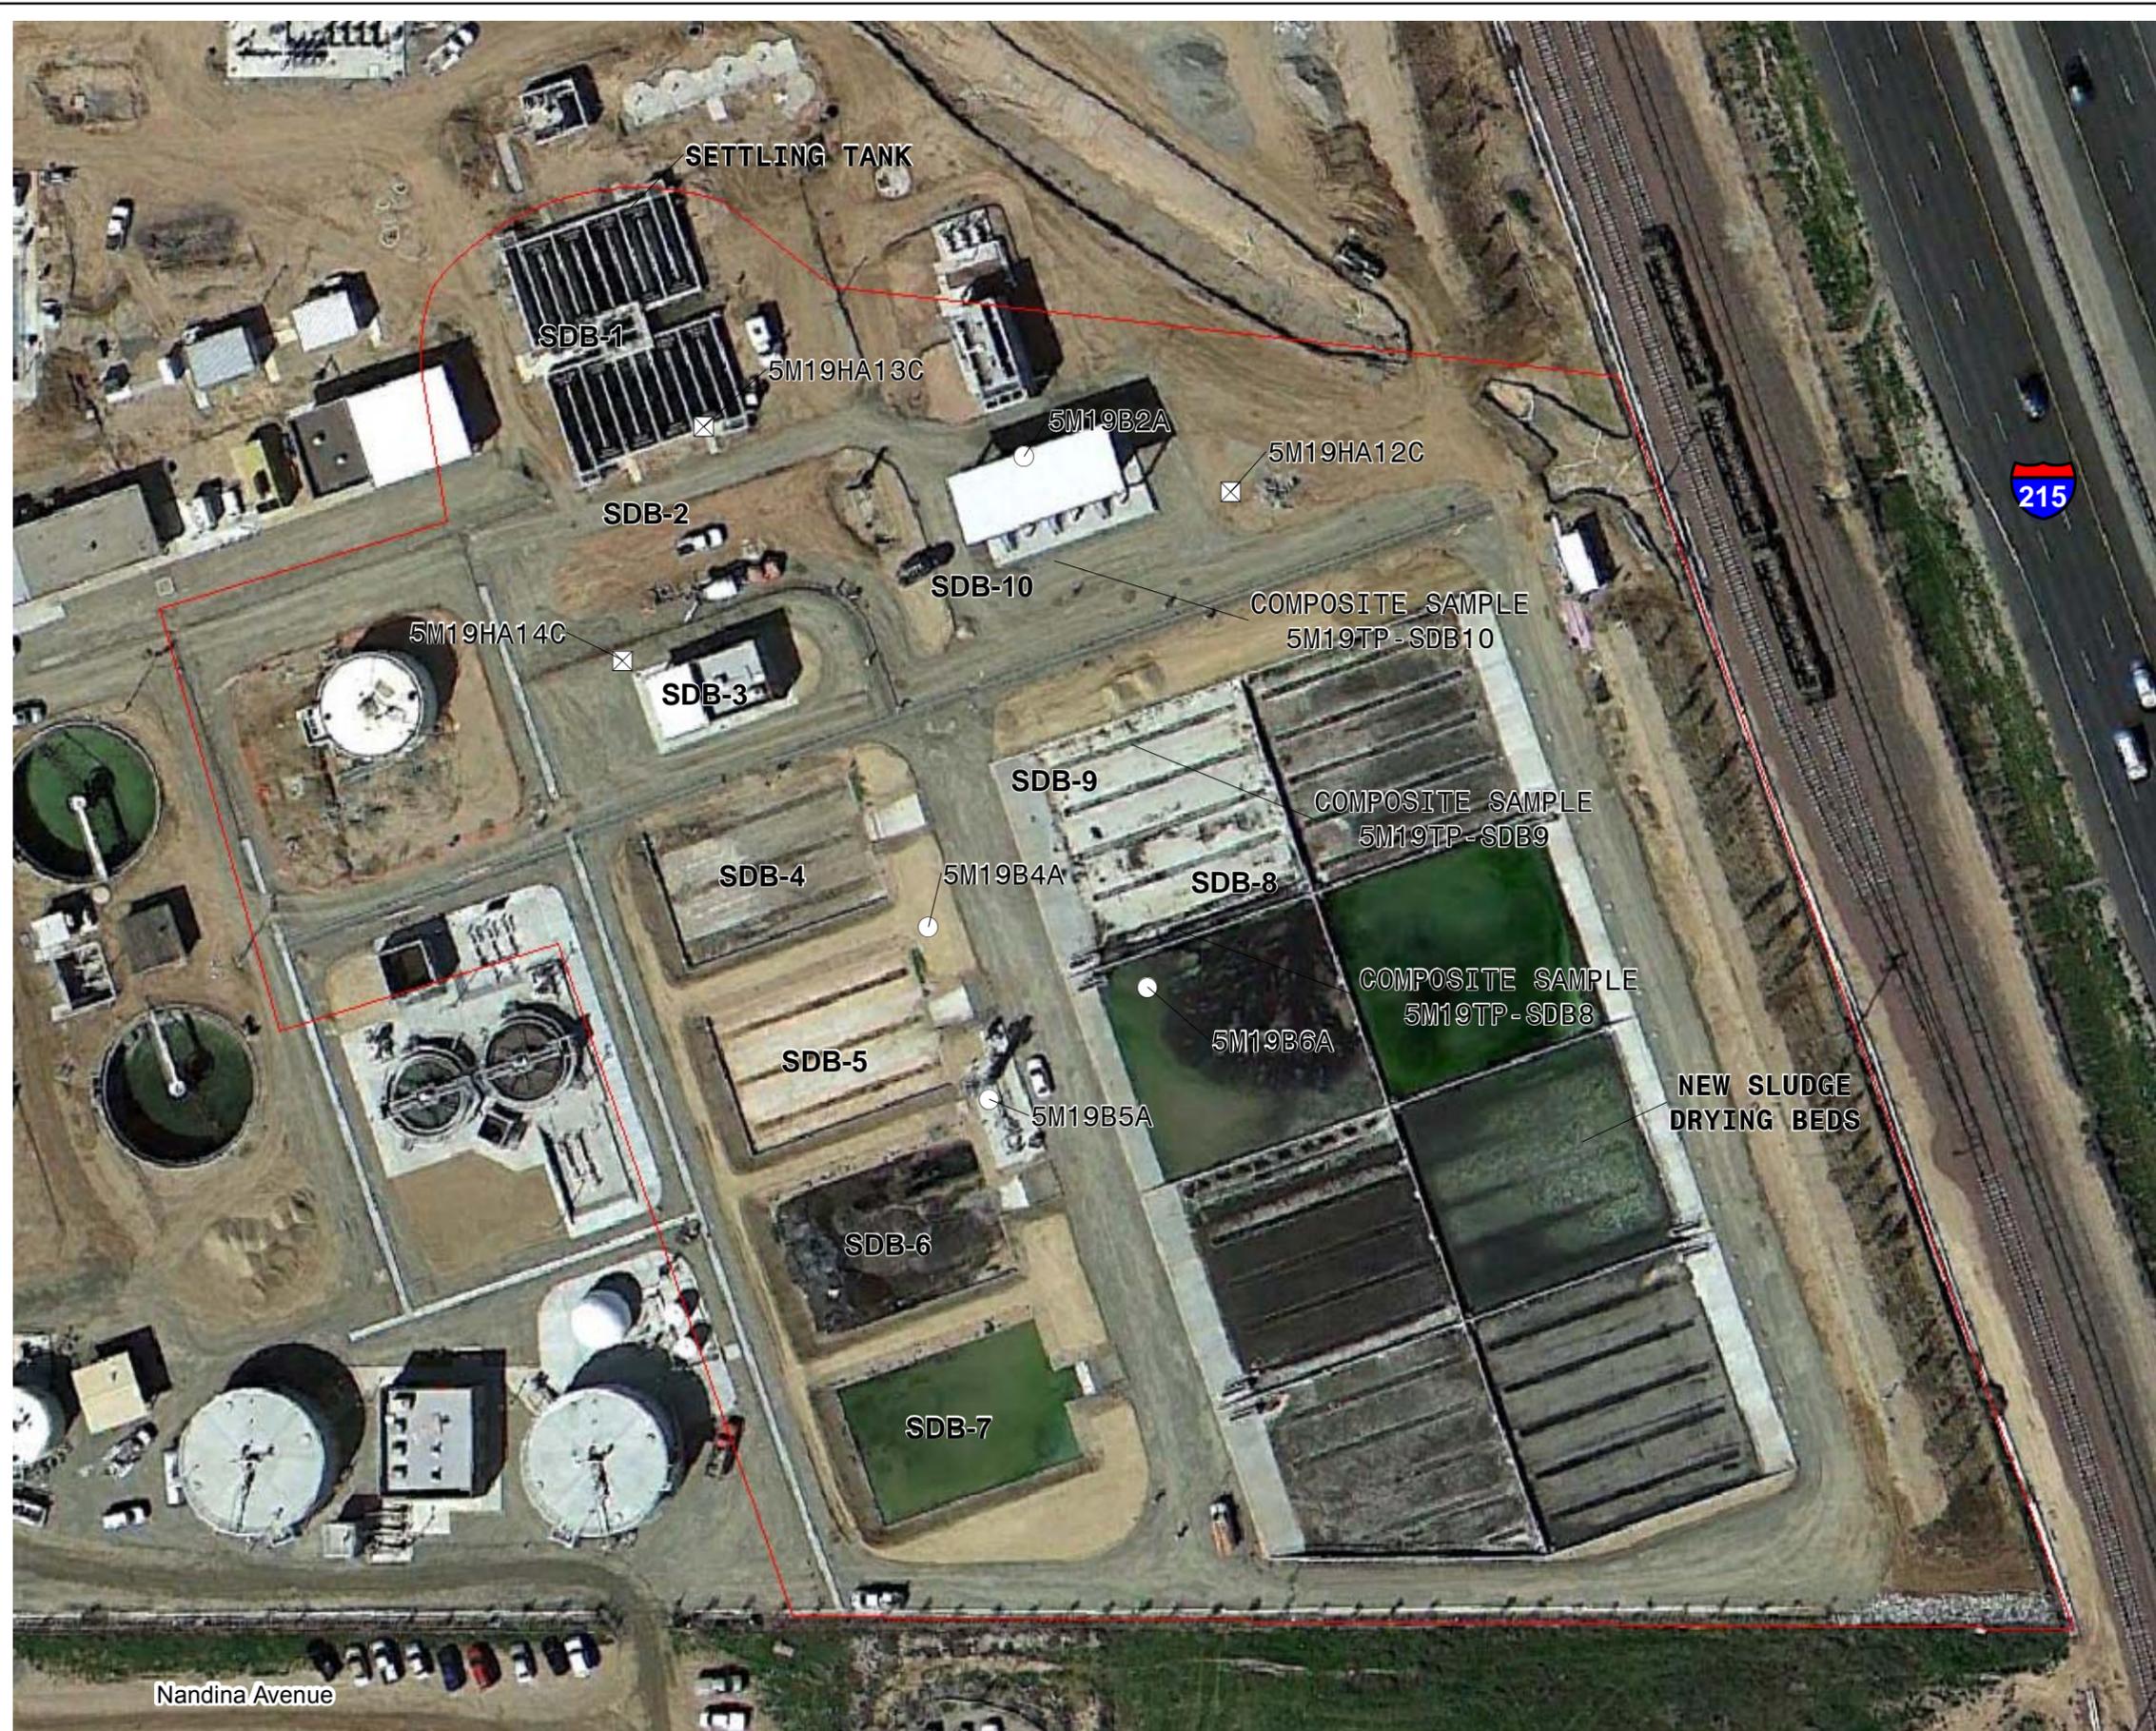
Third Five-Year Review Report		<b>Site 19 Layout Mid Upgrade (3/9/2011)</b>	
Date	09-14	<b>AECOM</b>	Figure
Project No.	60271680		5-5
		March ARB and Former March AFB, CA

- SOIL BORING
- ⊗ HAND-AUGER BORING
- ▭ ACTIVE SLUDGE DRYING BED
- ▨ FORMER SLUDGE DRYING BED
- ▭ SITE 19 BOUNDARY
