THIRD FIVE YEAR REVIEW

OPERABLE UNIT 1

MOTOROLA 52ND STREET

SEPTEMBER 25, 2006

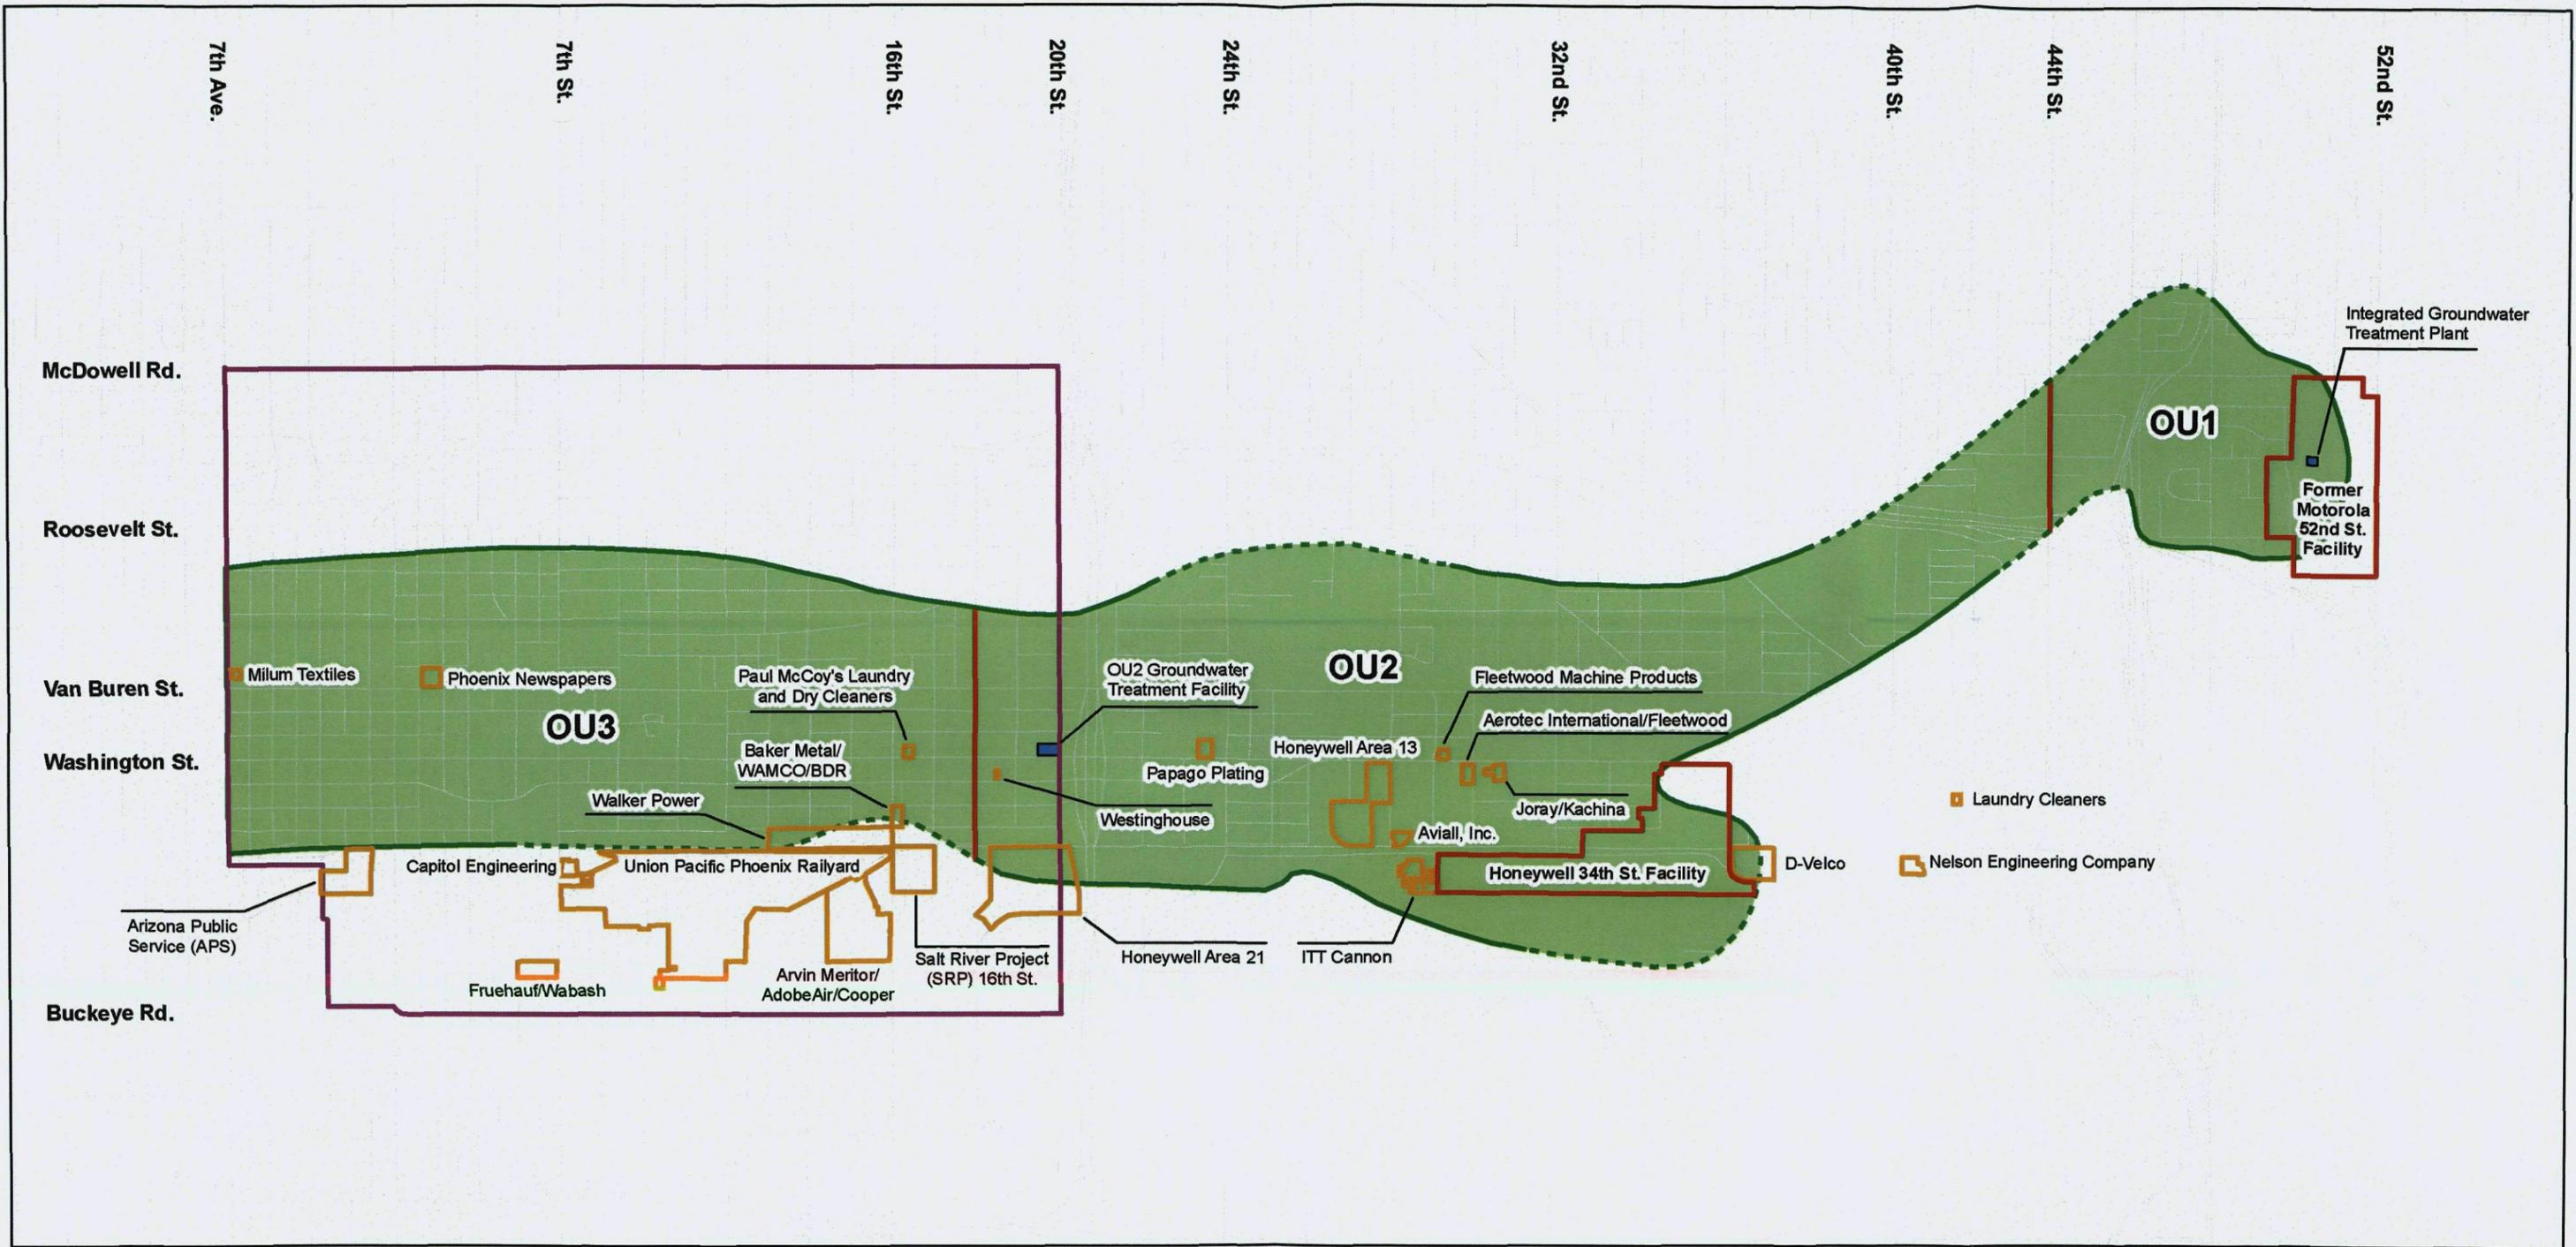
Figure 1
Site Vicinity Map

- LEGEND**
- Responsible Parties
 - Potentially Responsible Parties
 - OU3 Study Area
 - M52 Site Boundary
 - Treatment Systems
 - OU Boundaries
 - Streets

The OU1 Area is part of the Motorola 52nd Street Superfund Site. The Motorola 52nd Street Superfund Site consists of three operable units: OU1, OU2, and Operable Unit 3 (OU3) (Figure 1). The Motorola 52nd Street Facility (formerly owned/operated by Motorola and currently owned/operated by ON Semiconductor) is located on the southwest corner of the intersection of 52nd Street and McDowell Road in the eastern part of Phoenix, Arizona. OU1 is defined by the contaminant plume to the north (Palm Lane) and south (Roosevelt Street) and by the zone of hydraulic capture to the west (46th Street). The property occupies approximately 90 acres and contains more than 20 buildings on-site. Major geographic features include: the Papago Buttes about one mile east of the Facility, the Salt River one mile south of the Facility, the Old Crosscut Canal located along 46th Street, and the Grand Canal located through the area west of 40th Street and Van Buren Street. The Phoenix Sky Harbor Airport is located approximately 1.5 miles southwest of the Facility. Figure 2 is a site plan of the Facility that shows the locations and names of the primary features and monitor wells. The following paragraphs provide a brief summary of the site activities associated with OU1 at the Motorola 52nd Street Superfund Site.

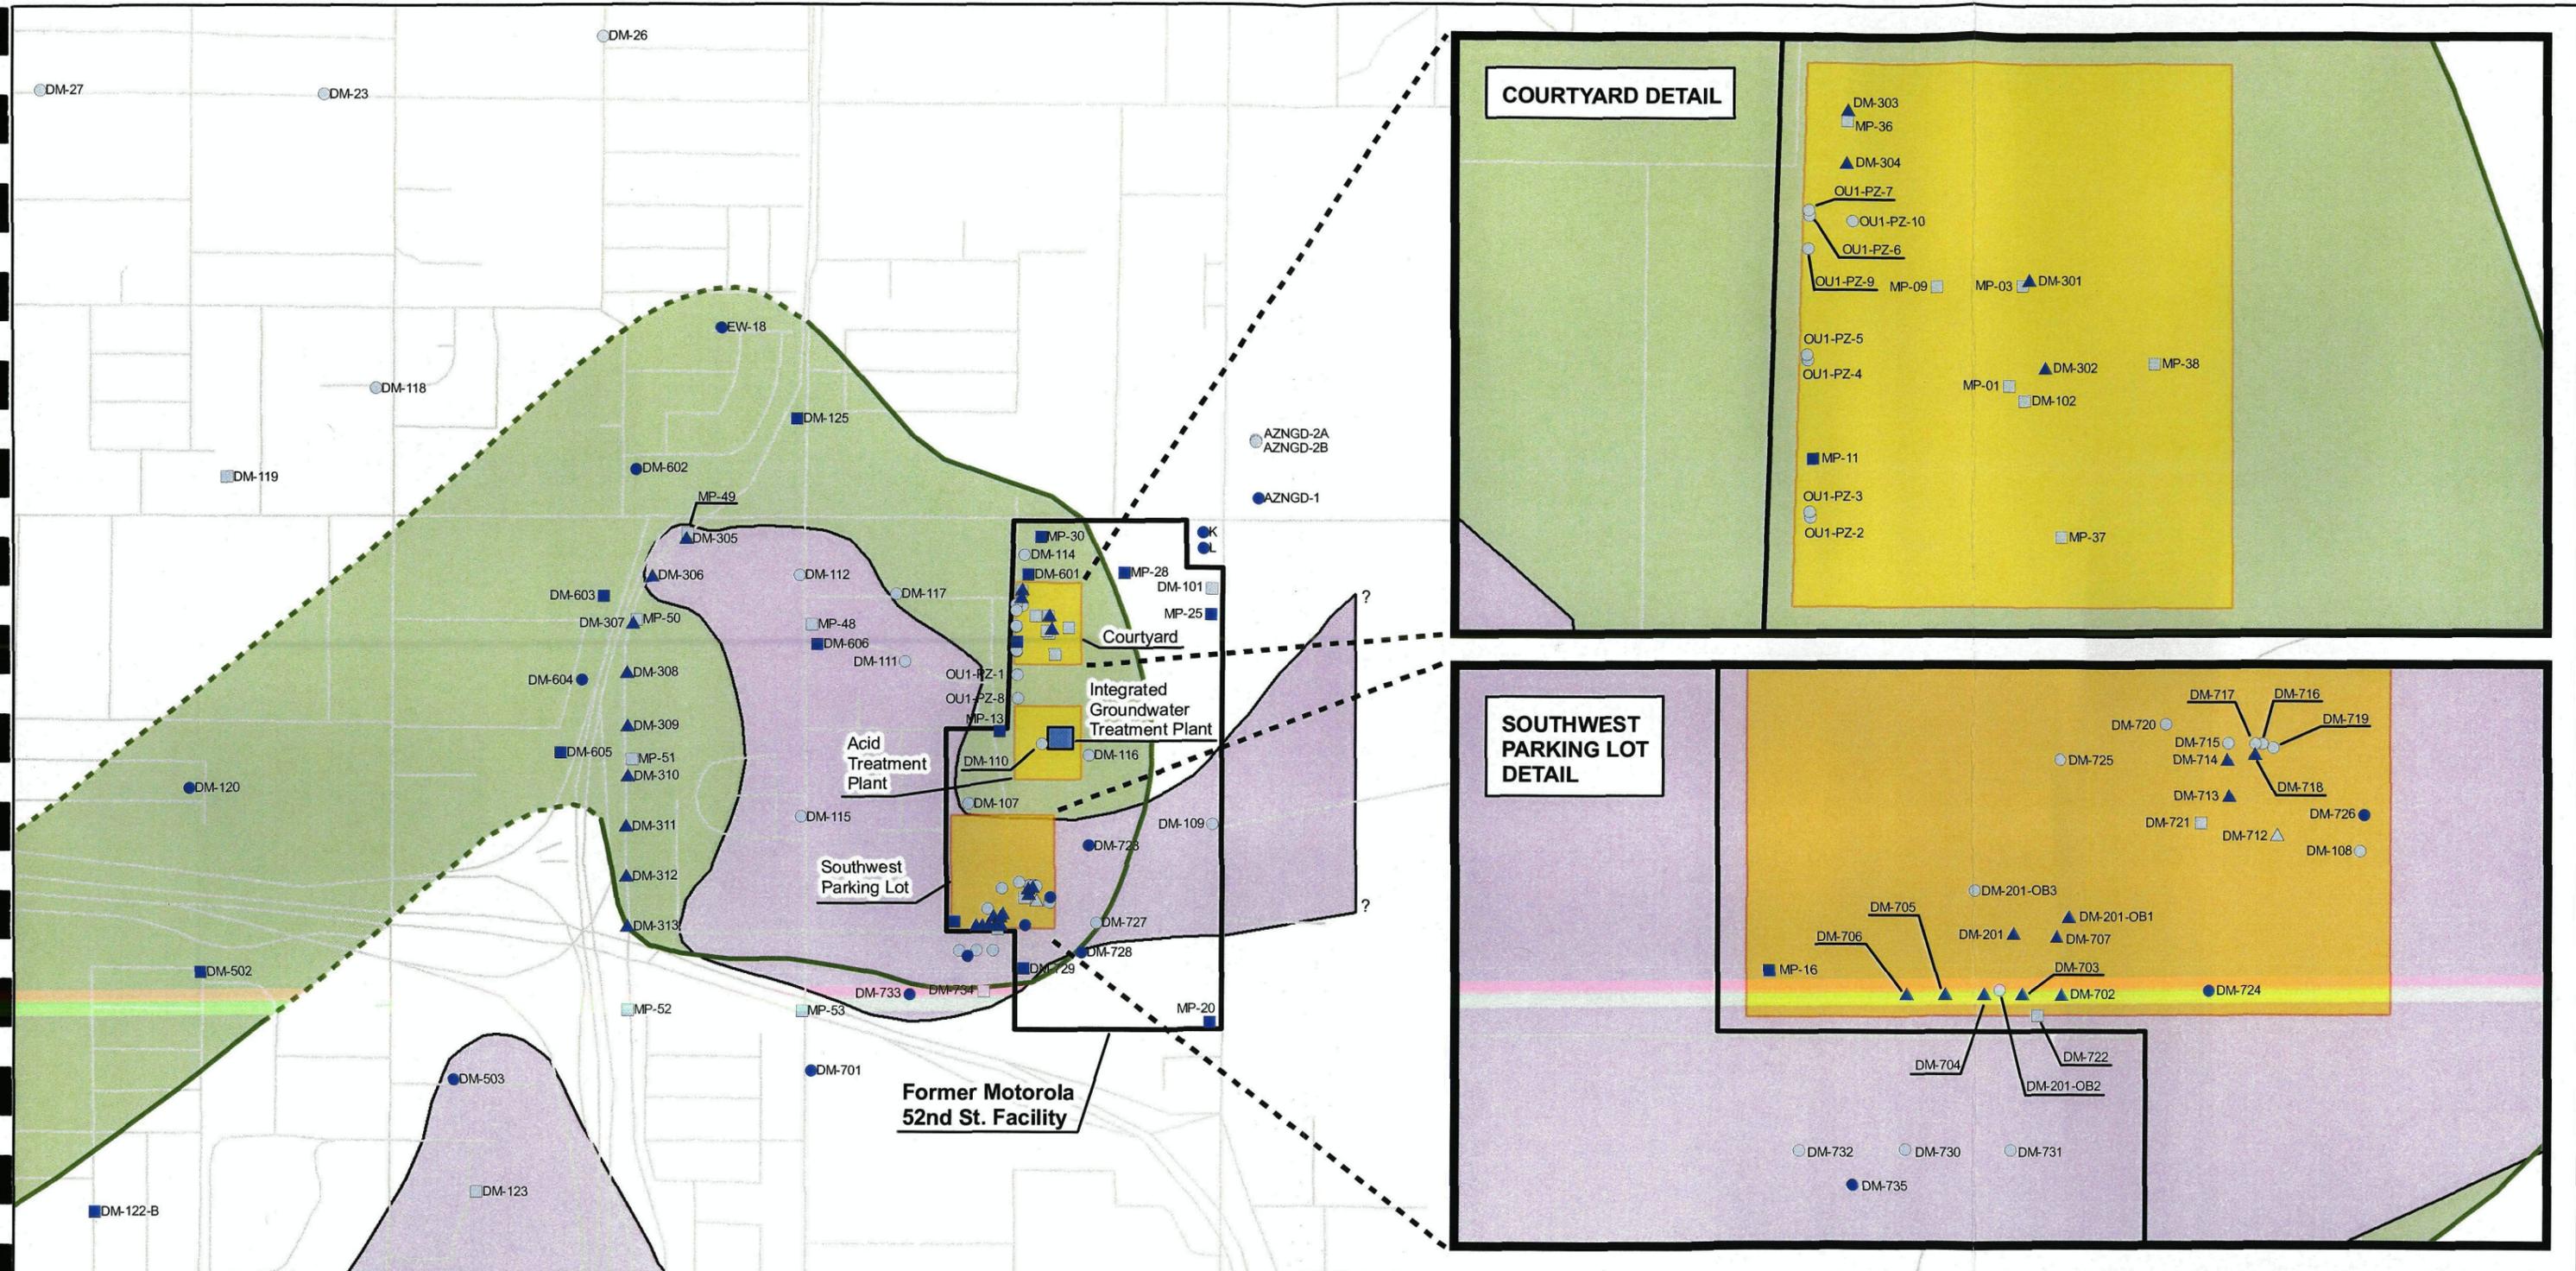
Figure 2
Site Plan

- LEGEND**
- M52 Site Boundary
 - Unsaturated Basin Fill
 - Integrated Groundwater Treatment Plant
 - Streets
 - Conventional Monitor Well, OU1 Network
 - Westbay or Multi-port Well, OU1 Network
 - Groundwater Extraction Well, OU1 Network
 - Conventional Monitor Well, Non-network
 - Westbay or Multi-port Well, Non-network
 - Groundwater Extraction Well, Non-network

The Motorola 52nd Street Facility commenced manufacturing operations in 1956. In November of 1982, Freescale discovered a discrepancy in the inventory for trichloroethane (TCA) in a 5,000 gallon underground storage tank (UST) located in the Courtyard Area (Figure 2). The UST was tested and determined to be leaking. The Arizona Department of Health Services (ADHS; ADHS was the precursor to ADEQ) was notified and a preliminary investigation of soil and groundwater contamination was initiated. Freescale discontinued the use of the tank and began to order solvents in 55-gallon drums.

The groundwater PTP within the Courtyard area was in operation until July 1992 when the permanent IGWTP became operational (Figure 2).

On May 12, 1987, a task specification document was submitted to ADEQ to establish a long-term groundwater monitoring plan for the Site. This plan was updated by Freescale and approved by ADEQ on January 26, 1998. Under this monitoring plan, wells associated with OU1 would be sampled on a semiannual or annual basis with water levels measured quarterly. The locations of the OU1 wells are shown in Figure 2.

From December 20, 1990 to May 4, 1993, an SVE pilot test was completed at the Courtyard Area. On May 7, 1992, the installation of the Courtyard SVE system was completed. The Courtyard SVE blowers were located within the groundwater PTP (Figure 2), and the extracted soil vapor was treated through the existing vapor phase carbon vessels used during the initial groundwater PTP testing. From May 8 through May 13, 1992, the baseline data was collected for the Courtyard SVE system. The pilot program was then initiated on September 21, 1992 and completed on March 31, 1993. Upon completion of the pilot program, the Courtyard SVE system was never restarted.

In 1991, Freescale initiated the investigation of groundwater and the implementation of a voluntary groundwater extraction program within the SWPL Area. The voluntary program was implemented because the results of the periodic sampling of well DM-201, located within the SWPL Area (Figure 2), indicated that TCA and 1,1-DCE were increasing in concentrations.

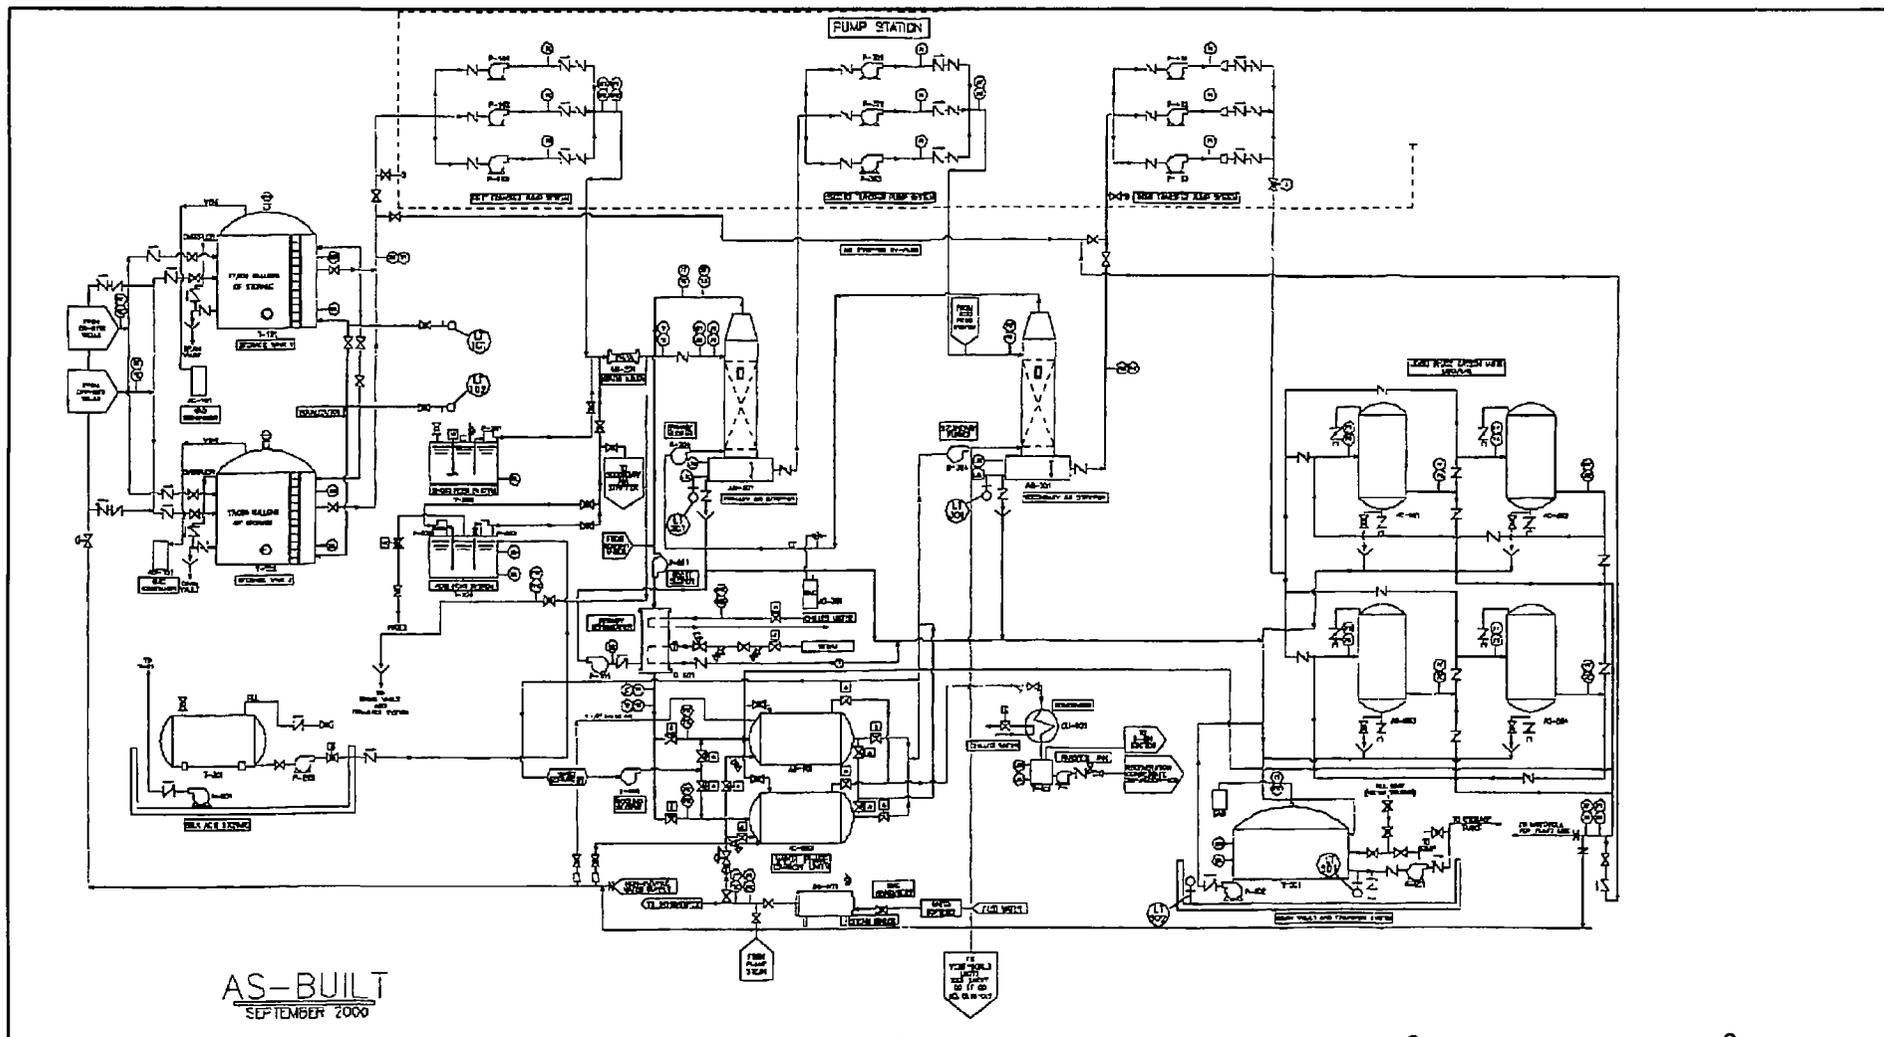
OU1 Process and Instrumentation Diagram

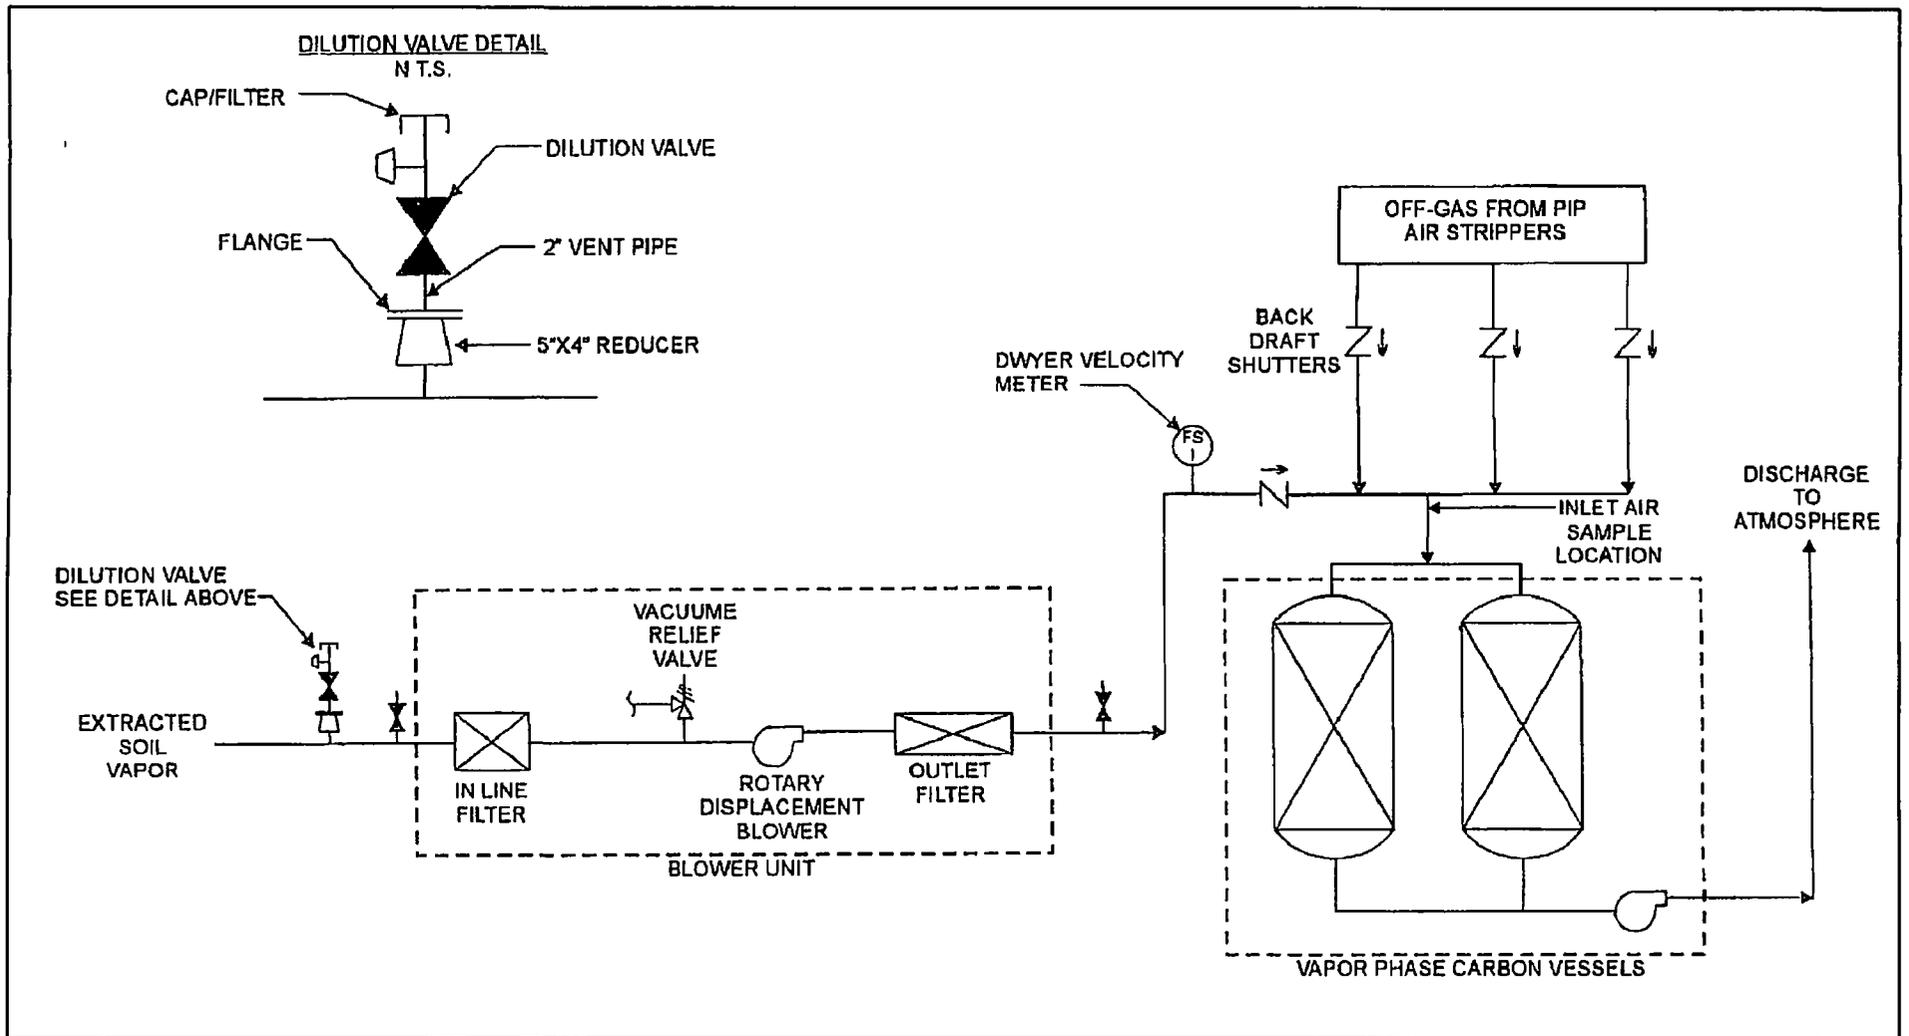
Figure 4

SOIL VAPOR EXTRACTION SUBSYSTEM

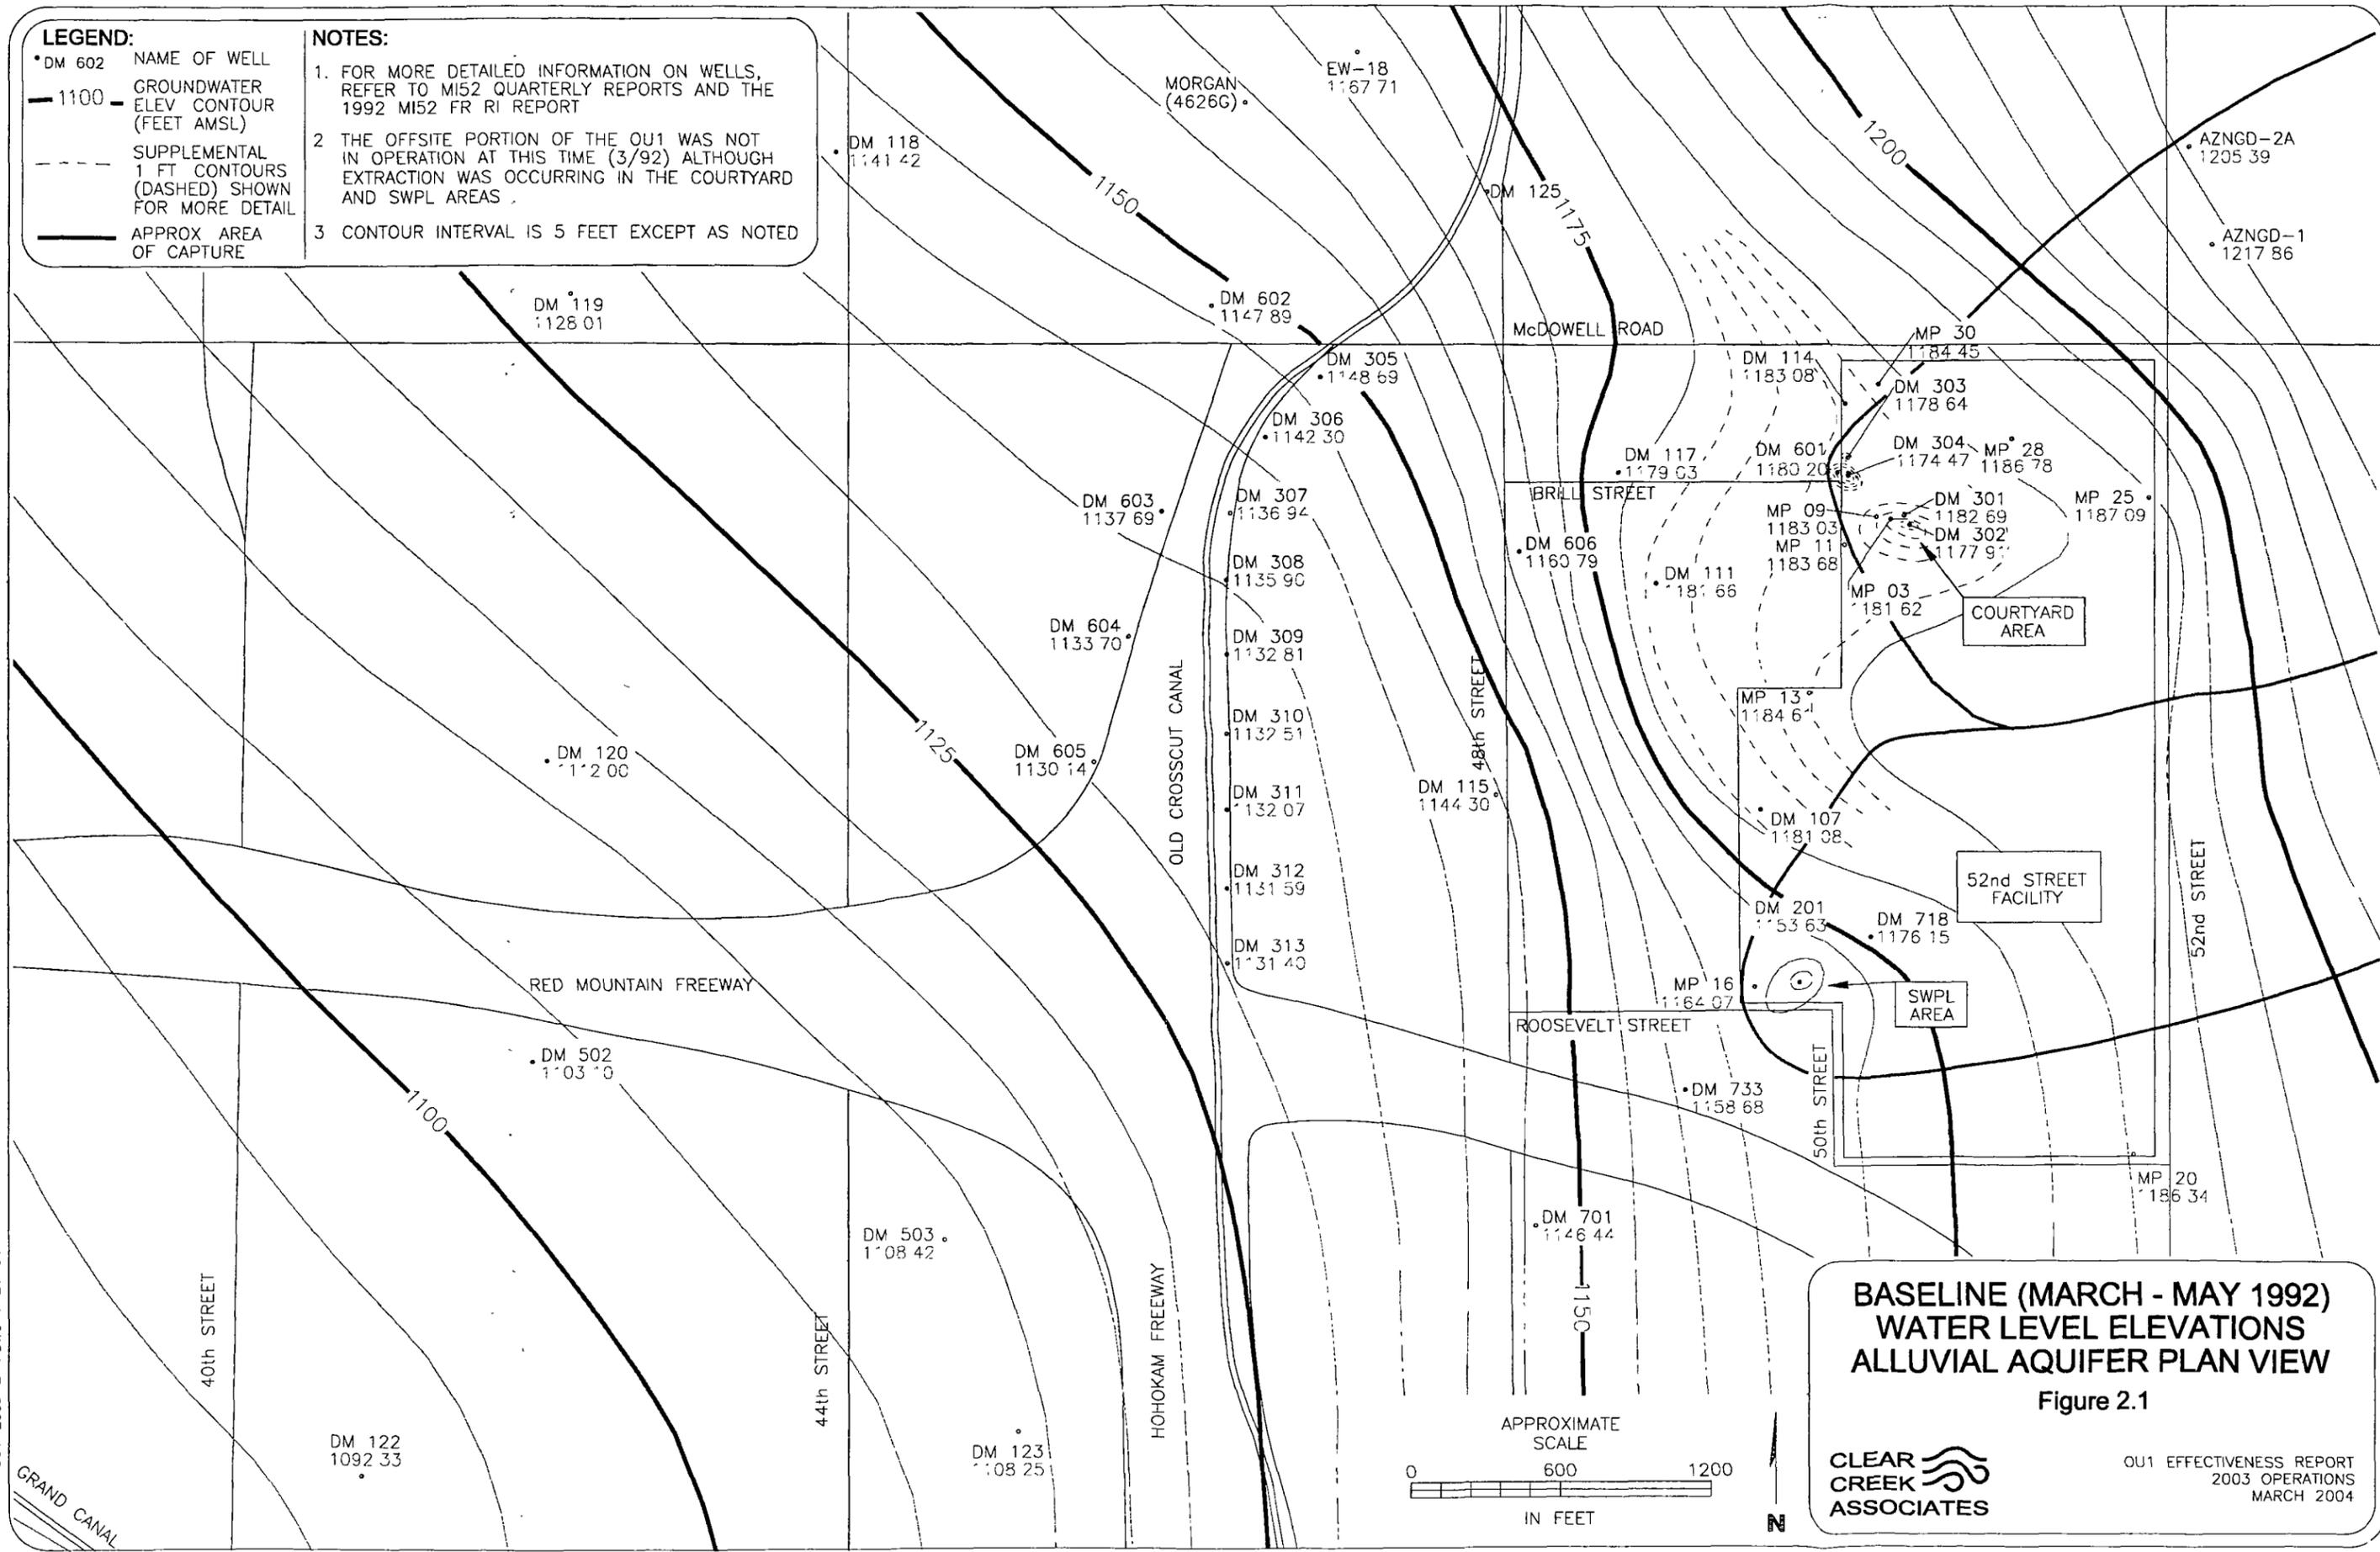
Figure 2.1

1. FOR MORE DETAILED INFORMATION ON WELLS, REFER TO M152 QUARTERLY REPORTS AND THE 1992 M152 FR RI REPORT
2. THE OFFSITE PORTION OF THE OU1 WAS NOT IN OPERATION AT THIS TIME (3/92) ALTHOUGH EXTRACTION WAS OCCURRING IN THE COURTYARD AND SWPL AREAS.
3. CONTOUR INTERVAL IS 5 FEET EXCEPT AS NOTED

**BASELINE (MARCH - MAY 1992)
WATER LEVEL ELEVATIONS
ALLUVIAL AQUIFER PLAN VIEW**

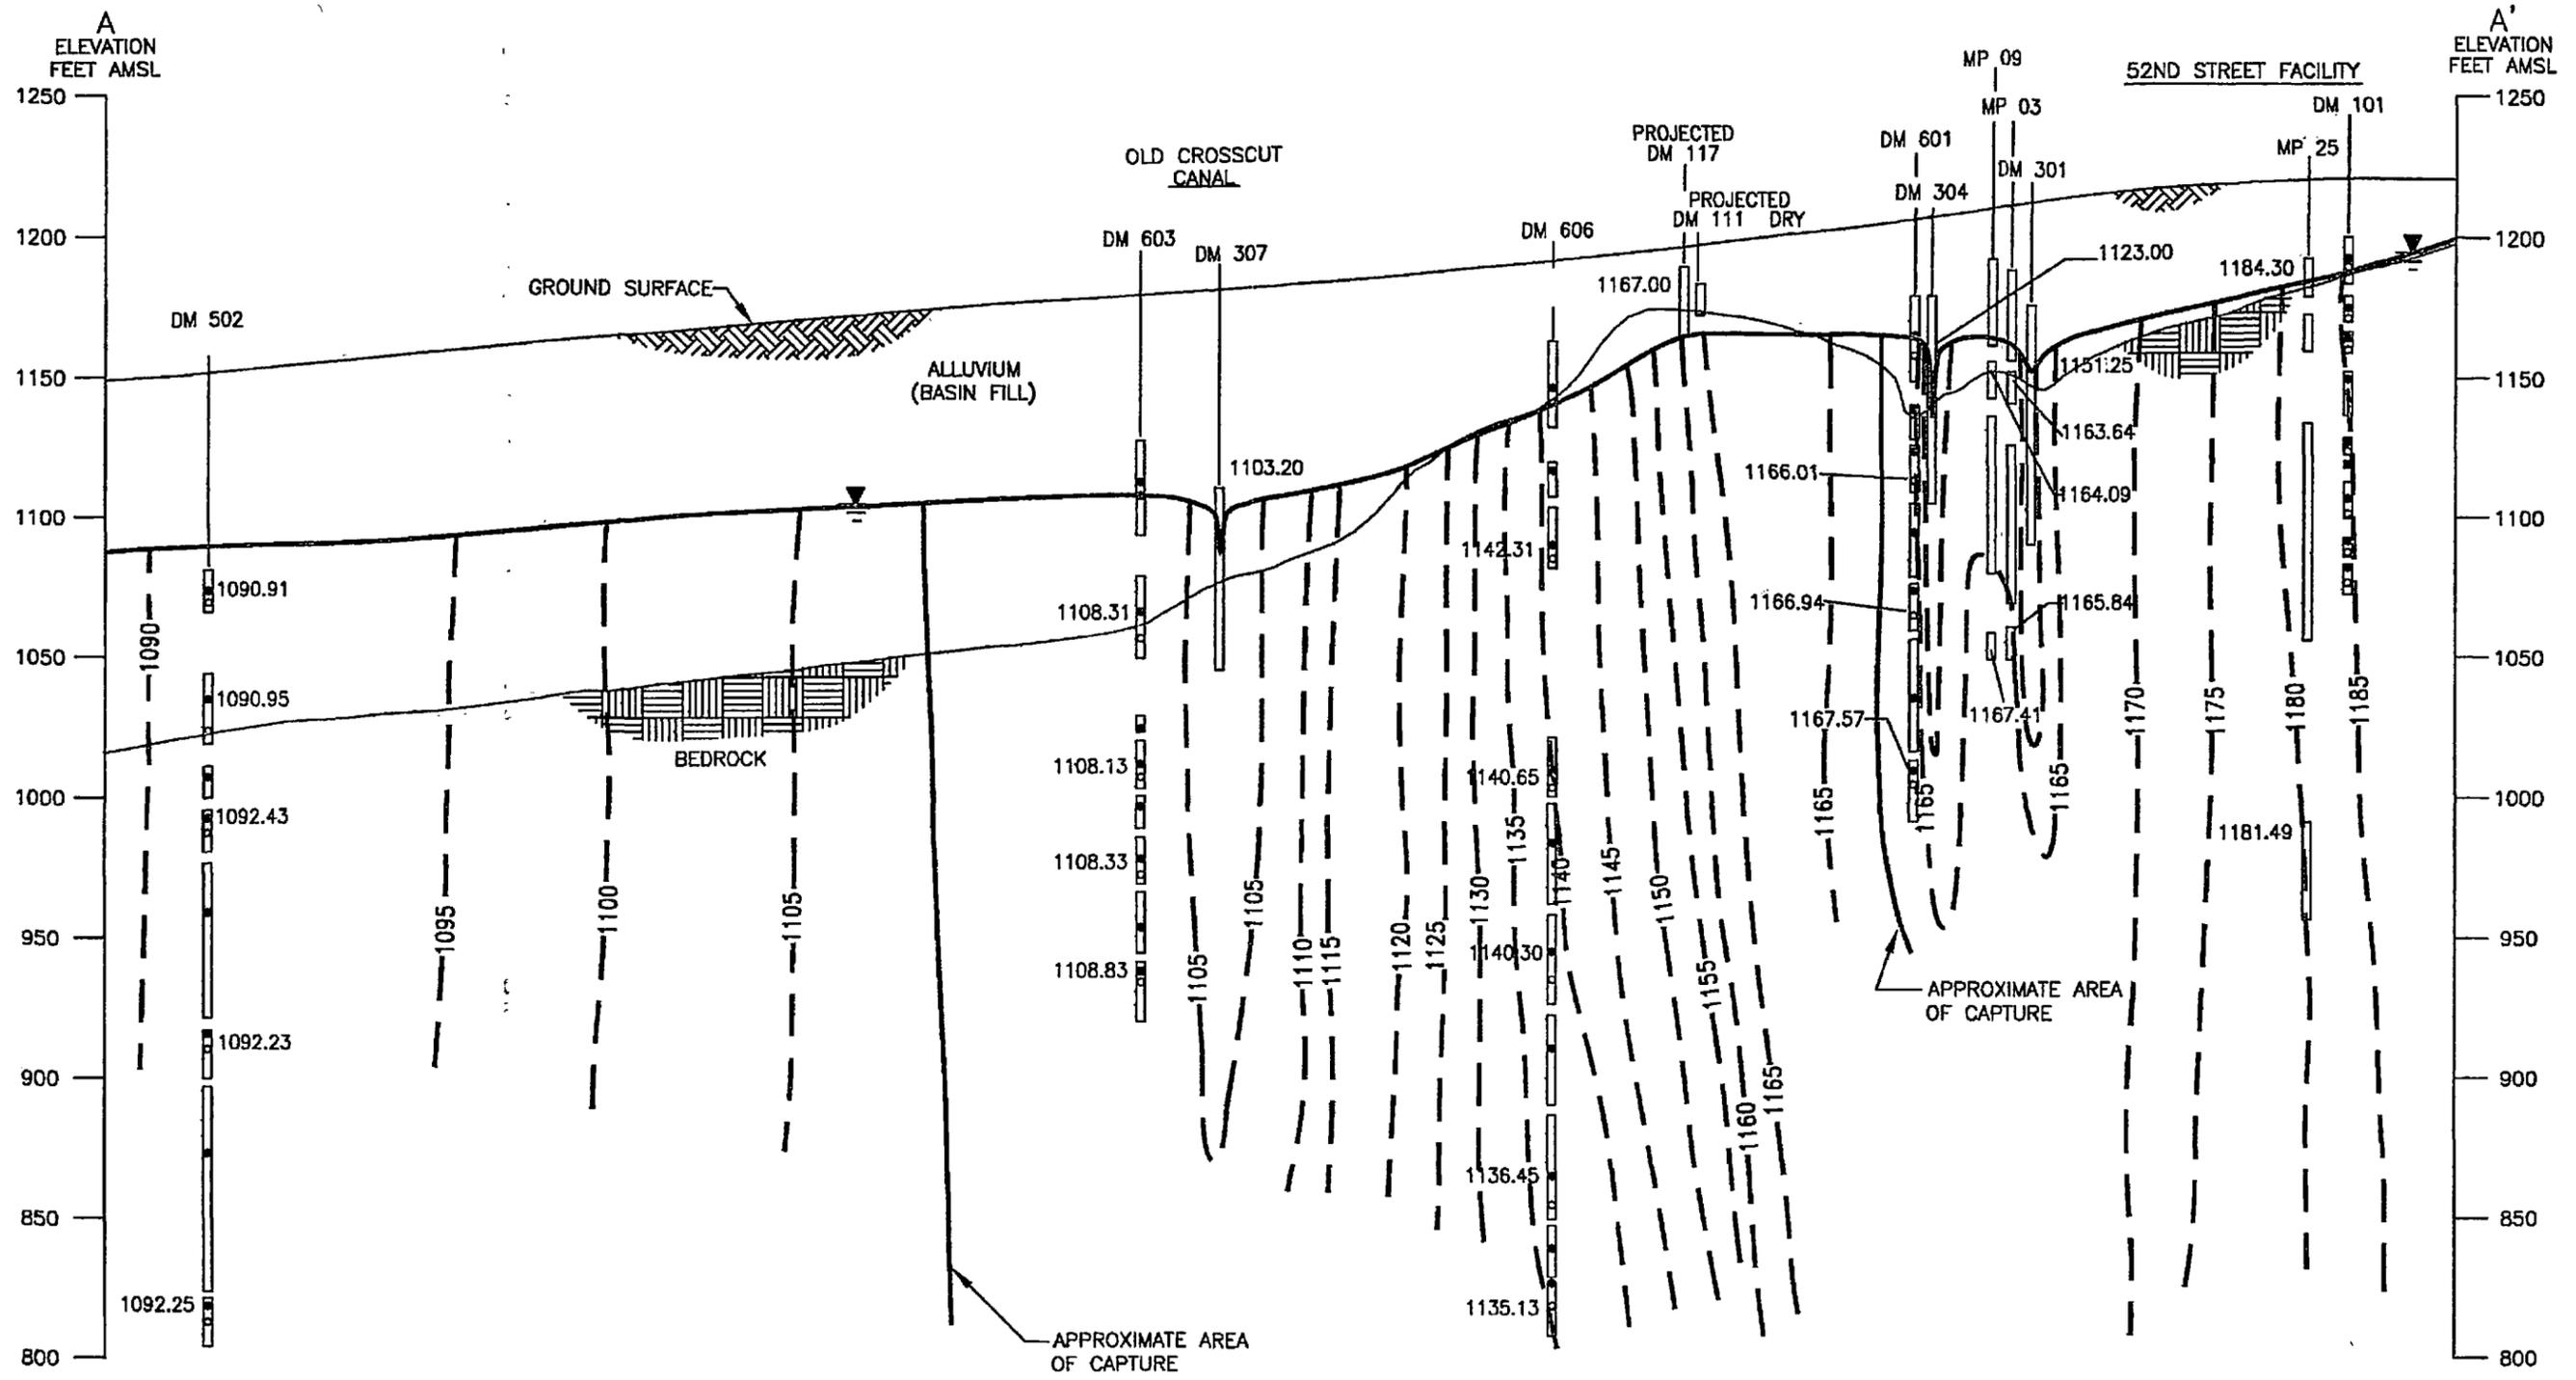
- DM 606 — NAME OF WELL
- GROUND SURFACE
- BEDROCK CONTACT
- MONITOR ZONE
- MEASUREMENT PORT
- PUMPING PORT
- 1142.31 — WATER LEVEL ELEVATION (IN FEET AMSL)

1. LOCATION OF SECTION A-A' IS SHOWN ON FIGURE 1.1.
2. THE WATER TABLE WAS PLOTTED USING FALL 2002 DATA.
3. FIGURE 2.2 SHOWS WHERE THE CROSS SECTION CROSSES THE CAPTURE ZONE NEAR THE OCC. GROUNDWATER FLOW IS SOUTH-EAST TOWARD THE EXTRACTION WELLS. IN FIGURE 2.7 THIS MEANS WATER ON THE EAST SIDE OF THE CAPTURE ZONE WOULD BE COMING OUT OF THE PAPER AND TO THE READER'S RIGHT, TOWARD THE EXTRACTION WELLS. THEREFORE, THE STAGNATION POINT DOES NOT APPEAR AS THE HIGH POINT IN THE WATER LEVEL ELEVATION PROFILE.
4. WATER LEVEL FOR DM 307 ADJUSTED FOR WELL EFFICIENCY. SEE DISCUSSION IN SECTION 2 OF THIS REPORT.

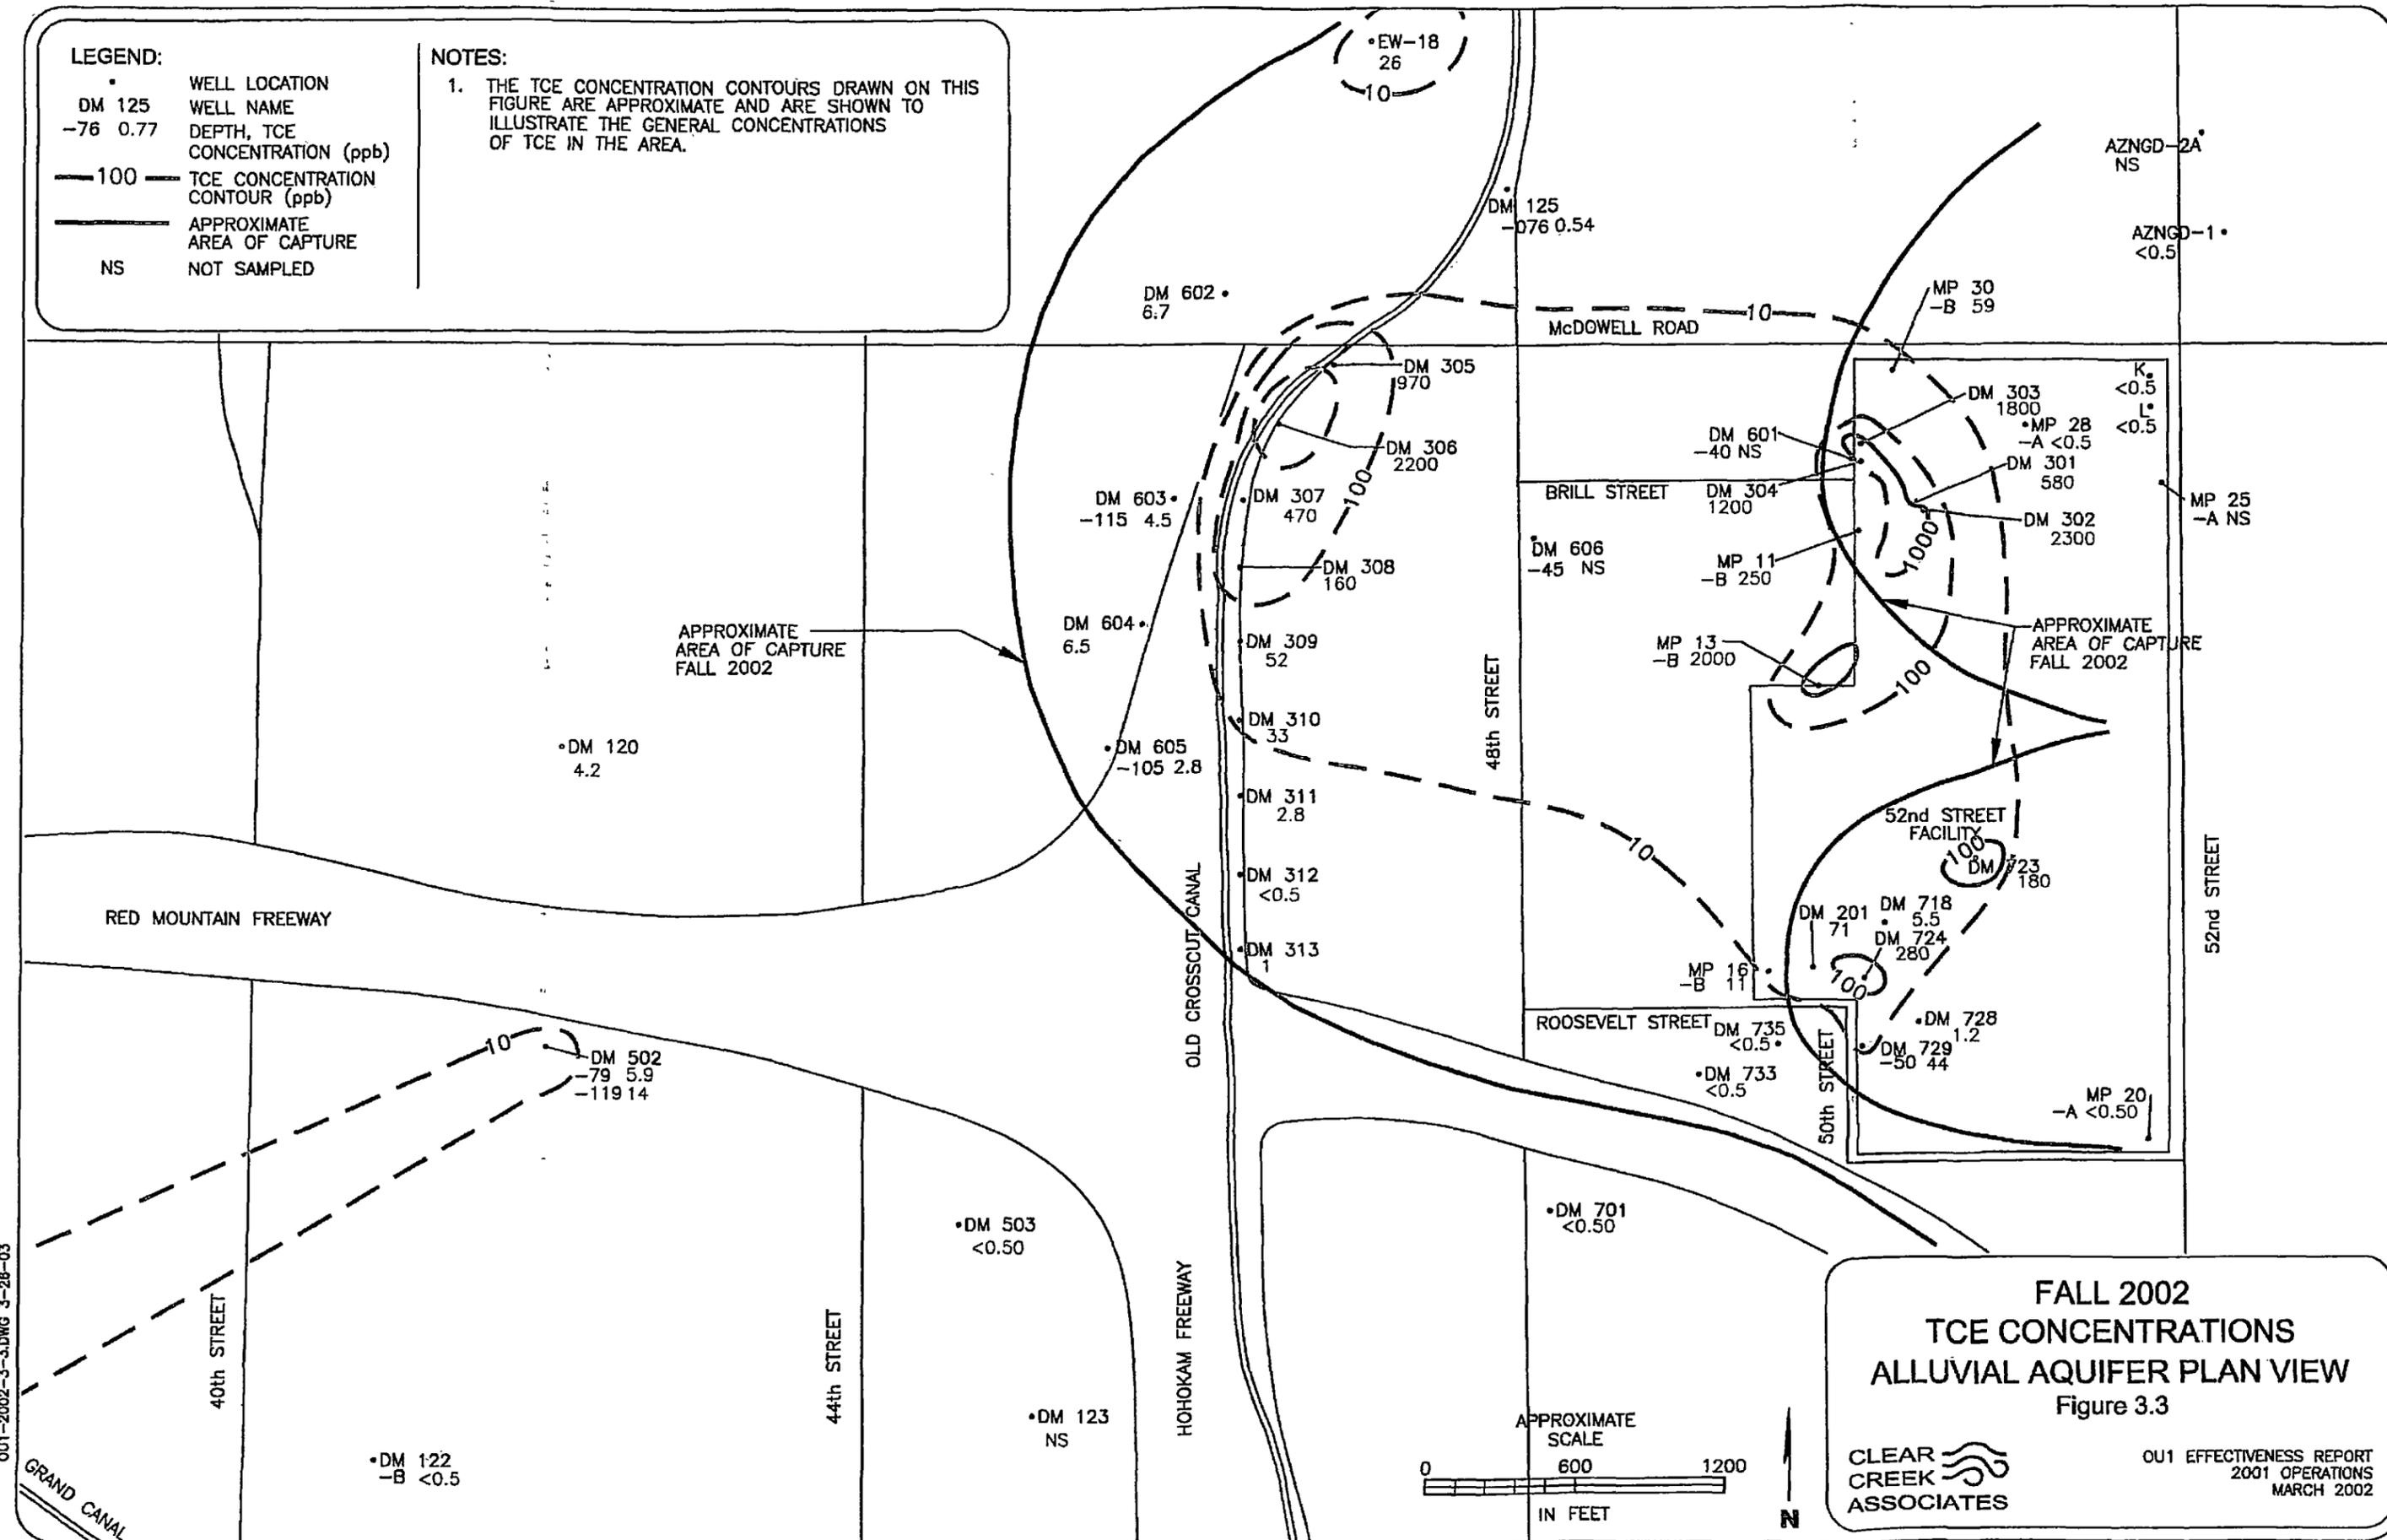
1. THE TCE CONCENTRATION CONTOURS DRAWN ON THIS FIGURE ARE APPROXIMATE AND ARE SHOWN TO ILLUSTRATE THE GENERAL CONCENTRATIONS OF TCE IN THE AREA.

**FALL 2002
TCE CONCENTRATIONS
ALLUVIAL AQUIFER PLAN VIEW
Figure 3.3**
