THIRD FIVE YEAR REVIEW

OPERABLE UNIT 1

MOTOROLA 52ND STREET

SEPTEMBER 25, 2006

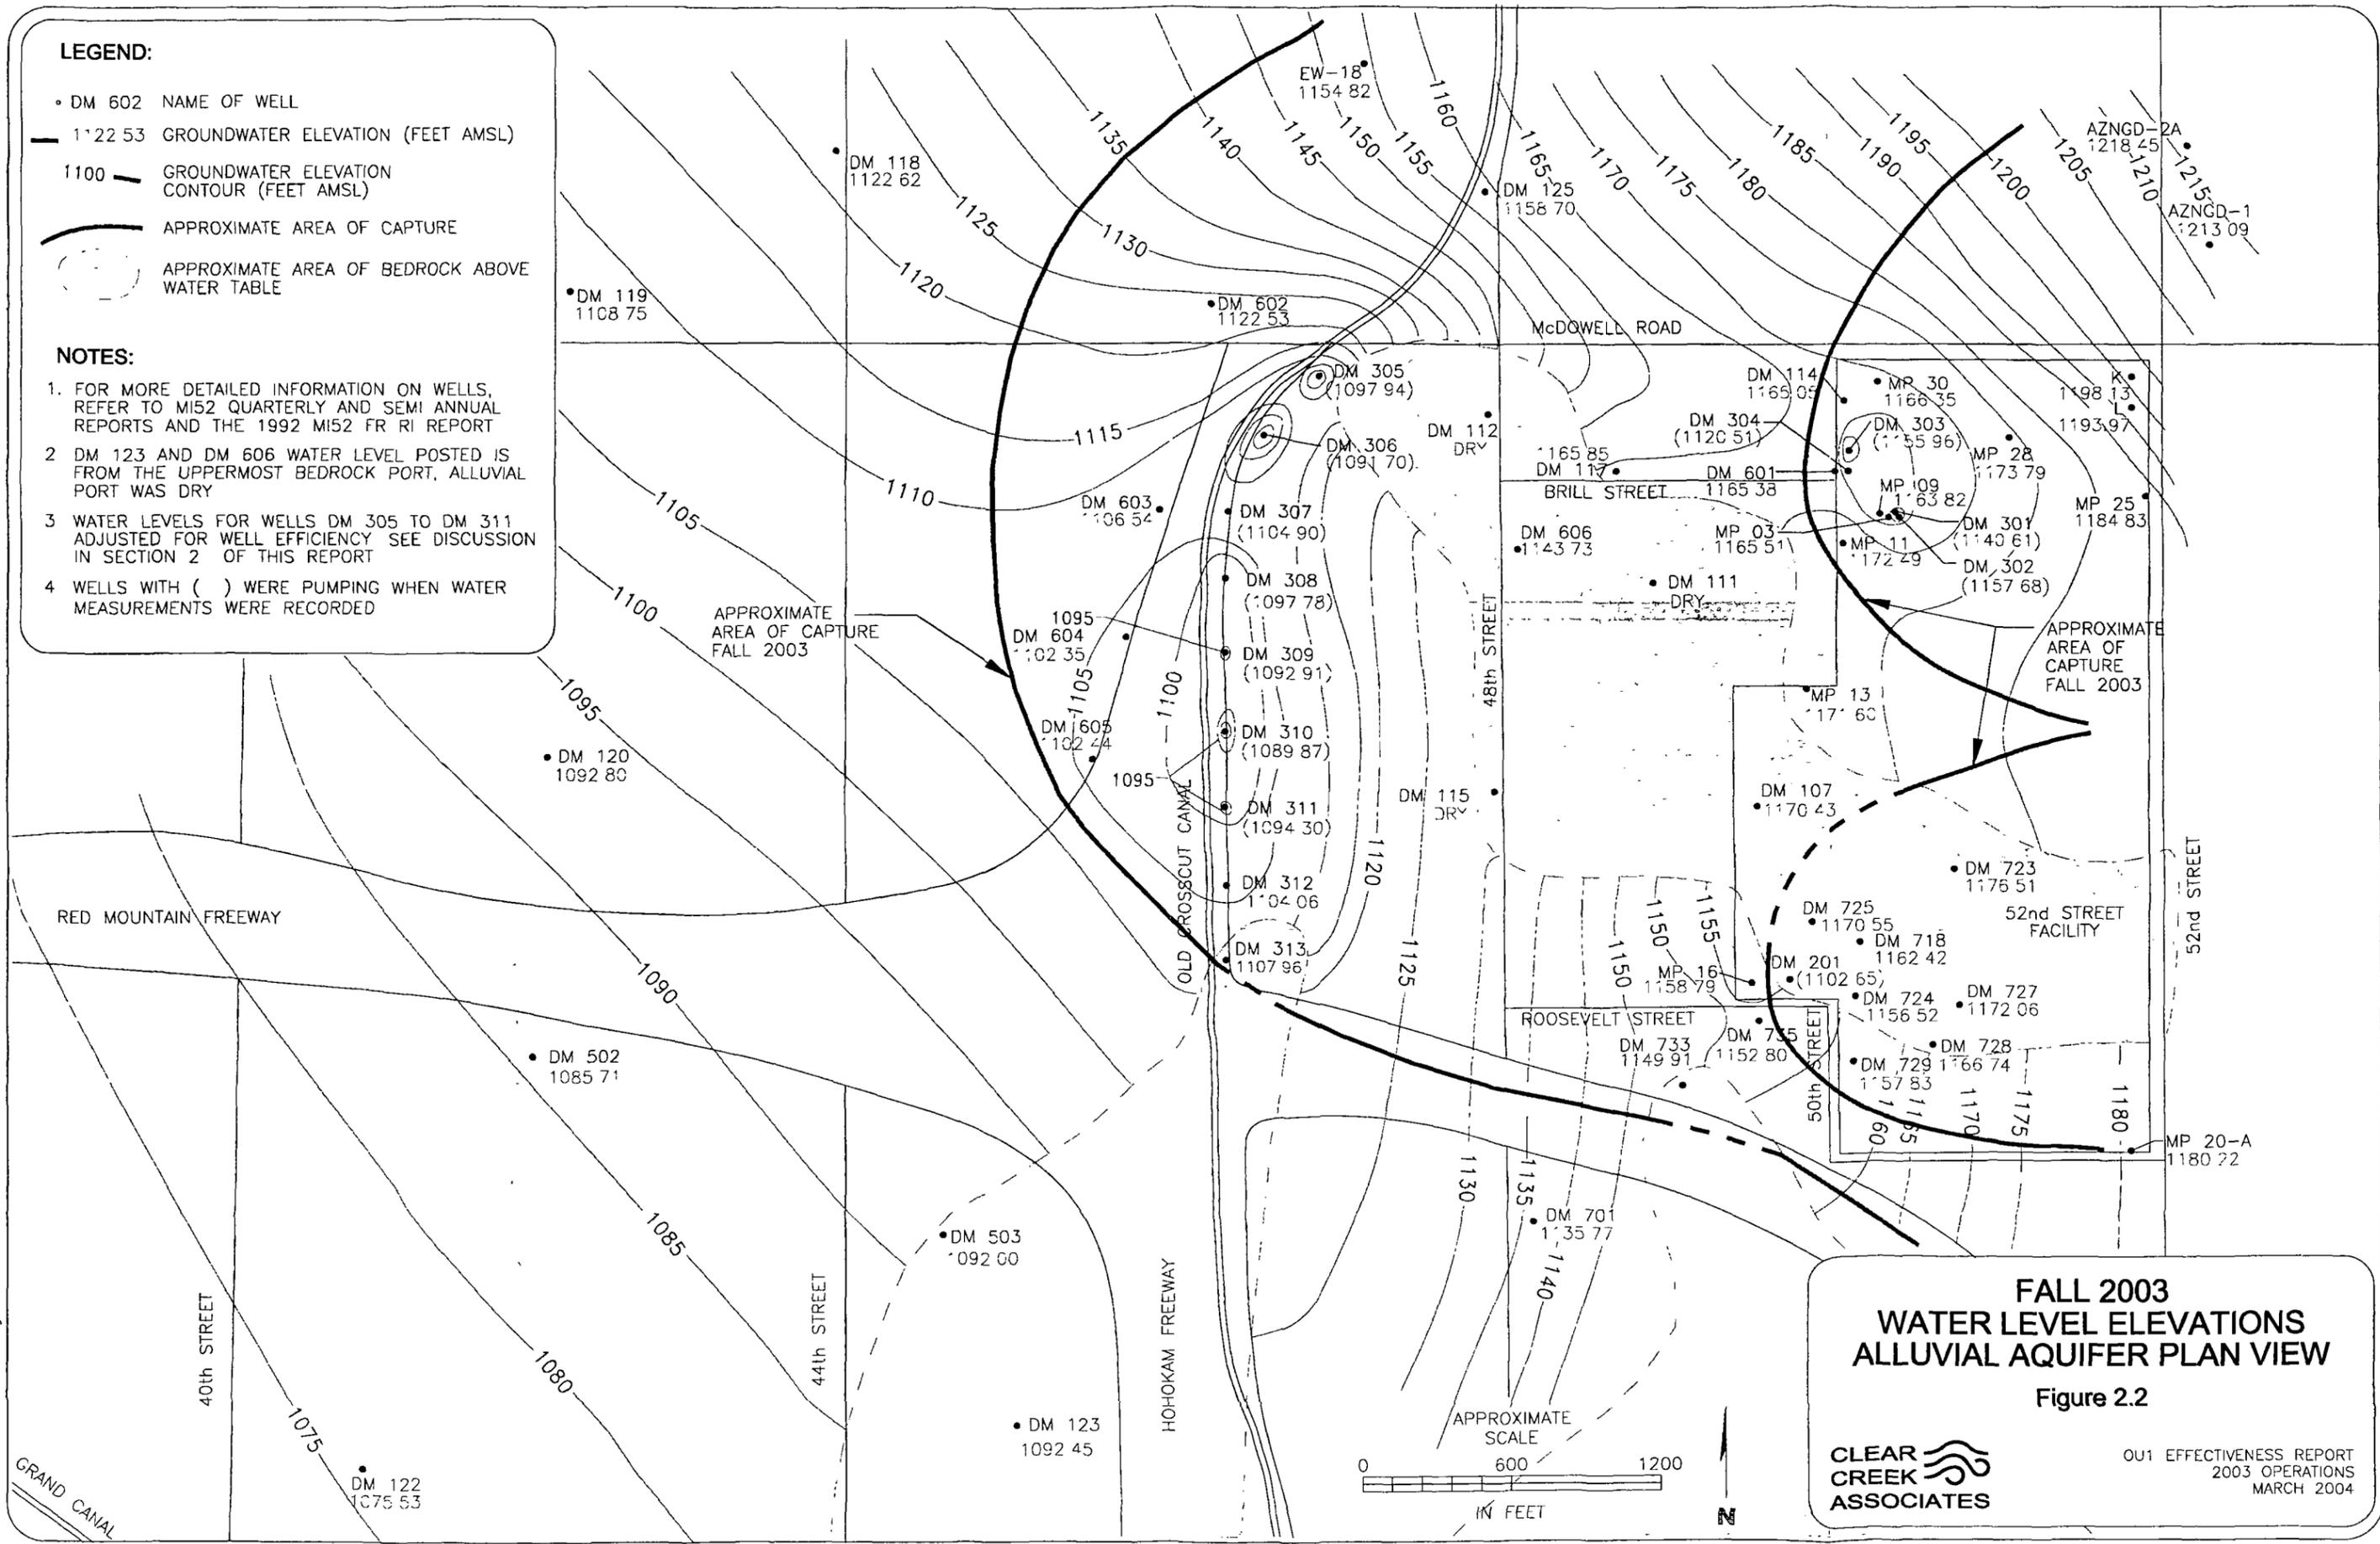
Figure 2.2

1. FOR MORE DETAILED INFORMATION ON WELLS, REFER TO M152 QUARTERLY AND SEMI ANNUAL REPORTS AND THE 1992 M152 FR RI REPORT
2. DM 123 AND DM 606 WATER LEVEL POSTED IS FROM THE UPPERMOST BEDROCK PORT, ALLUVIAL PORT WAS DRY
3. WATER LEVELS FOR WELLS DM 305 TO DM 311 ADJUSTED FOR WELL EFFICIENCY SEE DISCUSSION IN SECTION 2 OF THIS REPORT
4. WELLS WITH () WERE PUMPING WHEN WATER MEASUREMENTS WERE RECORDED

**FALL 2003
WATER LEVEL ELEVATIONS
ALLUVIAL AQUIFER PLAN VIEW**

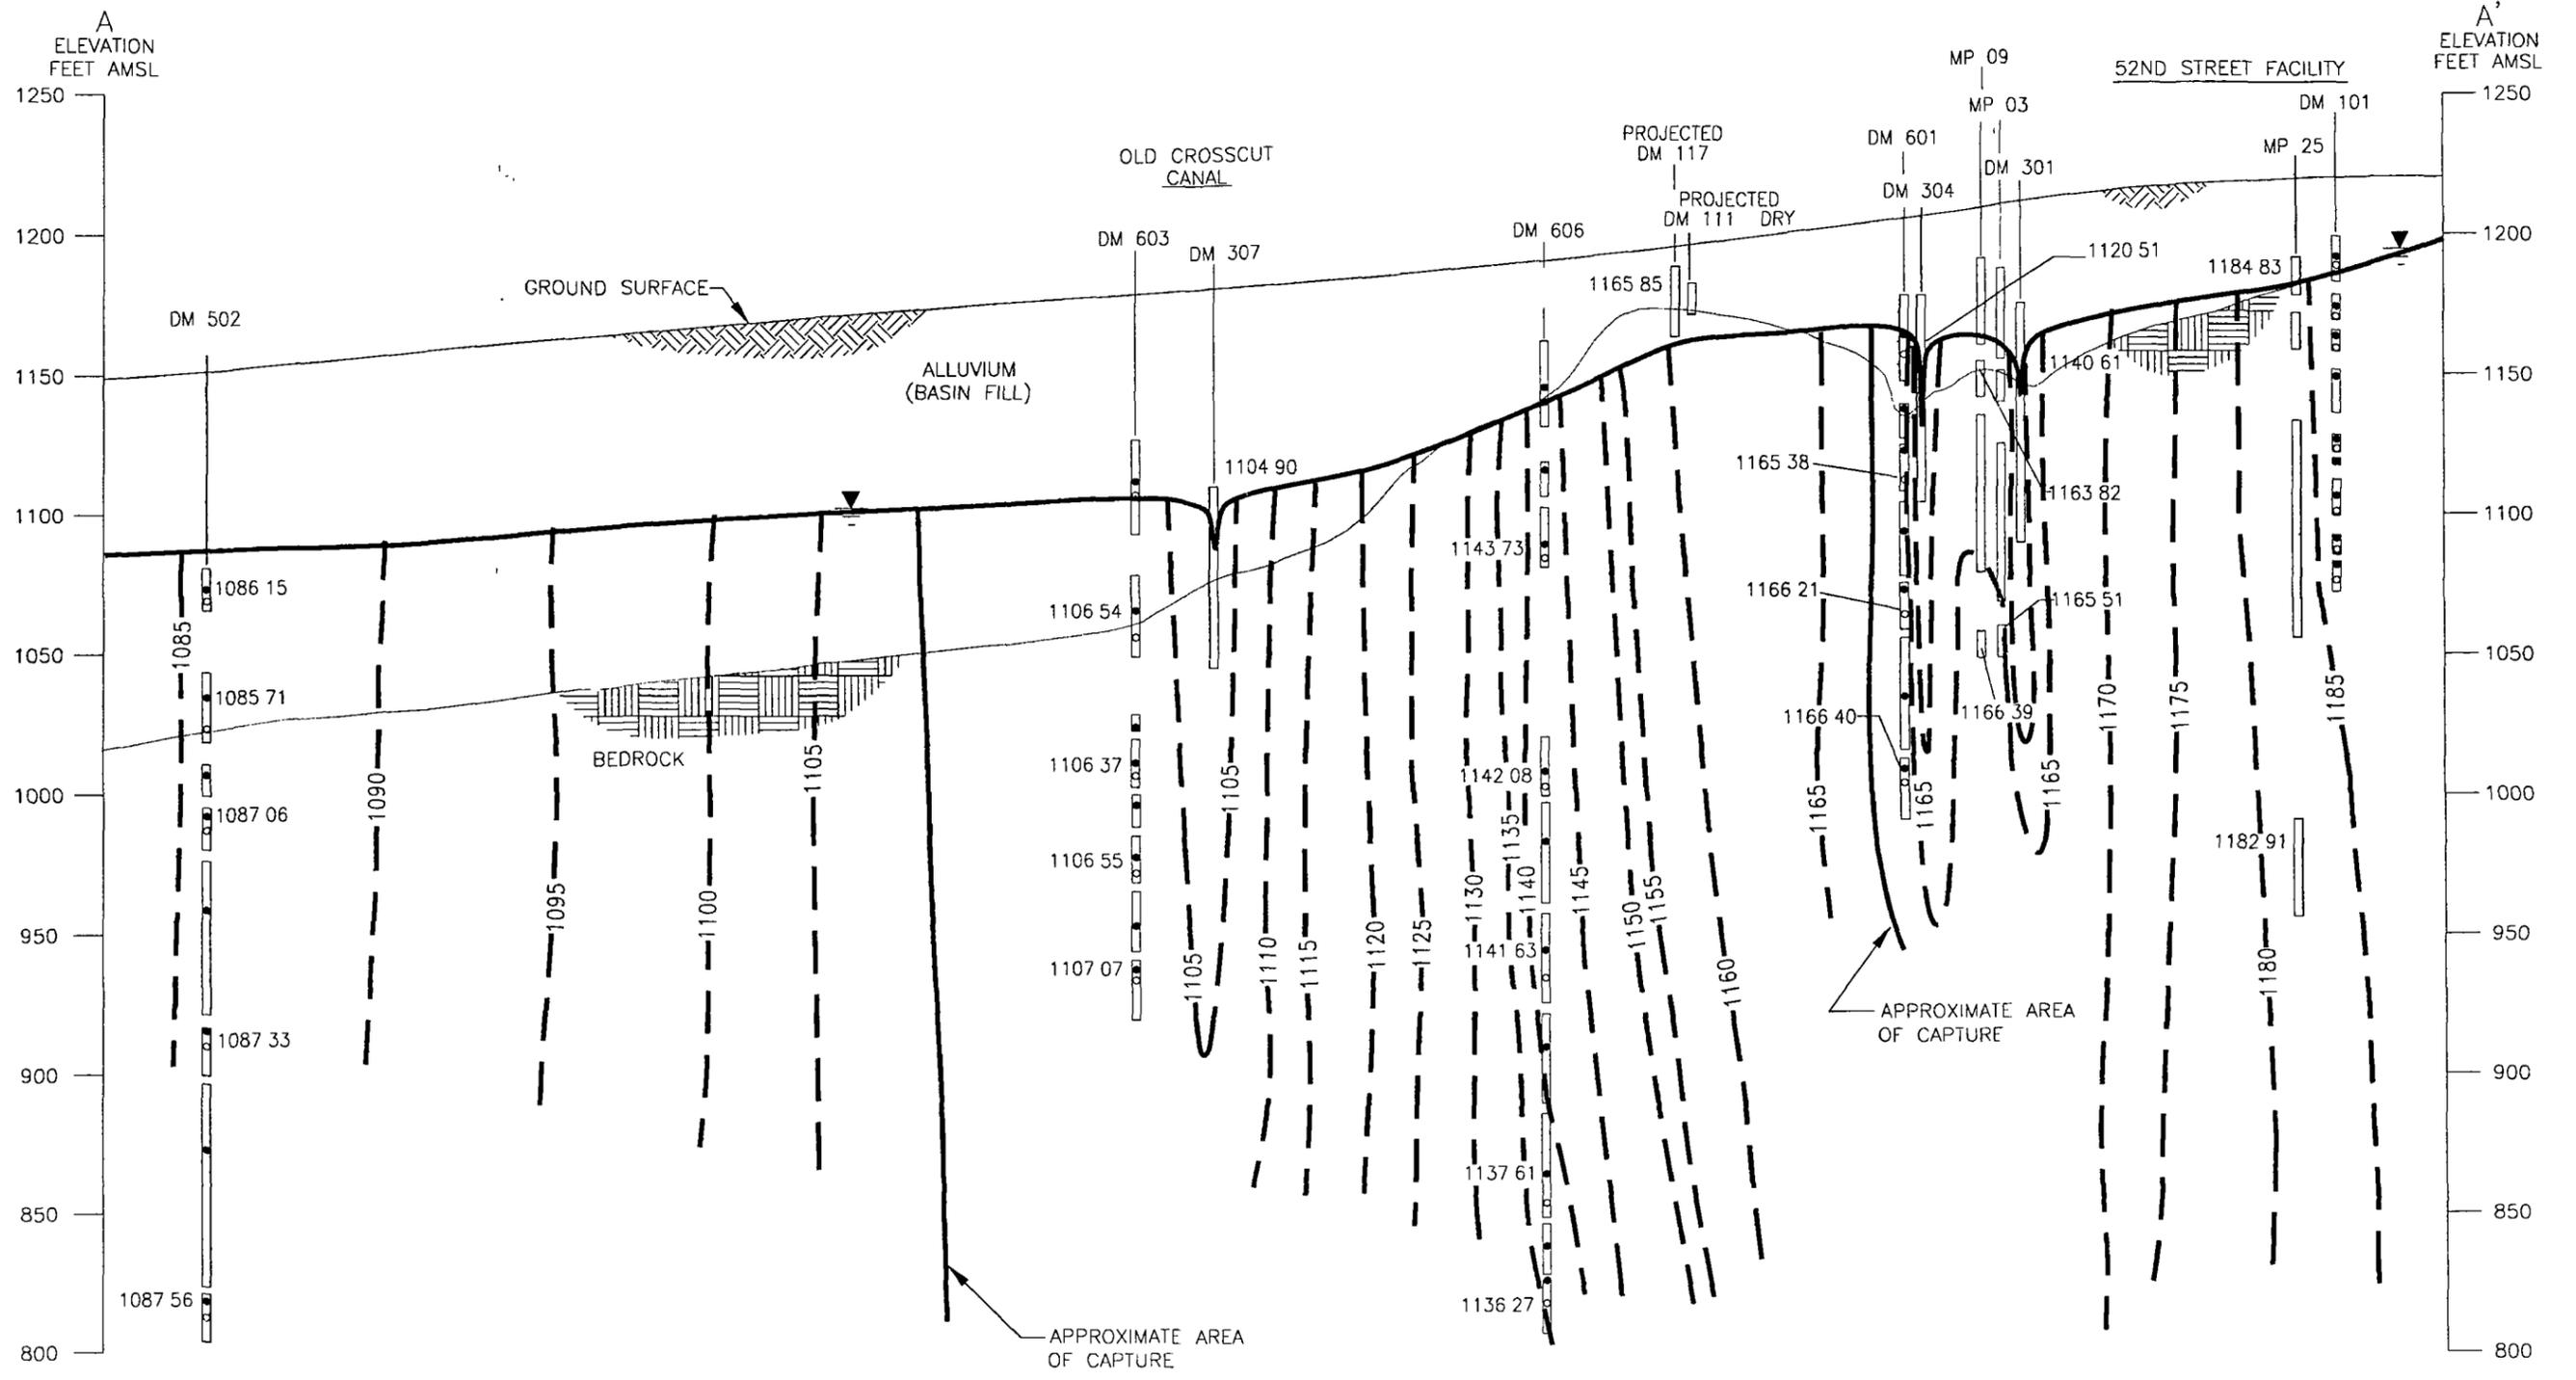
- DM 606 — NAME OF WELL
- GROUND SURFACE
- BEDROCK CONTACT
- MONITOR ZONE
- MEASUREMENT PORT
- PUMPING PORT
- 1142 08 — WATER LEVEL ELEVATION (IN FEET AMSL)

- 1 LOCATION OF SECTION A-A' IS SHOWN ON FIGURE 1 1
- 2 THE WATER TABLE WAS PLOTTED USING FALL 2003 DATA
- 3 FIGURE 2 2 SHOWS WHERE THE CROSS SECTION CROSSES THE CAPTURE ZONE NEAR THE OCC GROUNDWATER FLOW IS SOUTH-EAST TOWARD THE EXTRACTION WELLS IN FIGURE 2 7 THIS MEANS WATER ON THE EAST SIDE OF THE CAPTURE ZONE WOULD BE COMING OUT OF THE PAPER AND TO THE READER'S RIGHT, TOWARD THE EXTRACTION WELLS THEREFORE, THE STAGNATION POINT DOES NOT APPEAR AS THE HIGH POINT IN THE WATER LEVEL ELEVATION PROFILE
- 4 WATER LEVEL FOR DM 307 ADJUSTED FOR WELL EFFICIENCY SEE DISCUSSION IN SECTION 2 OF THIS REPORT

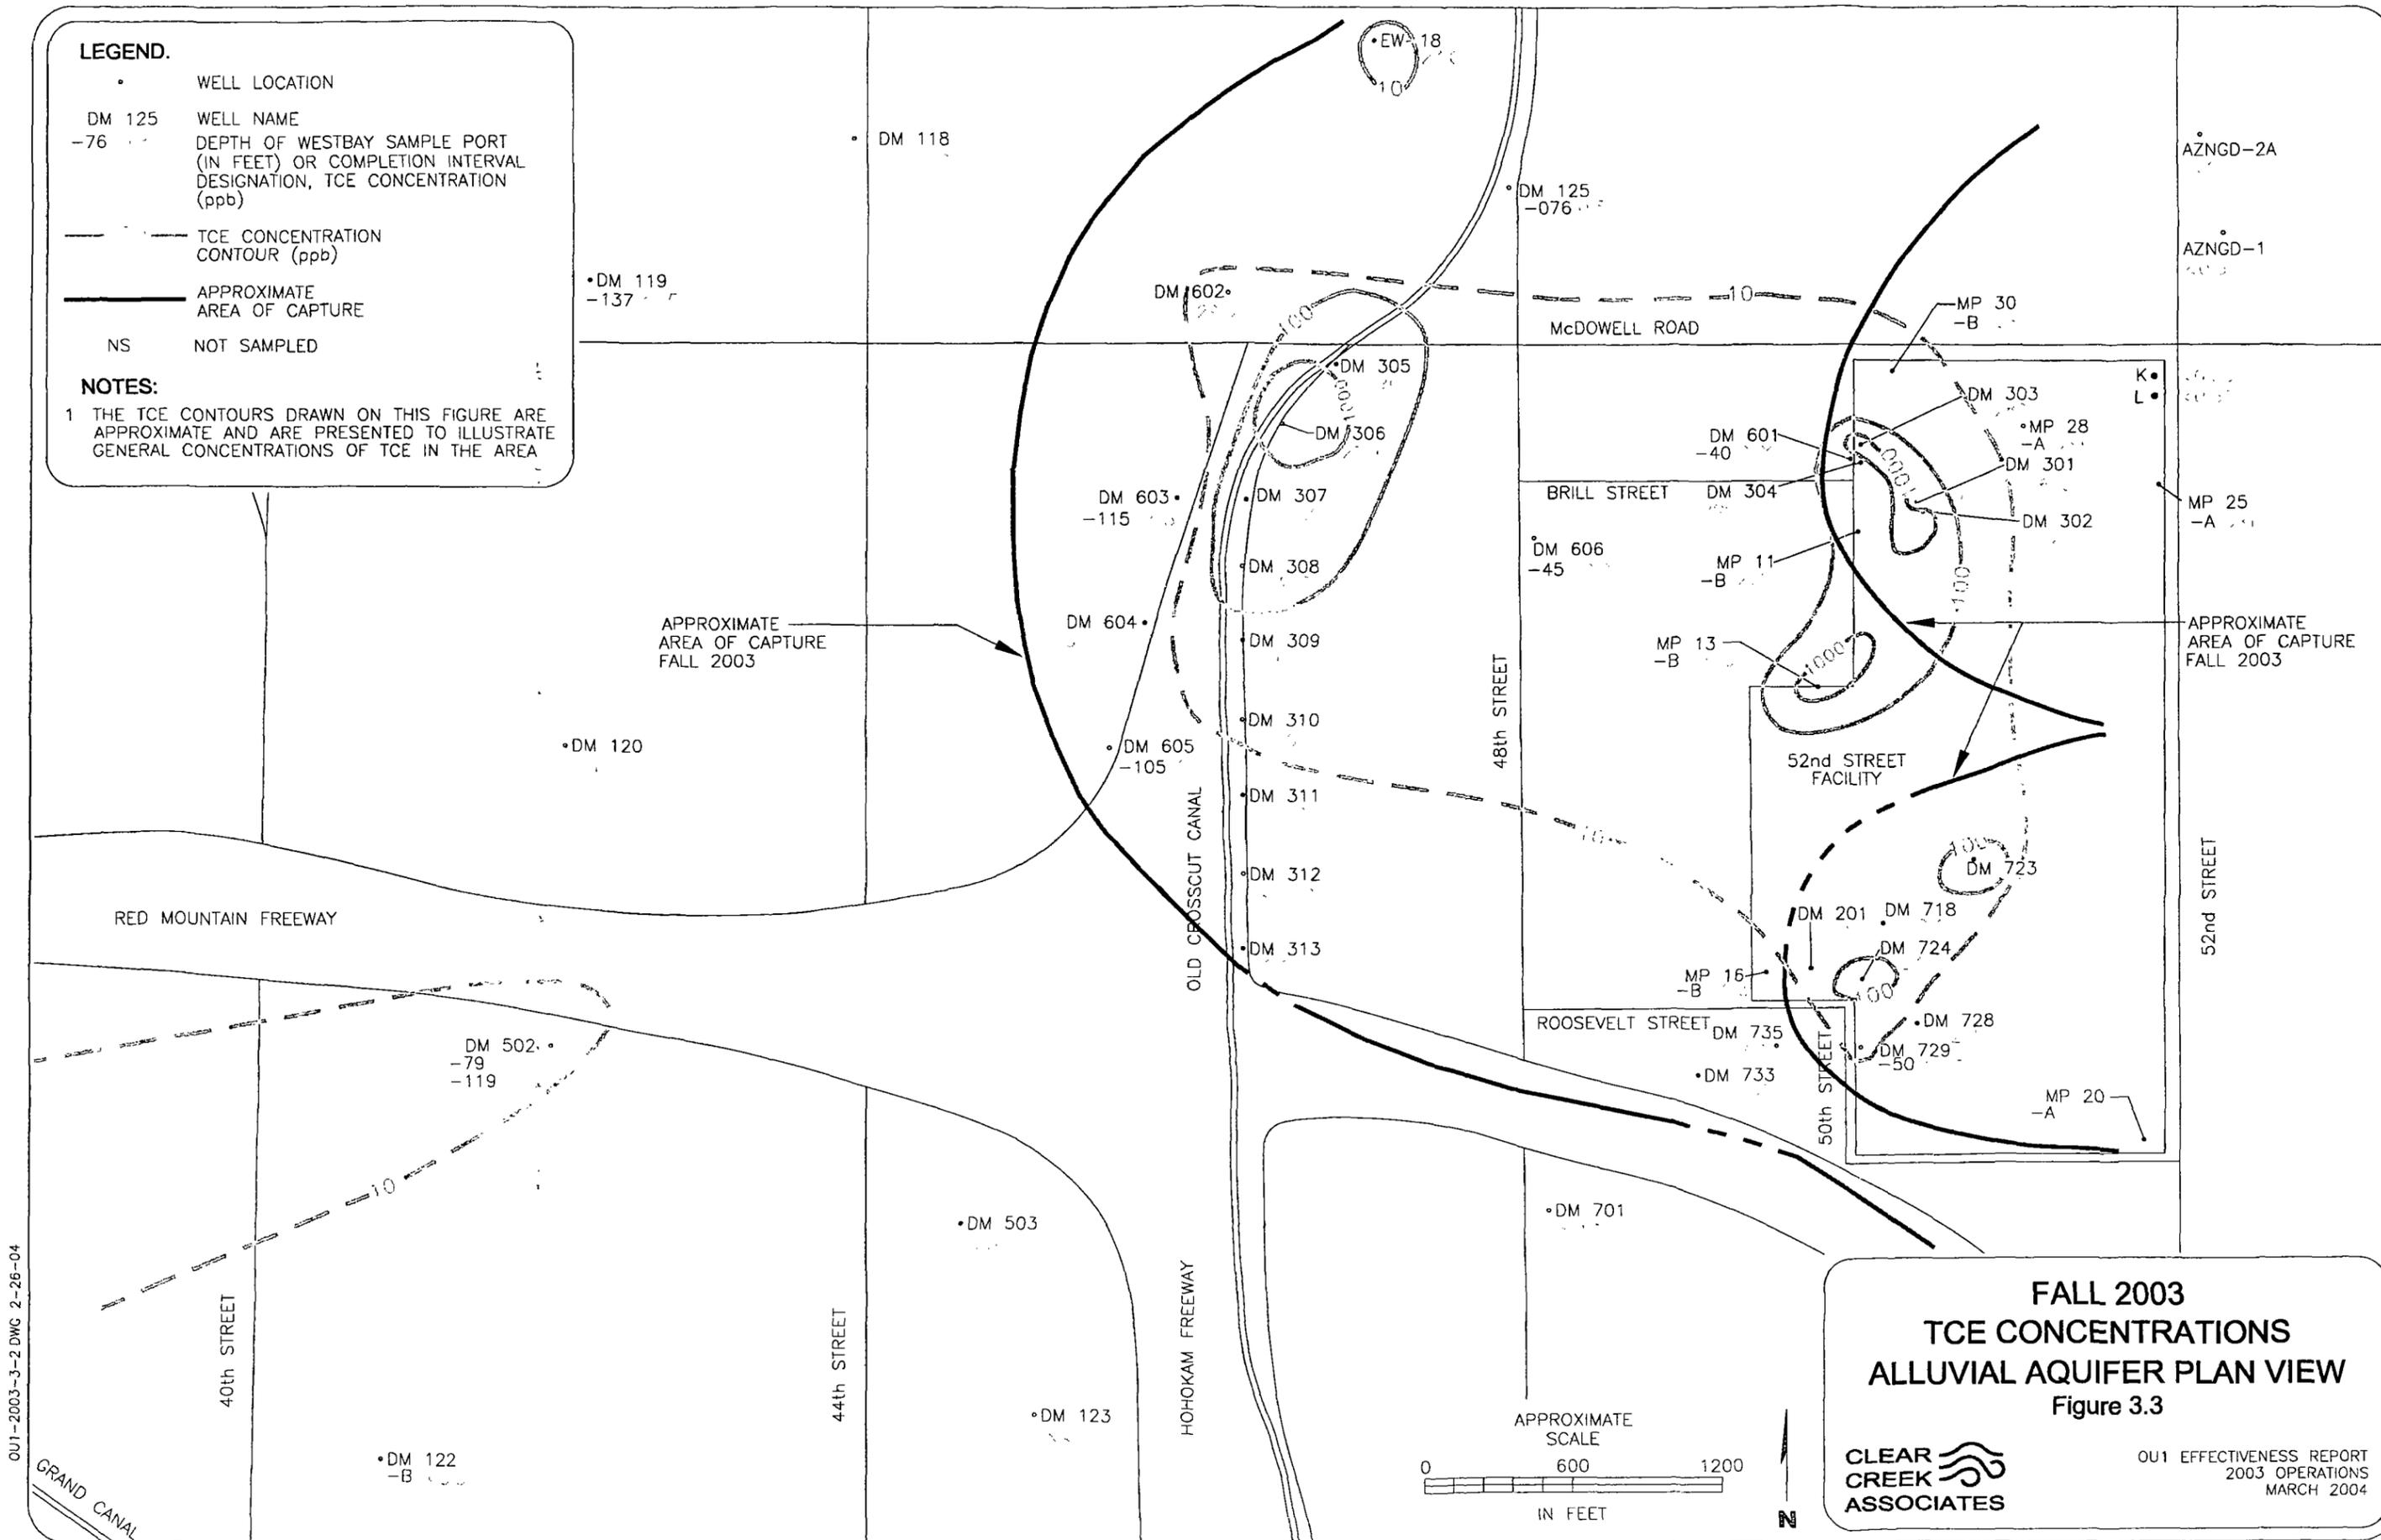
1 THE TCE CONTOURS DRAWN ON THIS FIGURE ARE APPROXIMATE AND ARE PRESENTED TO ILLUSTRATE GENERAL CONCENTRATIONS OF TCE IN THE AREA

**FALL 2003
TCE CONCENTRATIONS
ALLUVIAL AQUIFER PLAN VIEW
Figure 3.3**

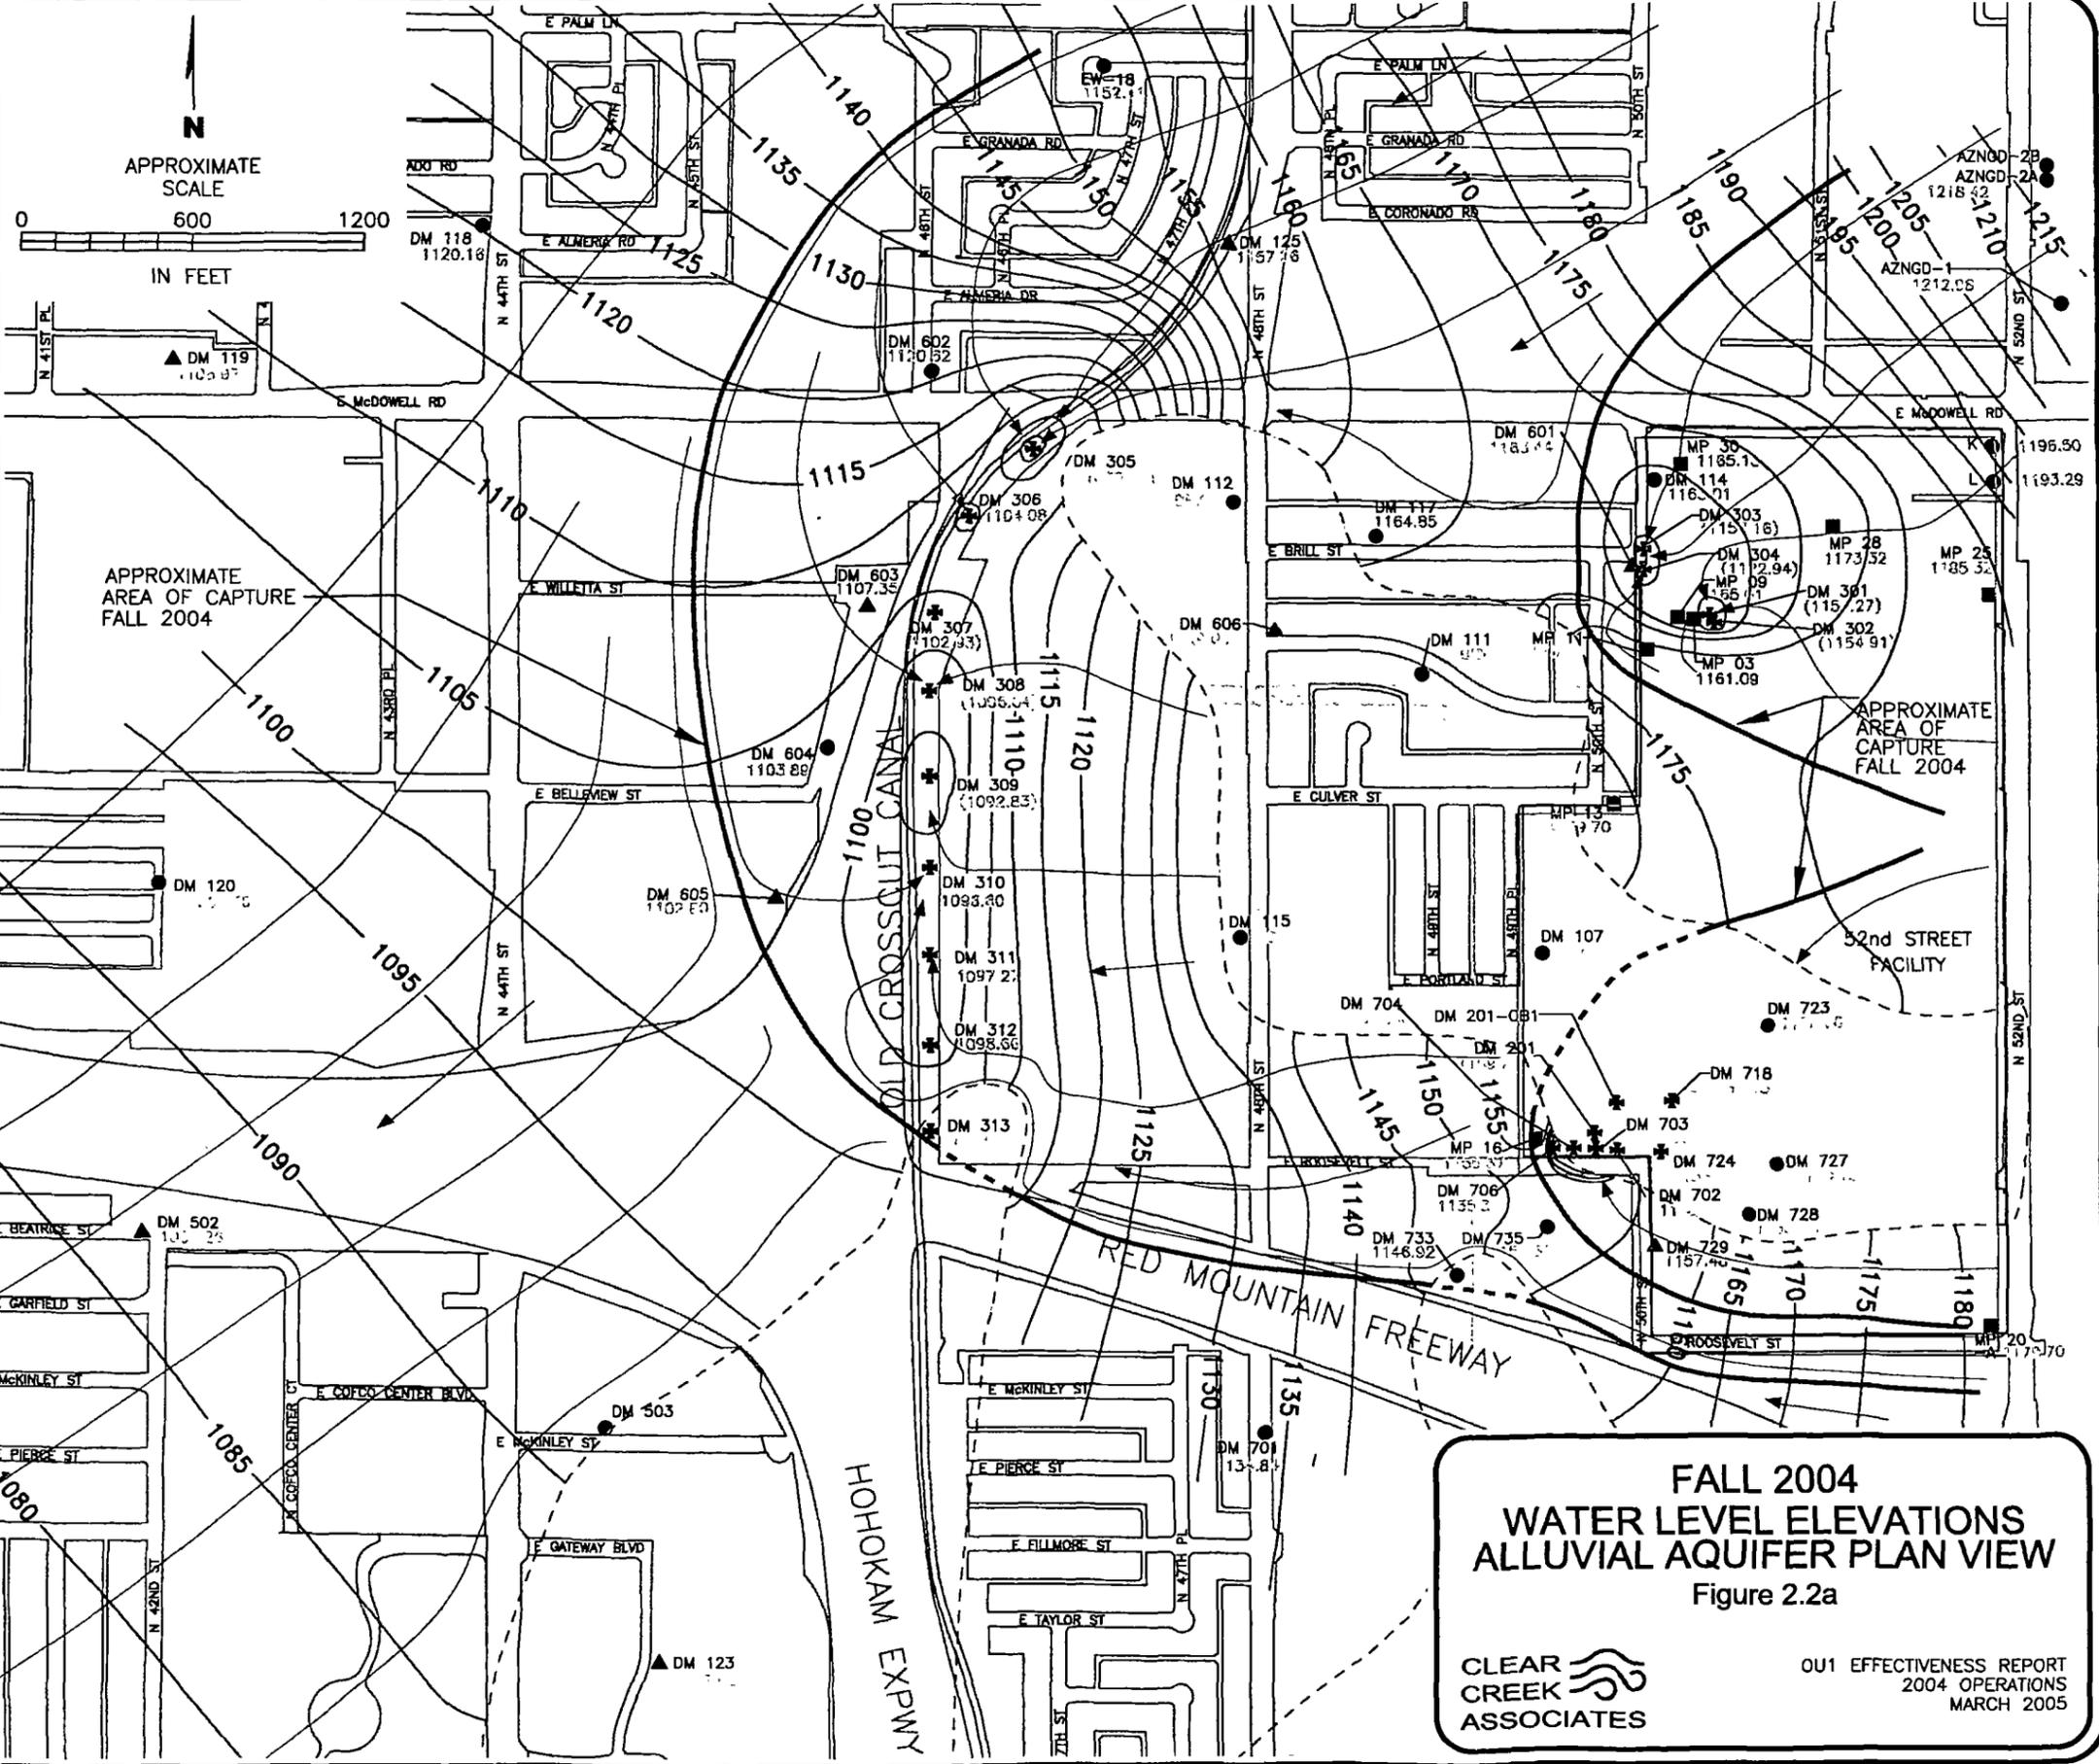
1. FOR MORE DETAILED INFORMATION ON WELLS, REFER TO M152 QUARTERLY AND SEMI ANNUAL REPORTS AND THE 1992 M152 FR RI REPORT.
2. DM123 AND DM 606 WATER LEVEL POSTED IS FROM THE UPPERMOST BEDROCK PORT; ALLUVIAL PORT WAS DRY.
3. WATER LEVELS FOR WELLS DM305, DM307, DM308 AND DM309 ADJUSTED FOR WELL EFFICIENCY, SEE DISCUSSION IN SECTION 2 OF THIS REPORT.
4. WELLS WITH () WERE PUMPING WHEN WATER MEASUREMENTS WERE RECORDED.

**FALL 2004
WATER LEVEL ELEVATIONS
ALLUVIAL AQUIFER PLAN VIEW**
Figure 2.2a

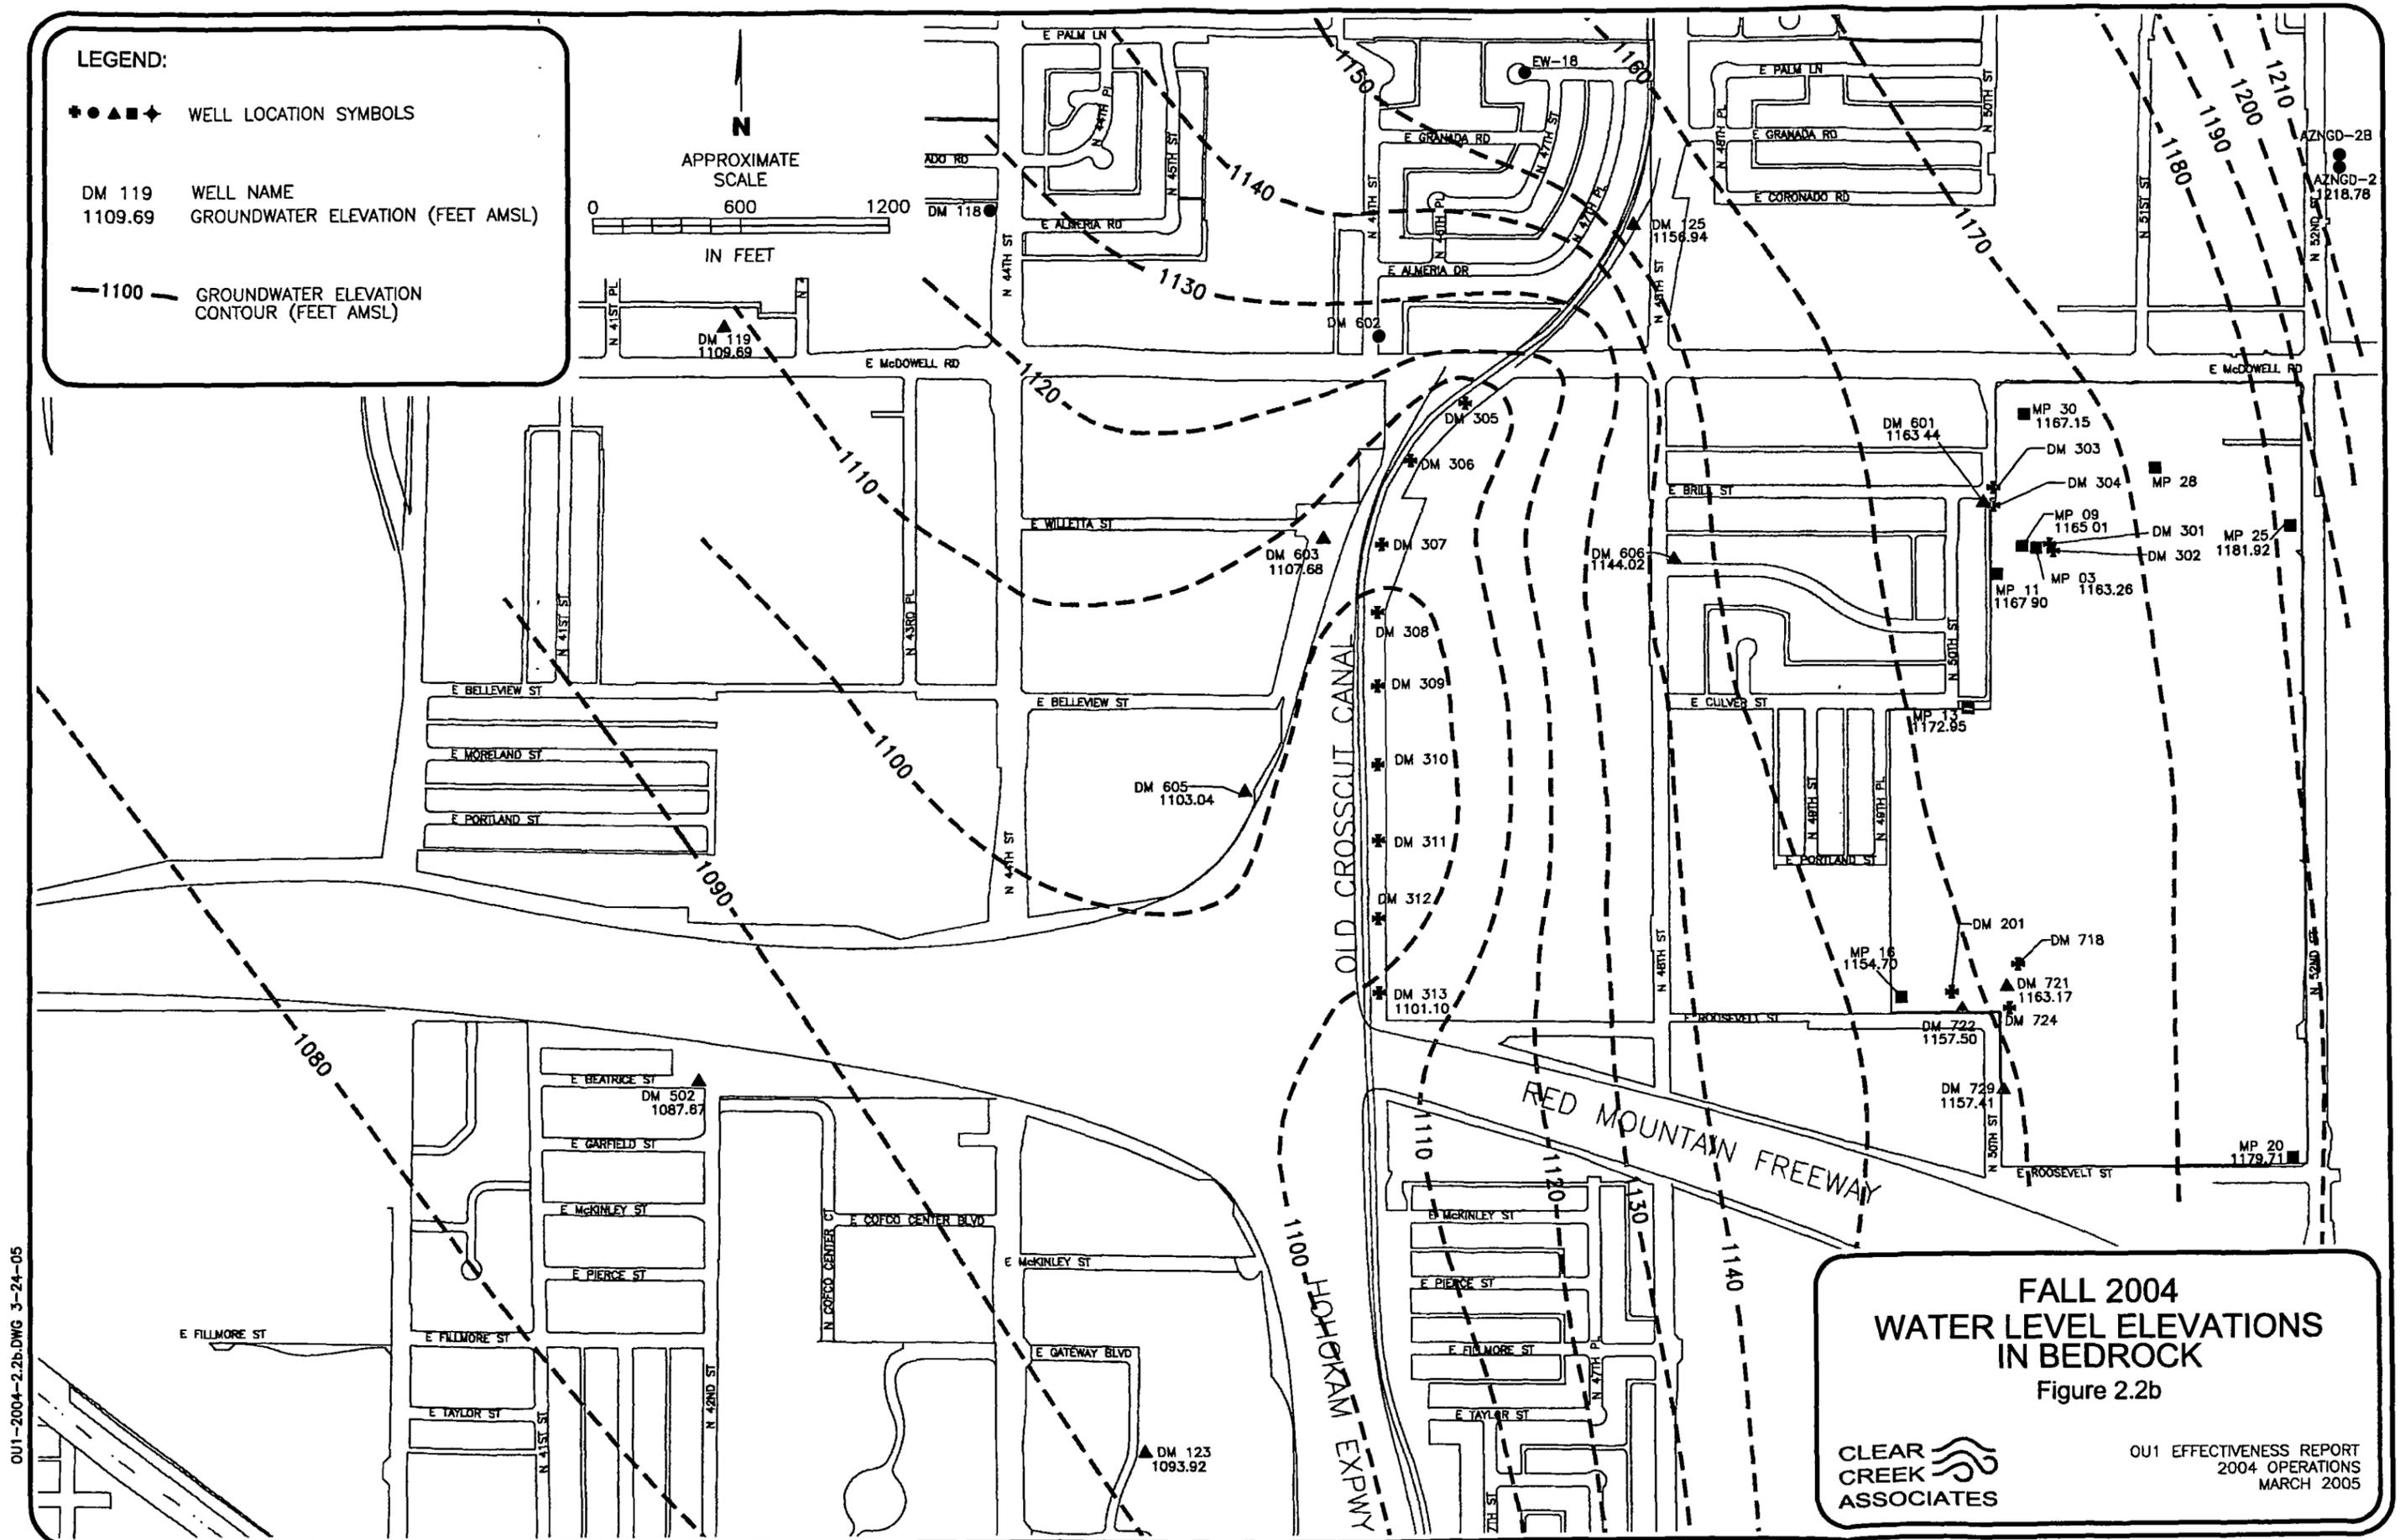
DM 119 WELL NAME
1109.69 GROUNDWATER ELEVATION (FEET AMSL)

---1100--- GROUNDWATER ELEVATION CONTOUR (FEET AMSL)

**FALL 2004
WATER LEVEL ELEVATIONS
IN BEDROCK**
Figure 2.2b

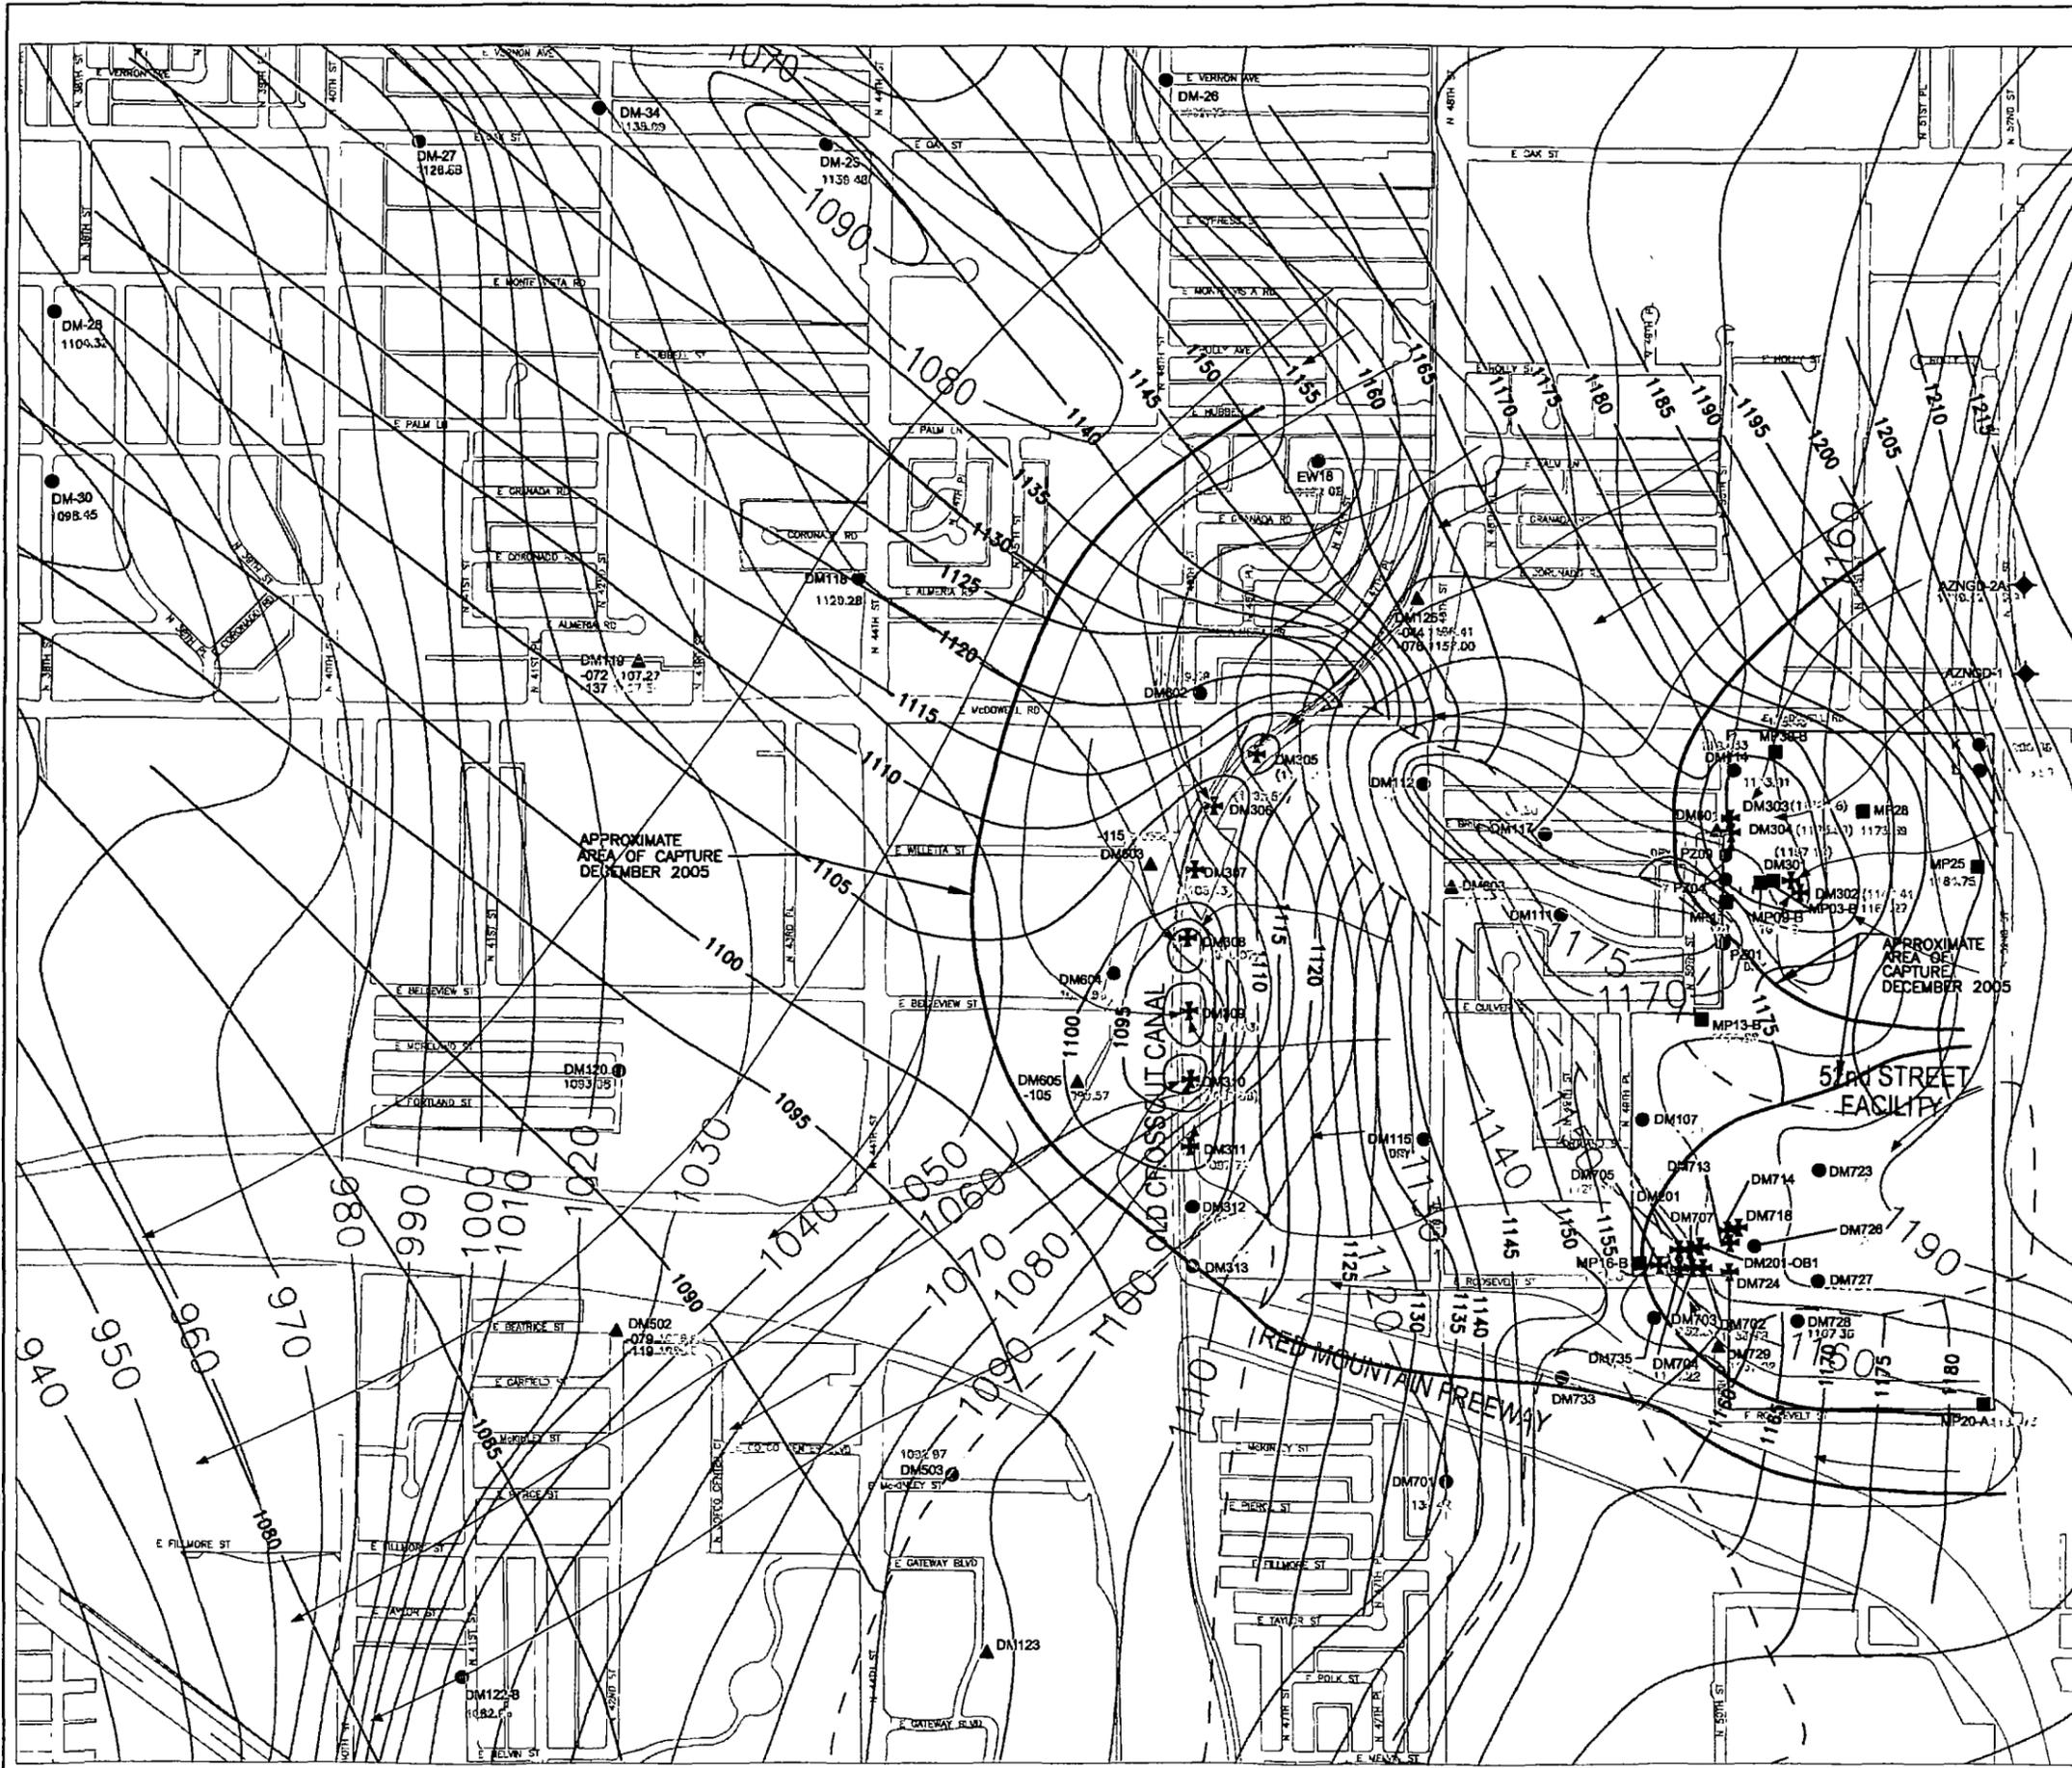
Figure 2.2a

- ▲◆ WELL LOCATION SYMBOLS
- DM 602 WELL NAME
- 1120.62 GROUNDWATER ELEVATION (FEET AMSL)
- 1100- GROUNDWATER ELEVATION CONTOUR (FEET AMSL)
- () APPROXIMATE AREA OF CAPTURE
- () APPROXIMATE AREA OF BEDROCK ABOVE WATER TABLE
- ← DIRECTION OF GROUNDWATER FLOW
- 1070- BEDROCK ELEVATION CONTOUR (FT AMSL)

- NOTES:**
1. FOR MORE DETAILED INFORMATION ON WELLS, REFER TO M152 QUARTERLY AND SEMI ANNUAL REPORTS AND THE 1992 M152 FR RI REPORT.
 2. DM123 AND DM 606 WATER LEVEL POSTED IS FROM THE UPPERMOST BEDROCK PORT; ALLUVIAL PORT WAS DRY.
 3. WATER LEVELS FOR WELLS DM305, DM306, DM307, DM308, DM309 AND DM310 ADJUSTED FOR WELL EFFICIENCY; SEE DISCUSSION IN SECTION 2 OF THIS REPORT.
 4. WELLS WITH () WERE PUMPING WHEN WATER MEASUREMENTS WERE RECORDED.
 5. WATER LEVELS IN WELLS DM-23, DM-26, DM-27, DM-28, DM-30 AND DM-34 WERE MEASURED IN OCTOBER 2005.

**DECEMBER 2005
WATER LEVEL ELEVATIONS
ALLUVIAL AQUIFER PLAN VIEW**
