THIRD FIVE YEAR REVIEW

OPERABLE UNIT 1

MOTOROLA 52ND STREET

SEPTEMBER 25, 2006

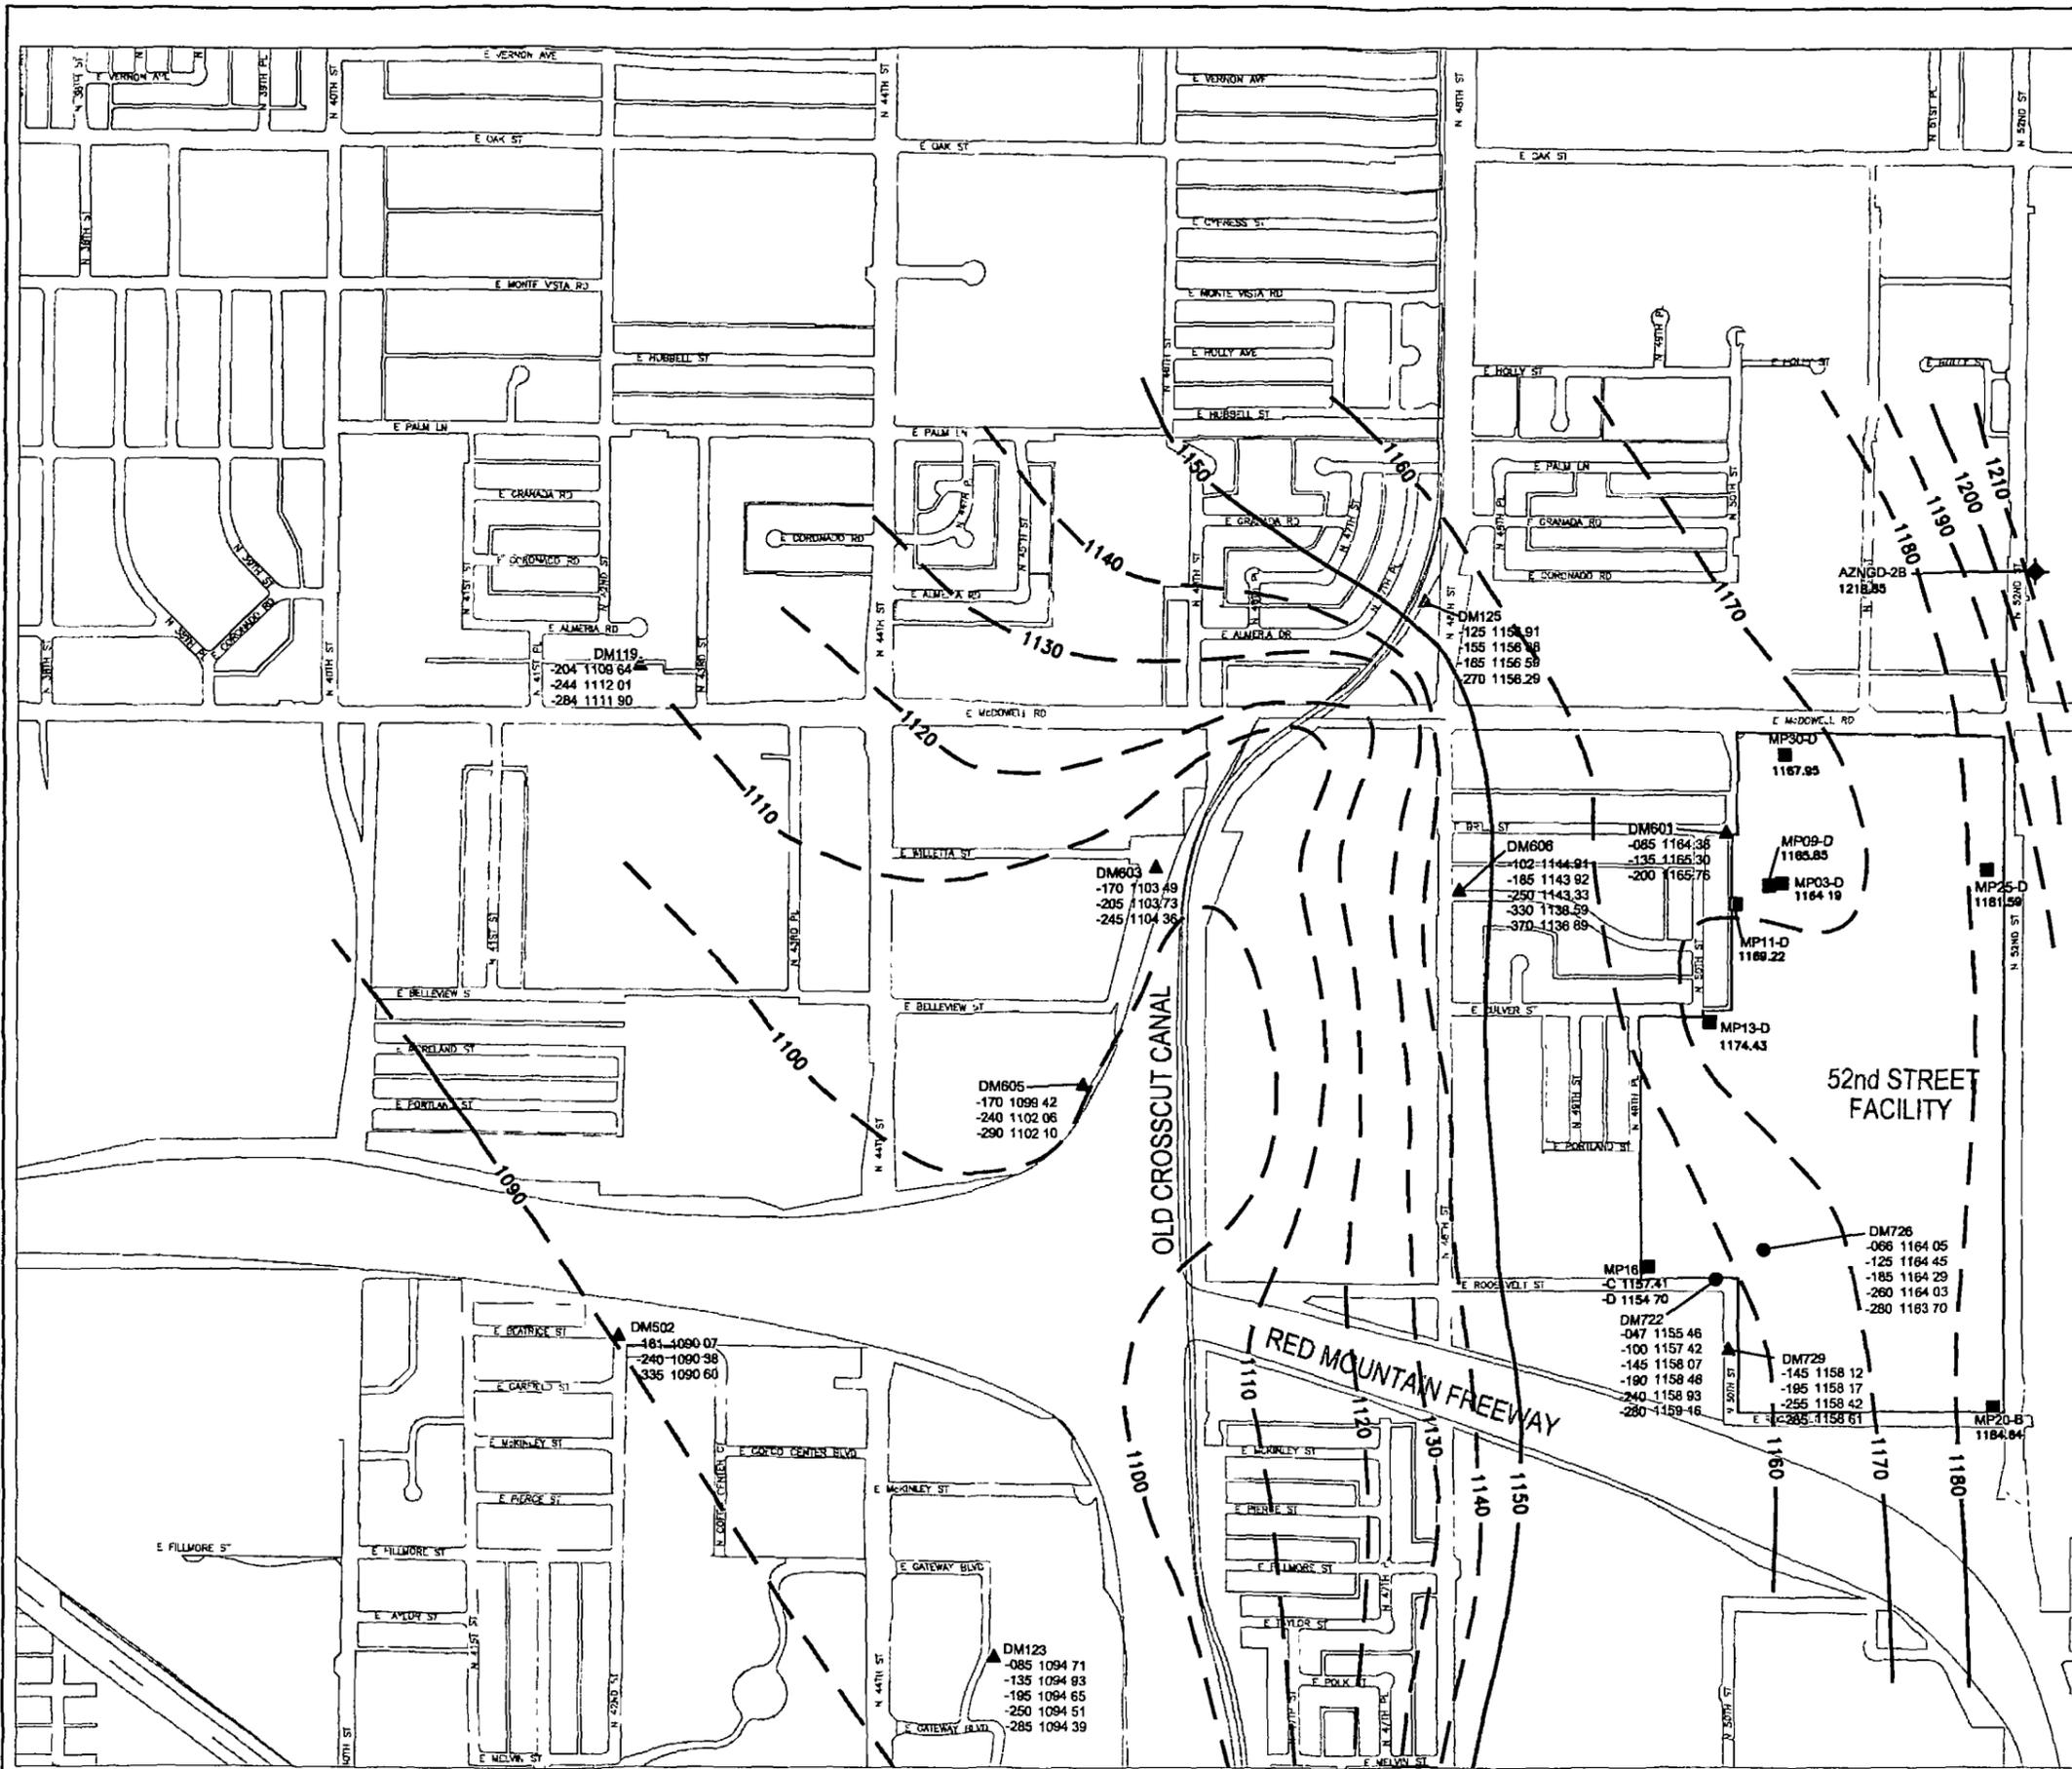
- LEGEND:**
- ◆ ● ▲ ◆ WELL LOCATION SYMBOLS
 - DM 602 WELL NAME
 - 1120.62 GROUNDWATER ELEVATION (FEET AMSL)
 - 1100- GROUNDWATER ELEVATION CONTOUR (FEET AMSL)

DECEMBER 2005
 WATER LEVEL ELEVATIONS
 IN BEDROCK
 Figure 2.2b

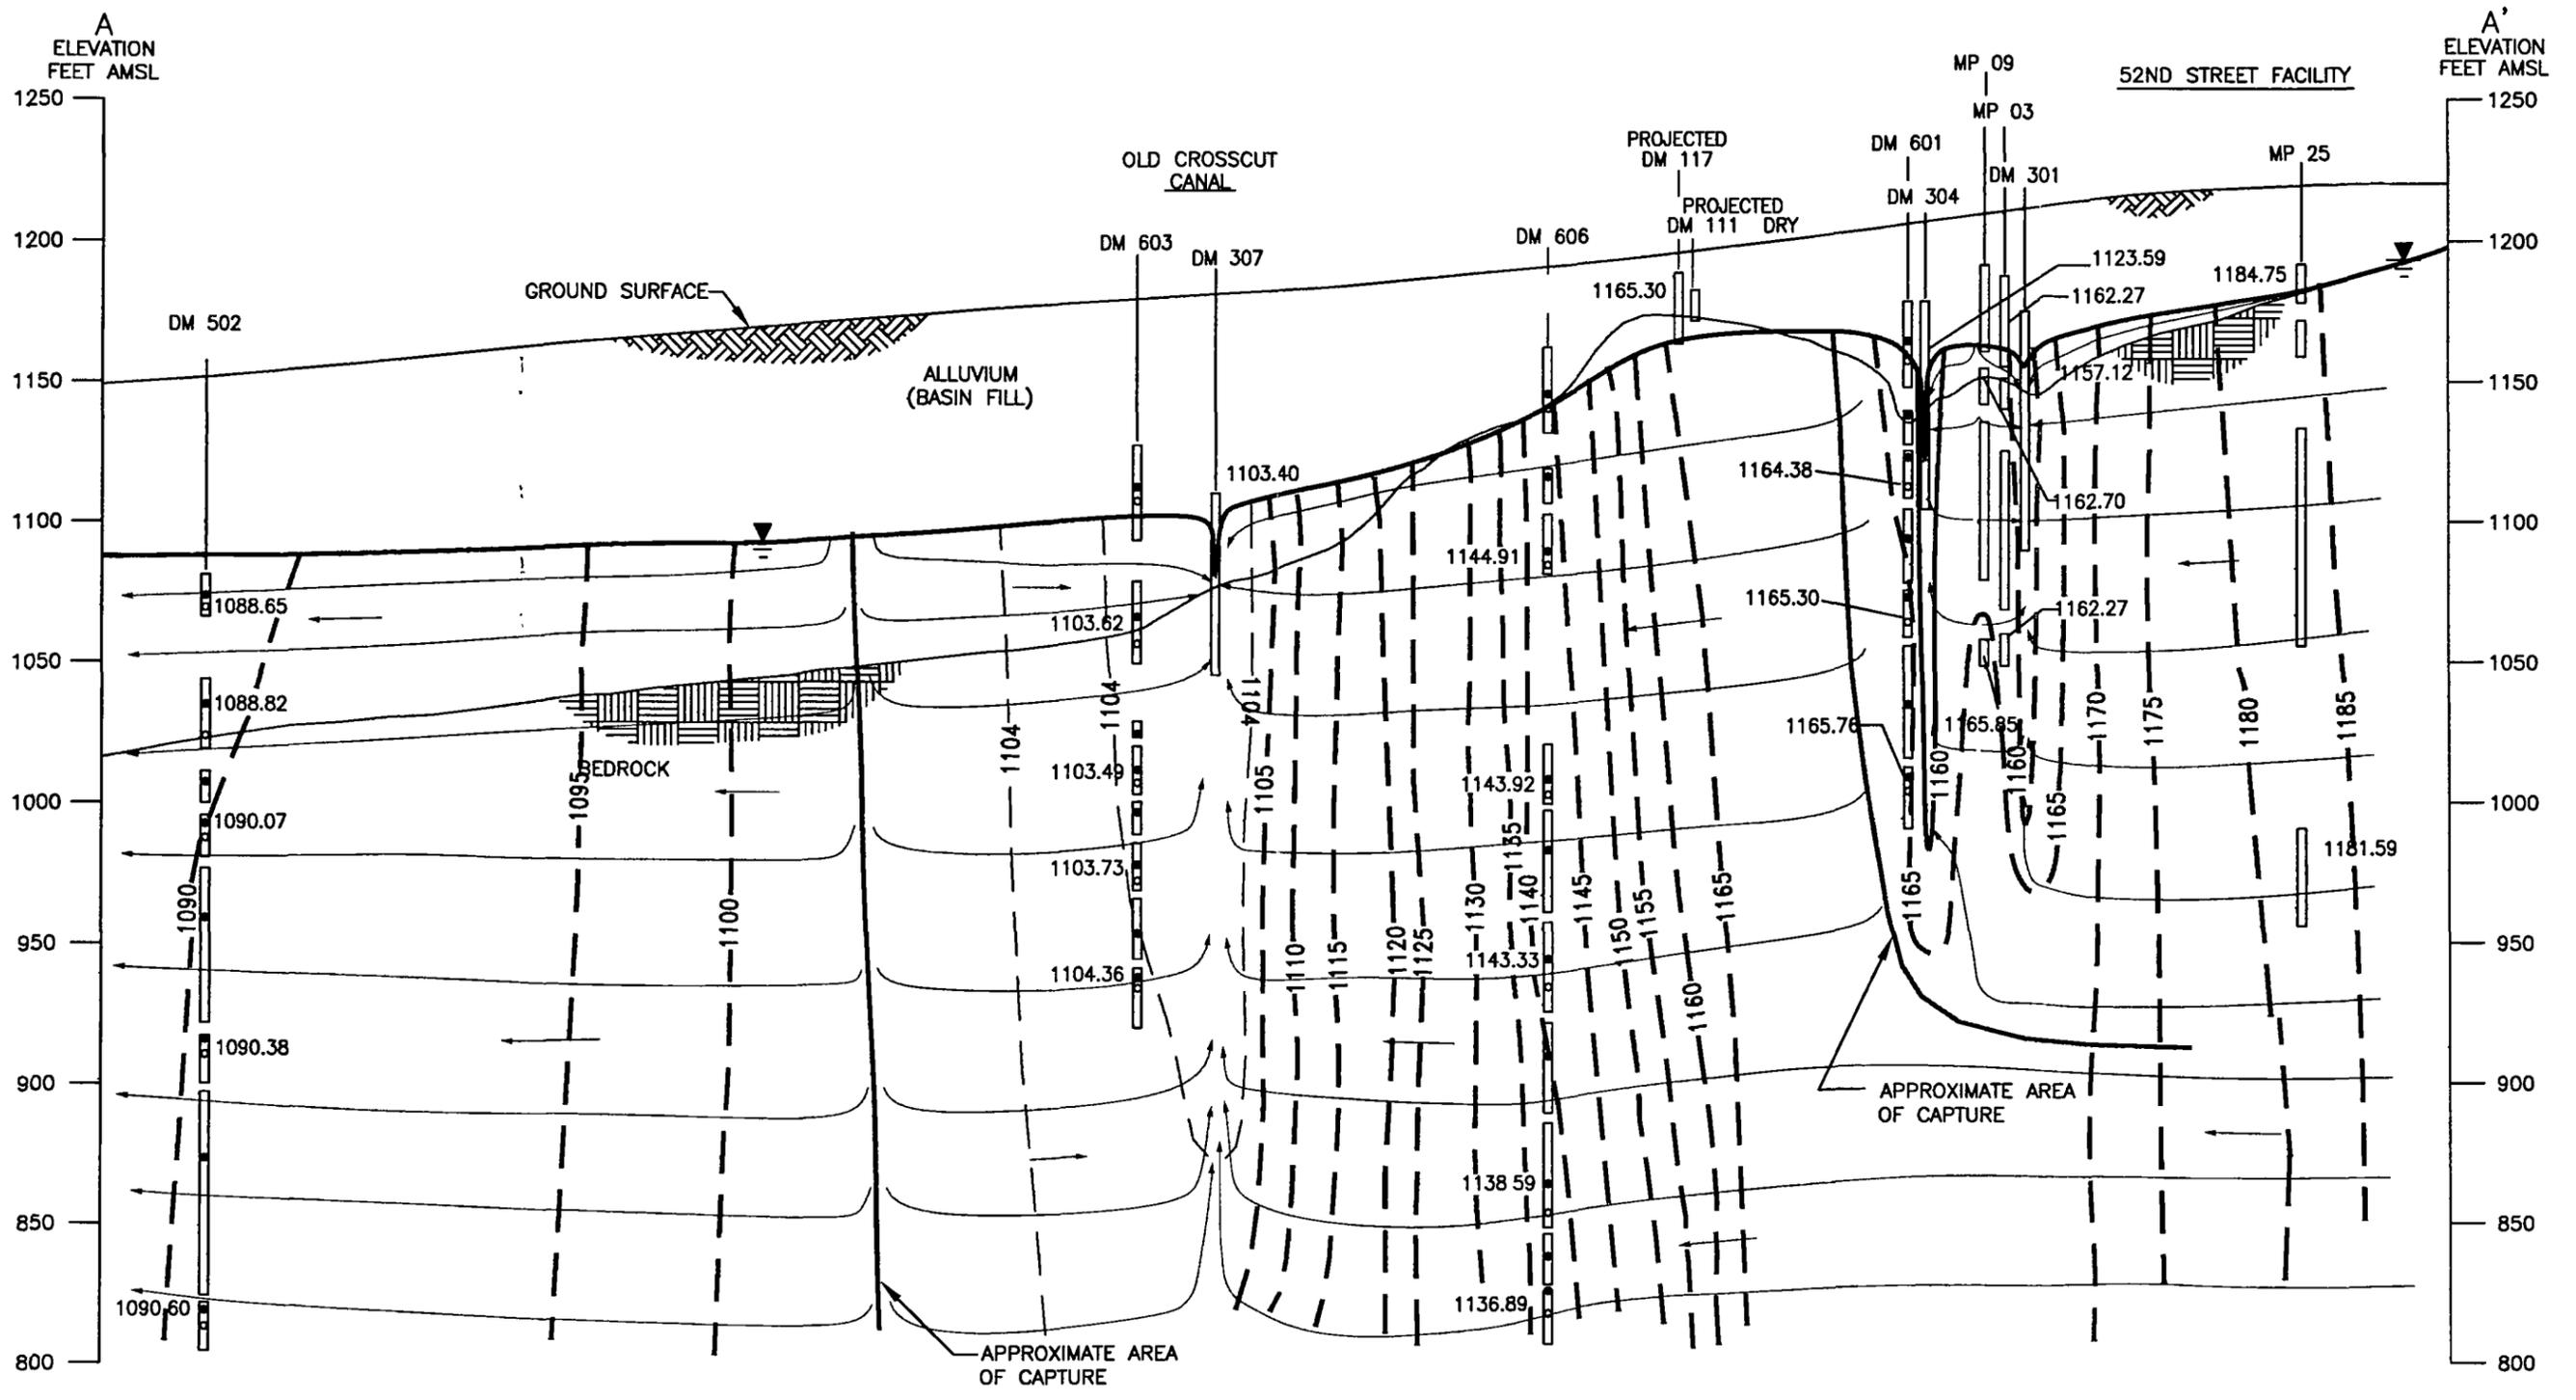
1. LOCATION OF SECTION A-A' IS SHOWN ON FIGURE 1.1.
2. THE WATER TABLE WAS PLOTTED USING DECEMBER 2005 DATA.
4. WATER LEVEL FOR DM 307 ADJUSTED FOR WELL EFFICIENCY. SEE DISCUSSION IN SECTION 2 OF THIS REPORT.
3. FIGURE 2.2 SHOWS WHERE THE CROSS SECTION CROSSES THE CAPTURE ZONE NEAR THE OCC. GROUNDWATER FLOW IS SOUTH-EAST TOWARD THE EXTRACTION WELLS. IN FIGURE 2.7 THIS MEANS WATER ON THE EAST SIDE OF THE CAPTURE ZONE WOULD BE COMING OUT OF THE PAPER AND TO THE READER'S RIGHT, TOWARD THE EXTRACTION WELLS. THEREFORE, THE STAGNATION POINT DOES NOT APPEAR AS THE HIGH POINT IN THE WATER LEVEL ELEVATION PROFILE.

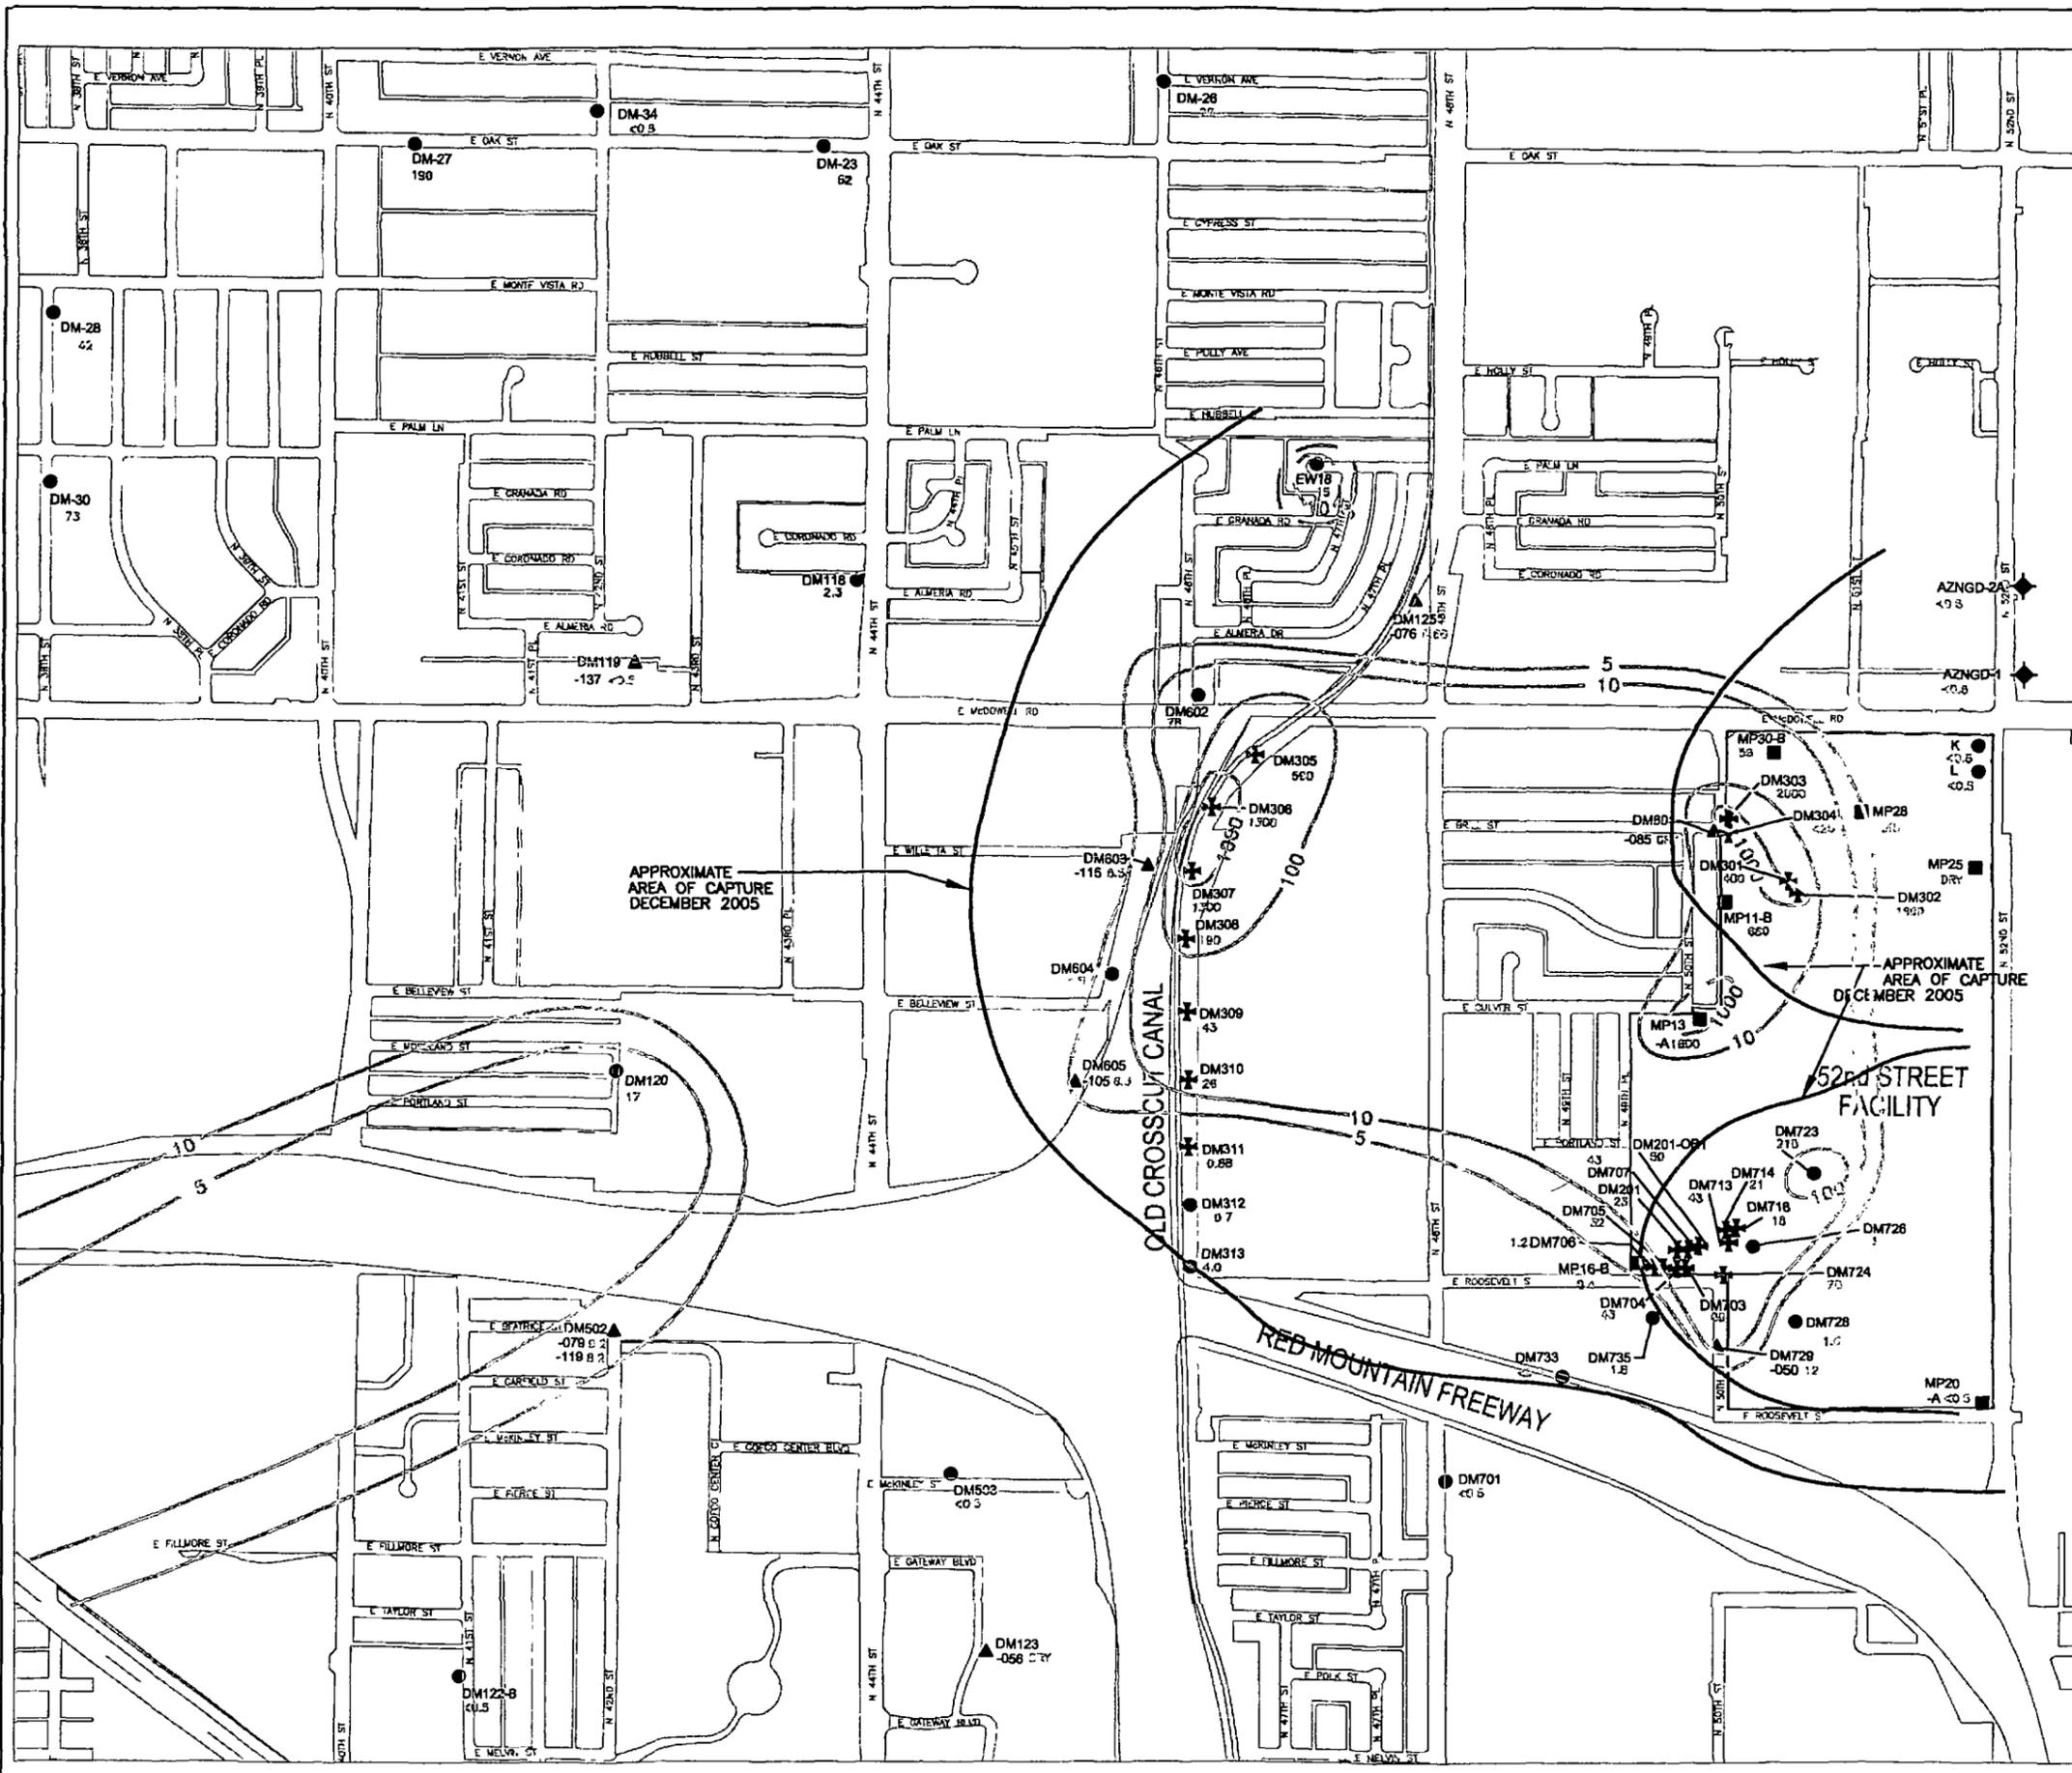
- LEGEND:**
- ▲▲◆◆ WELL LOCATION SYMBOLS
 - DM 603 WELL NAME
 - 115 6.5 DEPTH OF WESTBAY SAMPLE PORT (IN FEET BGS) OR COMPLETION INTERVAL DESIGNATION; TCE CONCENTRATION (ug/L)
 - 5 TCE CONCENTRATION CONTOUR (ug/l)
 - APPROXIMATE AREA OF CAPTURE
 - NS NOT SAMPLED

- NOTES:**
1. THE TCE CONTOURS DRAWN ON THIS FIGURE ARE APPROXIMATE, AND ARE REPRESENTED TO ILLUSTRATE GENERAL CONCENTRATIONS OF TCE IN THE AREA.
 2. WELLS DM-23 THROUGH DM-34 ARE PART OF THE 56TH ST. AND EARLL DRIVE MONITORING WELL NETWORK. THESE WELLS WERE SAMPLED IN OCTOBER 2005.

**SEPTEMBER 2005
TCE CONCENTRATIONS
ALLUVIAL AQUIFER PLAN VIEW**
Figure 3.3a

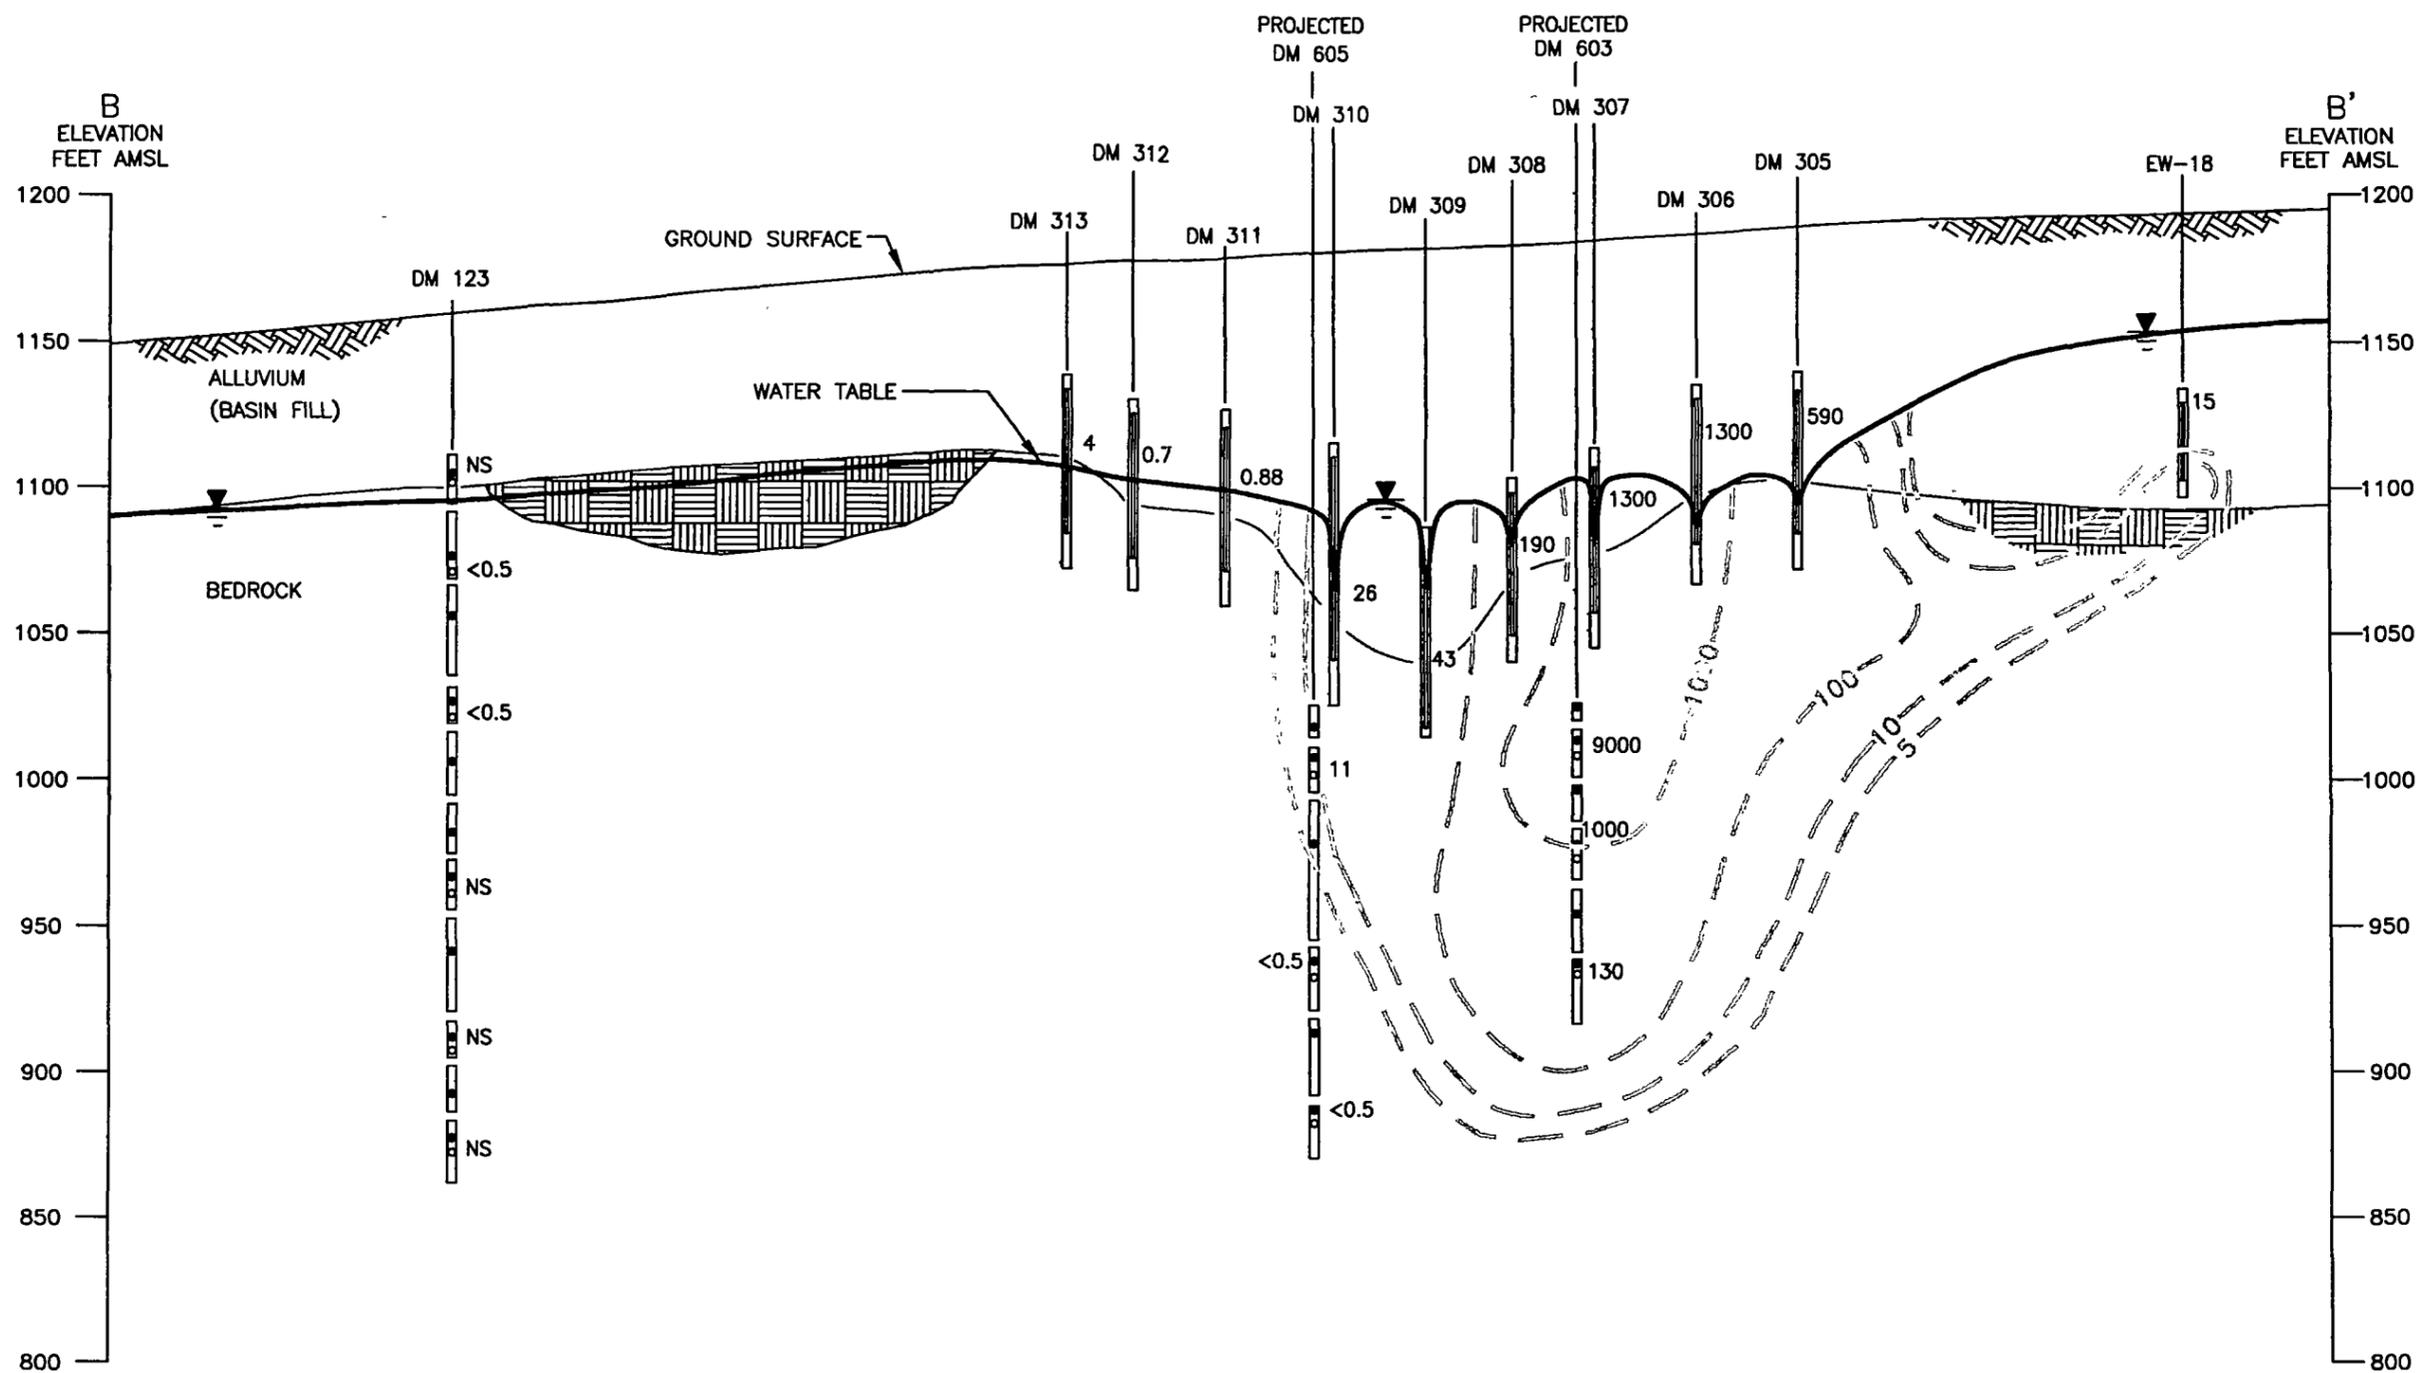
OU1 EFFECTIVENESS REPORT
2005 OPERATIONS
MARCH 2006

- DM 123 — NAME OF WELL
- GROUND SURFACE
- BEDROCK CONTACT
- 2005 WATER TABLE
- MONITOR ZONE
- MEASUREMENT PORT
- PUMPING PORT
- MONITOR ZONE
- WELL SCREEN

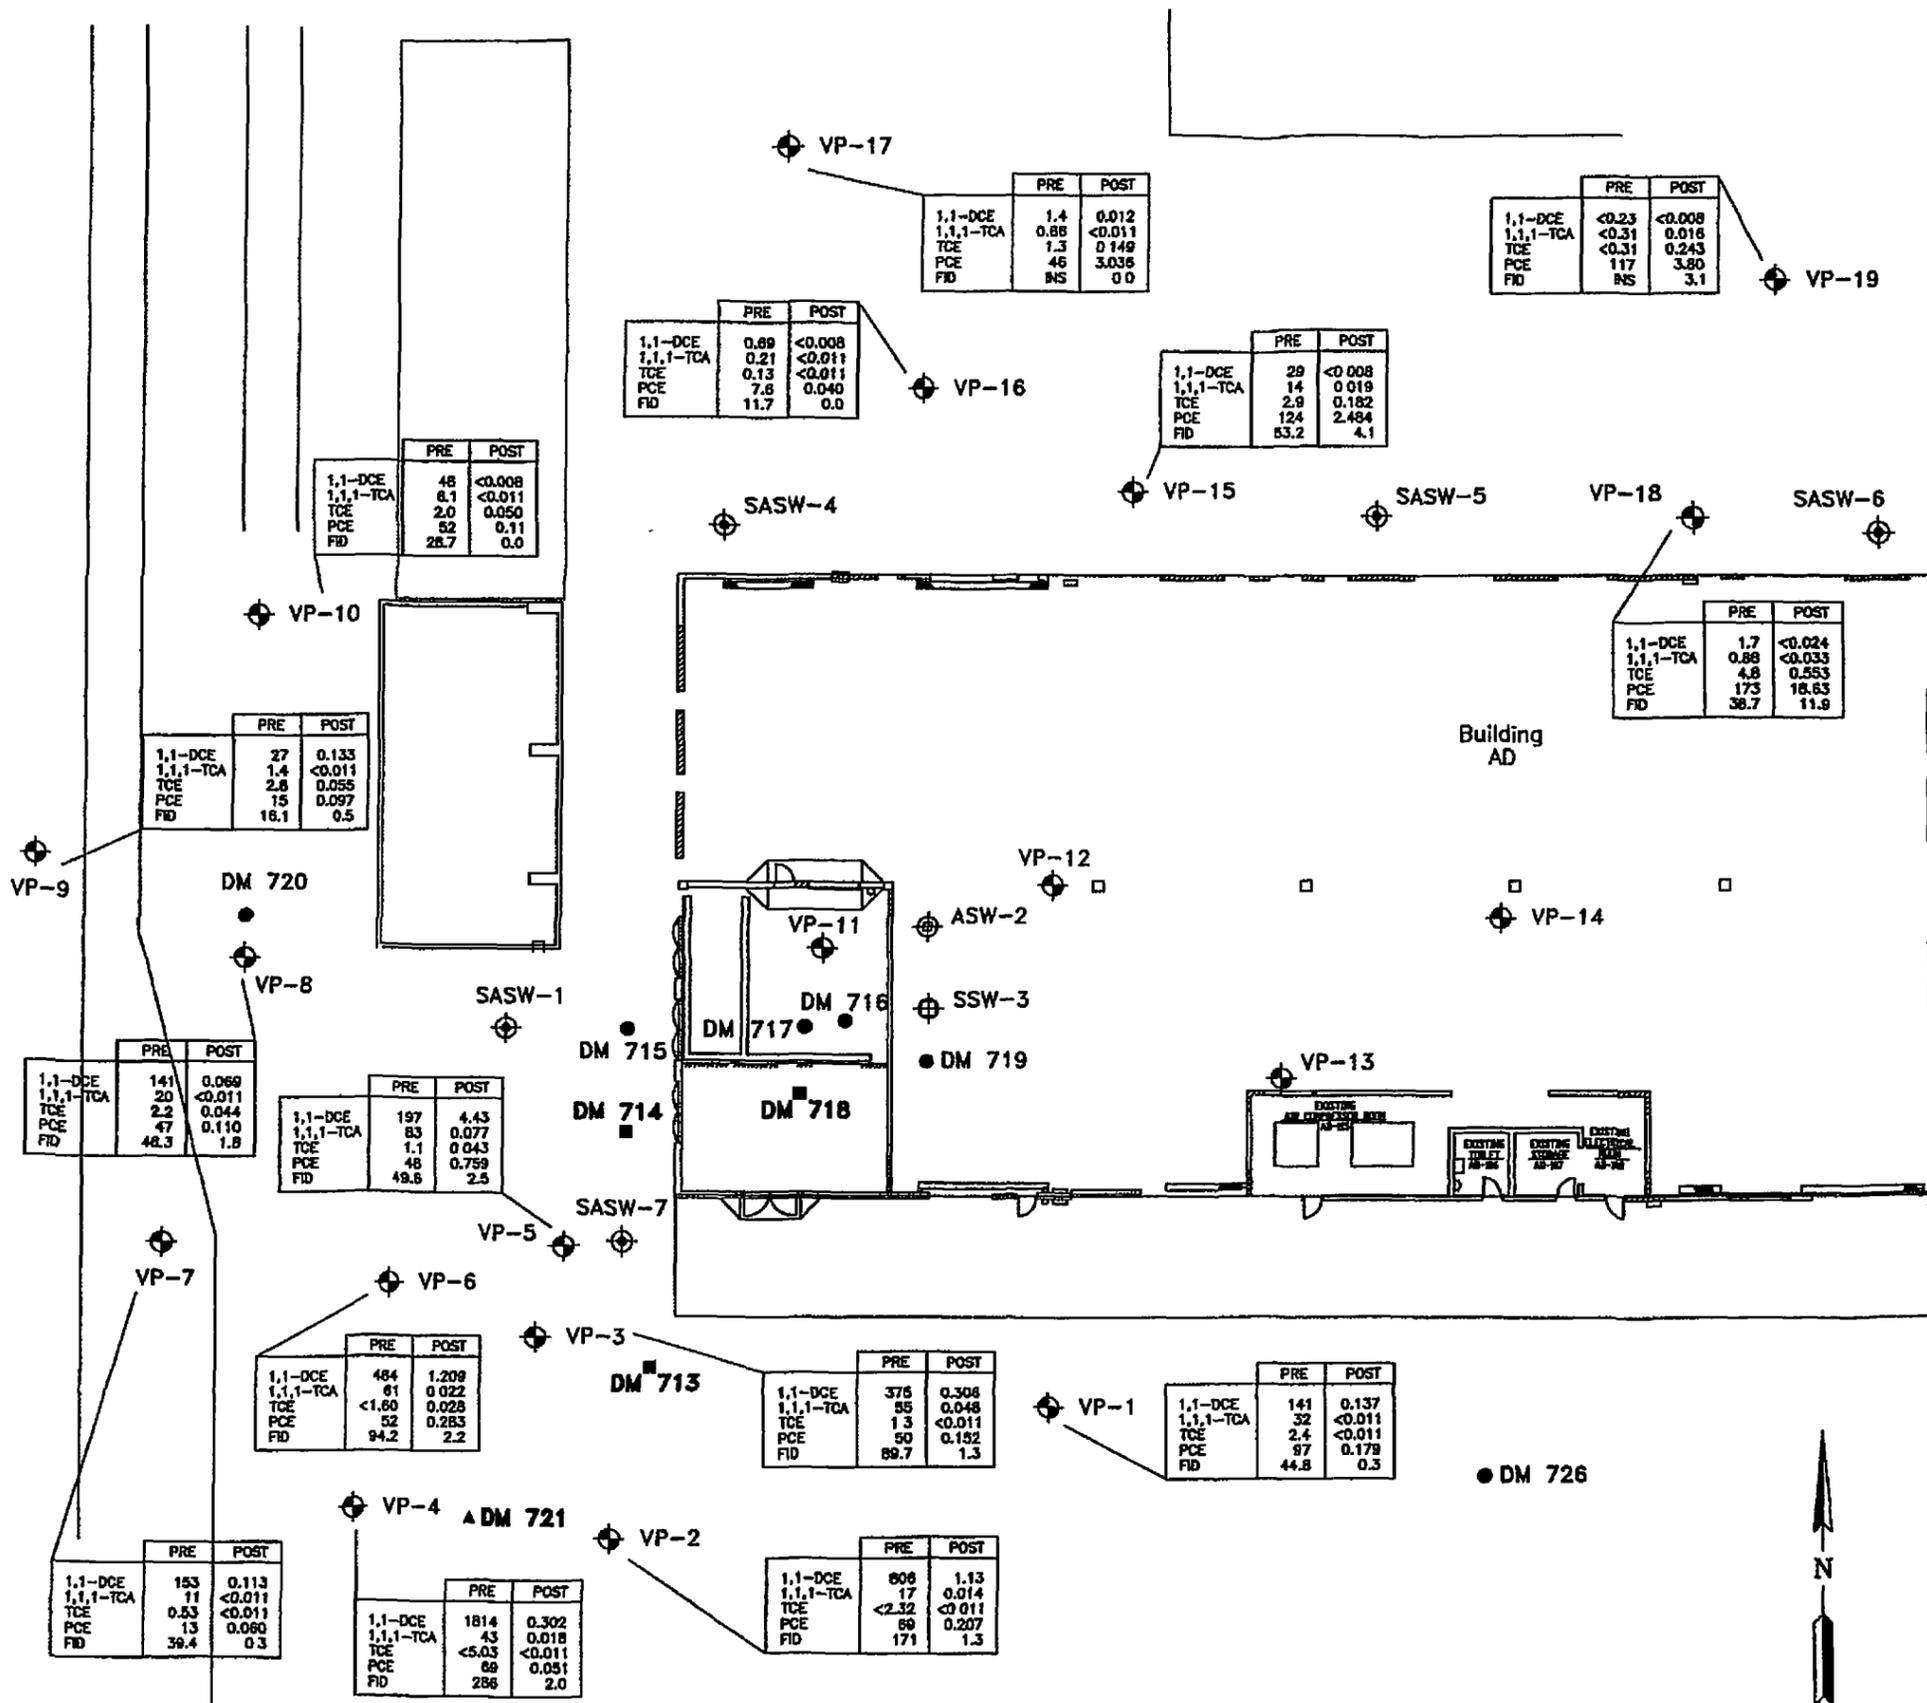
PLATE
5

EXPLANATION

- ⊕ VP-1 Vapor Monitoring Point
- ⊕ SASW-1 SVE/Air Sparging Well
- ⊕ ASW-2 Air Sparging Well
- ⊕ SSW-3 SVE Well
- DM 726 Conventional Groundwater Well
- ▲ DM 721 Westbay Groundwater Well
- DM 714 Groundwater Extraction Well

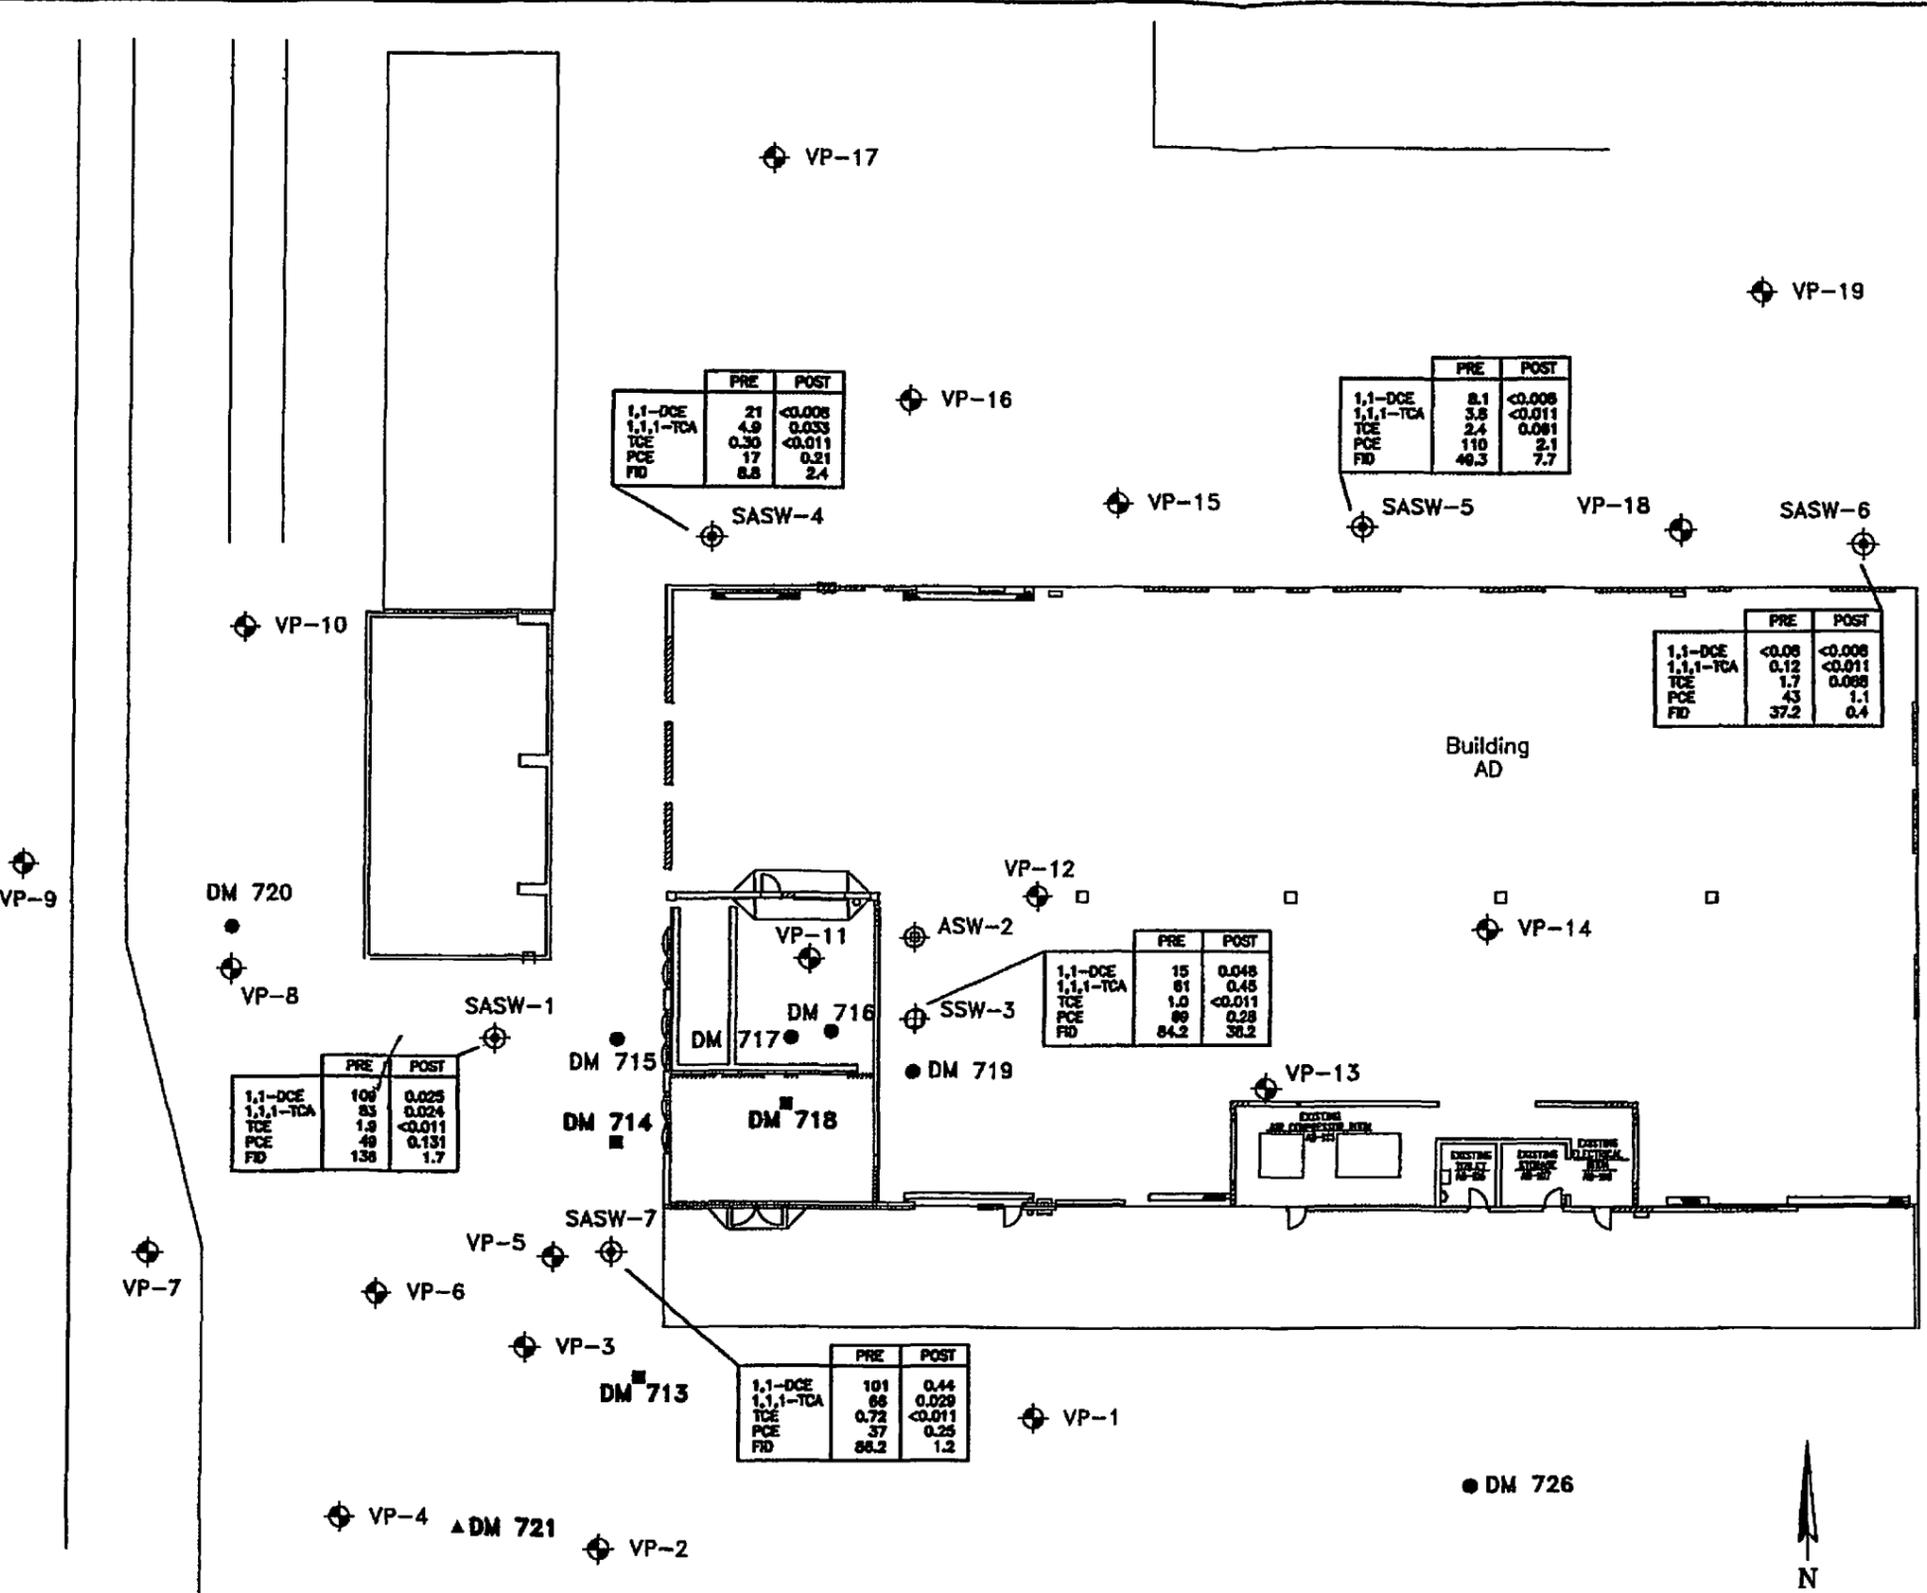
PRE	POST
1,1-DCE	21	<0.008
1,1,1-TCA	4.9	0.033
TCE	0.30	<0.011
PCE	17	0.21
FID	8.8	2.4

PRE	POST
1,1-DCE	8.1	<0.008
1,1,1-TCA	3.8	<0.011
TCE	2.4	0.081
PCE	110	2.1
FID	49.3	7.7

All concentrations in parts per million by volume (ppmv).
 Total VOCs measured with a flame ionization detector (FID) calibrated with 100 ppmv 1,1,1-Trichloroethane.
 VOC concentrations corrected for instrument out of calibration conditions and erroneous data.

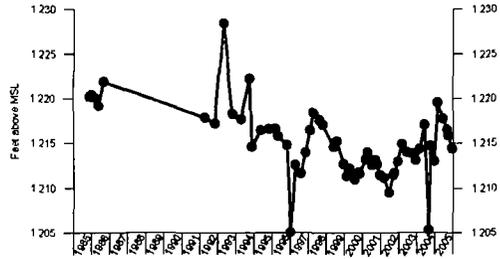
**GW Elevation
AZNGD-1**

**GROUNDWATER ELEVATION AND CONCENTRATION
HYDROGRAPHS FOR SELECTED WELLS**

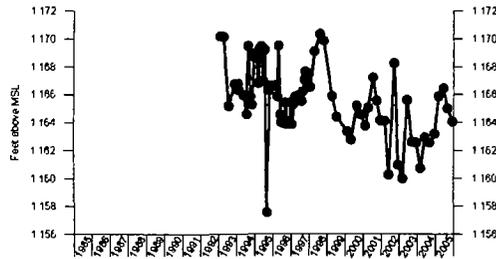
**GW Elevation
DM721-065**

**Time-Series Graphs
Selected Wells
52nd Street Superfund Site
Phoenix, Arizona**

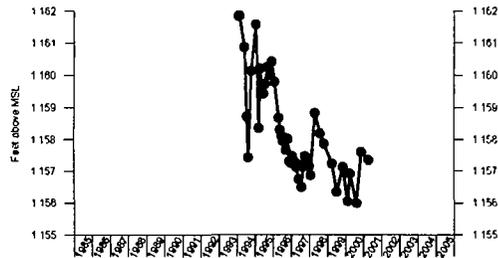
**GW Elevation
DM734-110**

**Time-Series Graphs
Selected Wells
52nd Street Superfund Site
Phoenix, Arizona**
