THIRD FIVE YEAR REVIEW

OPERABLE UNIT 1

MOTOROLA 52ND STREET

SEPTEMBER 25, 2006

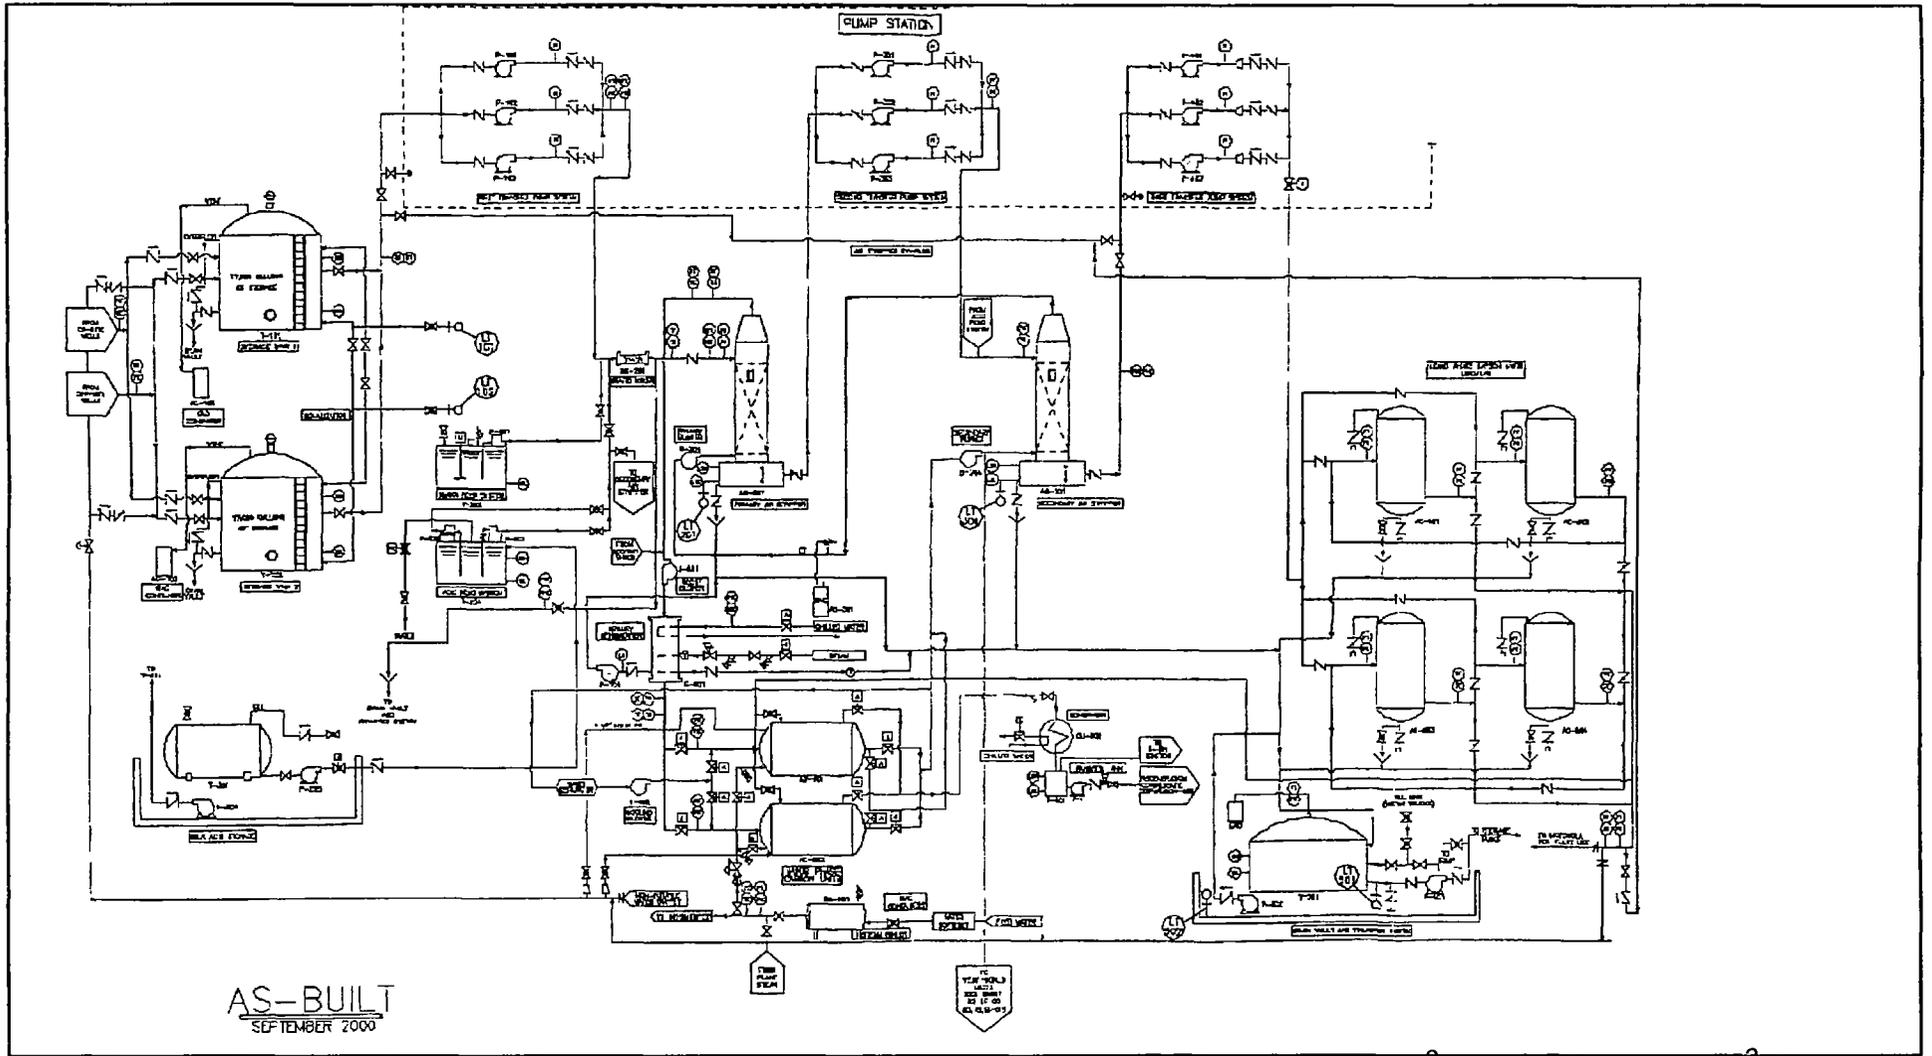
AS-BUILT
SEPTEMBER 2000

OU1 Process and Instrumentation Diagram

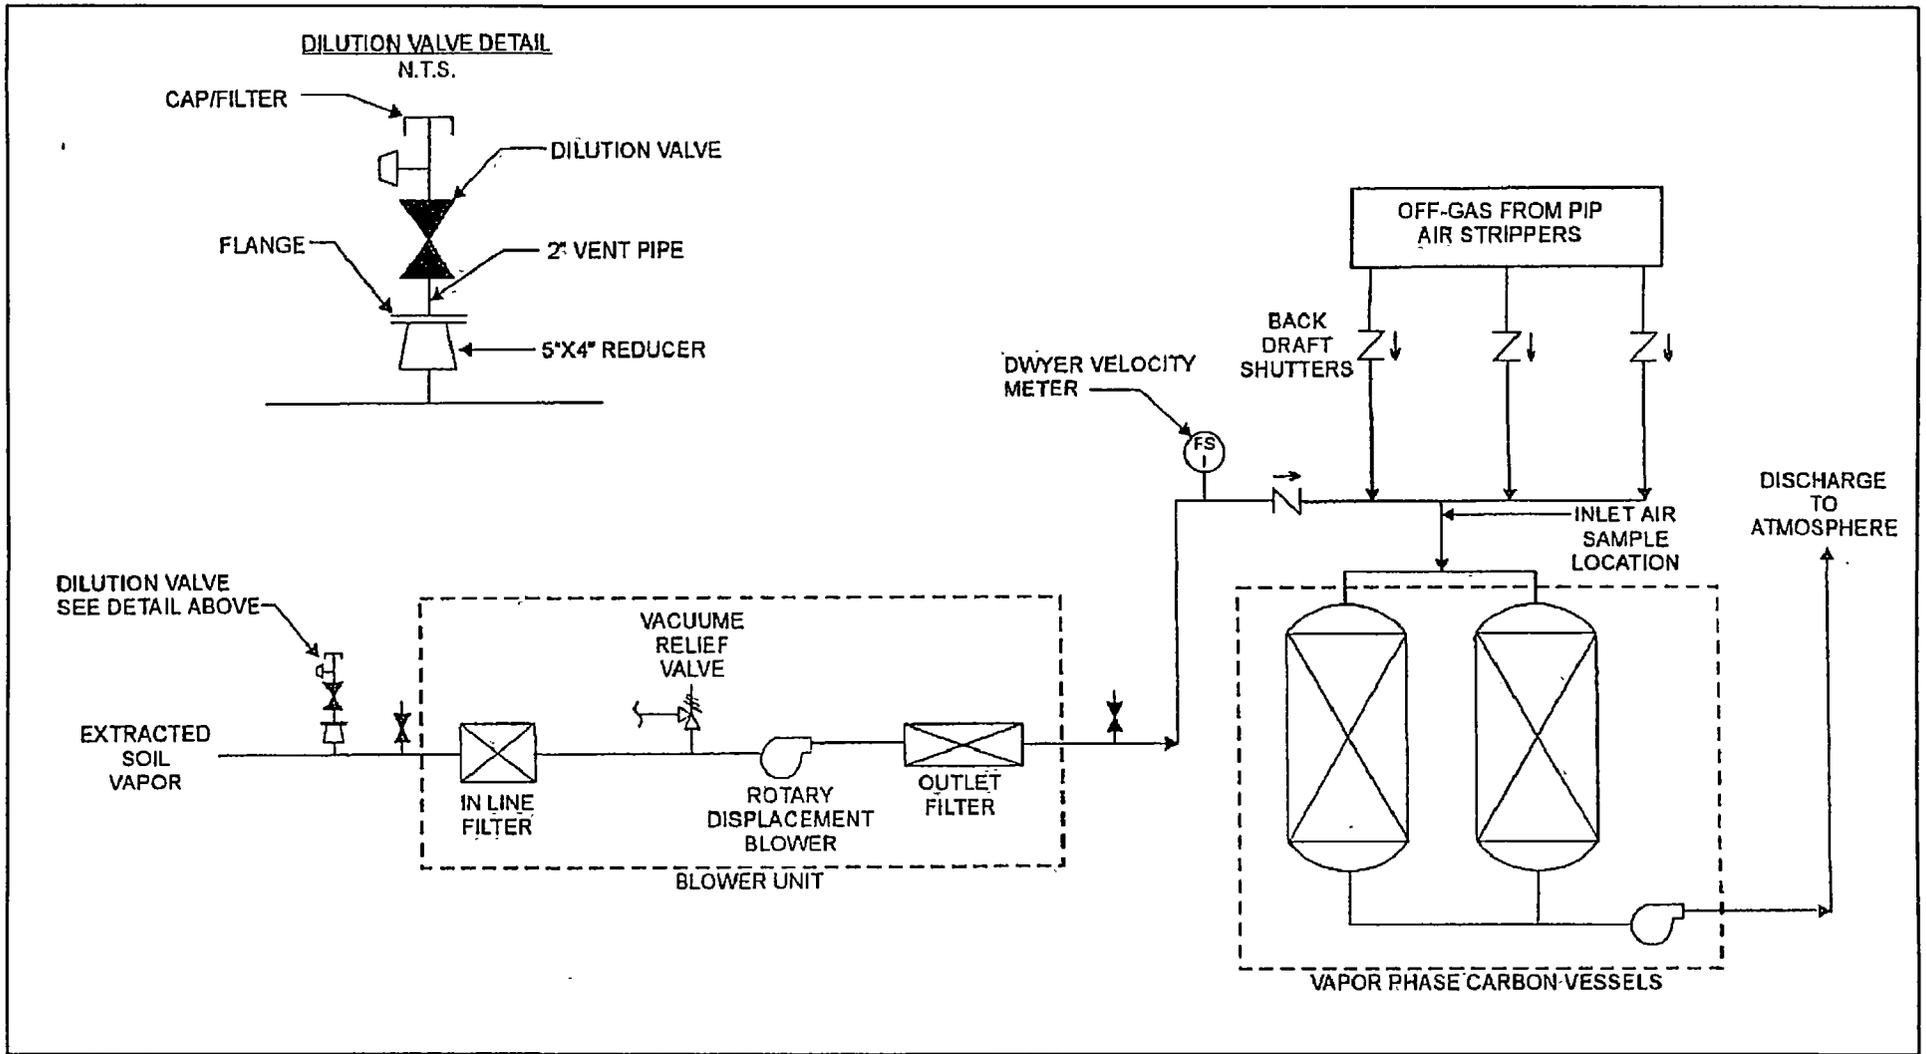
Figure 4

OU1 Courtyard SVE Process Flow Diagram

The Courtyard SVE remedial system was never modified from the pilot treatment system because the effectiveness evaluation performed by Freescale (See Section 3.3.14) concluded that additional SVE in the Courtyard area was considered to have no significant remedial benefit. The Courtyard SVE system consisted of one SVE well (EX-1) that was connected to a vapor treatment system within the PTP area. The process flow diagram for this system shows that the extracted vapor from the well was routed to the vapor treatment system consisting of two vapor phase GAC vessels which remove the VOCs prior to discharge into the atmosphere (Figure 4). The system was designed to produce an effective radius of influence of 25 feet. The SVE system was in operation from September 21, 1992 to March 31, 1993.
