SUBAREA 7 FSP ADDENDUM
SANTA SUSANA FIELD LABORATORY SITE
AREA IV RADIOLOGICAL STUDY

TO: Andrew Bain, EPA Region 9 RPM
FROM: T. Stewart Williford, HGL Associate Manager
THROUGH: L. Steven Vaughn, R.G., HGL Project Manager
Rene R. Rodriguez, P.E., HGL Deputy Project Manager
CC: Mary Aycock, EPA Region 9 RPM
Gregg Dempsey, Technical Advisor
DATE: September 13, 2011
SUBJECT: FSP Addendum for Subarea 7
CONTRACT NO: EP-S7-05-05
TASK ORDER NO: 0038

This addendum documents the rationale used to determine the location and depth of soil samples to be collected during the first phase (Round 1) of soil sampling within Subarea 7. Sample locations are summarized in Table 1 (Attachment 1) and illustrated on the figures provided in Attachment 2. This addendum also documents the laboratory analyses that will be performed for each soil sample, derived from the default suite from Table 2.4 of the FSP (HGL, 2010) and adding site-specific analytes to that list by location as appropriate.

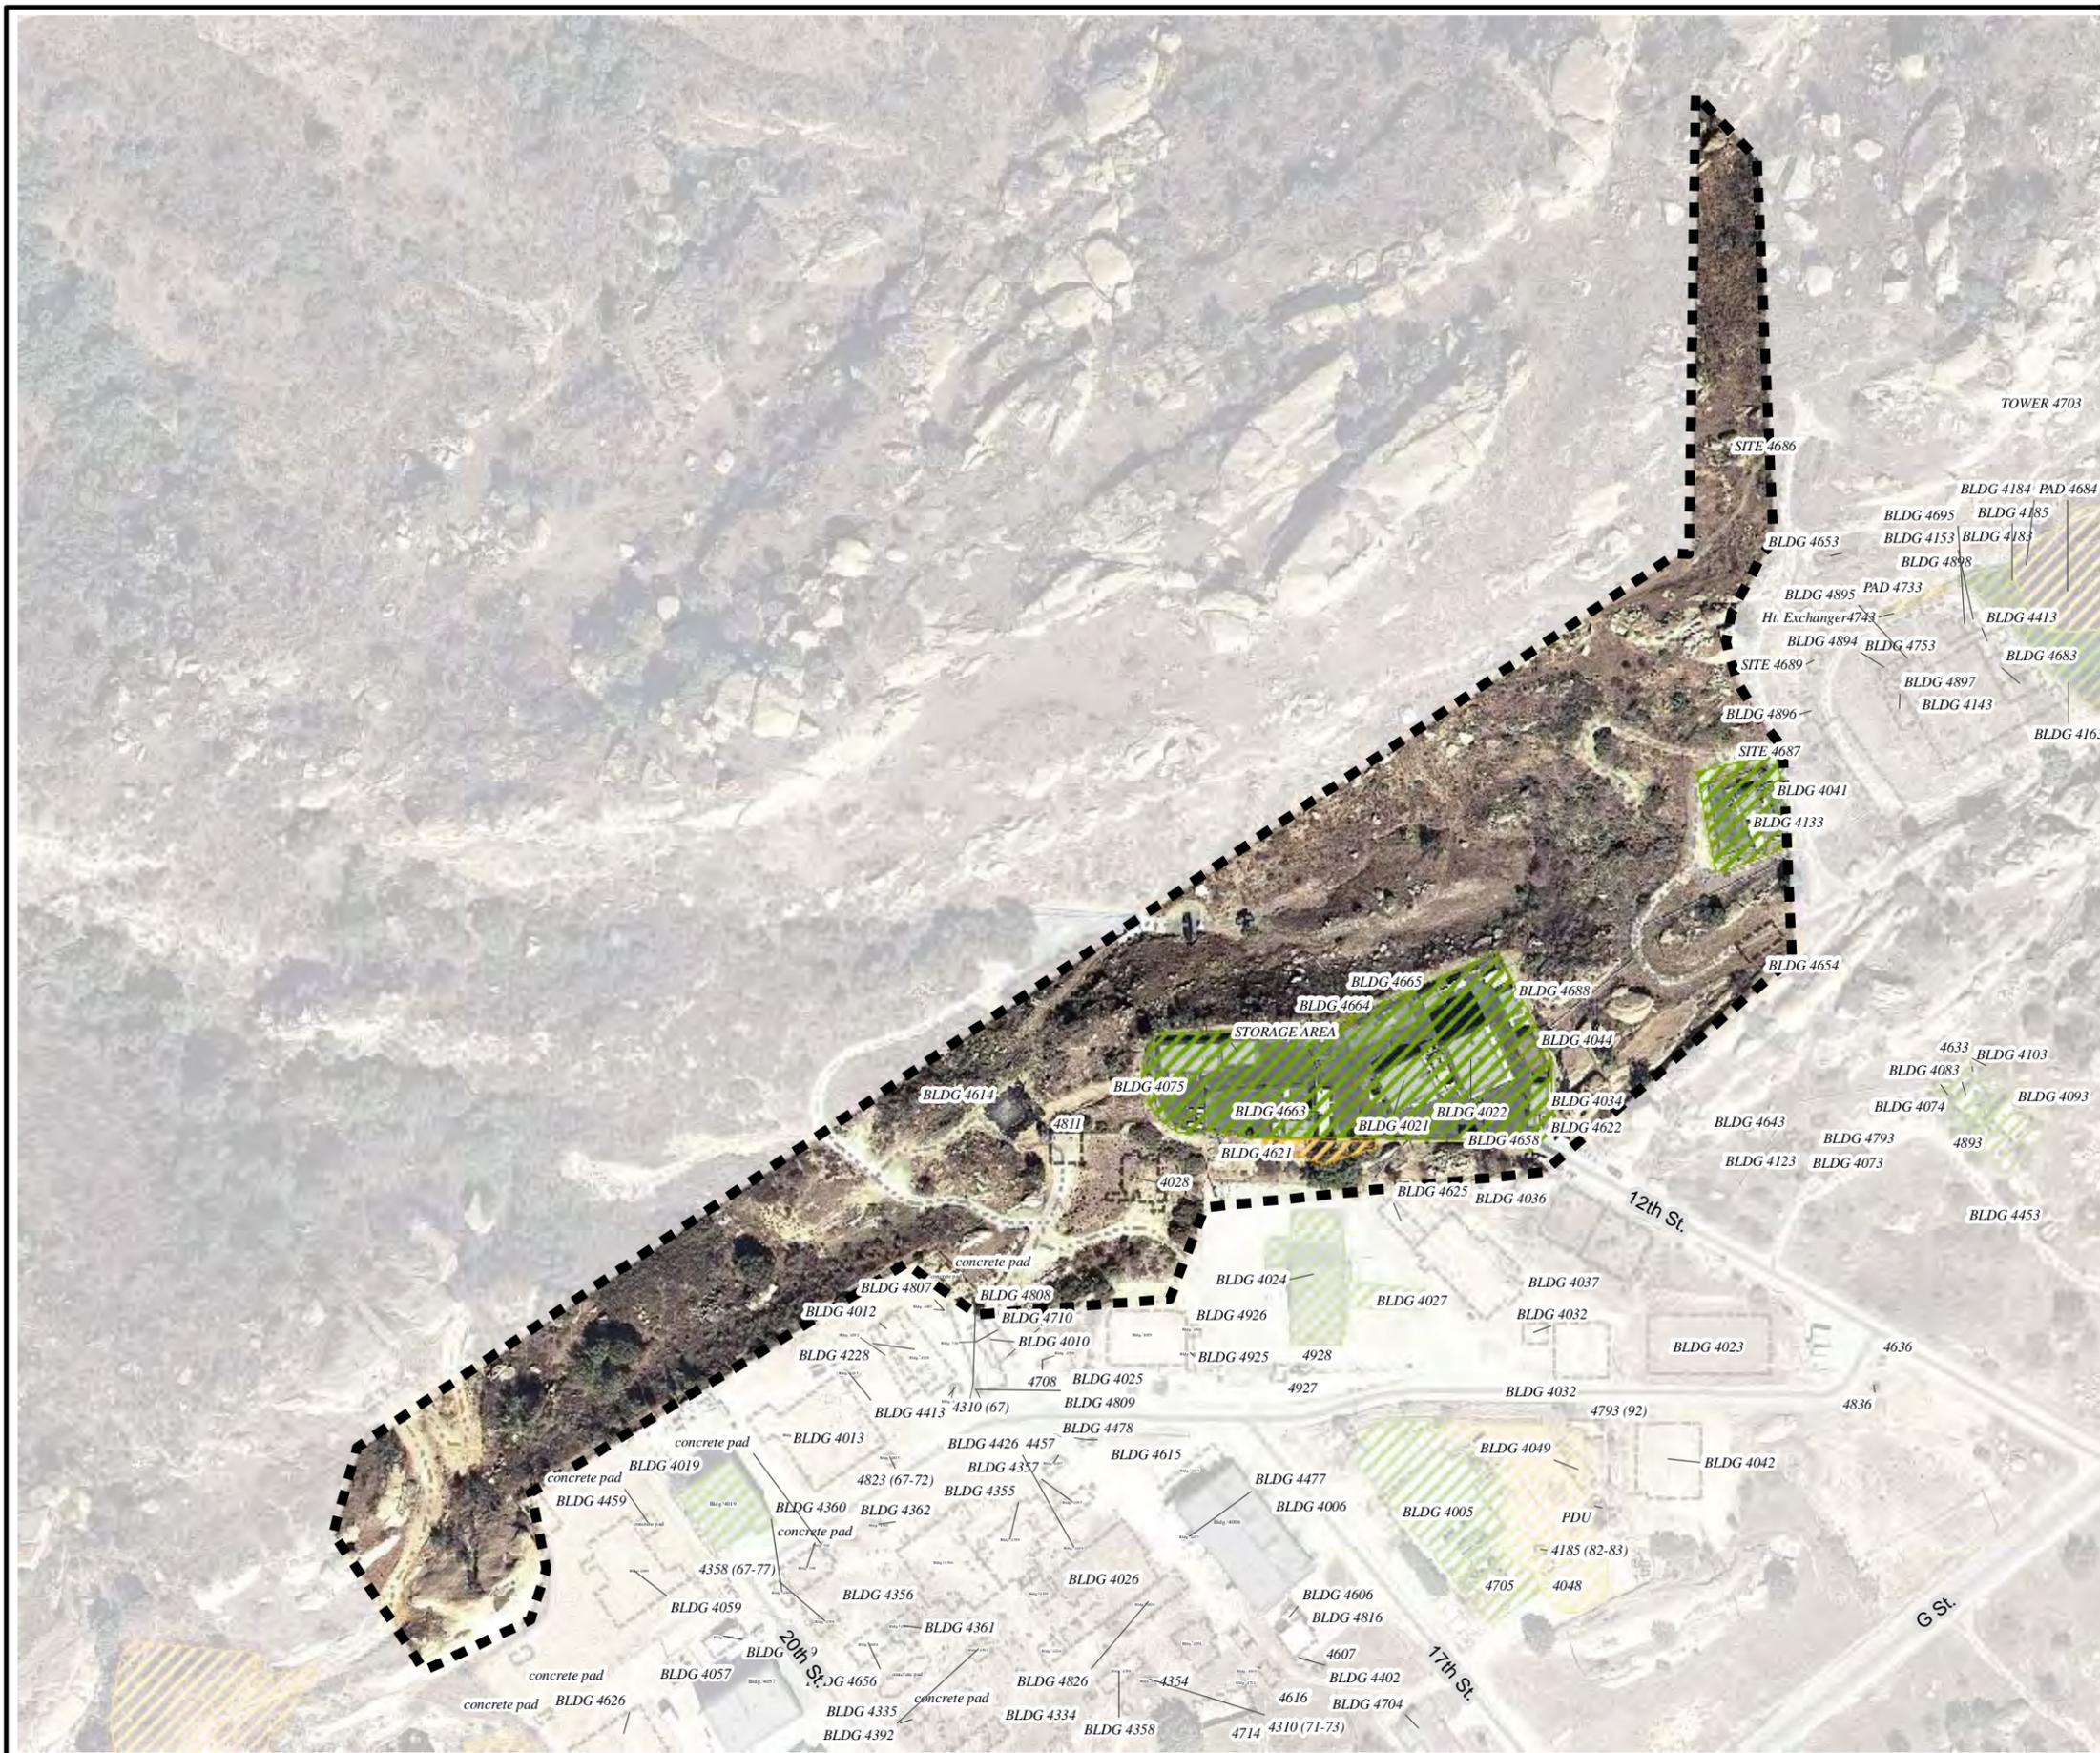
Figure 1
Subarea 7 Overview
Santa Susana Field Laboratory

Figure 1 provides a base map that shows the current and former buildings within Subarea 7. Figures 2 through 4 are maps that show the location and type (e.g. surface, subsurface, drainage) of each sample within Subarea 7 (Attachment 2). Table 2 below, provides a summary of sample numbers by sample type.

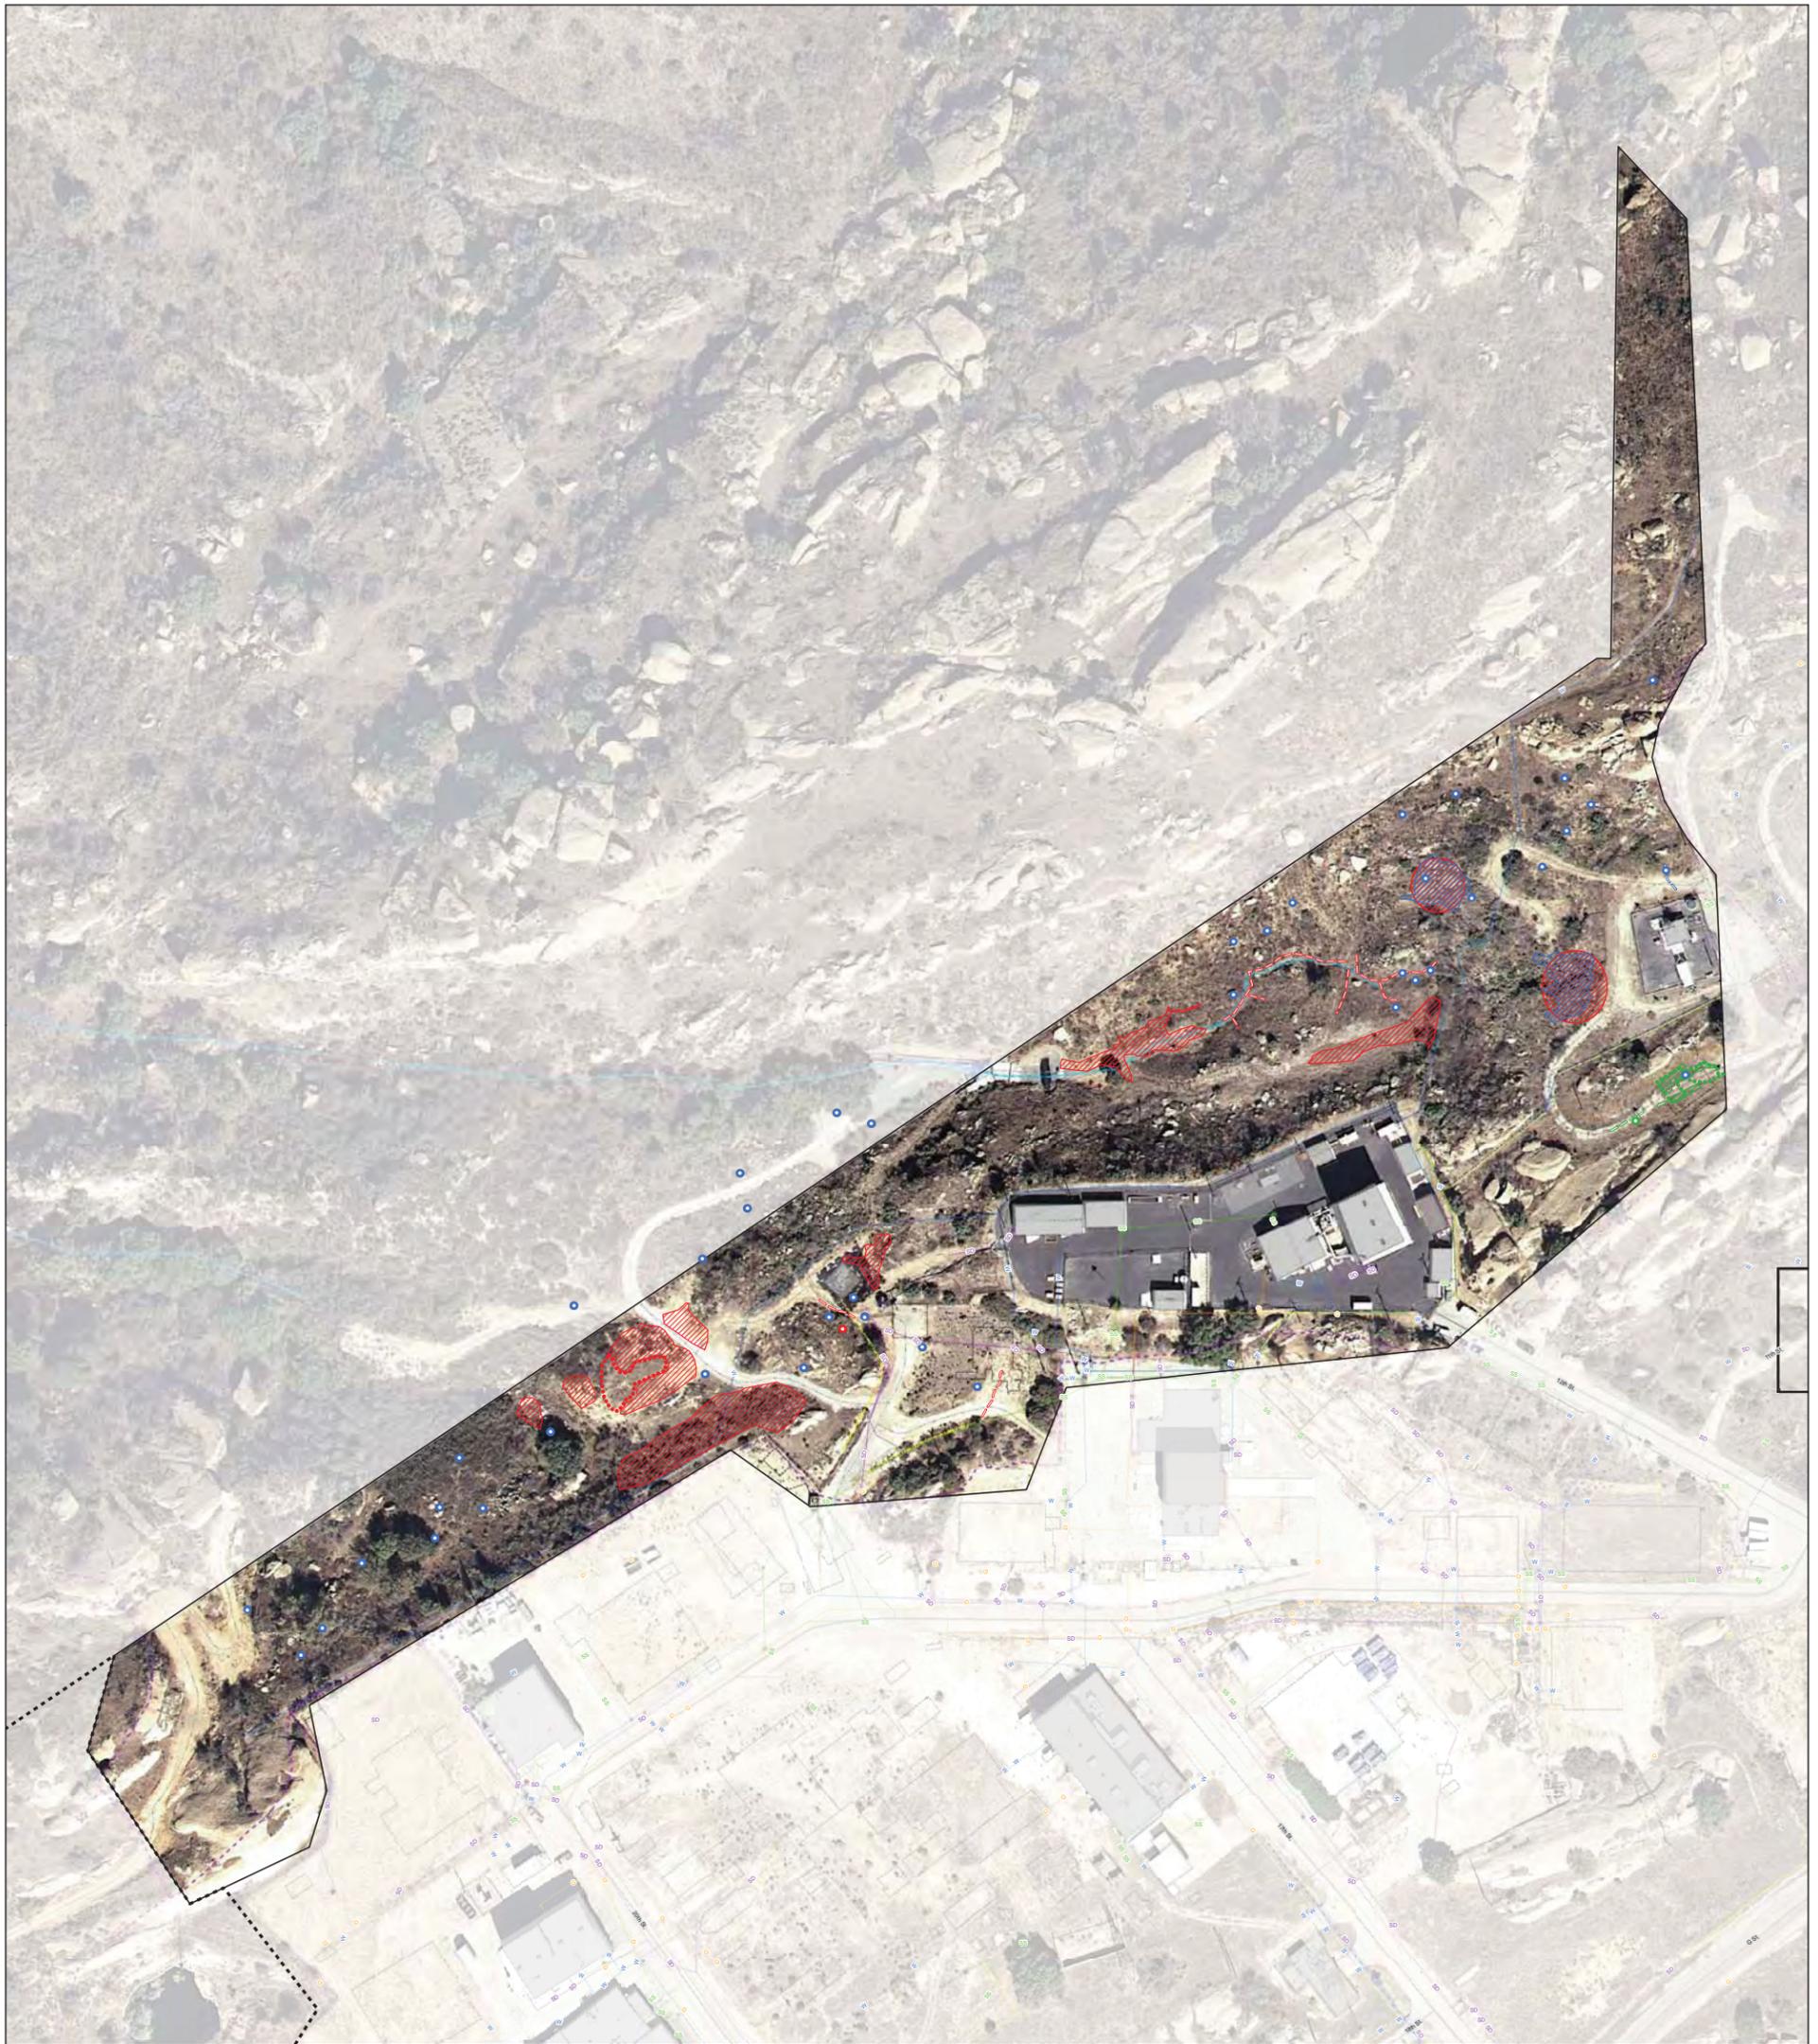
**Geophysical Anomalies
 Subarea 7
 Santa Susana Field Laboratory**

- Terrain Conductivity
- Magnetometer
- Ground Penetrating Radar
- Cut and Fill Boundaries
- Magnetometer Anomaly Linear
- Terrain Conductivity Anomaly Linear
- Ground Penetrating Radar
- Interpreted Drain Remnant
- Buried Metals

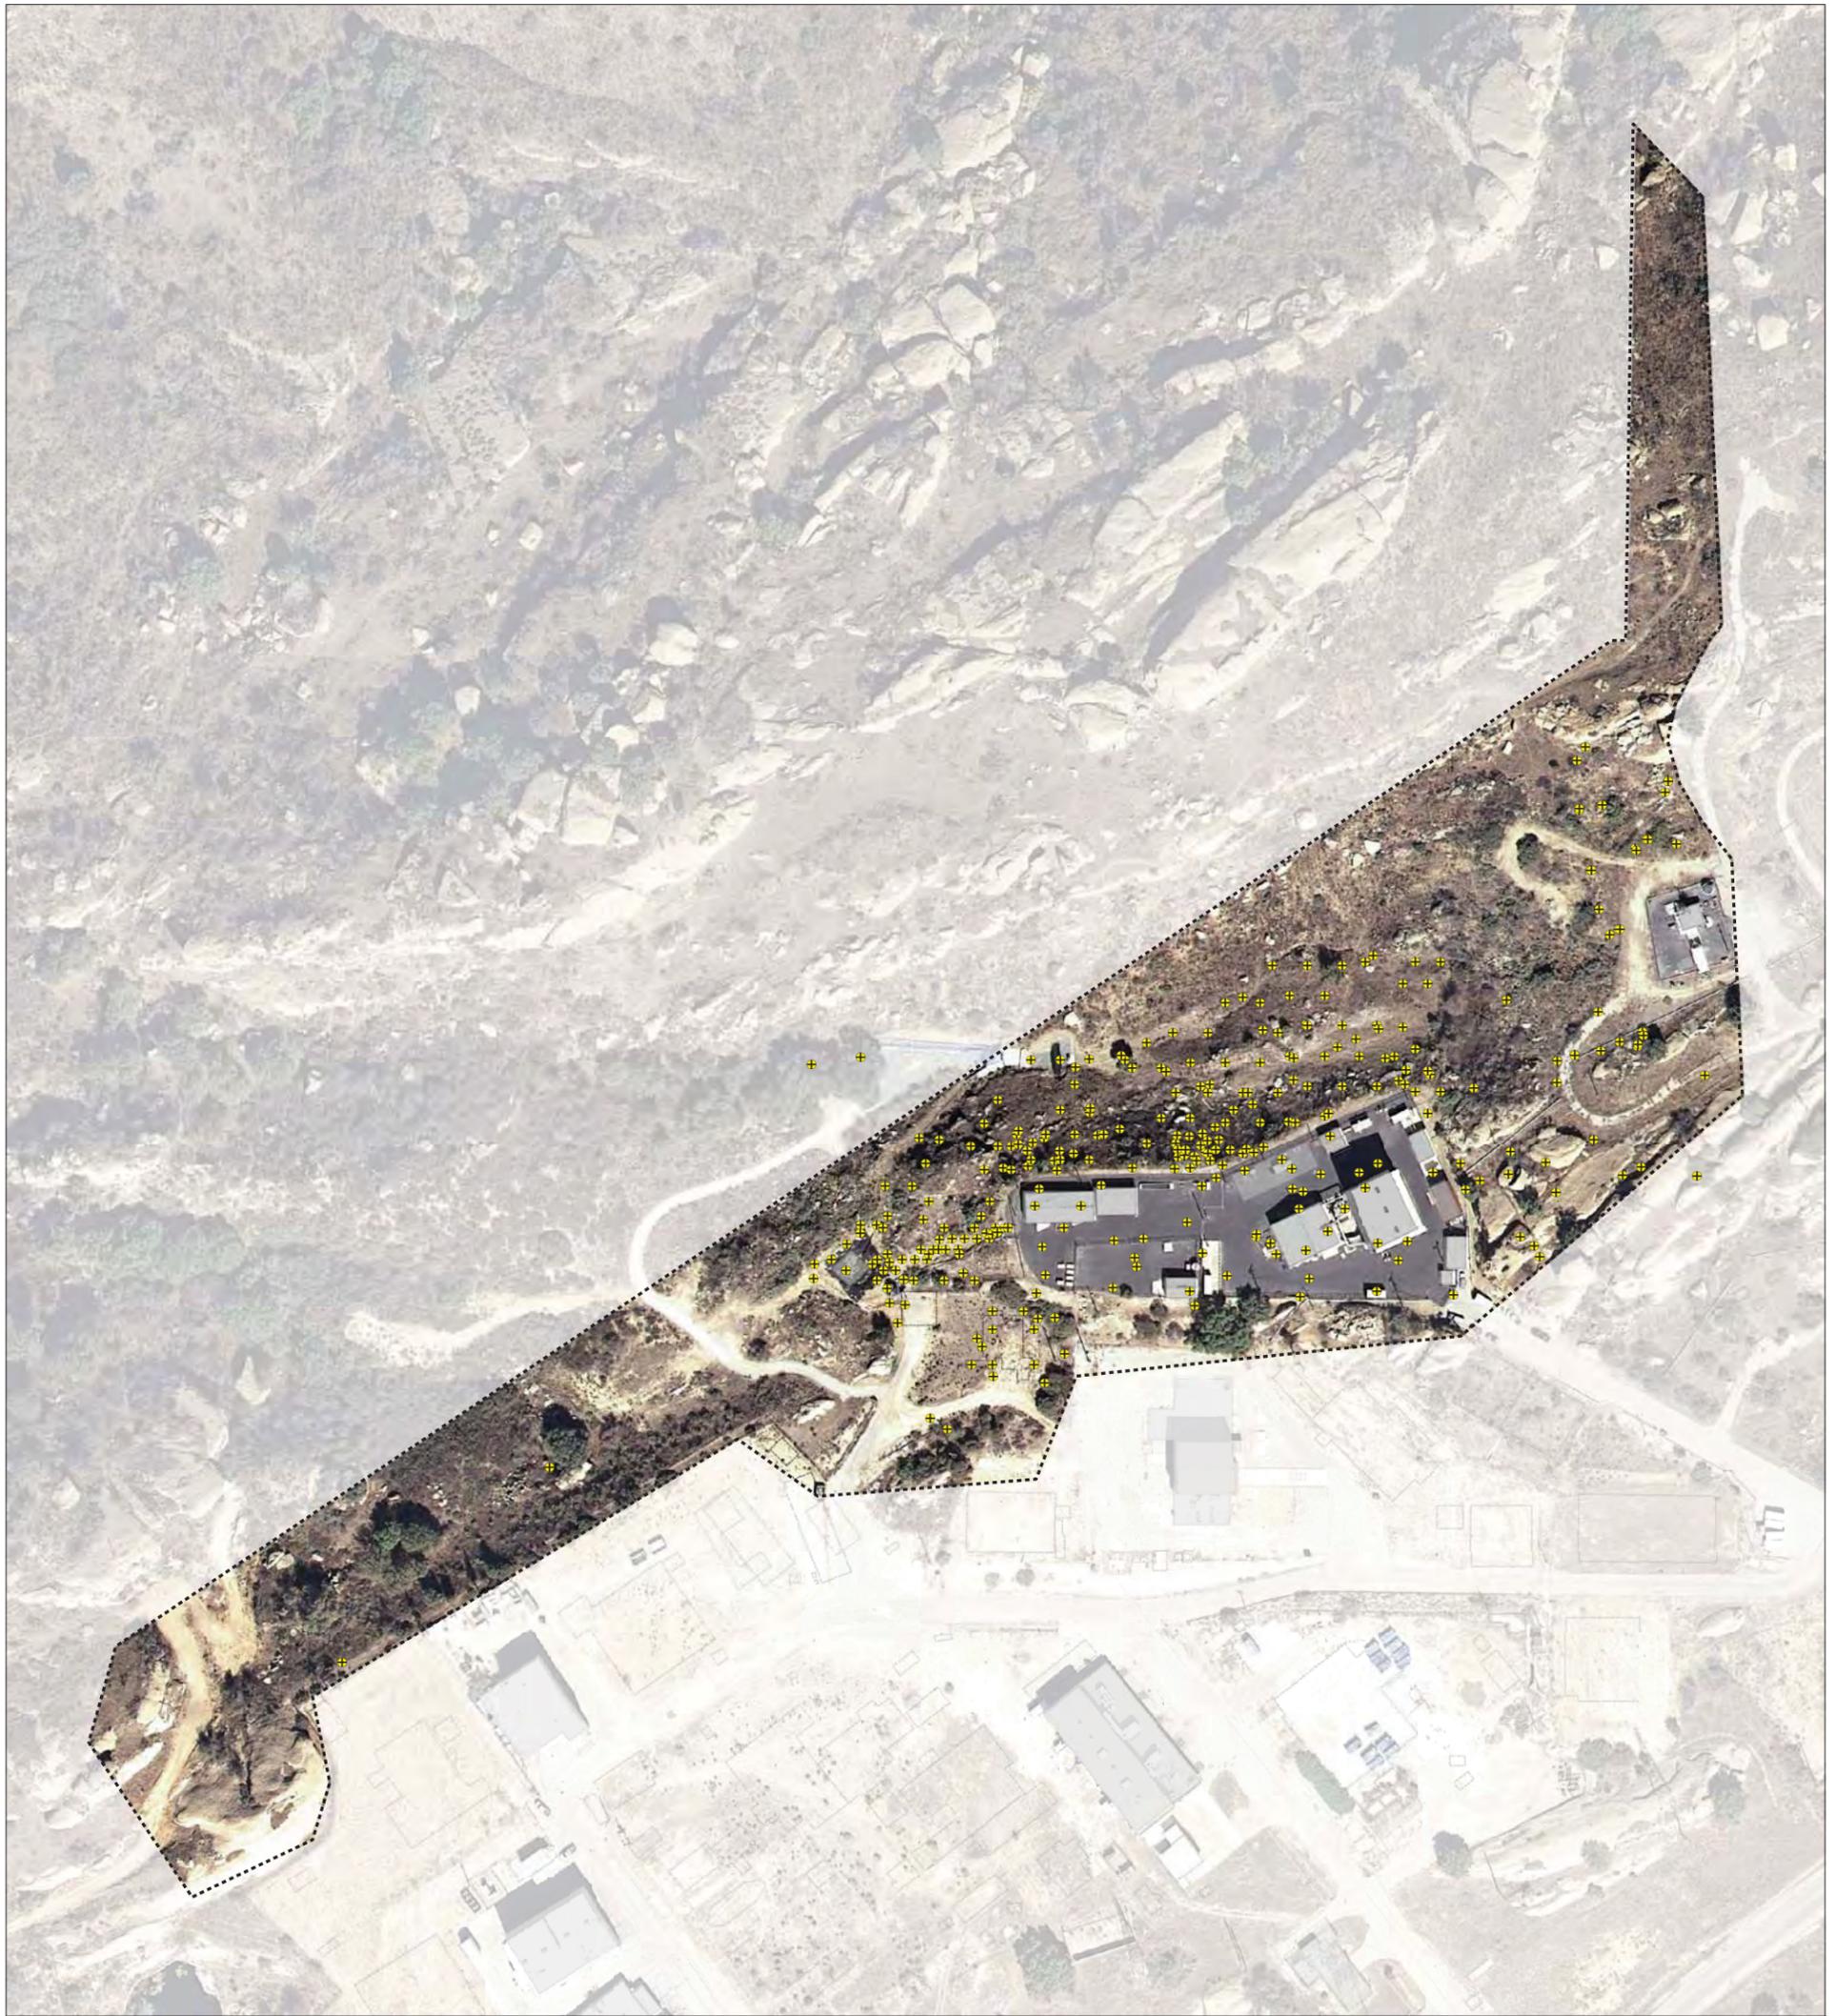
**Past Radiological Soil Investigations
Subarea 7
Santa Susana Field Laboratory**

Samples with readings above Preliminary BTV's
