**Selected Maps and Cross Sections  
from Prior Geologic Investigations (Exhibits H-1 through H-6, as  
provided from EPA – September 25, 2005)**

**Description**

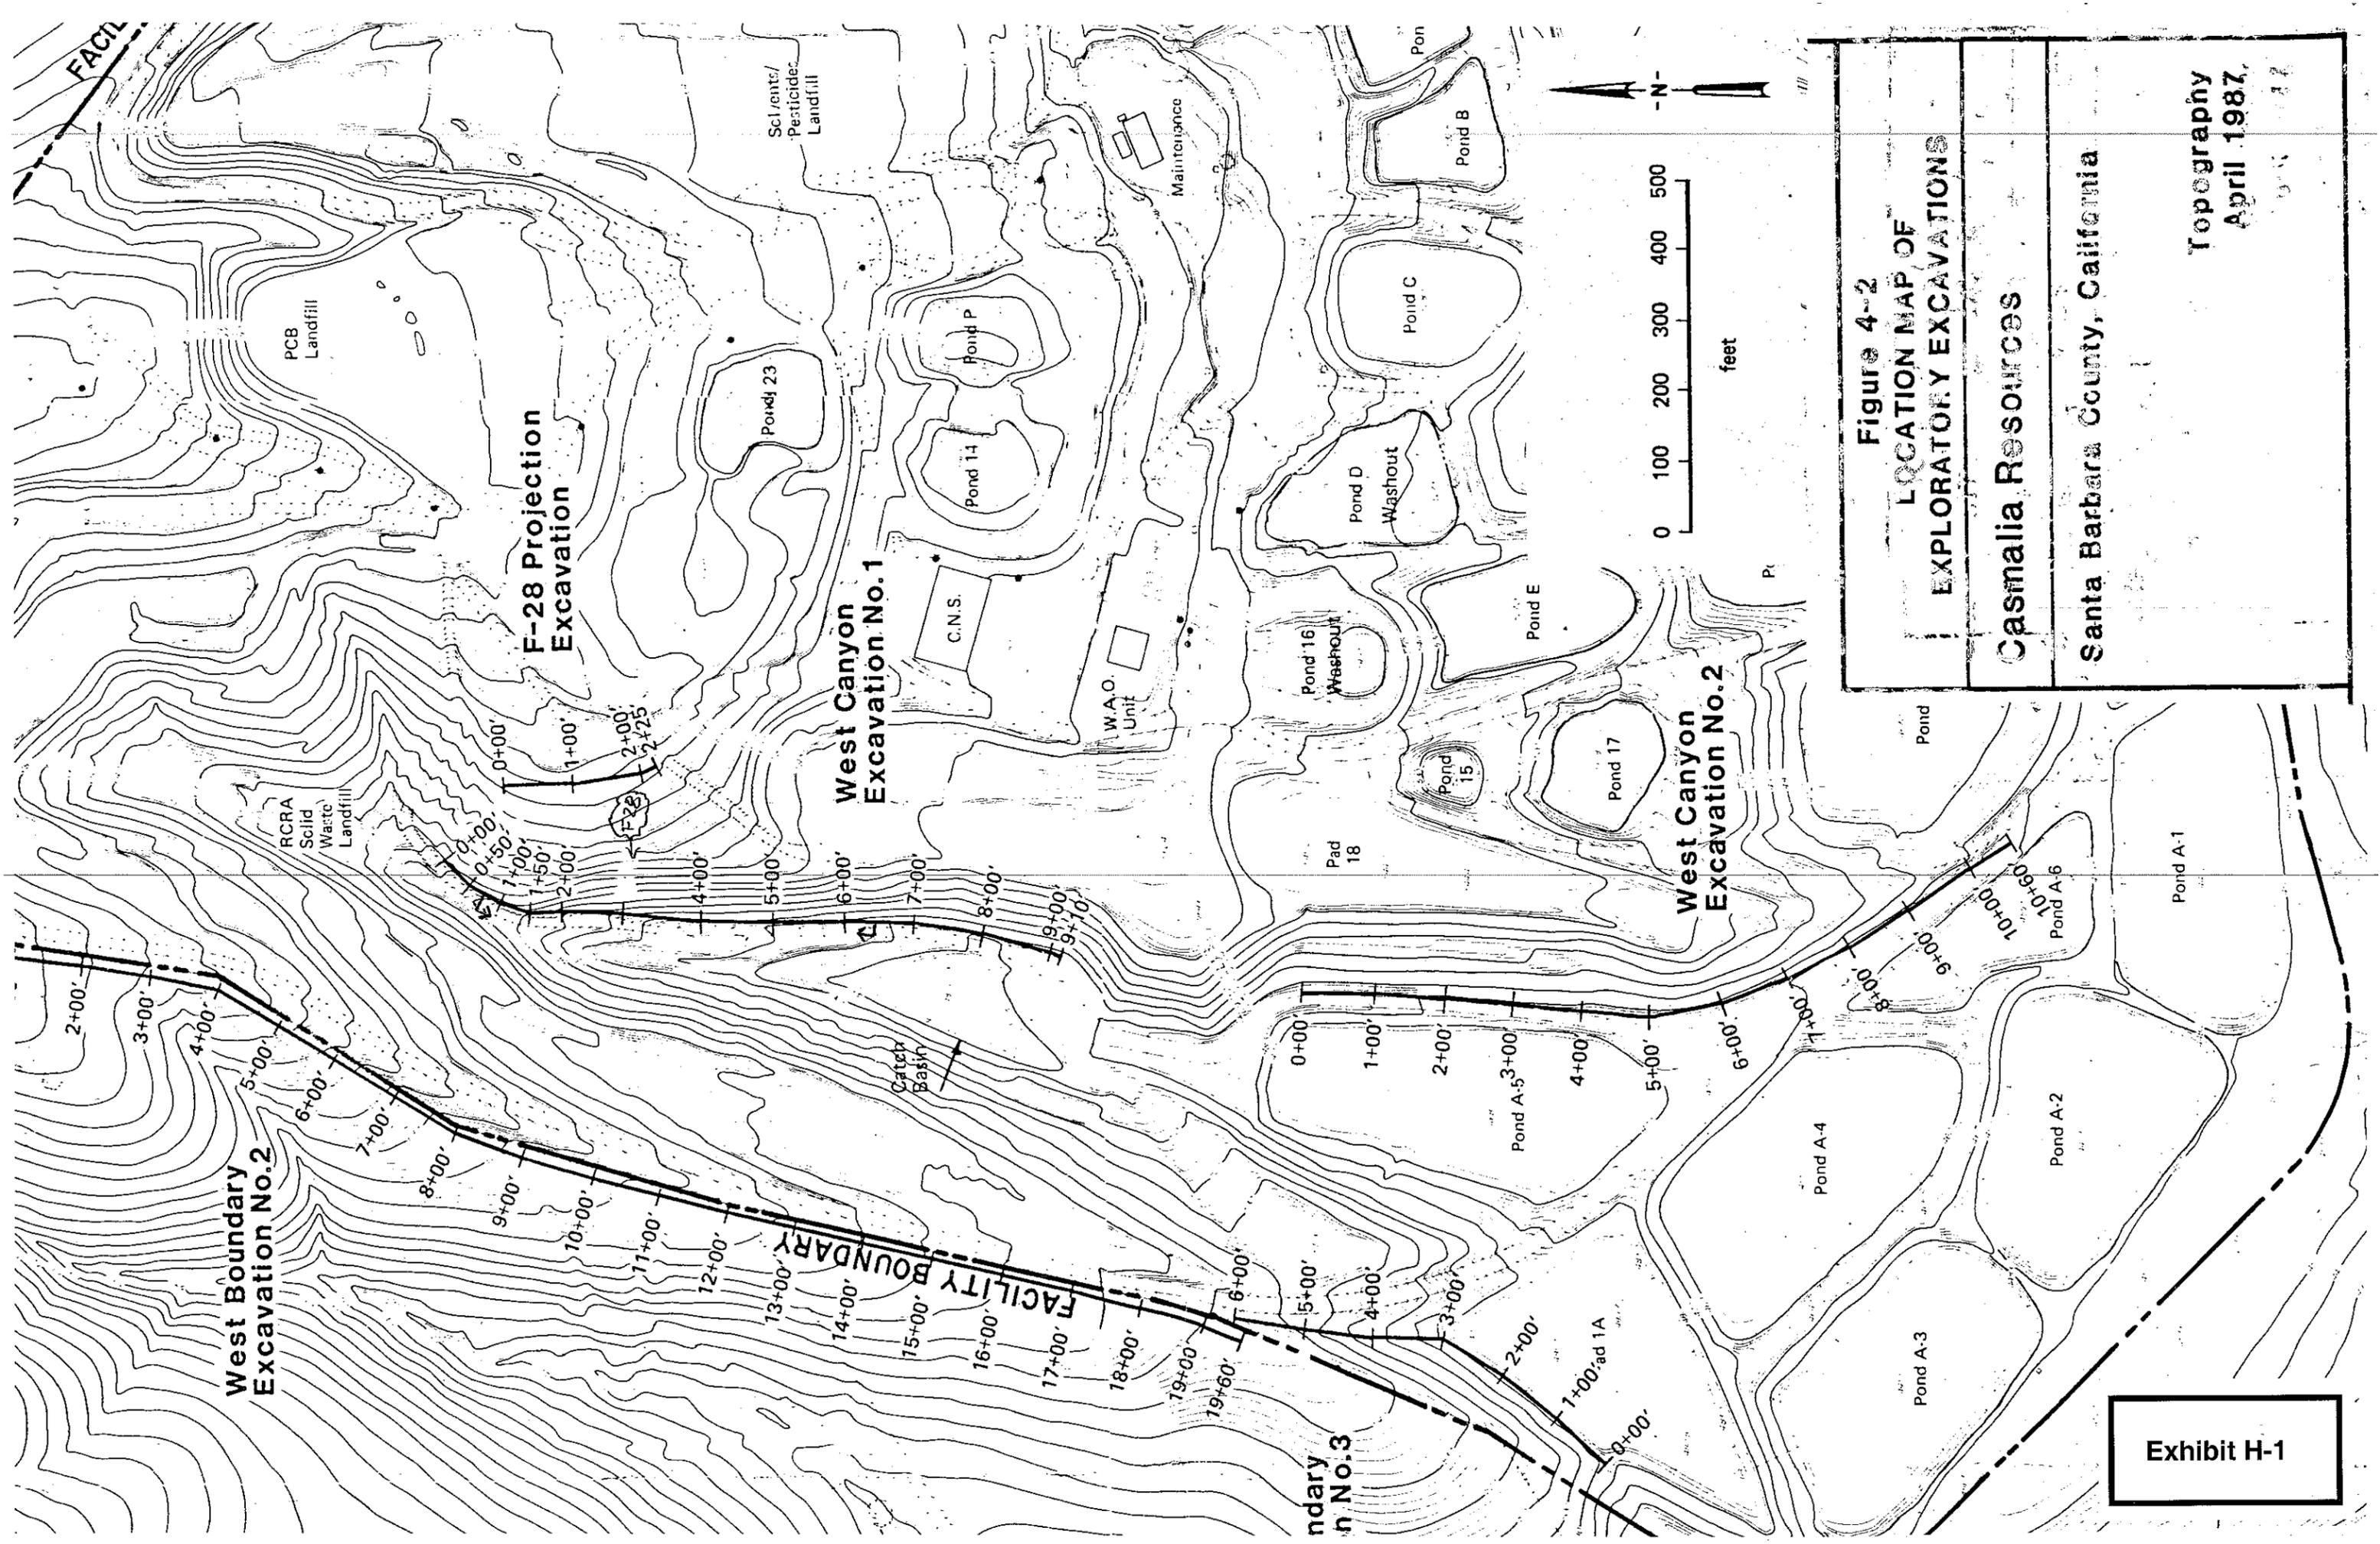
**Exhibit H-1**

**Figure 4-2**  
**LOCATION MAP OF**  
**EXPLORATORY EXCAVATIONS**

**Topography**  
**April 1987**

Exhibit H-1 – Figure 4-2 Location Map of Exploratory Excavations

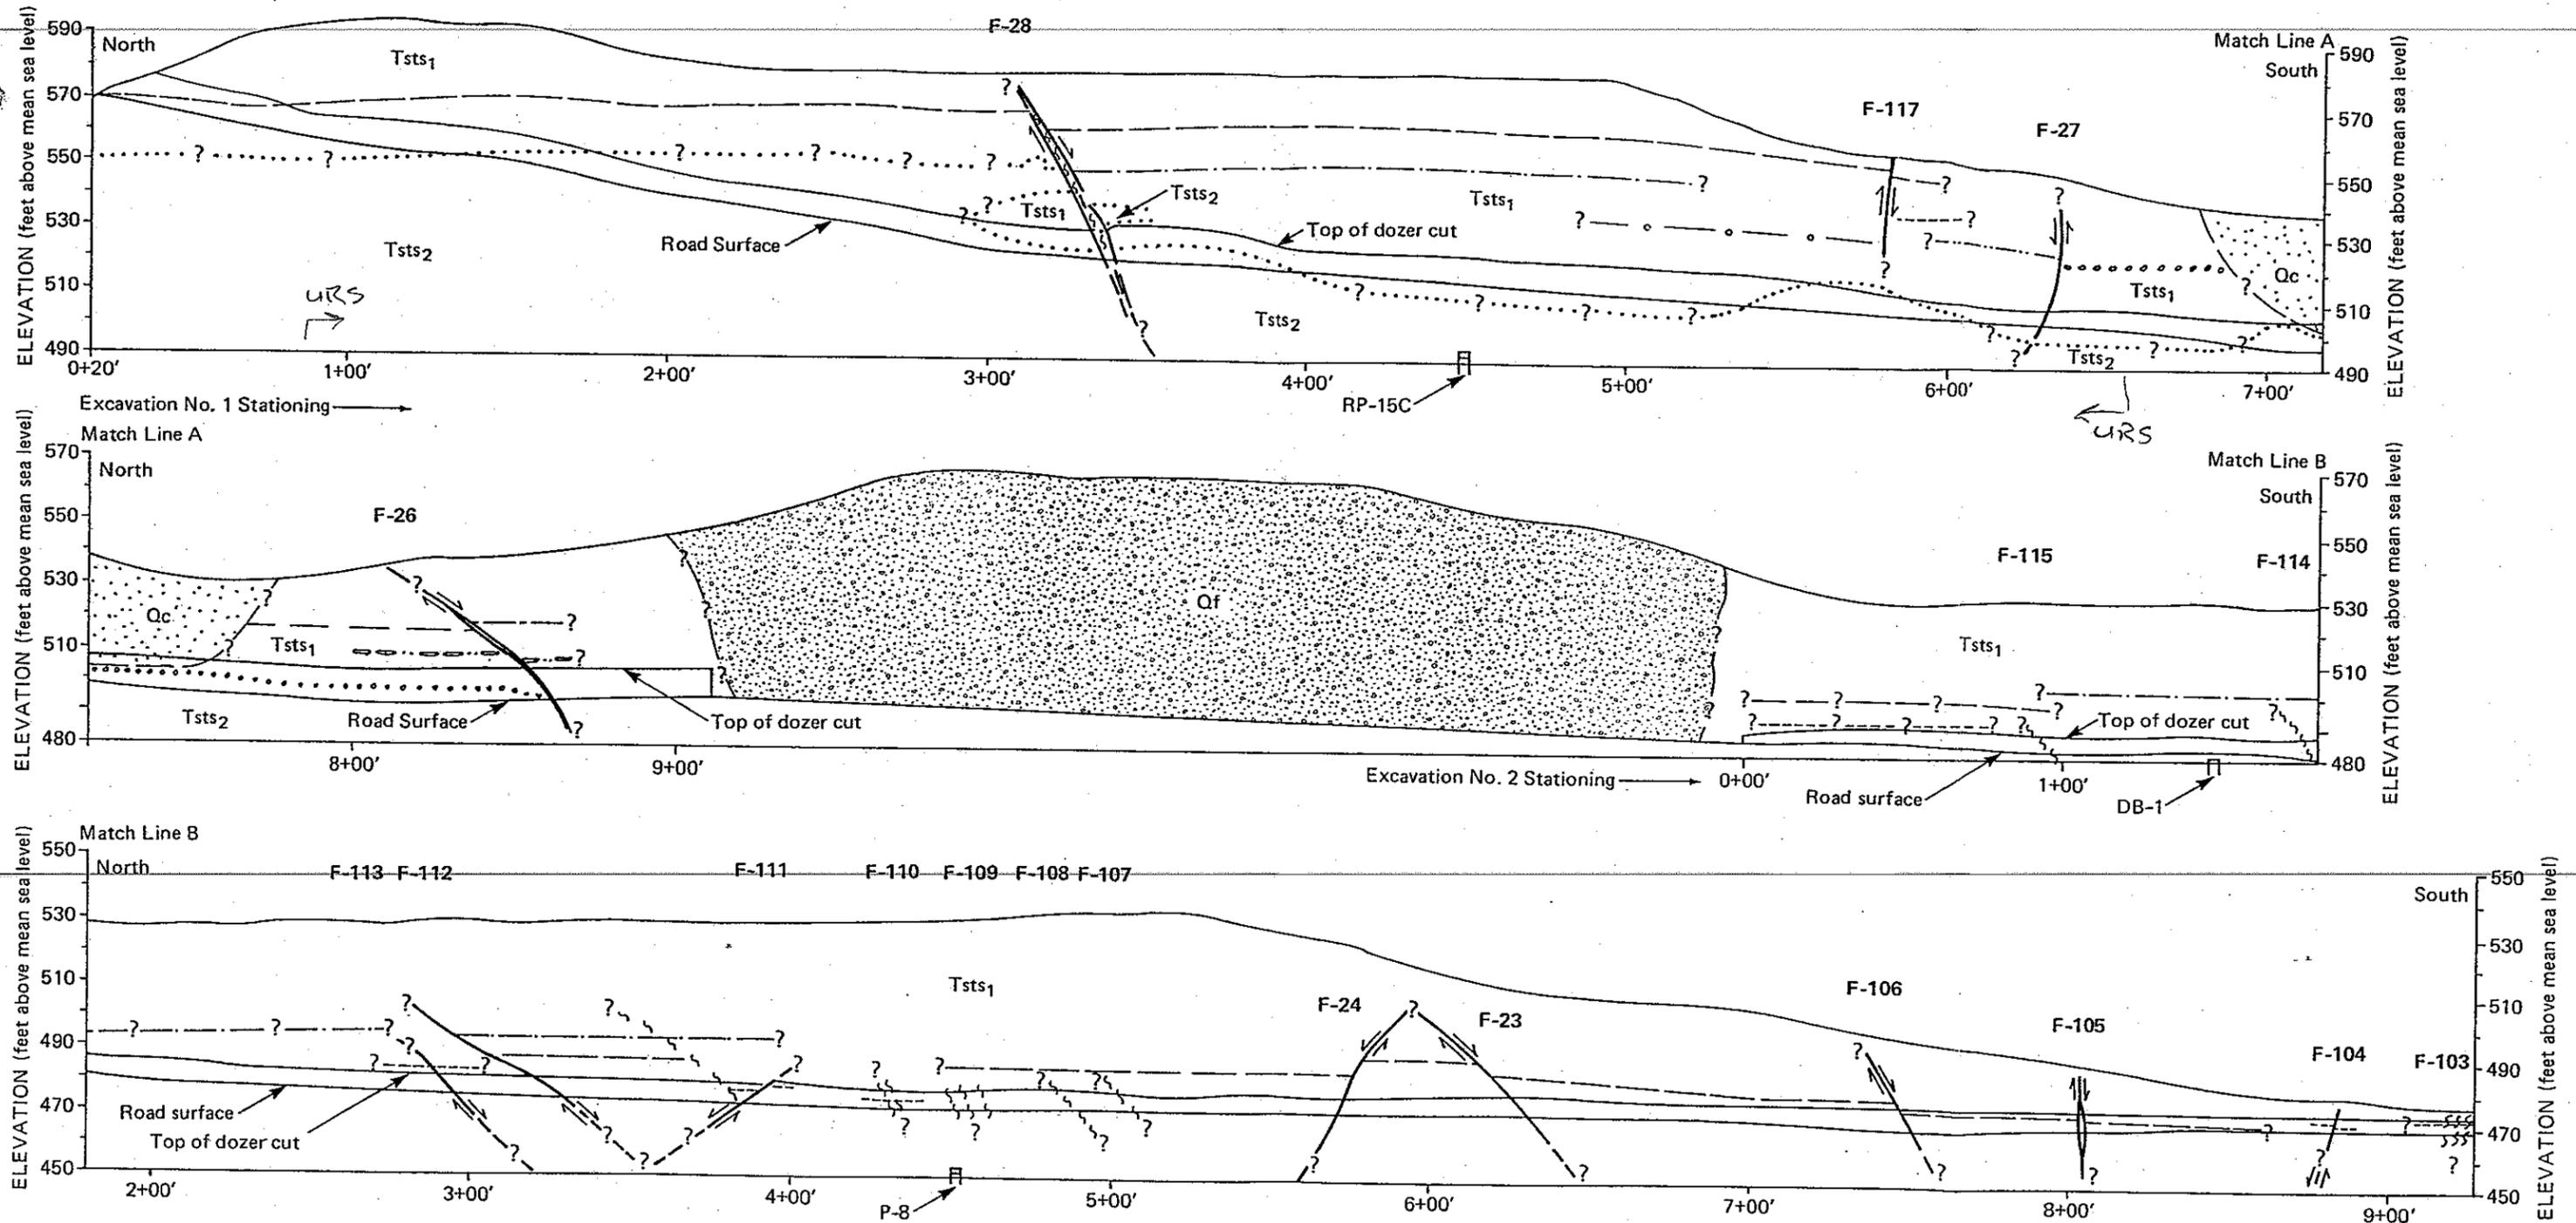
**Exhibit H-2**

**EXPLANATION**

- Fault, dashed where inferred, queried where uncertain.
- Shear zone, queried where uncertain.
- Orange concretionary bed, 0.1' to 2.0' thick.
- Resistant claystone beds that form distinct side-hill ridges.

Contact between brown, "weathered" claystone and blue-grey, "unweathered" claystone.

- Artificial fill
- Colluvium
- Brown, "weathered", Todos Santos claystone member
- Blue-grey, "unweathered", Todos Santos claystone member

1. Faults and shears plotted without vertical exaggeration.
2. Fault and shear numbers correspond to those in Table 4-2.

Project No. 90395N	Casmalia Resources	<b>SCHEMATIC LOG OF WEST CANYON EXCAVATIONS 1 AND 2</b>	Figure 4-11
<b>Woodward-Clyde Consultants</b>

Exhibit H-2 – Figure 4-11 Schematic Log of West Canyon Excavations 1 and 2

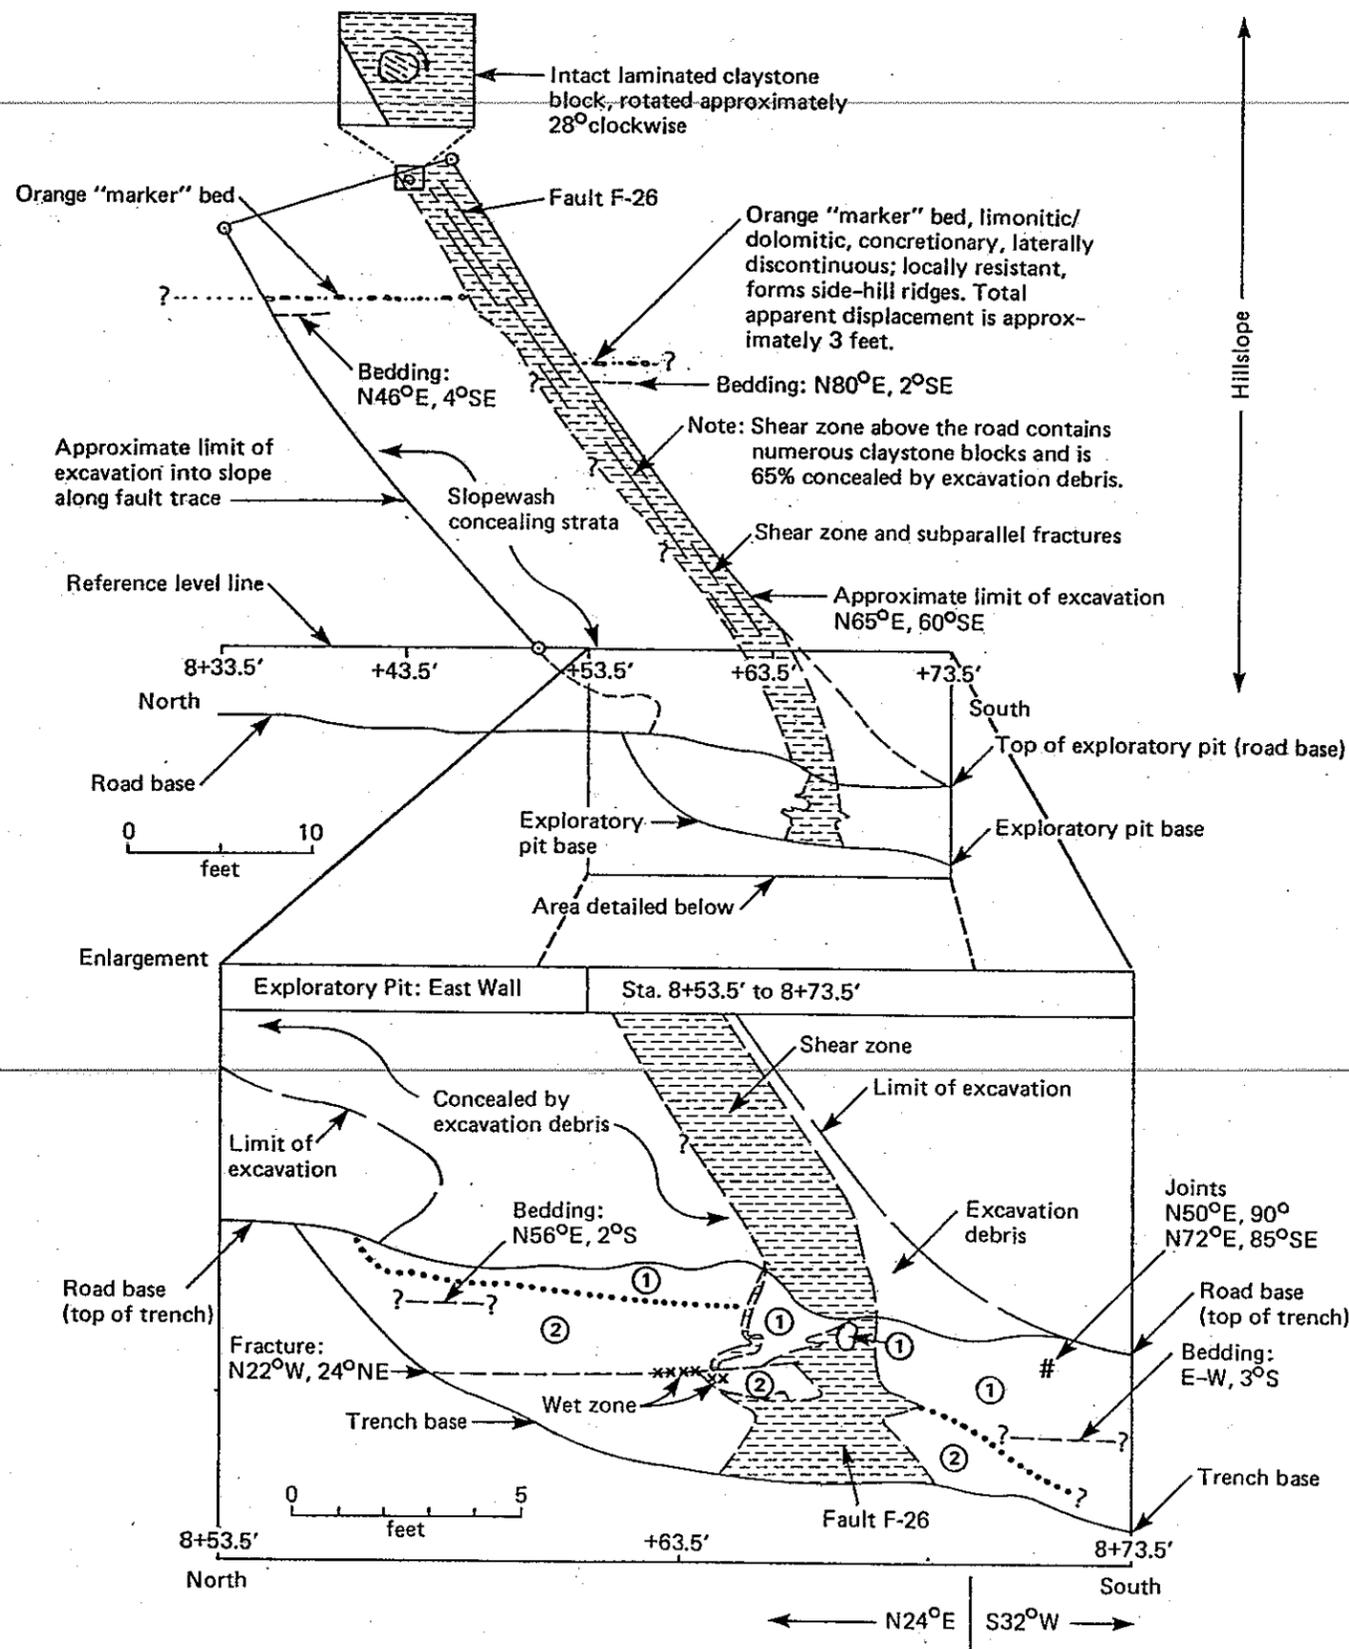
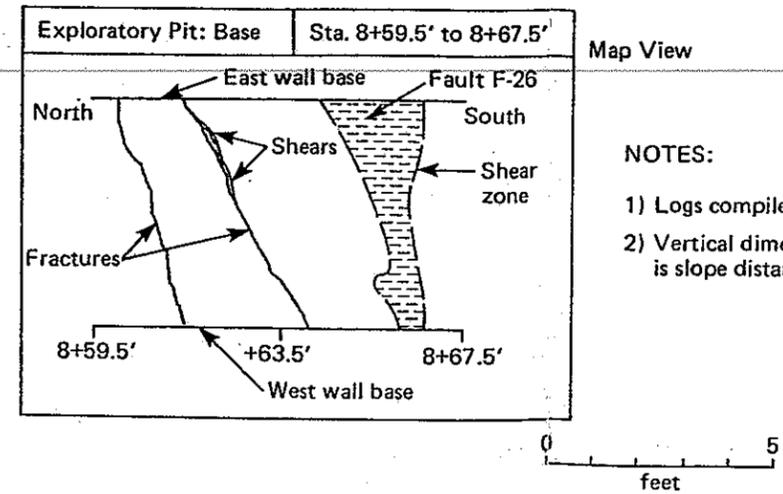
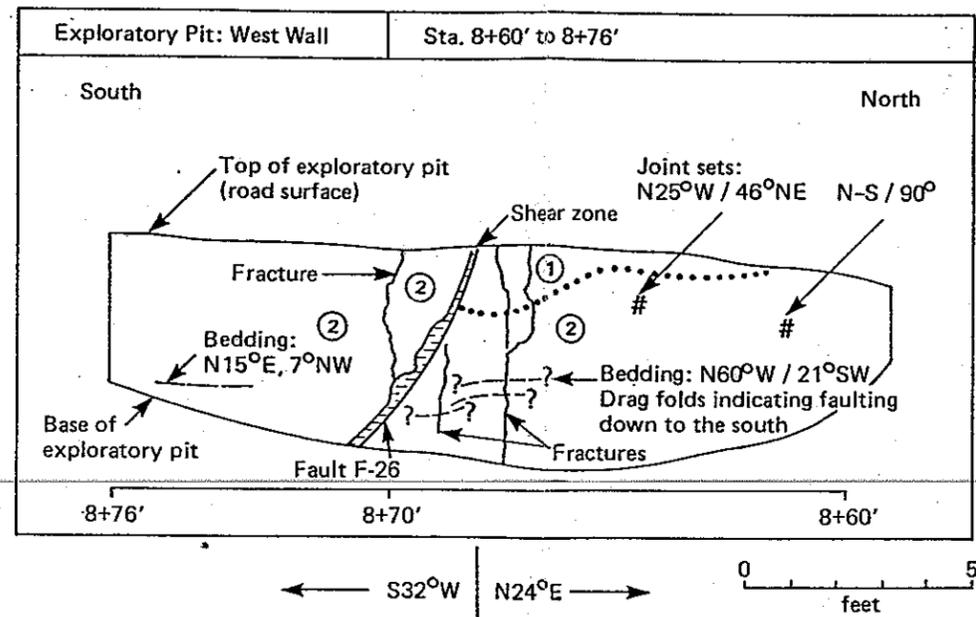
**Exhibit H-3**

- ..... Approximate contact between unweathered, blue-grey claystone and weathered, brown claystone
- Shear zone, crushed claystone and clay, widely scattered intact blocks, slickensides common

- ① Brown claystone, slightly to highly fractured, moderately to highly weathered, Fe-stains common
- ② Blue-grey claystone, slightly fractured, unweathered to slightly weathered, massive to locally laminated

Project No. 90395N	Casmalia Resources	DETAILED LOG OF FAULT F-26 WEST CANYON	Figure 4-4
<b>Woodward-Clyde Consultants</b>

Exhibit H-3 – Figure 4-4 Detailed Log of Fault F-26 West Canyon

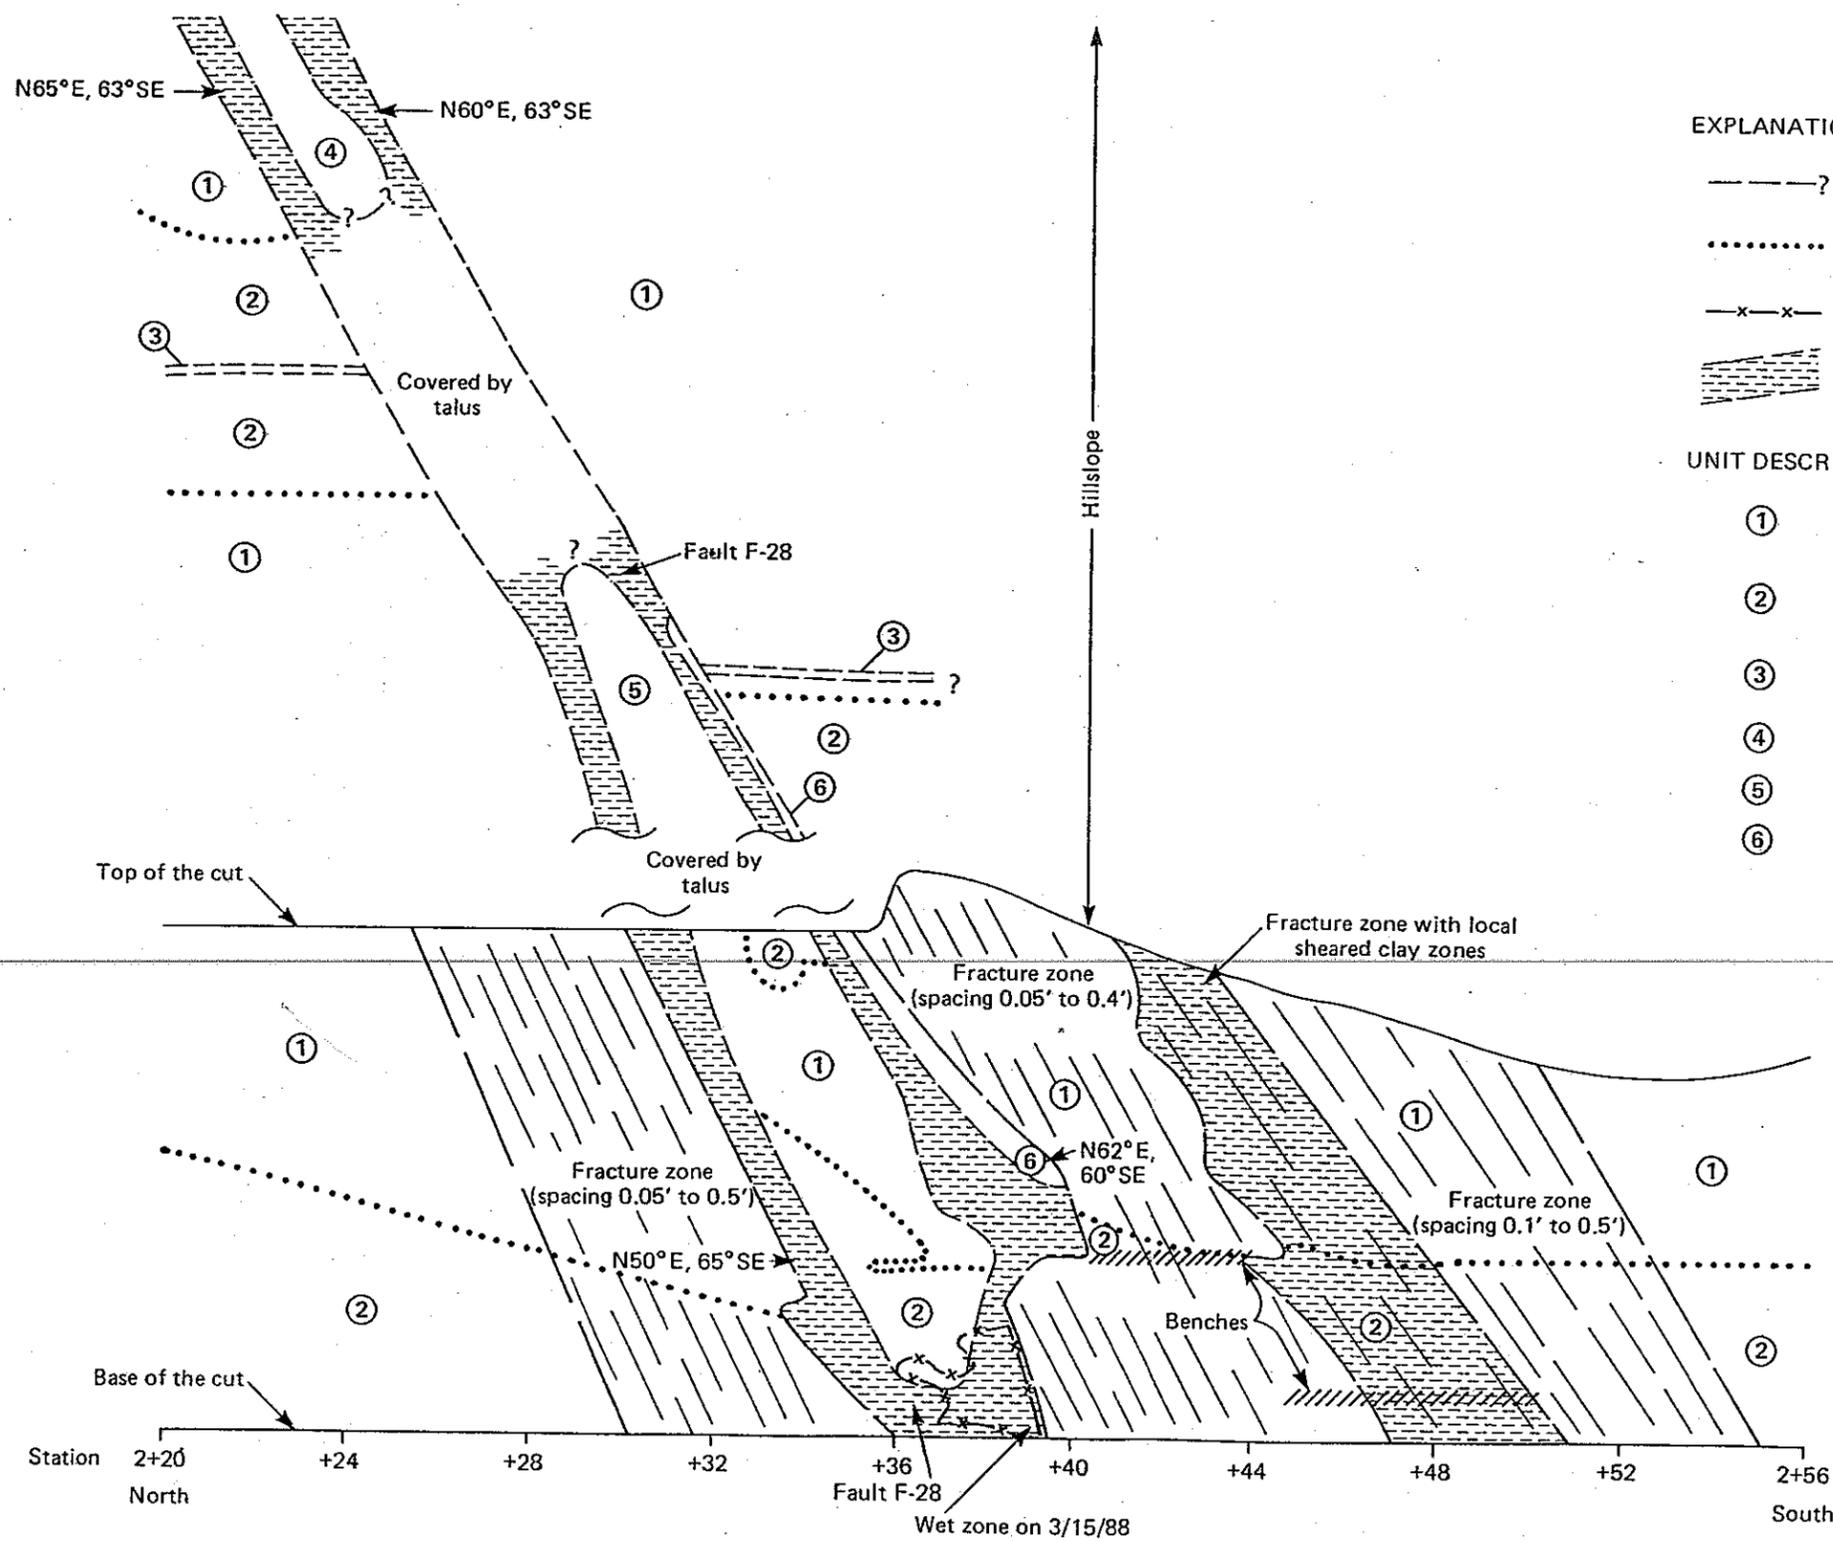
**Exhibit H-4**

- — — ? Approximate stratigraphic contact, queried where uncertain
- ..... Approximate contact between unweathered blue-grey claystone and weathered brown claystone
- x—x— Approximate limit of wet zone on 3/15/88
- Shear zone, brown to dark brown crushed claystone and clay with local gypsum sheets and Fe staining; slickensides common

- ① Pale brown claystone, laminated, highly fractured, highly weathered, Fe-stained
- ② Blue-grey claystone, locally laminated to massive, slightly to moderately fractured, unweathered to moderately weathered
- ③ Grey claystone, hard, slightly weathered with orange surface stains, forms distinct resistant rib in hillside
- ④ Brown claystone block, highly fractured
- ⑤ Blue-grey claystone block, moderately fractured
- ⑥ Blue-grey gypsum cemented breccia; very hard

- 1) Approximately 6 feet of apparent offset measured on Unit 3.
- 2) Log was compiled on 3/16/88.
- 3) Vertical scale approximated from slope distance (slope = 40%).

Project No. 90395N	Casmalia Resources	SCHEMATIC SKETCH OF FAULT F-28 WEST CANYON	Figure 4-3
<b>Woodward-Clyde Consultants</b>

Exhibit H-4 – Figure 4-3 Schematic Sketch of Fault F-28 West Canyon

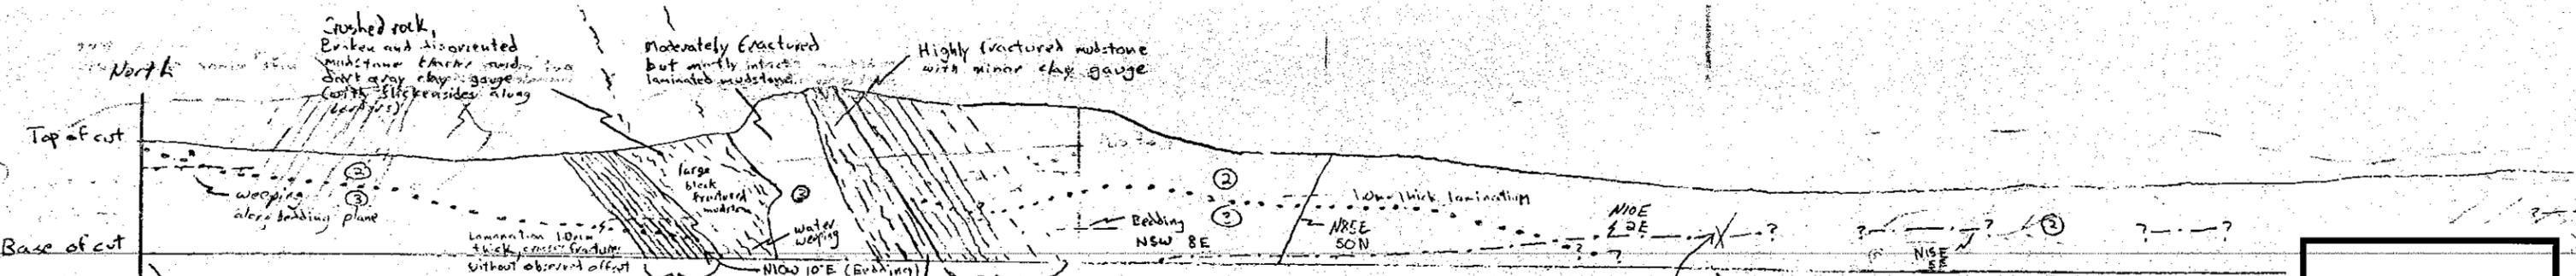
Zone of 12 prominent fractures: N50E 80°SE (water weeping) spaced - 0.15' to 0.5' apart. Filling, planarity, roughness (as before). Damp; water pathway.

Zone of 10 to 20 prominent fractures: N60E 70°SE spacing (same as the north side).

Fault: N60E 63°SE (Northern margin)  
 Zone N65E 63°SE (Southern margin)  
 spacing, aperture, infilling (as described and shown above)  
 planar to locally irregular, smooth, some slickensides.  
 Note: Feature is damp; rock is relatively dry to the south of and wet and weeping to the north. Feature represents a potential water barrier.

**Figure D-4.2**  
**FIELD LOG OF WEST CANYON**  
**EXCAVATION NO. 1**  
**STA. 3+00 TO 6+00**

Exhibit H-5 – Figure D-4.2 Field Log of West Canyon Excavation No. 1 STA.3 + 00 TO 6 + 00

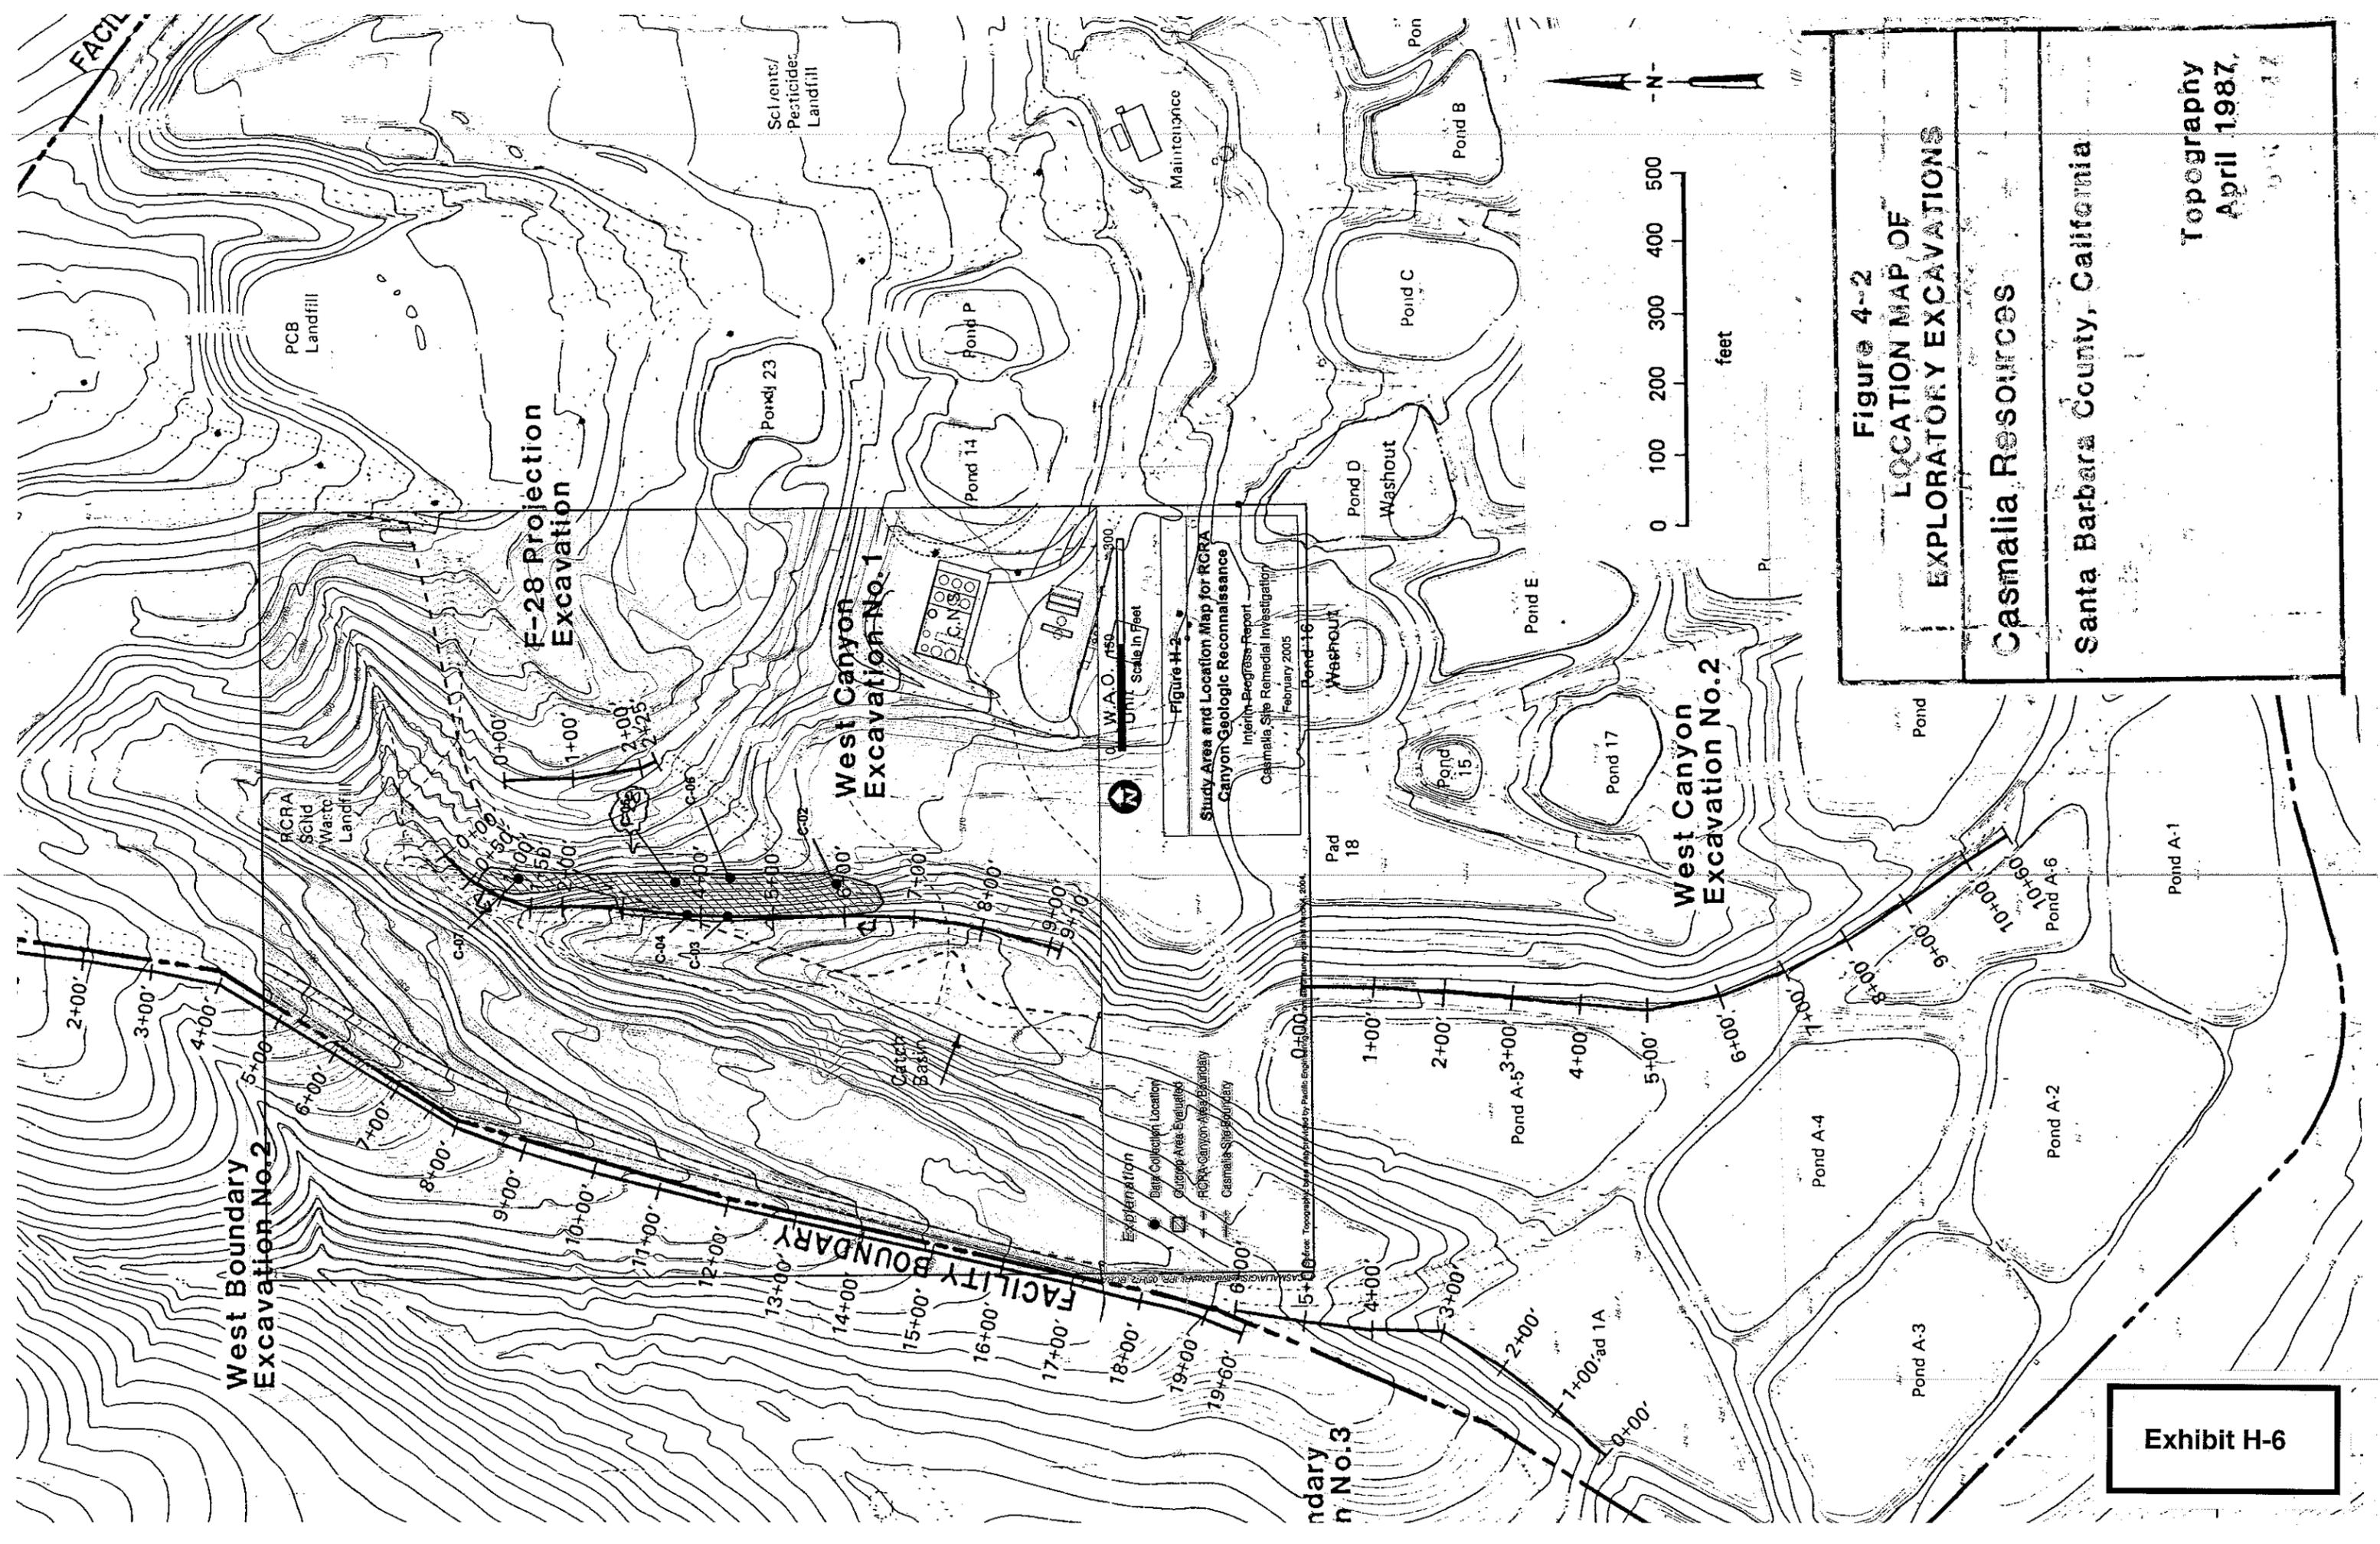
**Figure 4-2**  
**LOCATION MAP OF**  
**EXPLORATORY EXCAVATIONS**

Exhibit H-6 – Figure 4-2 Location Map of Exploratory Excavations
