SUBAREA 5B FSP ADDENDUM
SANTA SUSANA FIELD LABORATORY SITE
AREA IV RADIOLOGICAL STUDY

TO: Craig Cooper, EPA Region 9 RPM
FROM: Rene R. Rodriguez, P.E., HGL Deputy Project Manager
THROUGH: L. Steven Vaughn, R.G., HGL Project Manager
CC: Mary Aycock, EPA Region 9 RPM
Nicole Moutoux, EPA Region 9 RPM
Gregg Dempsey, Technical Advisor
DATE: December 15, 2010
SUBJECT: FSP Addendum for Subarea 5B
CONTRACT NO: EP-S7-05-05
TASK ORDER NO: 0038

HydroGeoLogic, Inc. (HGL) has been tasked by the U. S. Environmental Protection Agency (USEPA) to conduct a radiological characterization study at Area IV and the Northern Buffer Zone of the Santa Susana Field Laboratory (SSFL) site in Ventura County, California. This work is being executed under USEPA Region 7 Architect and Engineering Services Contract EP-S7-05-05, Task Order 0038. The technical lead on the project is USEPA Region 9.

This addendum documents the rationale used to determine the location and depth of soil samples to be collected during the first phase (Round 1) of soil sampling within Subarea 5B. Sample locations are summarized in Table 1 (Attachment 1) and illustrated on the figures provided in Attachment 2. This addendum also docum

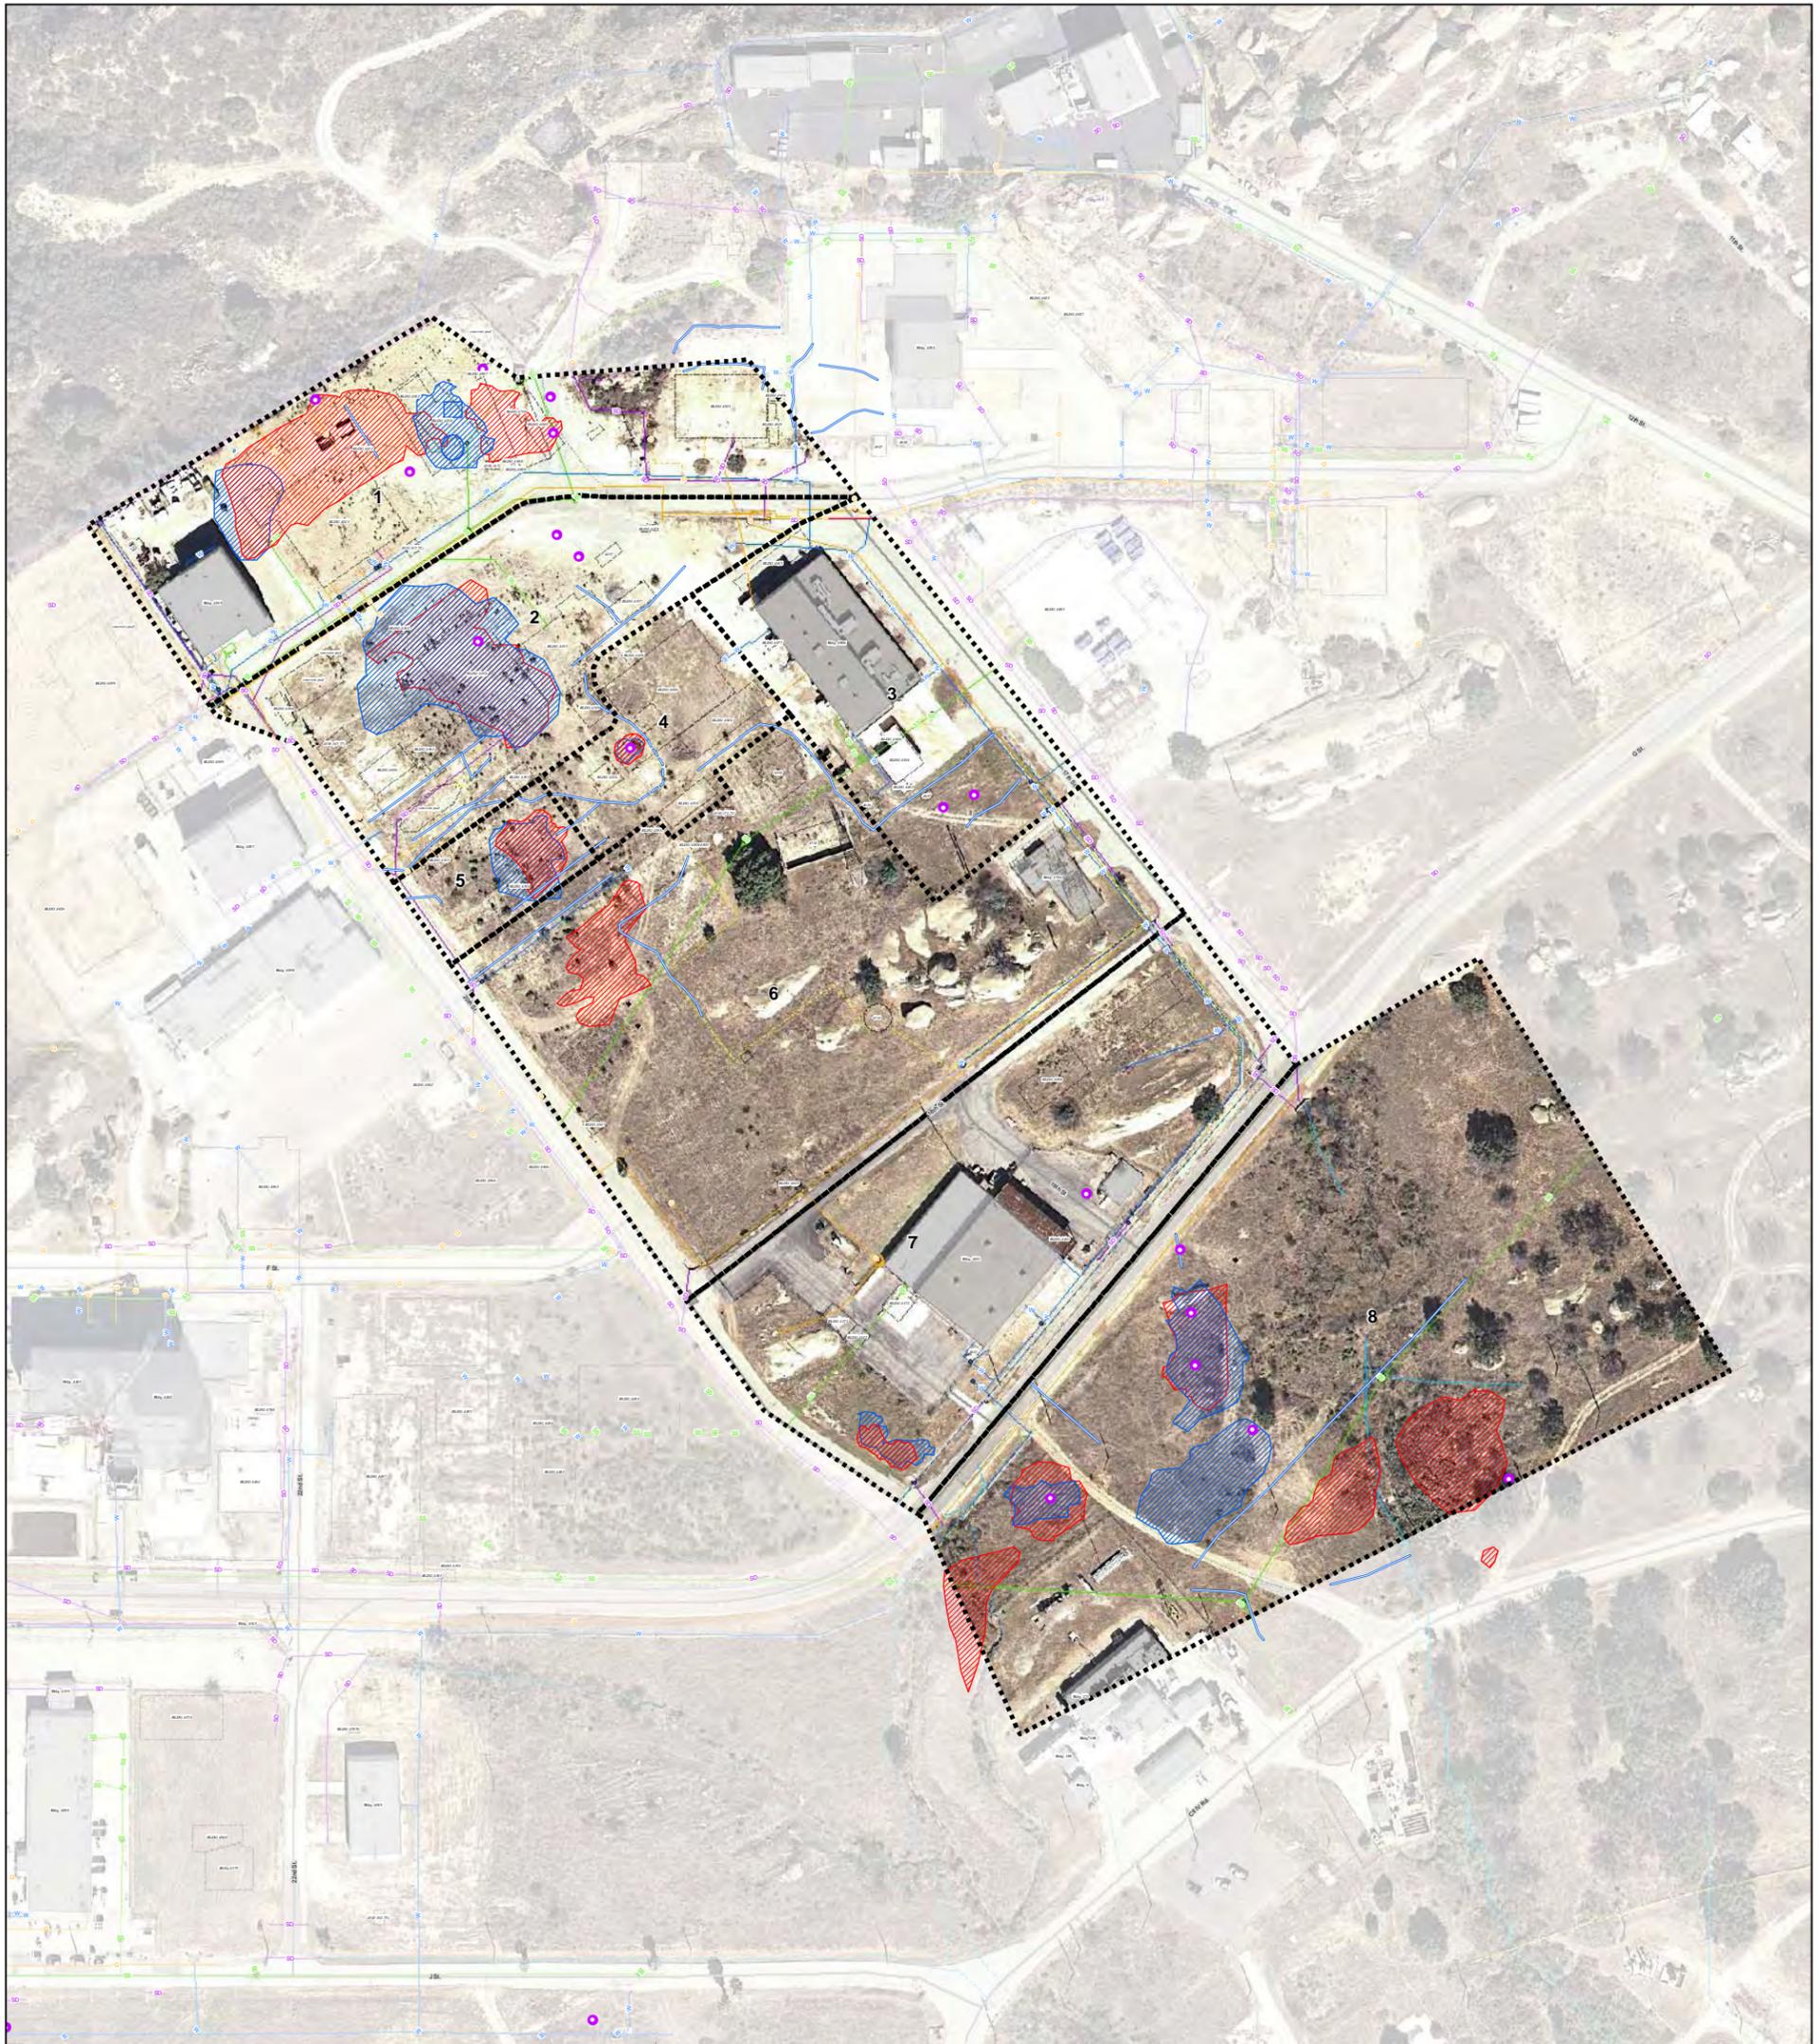
Gamma Scanning
Geophysical Anomaly
Past Radiological Soil Investigations
Plate 1 Subarea HSA-5B
