## FACT SHEET: Recreational Area Remediation – East of Rose Lake Boat Launch (August 2006)

### Project Summary

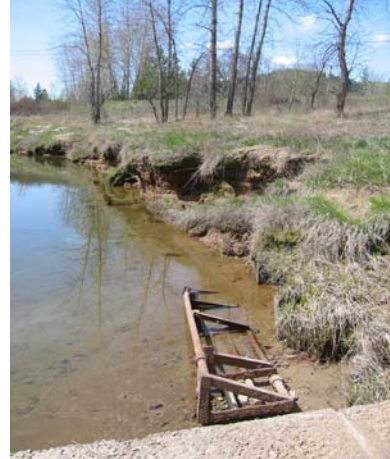
- The site is located adjacent to Highway 3 and is primarily owned by Idaho Dept. of Fish and Game (IDFG) with an eastern part of the property owned by US Forest Service (USFS). The site had a dusty dirt parking lot with high levels of metals in the soil/sediment that poses a health risk to humans, especially young children. (See attached before remediation photos.)

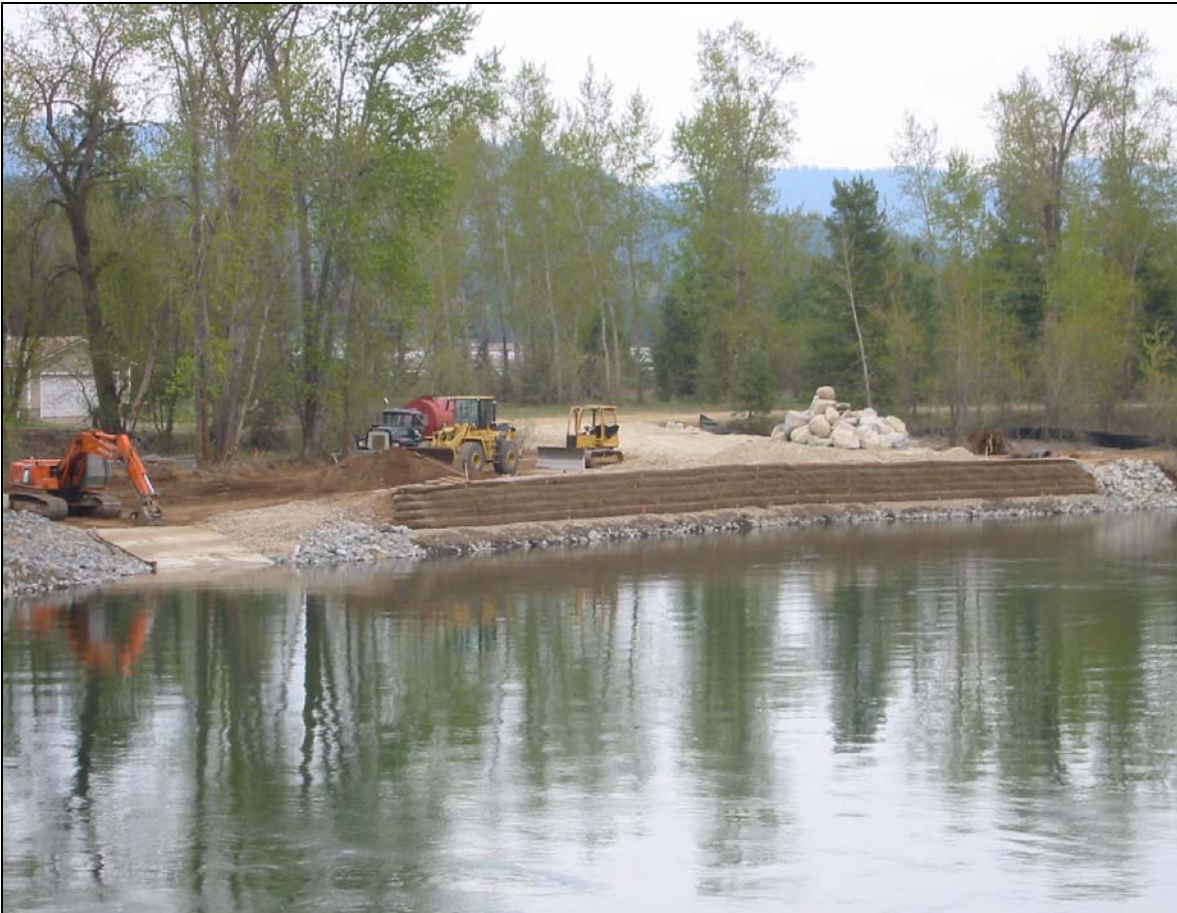
- Capped contaminated soil in the parking lot to accommodate vehicle/trailer parking and constructed a low-water access boat launch,
- Graded parking lot so majority of the runoff is directed away from river,

- Bank stabilization to reduce erosion and human exposure to the contaminated riverbank:
  - Vegetated rock toe wall with large boulders a few feet away from previously eroding bank

- Downstream of ramp, the slope is graded and vegetated with native plants
  - Upstream of ramp, the rock base grades into layers of synthetic fabric with engineered fill to create a vegetated and supporting steep slope

- Closed off the Highway 3 access, replaced with a safer access off East River Road, and paved road from Highway 3 to new parking lot access,
- Closed off informal access road on the USFS property with boulders and native vegetation,

- Installed a protective fence around the historic pioneer schoolhouse on the property, and
- Currently monitoring to assess effectiveness of remedial action.
